BUREAU OF SHIPS GROUP
TECHNICAL INSPECTION REPORT

⑥ OPERATION CROSSROADS.
U.S.S HUGHES (DD410).
TEST BAKER.

VOLUME II [u] ⑧

USS HUGHES (DD410)

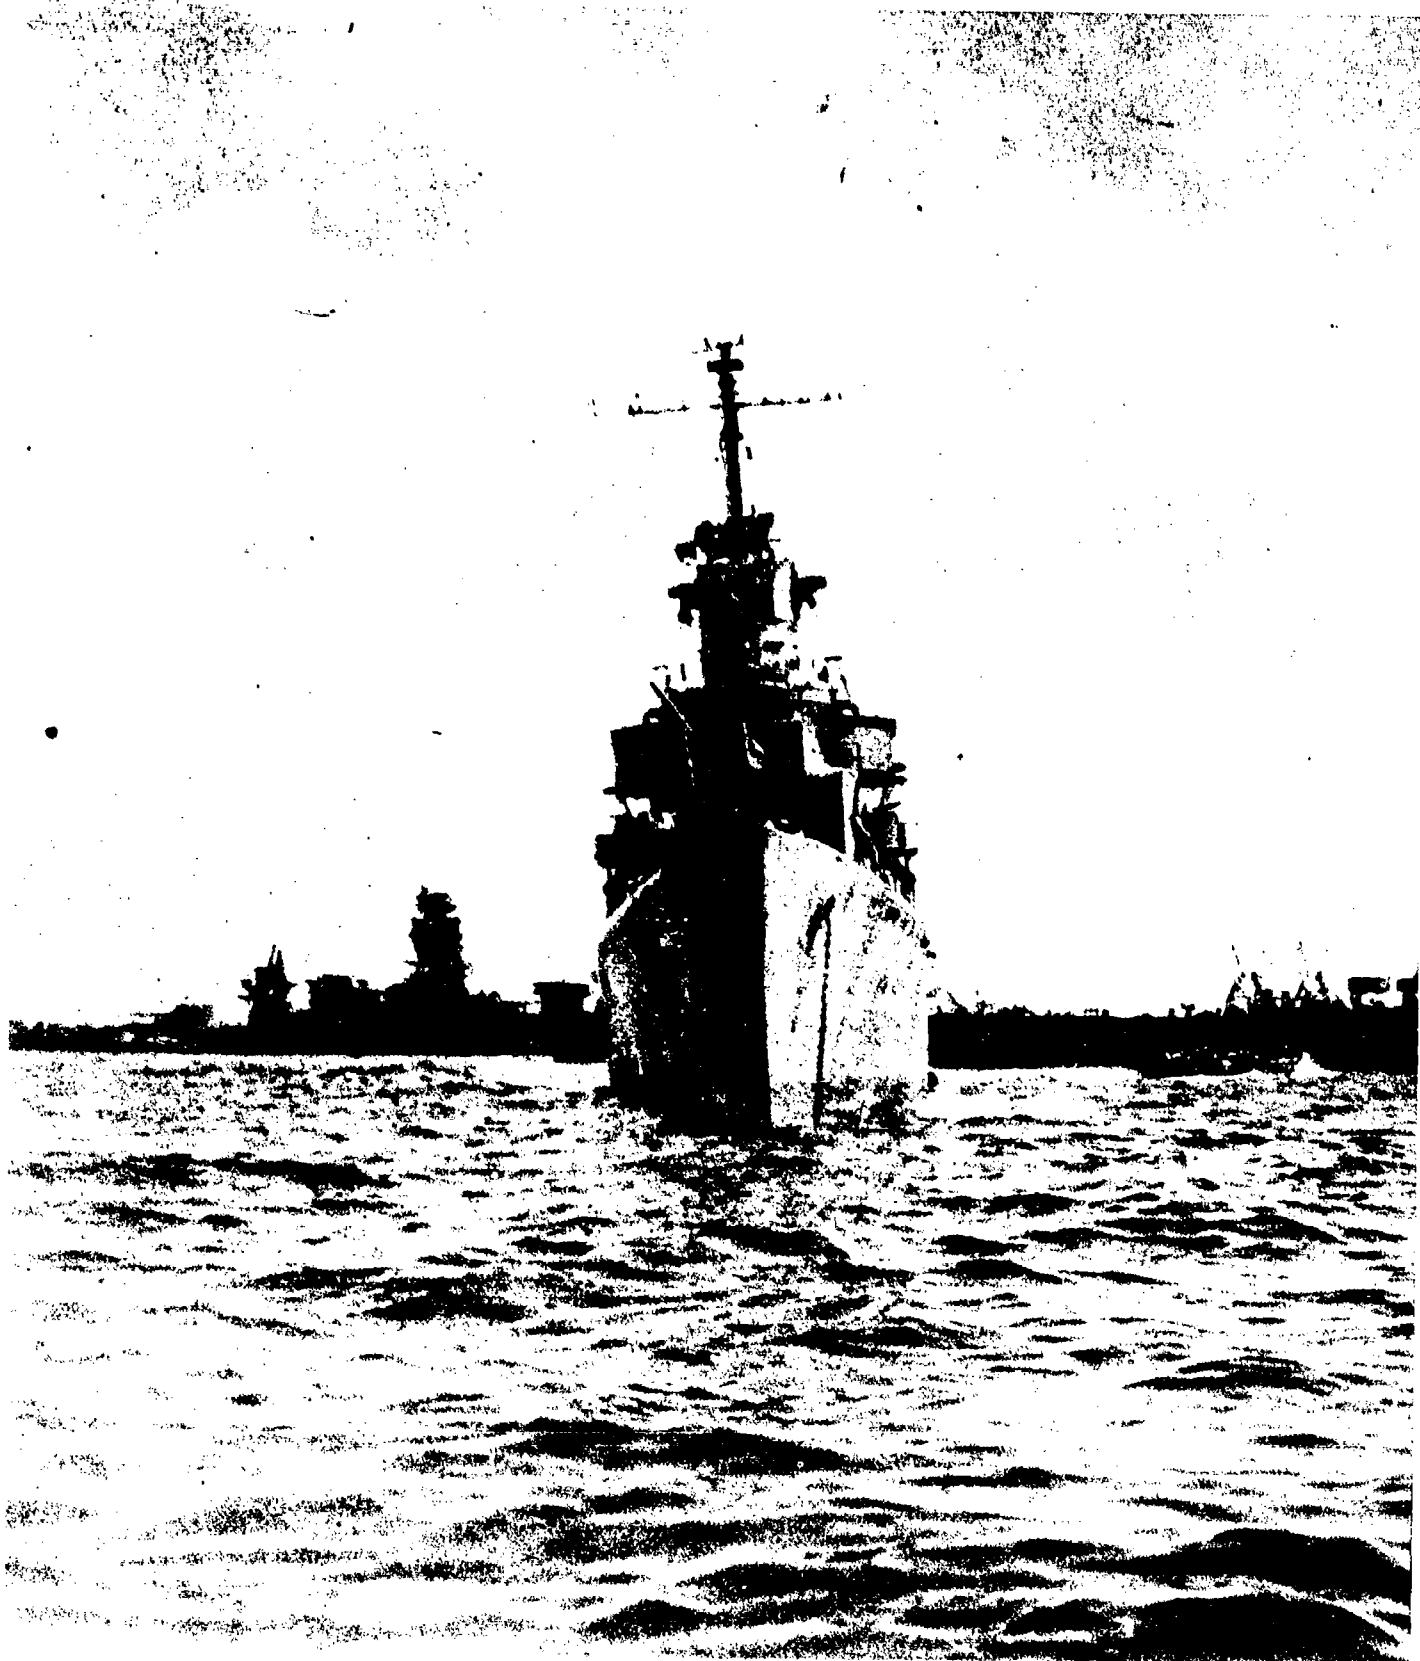
BB-CR-227-513-9. Bow before Test B.

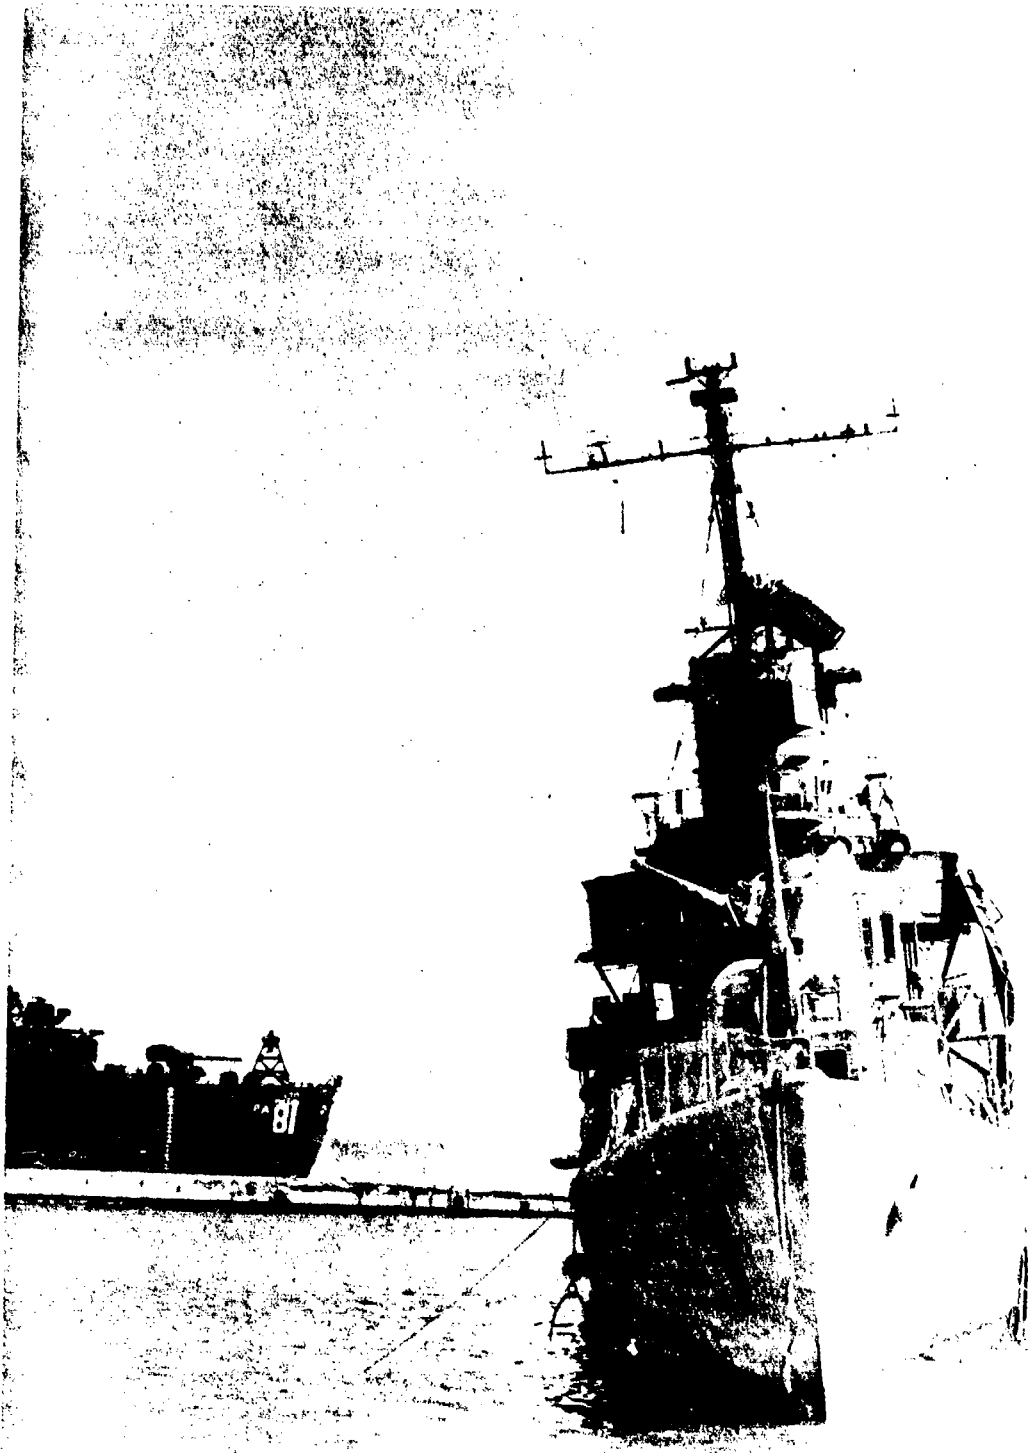
AB-CR-227-290-36. Bow after Test B.

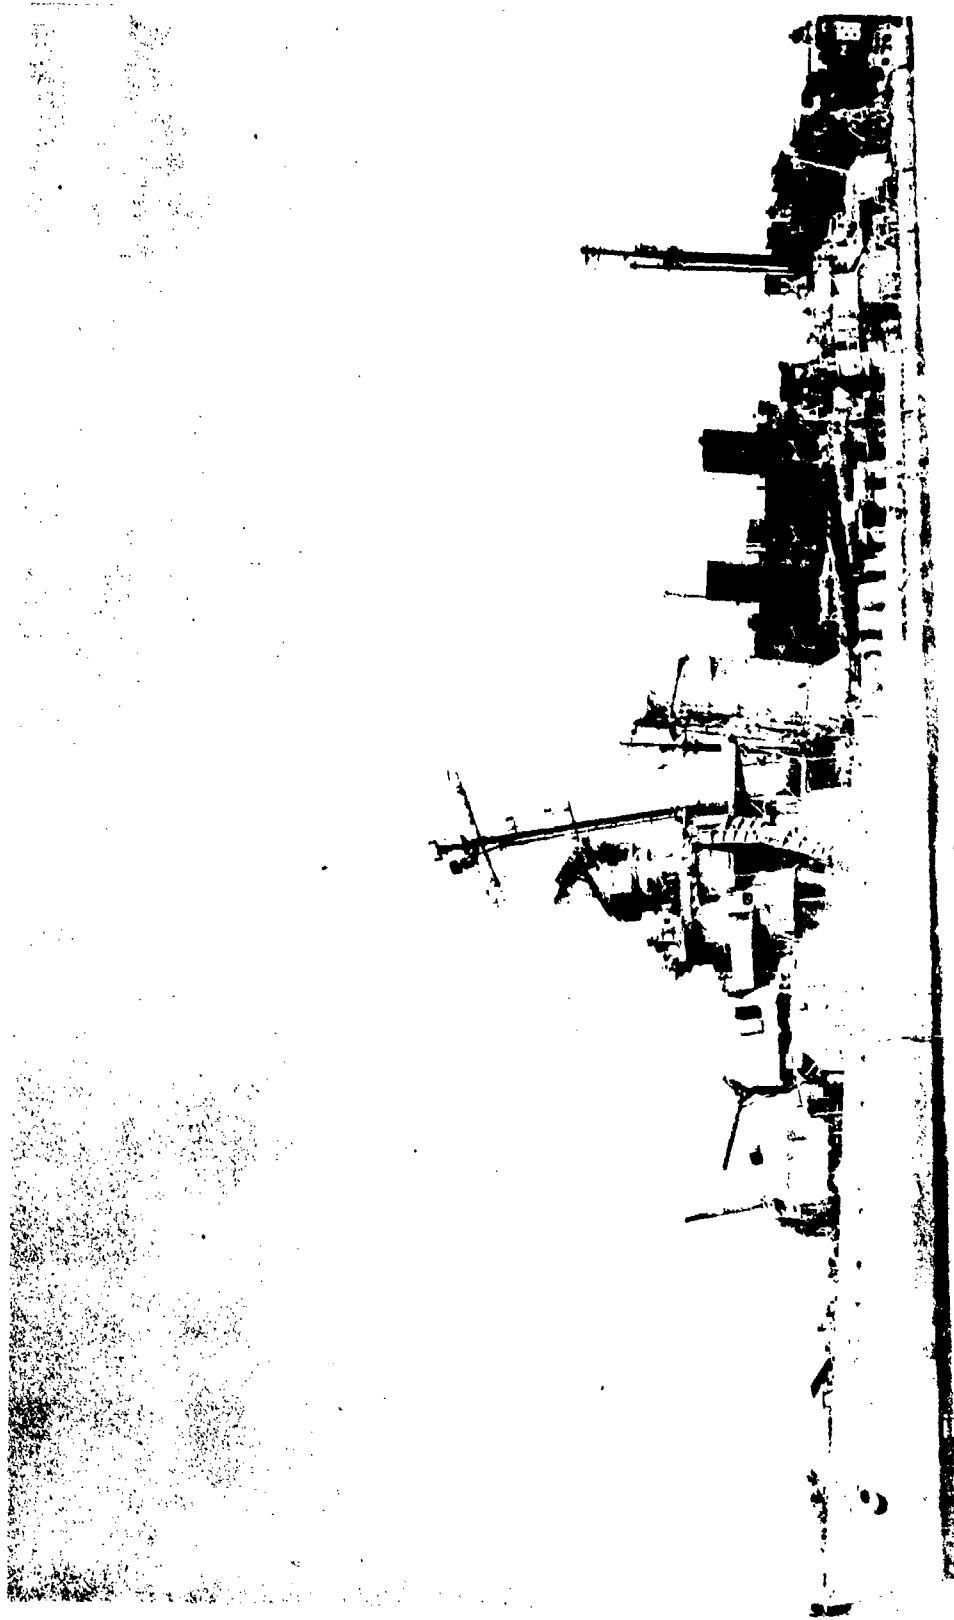
AB-CR-227-290-37. Port bow after Test B.

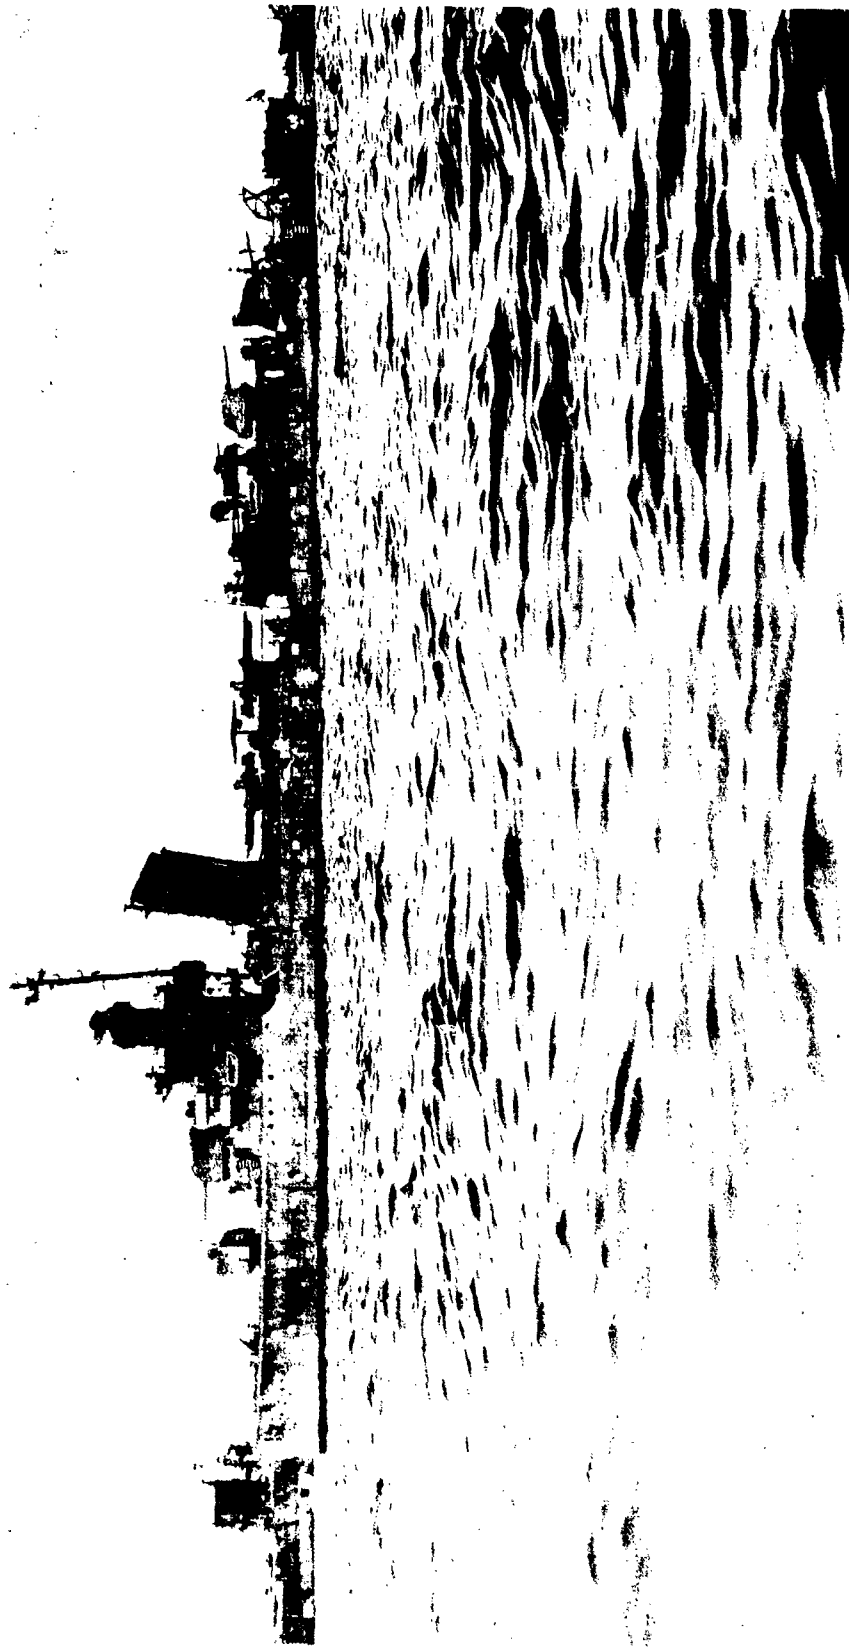
BB-CR-227-513-15. Port beam before Test B.

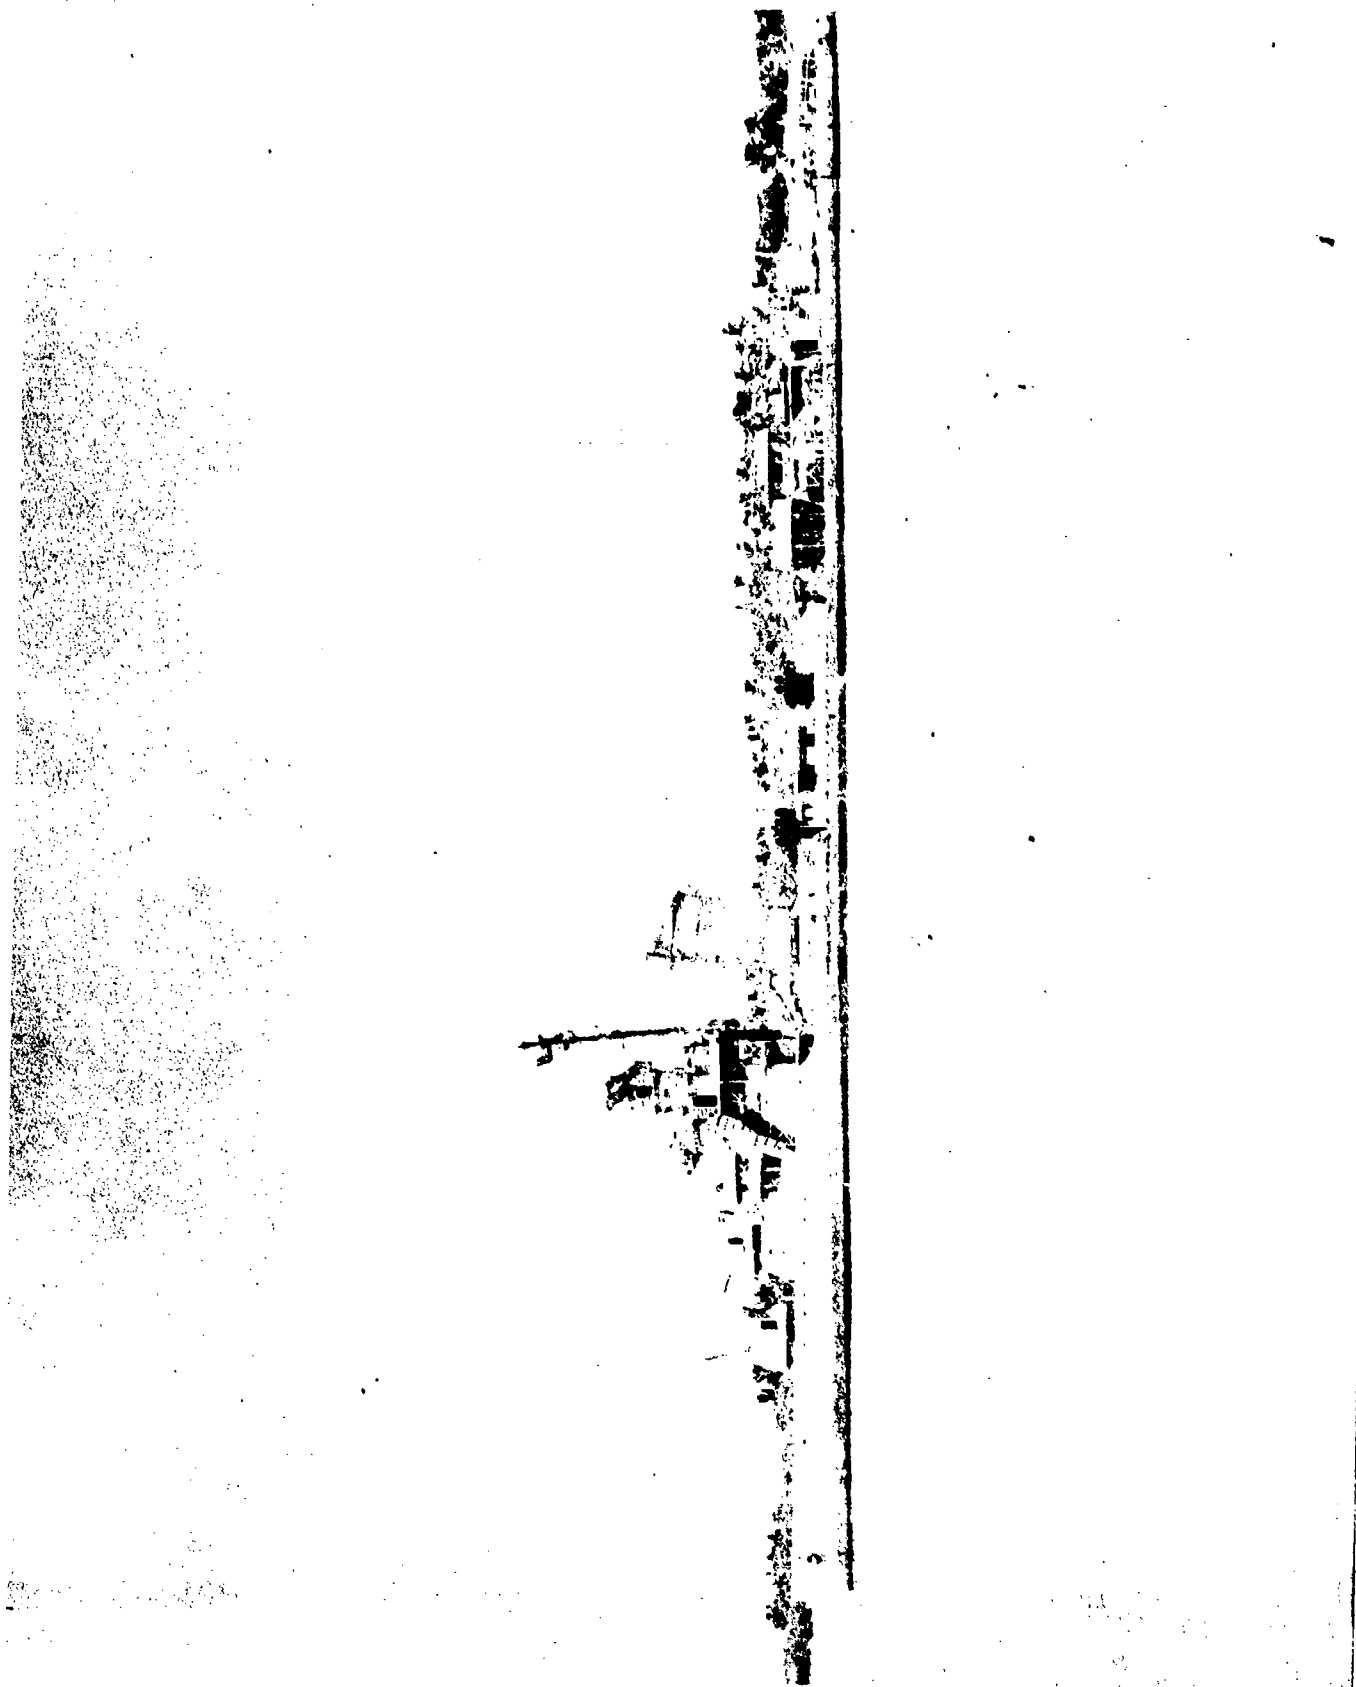
AB-CR-227-290-38. Port beam after Test B.

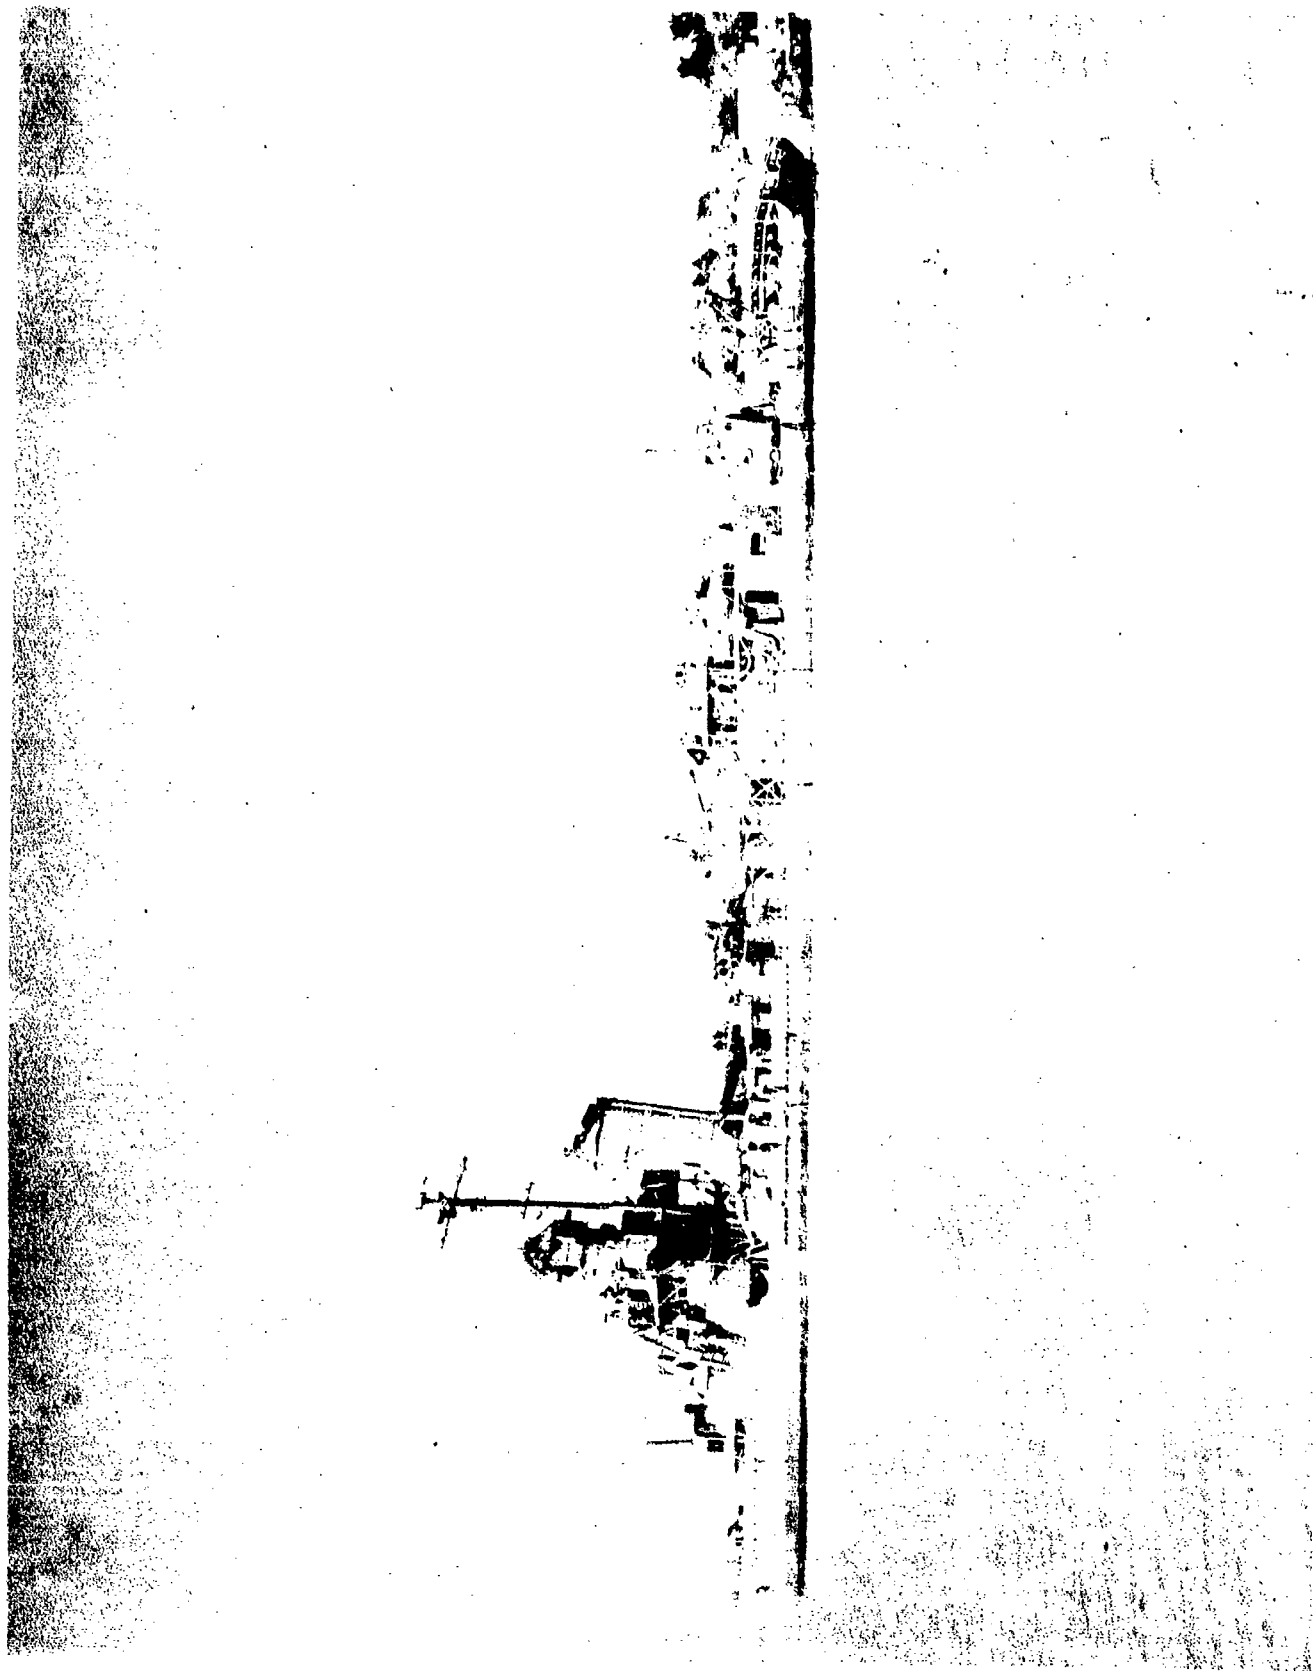
AB-CR-227-290-39. Port quarter after Test B.

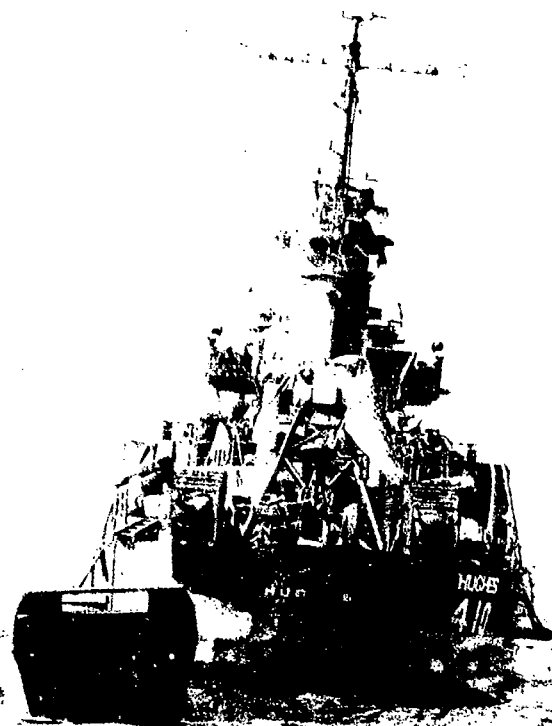
BB-CR-227-513-13. Stern before Test B.

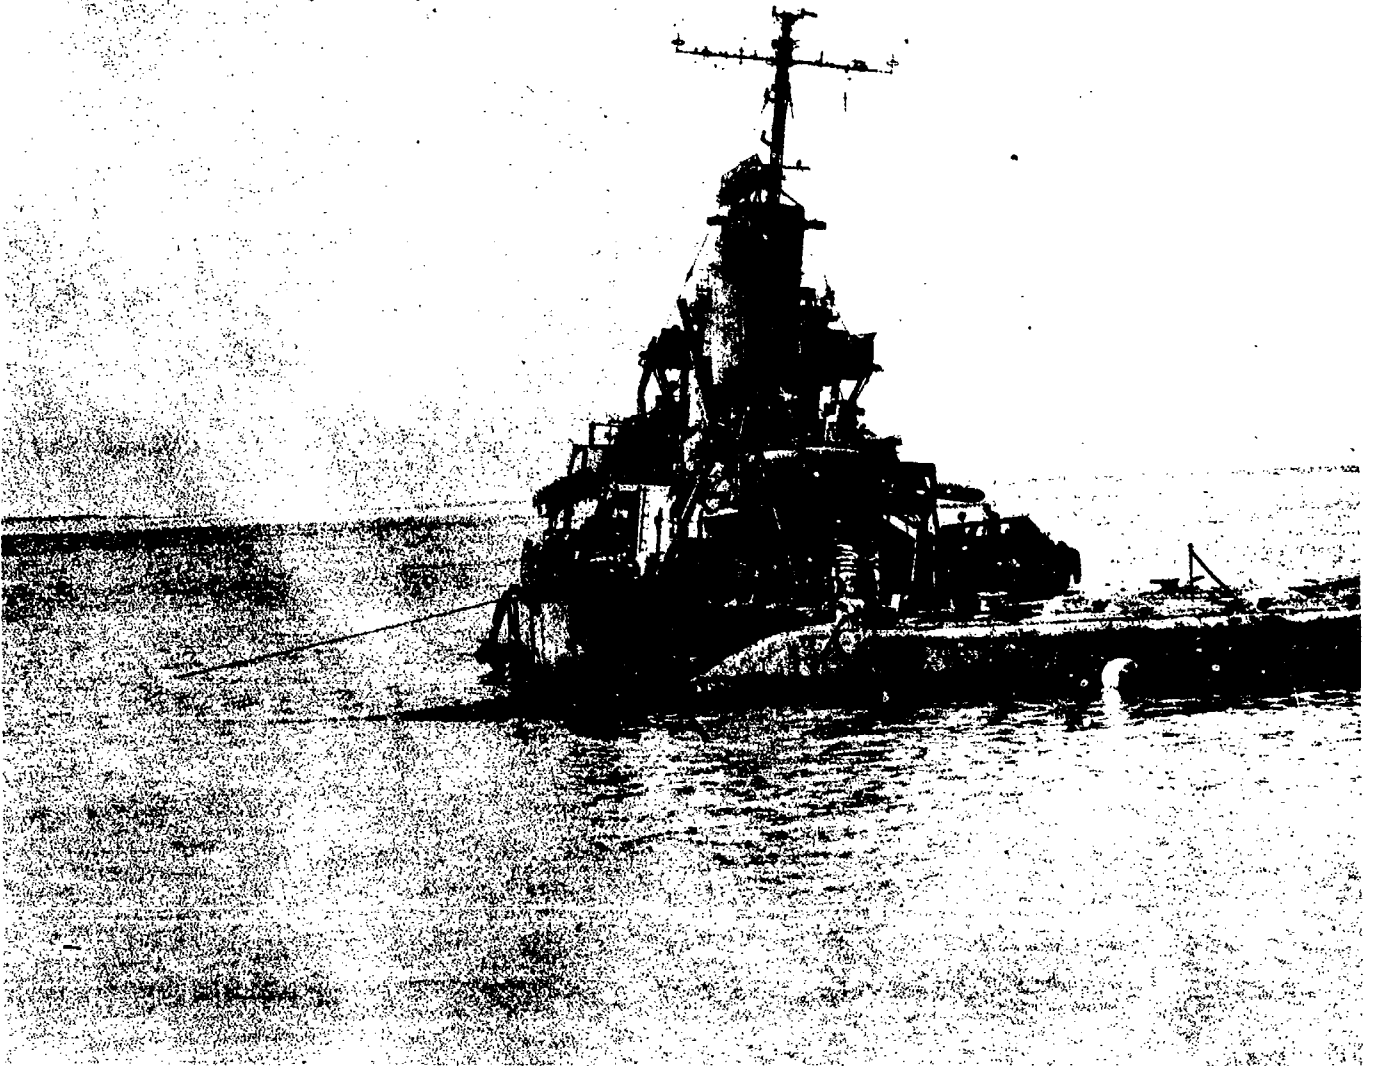
AB-CR-227-290-32. Stern after Test B.

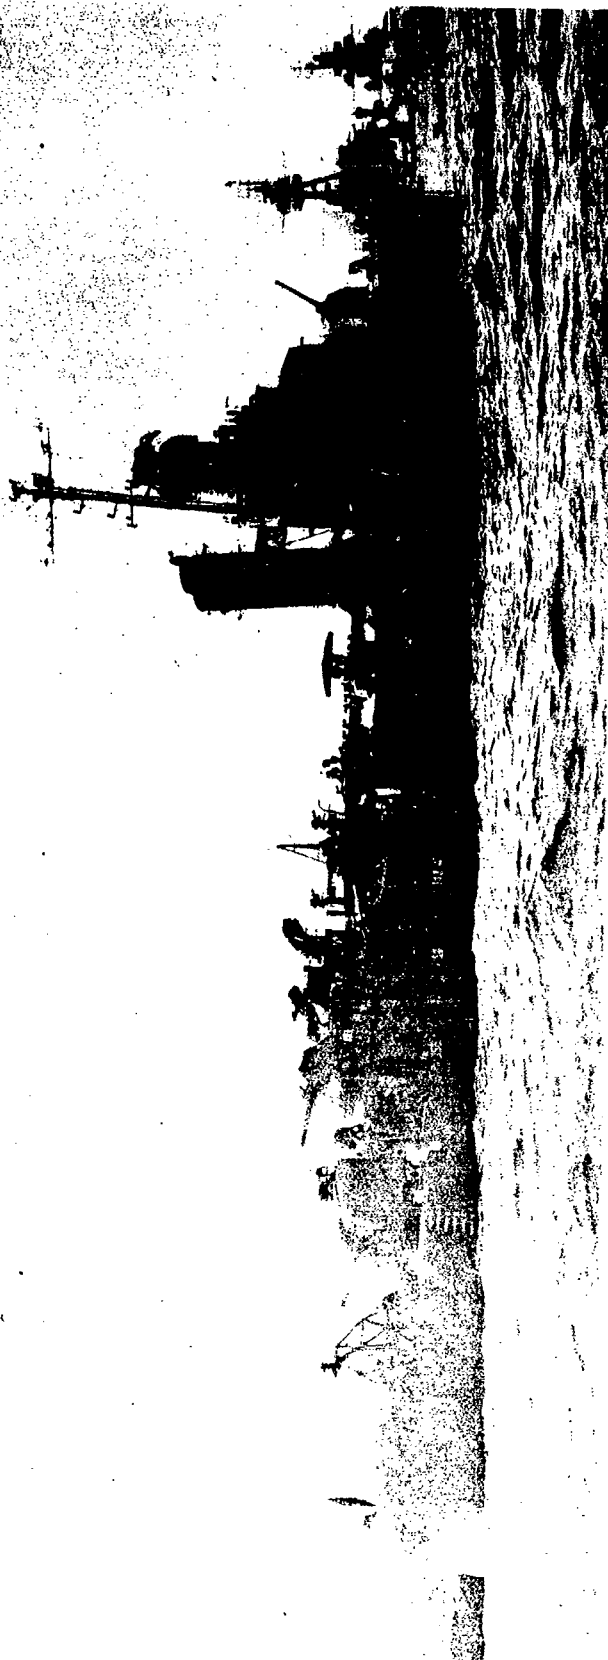
BB-CR-227-513-12. Starboard quarter before Test B.

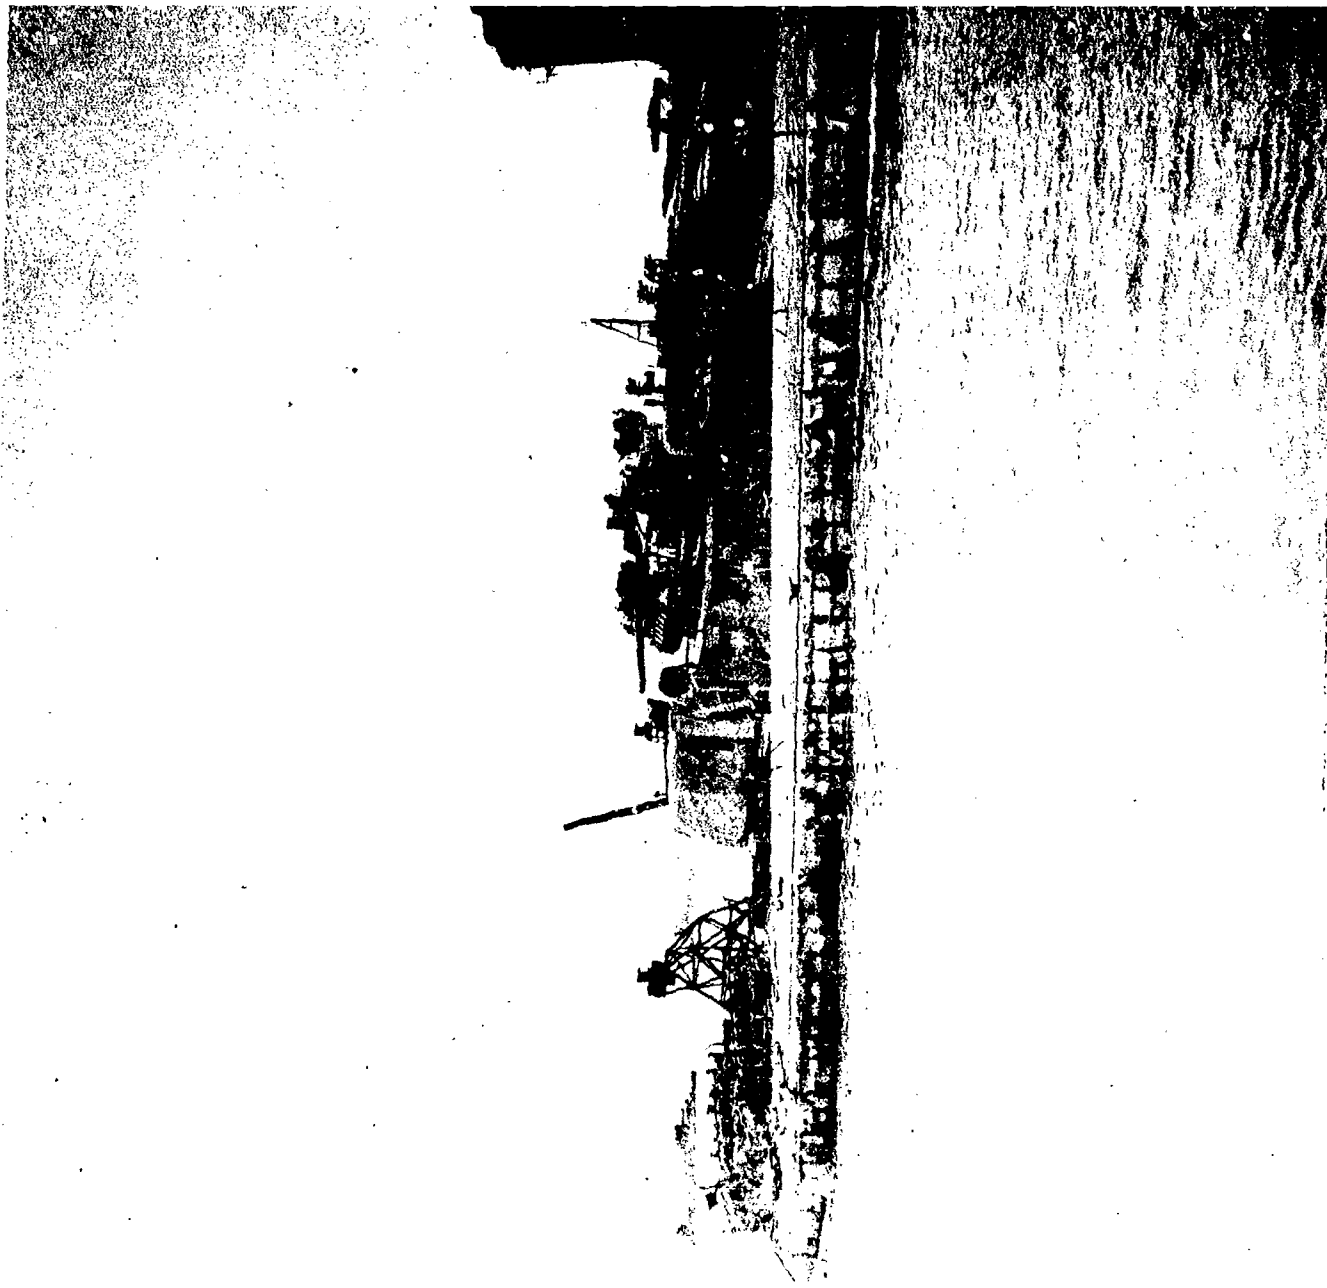
AB-CR-227-290-33. Starboard quarter after Test B.

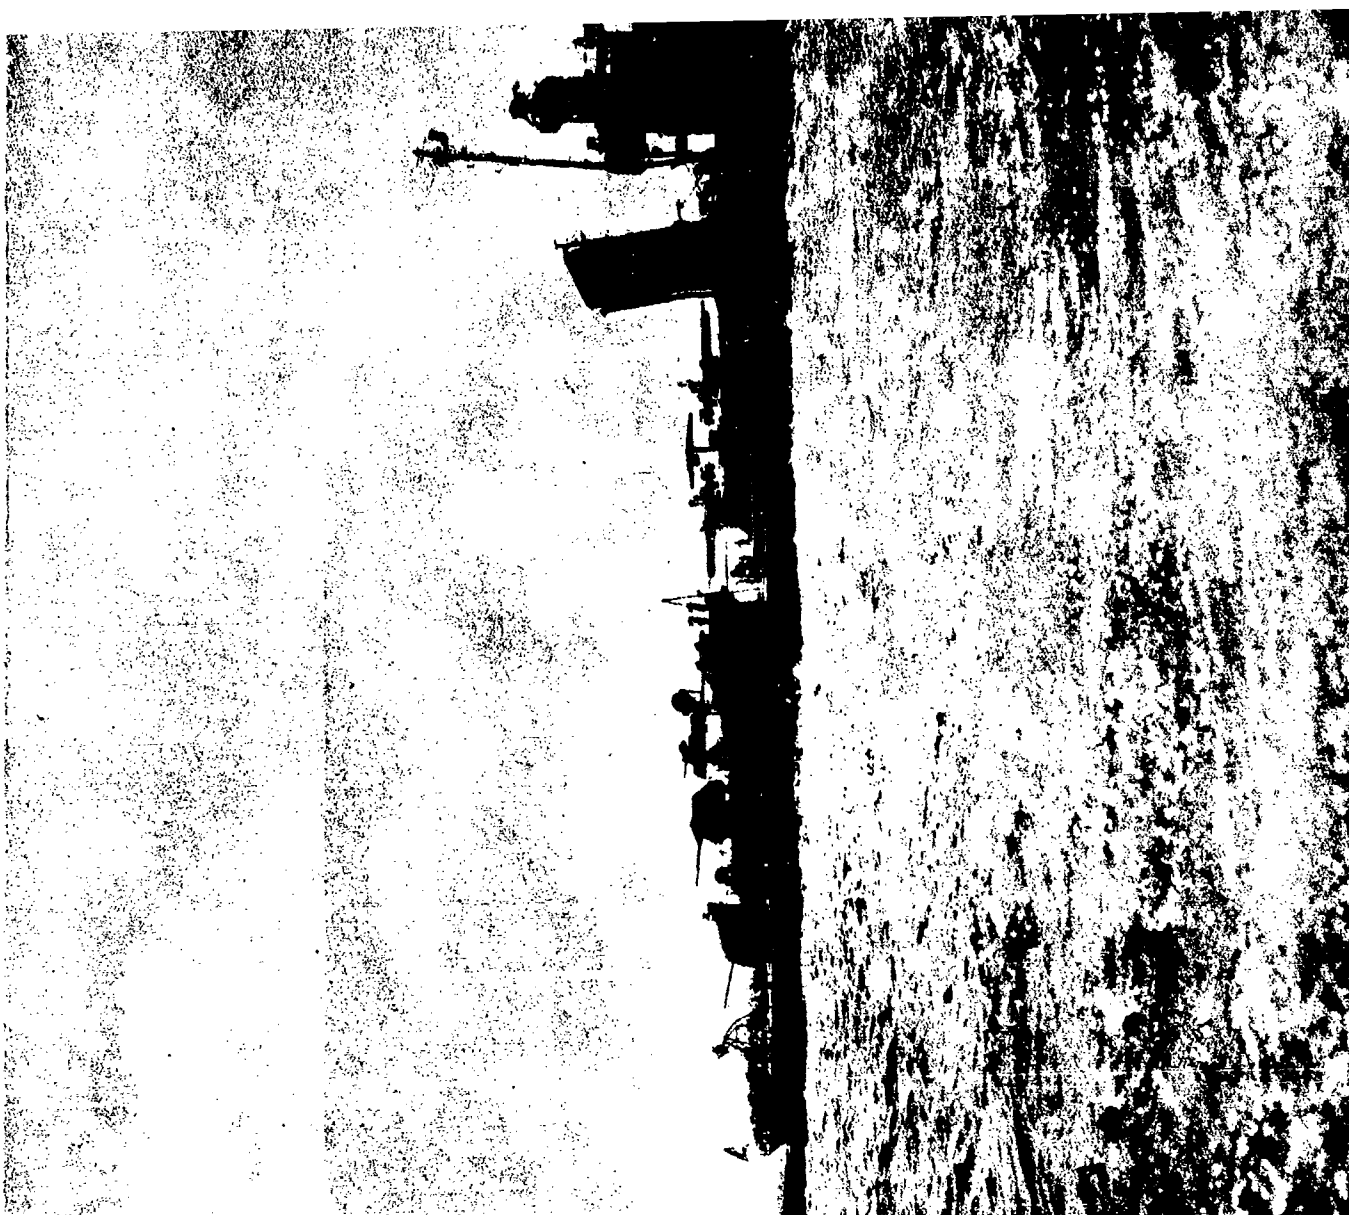
BB-CR-227-513-11. Starboard beam before Test B.

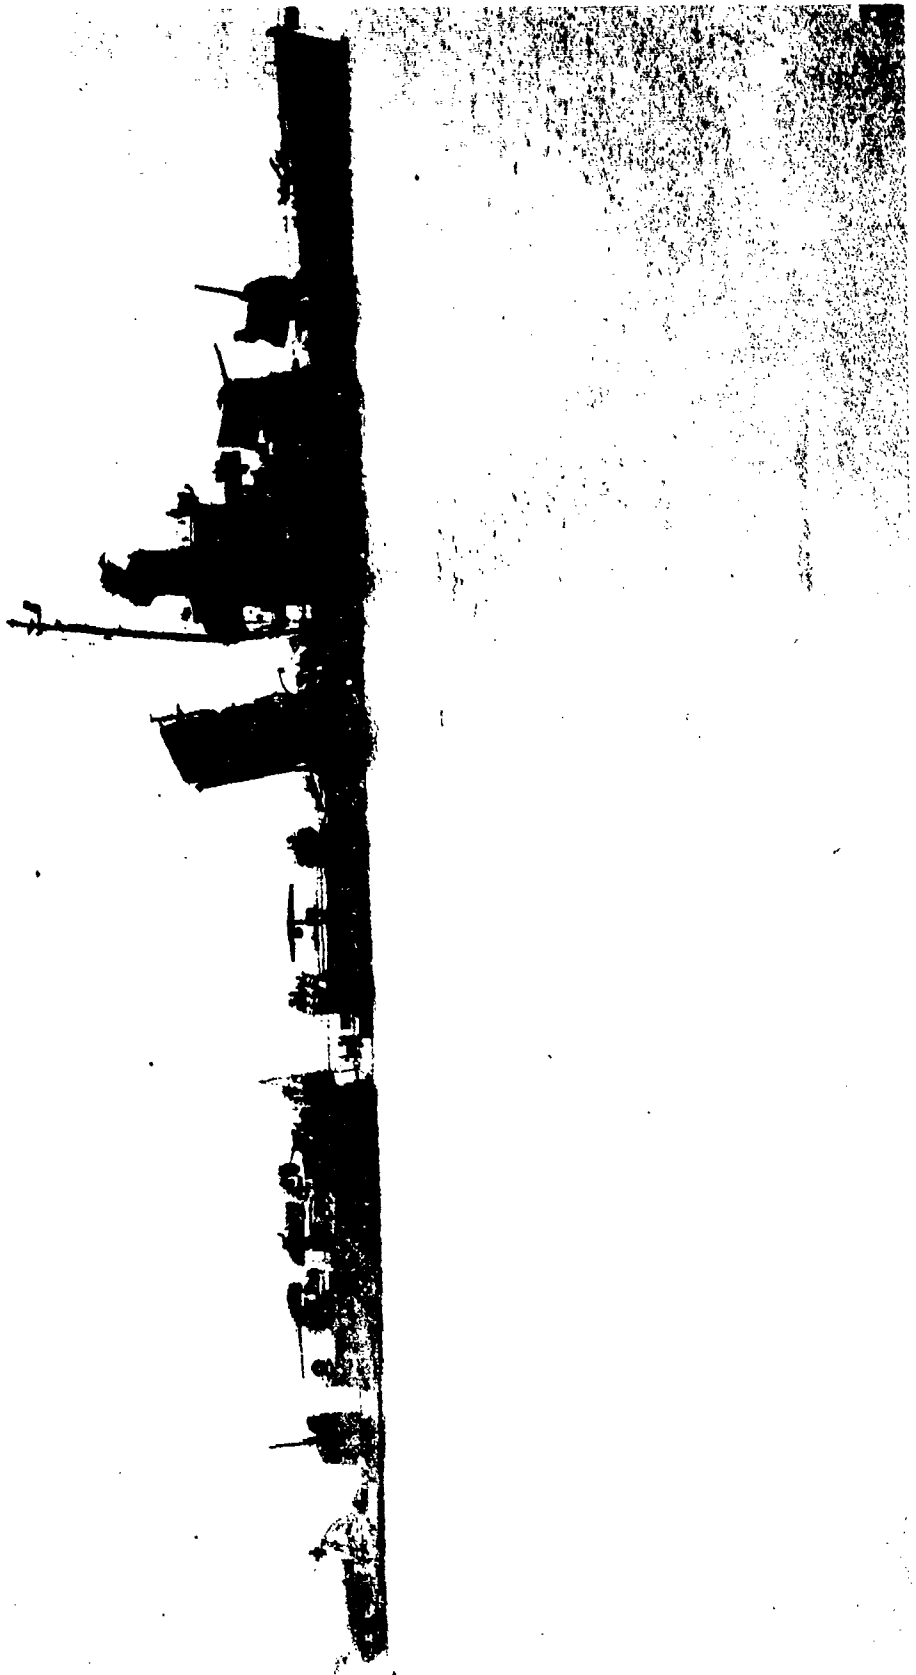
AB-CR-227-290-34. Starboard beam after Test B.

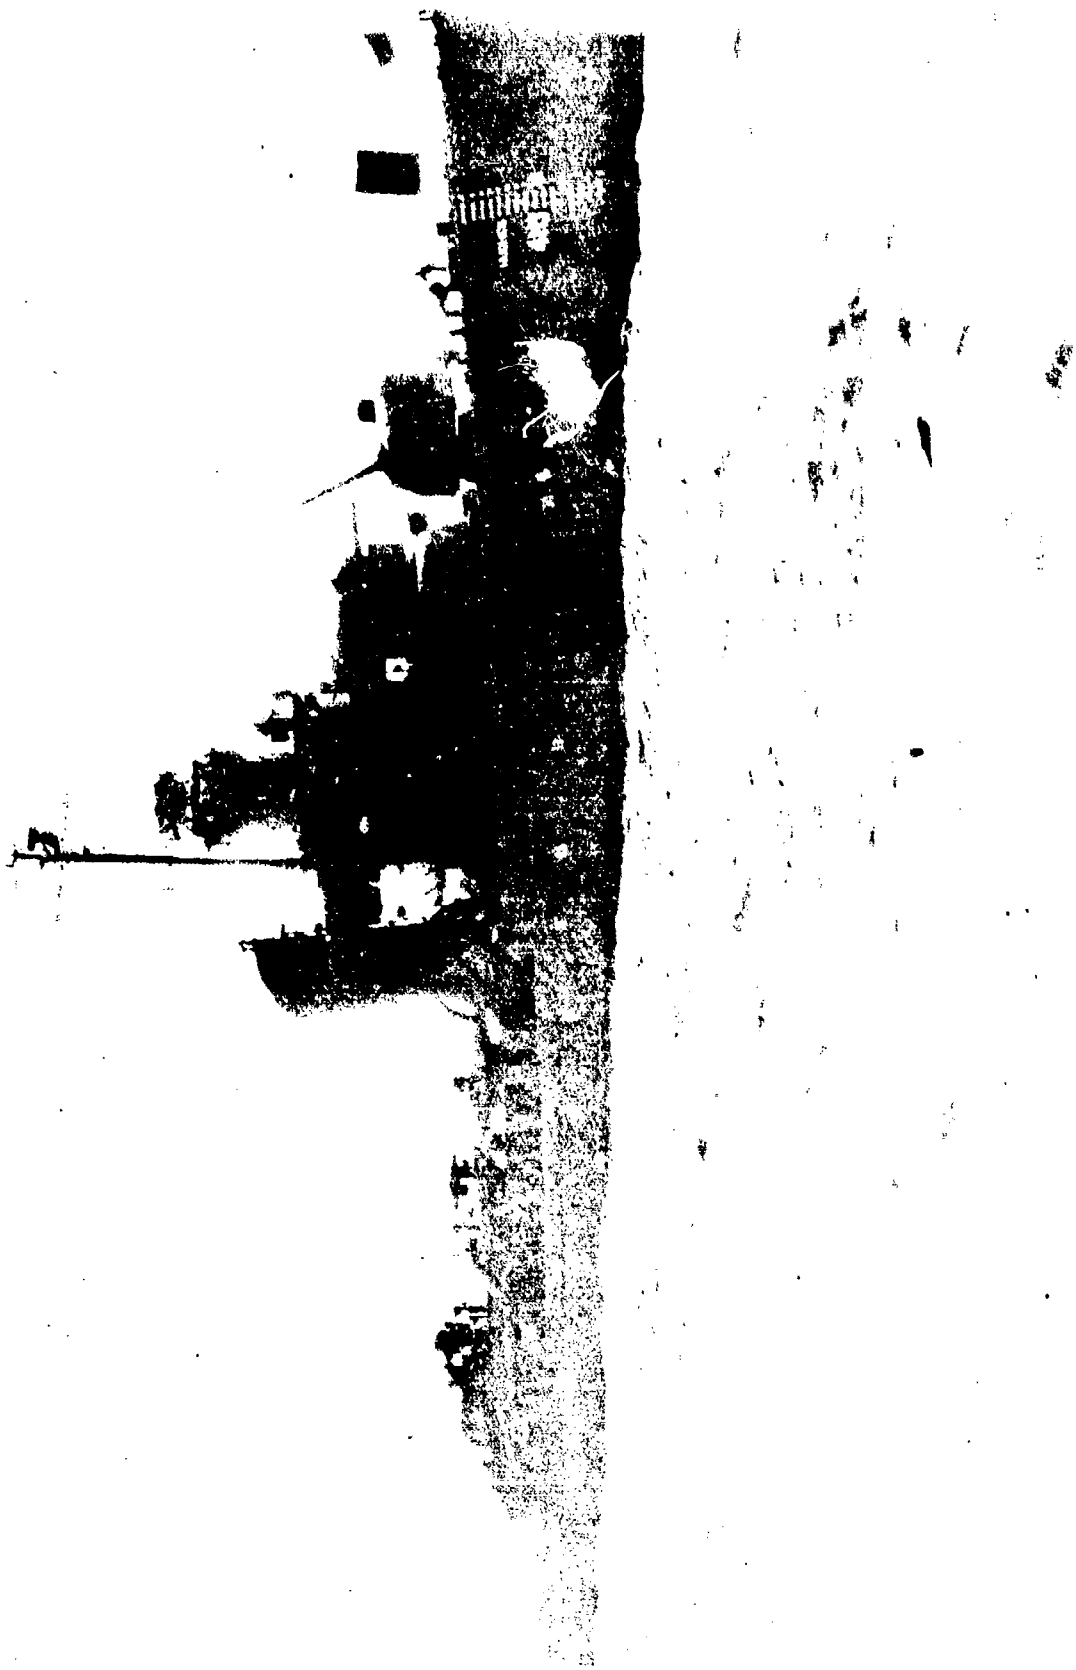
BB-CR-227-513-10. Starboard bow before Test B.

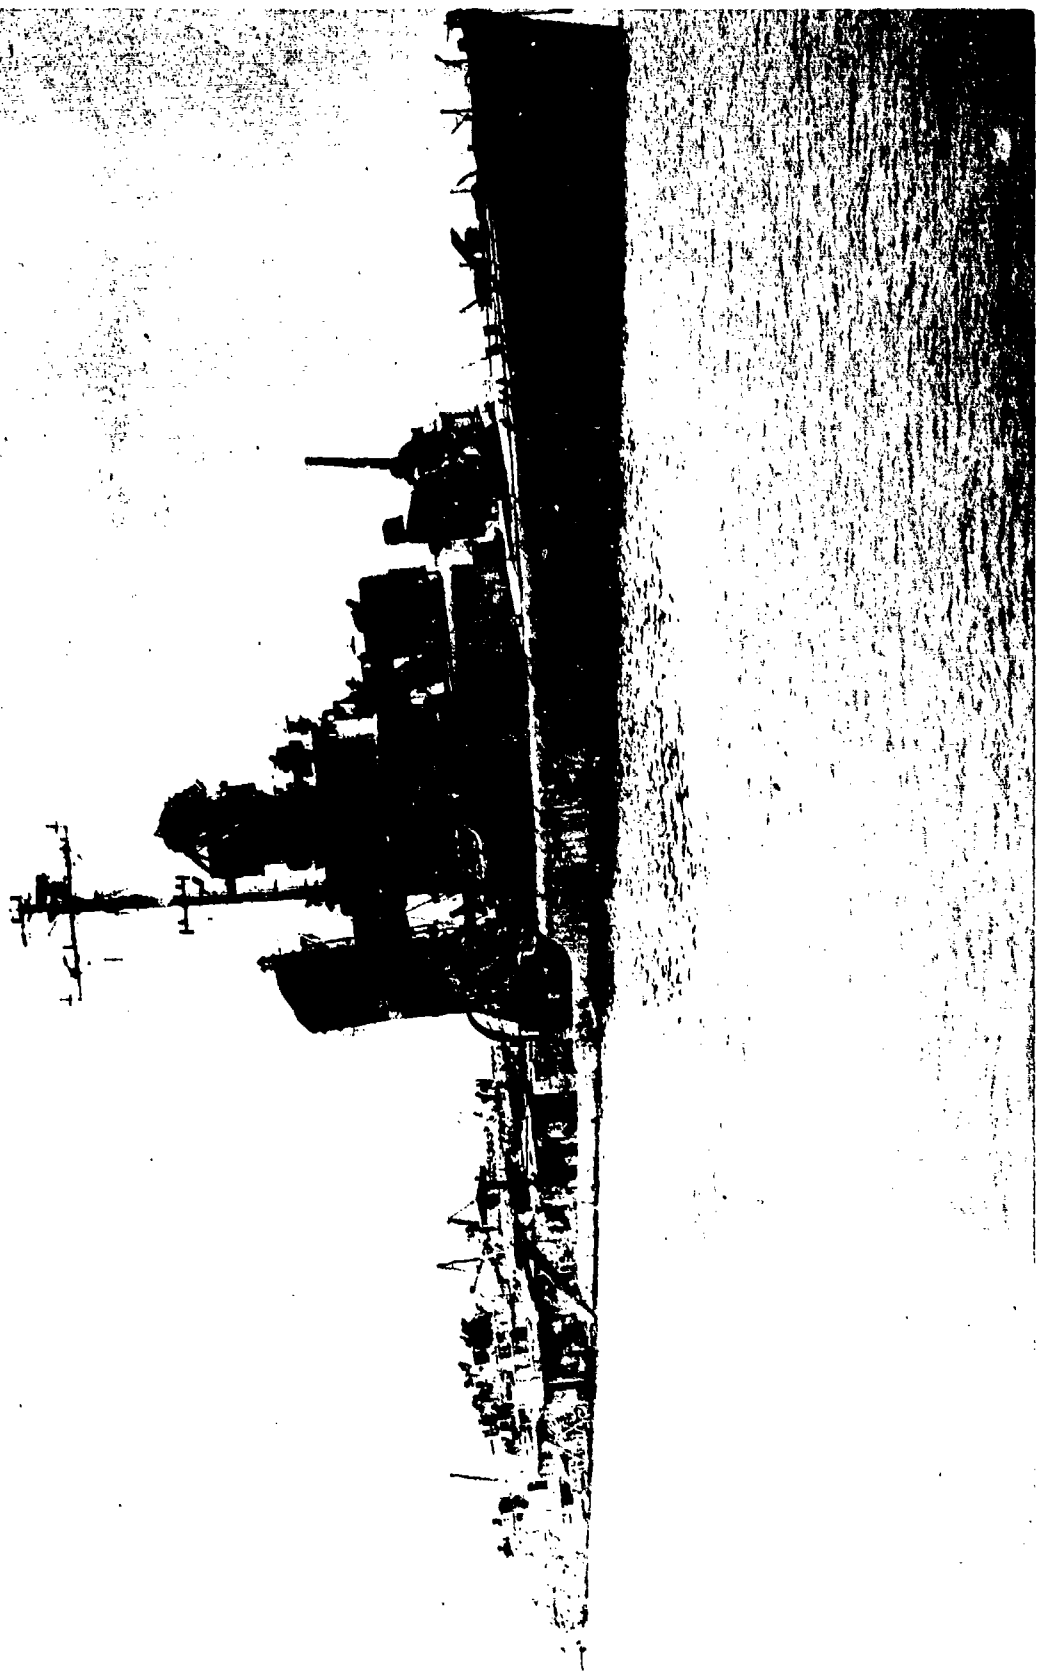
AB-CR-227-290-35. Starboard bow after test B.
