BUREAU OF SHIPS GROUP
TECHNICAL INSPECTION REPORT

⑥ OPERATION CROSSROADS.
U.S.S HUGHES (DD410).
TEST BAKER.

VOLUME II [u] ⑧

USS HUGHES (DD410)

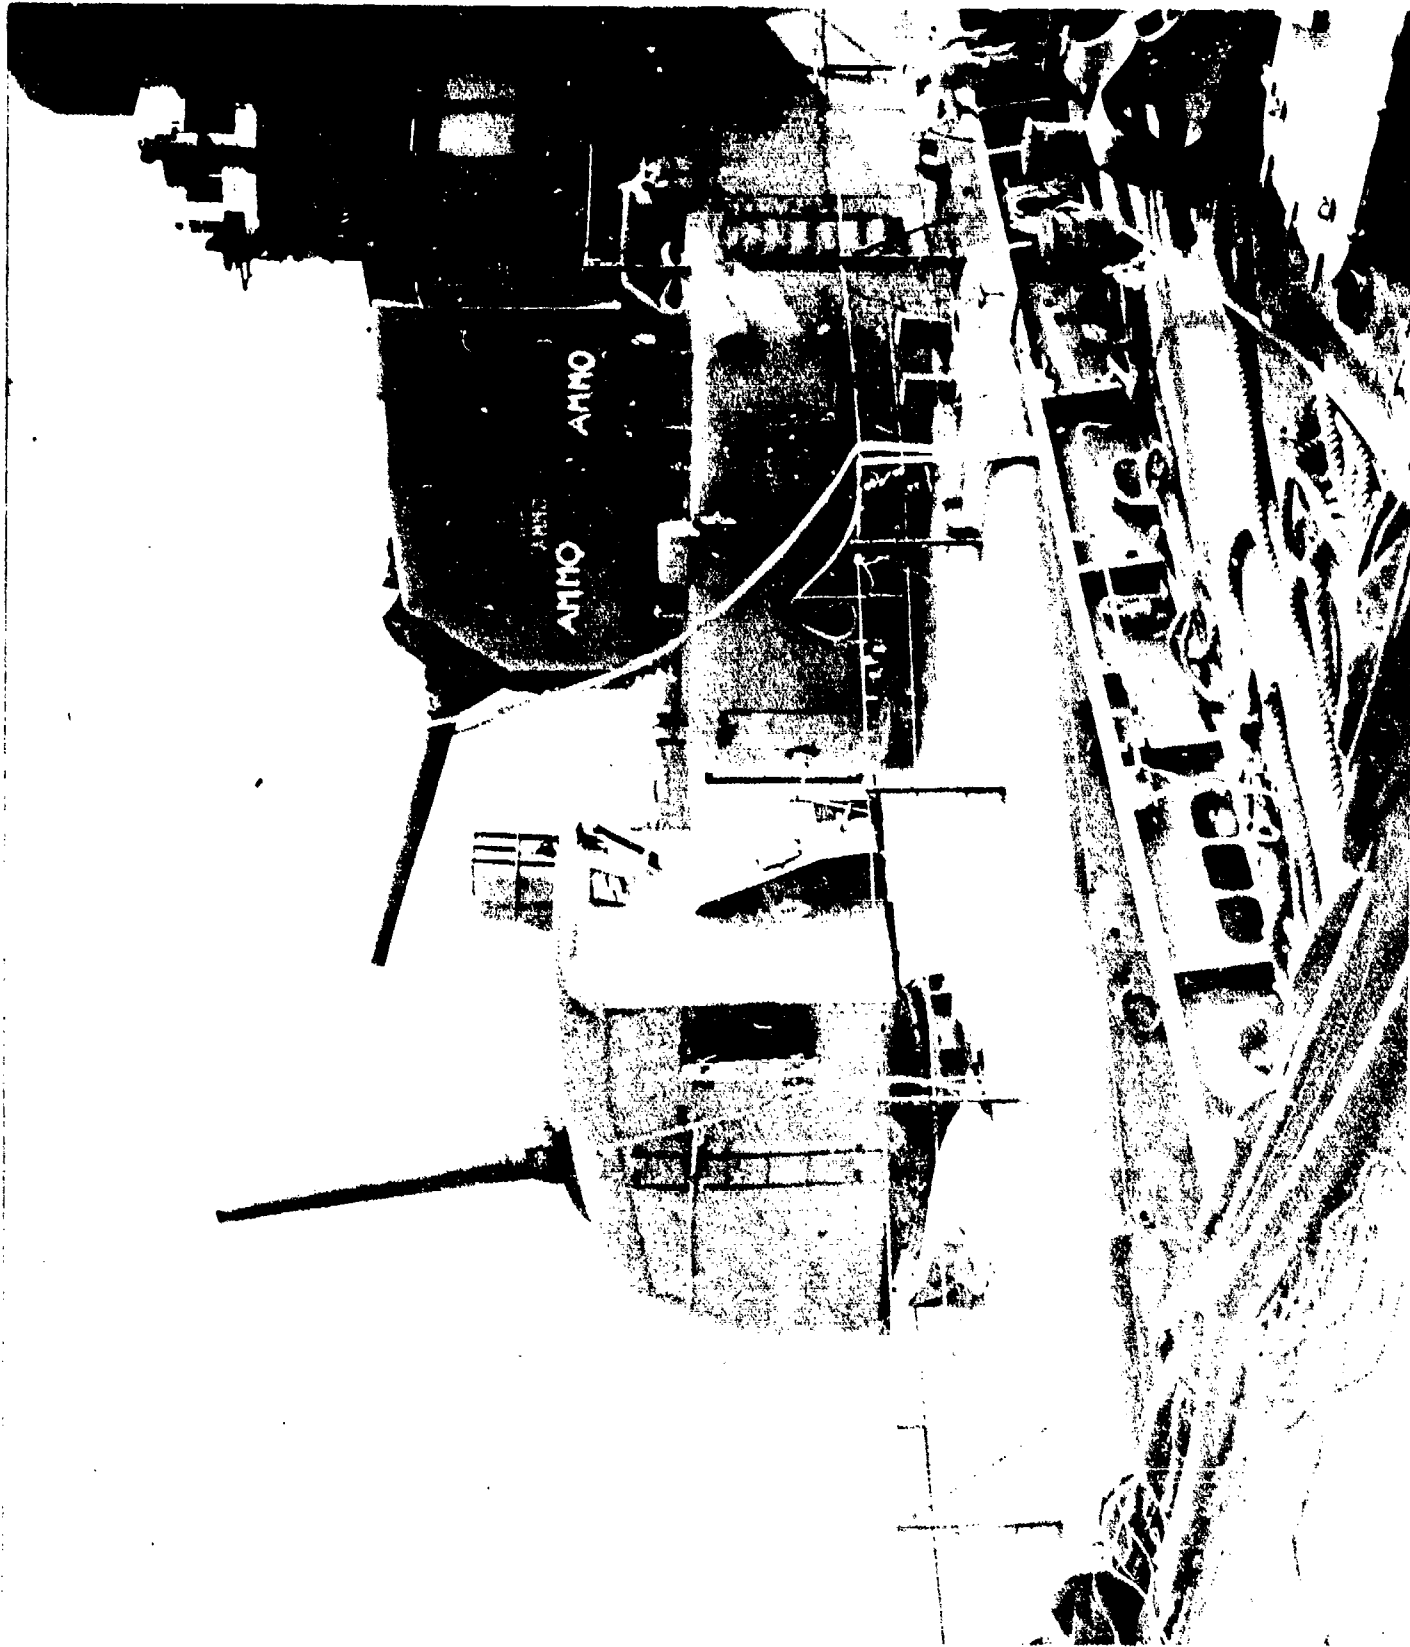
AB-CR-80-2062-1. Port sides of No. 1 and No. 2 mounts.

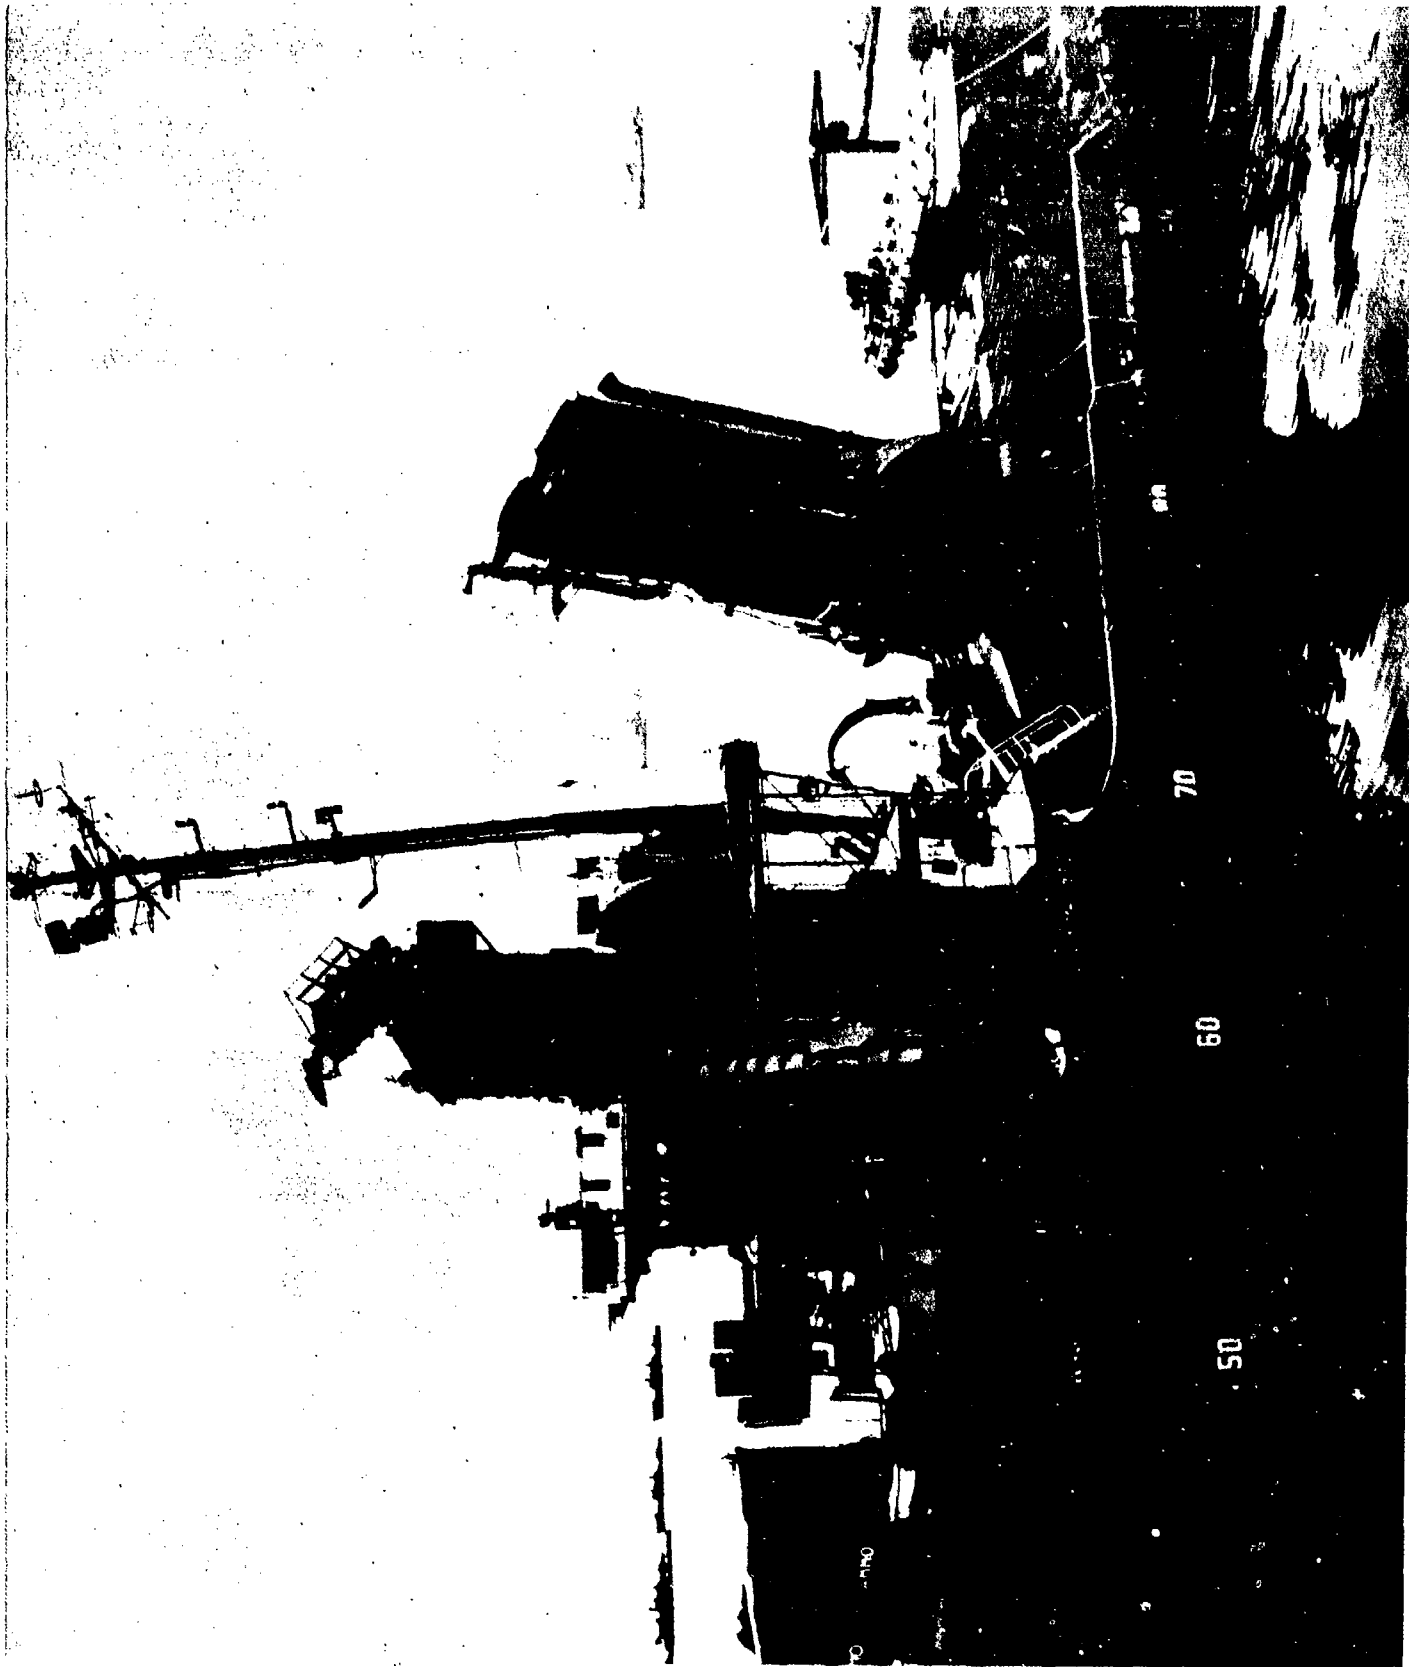
AB-CR-80-2061-7. View of superstructure from port side, amidships before beaching.

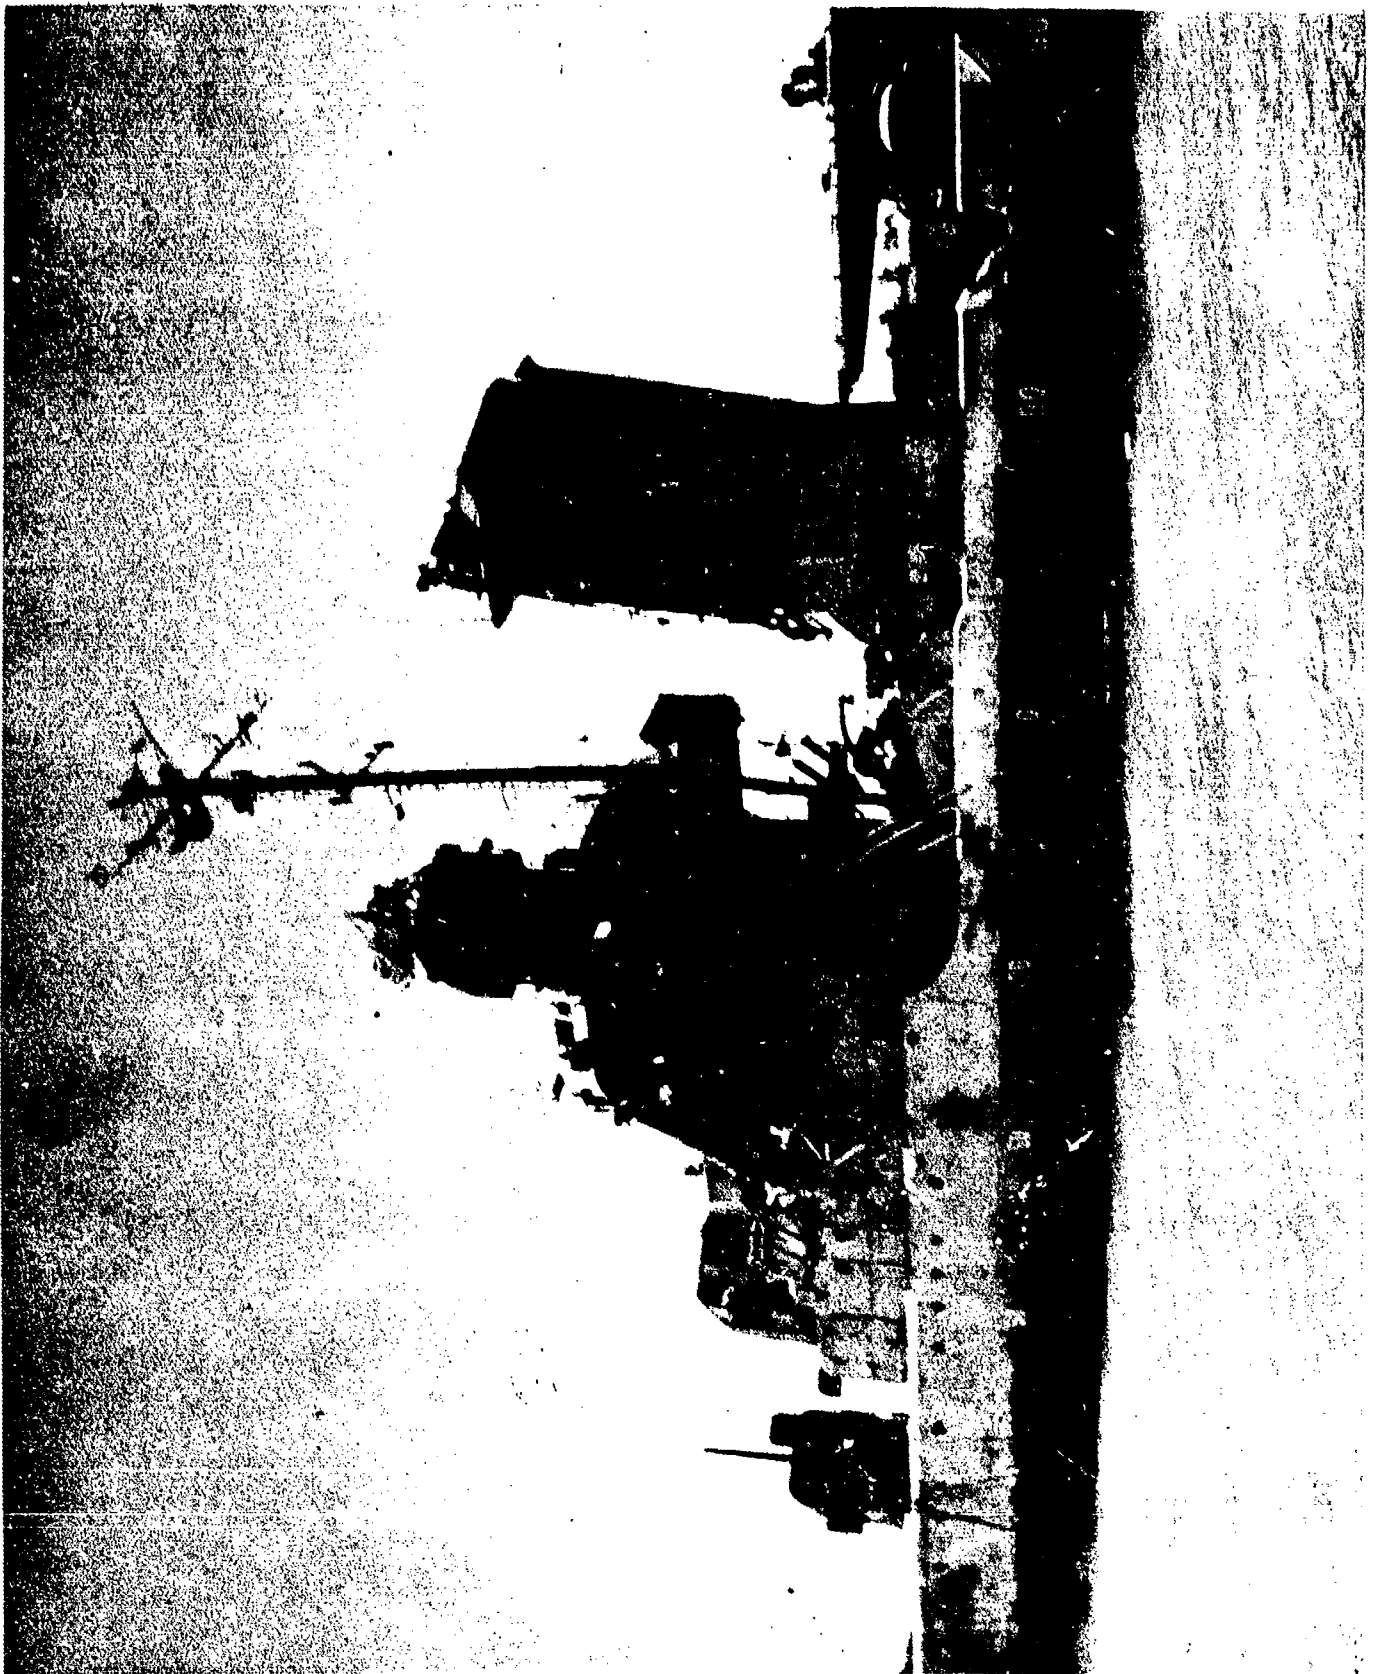
AB-CR-59-2996-10. View of forward superstructure from port side, amidships, after beaching.

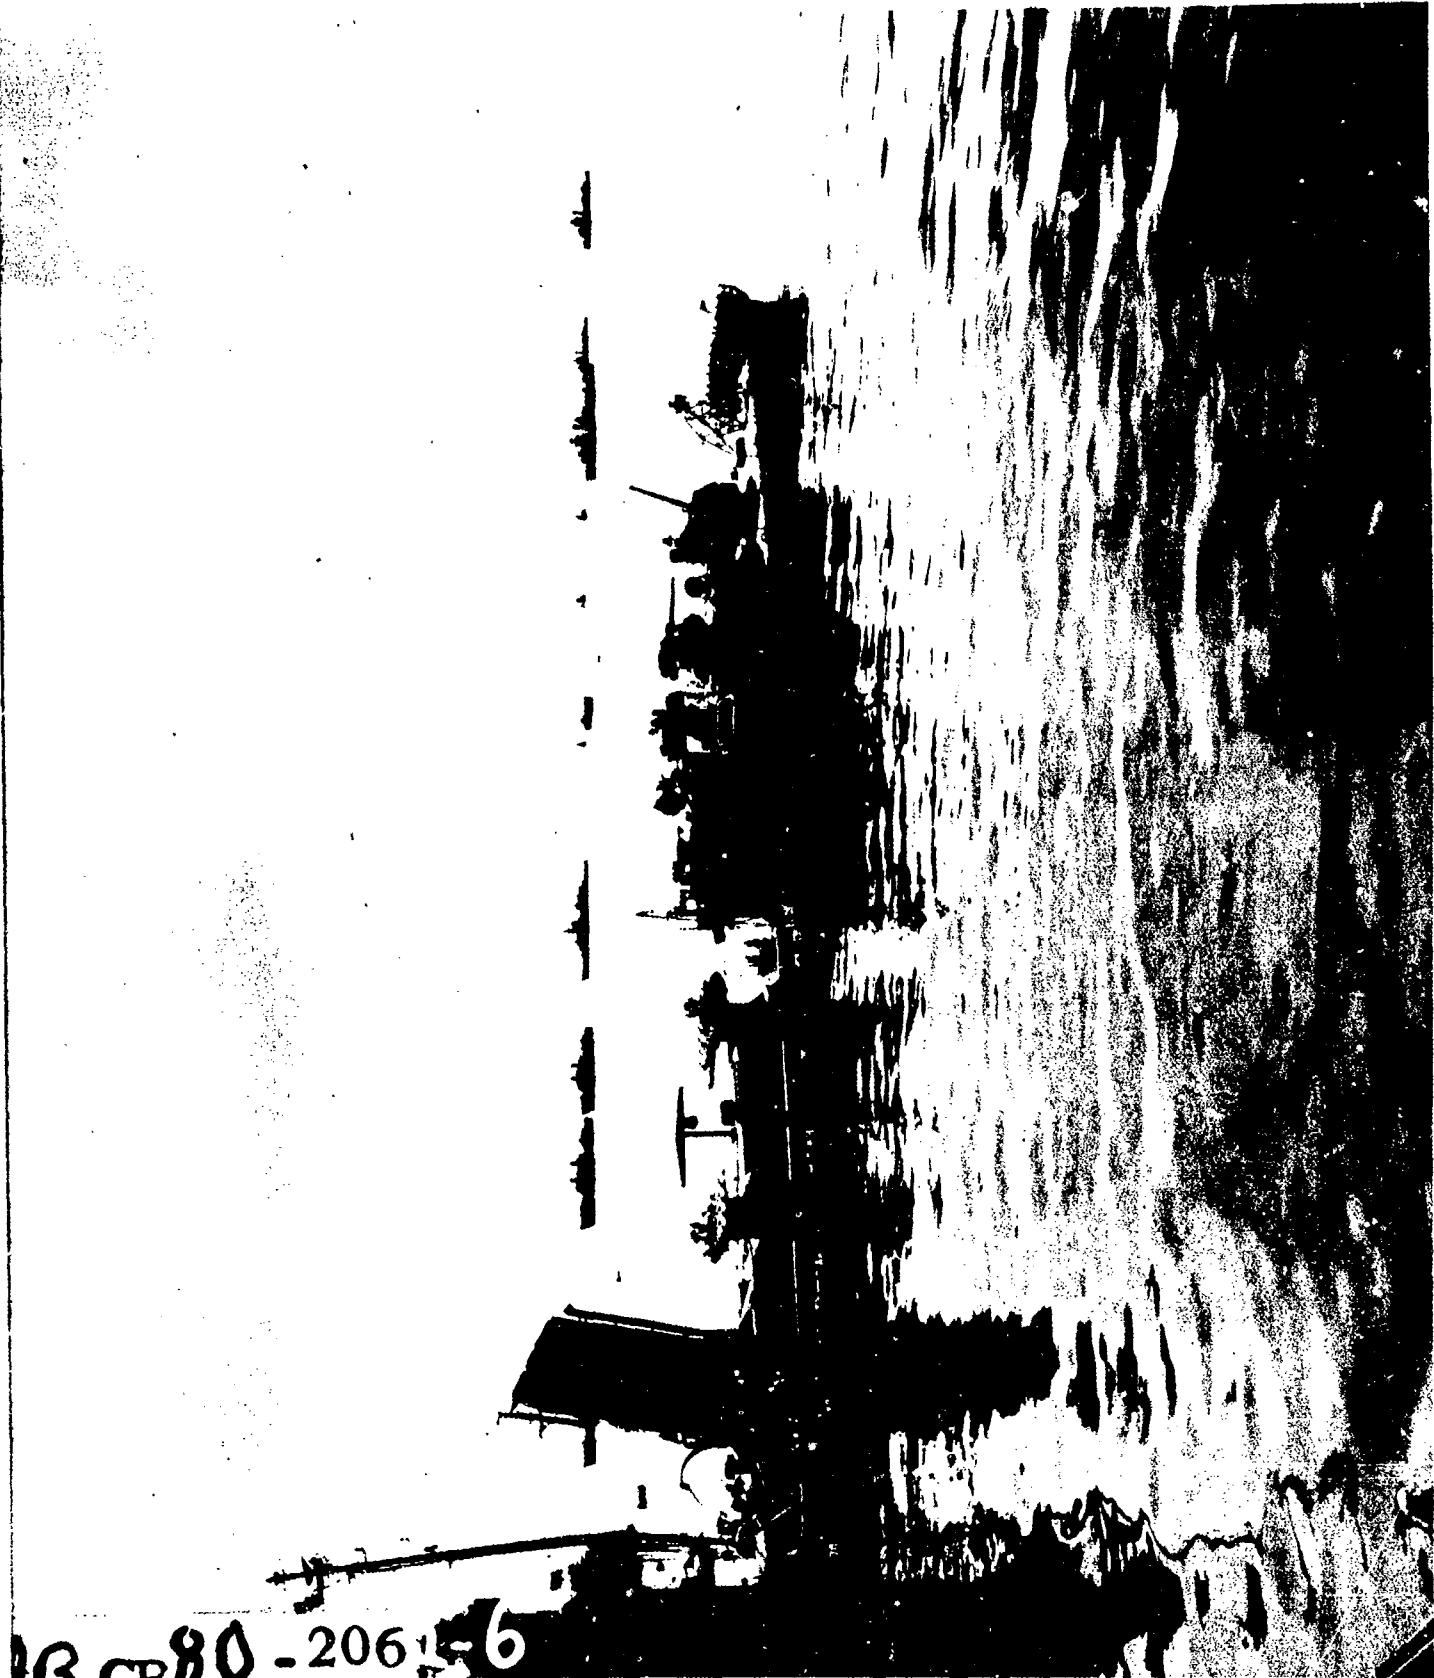
AB CR 80-2061-6

AB-CR-80-2061-6. After superstructure from port beam after beaching.

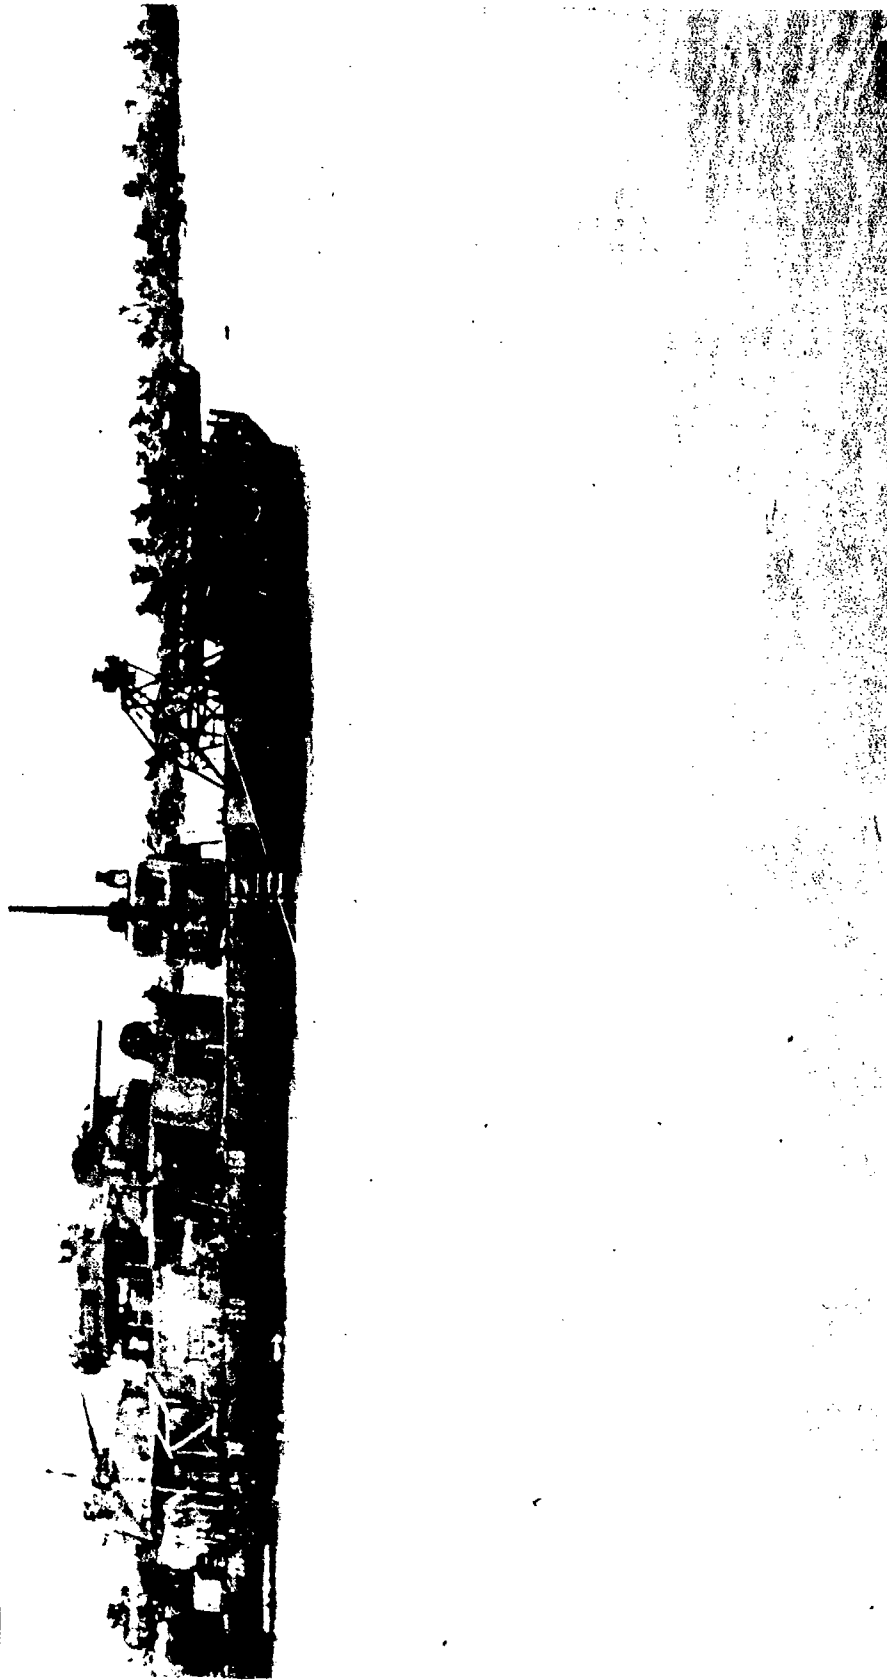
413 CR59-2996 -1

AB-CR-59-2996-8. View of stern, after grounding, from off port quarter.

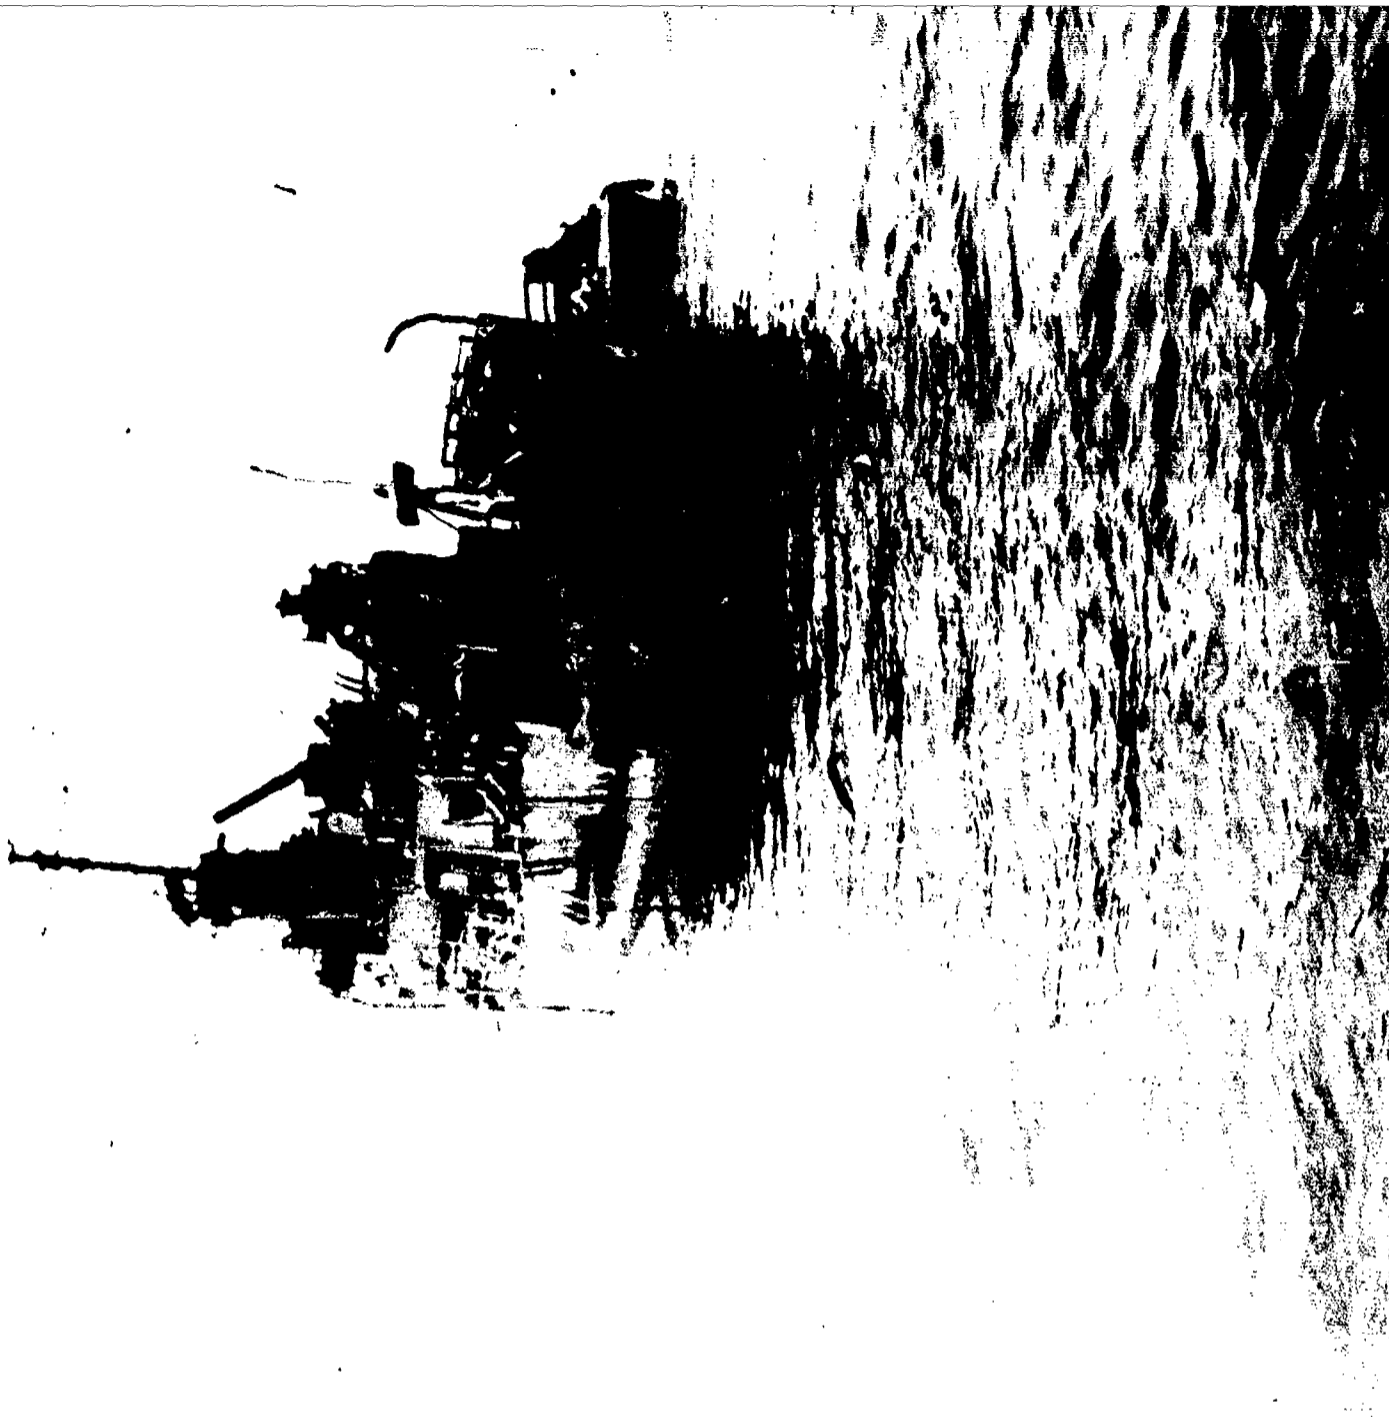
AB-CR-100-4211-9. View showing damage to transom and after
portion of port shell.

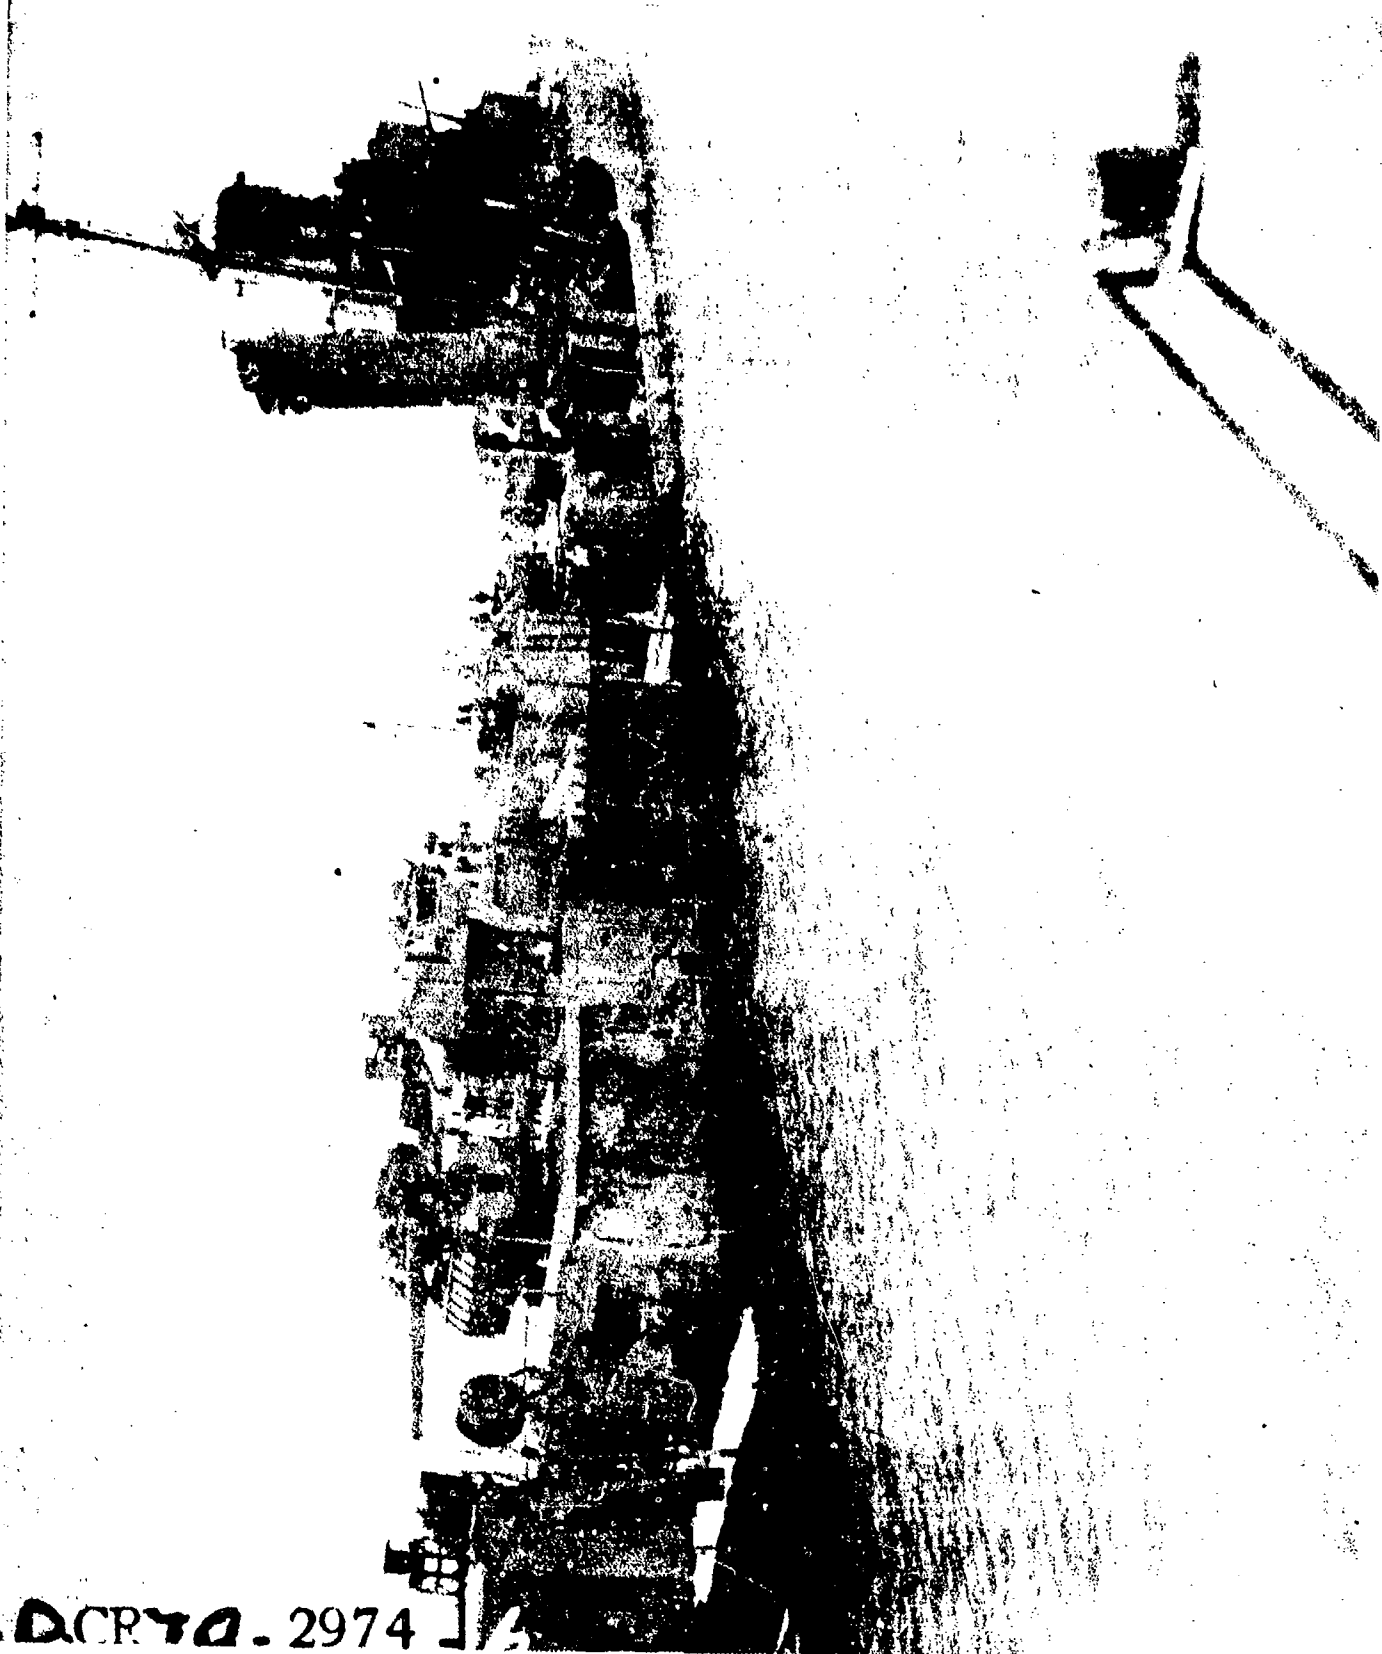
DCR 70. 2974

AB-CR-79-2974-6. View of after superstructure from starboard quarter.

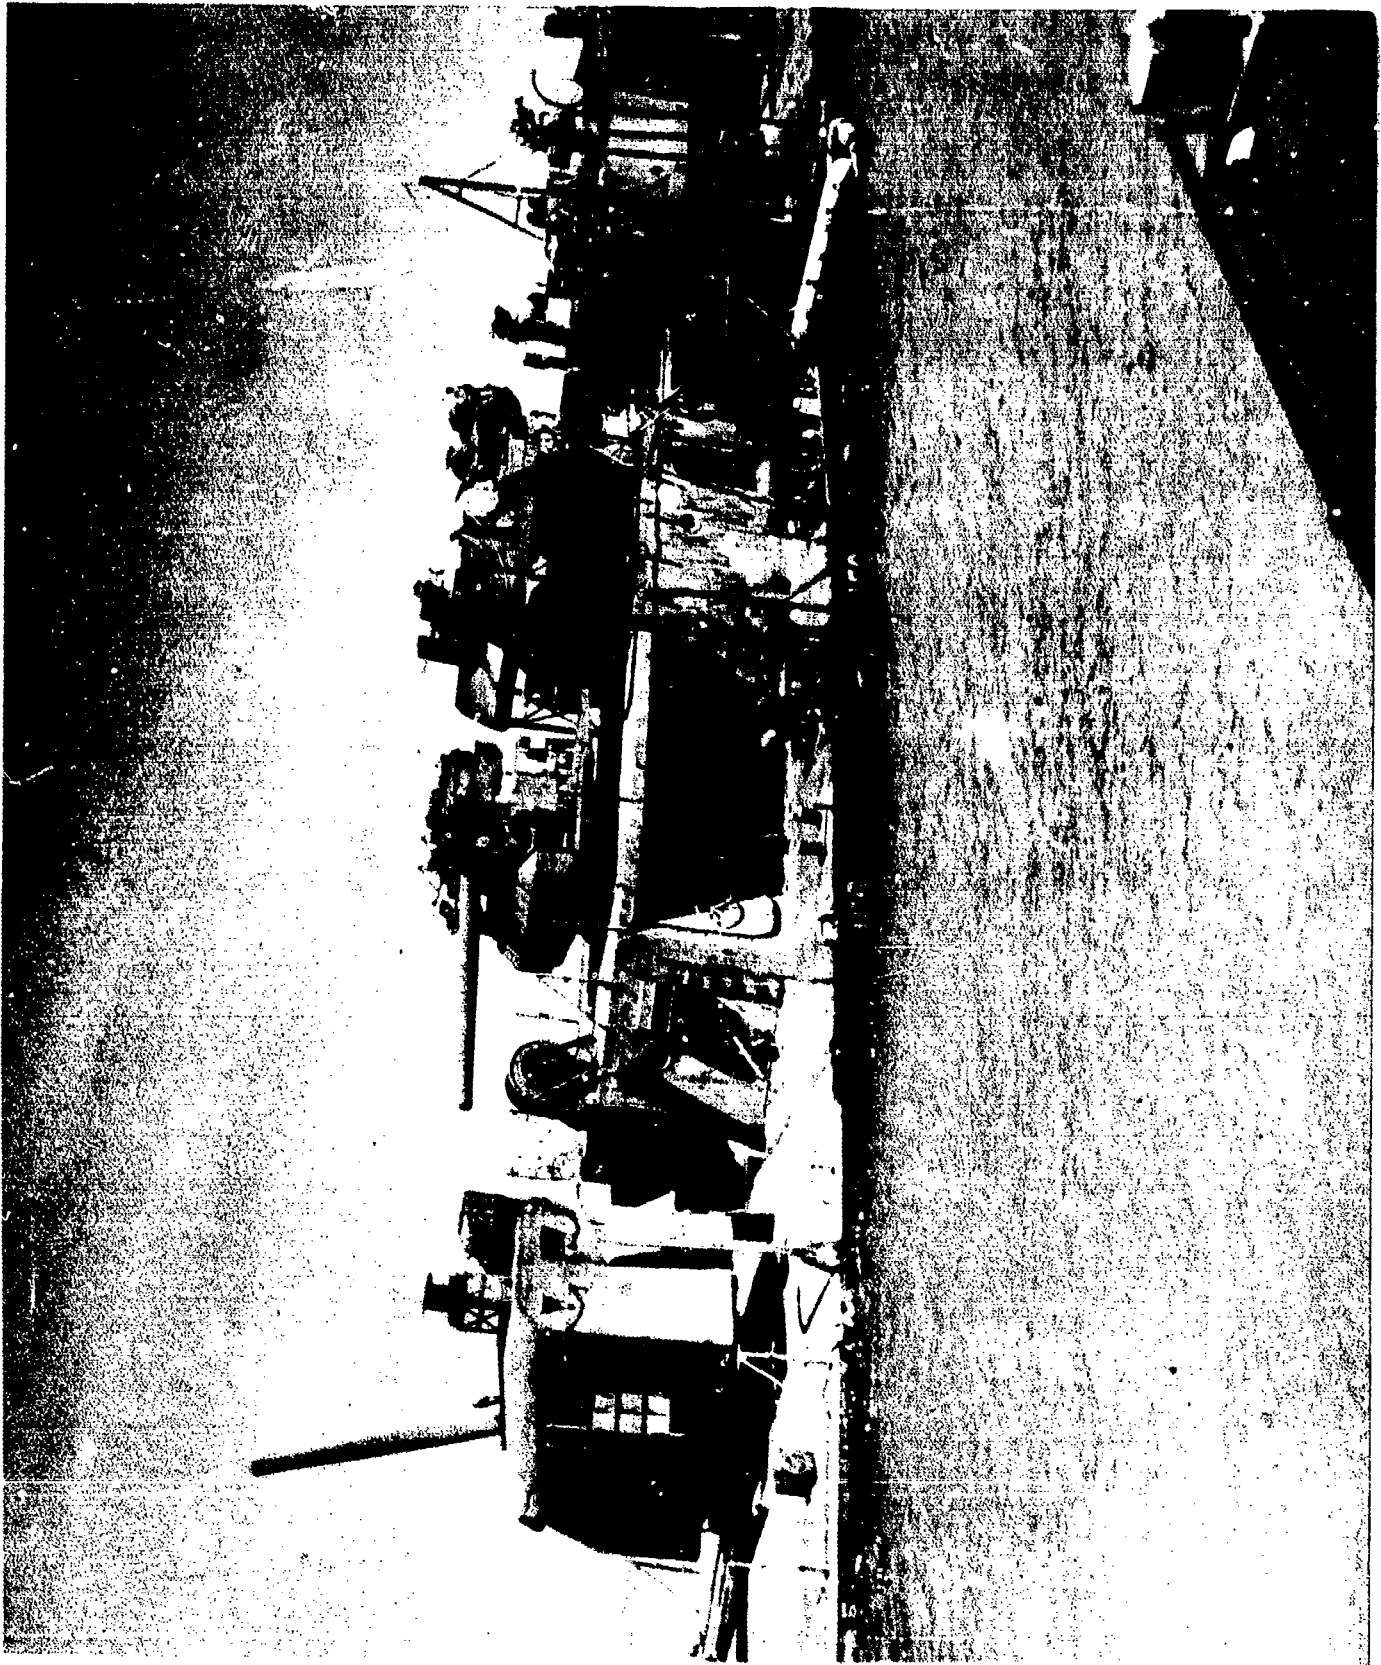
AB-CR-59-2996-3. View of after superstructure from starboard quarter.

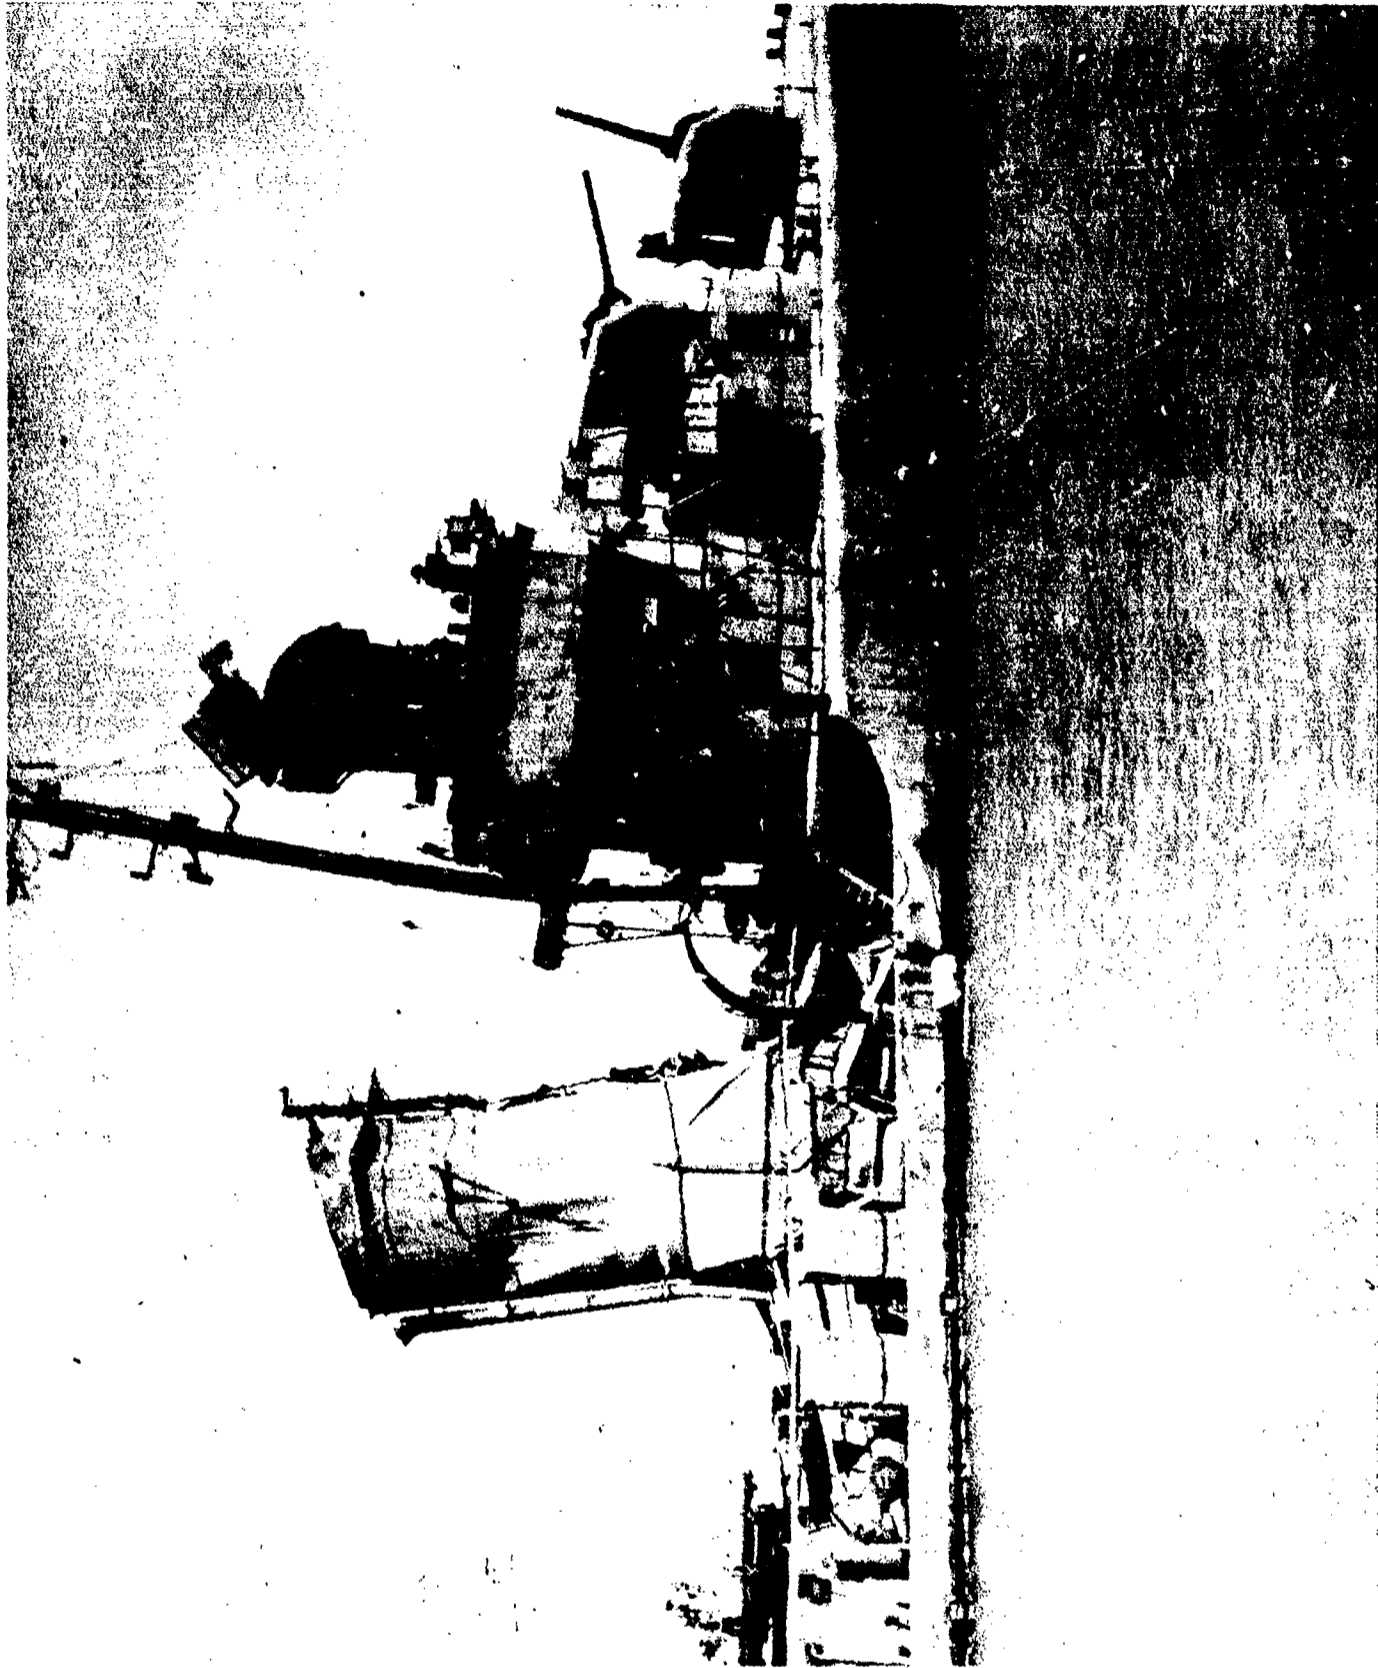
AB-CR-59-2996-4. View of forward superstructure from starboard side amidships.

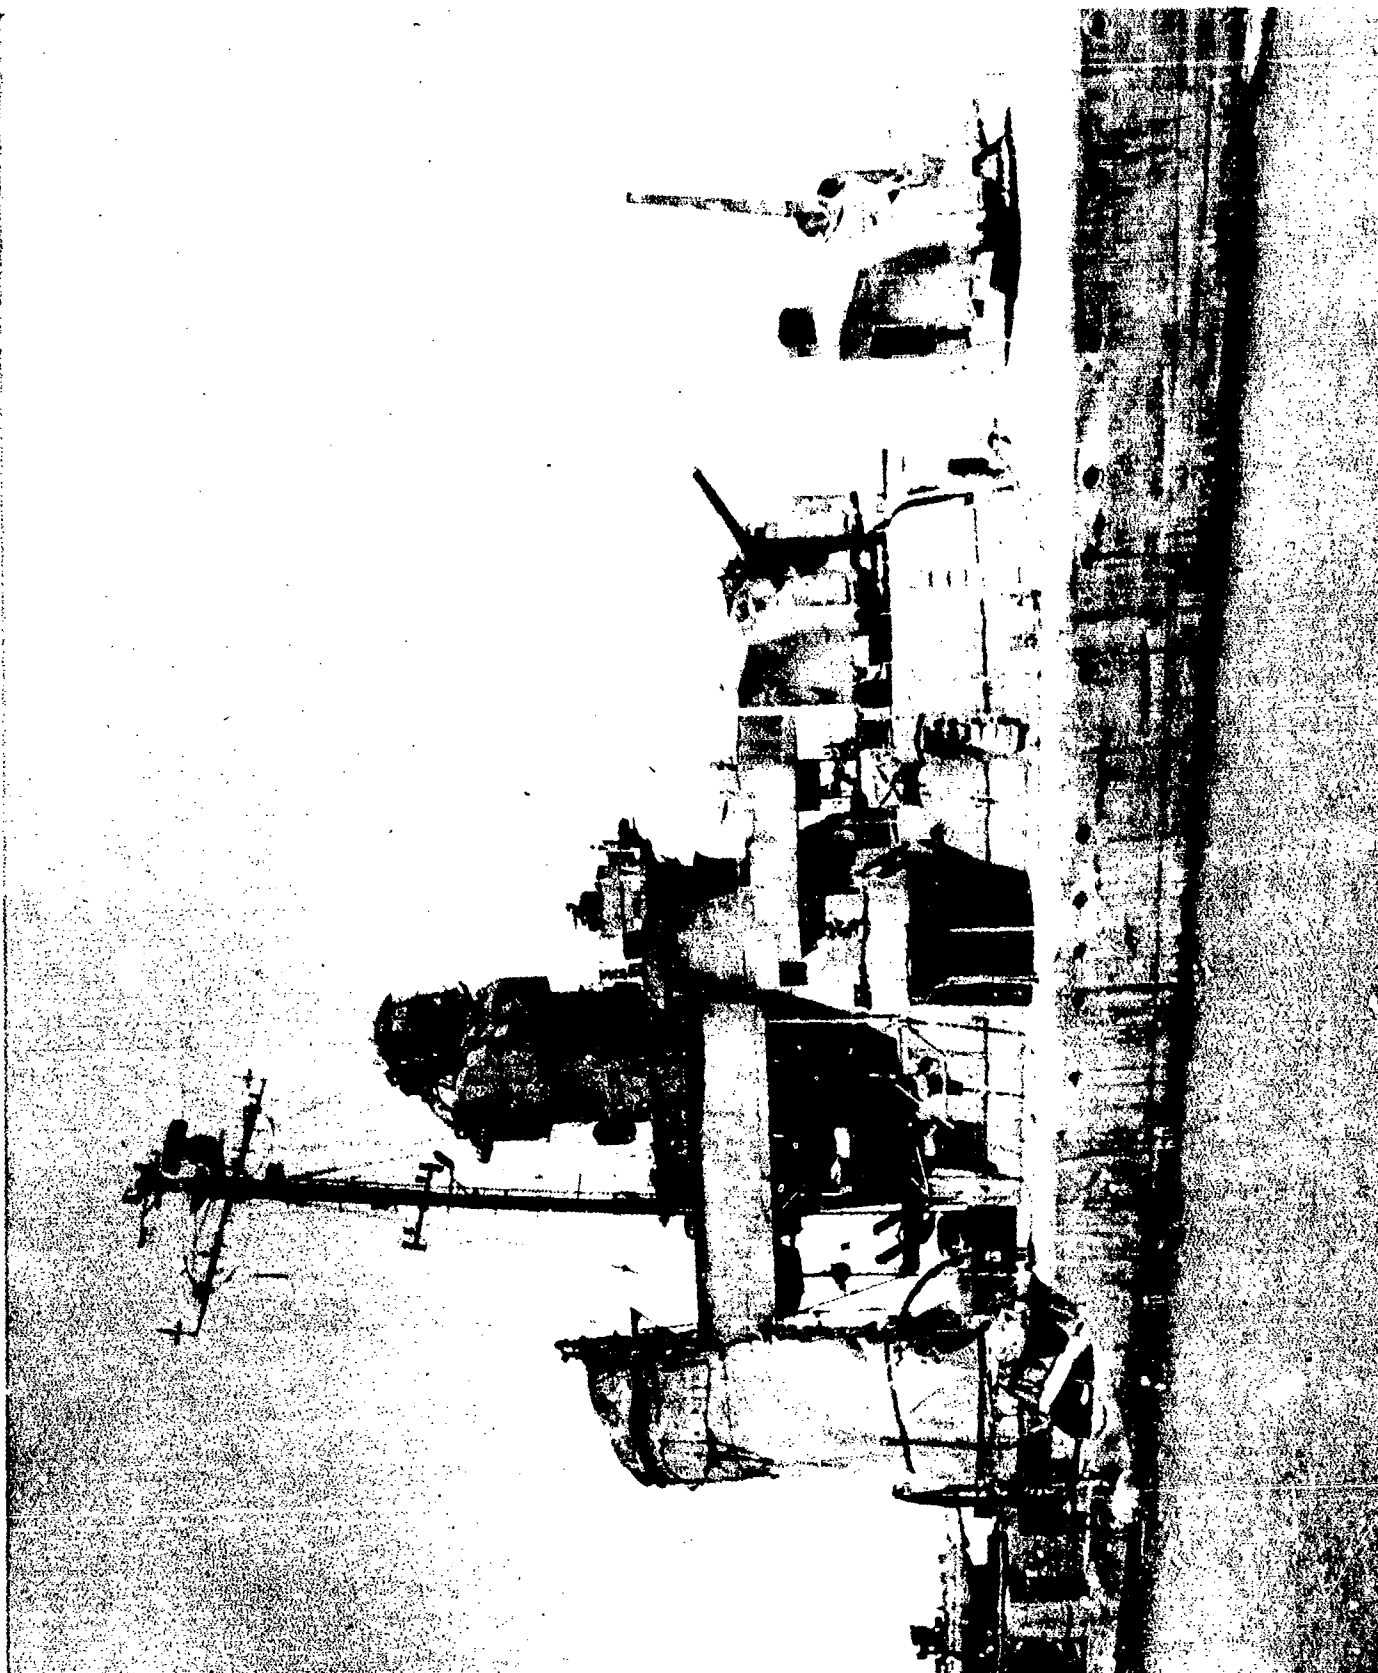
AB-CR-59-2996-5. View of superstructure from off starboard bow.
