BUREAU OF SHIPS GROUP
TECHNICAL INSPECTION REPORT

⑥ OPERATION CROSSROADS.
U.S.S HUGHES (DD410).
TEST BAKER.

VOLUME II [u] ⑧

USS HUGHES (DD410)

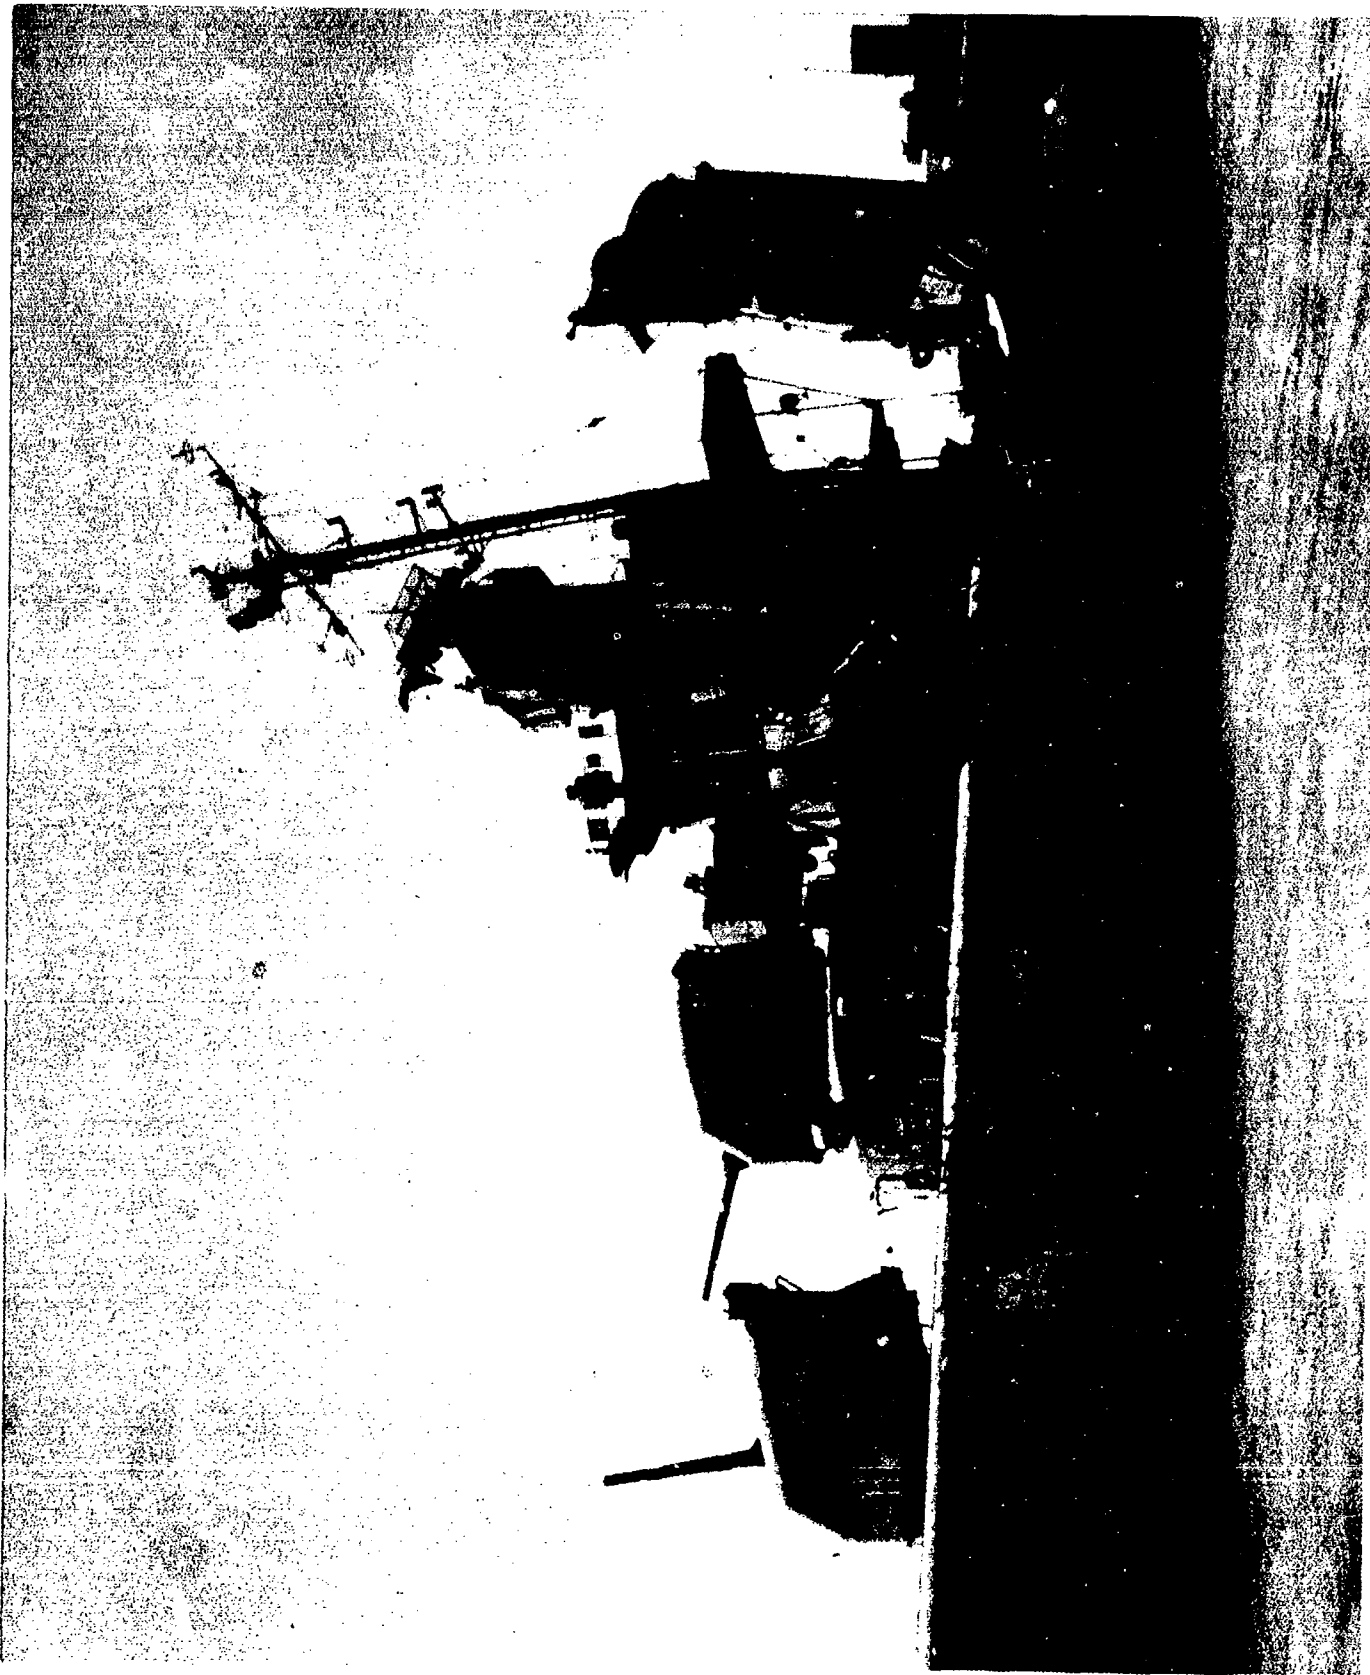
AB-CR-59-2996-11. View of forward superstructure from off port bow after beaching.

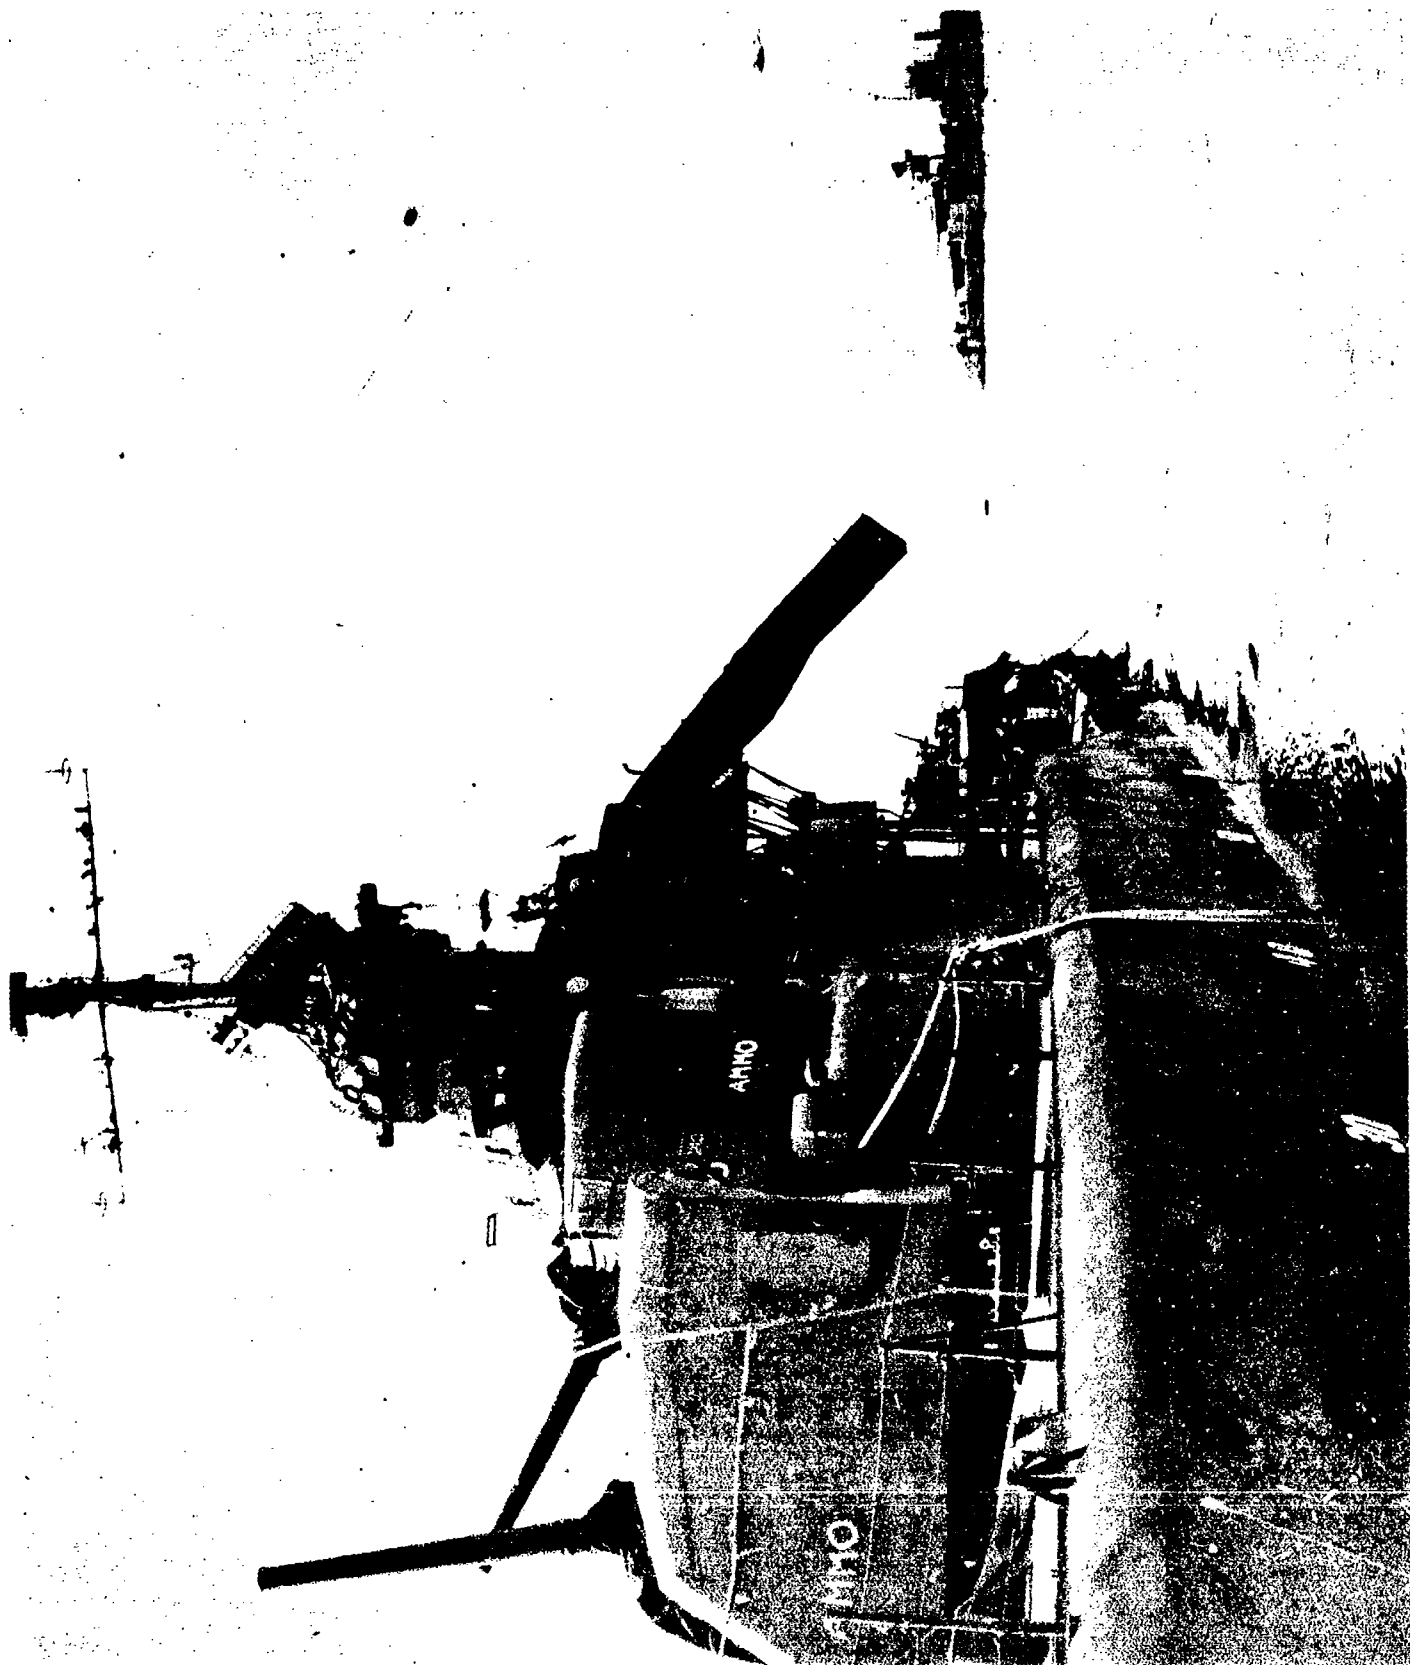
AB-CR-80-2061-9. View of superstructure from port bow. A section of the port bulwark has been torn away from the navigation bridge before beaching.

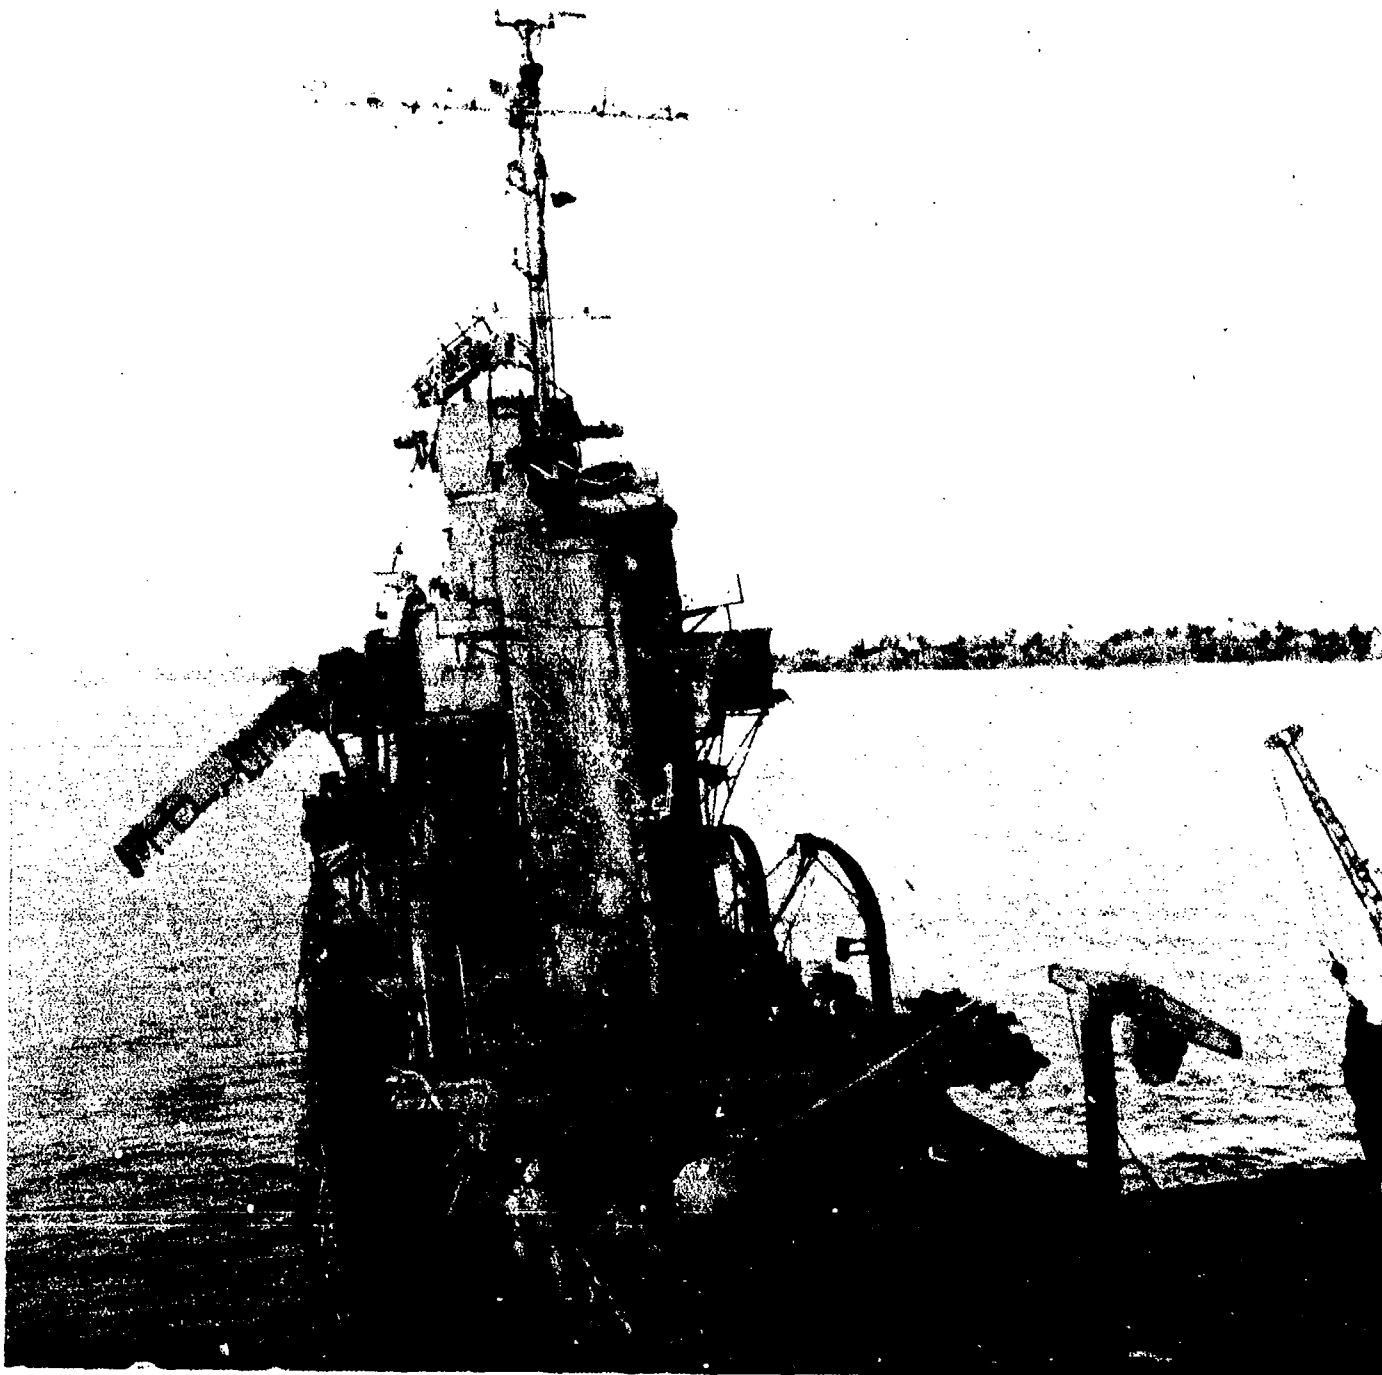
AB-CR-80-2062-5. View of superstructure looking forward from port 40MM gun director platform.

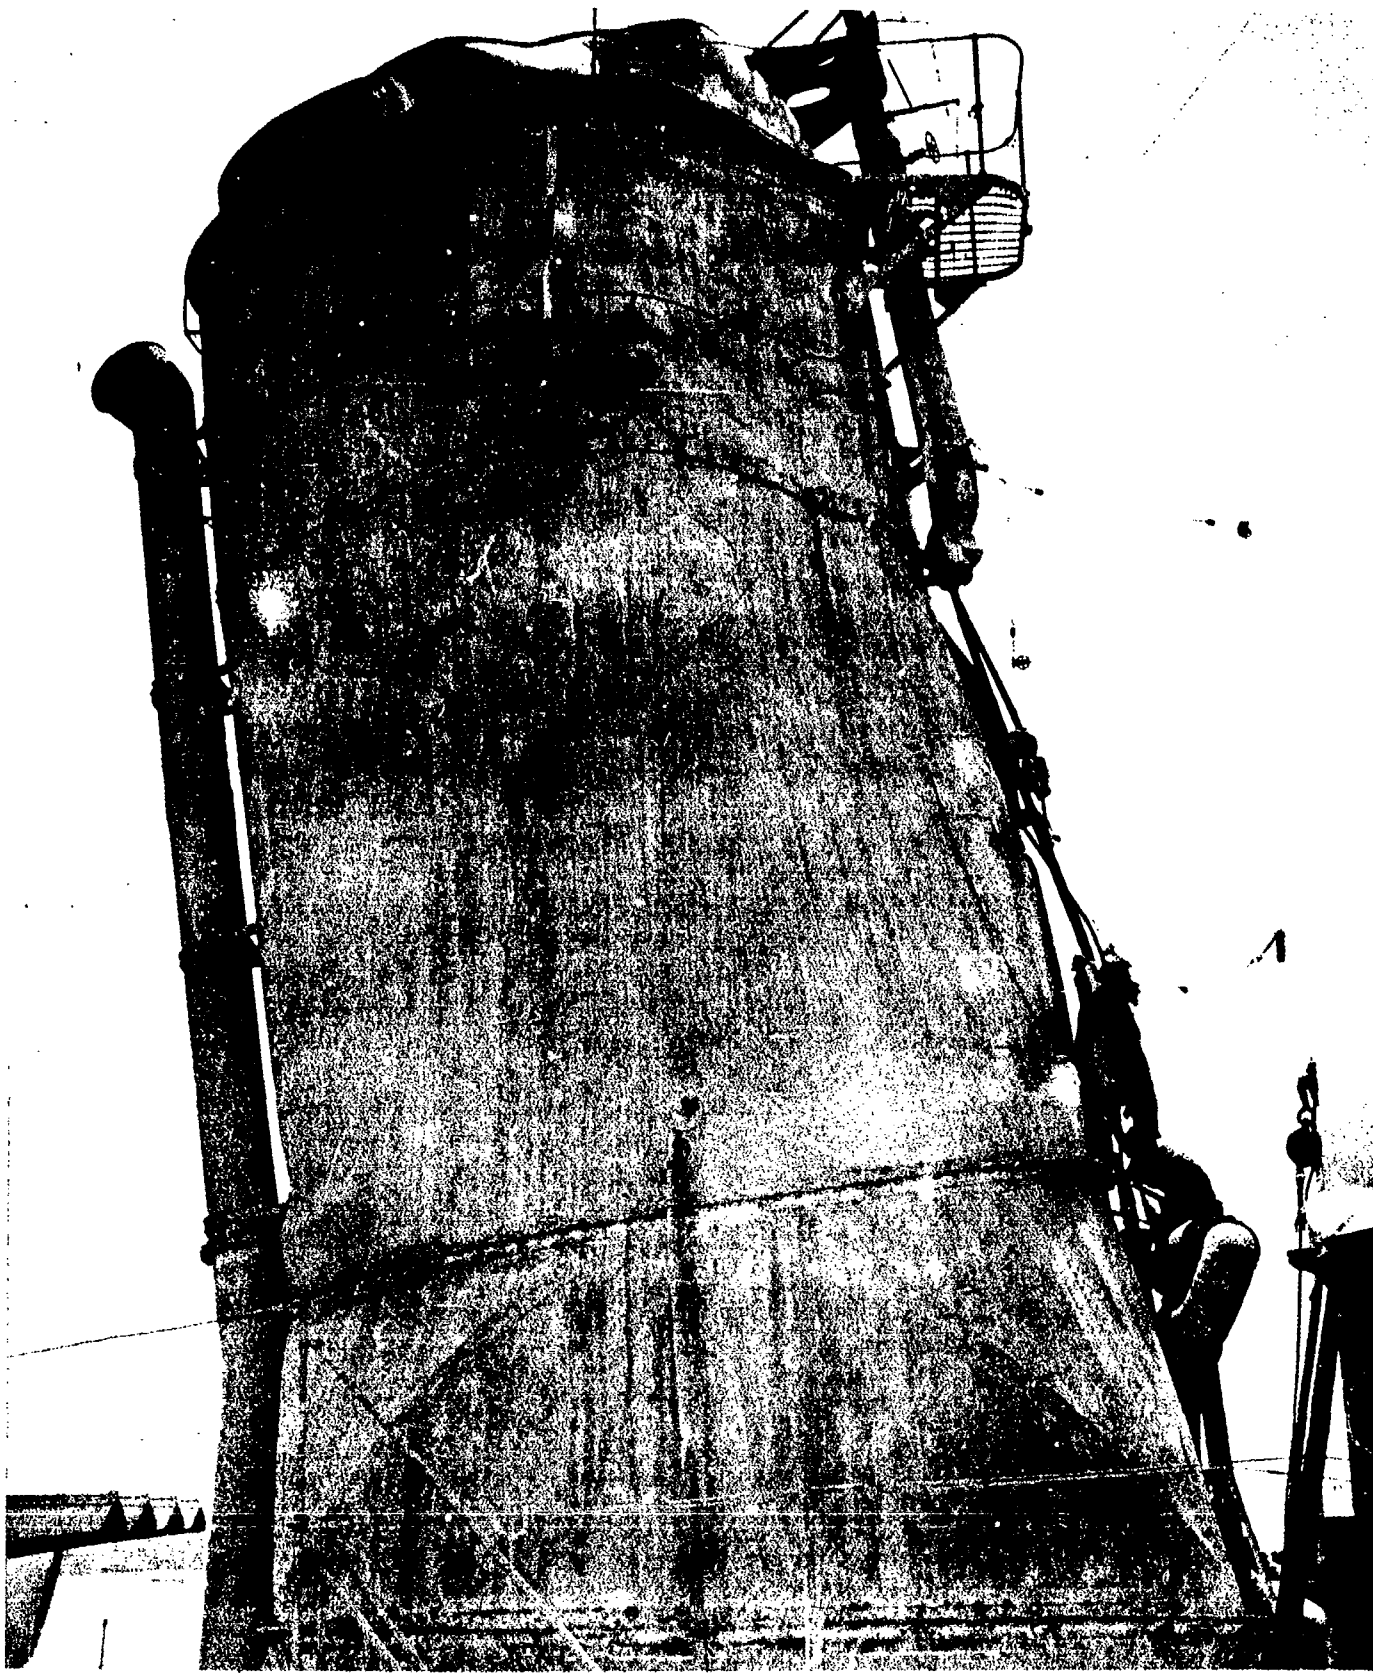
AB-CR-76-2077-2. Starboard side of stack.

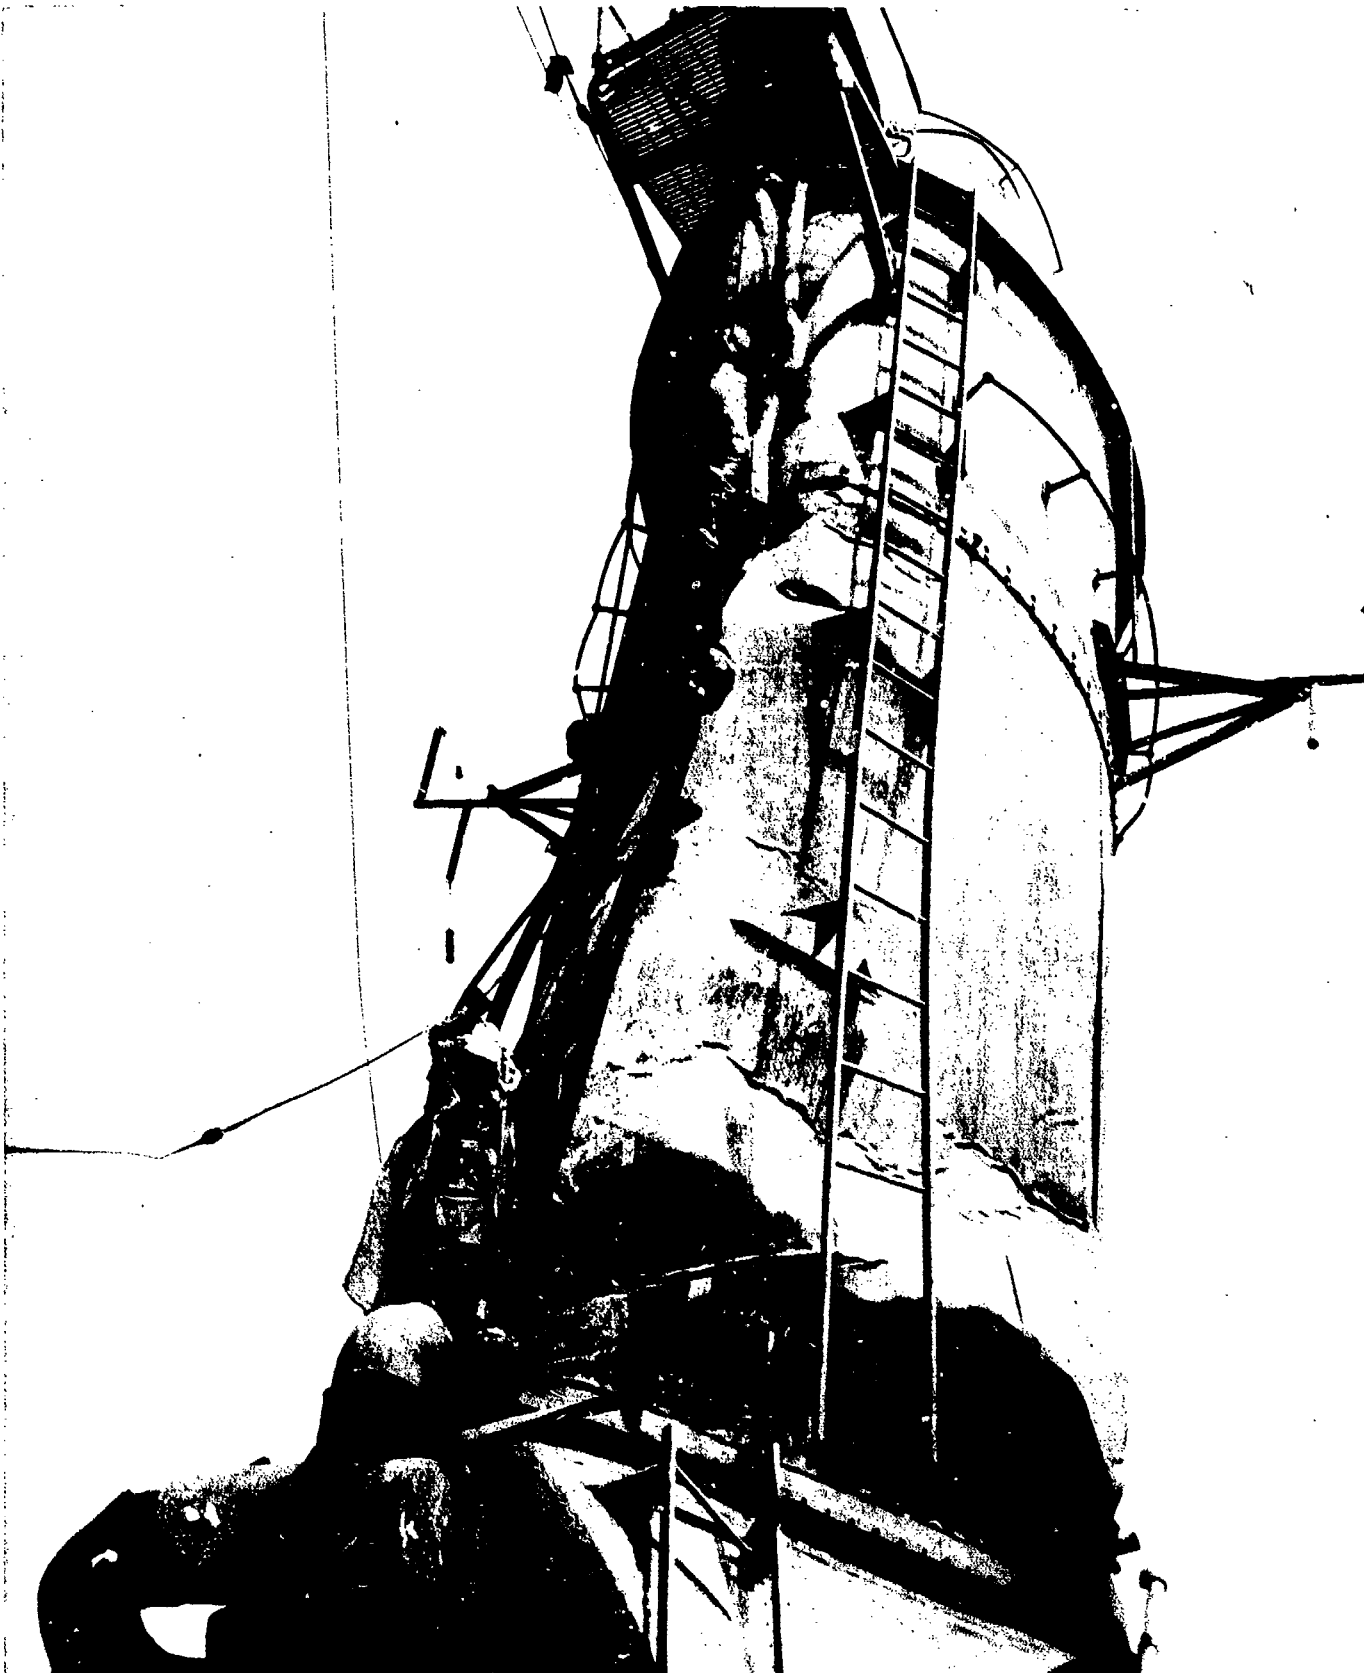
AB-CR-76-2077-5. Looking aft and to starboard at forward and port faces of stack.

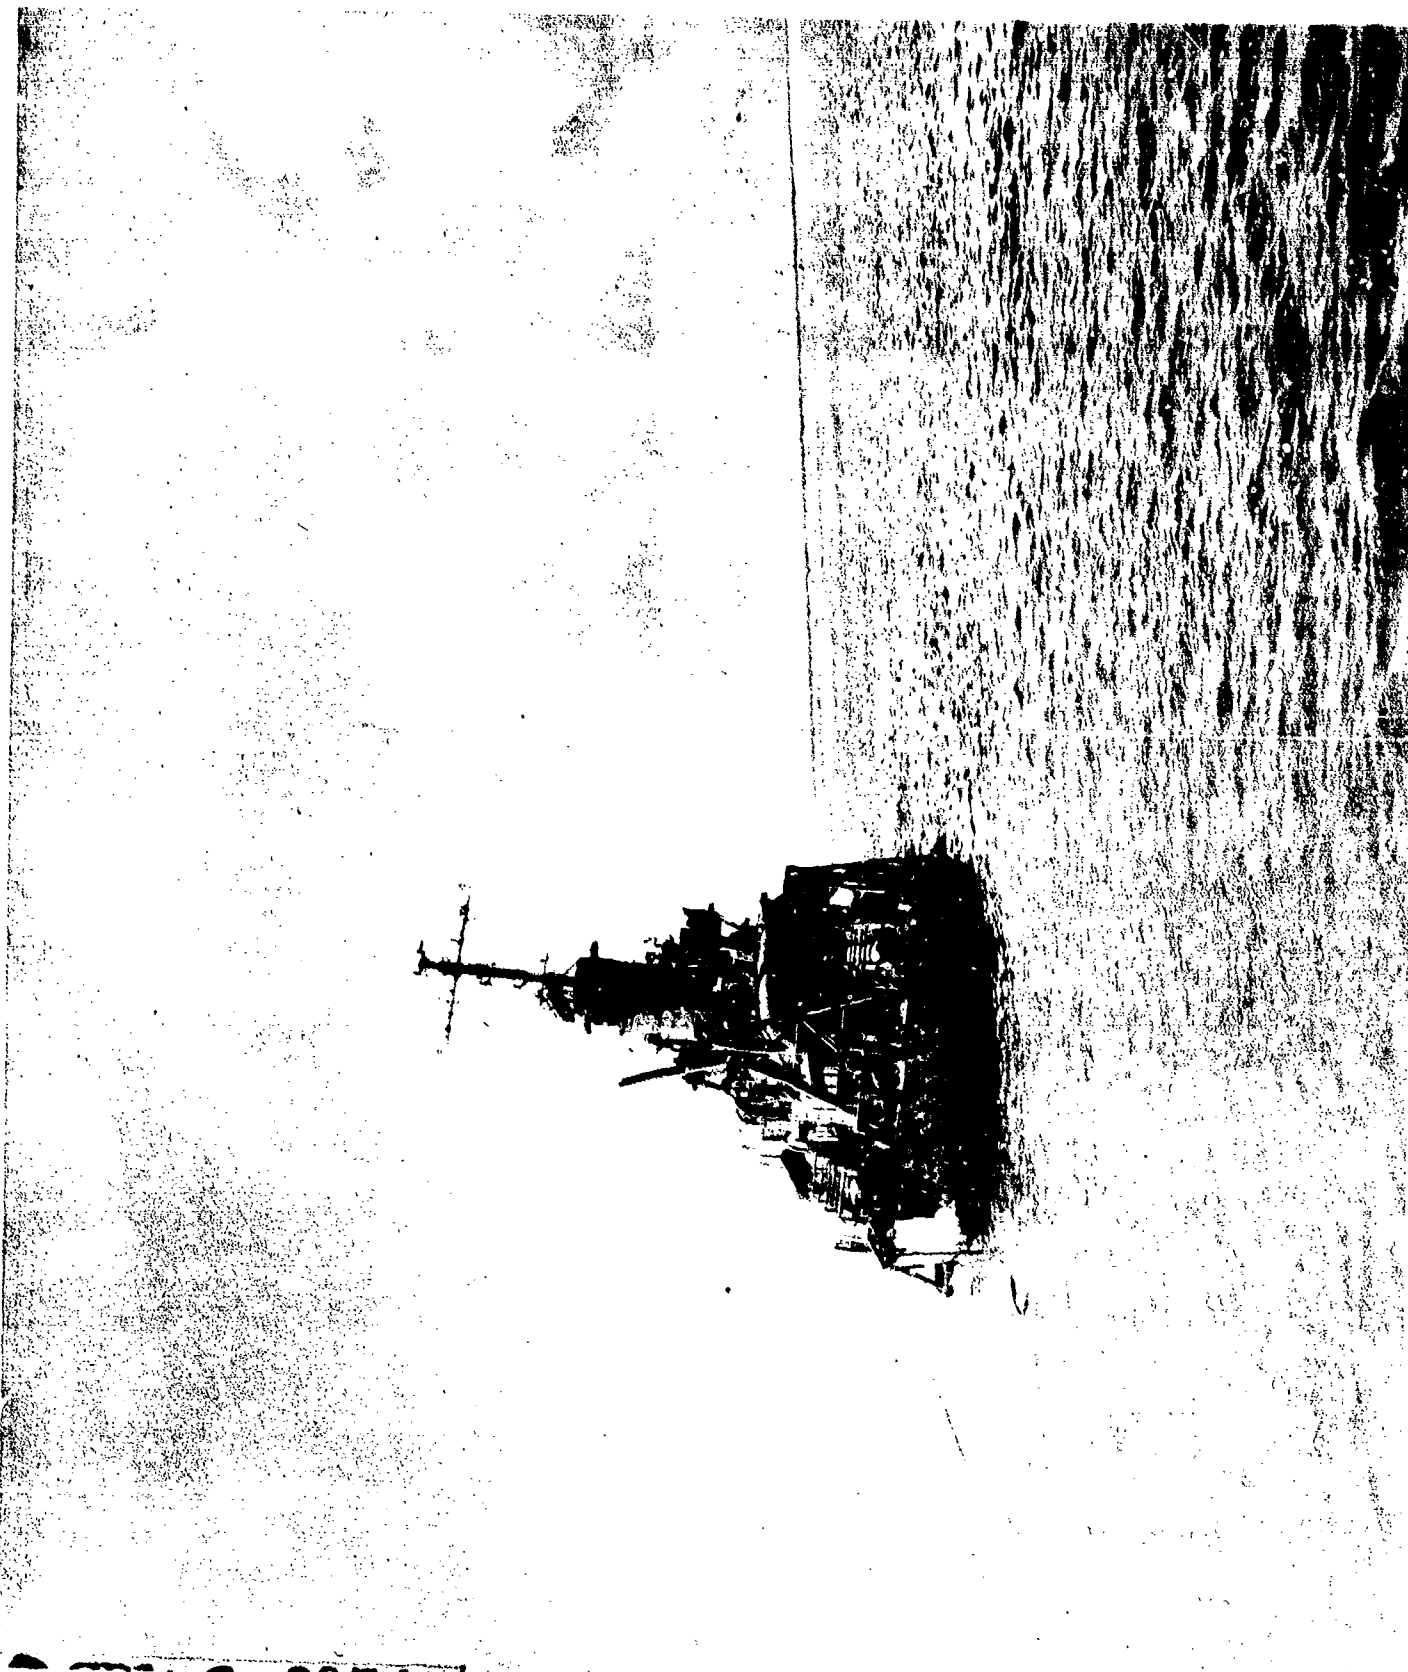
AB-CR-79-2974-4. View of ship after grounding from dead astern.

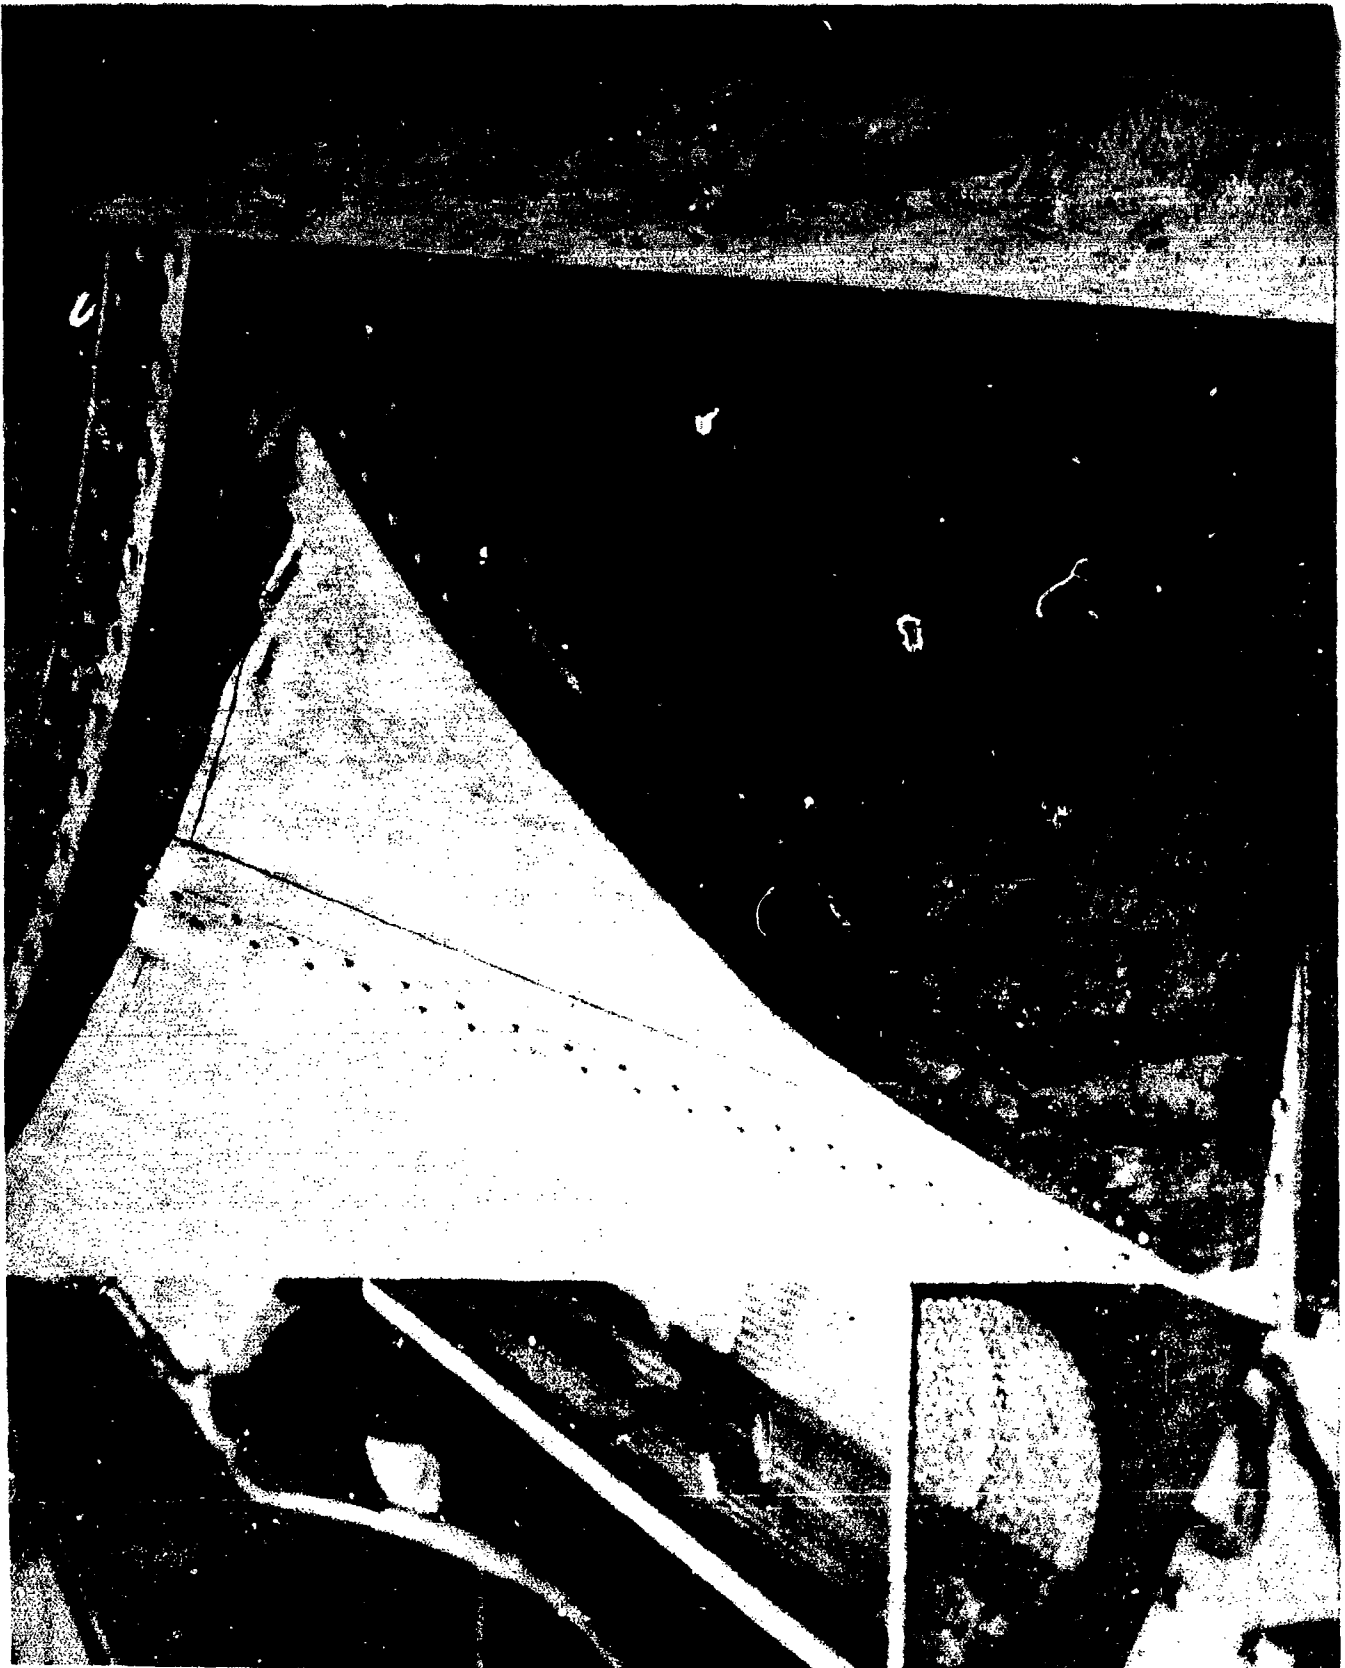
AB-CR-76-2077-10. Looking forward at after port side of stack transition piece.

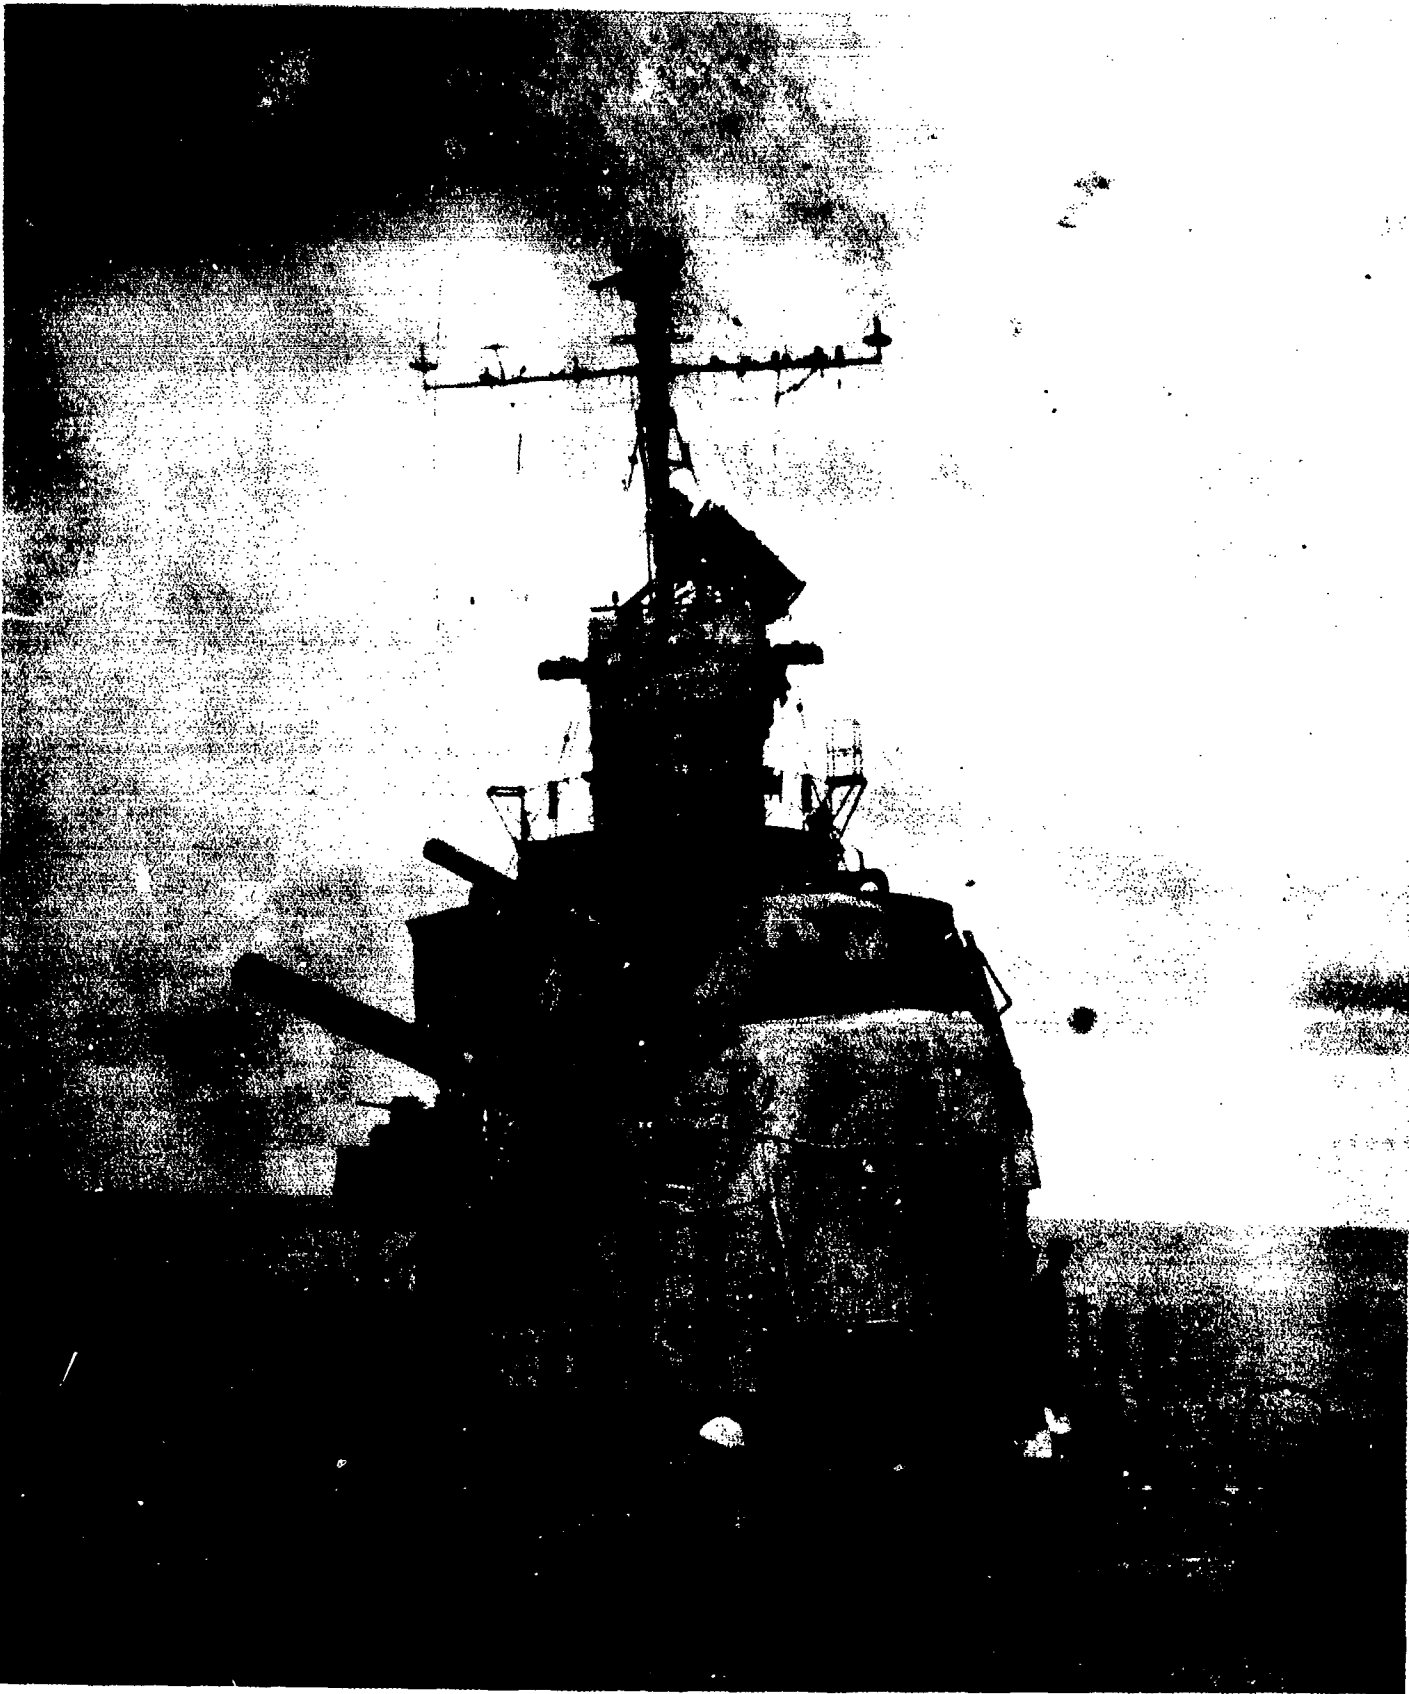
AB-CR-100-4204-1. General view of forecastle showing mounts.

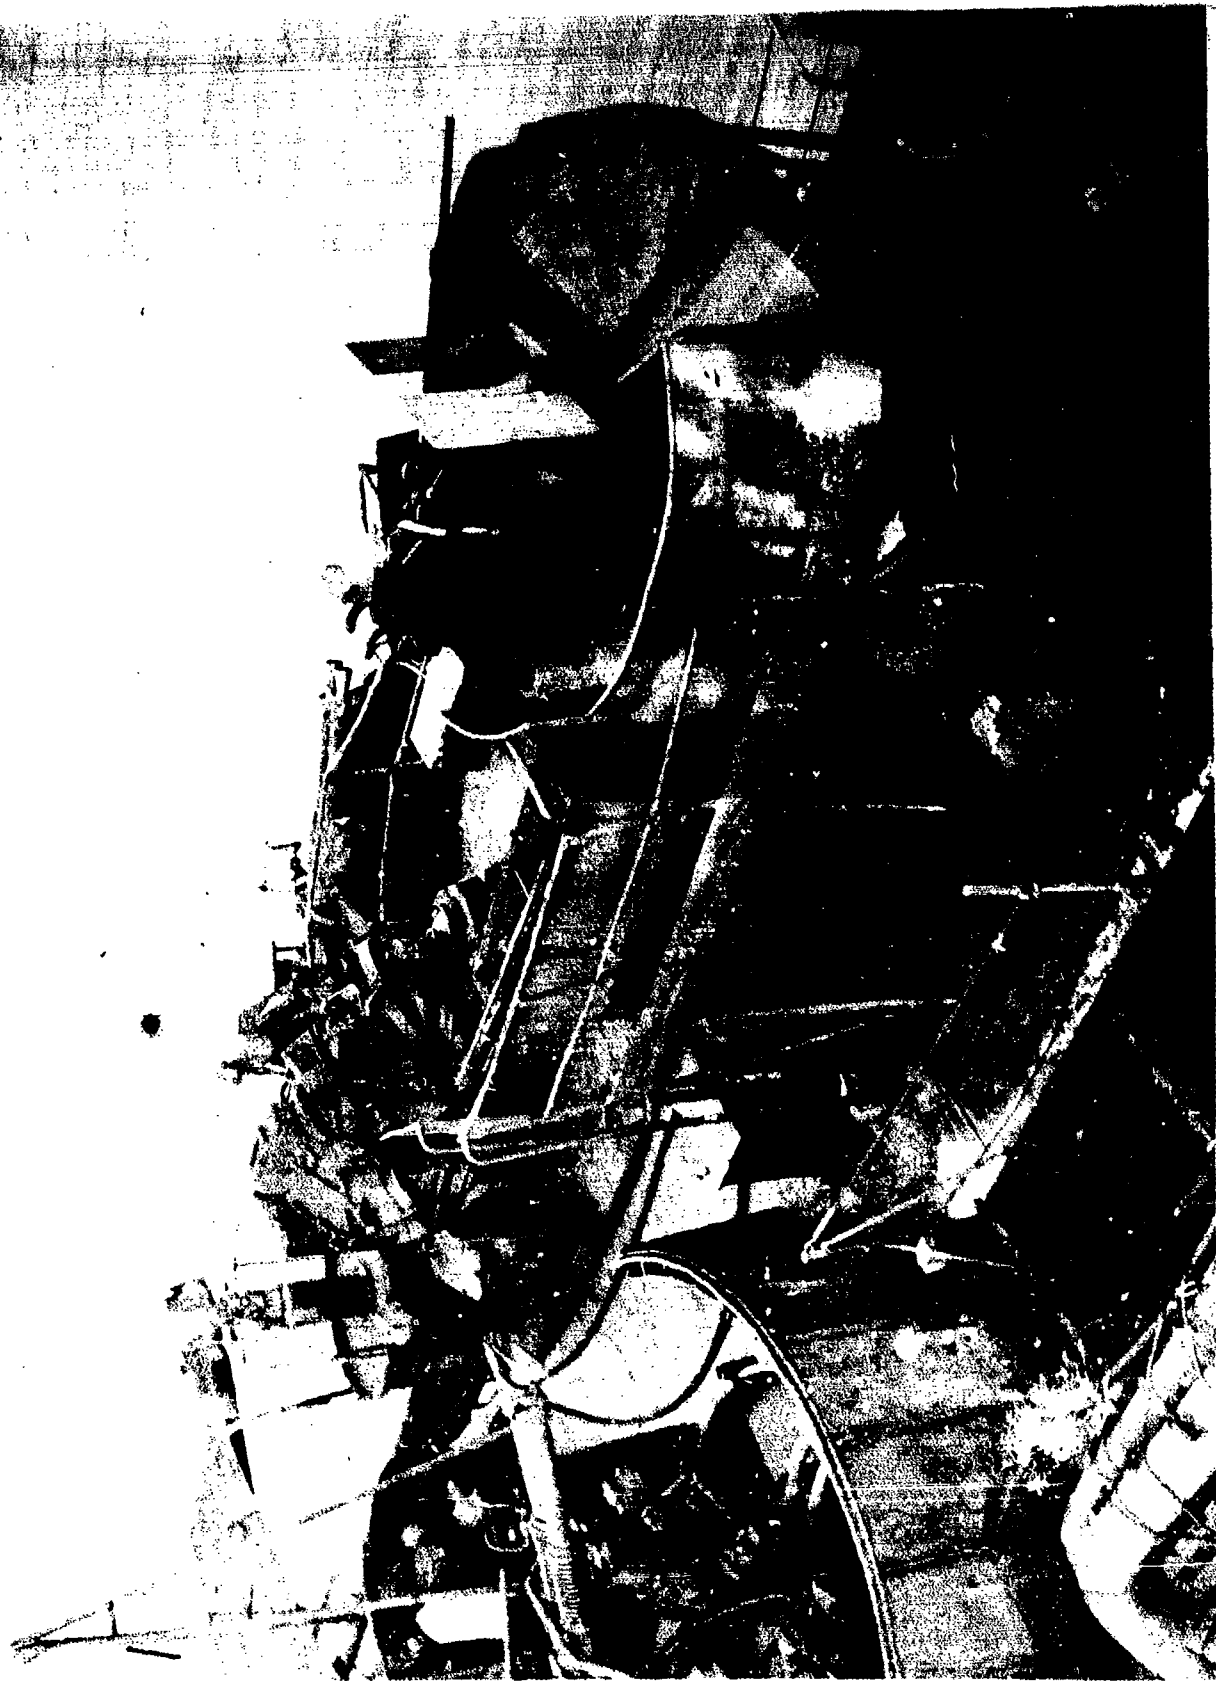
AB-CR-80-2062-3. Damage on after searchlight and gun platform, port.

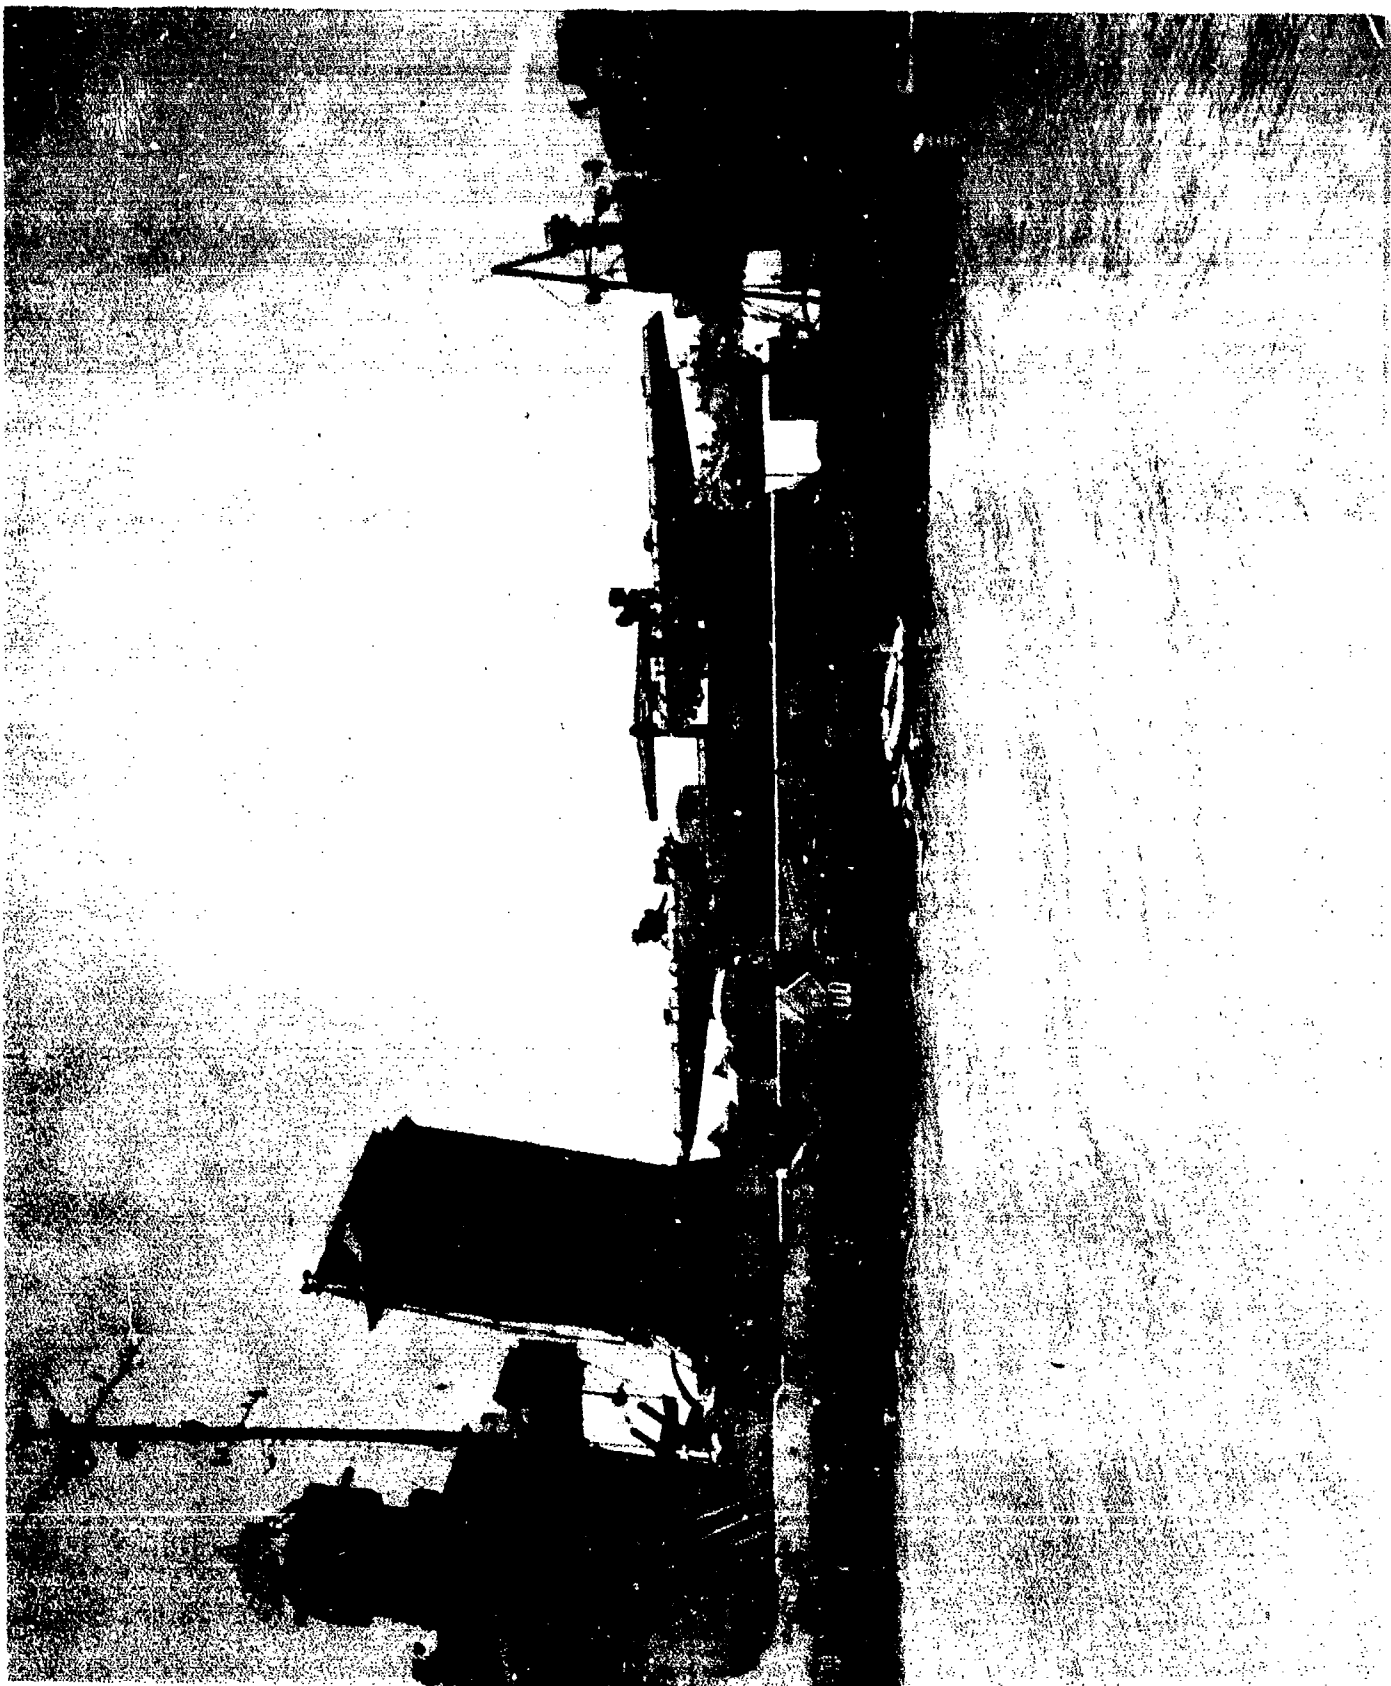
AB-CR-59-2996-9. View of superstructure amidships from port side after beaching.
