BUREAU OF SHIPS GROUP
TECHNICAL INSPECTION REPORT

⑥ OPERATION CROSSROADS.
U.S.S HUGHES (DD410).
TEST BAKER.

VOLUME II [u] ⑧

USS HUGHES (DD410)

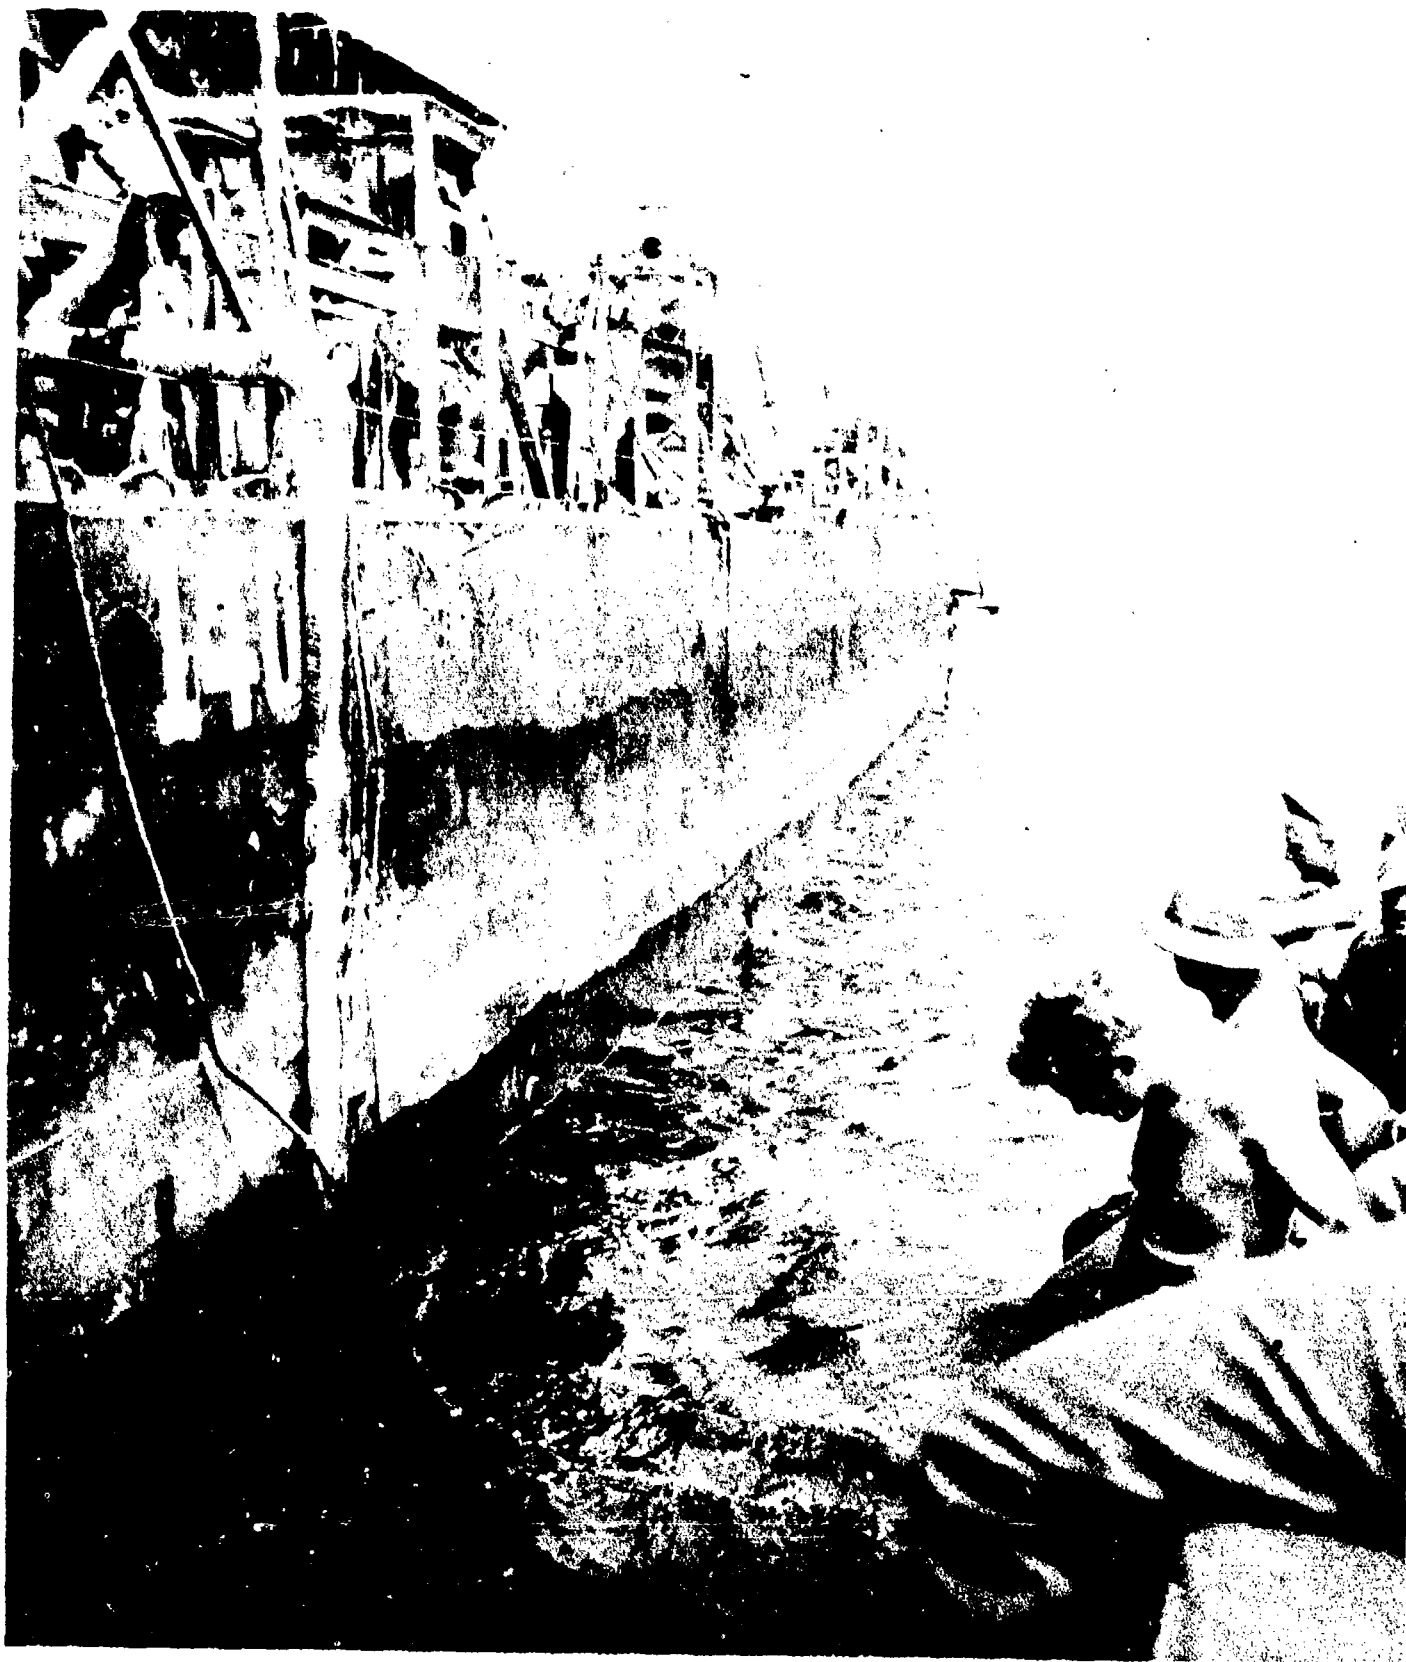
AB-CR-100-4211-11. Port shell, looking aft from frame 140.

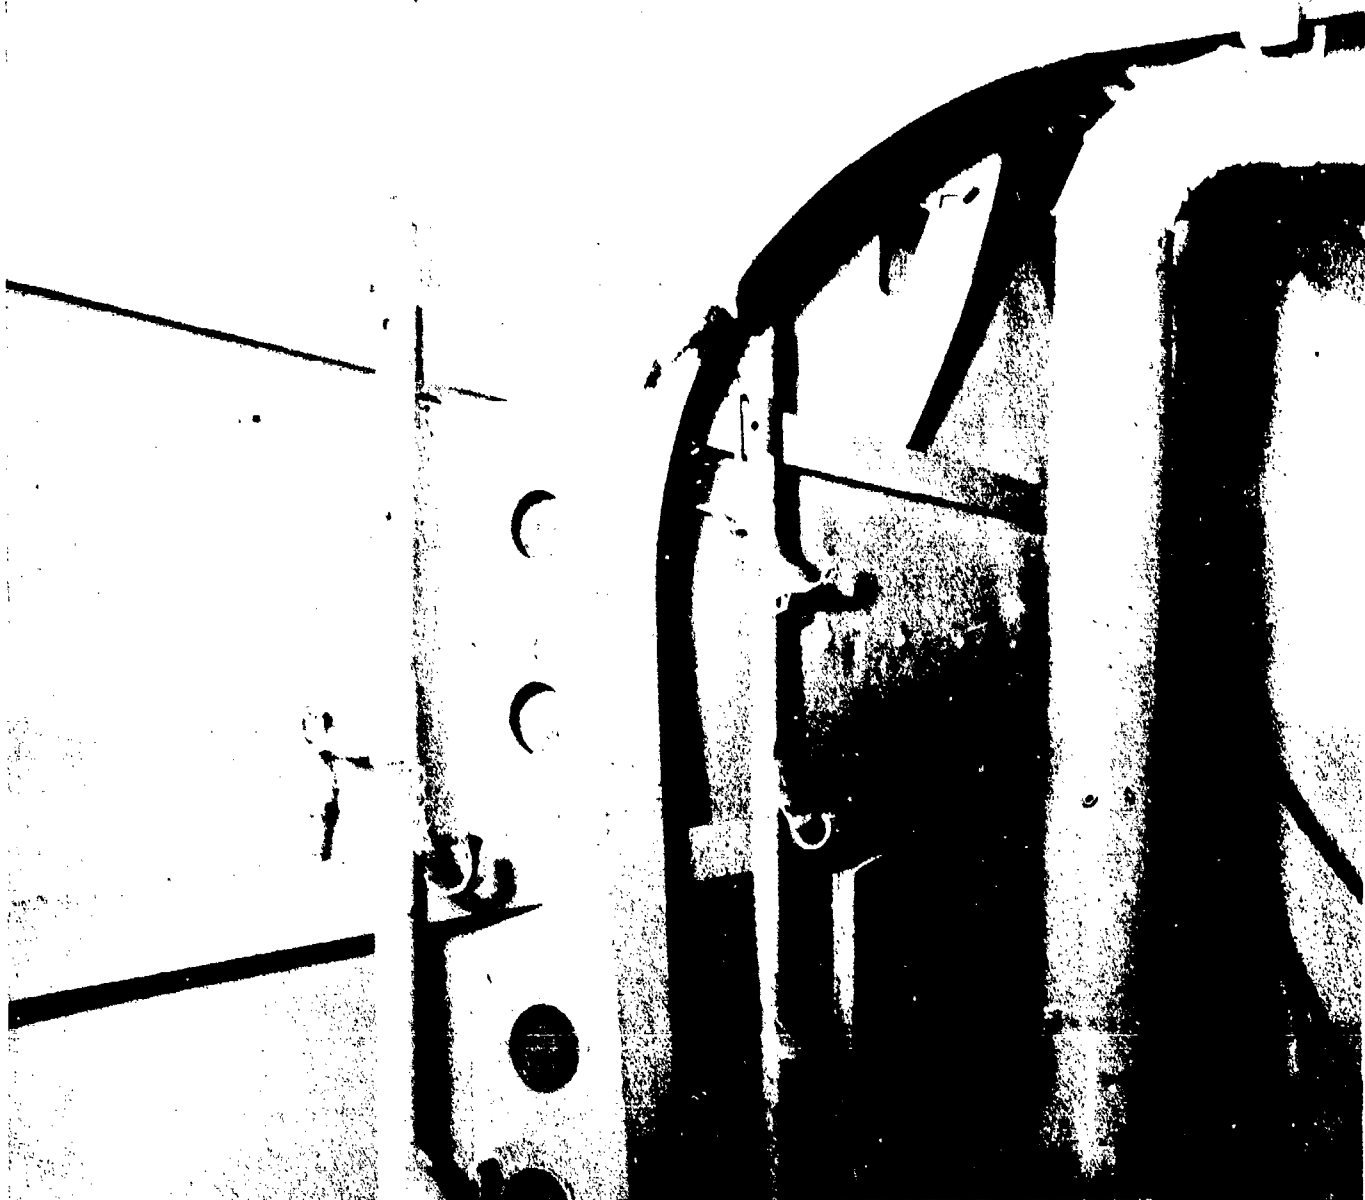
AB-CR-100-4208-9. Damaged web frame 175, port side looking forward on first platform in crews quarters.

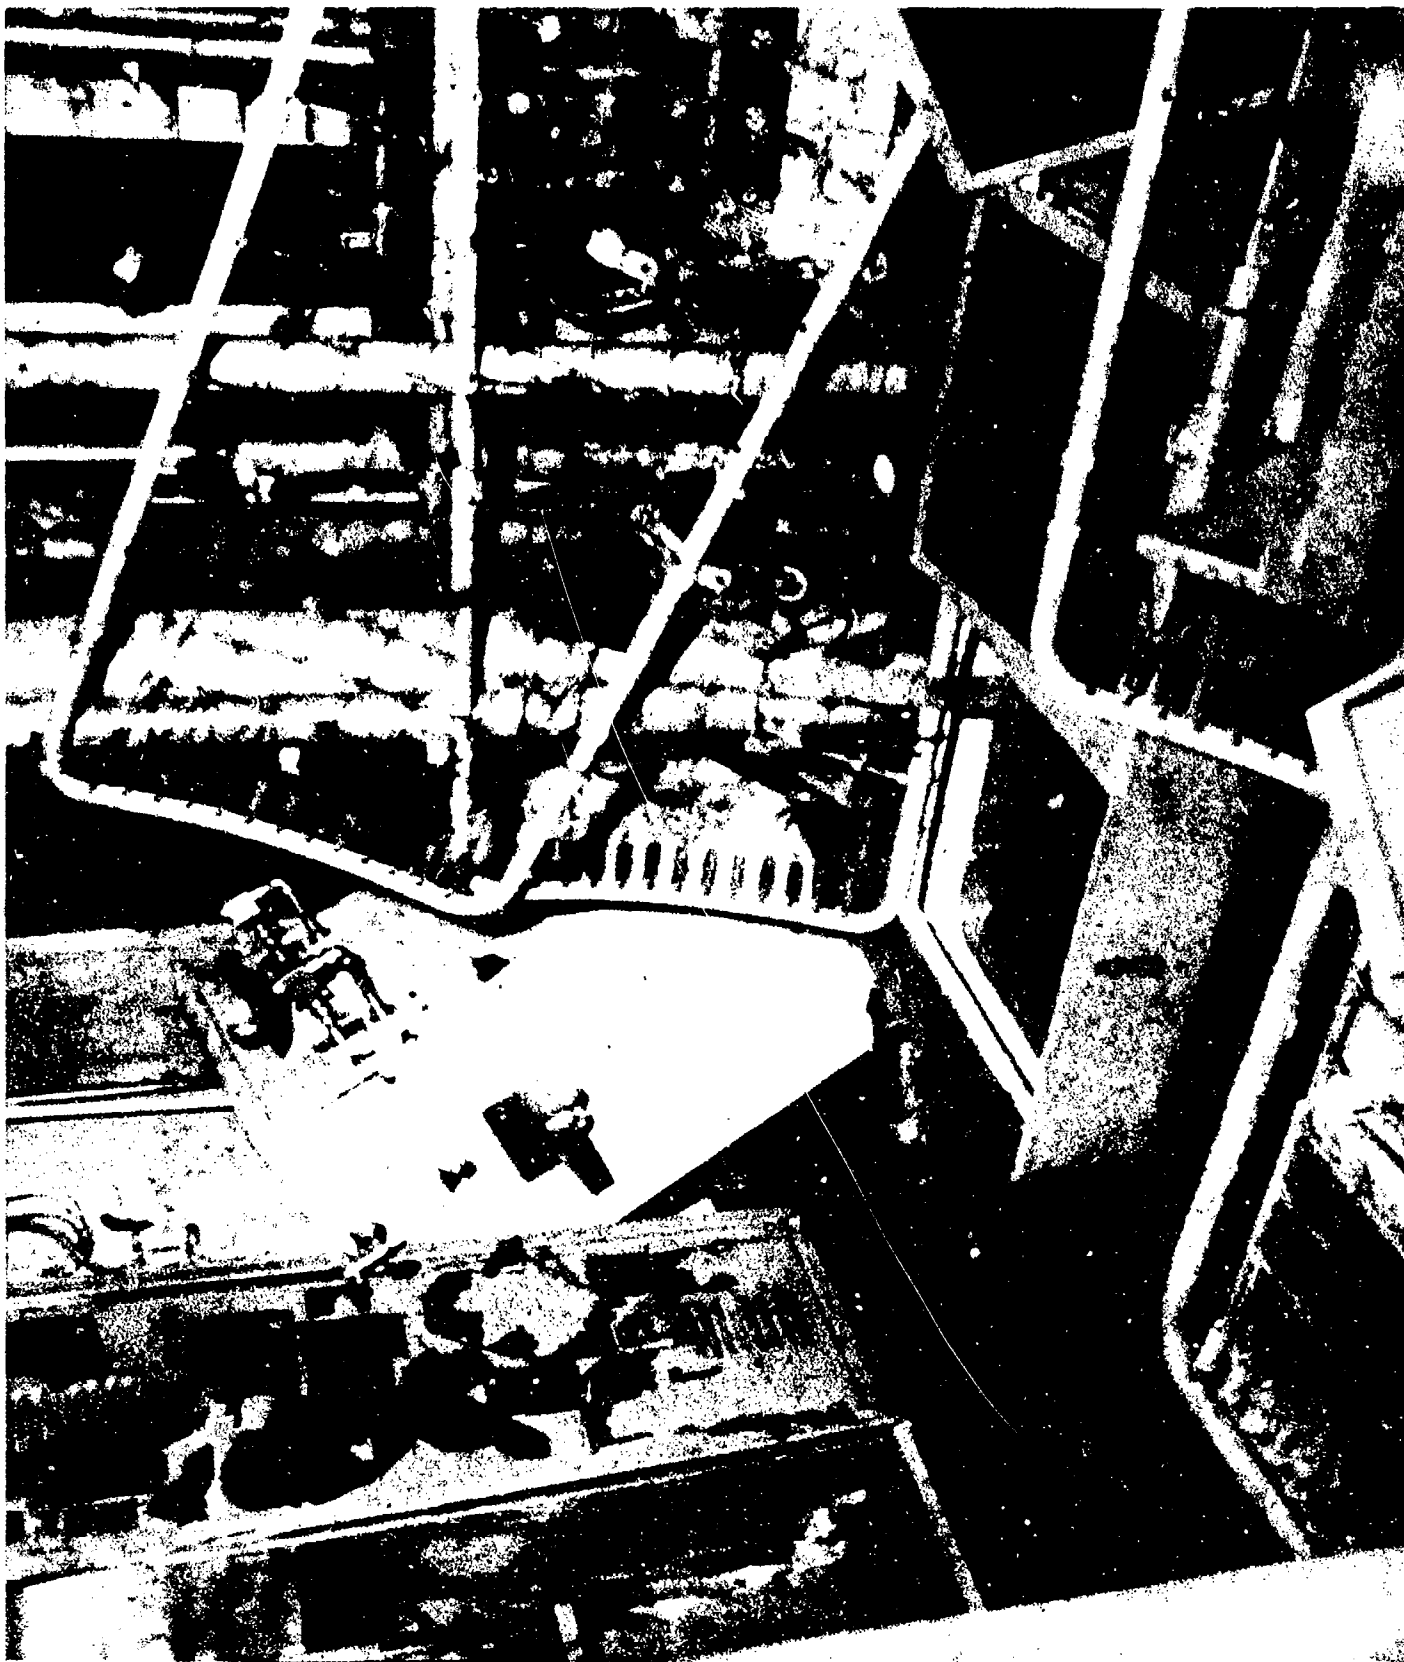
AB-CR-97-4058-12. C-201-L. Crews quarters, 1st platform, looking aft and to port at general disarrangement of equipment.

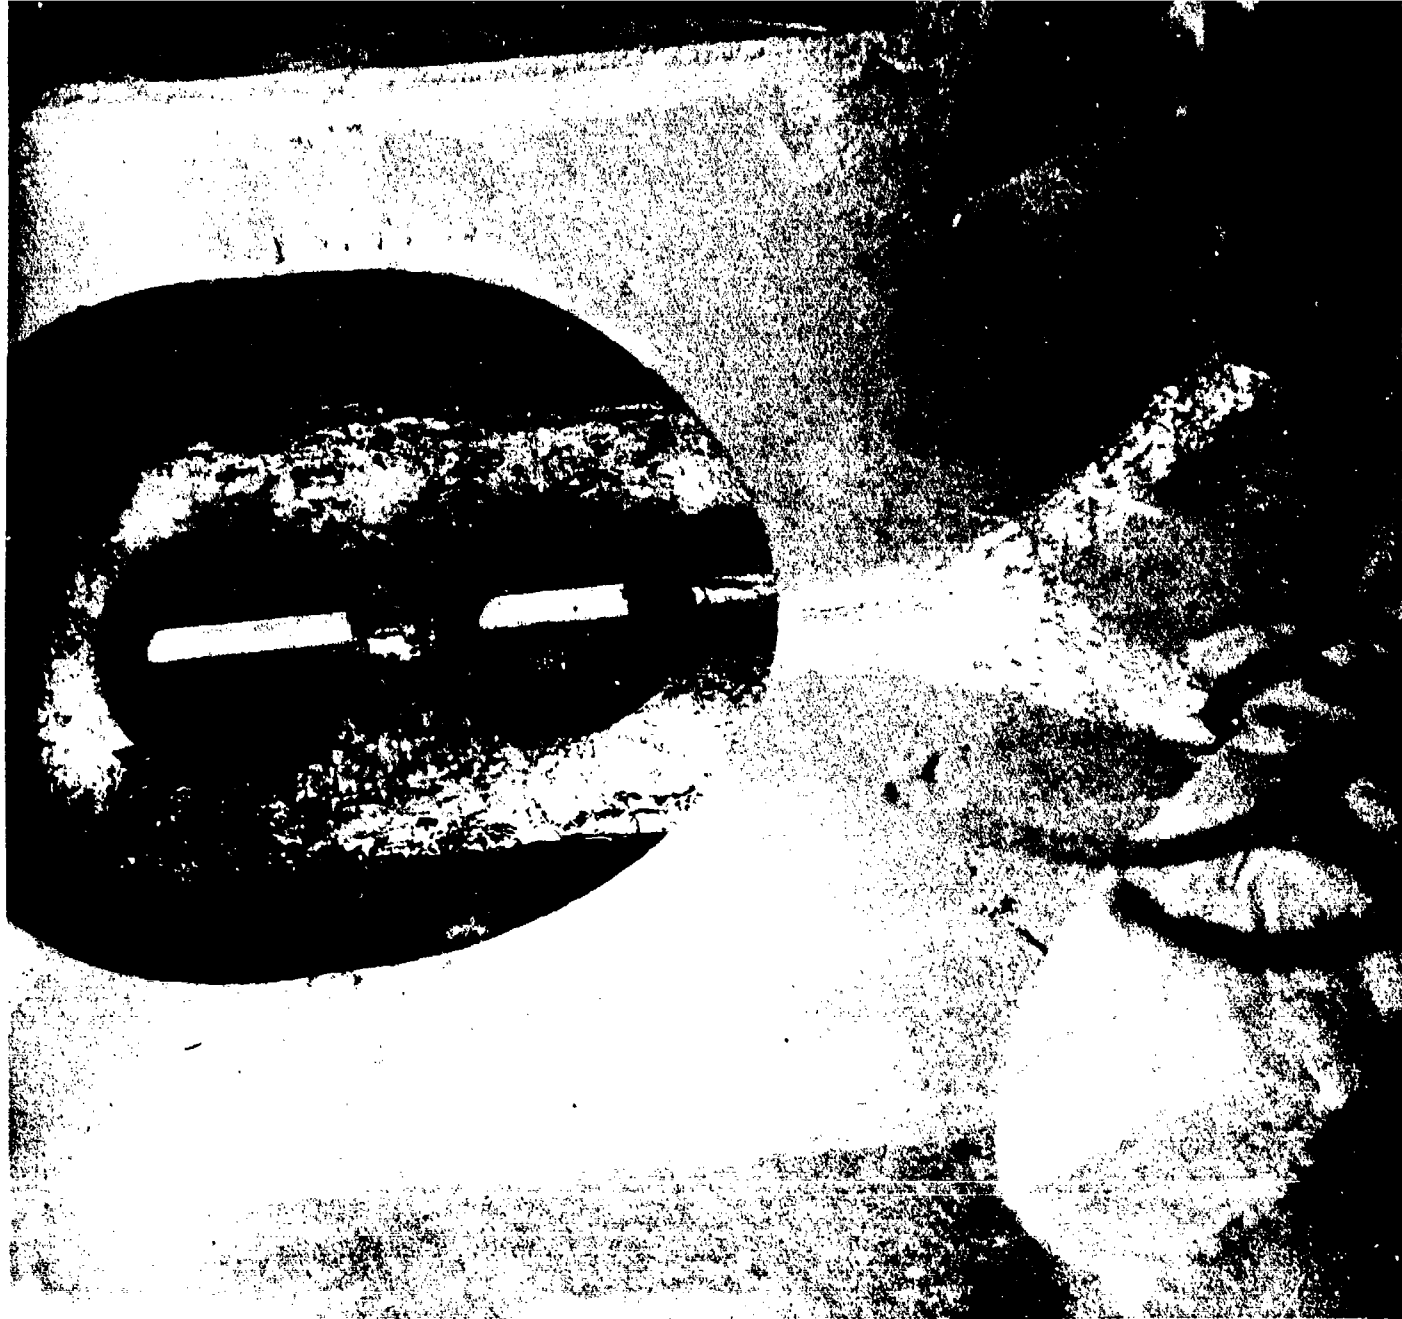
AB-CR-234-4062-6. A-1W. Looking forward in peak tank showing buckled floor at frame 3.

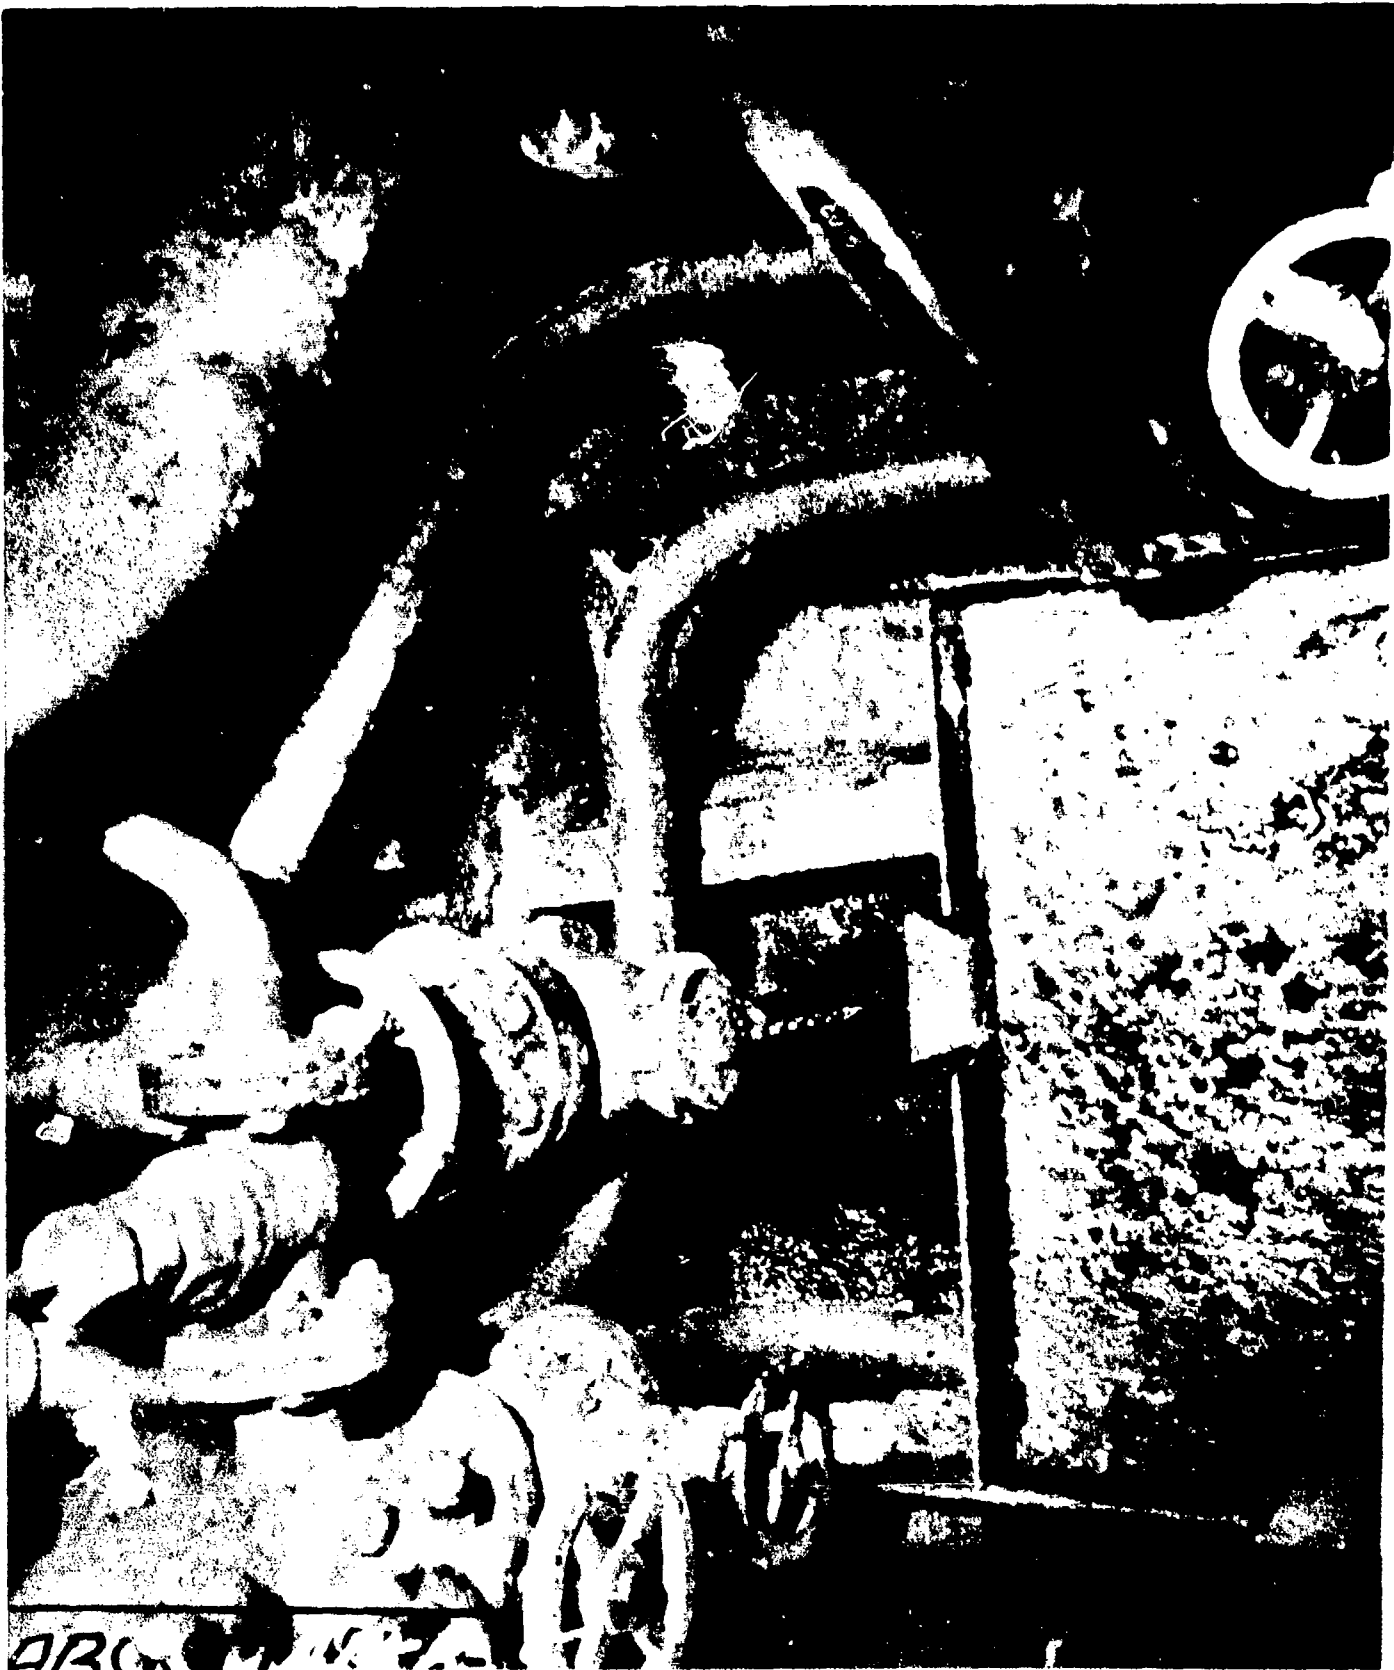
AB-CR-97-4058-5. Aft engine room B-4-1 distorted bottom longitudinal just forward of bulkhead 135, port.

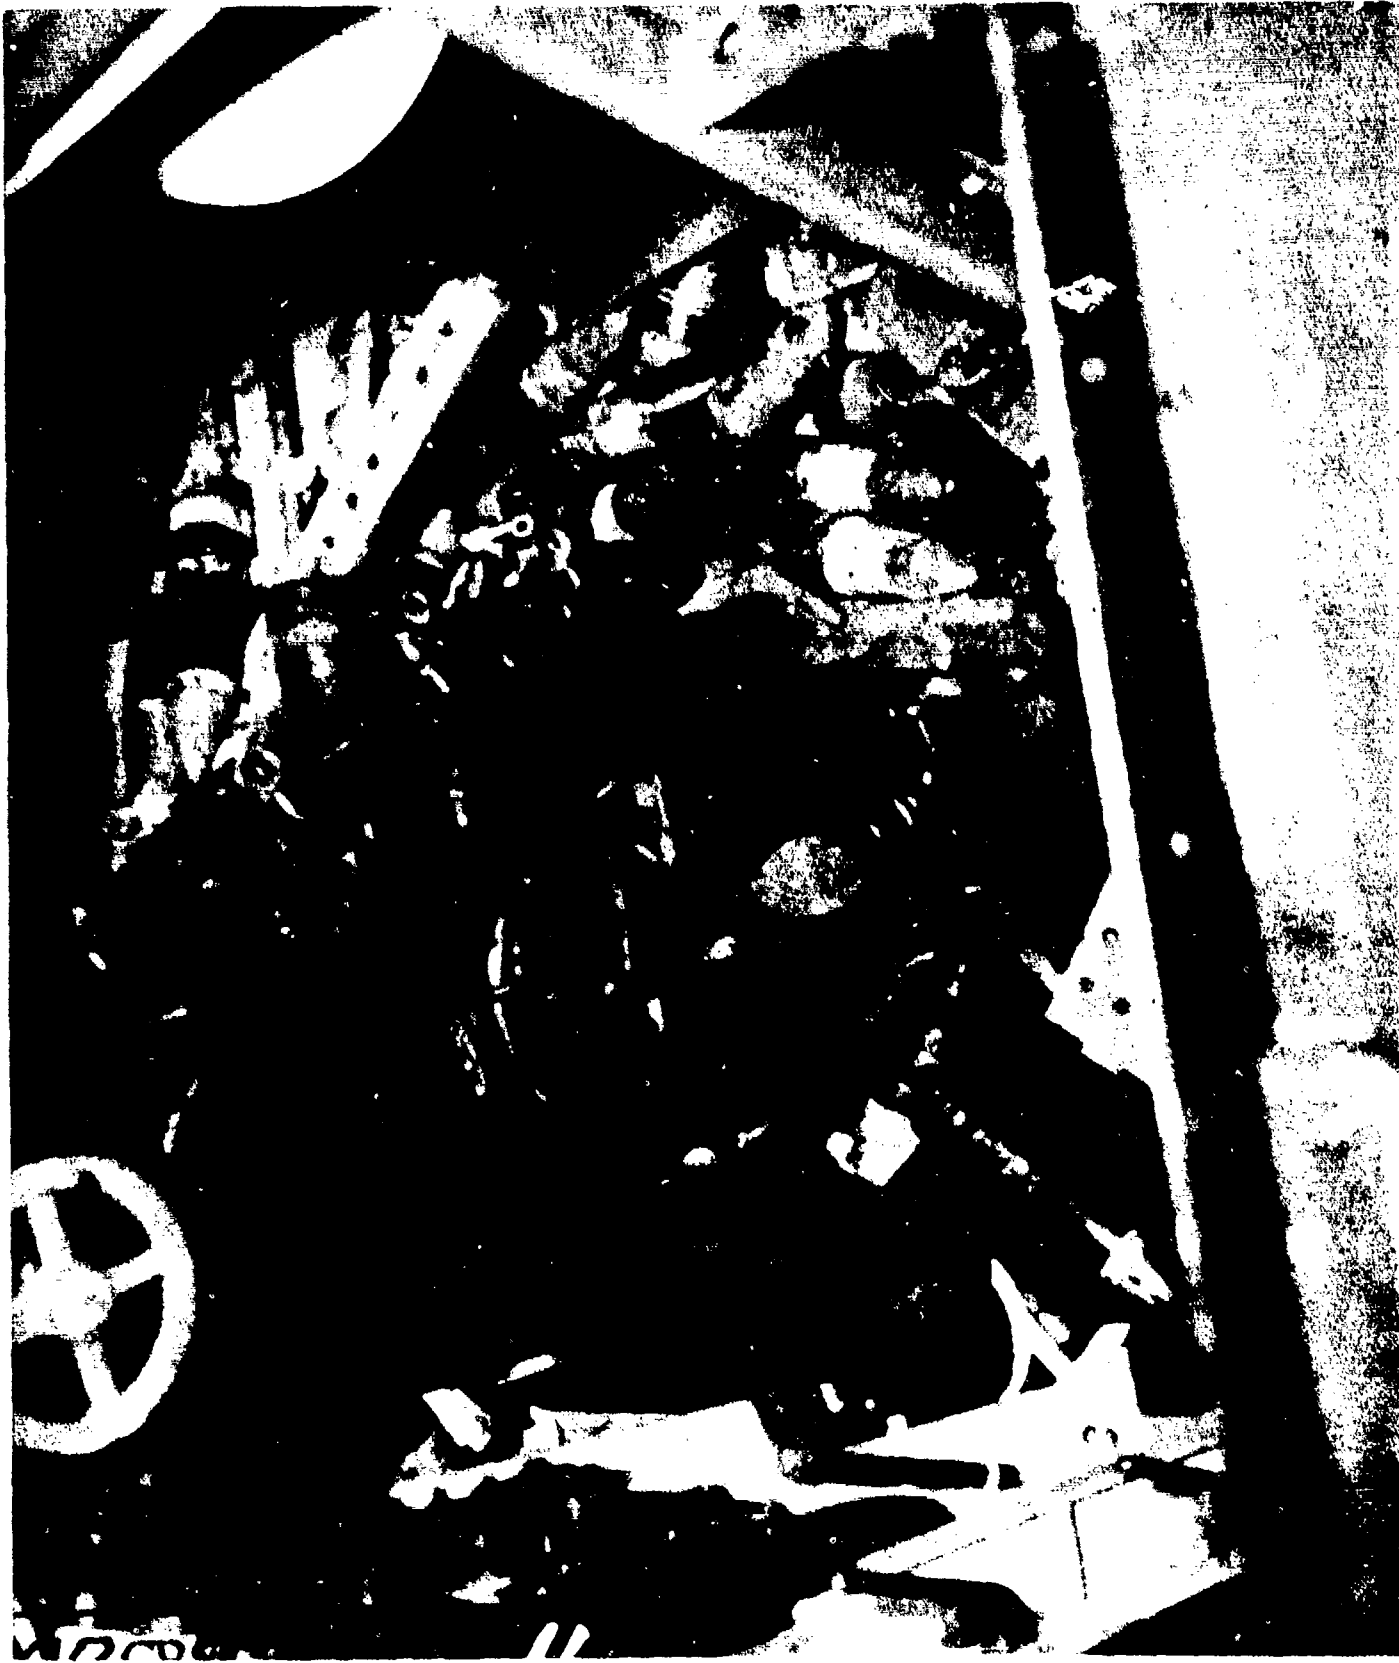
AB-CR-97-4058-11. C-201L. Looking down and to port through 1st platform hatch at frame 146 into 5" handling room C-301M showing disarrangement of projectile stowage.

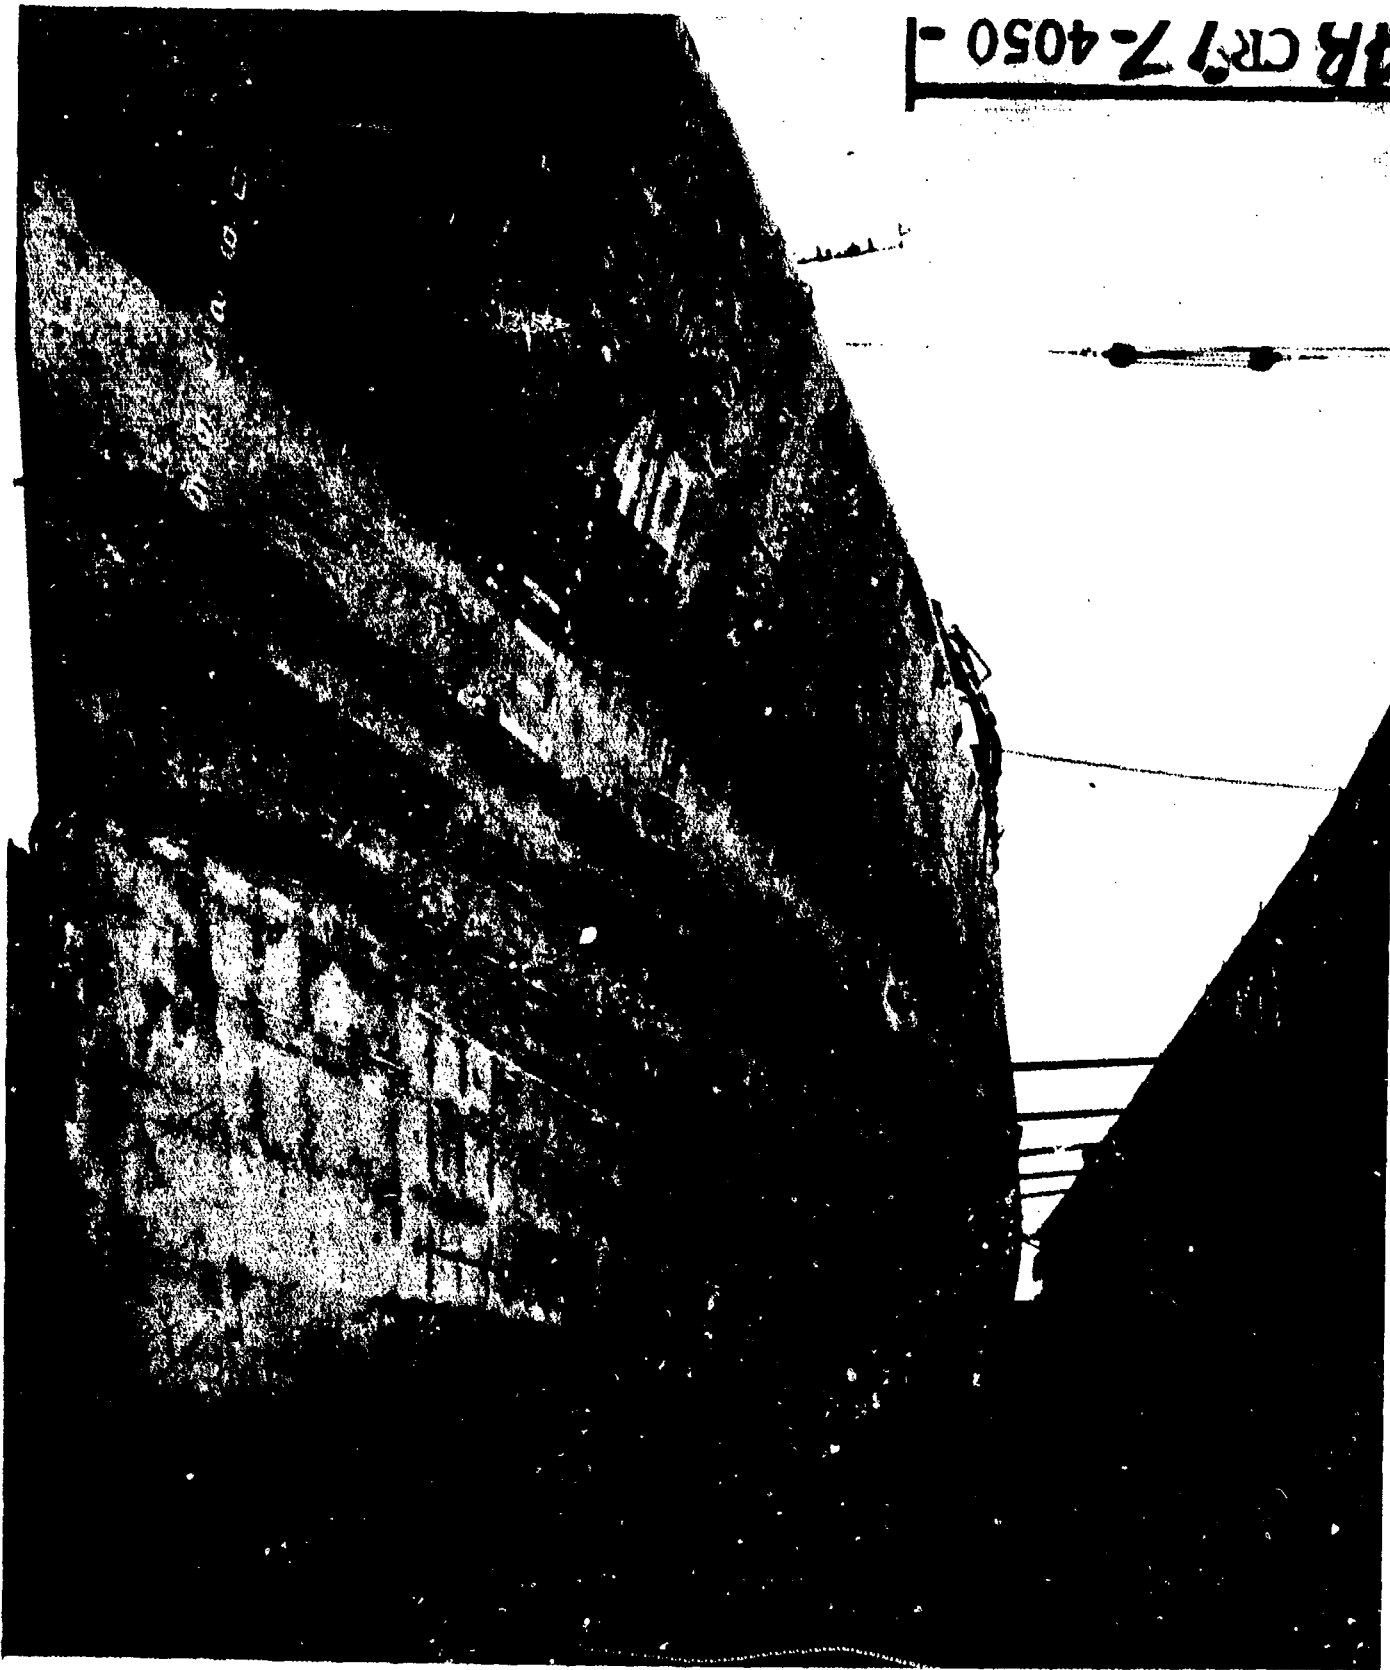
AB CR 97-4050 -

AB-CR-97-4050-8. Port bow looking aft, showing "washboarding" of underwater shell.

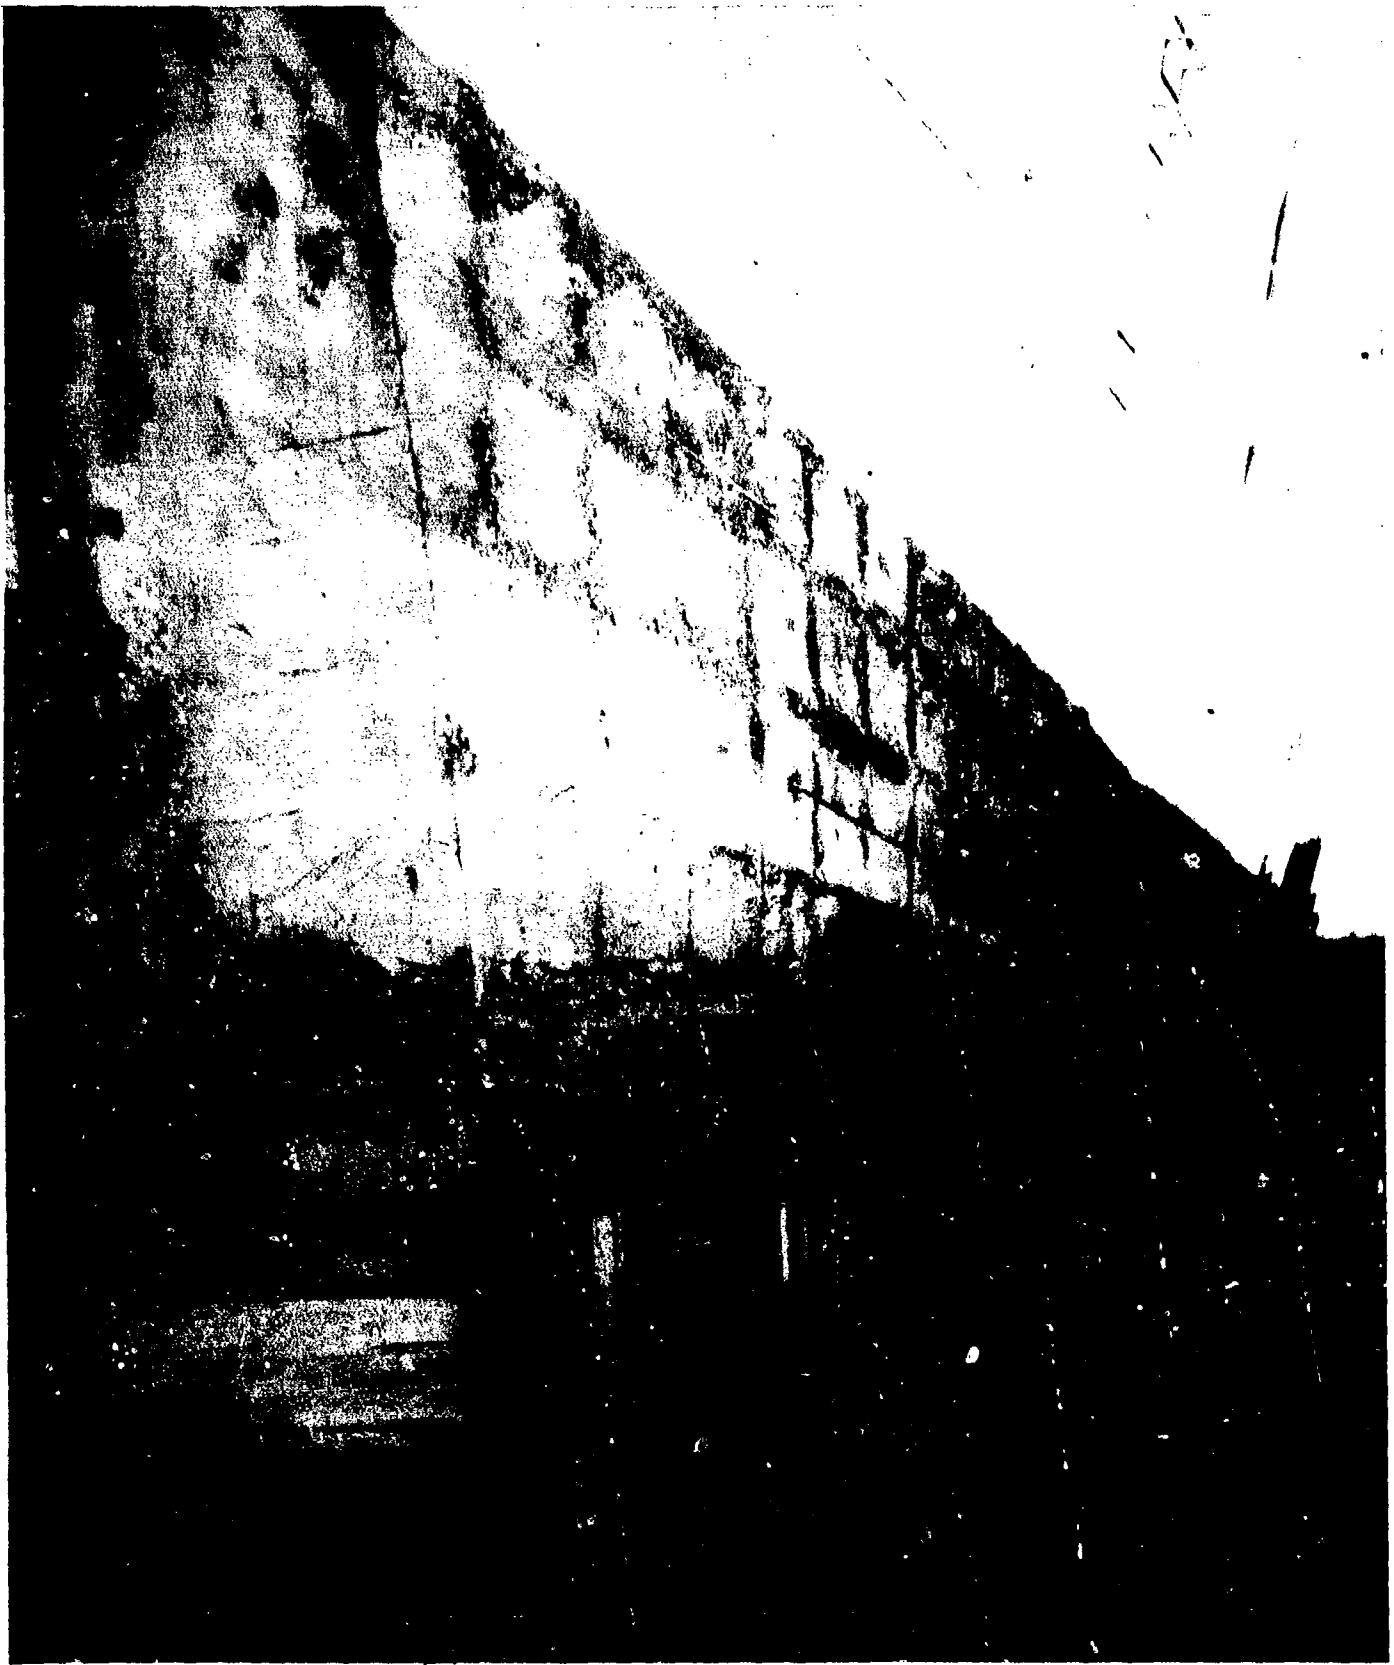
AB-CR-97-4044-12. Port shell looking aft from bow.

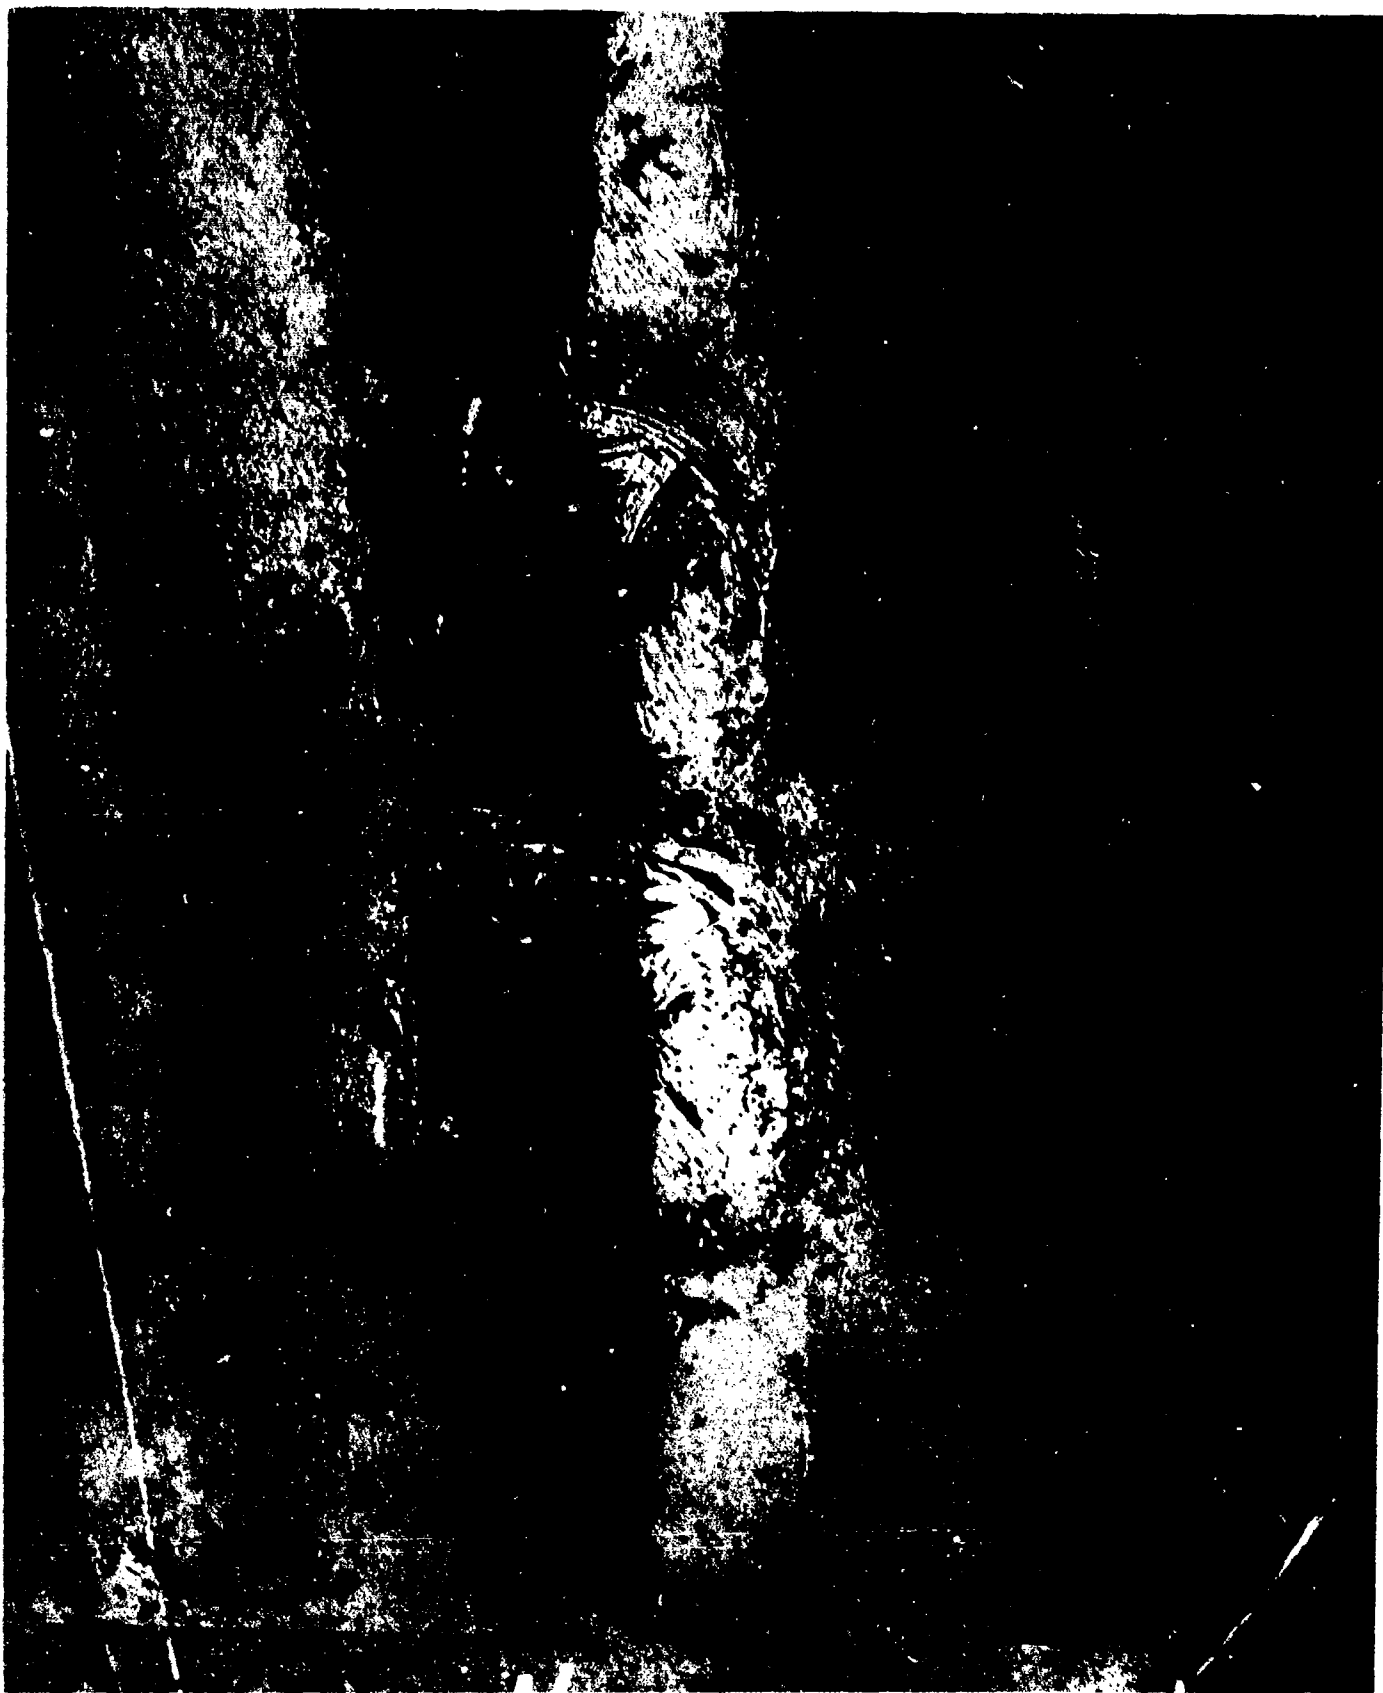
AB-CR-234-4062-4. Port shell, frame 26 to 28, stress patterns in B-strake. Refer to 4050-9.

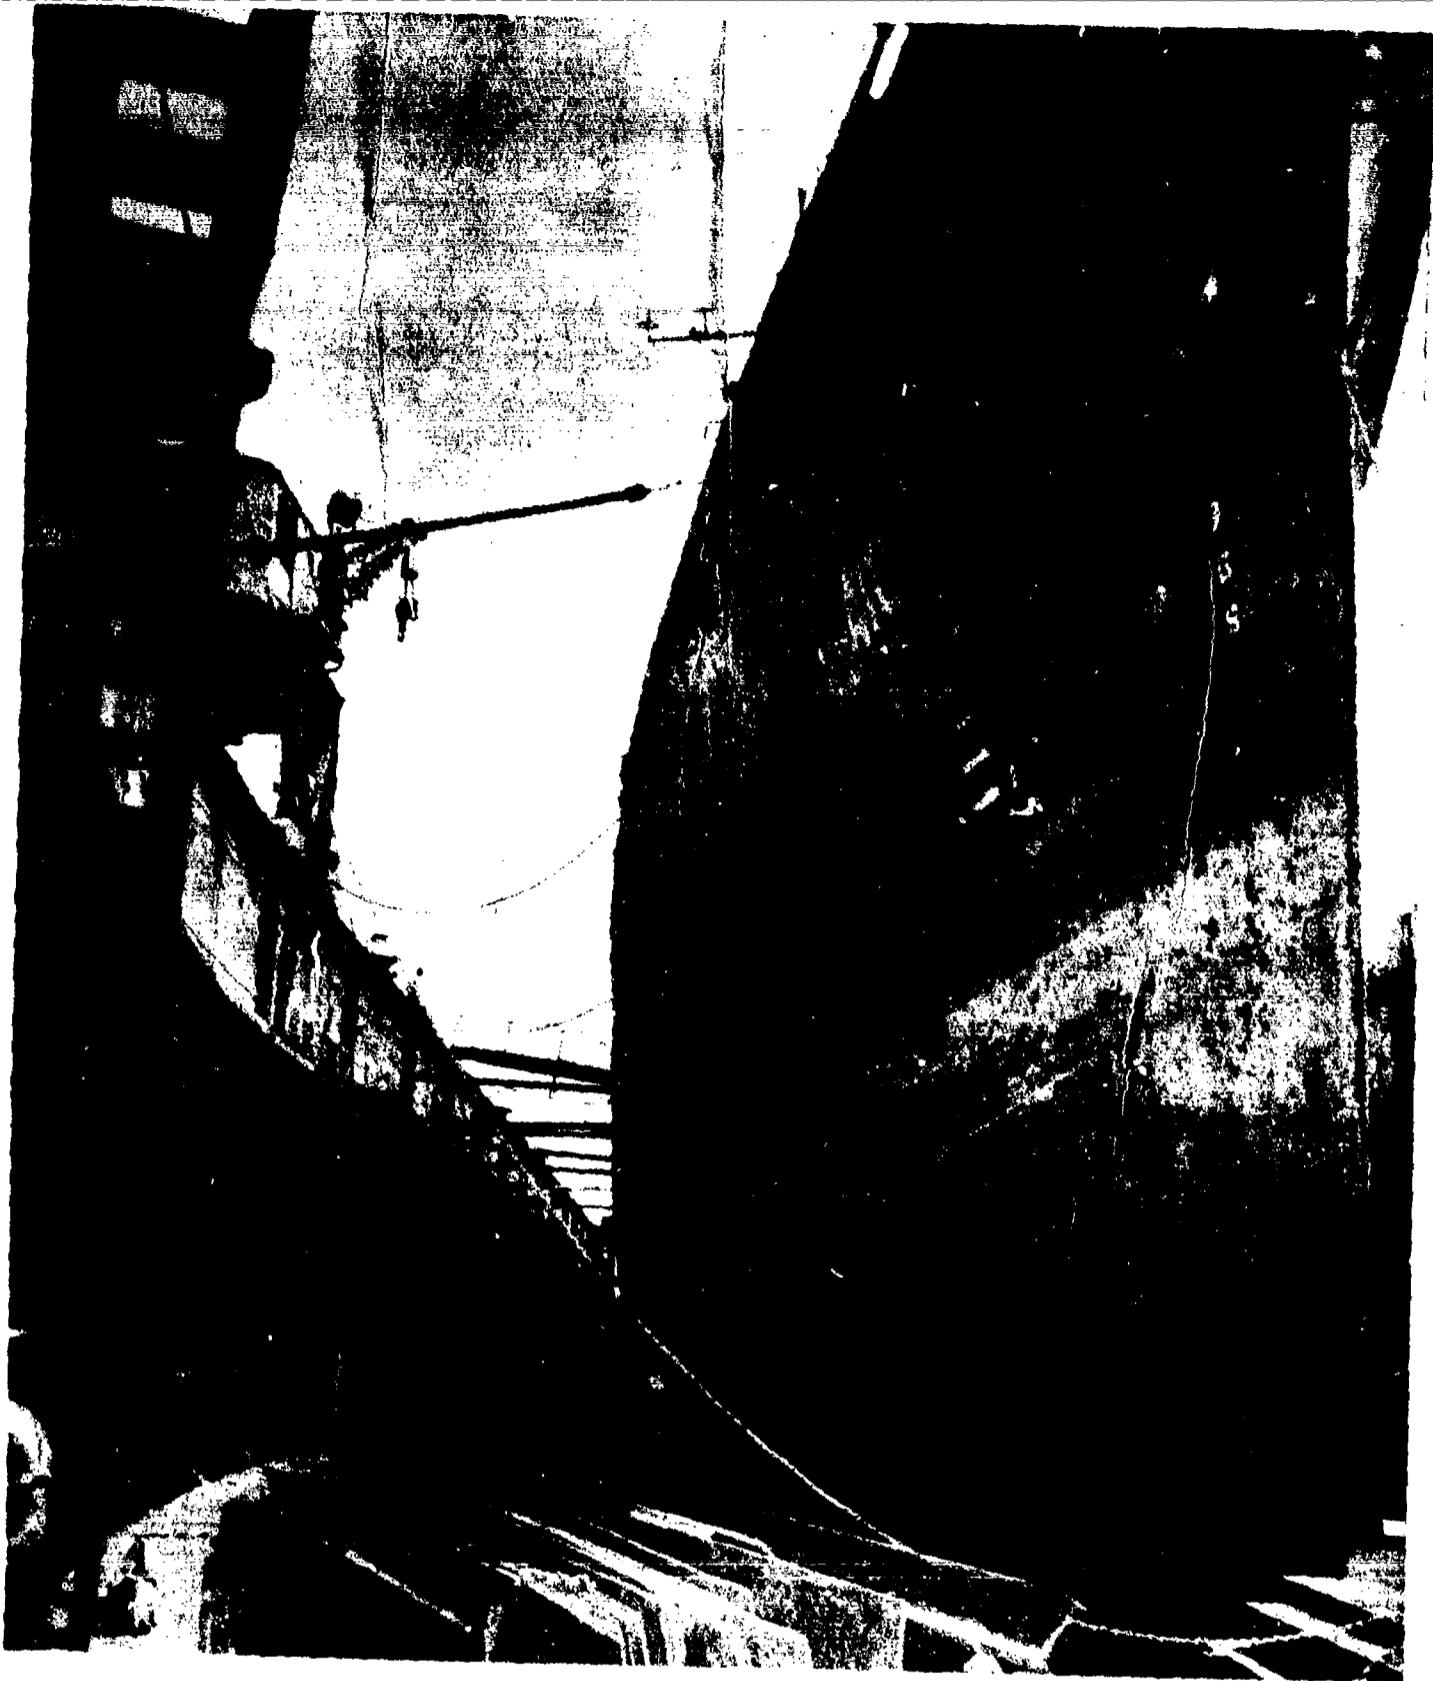
AB-CR-97-4058-1. Starboard shell looking aft from bow.
