BUREAU OF SHIPS GROUP
TECHNICAL INSPECTION REPORT

⑥ OPERATION CROSSROADS.
U.S.S HUGHES (DD410).
TEST BAKER.

VOLUME II [u] ⑧

USS HUGHES (DD410)

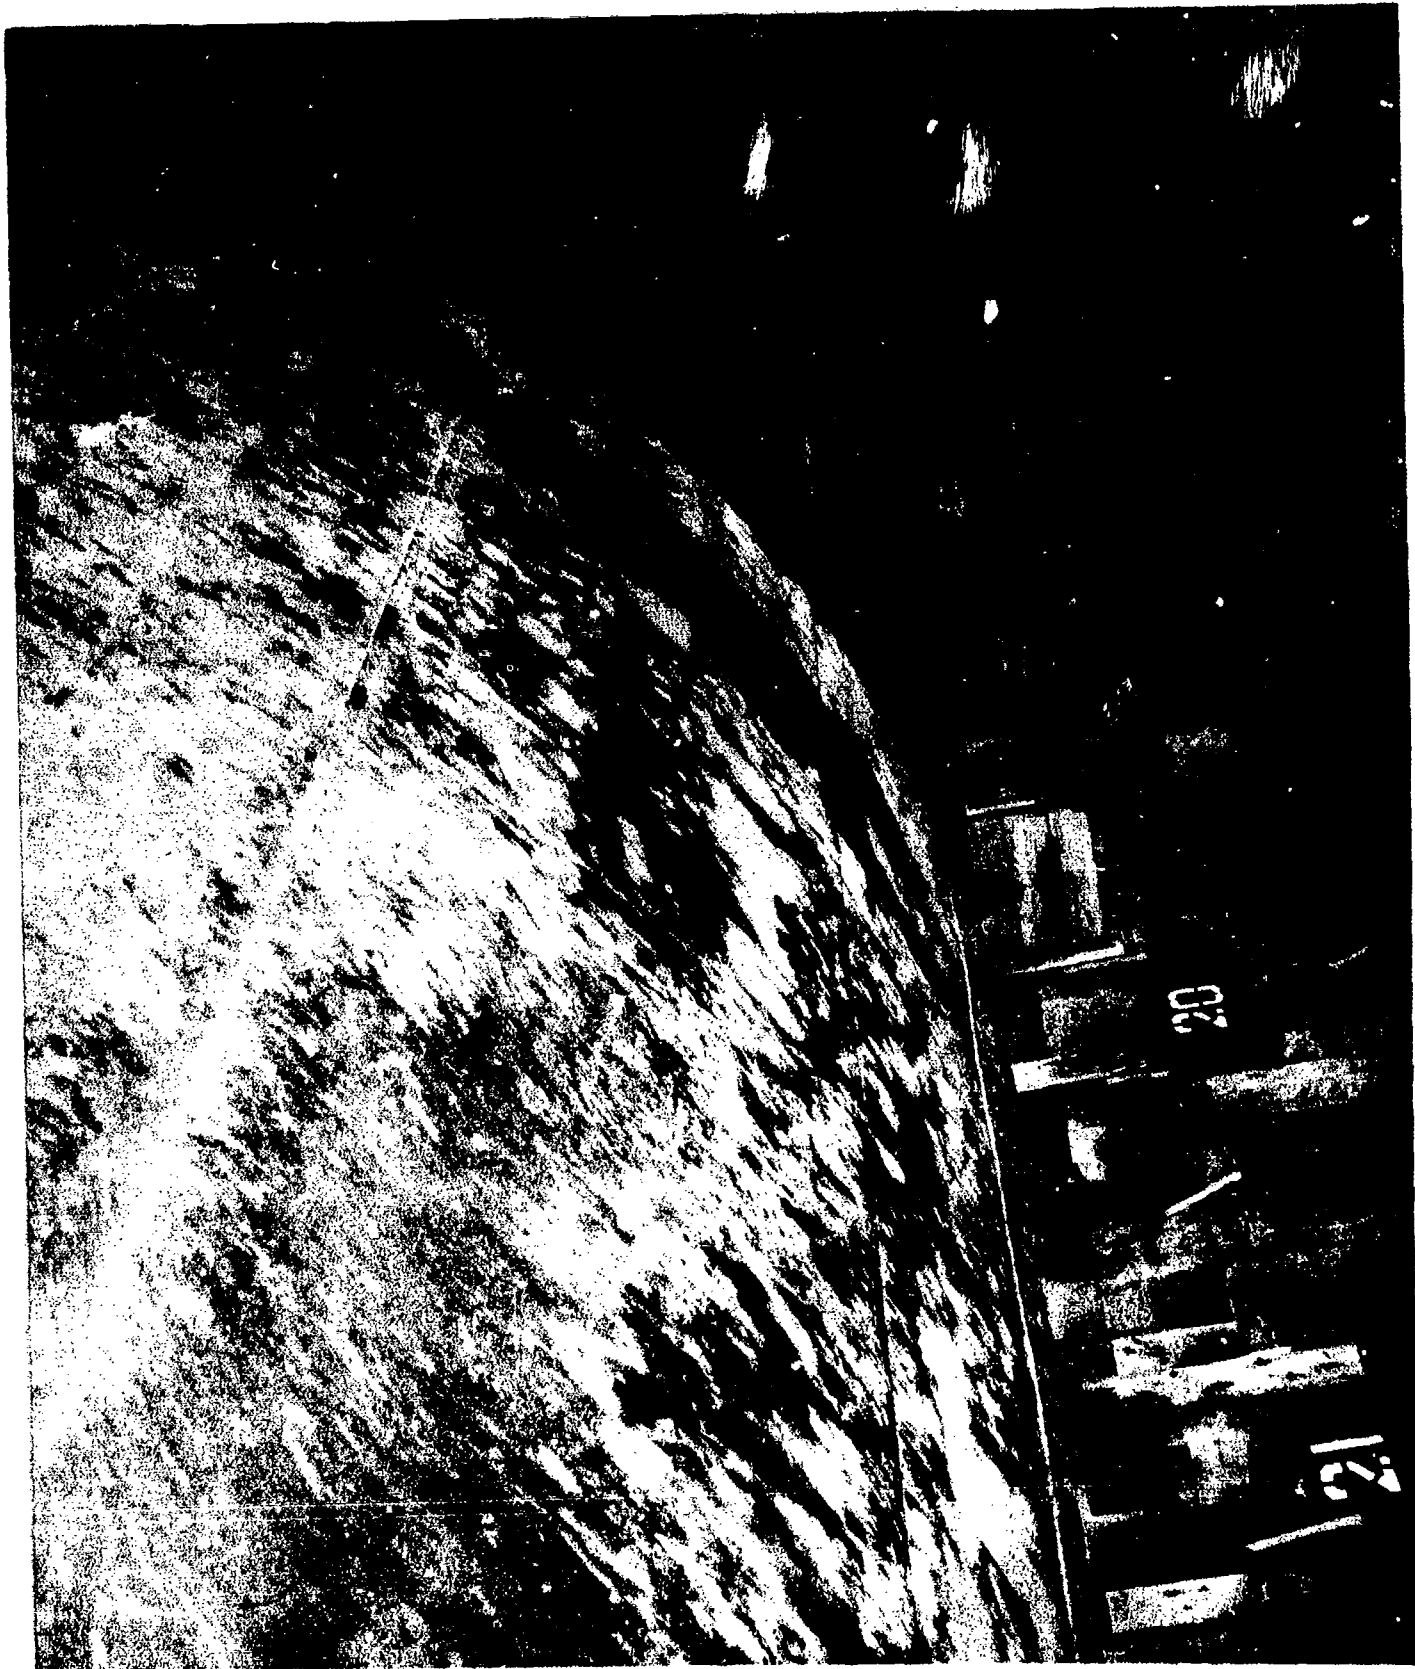
AB-CR-97-4050-2. Starboard bottom shell looking forward from frame 55.

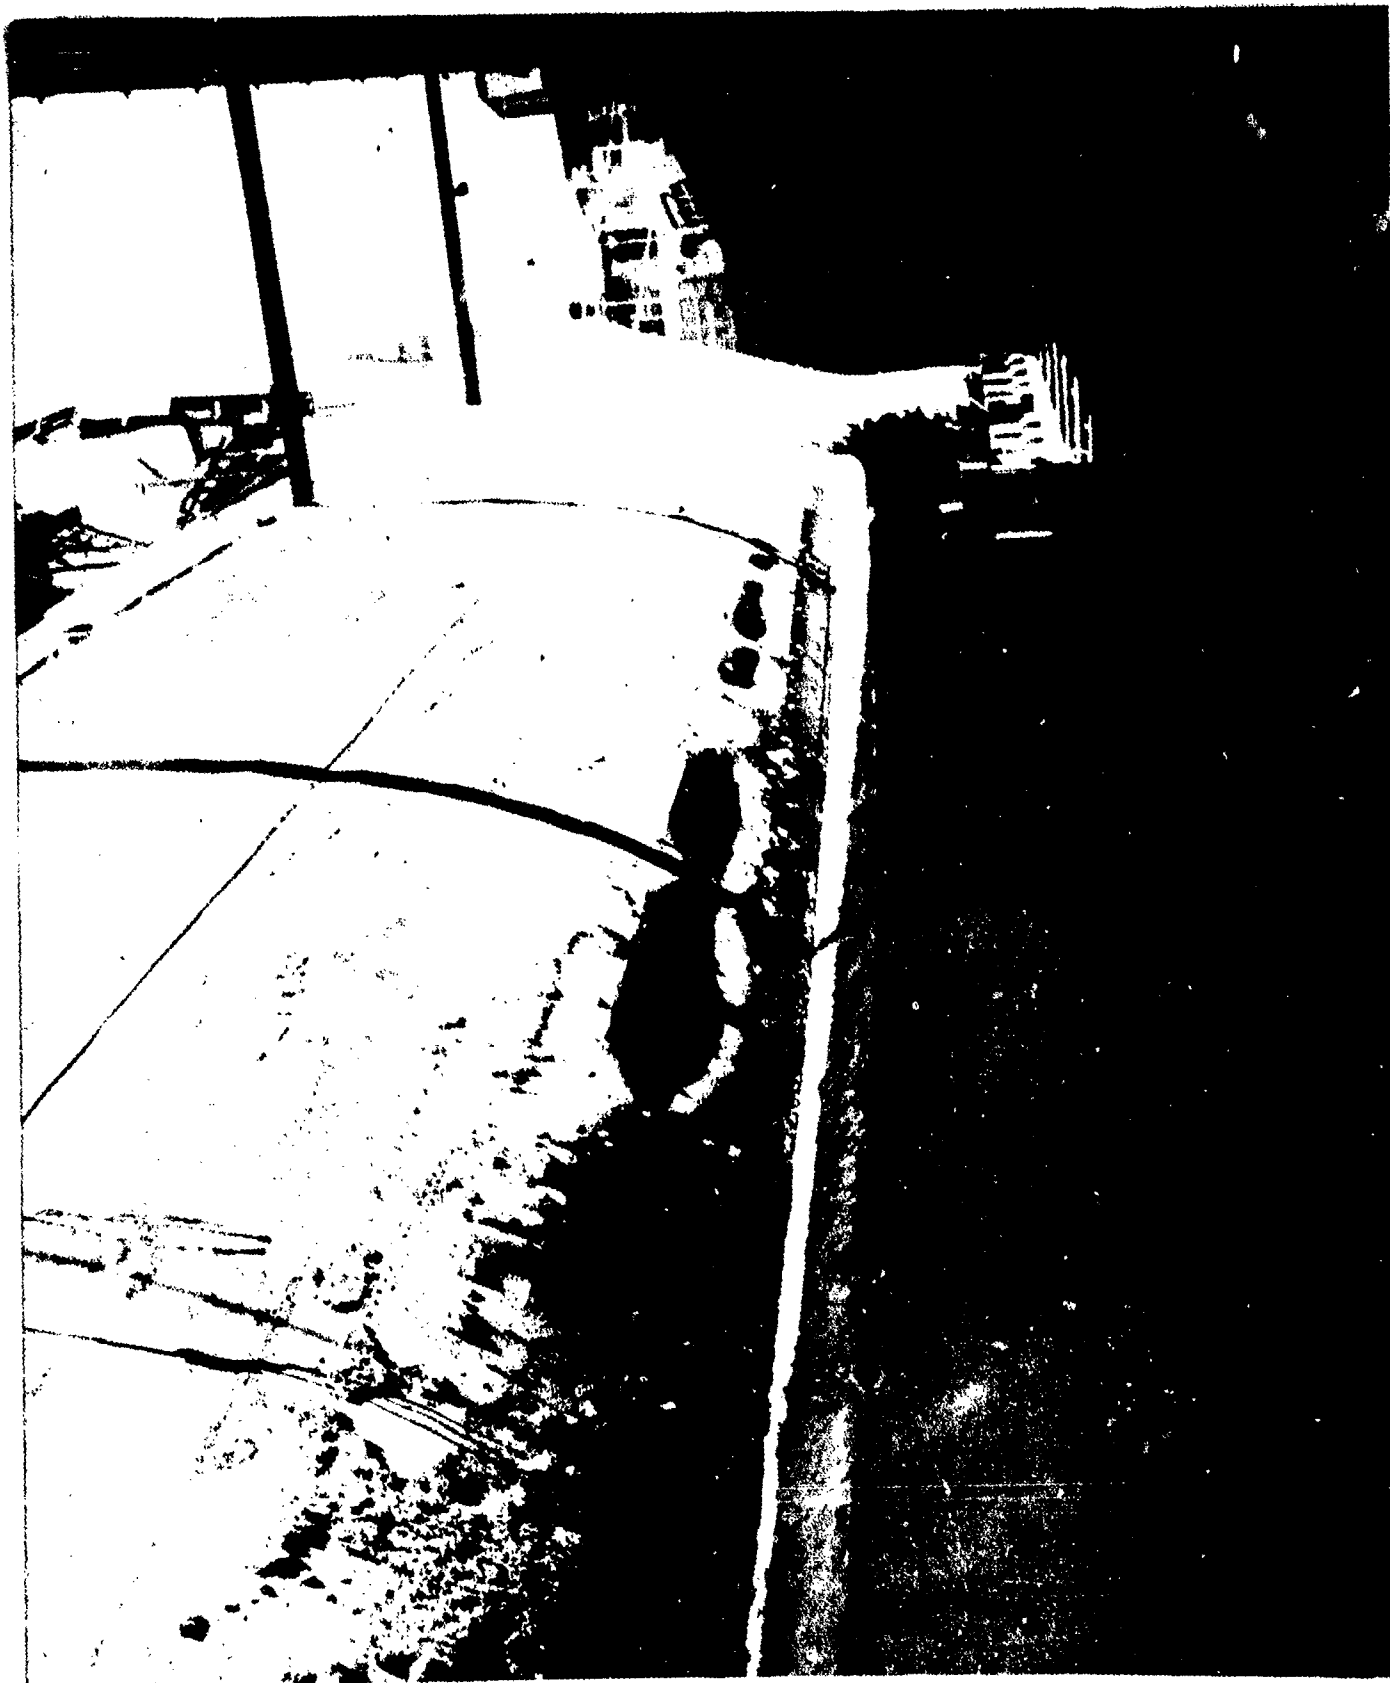
AB-CR-234-4062-3. Looking forward along port side showing buckles in shell plating above bilge keel.

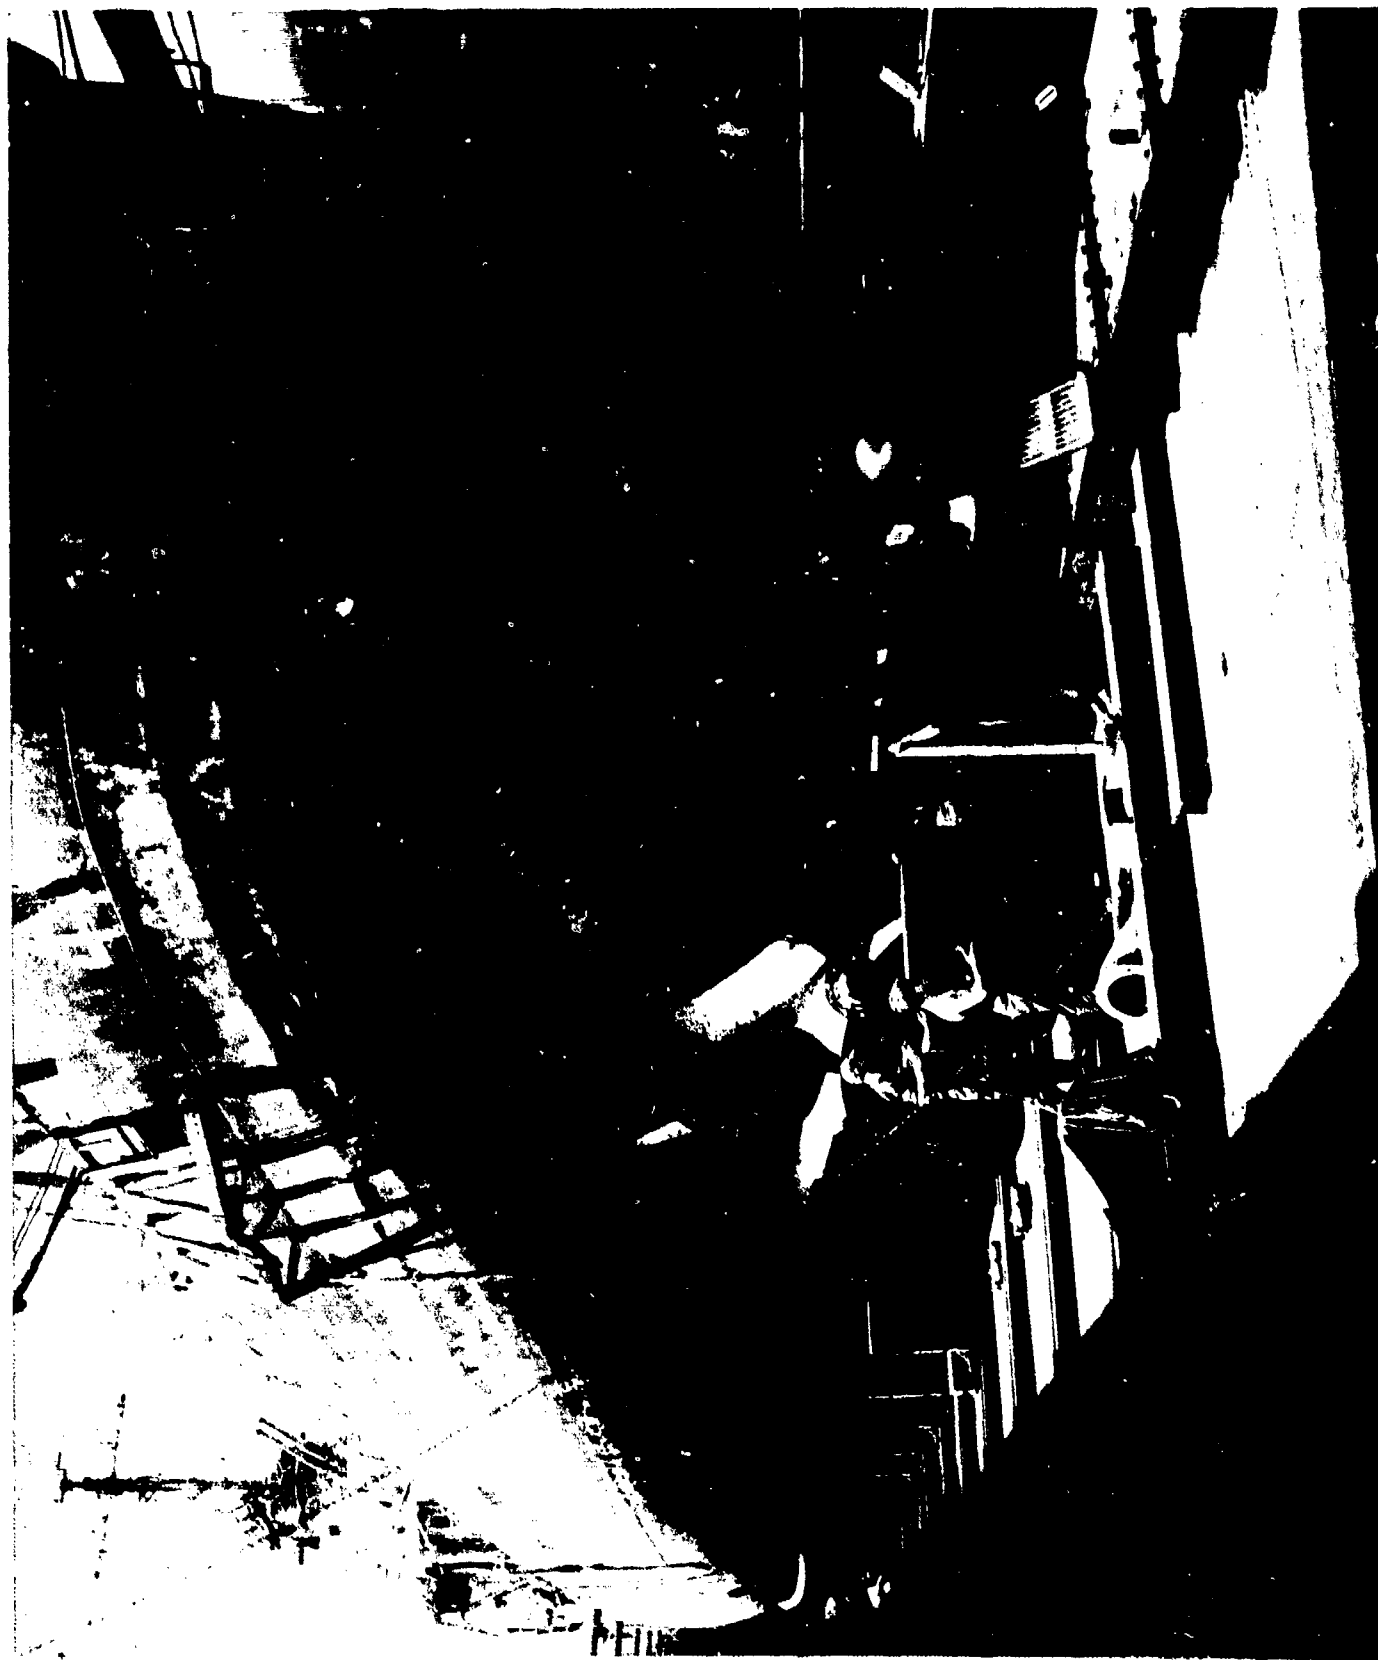
AB-CR-97-4057-4. Port shell and transom, looking forward from astern. Note dishing between longitudinals.

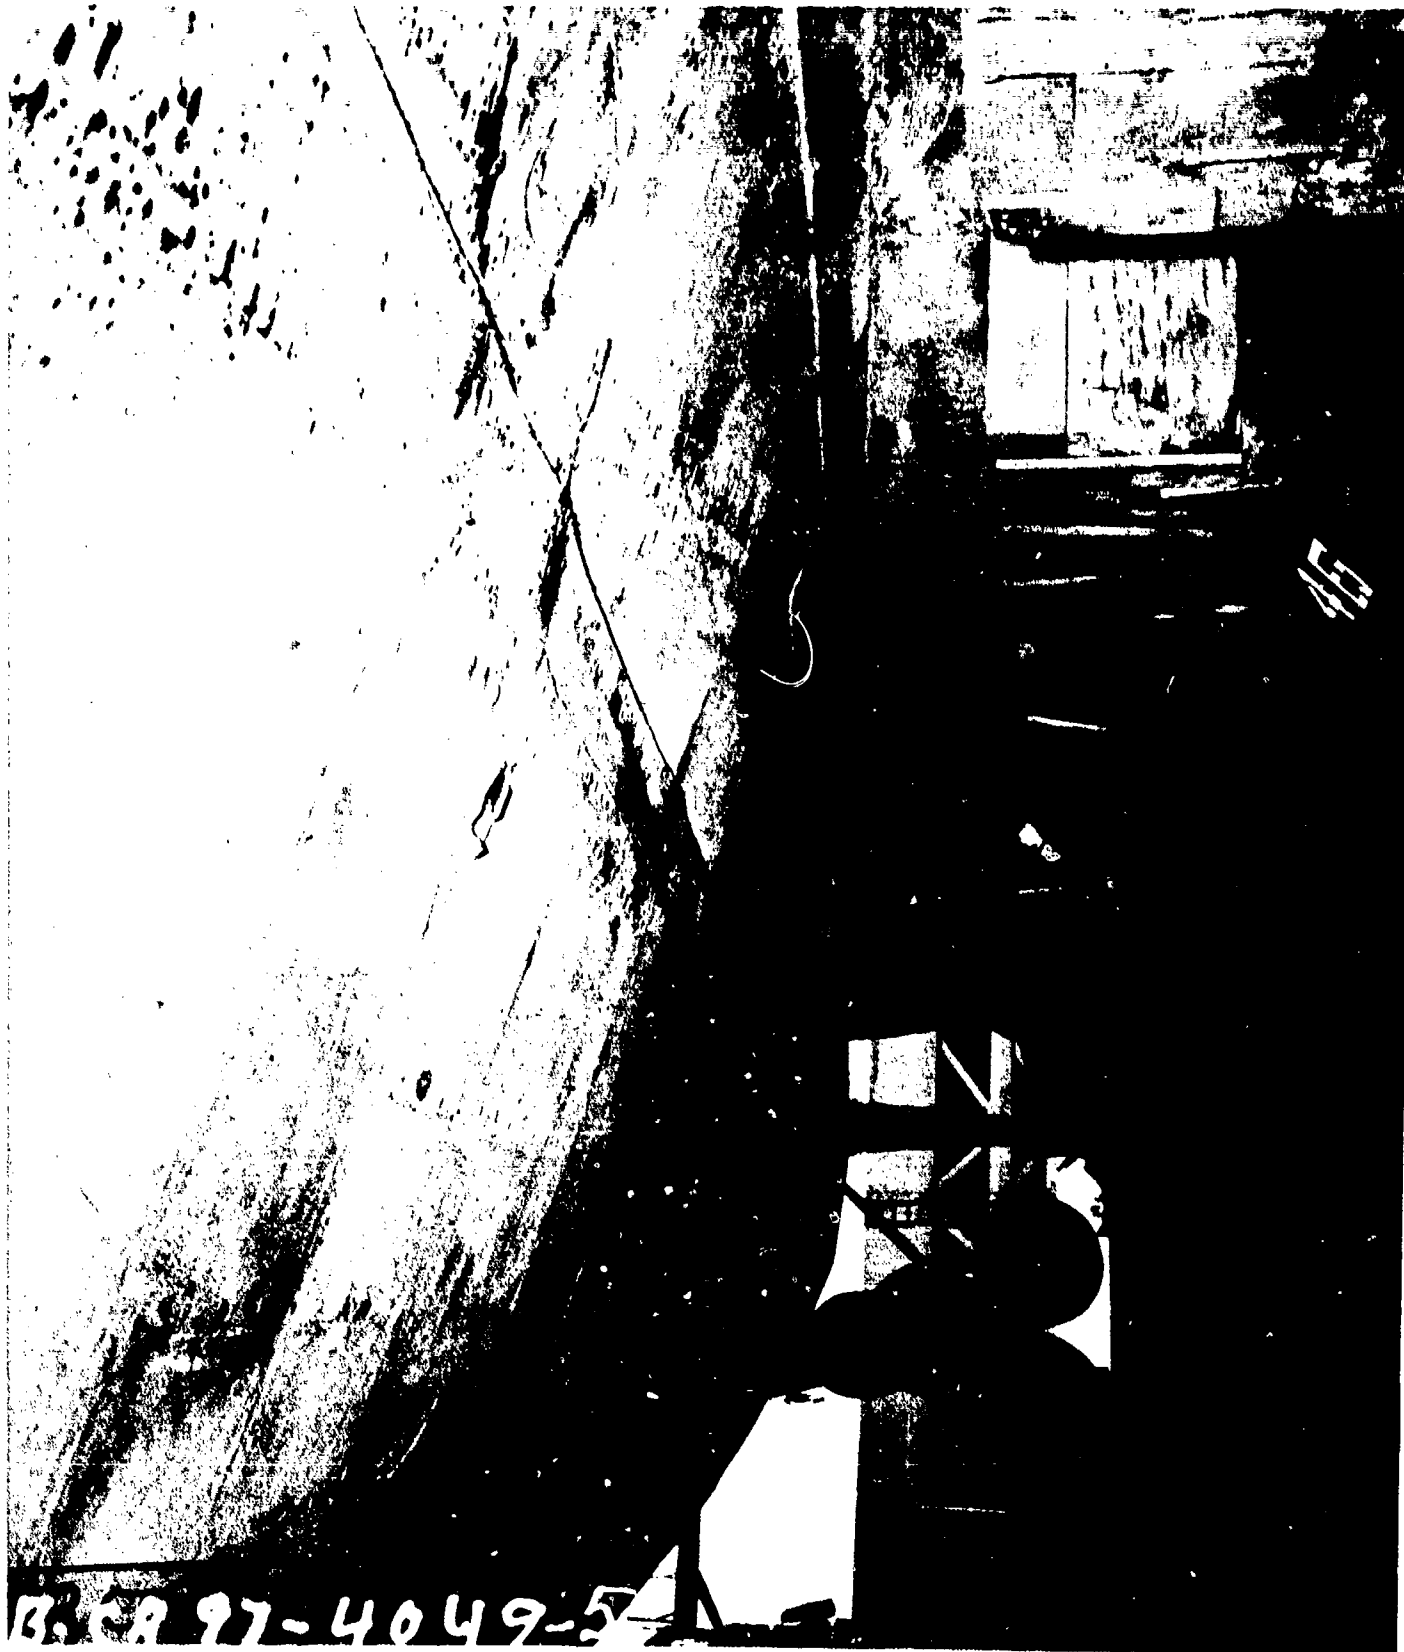
AB-CR-97-4049-5. Starboard bottom shell, looking aft from frame 140.

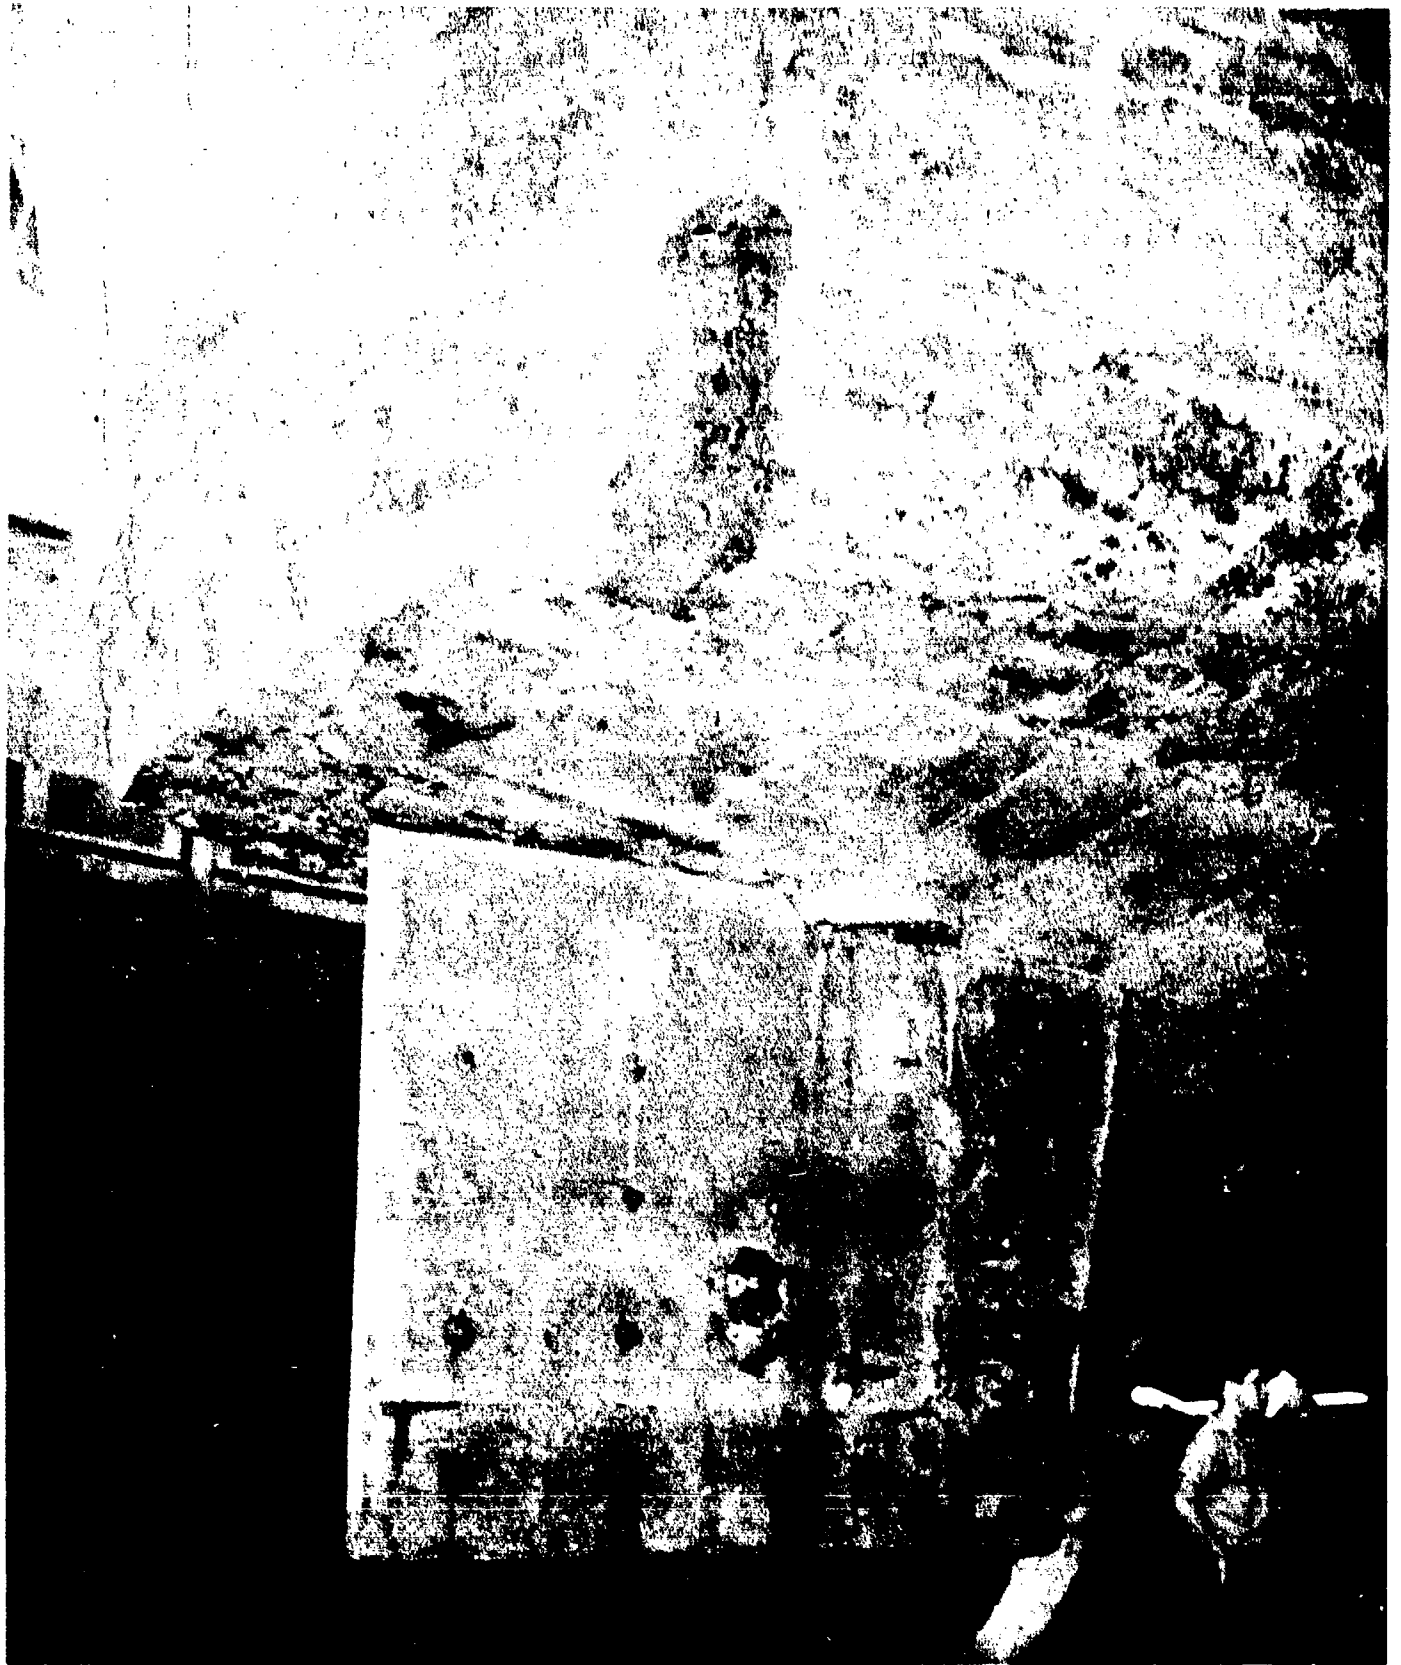
AB-CR-234-4060-12. Starboard side of rudder, hole in way of transom knuckle, and plugged hole in transom above water line.

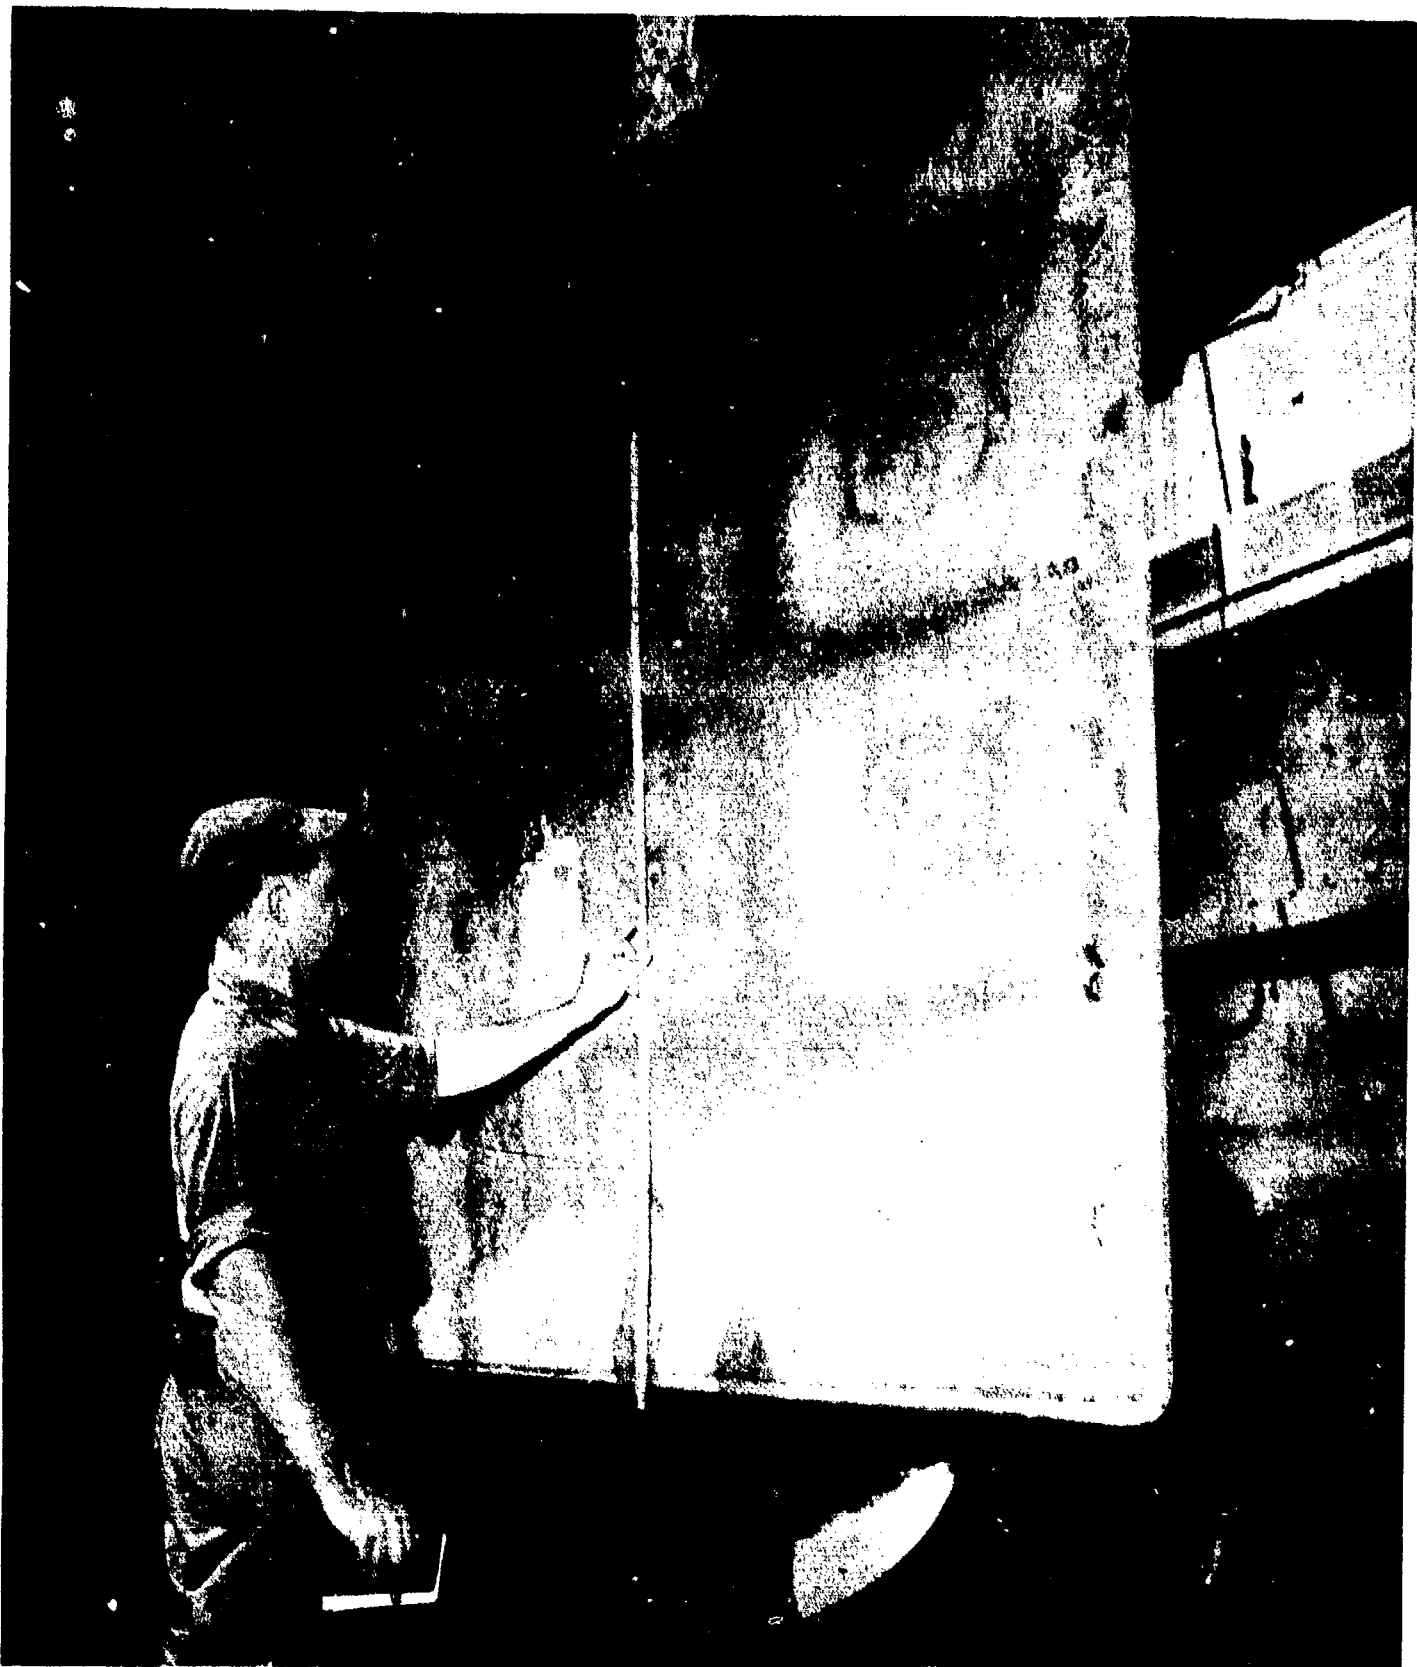
AB-CR-234-4062-1. Port side of rudder looking forward. Note panel dishing and stress marks in way of panel studs.

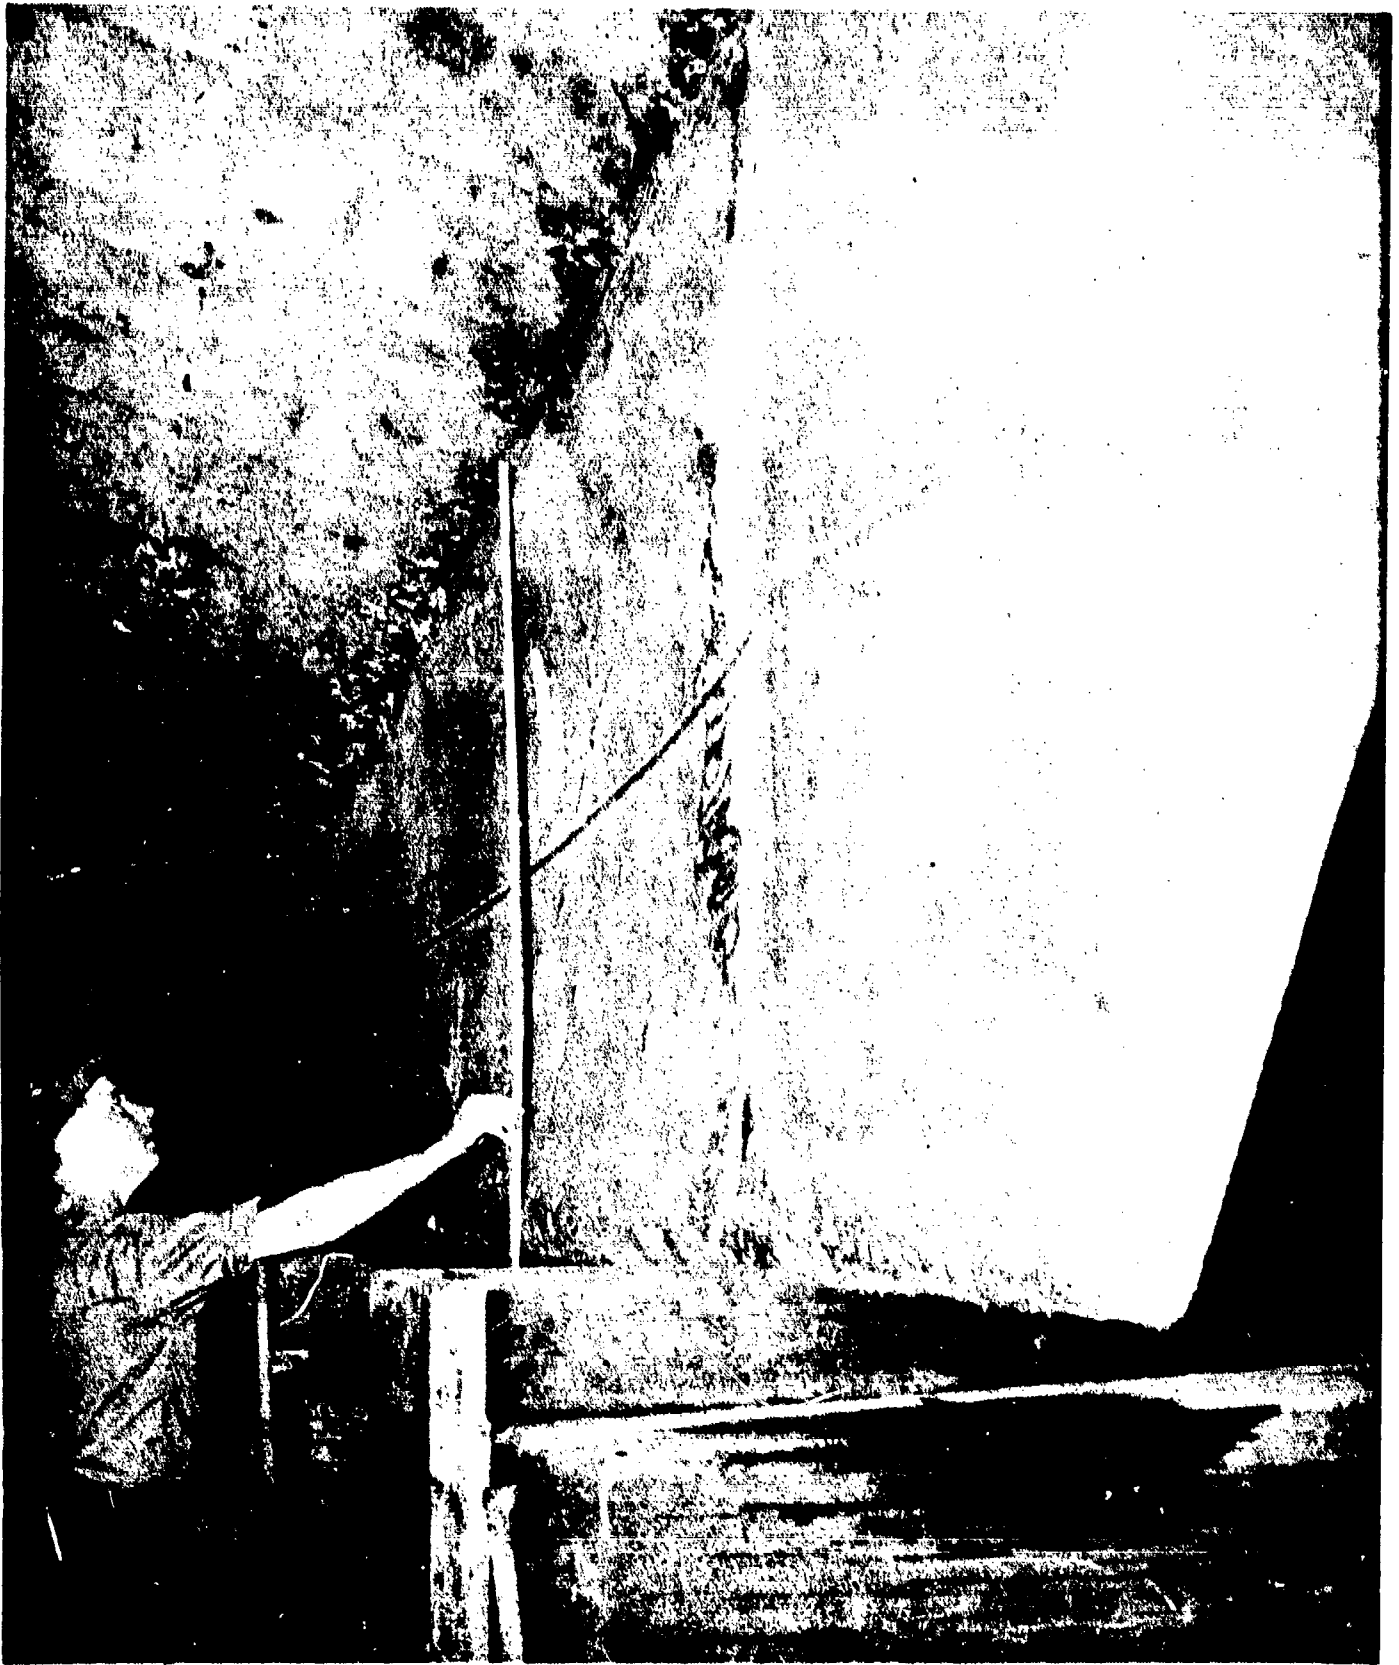
AB-CR-234-4060-8. Port side of skeg looking forward. (Note dishing.)

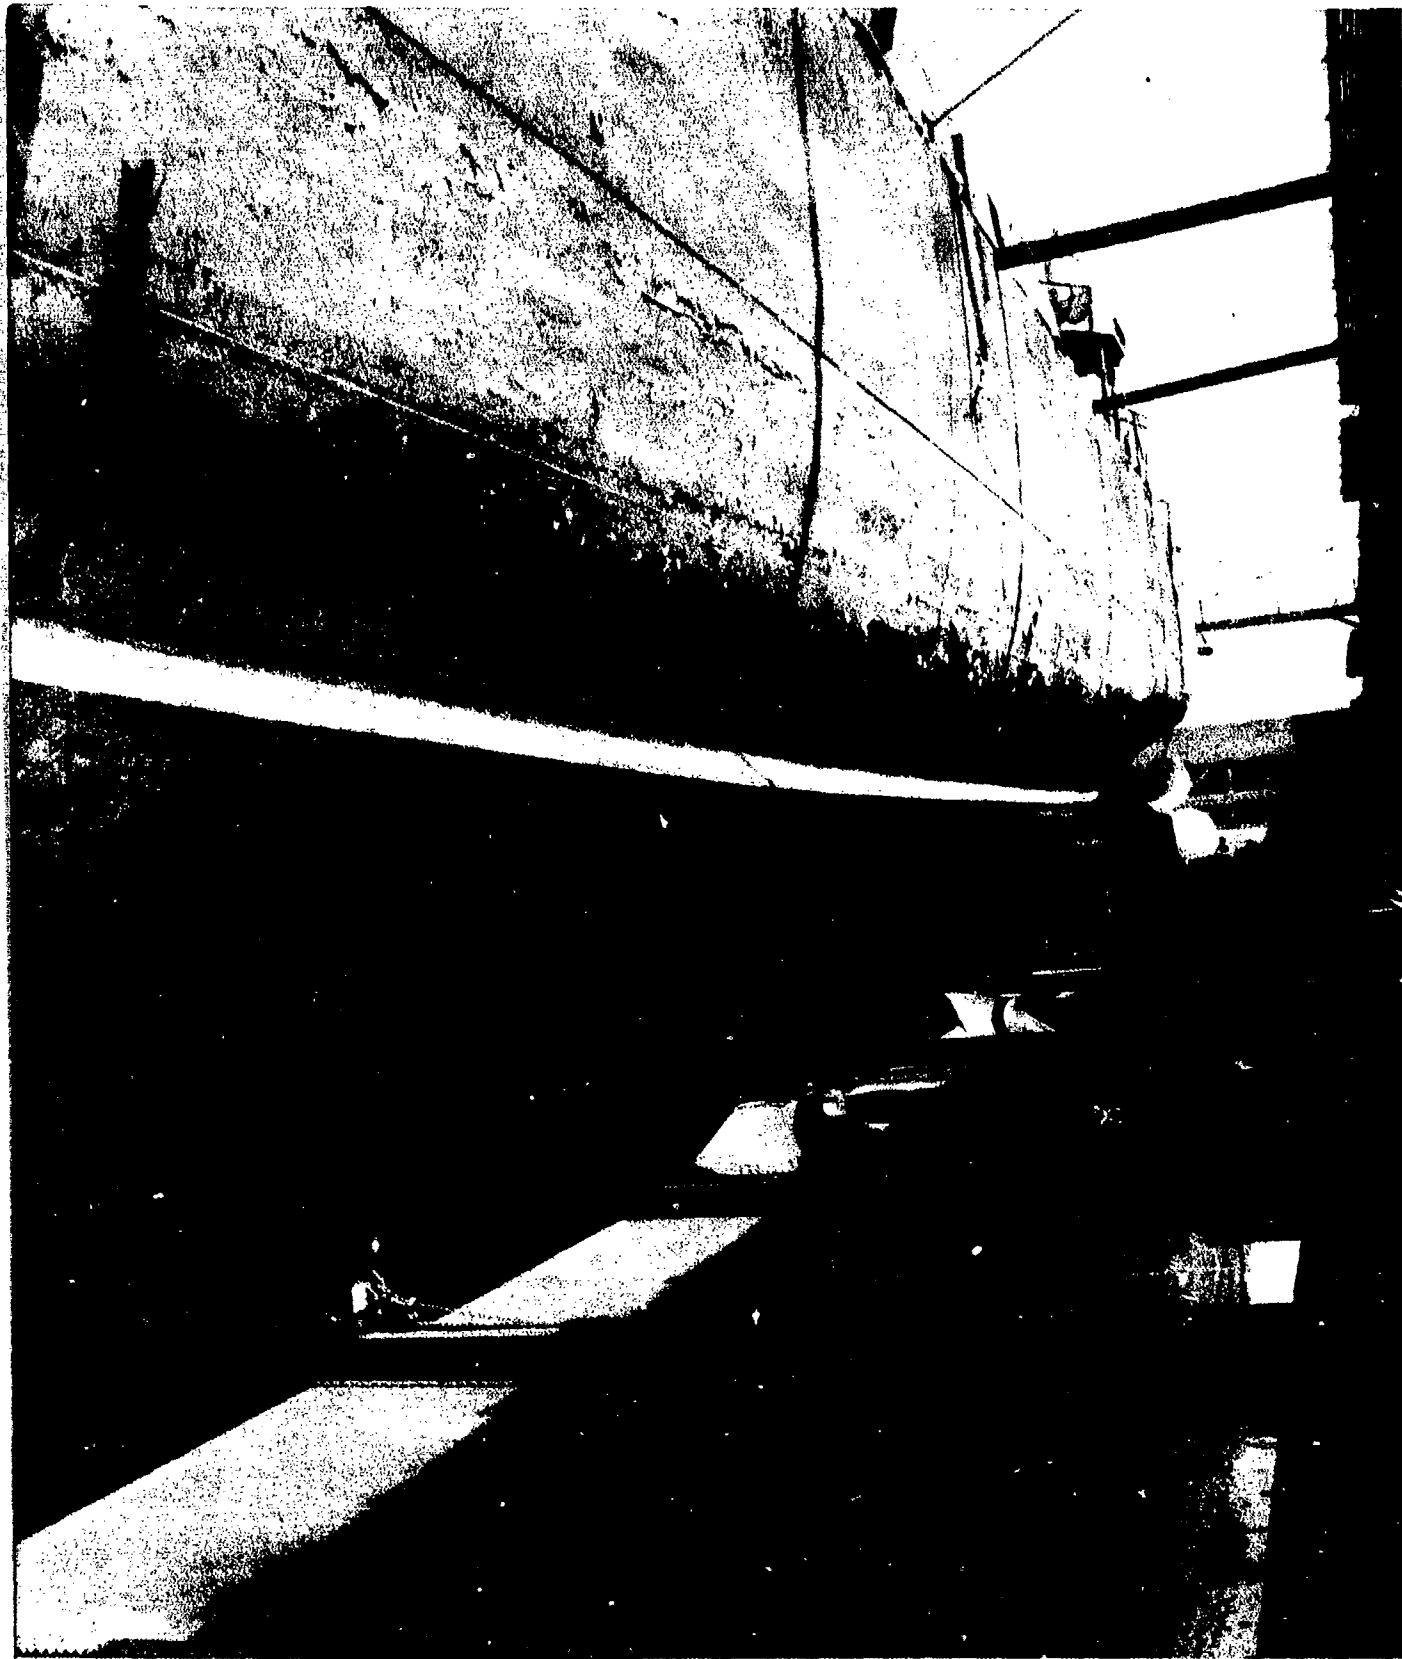
AB-CR-97-4050-12. Port shell looking aft, frames 80-110.

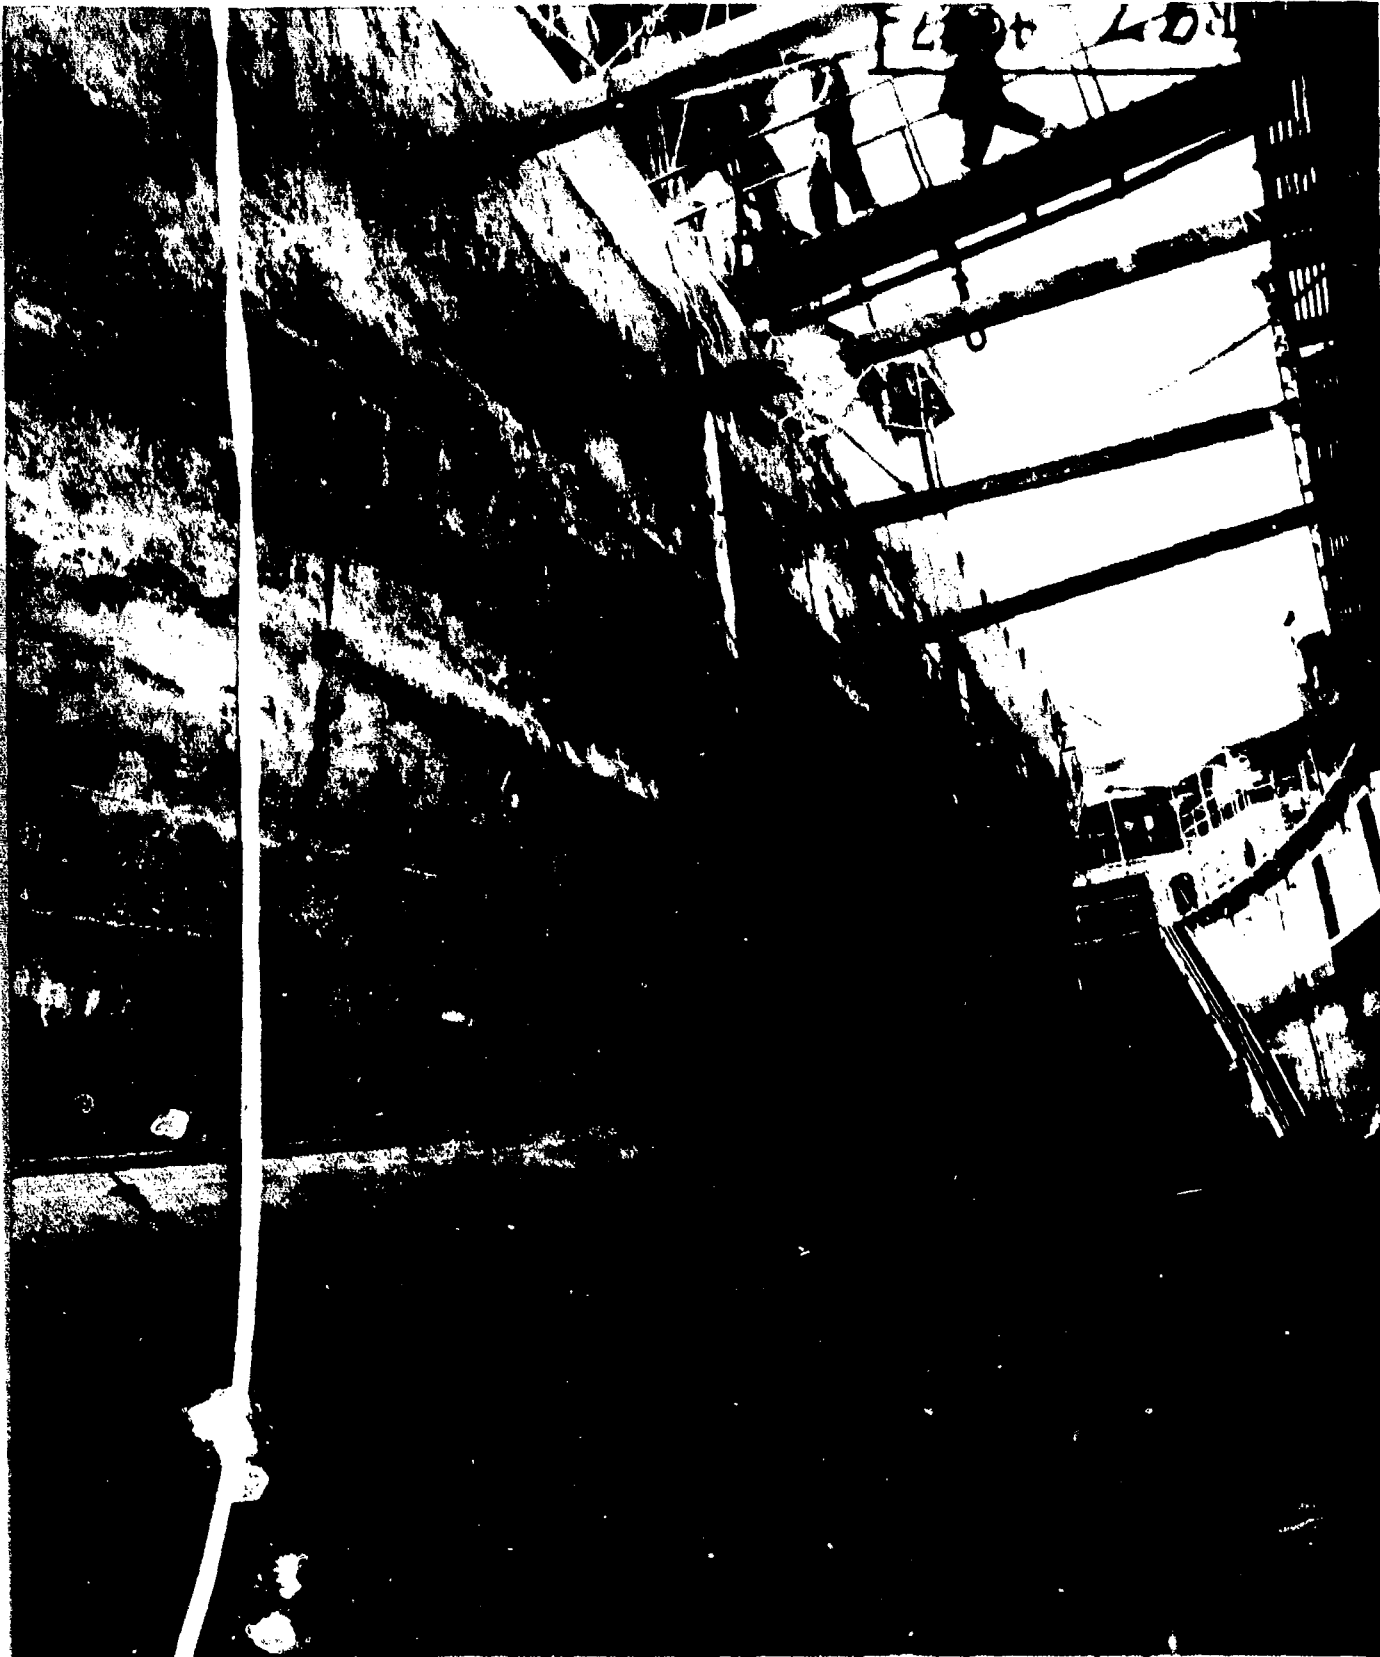
AB-CR-97-4057-9. Starboard shell looking forward, frames 100-50.
