BUREAU OF SHIPS GROUP
TECHNICAL INSPECTION REPORT

⑥ OPERATION CROSSROADS.
U.S.S HUGHES (DD410).
TEST BAKER.

VOLUME II [u] ⑧

USS HUGHES (DD410)

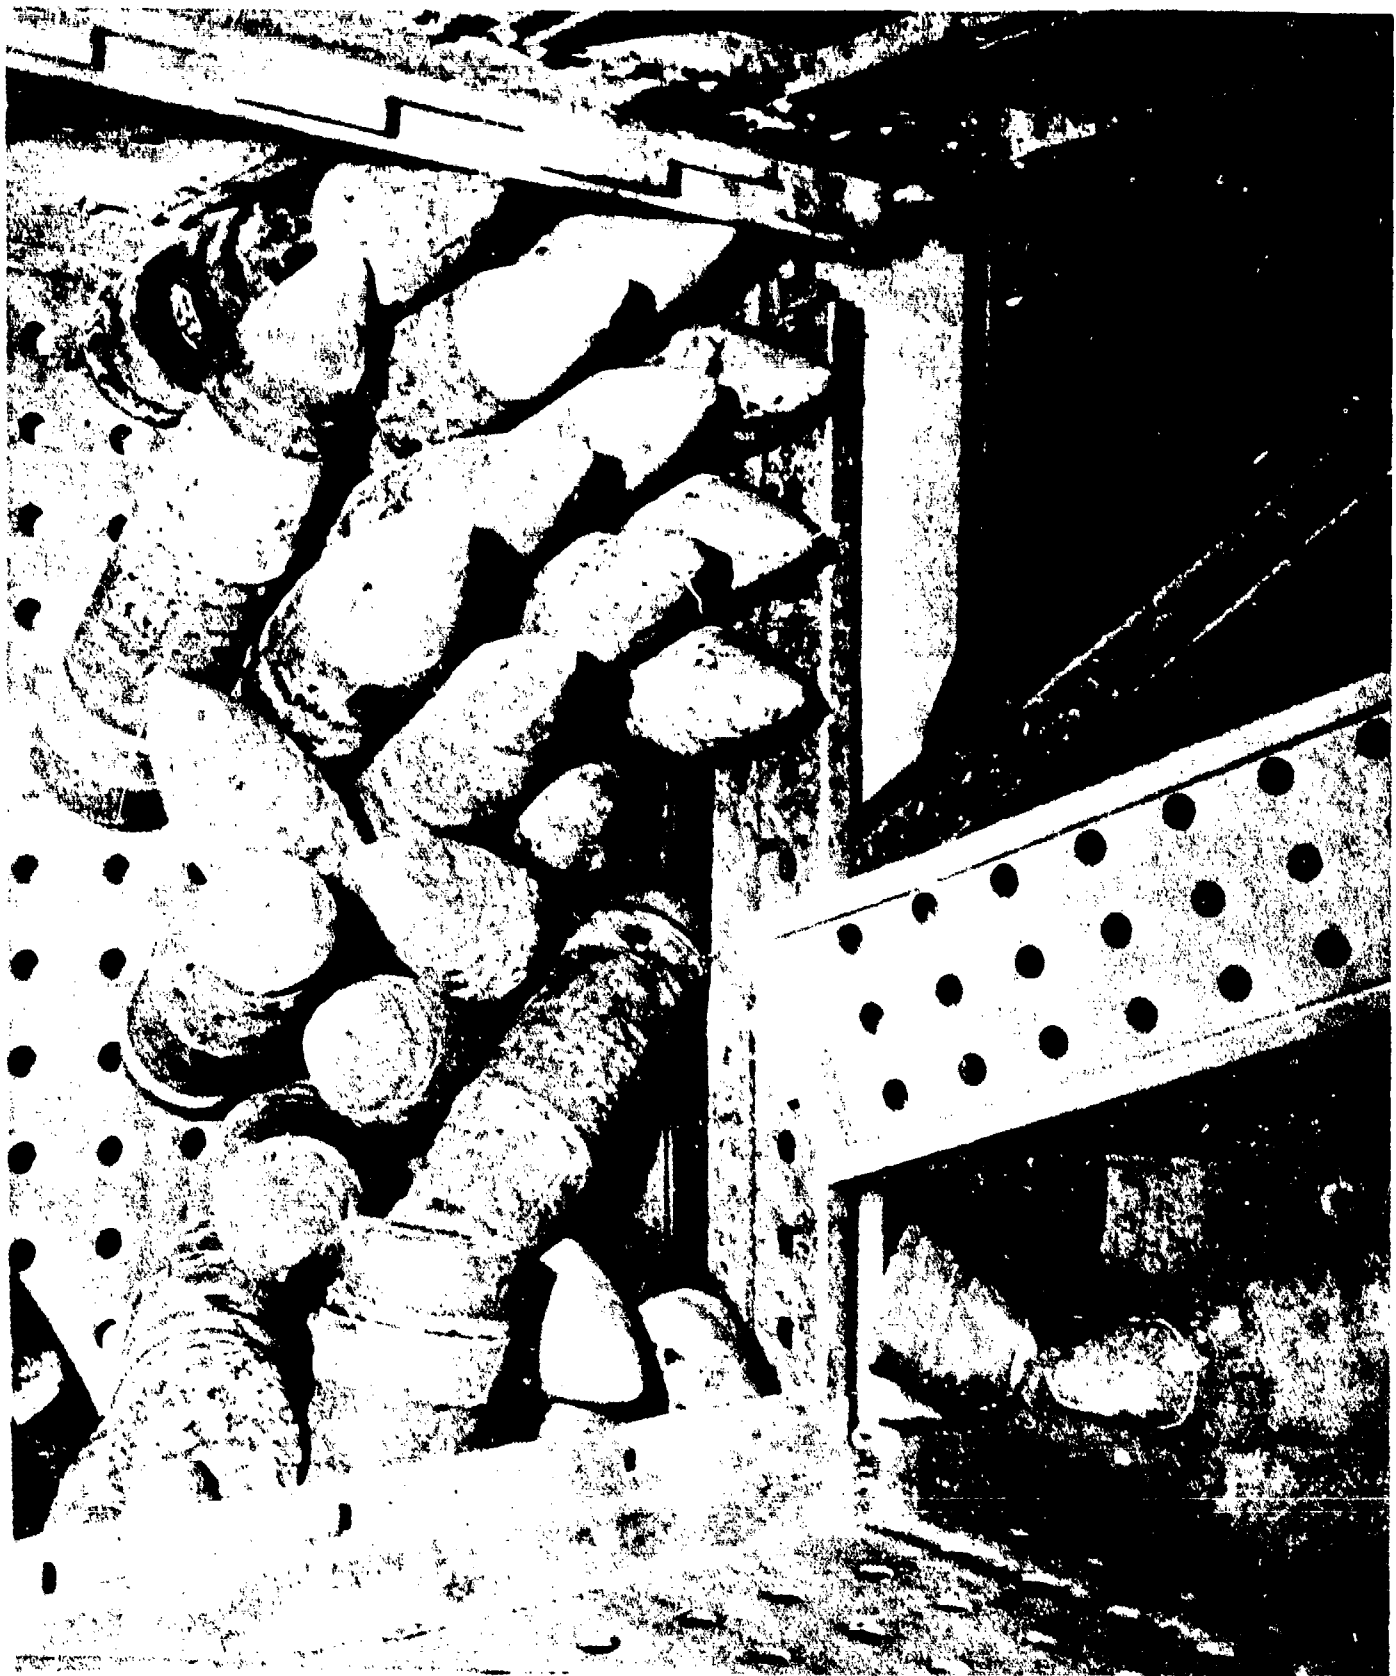
AB-CR-234-4061-6. Disarrangement of projectile stowage handling room (A-0101-M) for 40-46.

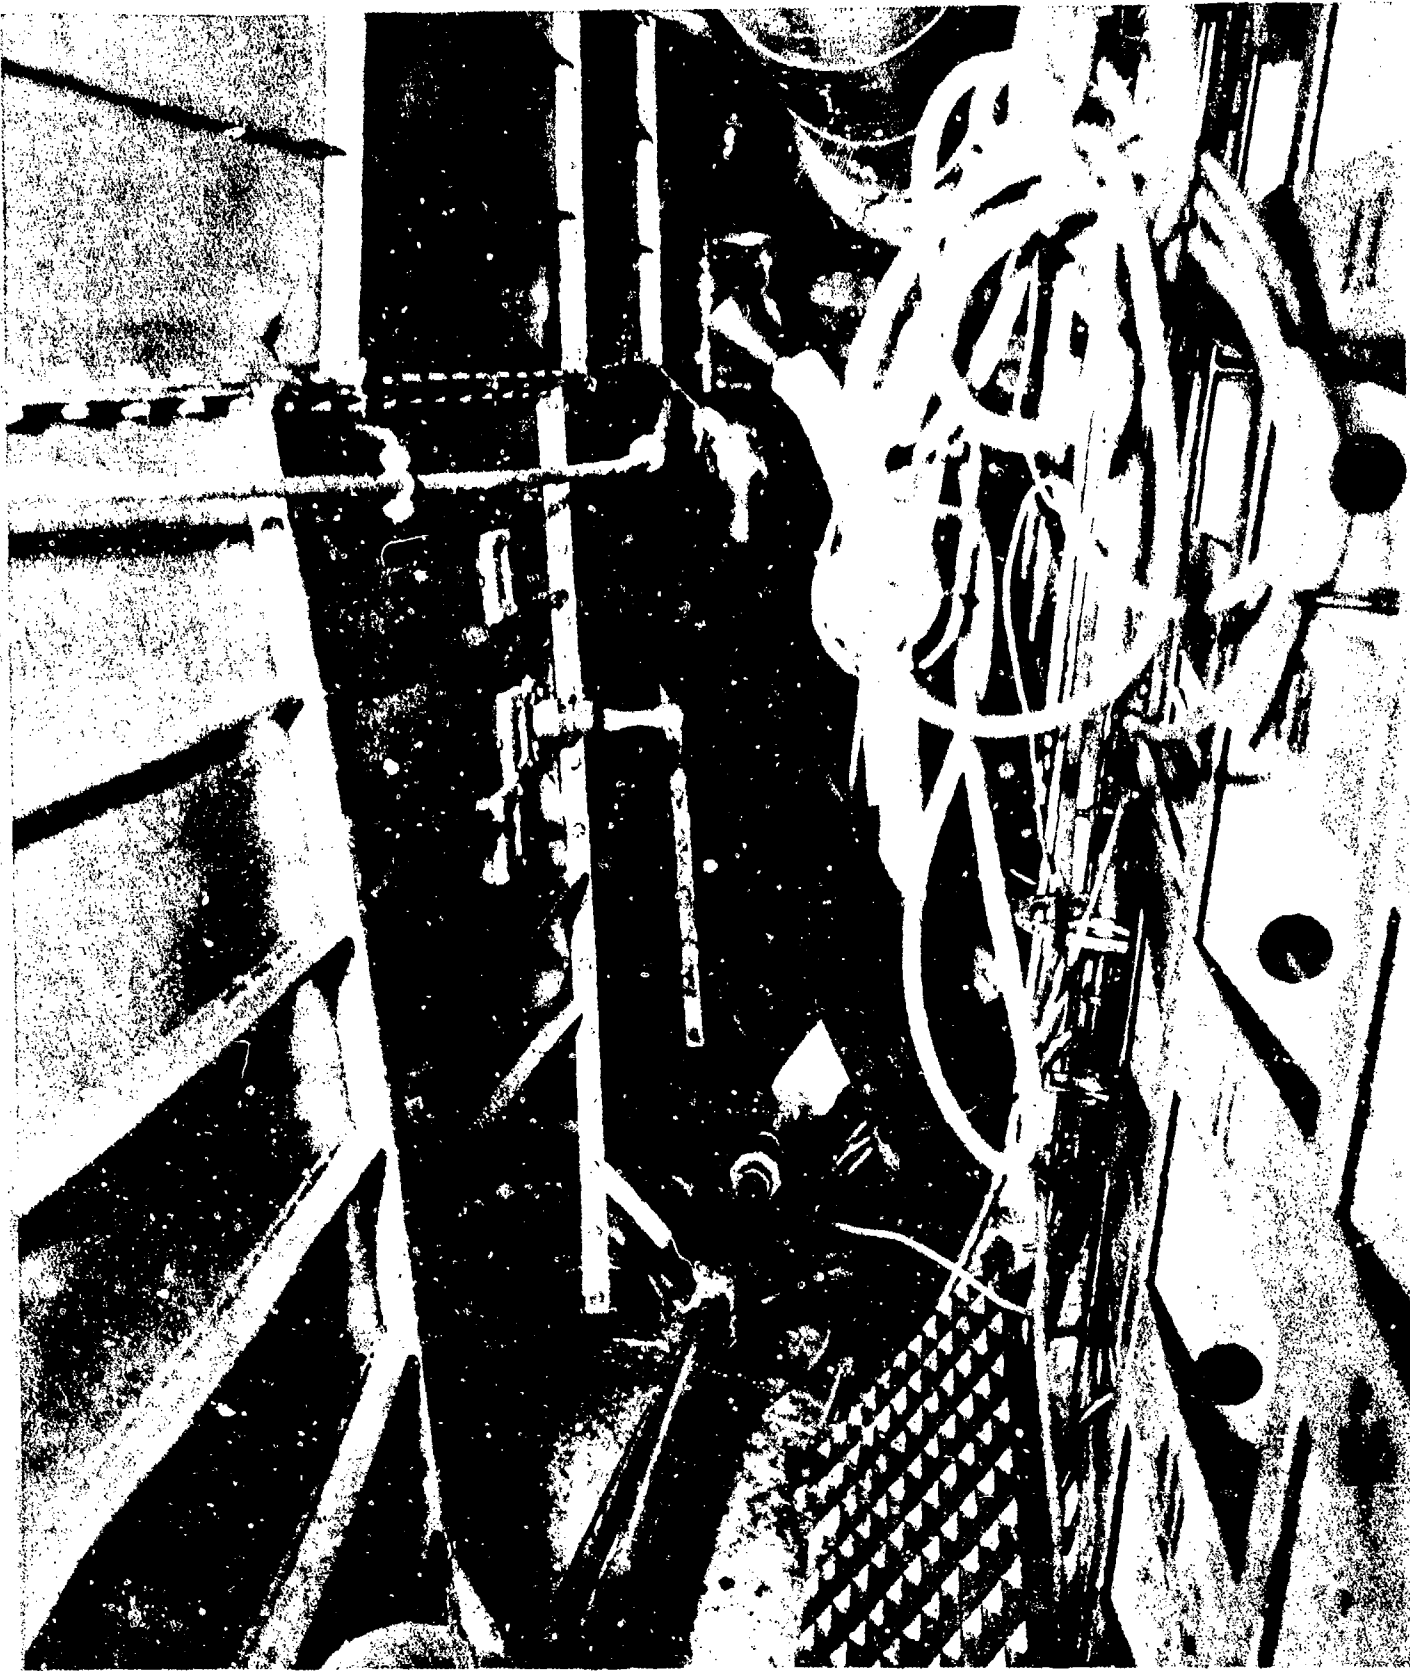
AB-CR-76-2078-5. No. 3 boiler, rear casing.

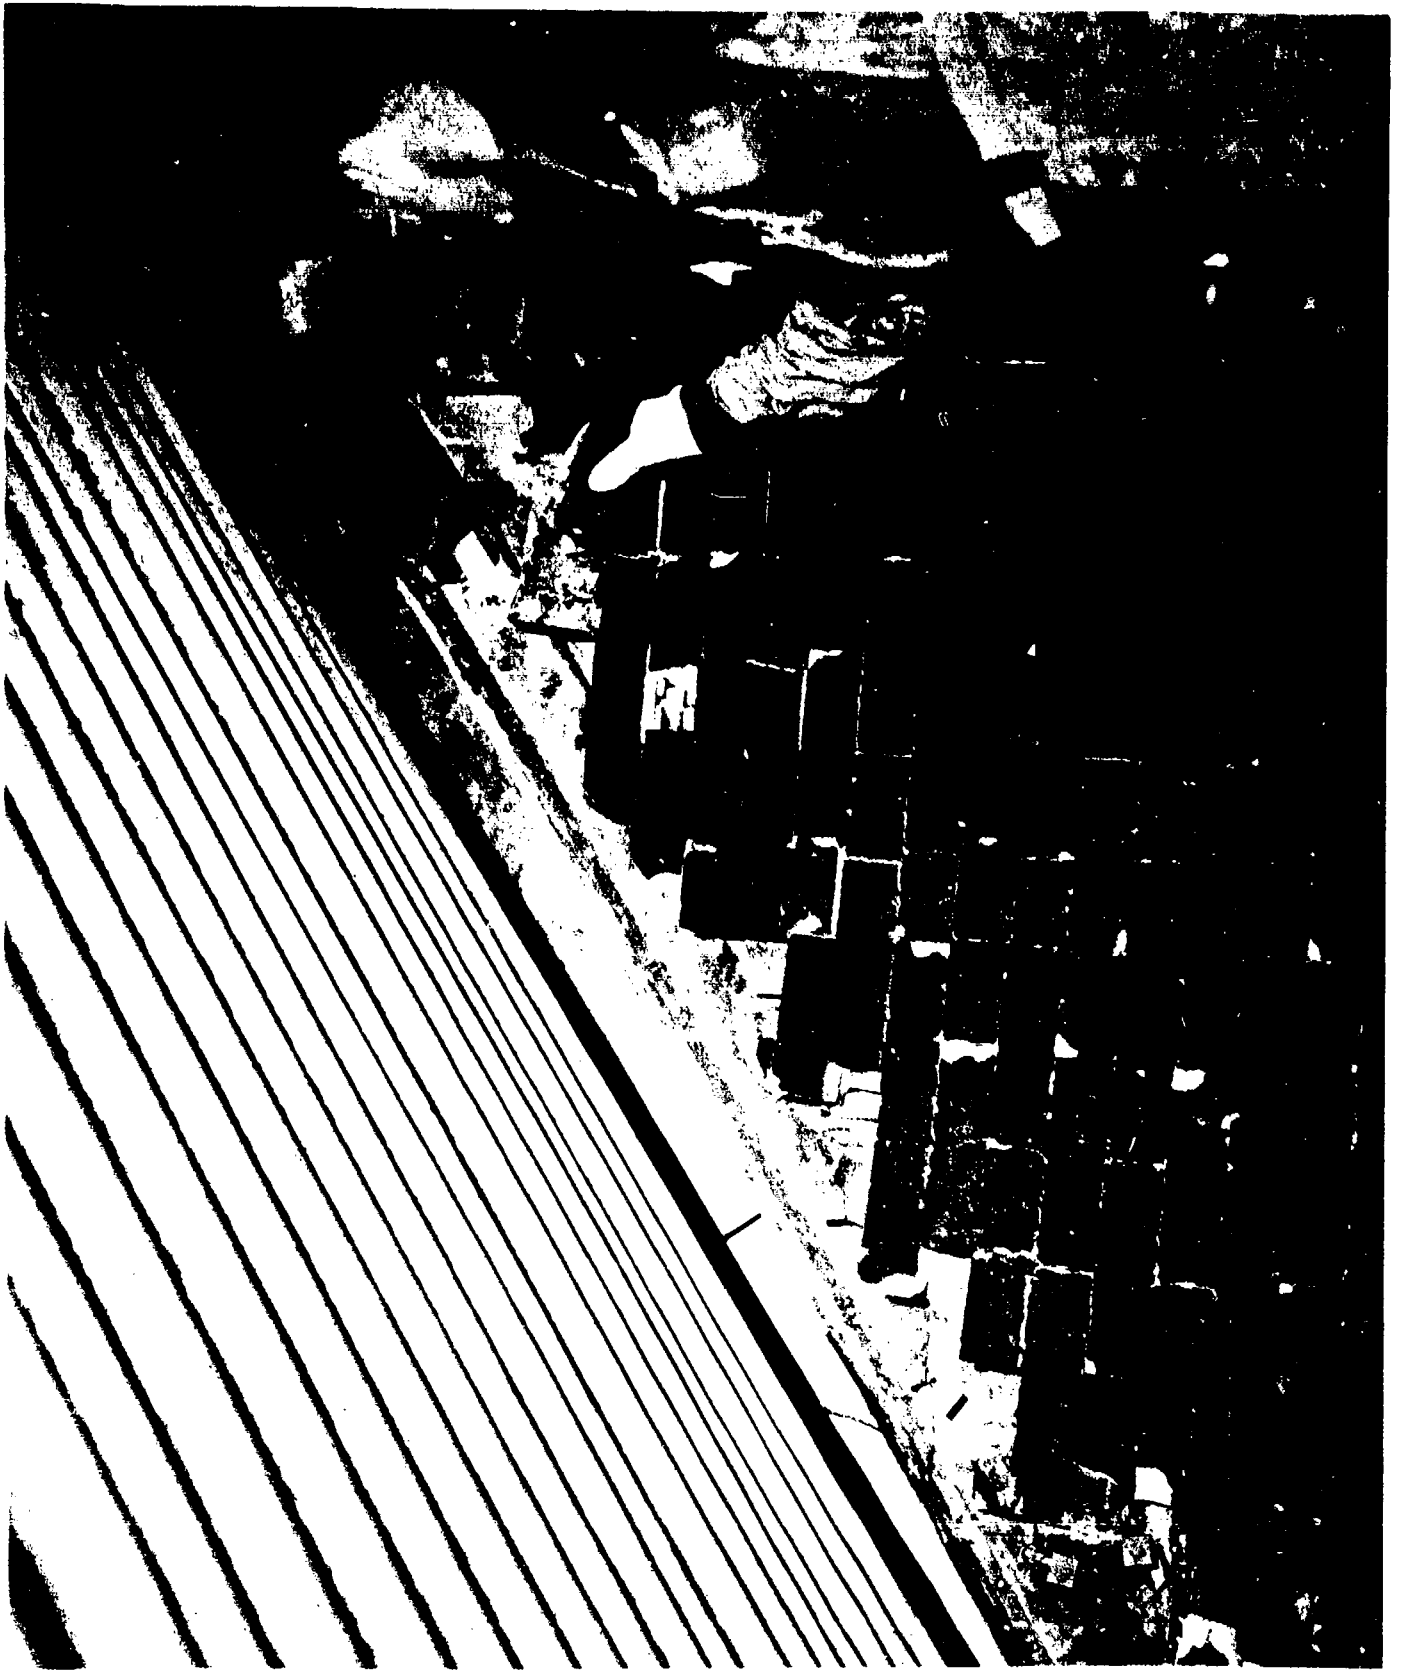
AB-CR-76-2075-7. No. 2 boiler, rear wall on superheater side.

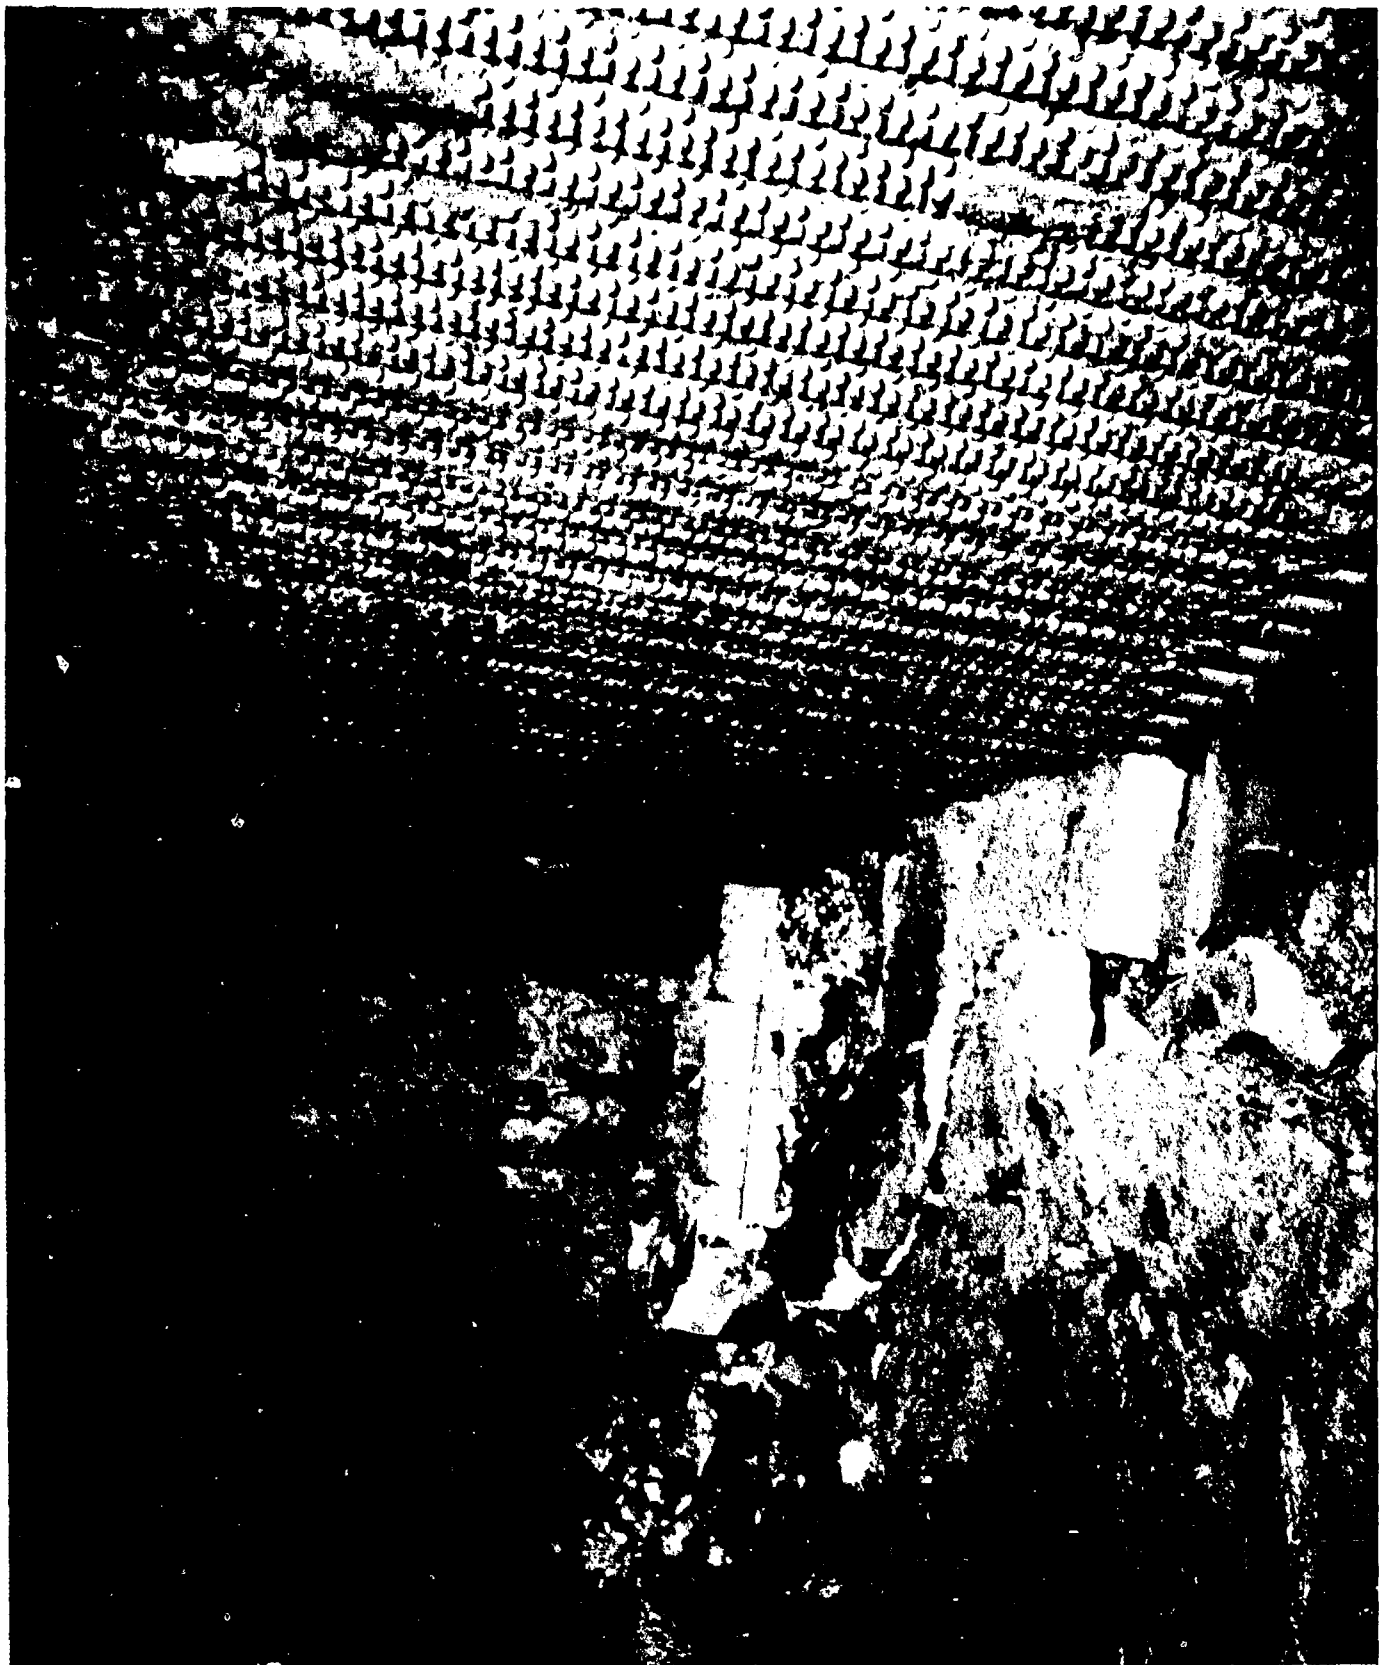
AB-CR-68-2952-1. Interior superheater side No. 1 boiler.

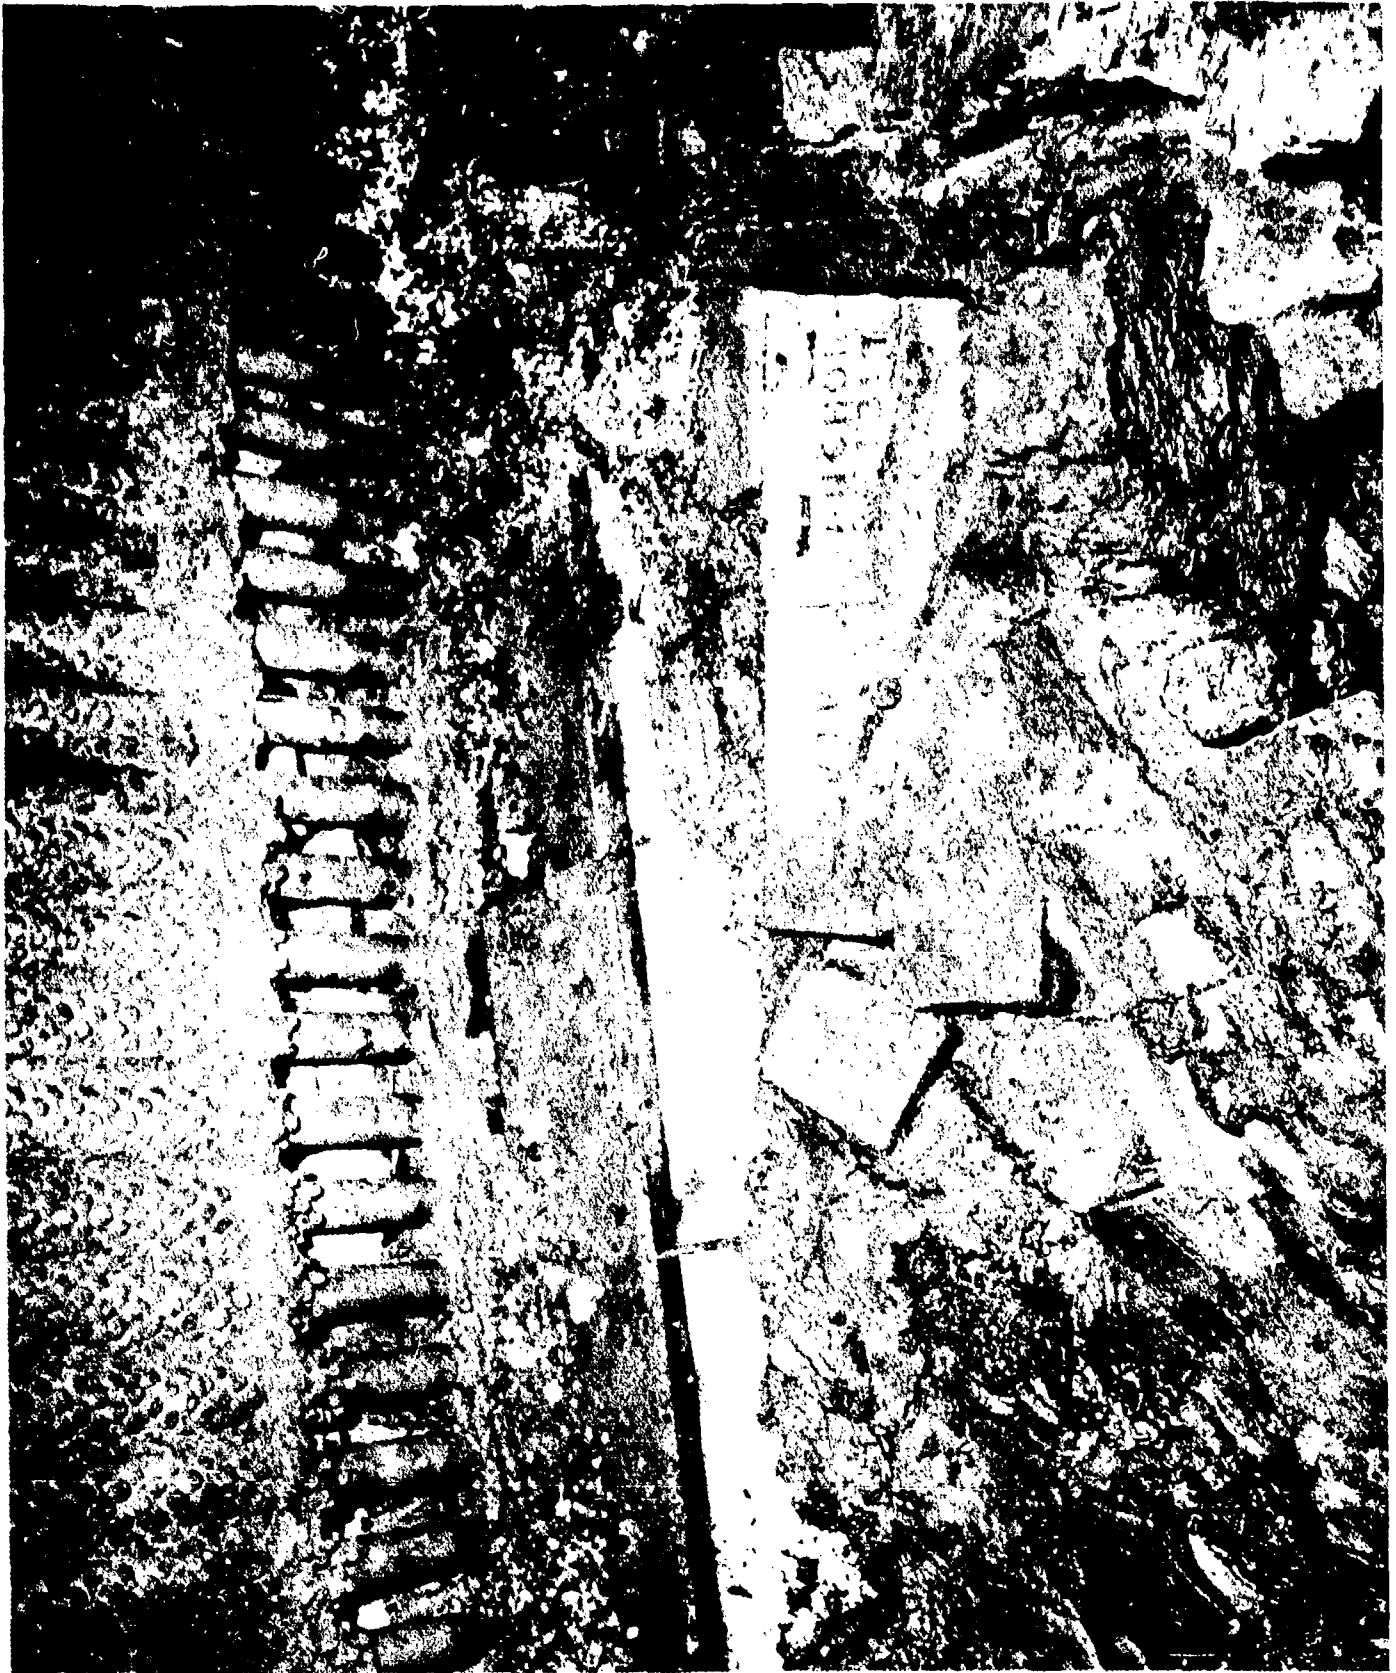
AB-CR-76-2076-4. No. 2 boiler, saturated side furnace, brickpan at division wall.

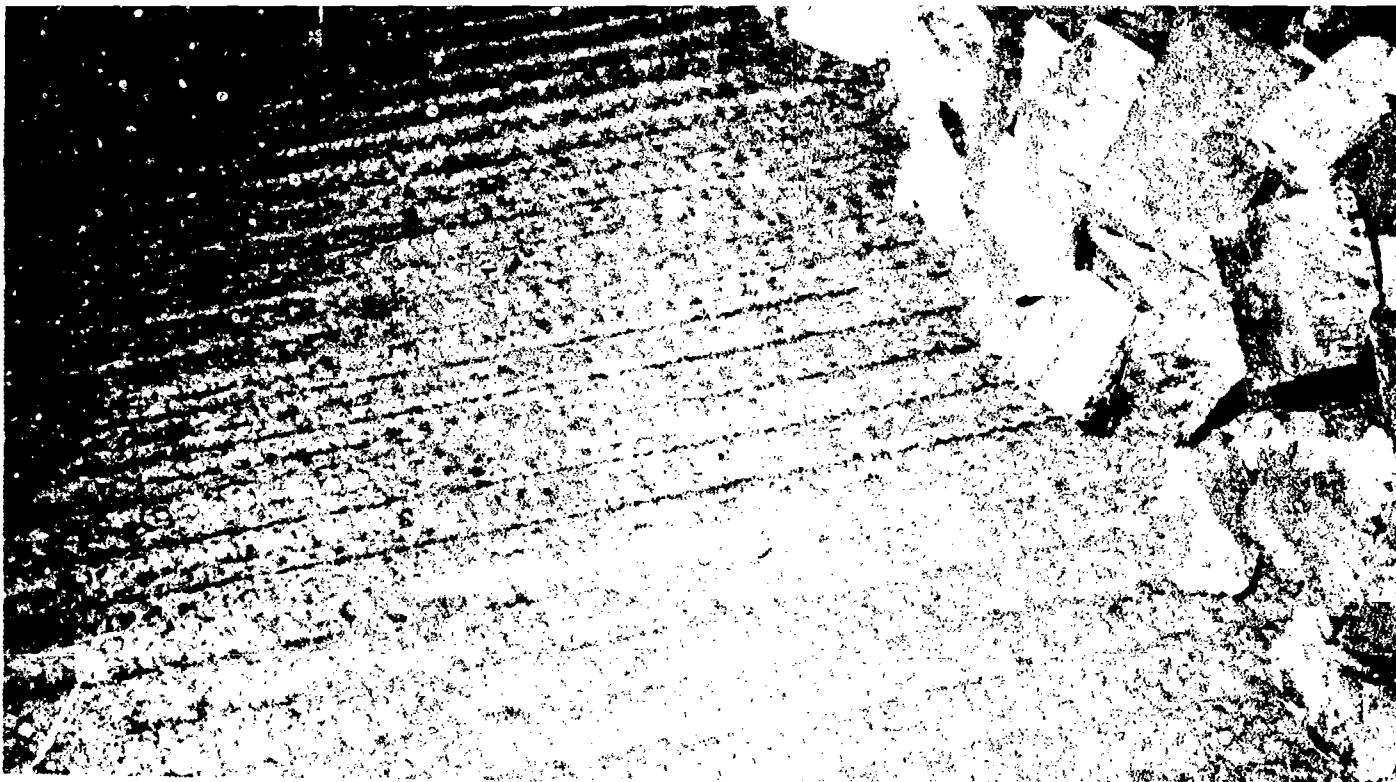
AB-CR-68-2951-12. Interior, saturated side, No. 1 boiler.

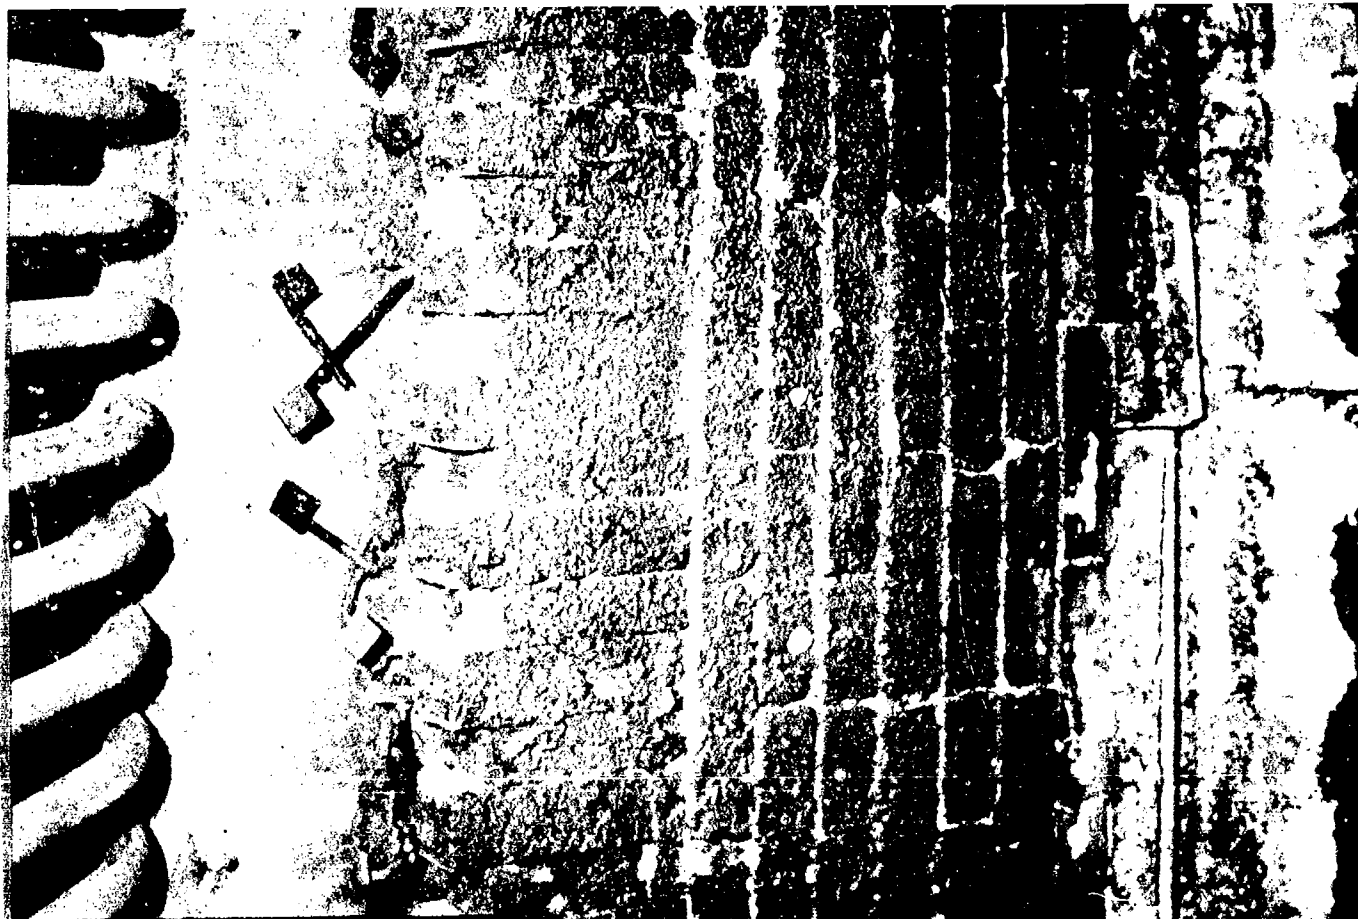
AB-CR-76-2075-9. No. 2 boiler superheater side furnace, side wall.

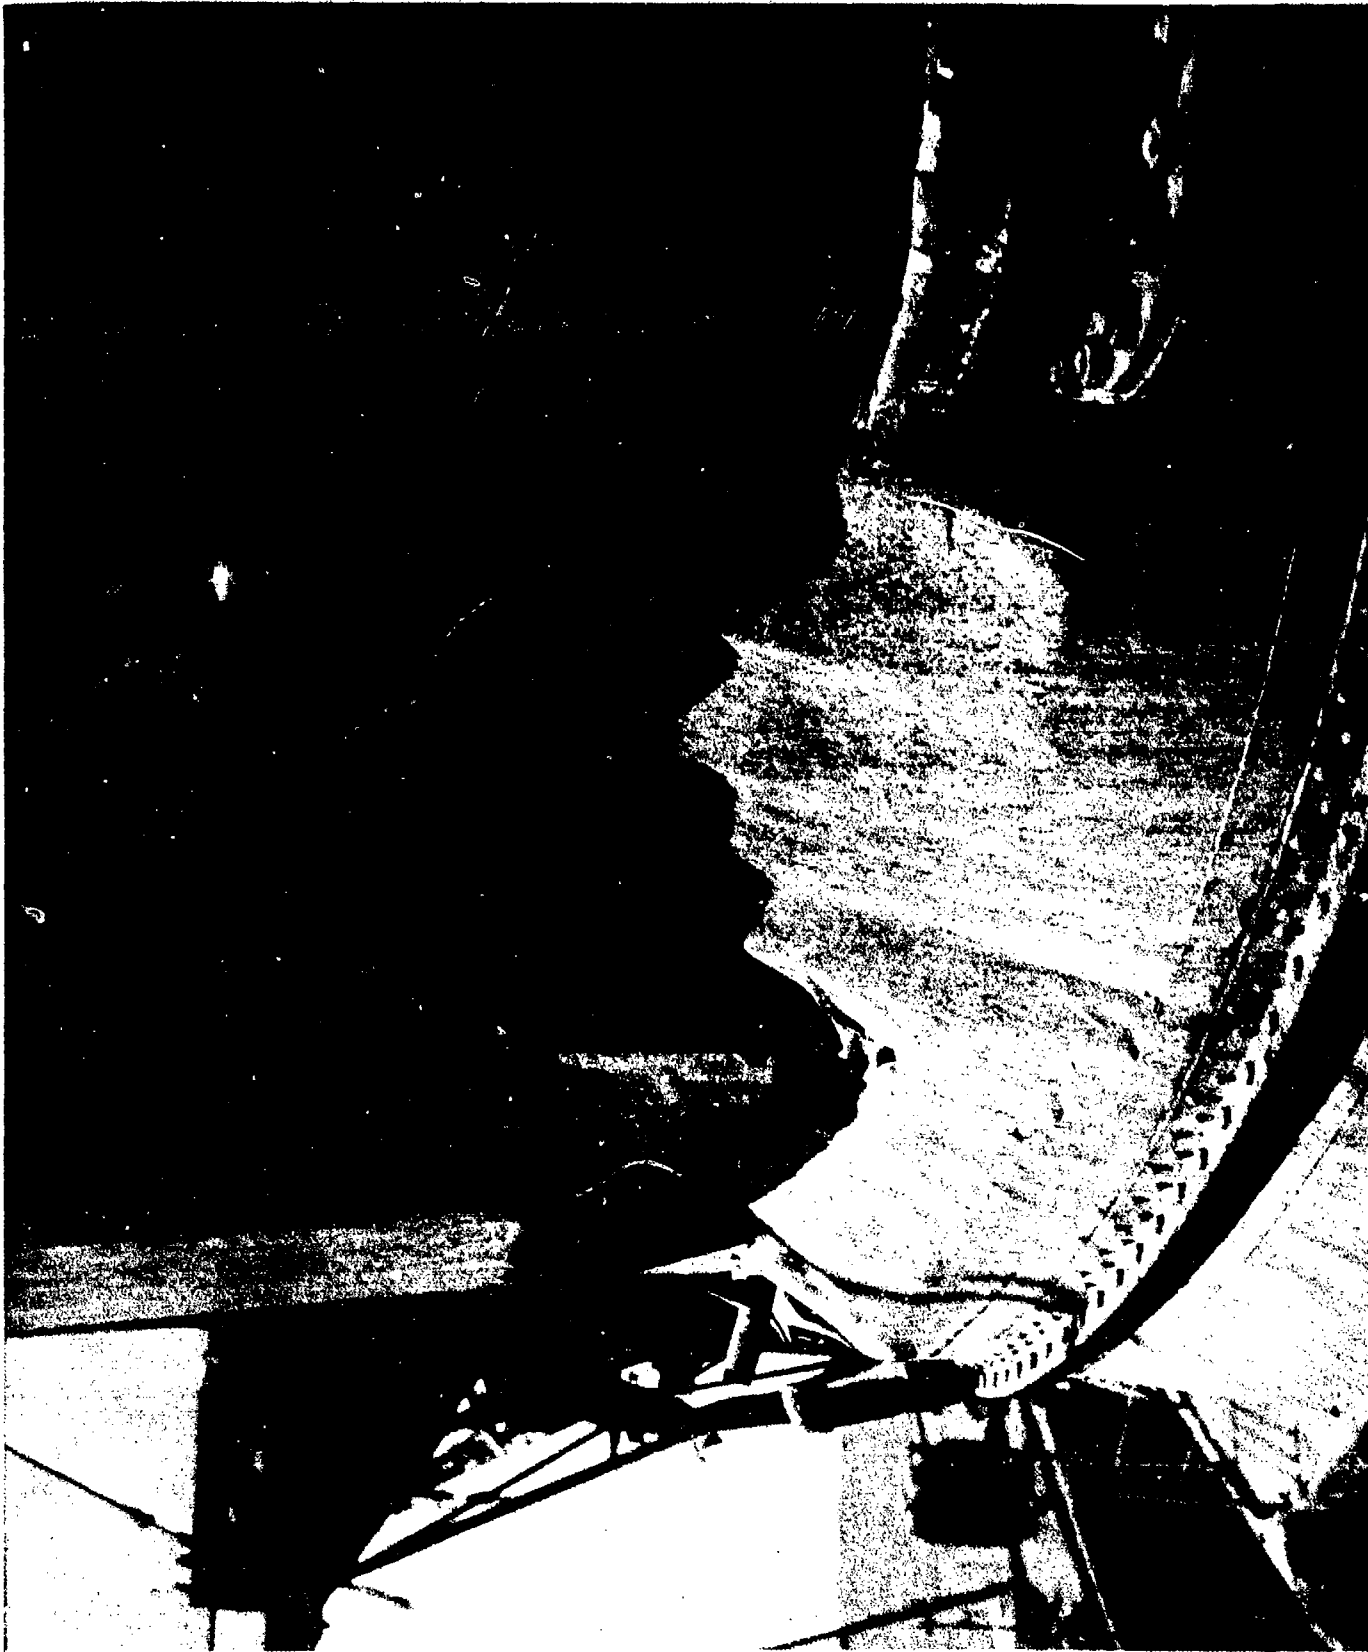
AB-CR-76-2077-11. After port side of stack showing buckle.

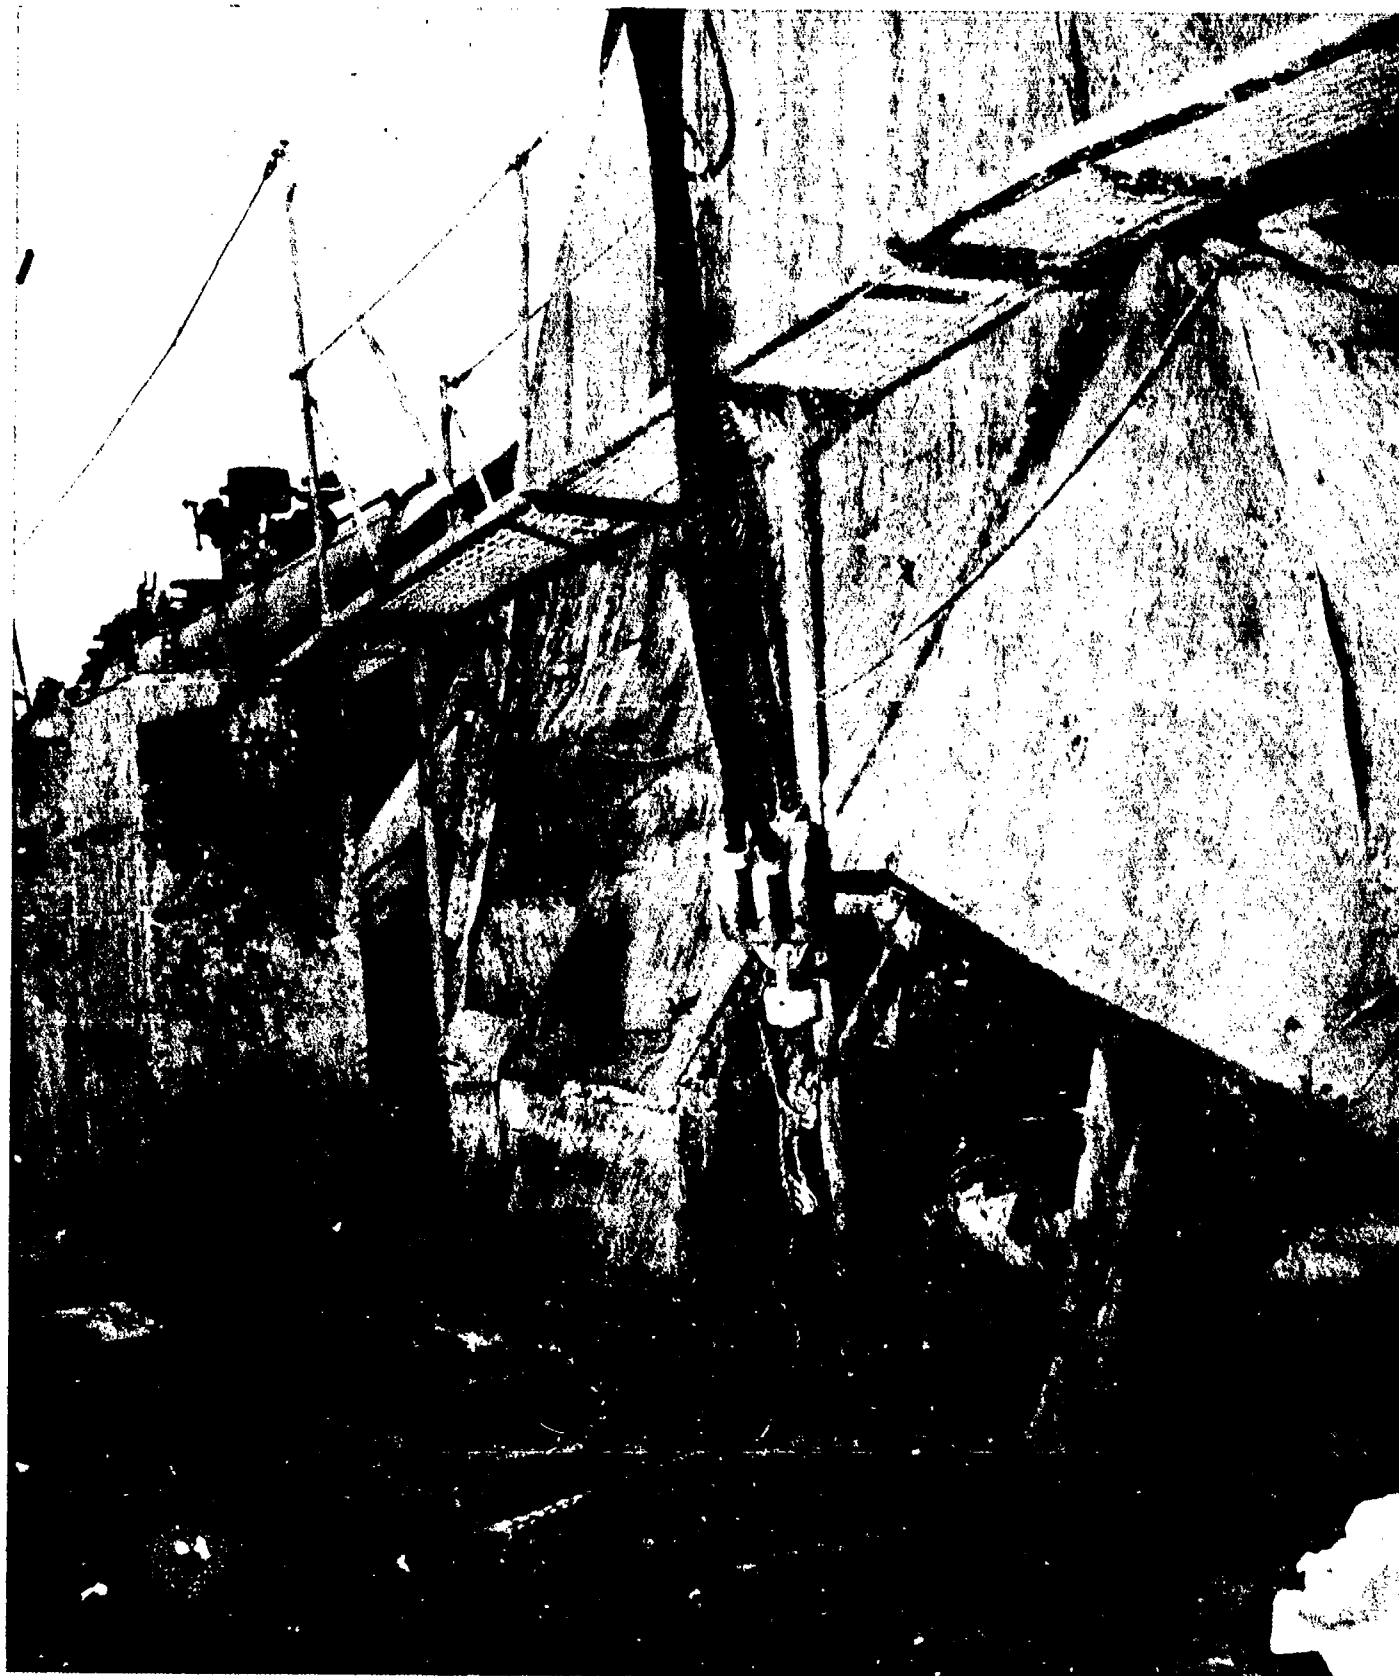
AB-CR-100-4204-6. Starboard side of uptakes, looking aft on main deck.

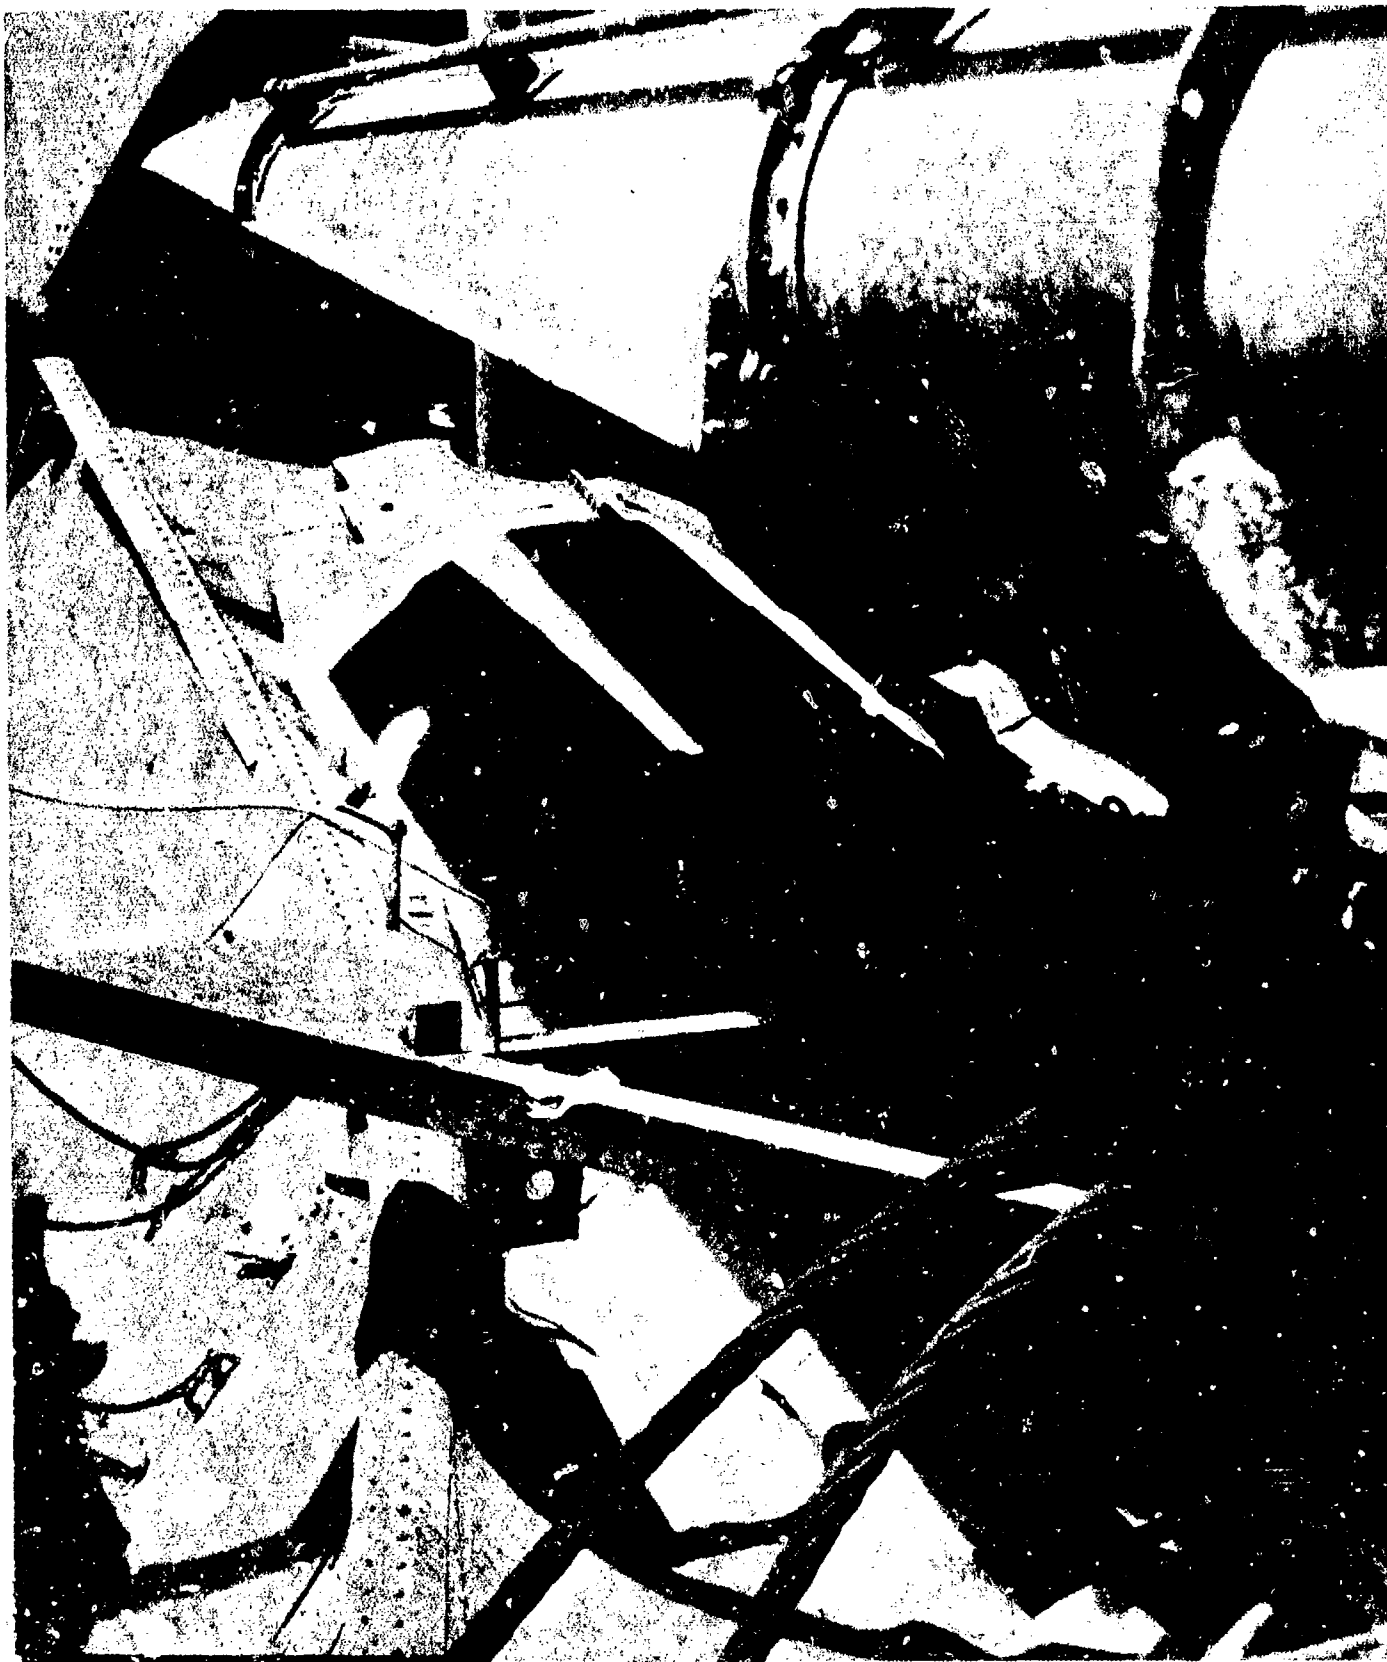
AB-CR-76-2077-8. No. 3 uptake, top of port leg.
