BUREAU OF SHIPS GROUP
TECHNICAL INSPECTION REPORT

⑥ OPERATION CROSSROADS.
U.S.S HUGHES (DD410).
TEST BAKER.

VOLUME II [u] ⑧

USS HUGHES (DD410)

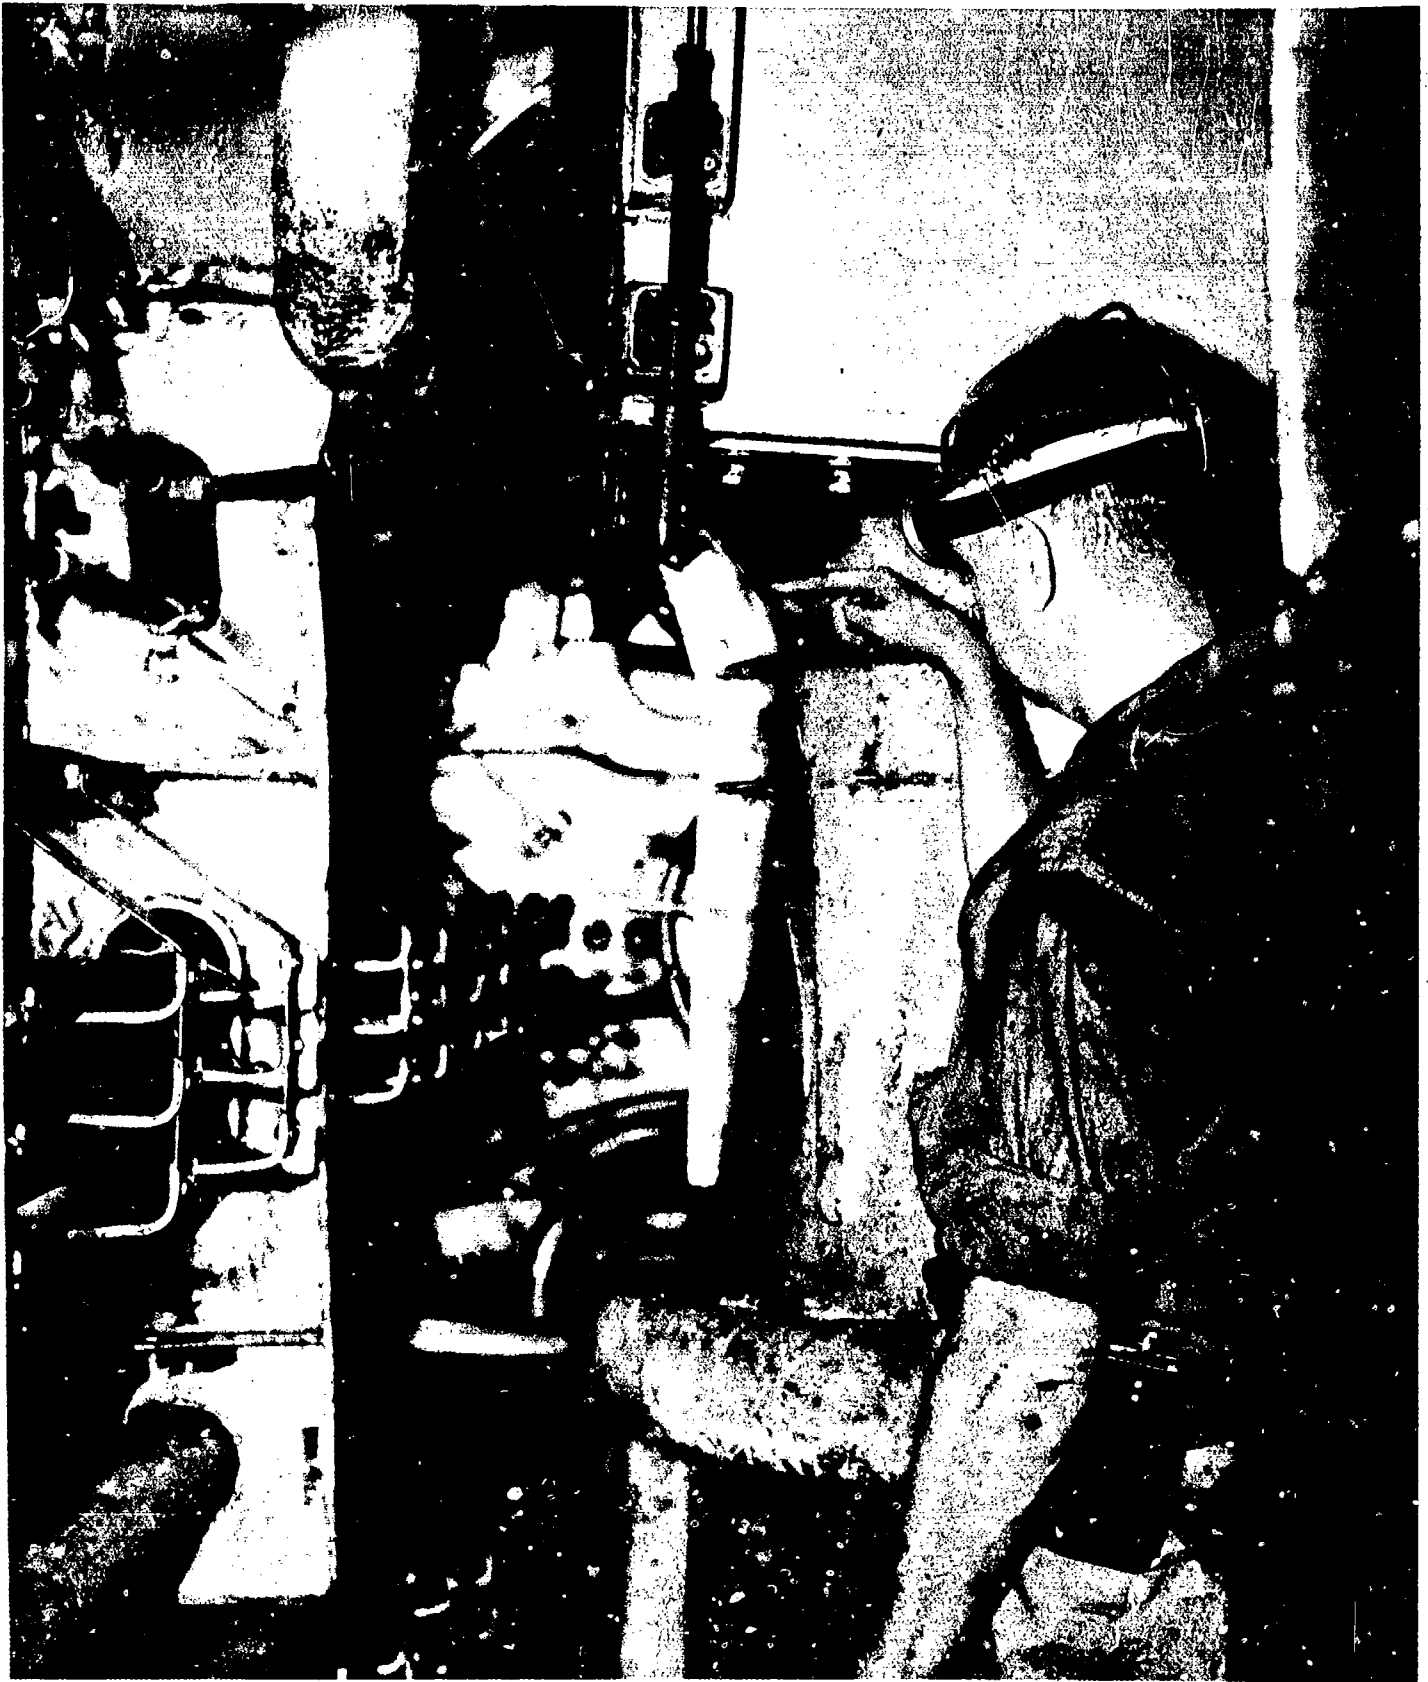
AB-CR-76-2075-6. No. 2 forced draft blower, showing buckled casing support ribs.

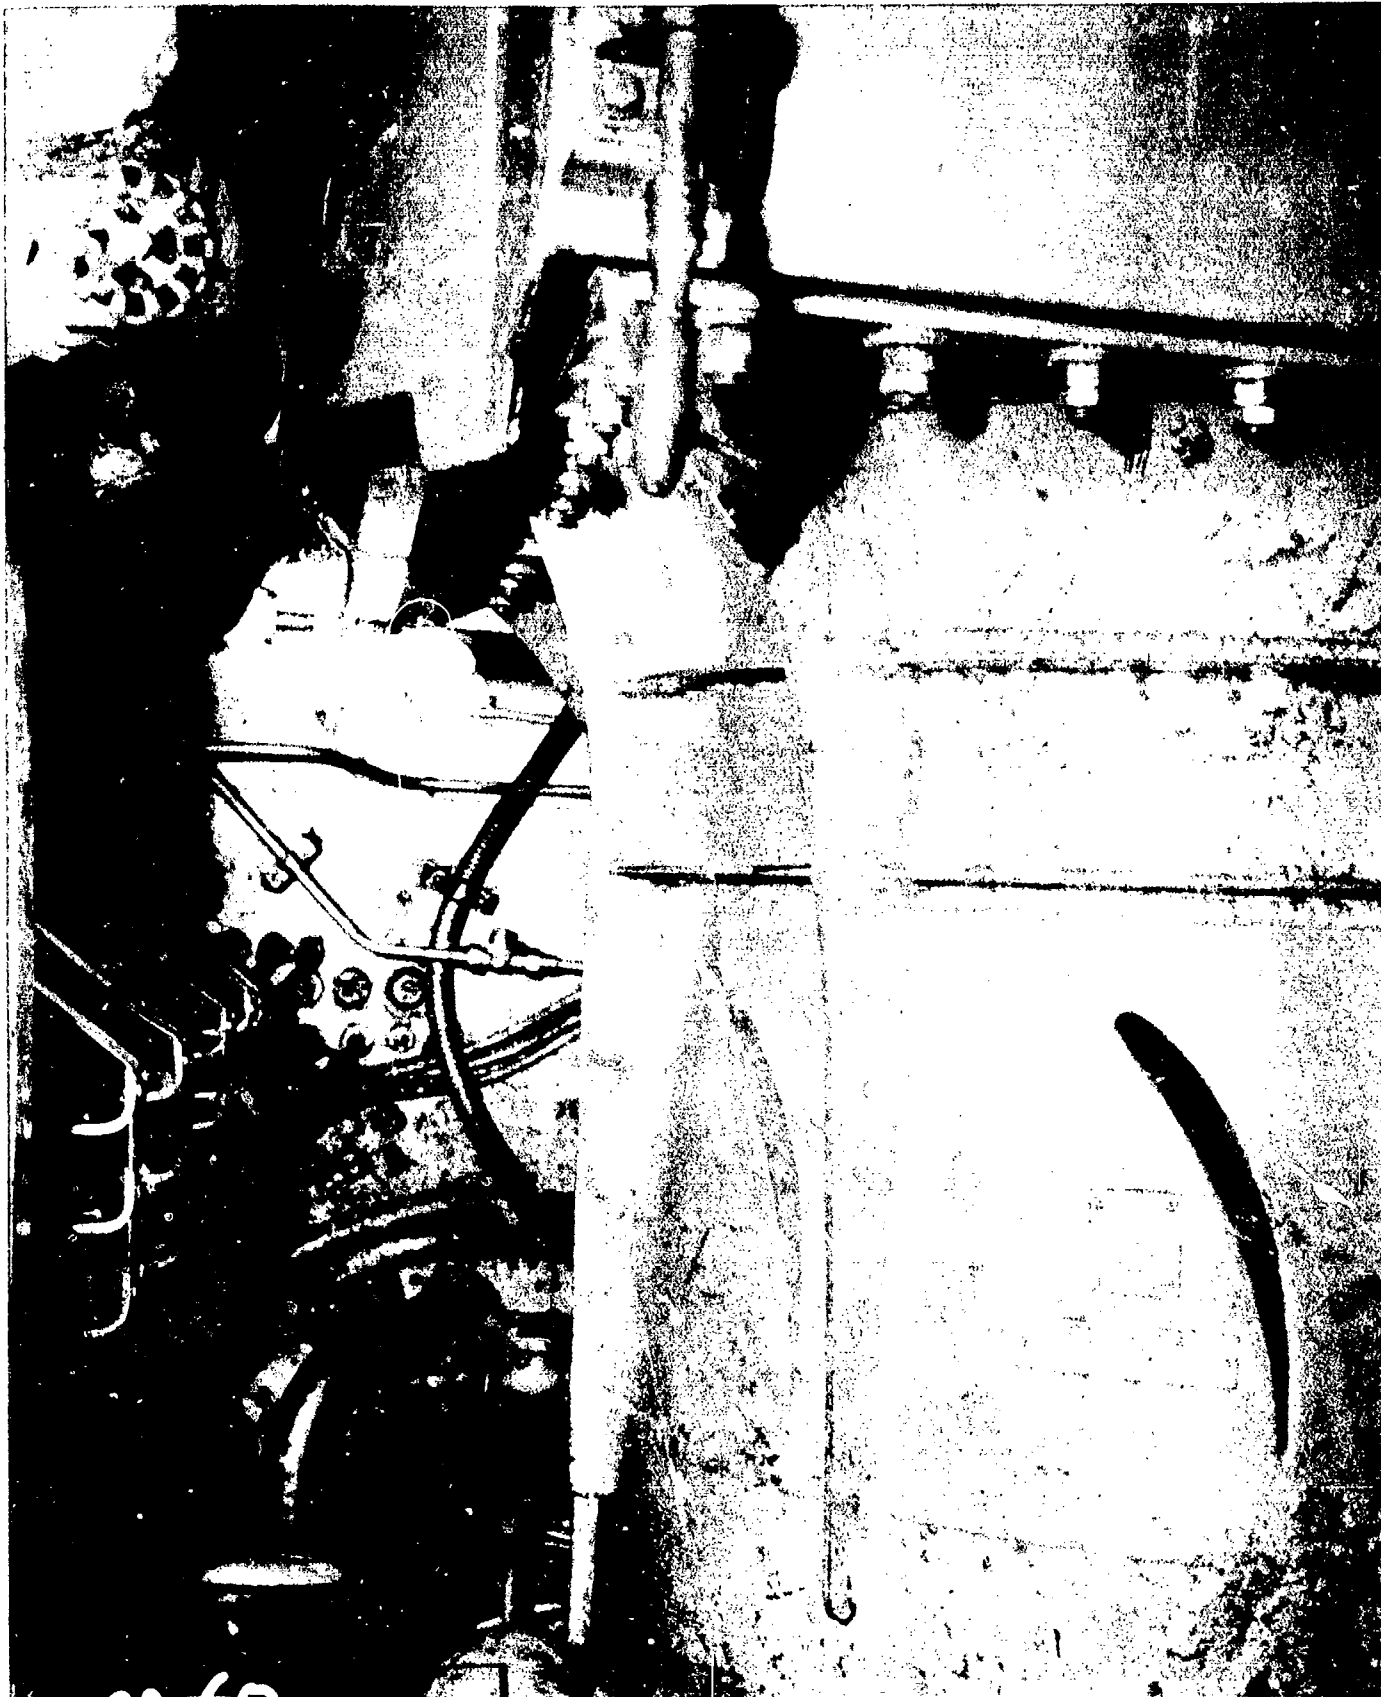
AB-CR-68-2952-4. No. 2 forced draft blower, port side. No. 1 fire-room, showing bent gusset plate.

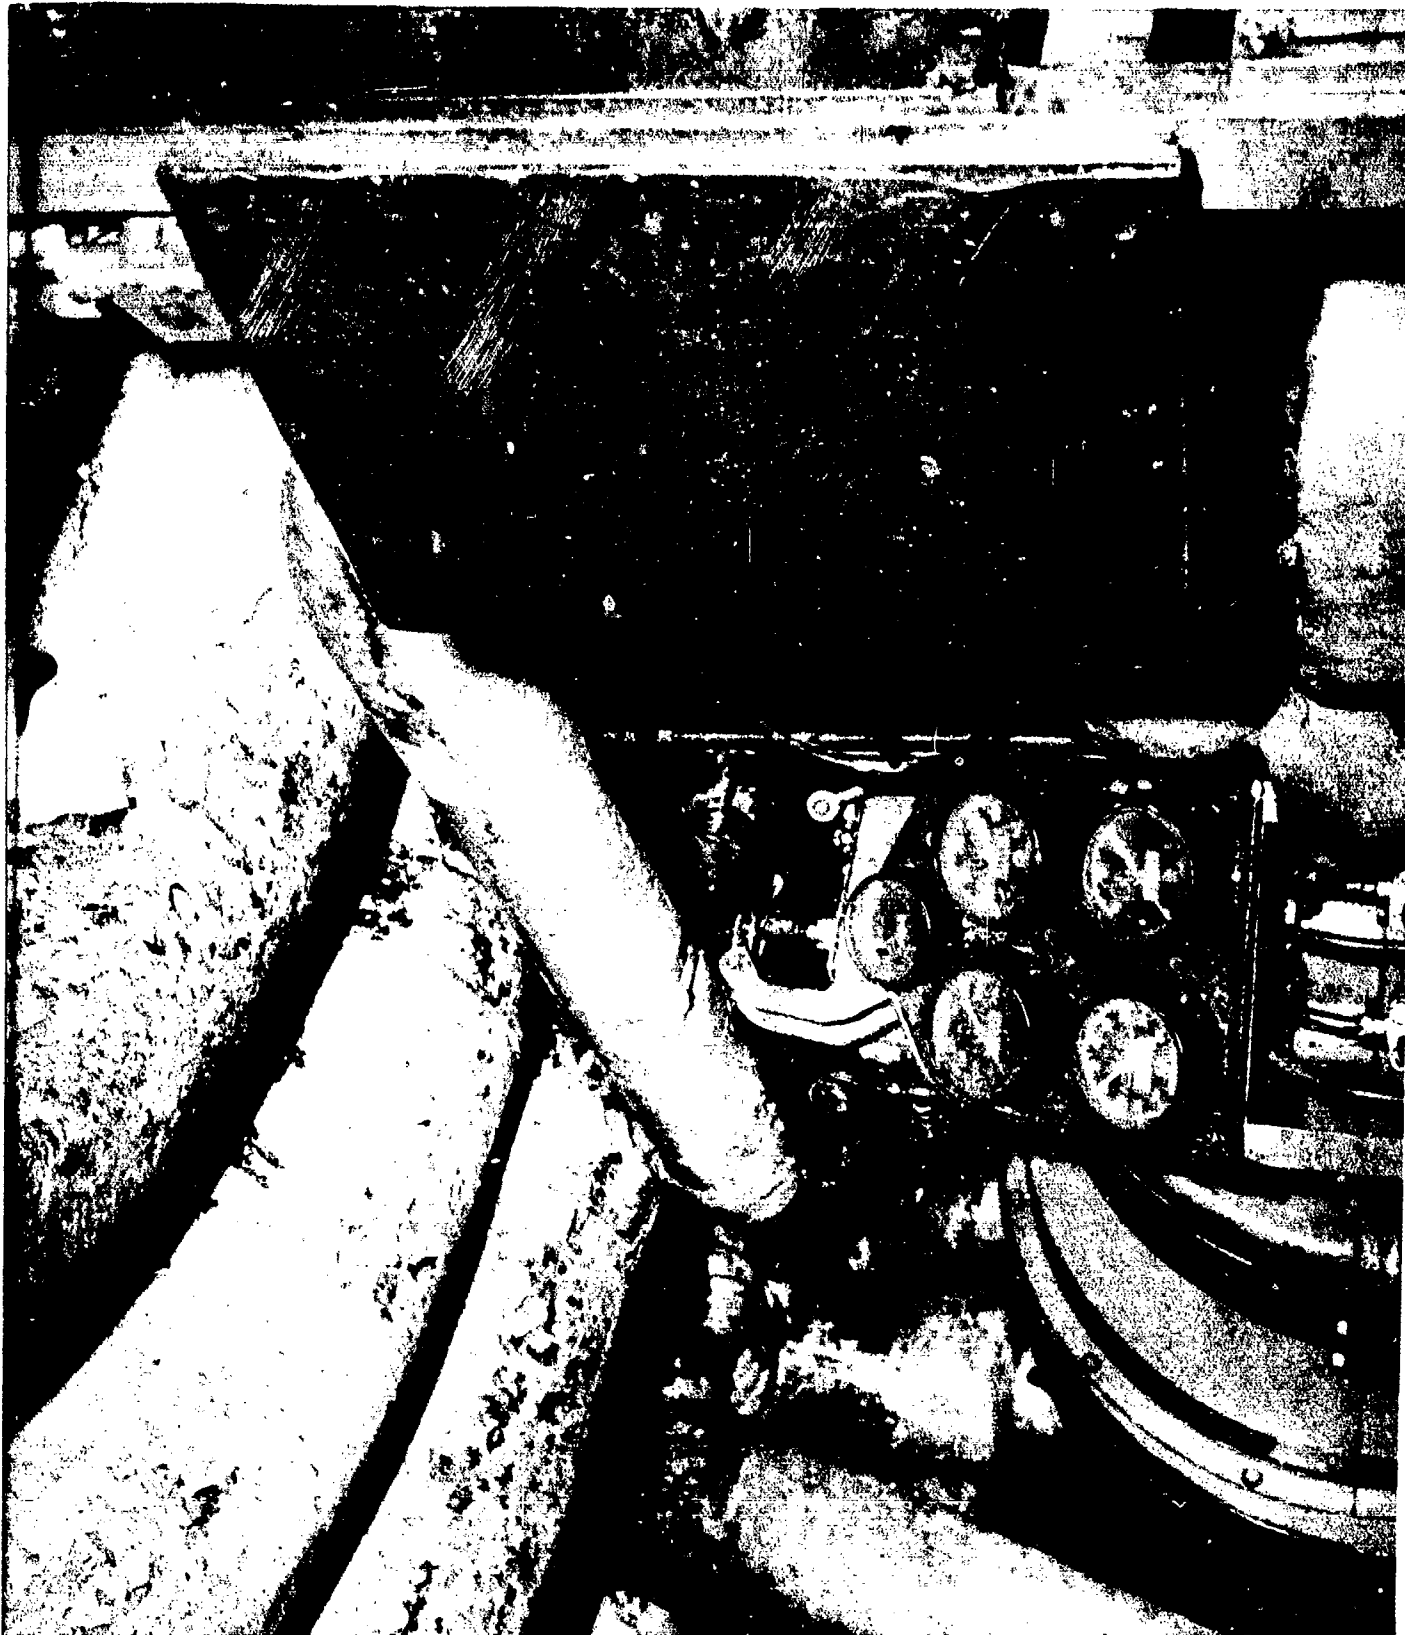
AB-CR-68-2950-11. Showing sagged main steam piping over No. 2 turbo generator No. 1 engine room.

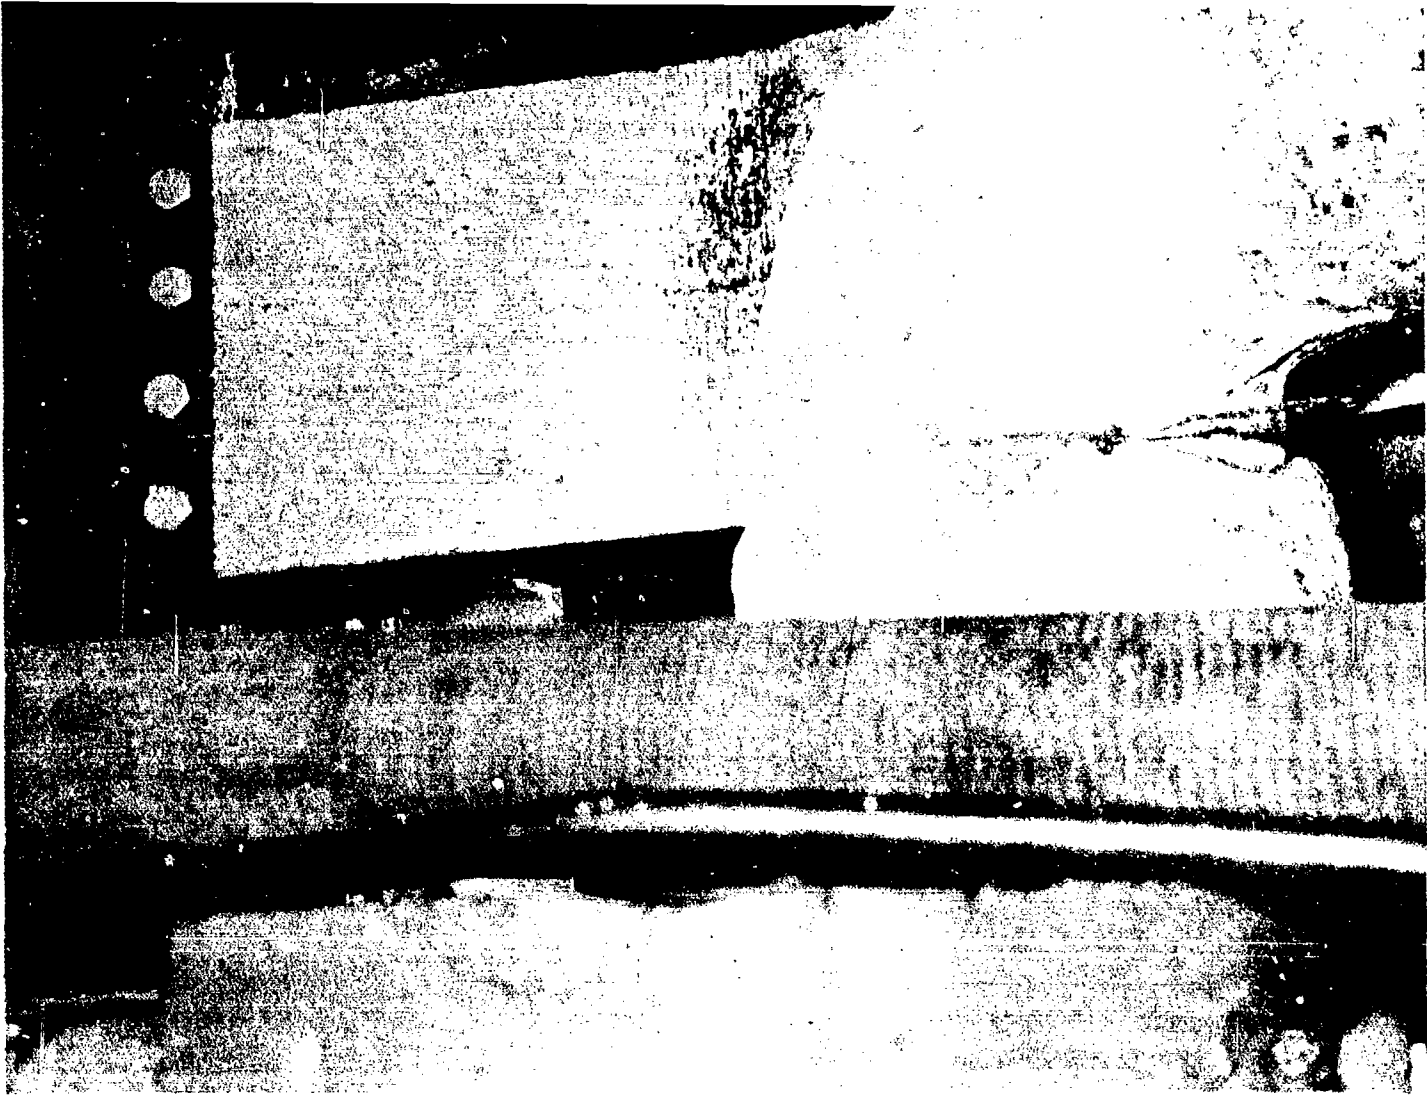
AB-CR-97-4059-6. Main steam manifold support forward engine room showing sheared forward bolt holes No. 1 engine room.

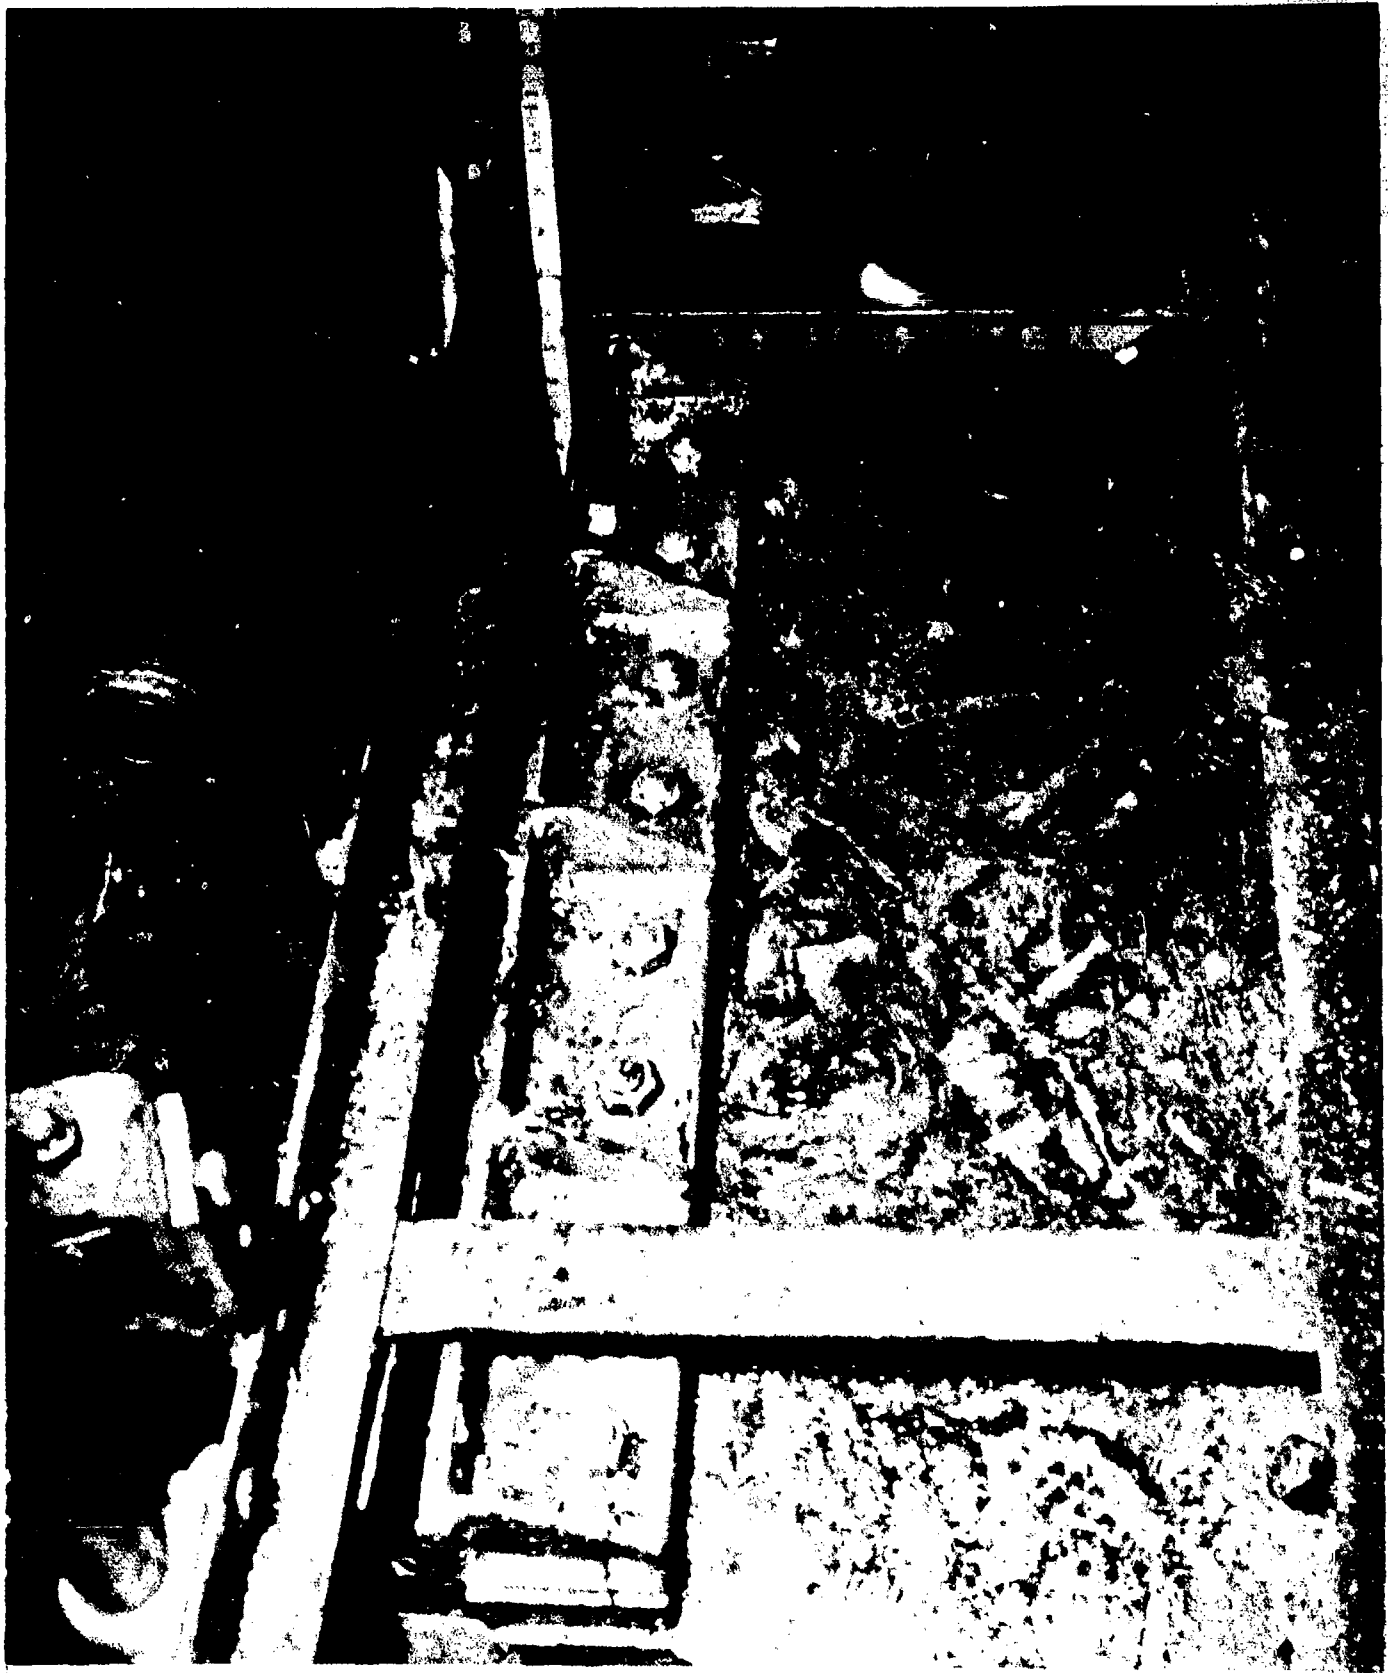
AB-CR-66-151-12. L.P. turbine, flexing plate No. 2 engine room.

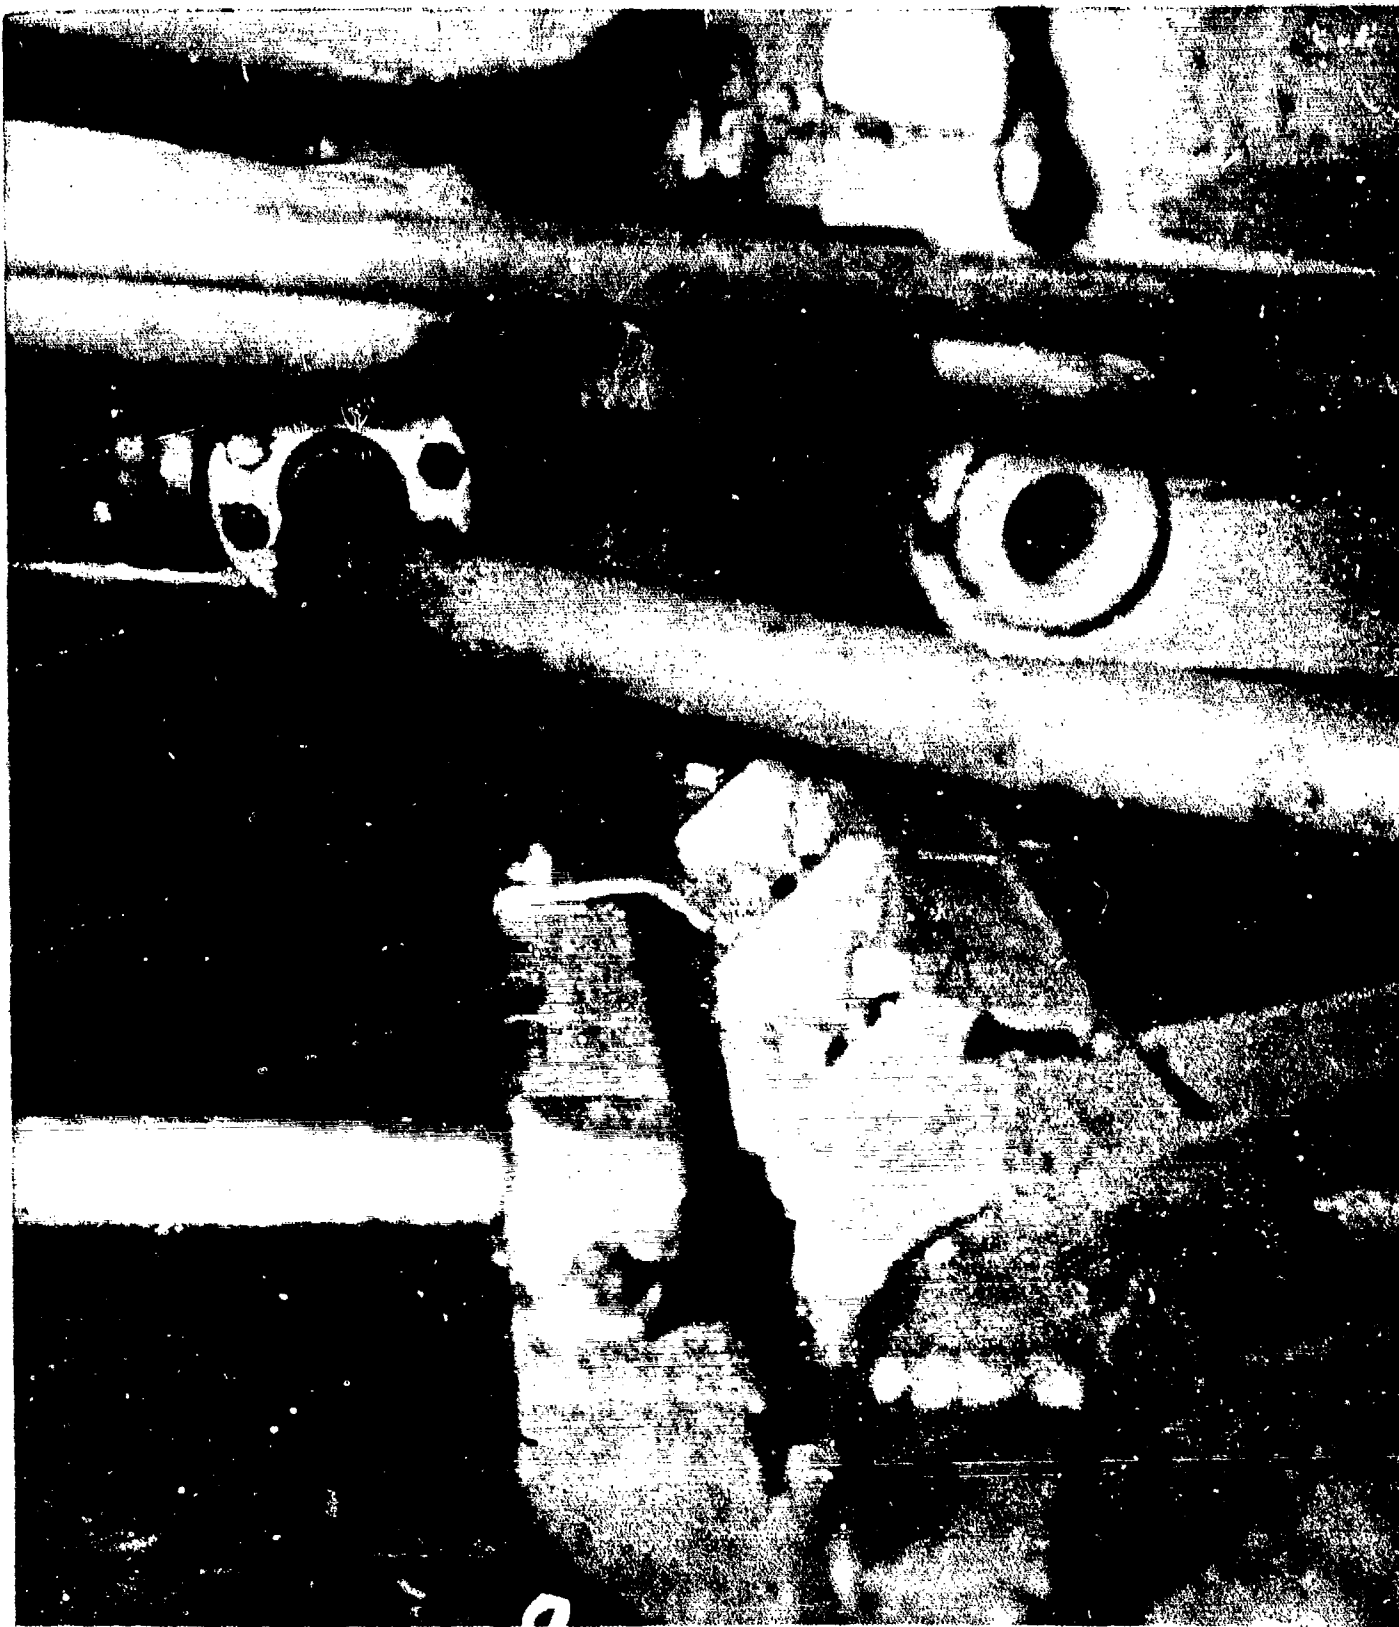
AB-CR-66-153-9. No. 2 engine room, bent structural engine girder looking from port inboard.

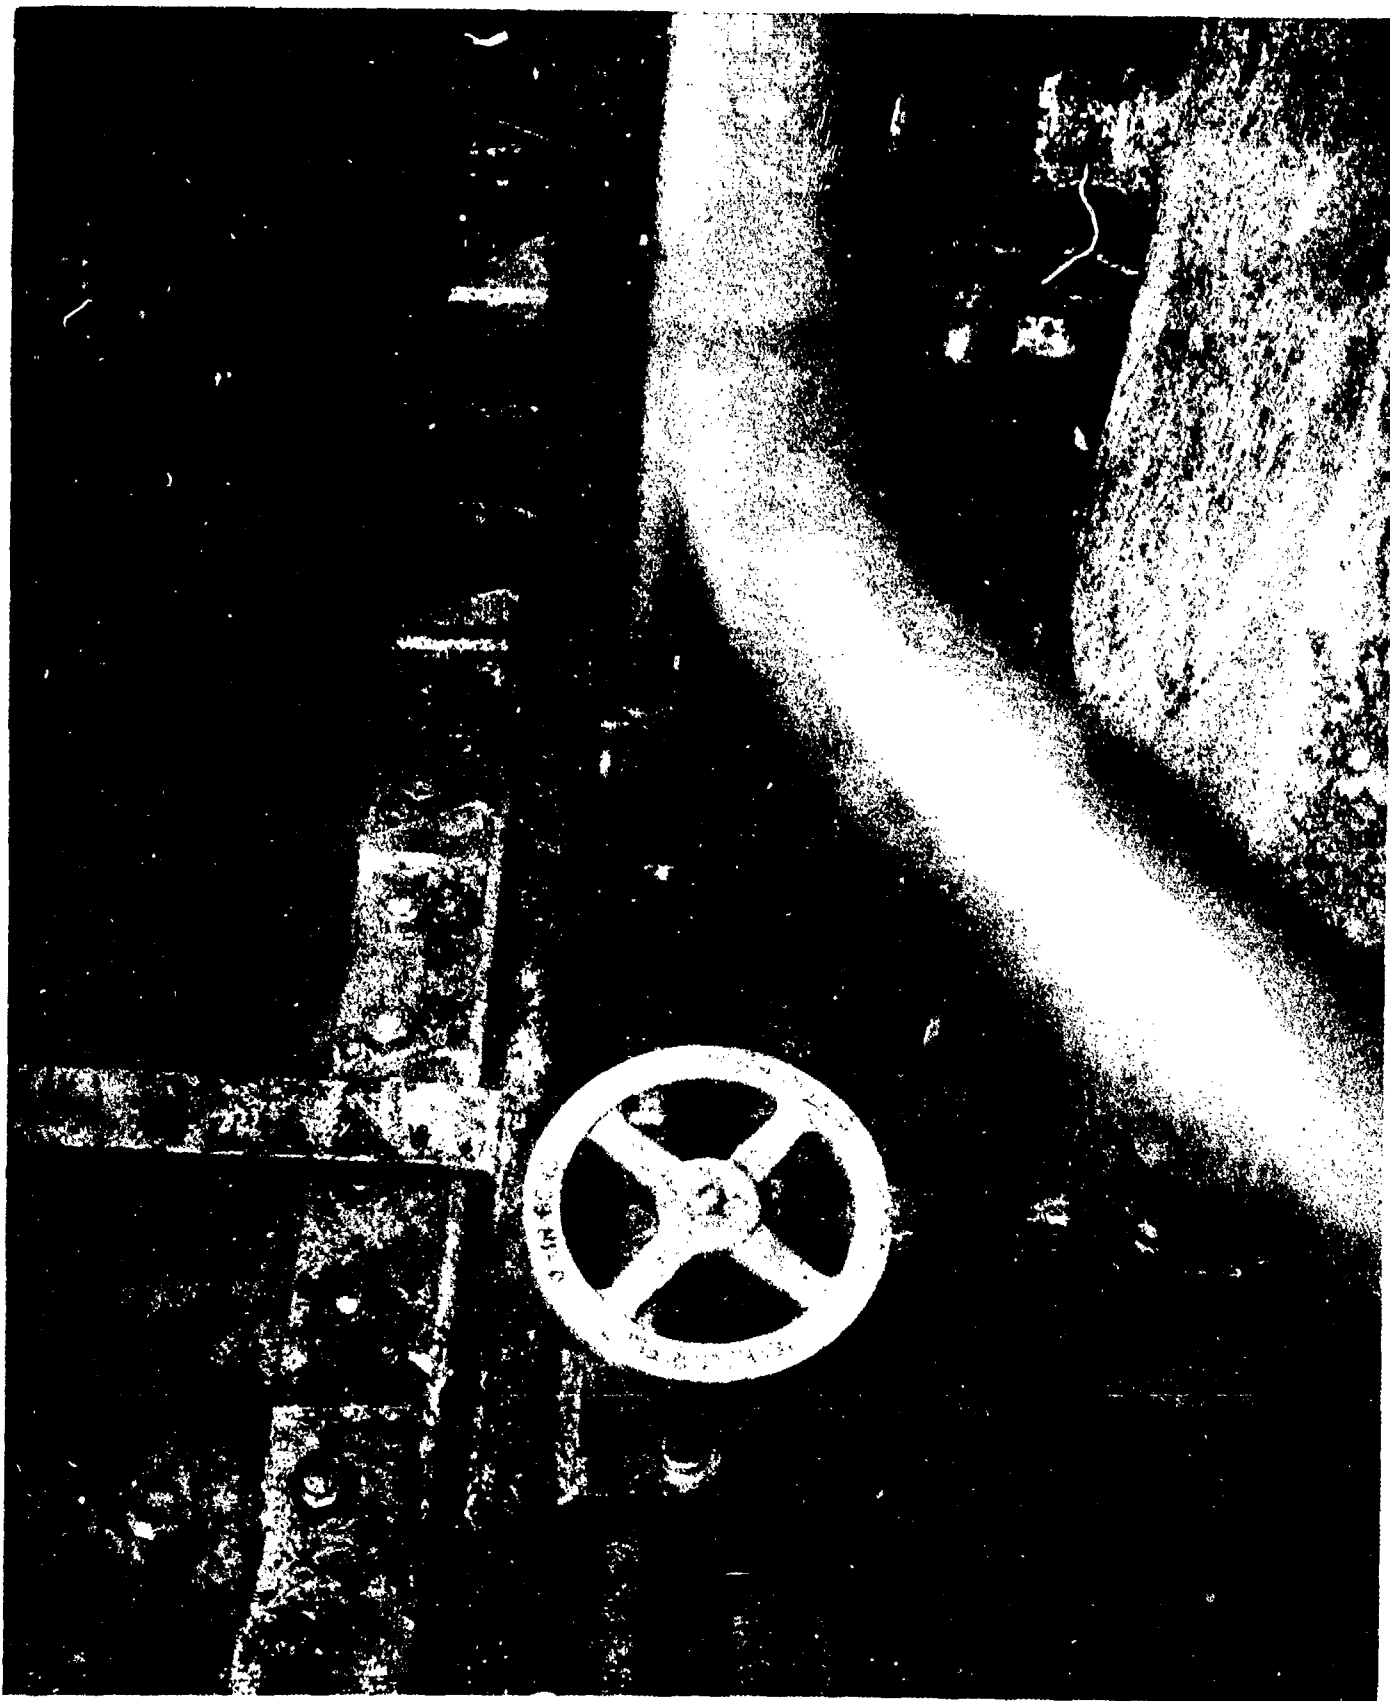
AB-CR-68-2951-2. Showing main engine support girder with flexing plate sheared off No. 1 engine room.

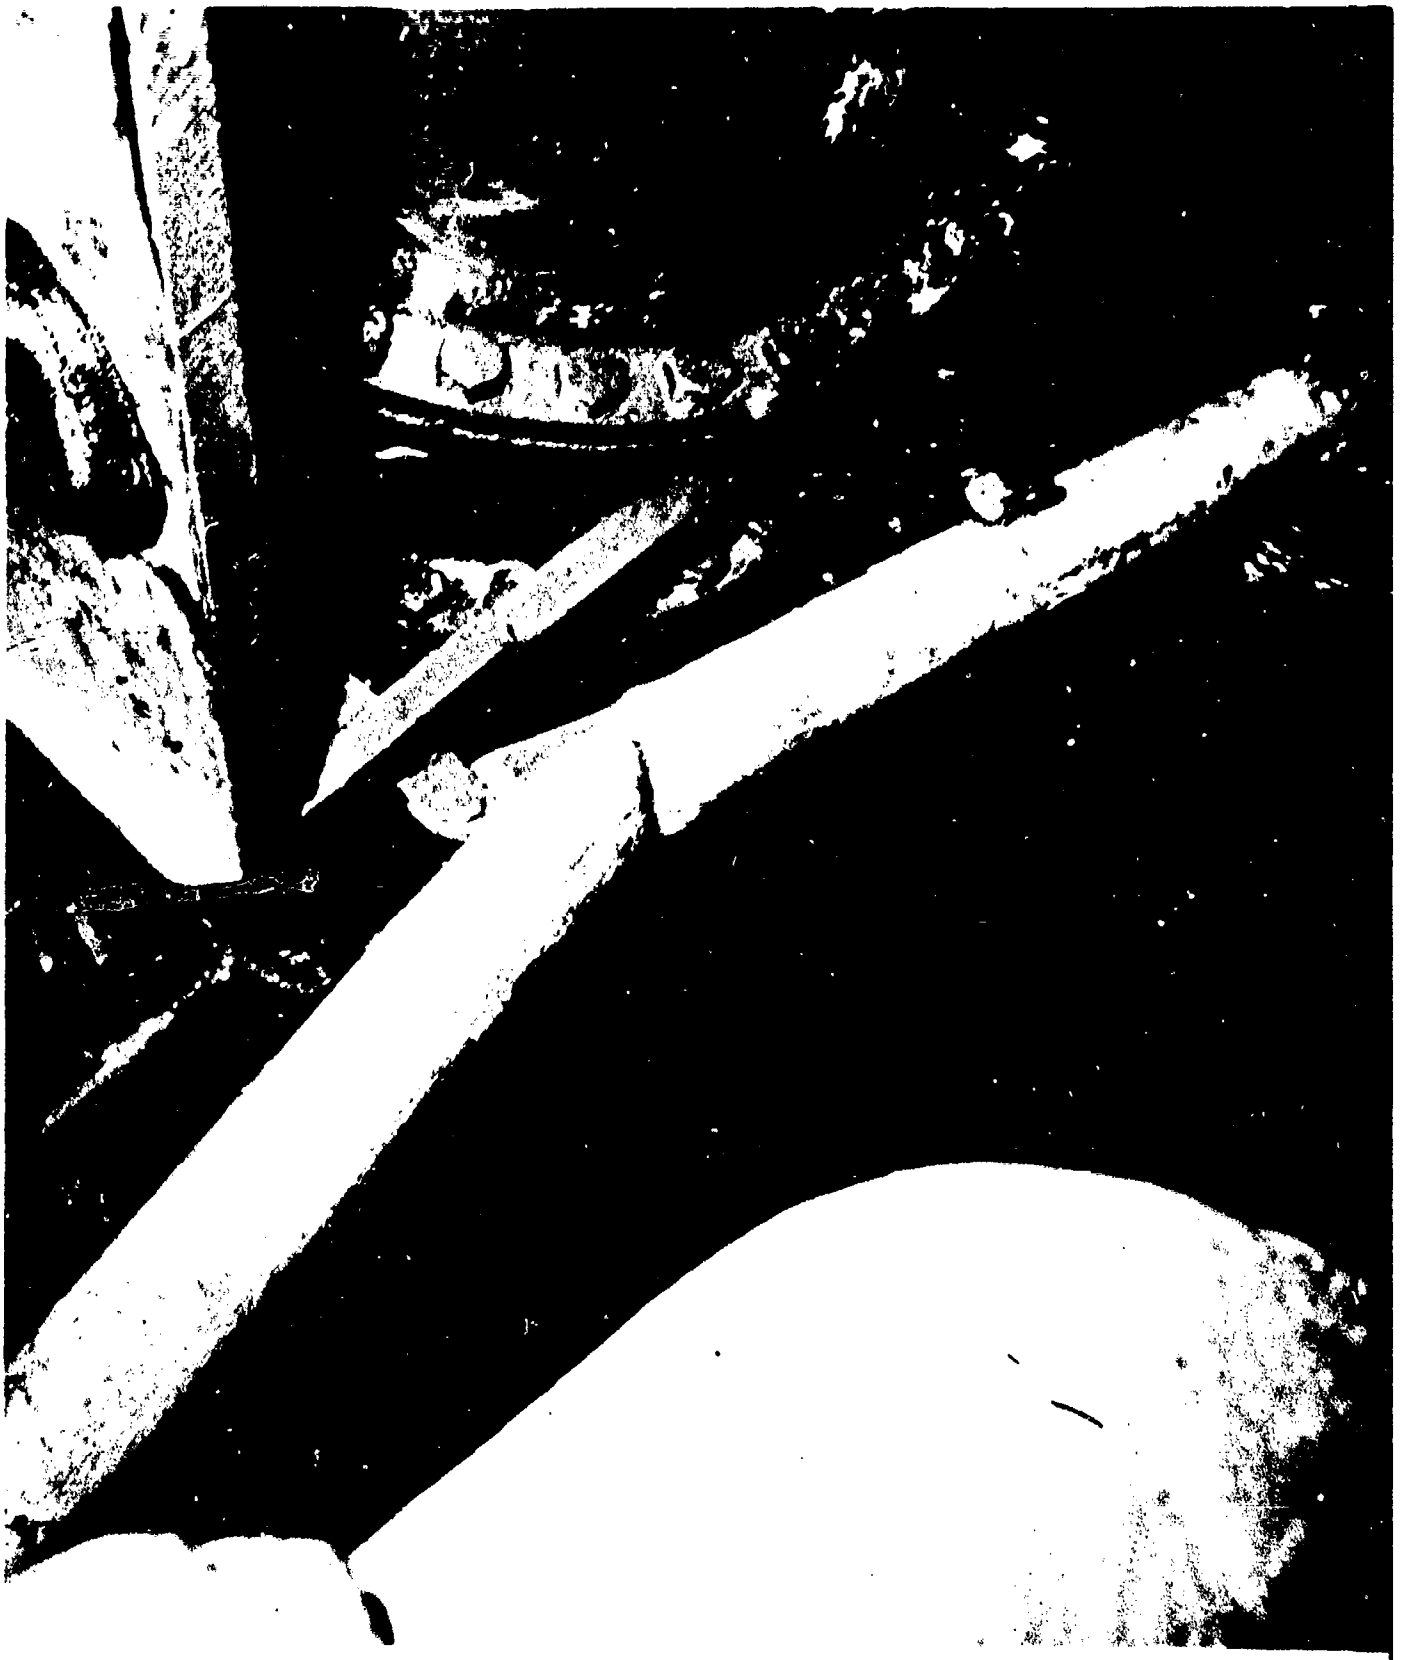
AB-CR-97-4059-1. No. 1 L.P. turbine flexing plate looking to starboard and down.

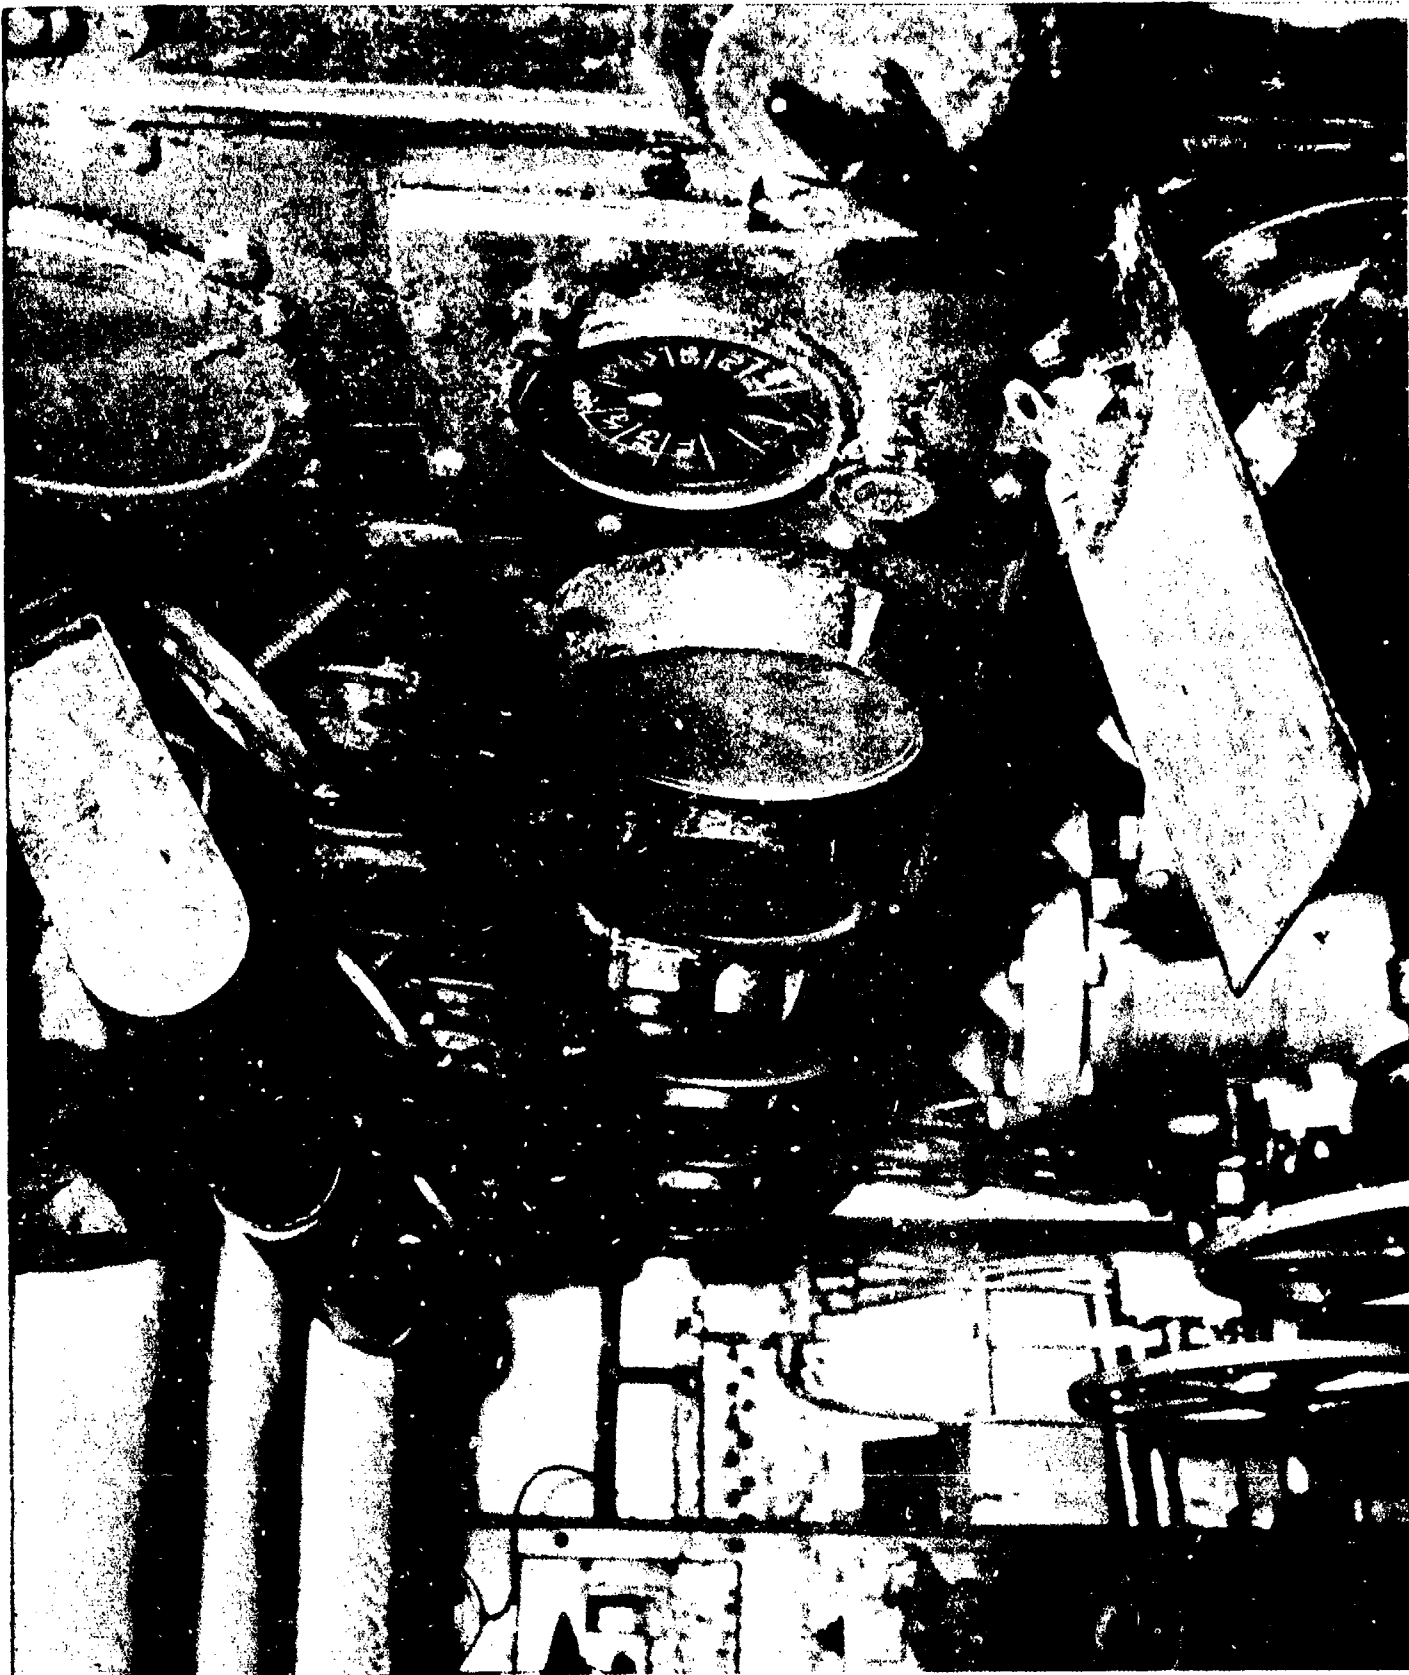
AB-CR-68-2950-7. Front of main gage board. No. 1 engine room, showing bent throttle by-pass valve stems.

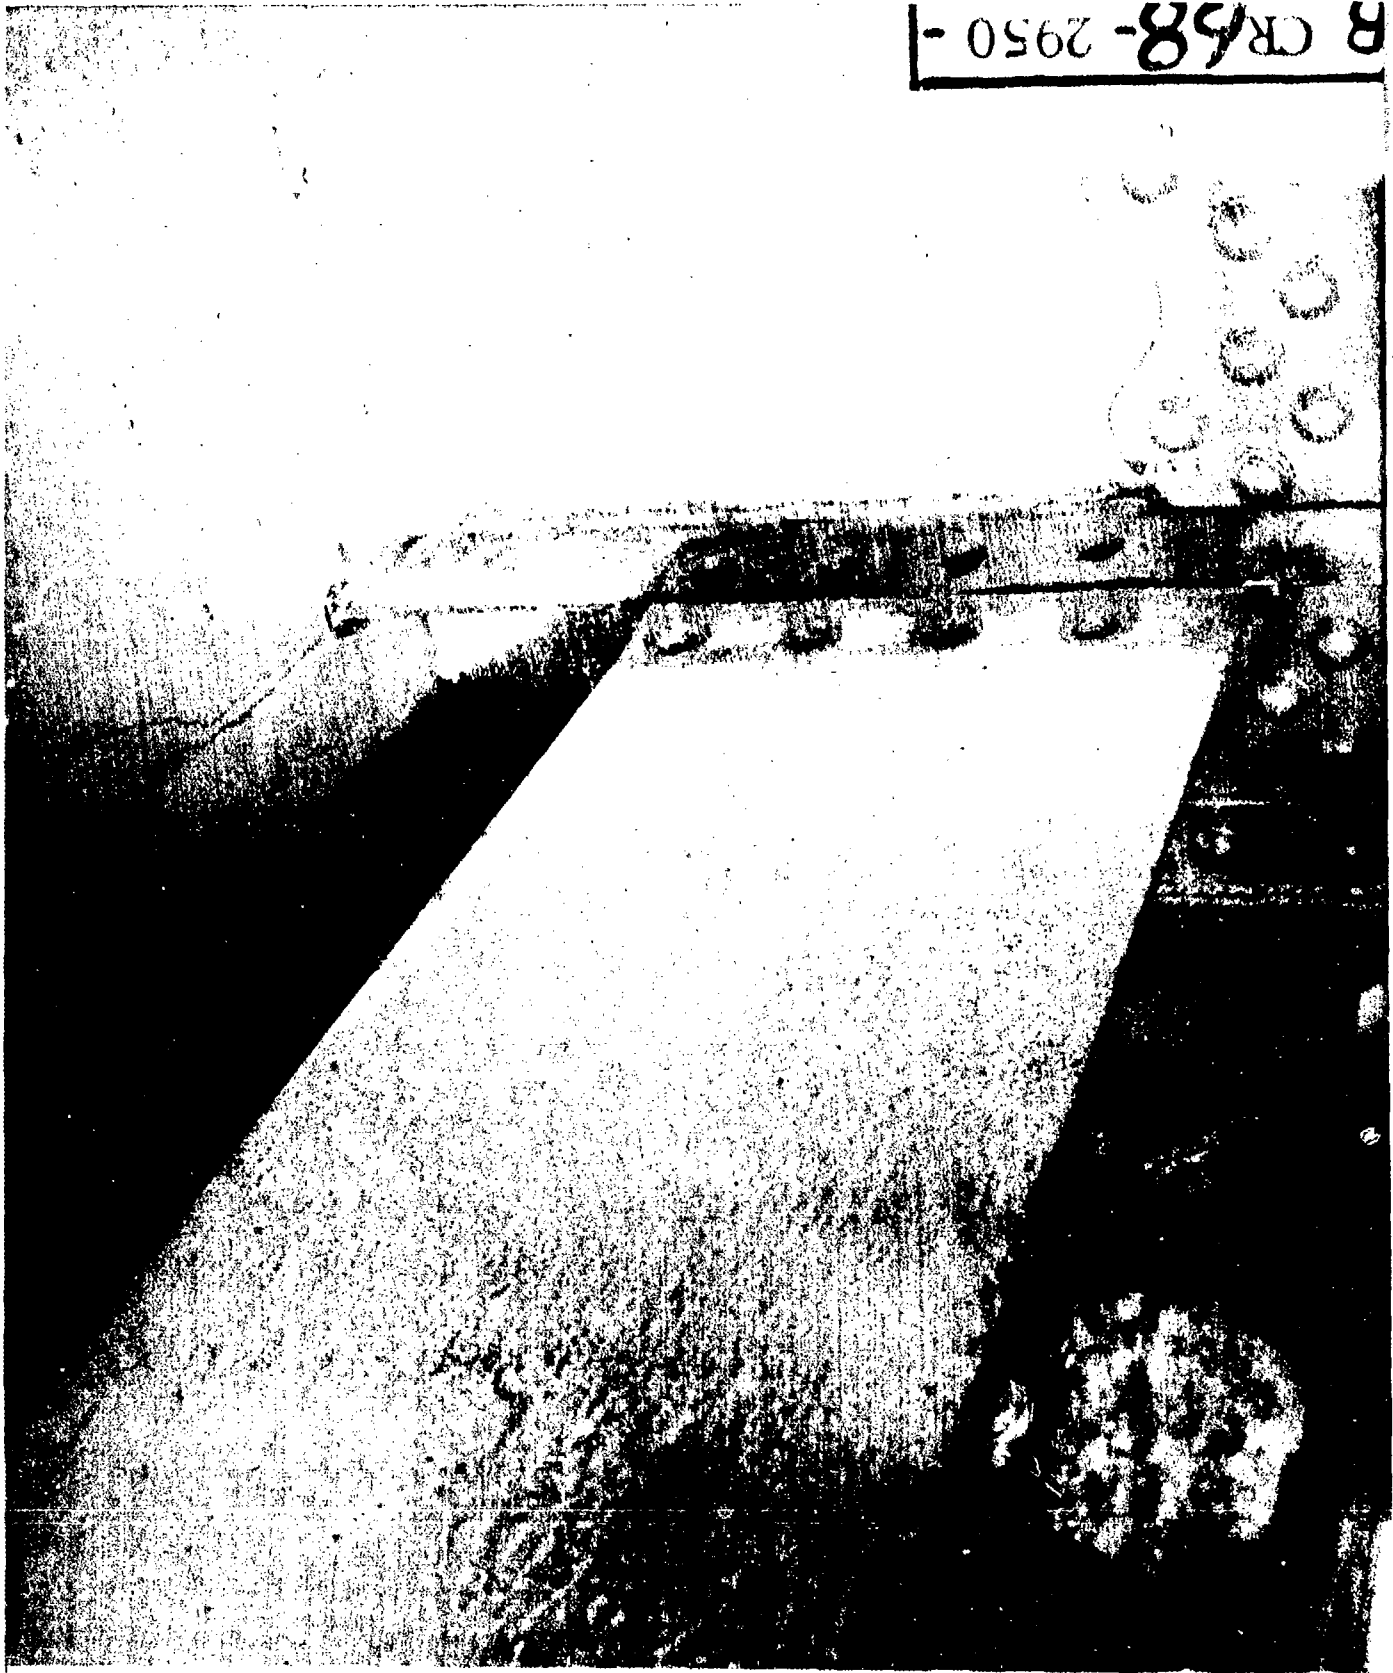
AB-CR-68-2950-8. No. 1 engine room outboard, throttle support showing break at main deck.
