BUREAU OF SHIPS GROUP
TECHNICAL INSPECTION REPORT

⑥ OPERATION CROSSROADS.
U.S.S HUGHES (DD410).
TEST BAKER.

VOLUME II [u] ⑧

USS HUGHES (DD410)

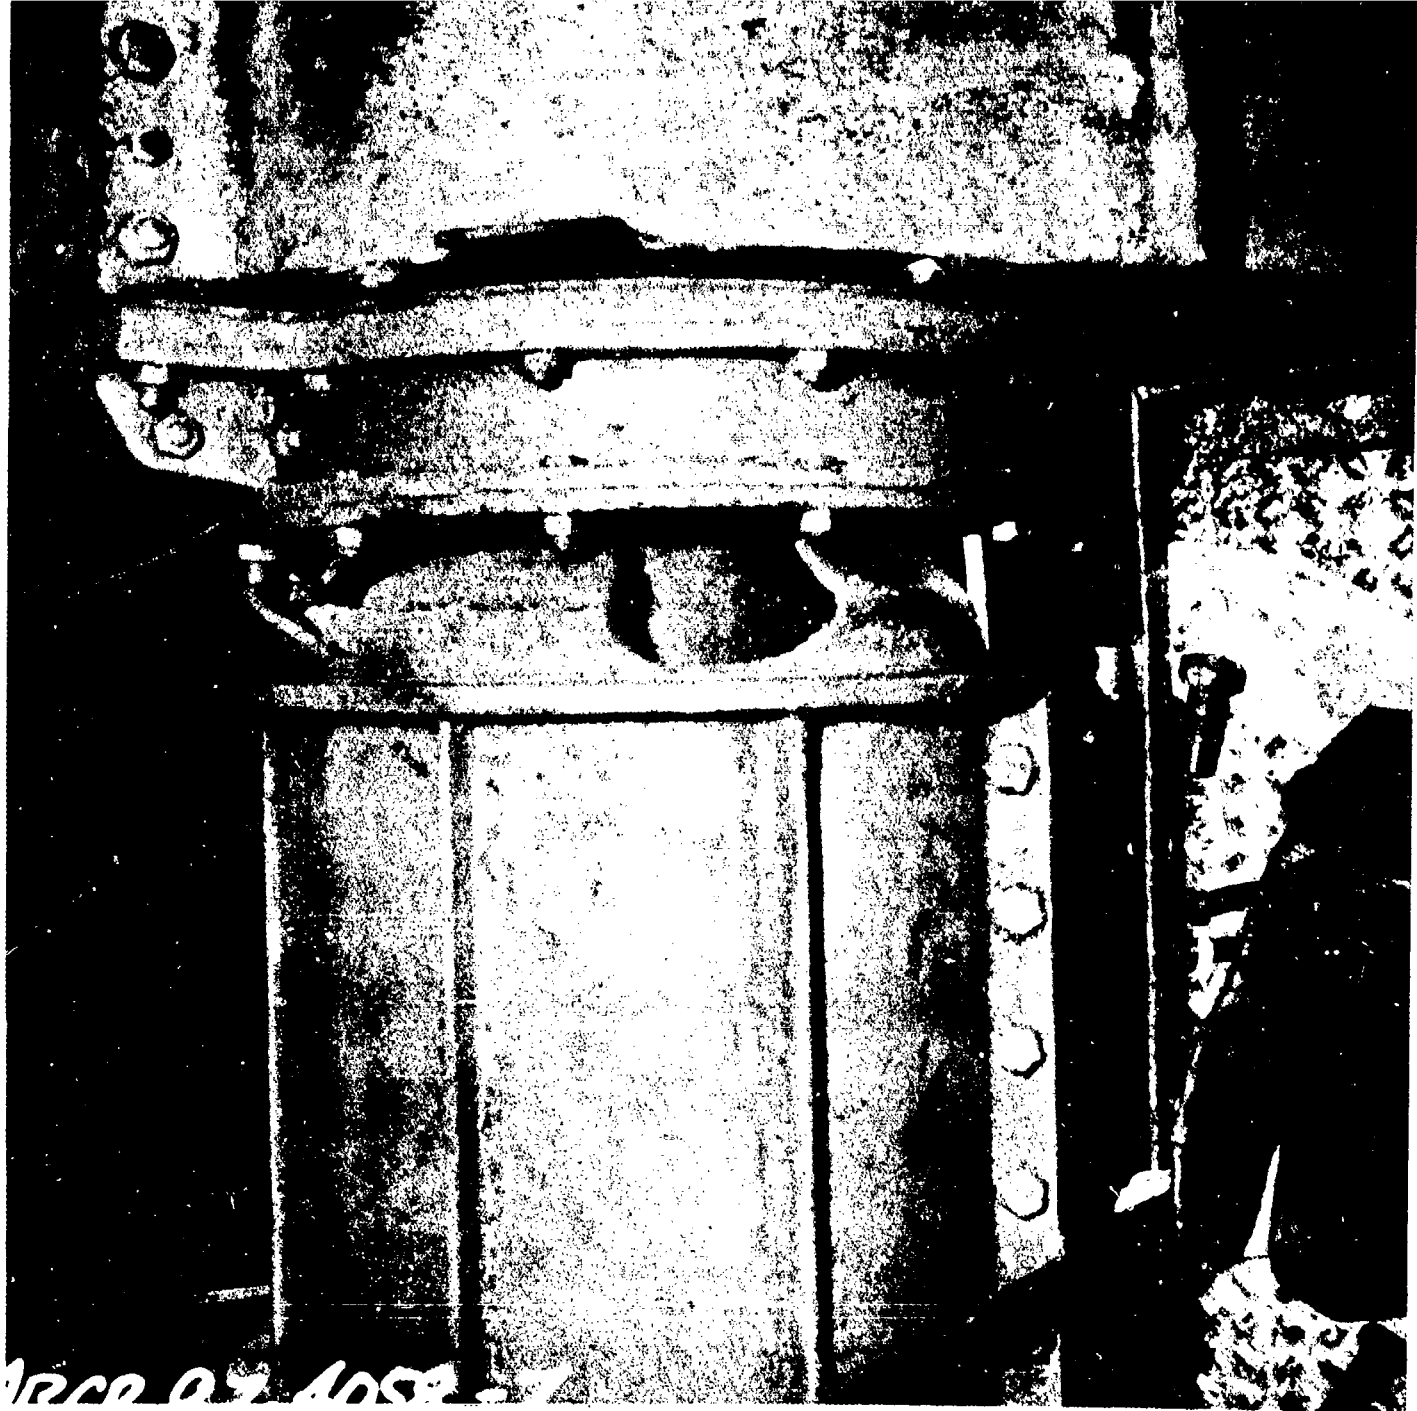
AB-CR-97-4058-7. No. 1 L.P. turbine coupling connector cover,
forward engine room.

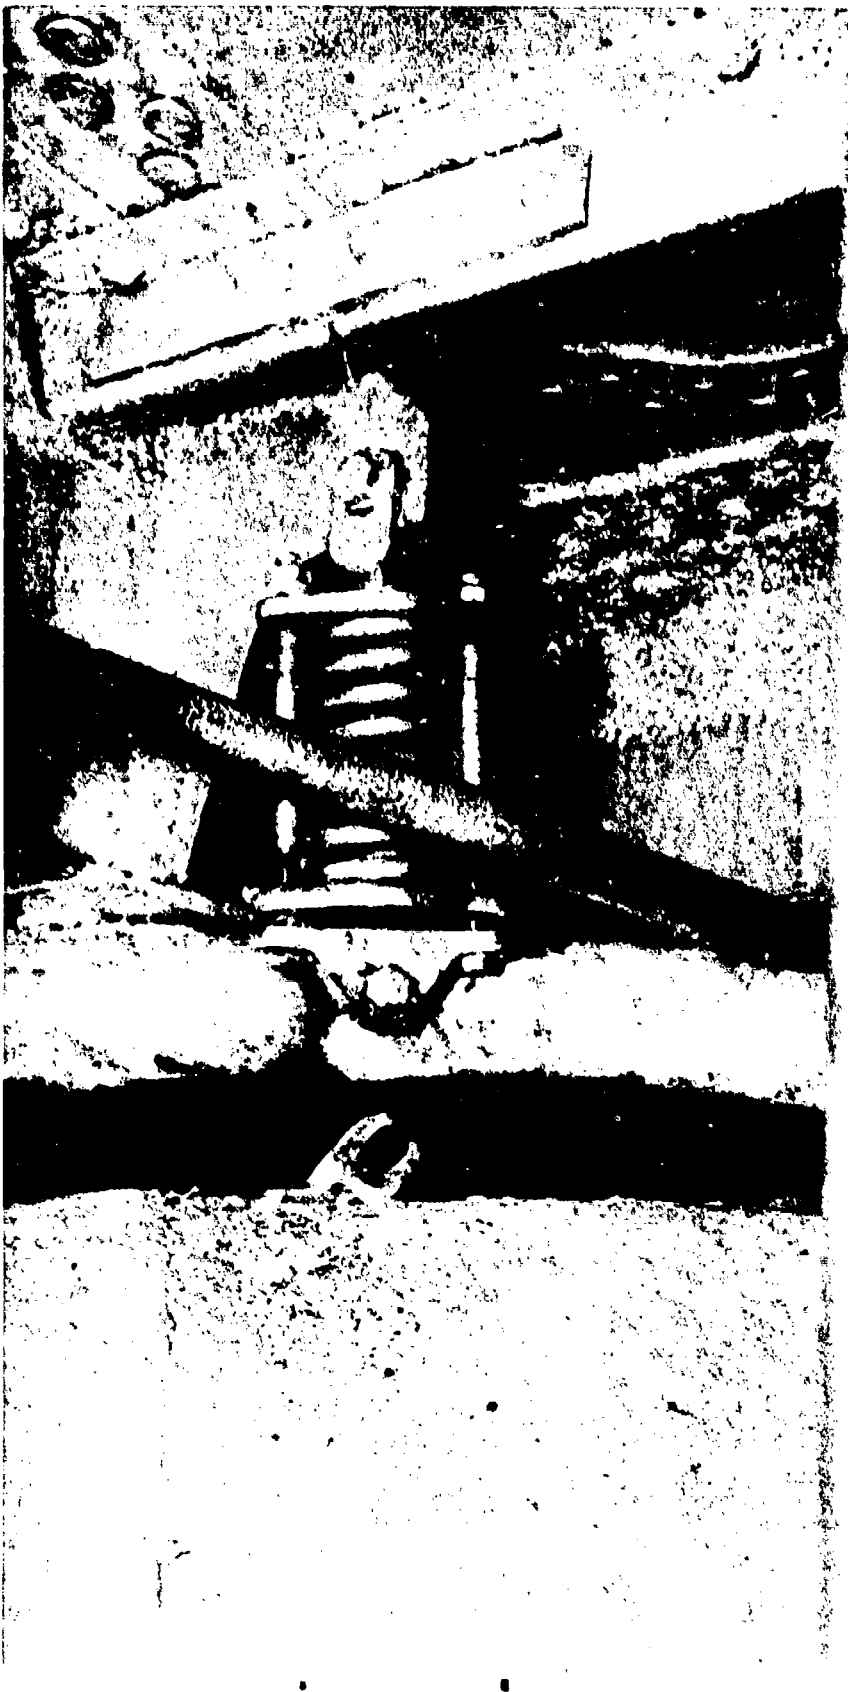
AB-CR-68-2951-7. Showing broken hanger on 7" main steam line to L.P. turbine, No. 1 engine room.

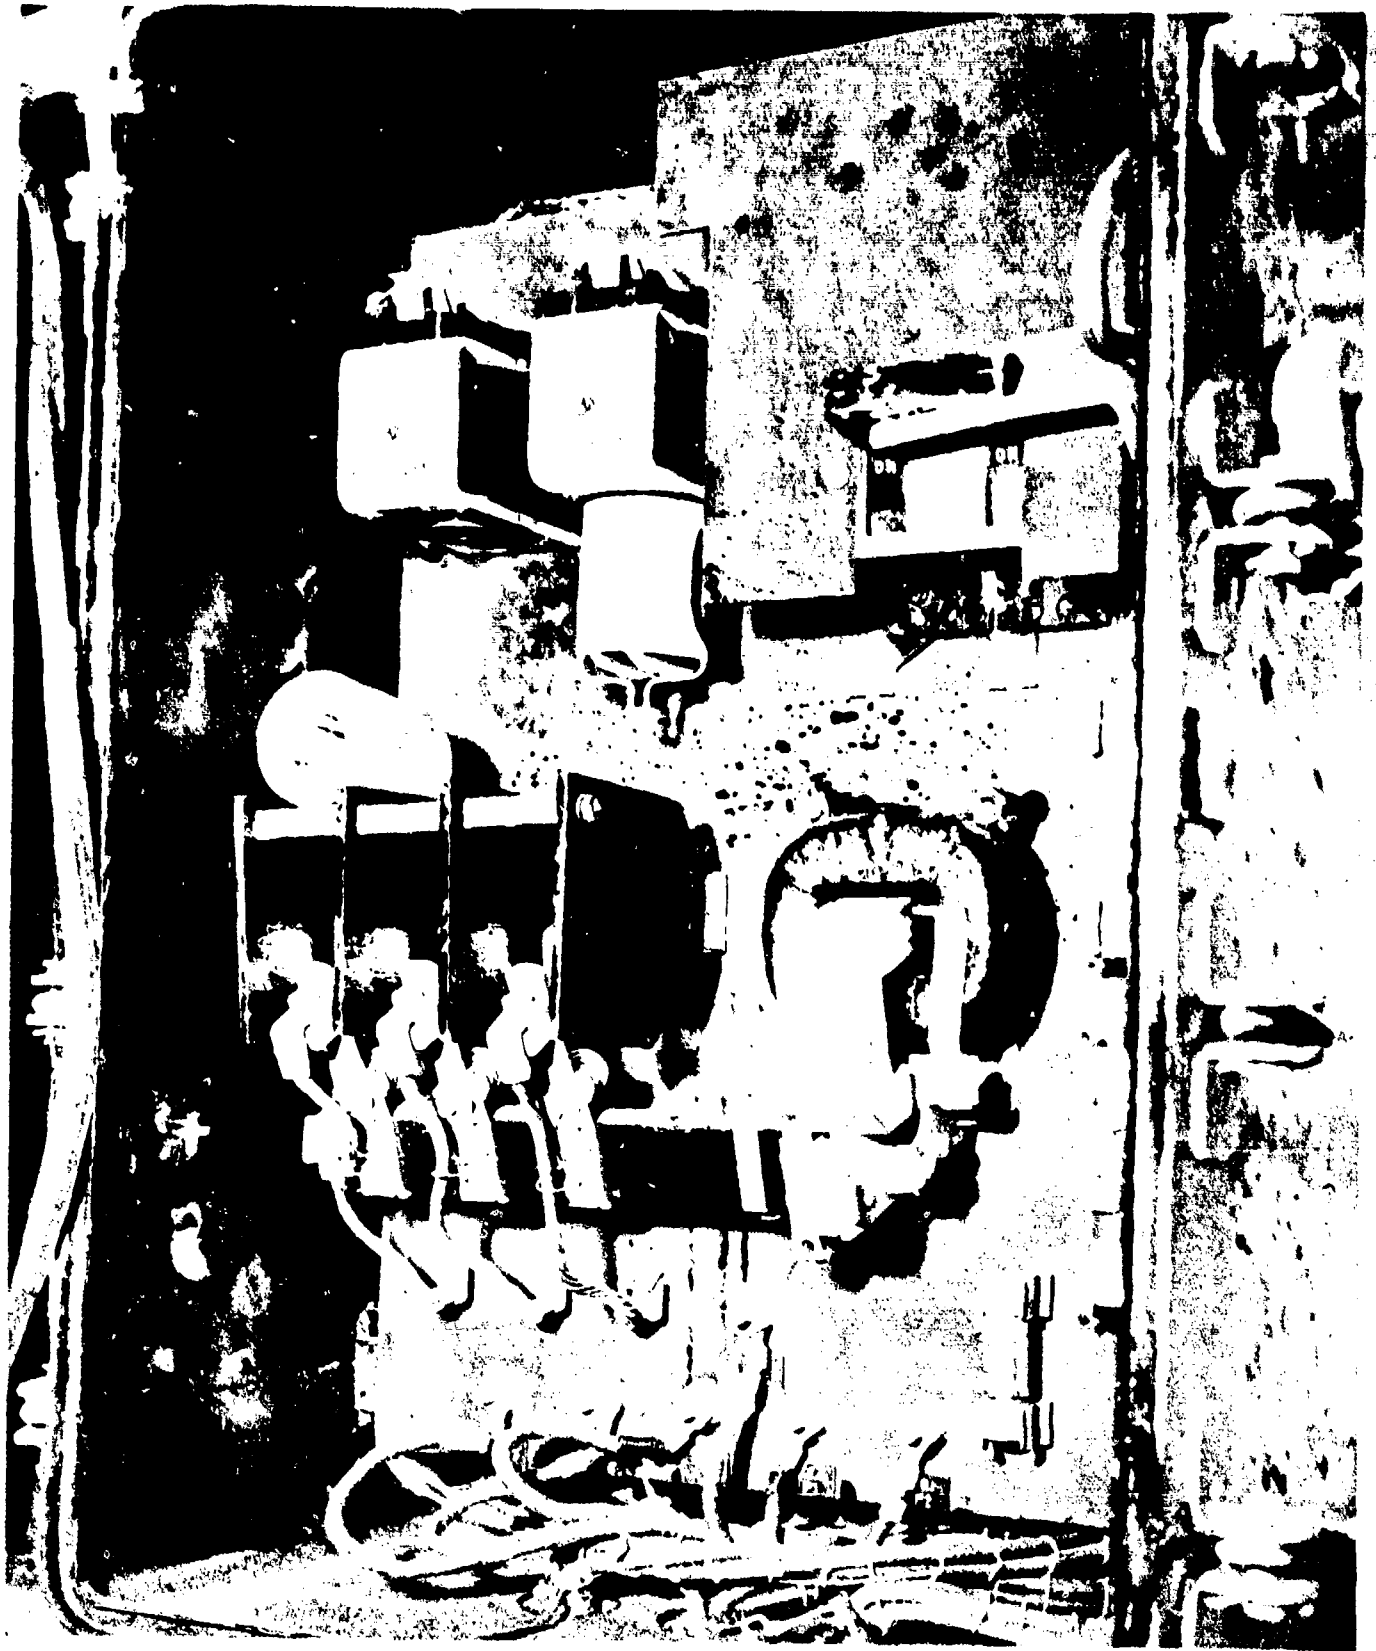
AB-CR-76-1932-8. Motor controller for 5 inch loading machine, mounted in the battery charging and electric workshop. Shows displaced overload dashpot.

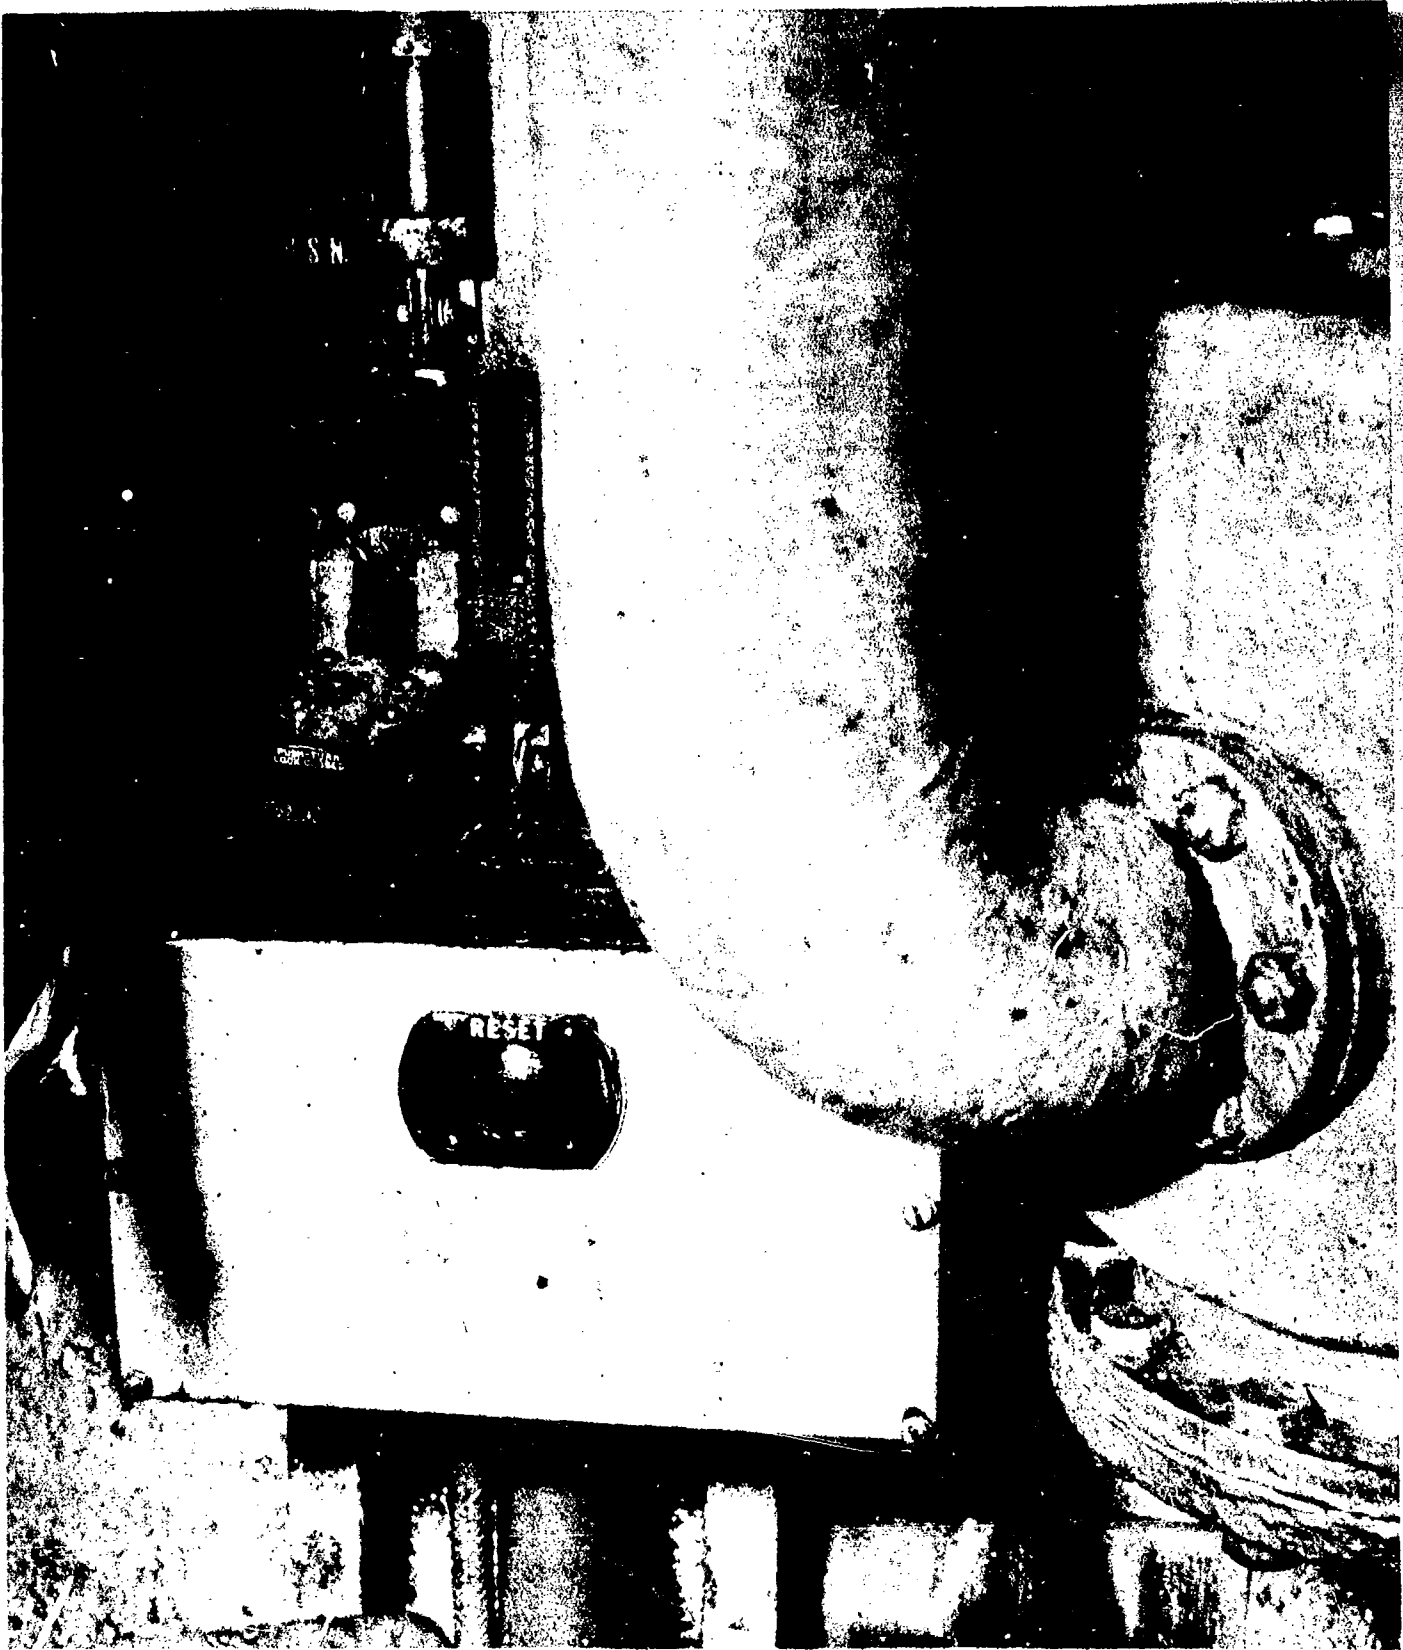
AB-CR-68-2950-1. No. 2 fire and flushing pump motor controller mounted in the starboard side of the lower level of the after engine room. Shows lock-in device distorted. Picture taken looking to starboard.

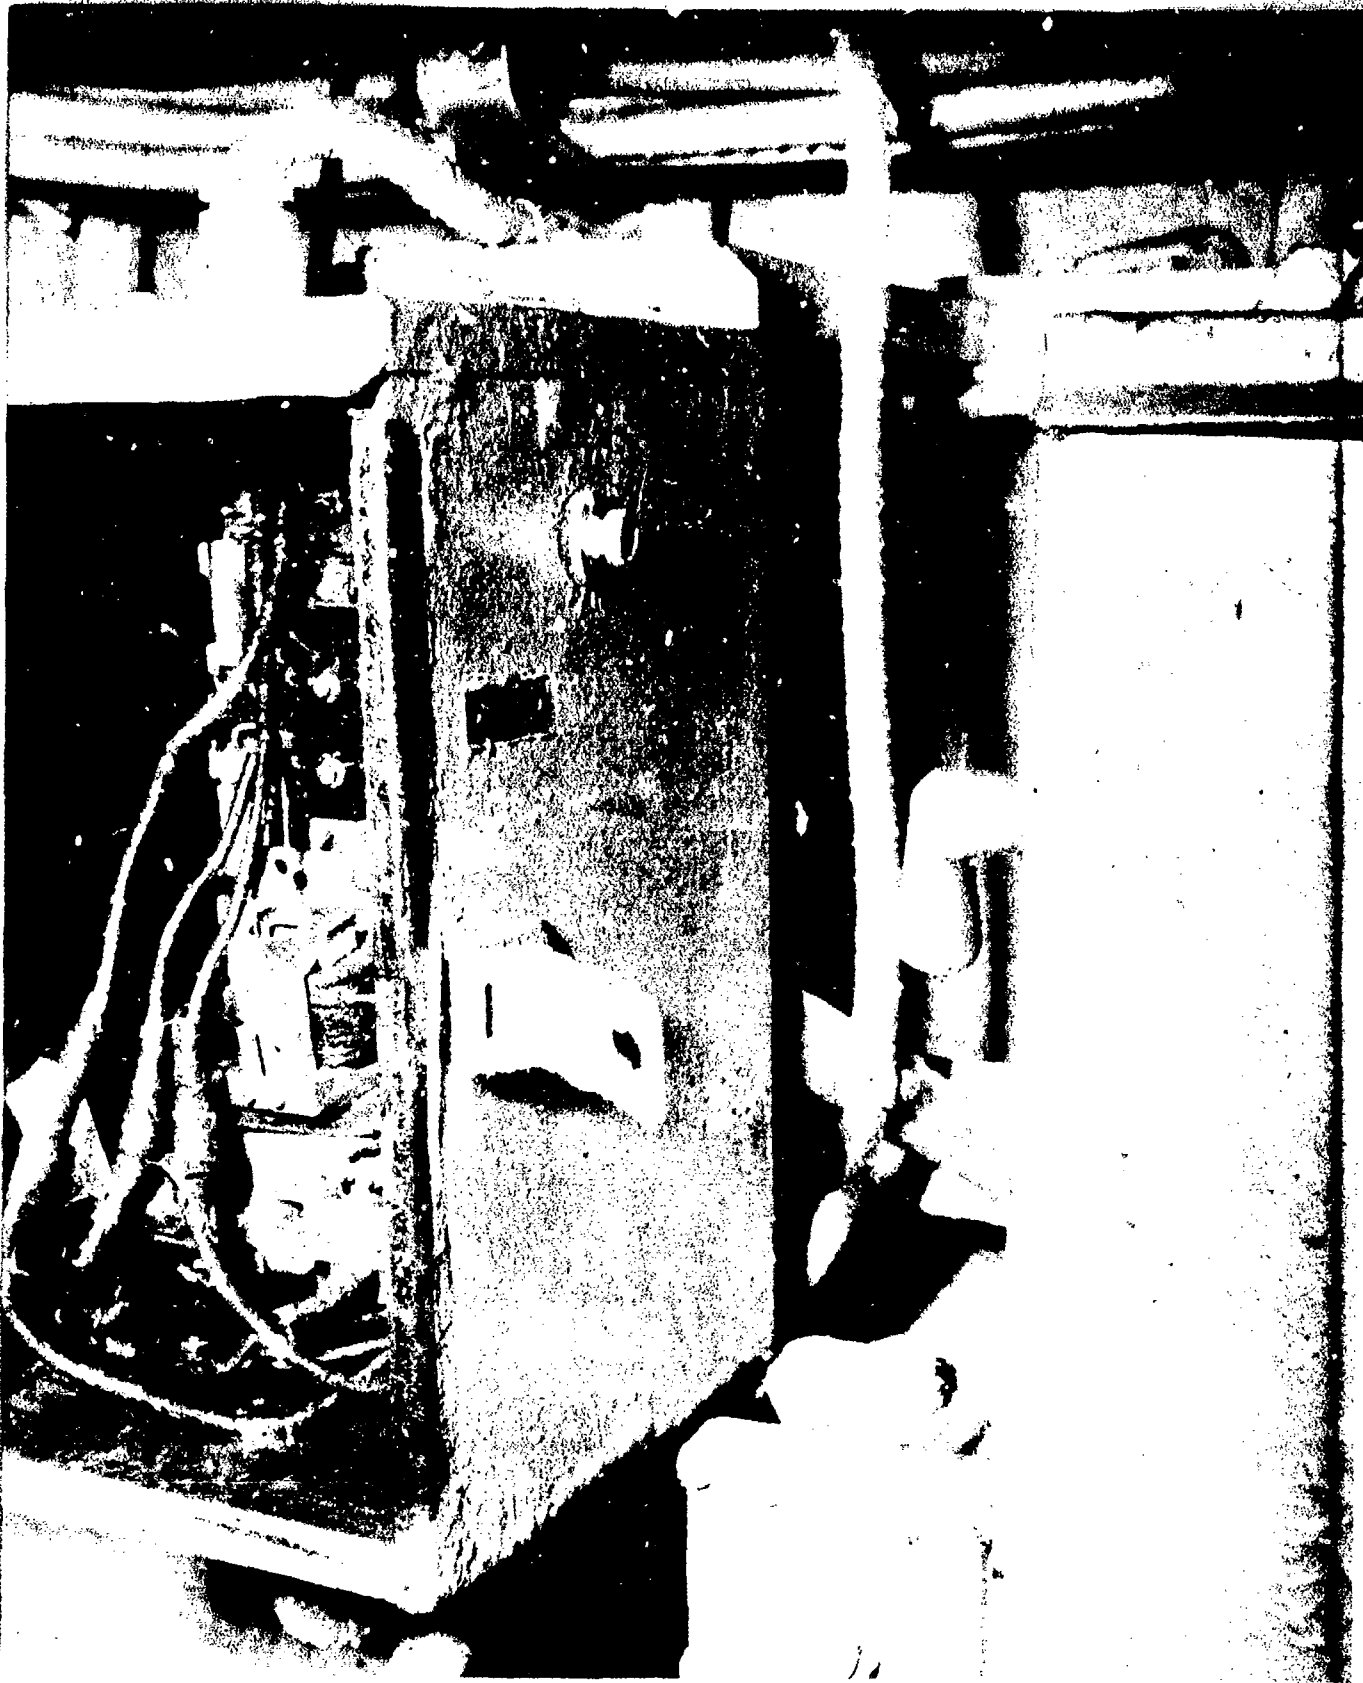
AB-CR-68-2950-2. Distiller condensate circulating pump motor controller mounted in the after engine room. Shows contactor dislodged from the phenolic mounting base. Picture taken looking to starboard.
