WT-1423

OPERATION PLUMBBOB

Armour Research Foundation
Chicago 16, Illinois

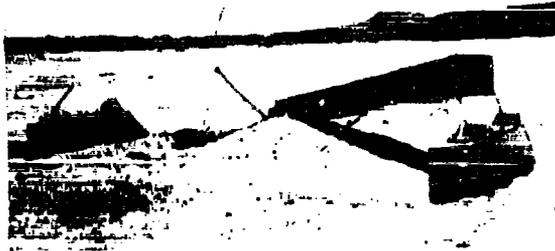
The UK 3.4e beam sensors failed at one end, allowing the beam to rotate approximately 35 degrees about the other support. (Figure 9.6). The forward sensor bar at this end was cracked almost all the way across the section and appeared to be on the verge of failing. There was no measurable permanent set in the beam itself. The fact that there was no spalling of the concrete fill in the beam indicates that it probably did not sustain an appreciable maximum deflection.

Figure 9.6 Posttest, UK 3.4c beam, front side view, facing southwest.

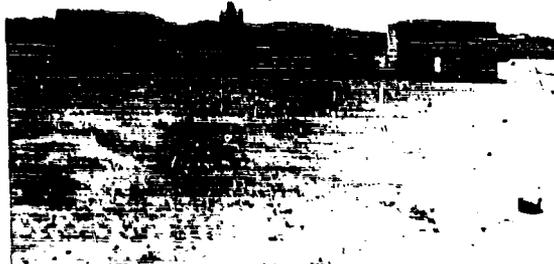
Posttest Damage: This structure suffered severe damage in this test (Figures 9.8 and 9.9). The grade beam at the front side of the structure was pulled up out of the ground about 4 feet, with failures occurring at the one-third points of the center cell. The back walls and roof of the center cells were completely destroyed, one portion coming to rest approximately 300 feet behind the structure. The cell on the south side of the structure appeared to be essentially undamaged, whereas the cell on the opposite side was damaged. A slab of concrete approximately 6 inches deep by 3 feet wide was pulled away from the end wall of the north cell and was supported only by the reinforcing steel. Figure 9.8 shows also a large horizontal crack in the front wall of this cell.

Figure 9.8 Posttest, UK 3.5c structure, front view, facing west.

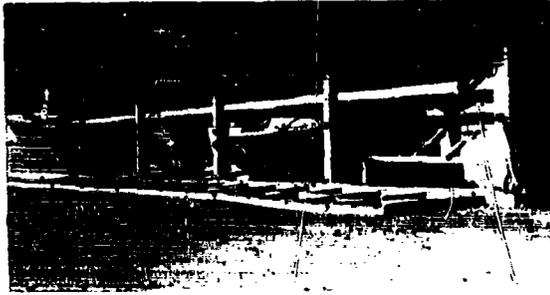
Figure 9.22 Posttest, UK 3.14 structure, rear side view, facing northeast.
