**FULL-SCALE DYNAMIC CRASH TEST
OF A
DOUGLAS DC-7 AIRCRAFT**

TECHNICAL REPORT

APRIL 1965

**Aviation Safety Engineering and Research
Division of Flight Safety Foundation, Inc.
Phoenix, Arizona**

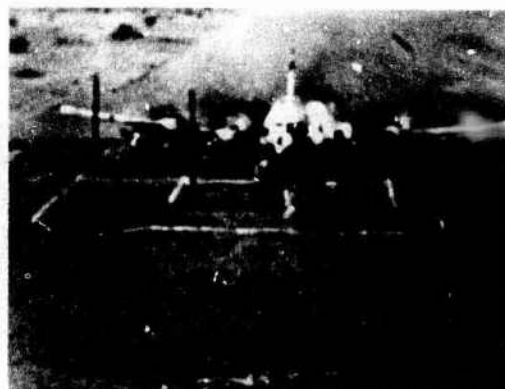
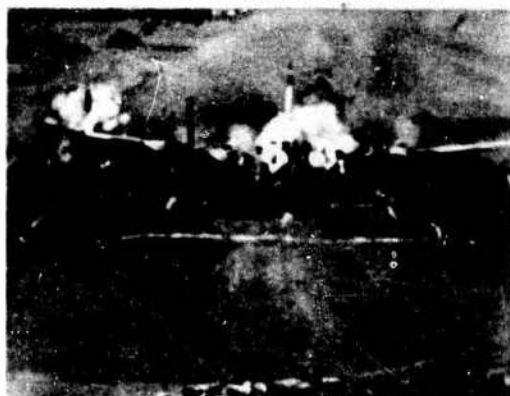
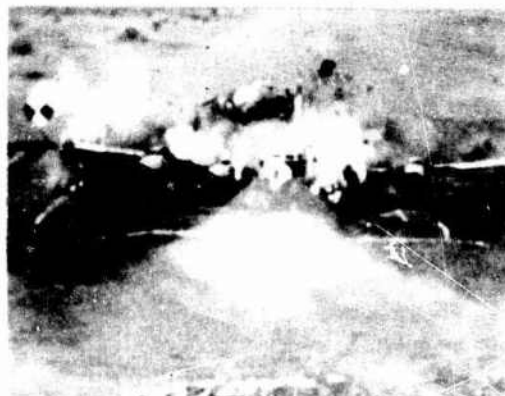
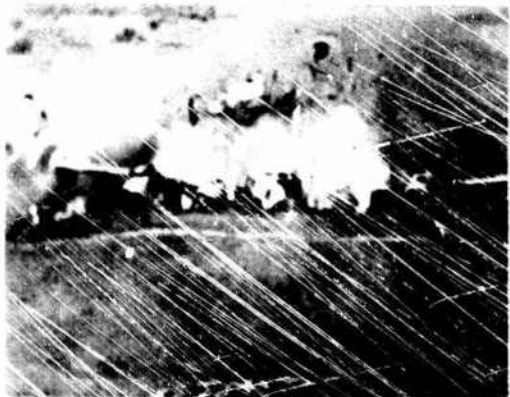
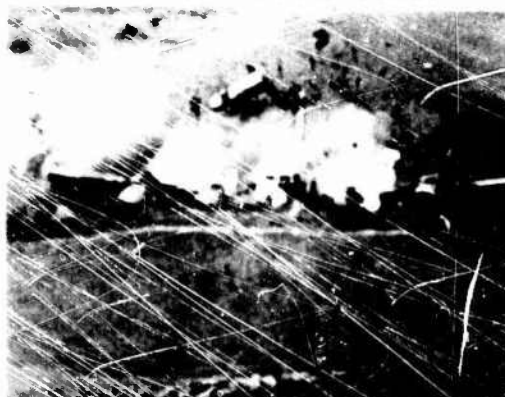
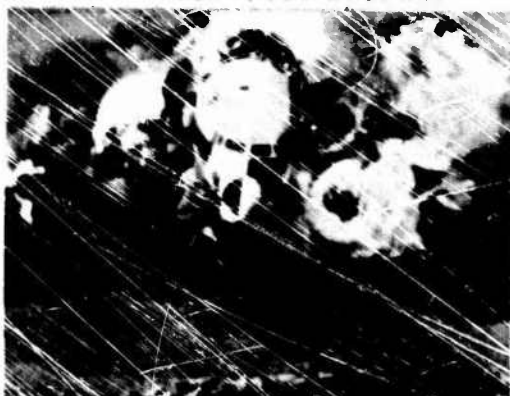
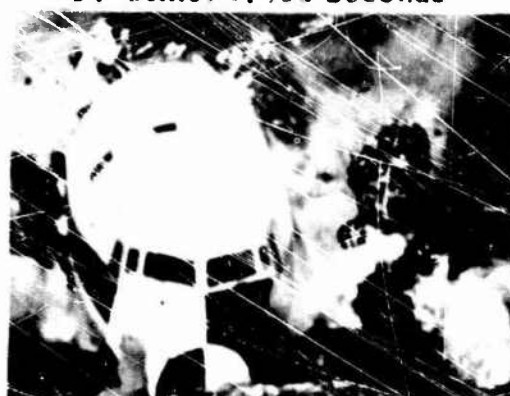
free of the main fuselage just behind the aft pressure bulkhead and rolled further to the left than the main fuselage, as shown in Figure 28. The wreckage distribution during the crash sequence has been plotted on a wreckage distribution chart, Figure 29. Although a large number of smaller parts were scattered over the crash course, most of the large pieces remained together during the entire sequence and came to rest in a small area on the center line of the original path. Sequence pictures of the crash are shown in Figures 30 and 31.

FIG. 30 SEQUENCE PHOTOS OF CRASH, SEEN FROM TOP
OF 20 DEGREE SLOPE

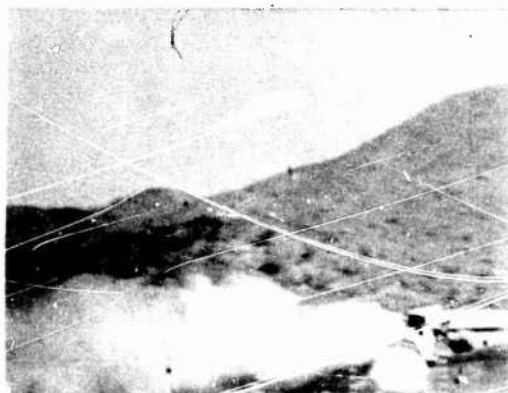
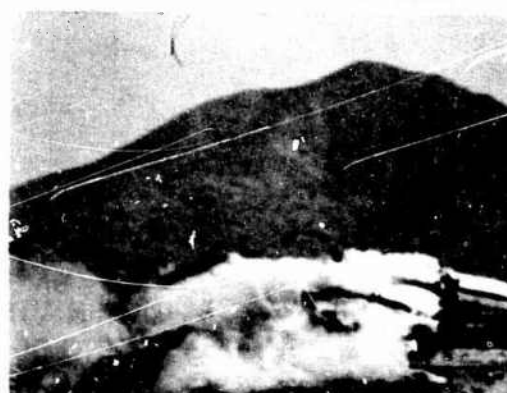
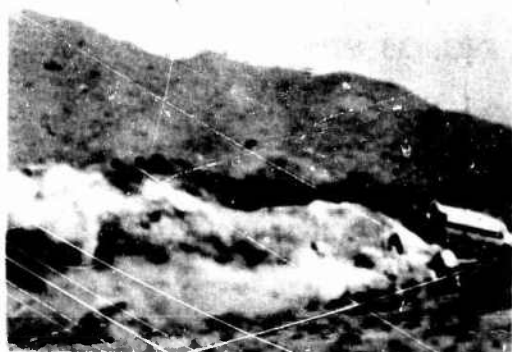
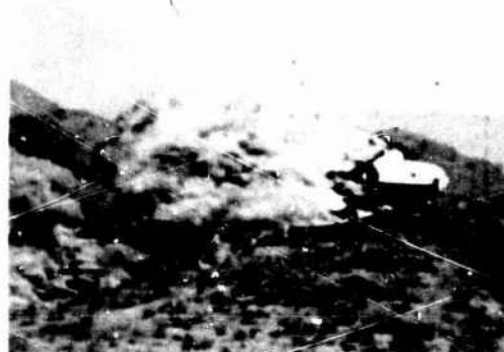
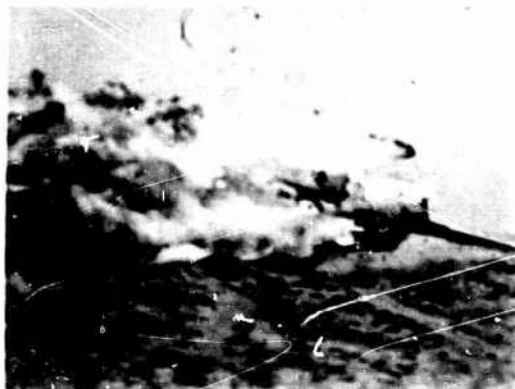
FIG. 31 SEQUENCE PHOTOS OF CRASH, SIDE VIEW

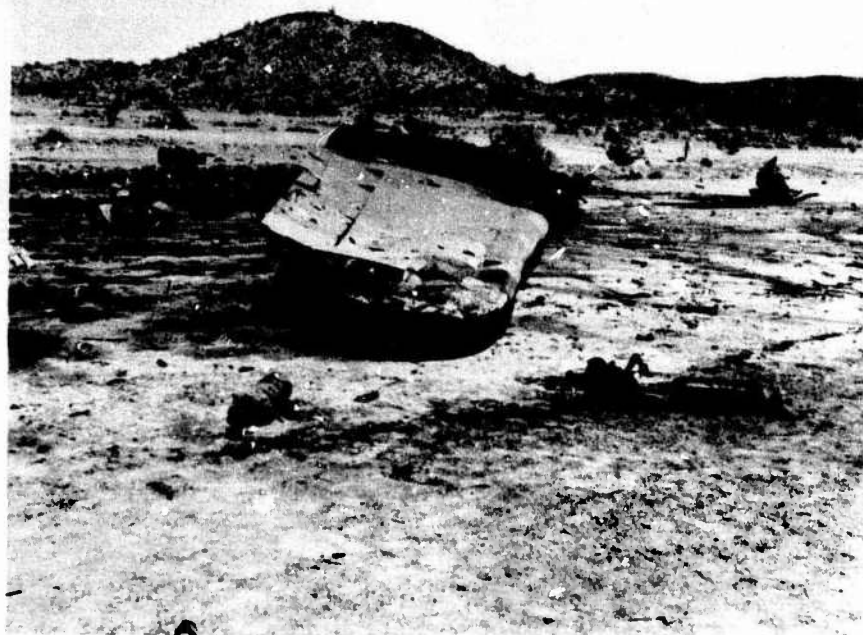
FIG. 32 POSTCRASH VIEW OF LEFT WING WHERE IT CAME TO REST LYING 50 FEET AHEAD OF MAJOR AIRCRAFT WRECKAGE

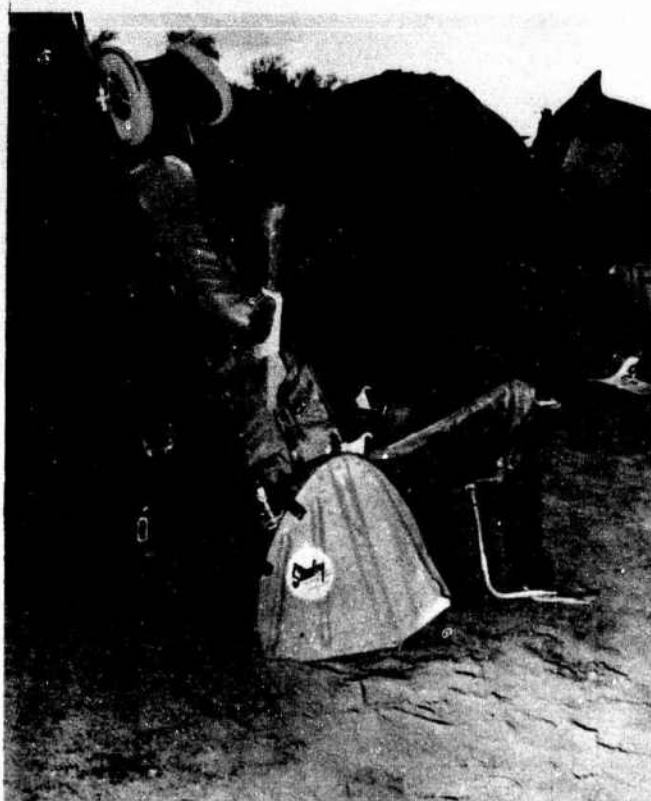
FIG. 44 RIGHT SIDE VIEW
OF PILOT SEAT
AFTER REMOVAL
FROM WRECKAGE

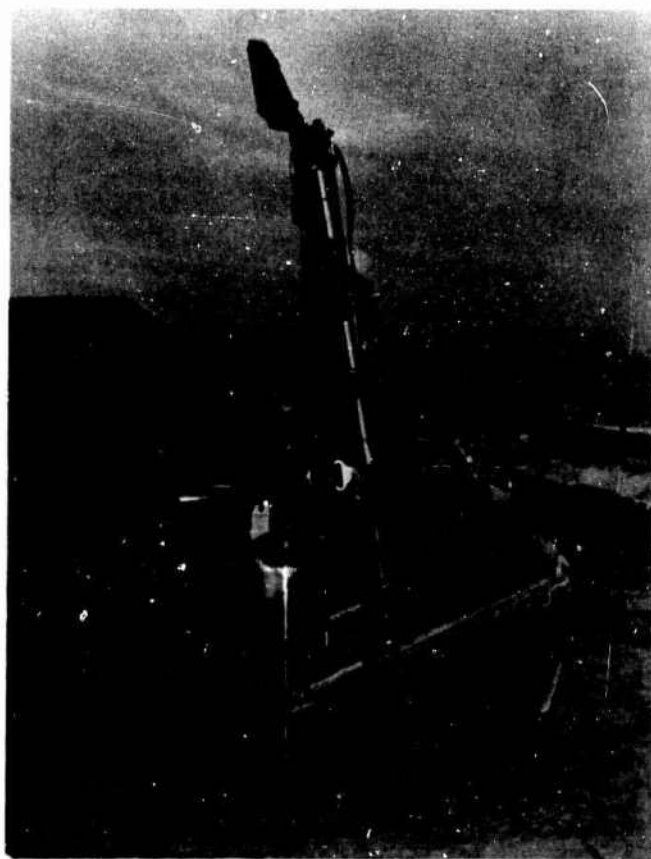
FIG. 49 LEFT SIDE VIEW
OF COPILOT
SEAT AFTER
REMOVAL FROM
WRECKAGE

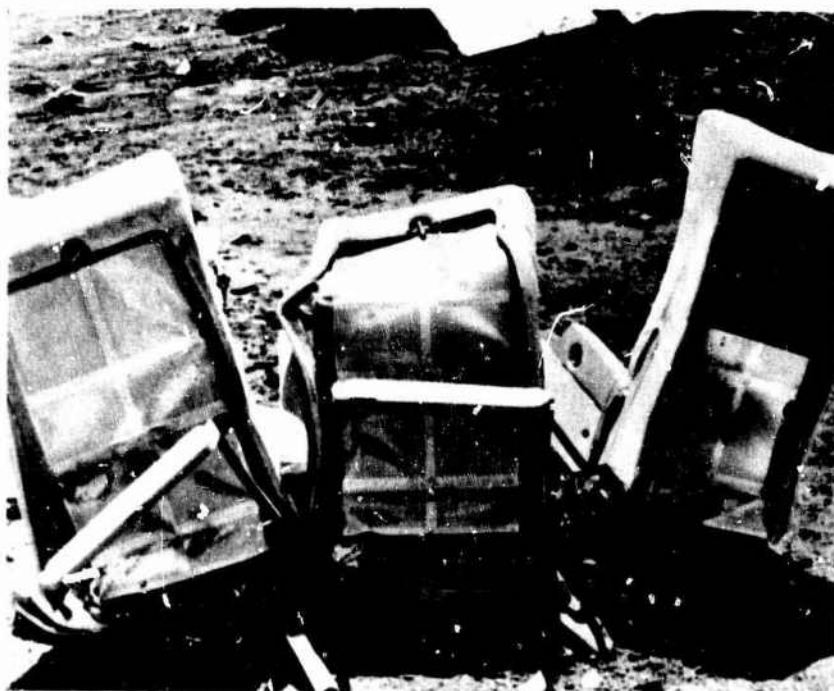
FIG. 73 REAR VIEW OF OCCUPIED THREE PASSENGER
FORWARD FACING SEAT AFTER REMOVAL FROM
WRECKAGE

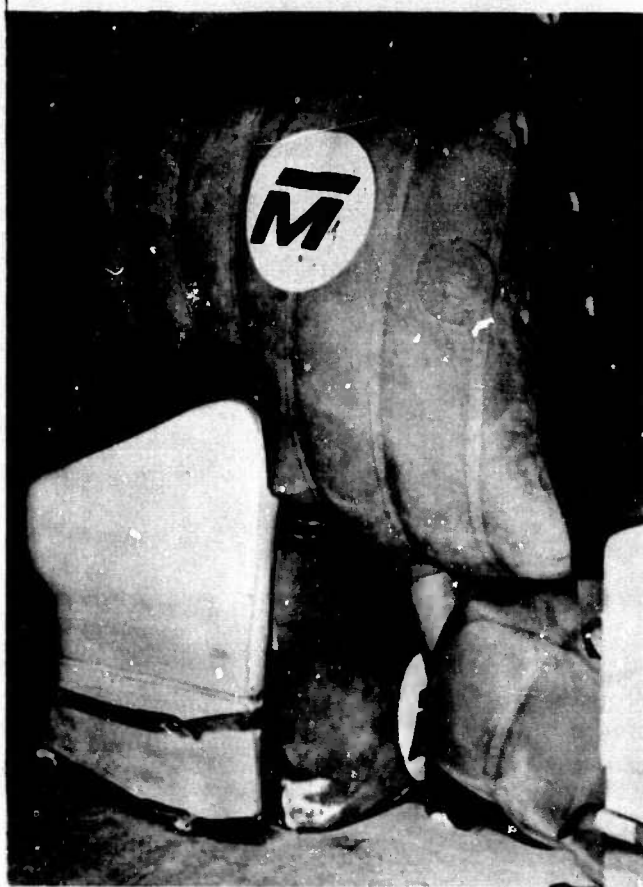
FIG. 83 VIEW SHOWING
PASSENGER
DUMMY CONTACT
WITH AIRBAGS

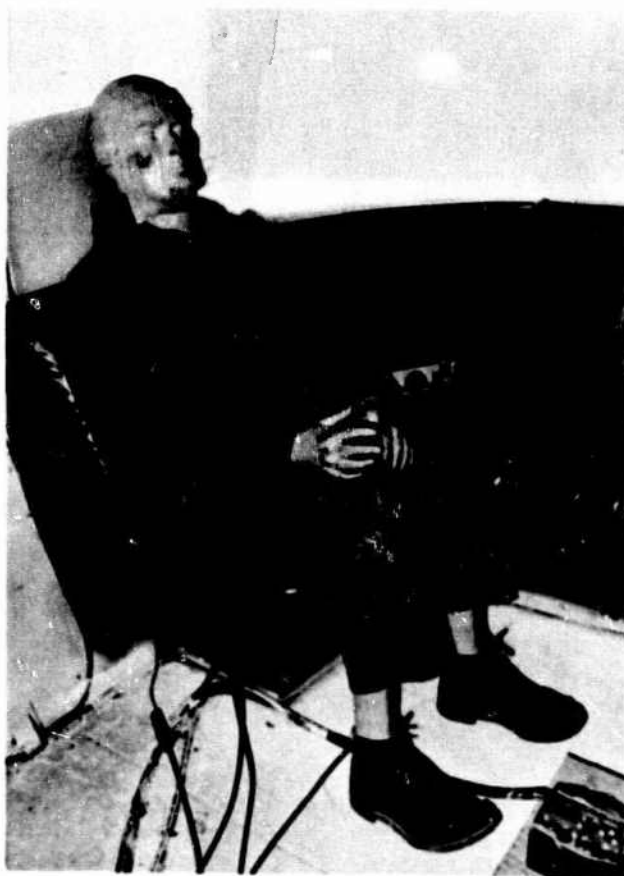
An unmodified DC-7 lounge seat on the right side of the aircraft at fuselage station 946.25 was used for this experiment. (Reference Figure 21) The existing lap belt, providing the only restraint, was connected to existing fasteners behind the lounge cushioning. Figure 93 shows this experiment with the occupant, a 95th percentile dummy, in place. A load link was installed to record lap belt force.

FIG. 93 VIEW LOOKING
AFT AT DUMMY
IN SIDE FACING
LOUNGE SEAT
