FULL-SCALE DYNAMIC CRASH TEST
OF A
LOCKHEED CONSTELLATION MODEL 1649 AIRCRAFT

TECHNICAL REPORT

OCTOBER 1965

Aviation Safety Engineering and Research
Division of Flight Safety Foundation, Inc.
Phoenix, Arizona

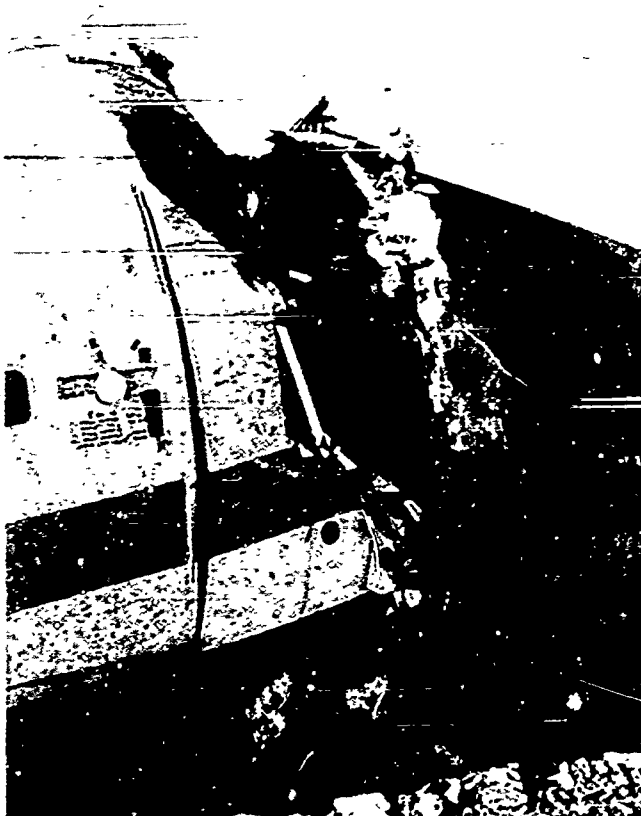
FIG. 31 FUSELAGE STATION 380 BREAK, RIGHT SIDE

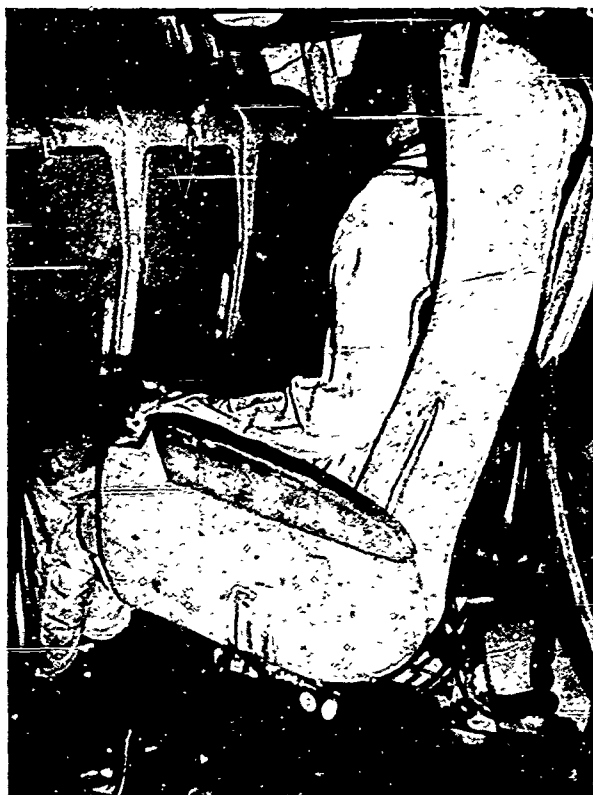
FIG. 78 FORWARD MOVEMENT EXPERIENCED IN CARGO LOADS

During the crash, neither pallet nor cargo separated from its original tiedown, however, both of the longitudinal restraint installations of the cargo pallets deformed approximately 2 inches forward as shown in Figure 77. The flexible nets survived the crash with no load ring deformation, and no failures occurred in either of the cargo tiedown systems. The rigid cargo stack slid forward on the pallet approximately 4 inches while the crushable cargo remained in place and parallel-grammed forward ten inches. An illustration of the cargo action is shown in Figure 78.

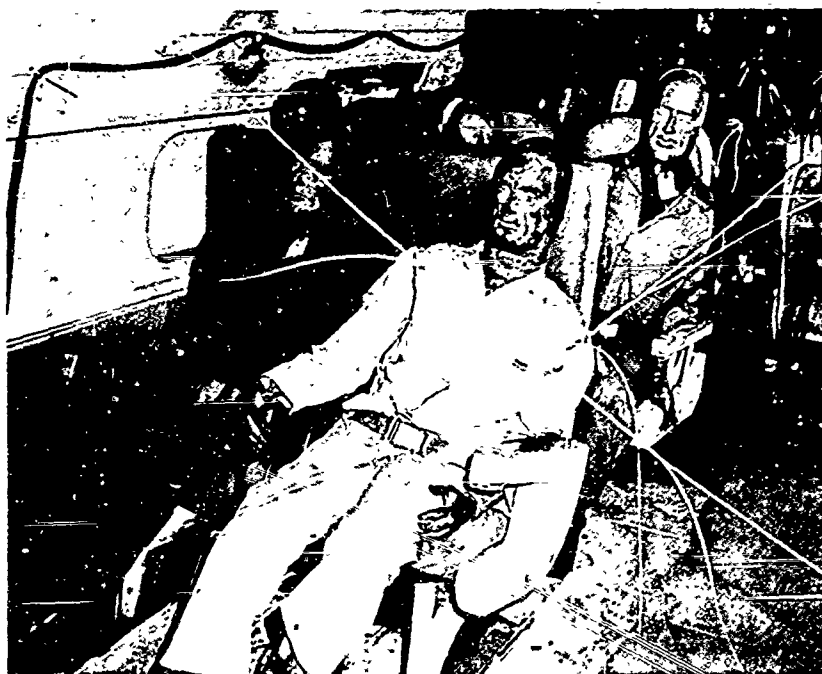
FIG. 83 POSTCRASH OVERALL VIEW OF REAR FACING SEATS

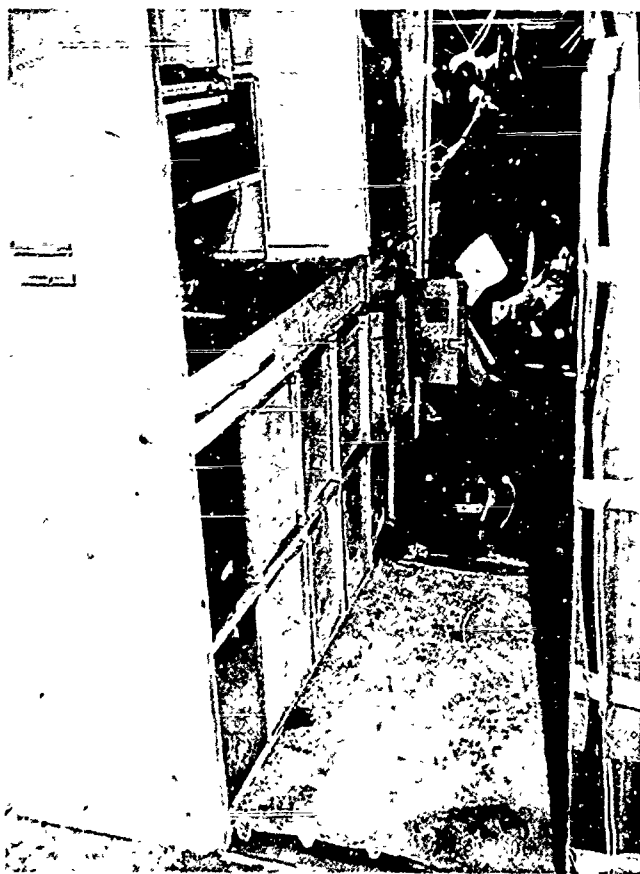
FIG. 89 RIGHT SIDE OF
GALLEY, POST-
CRASH, VIEW
LOOKING AFT

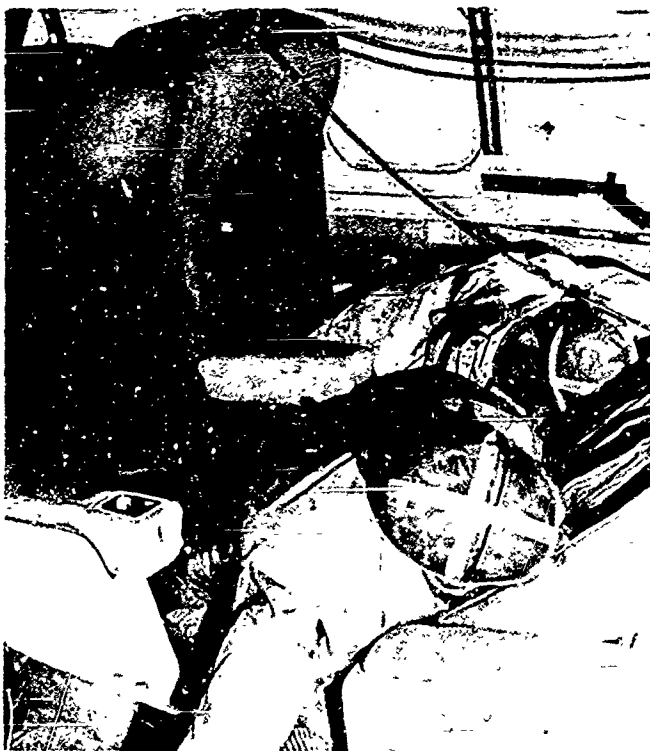
FIG. 97 VIEW SHOWING
UPPER BODY
CONTACT WITH
FORWARD SEAT
BACKS OF AFT
CONSTELLATION
SEAT EXPERI-
MENT
