Special Report 150

CAMP CENTURY REVISITED A PICTORIAL VIEW - JUNE 1969

Austin Kovacs

July 1970

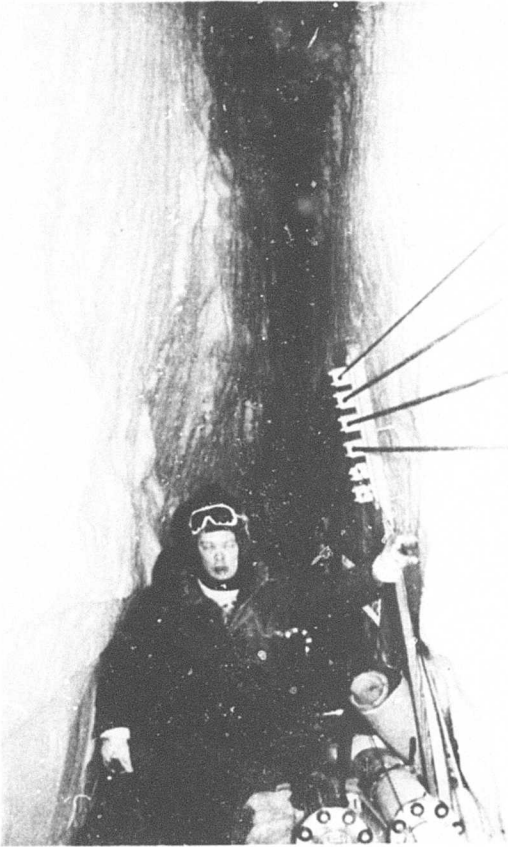
Figure 11. The glycol trench, once 9 ft wide, has undergone considerable deformation. Heat which once escaped from the glycol pipeline leading from the reactor to the glycol well and residual heat within the well increased the temperature of the surrounding snow. This in turn increased the deformation rate of the snow and accelerated trench closure.

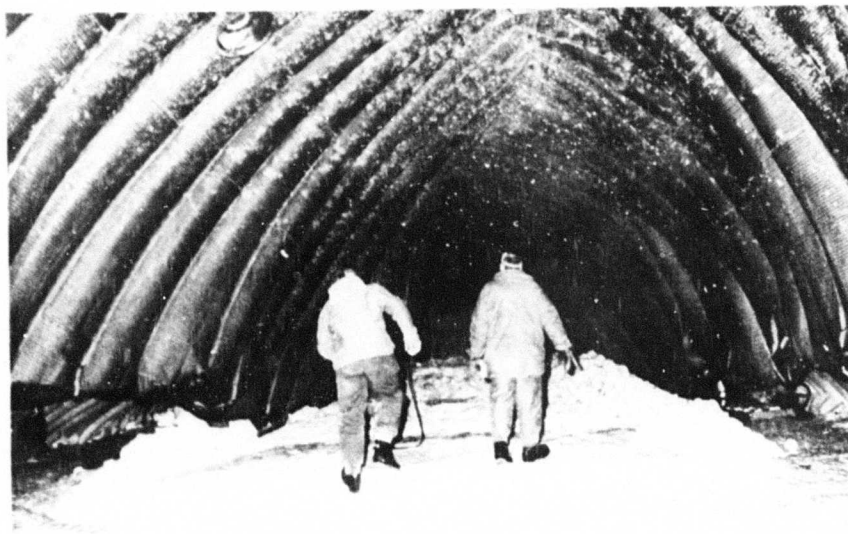
Figure 86. Arch deformation, Trench 21.
