FAA-AM-71-3

GENERAL AVIATION STRUCTURES DIRECTLY RESPONSIBLE FOR TRAUMA IN CRASH DECELERATIONS

SPECIAL REPORT

January 1971

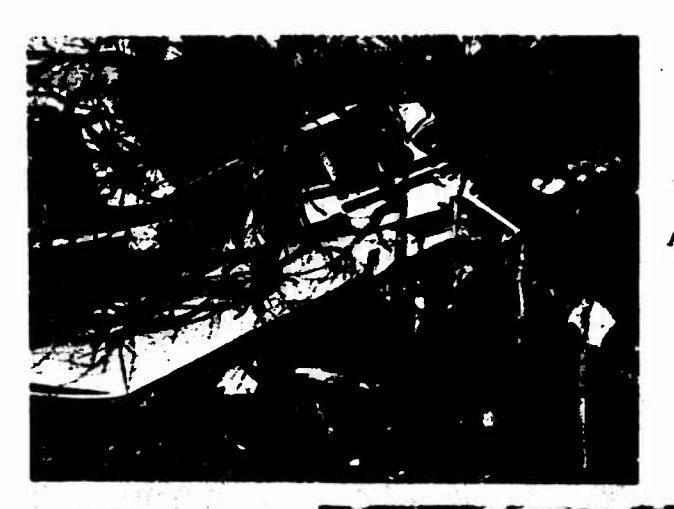
A. Overall view of aircraft impact with tree.

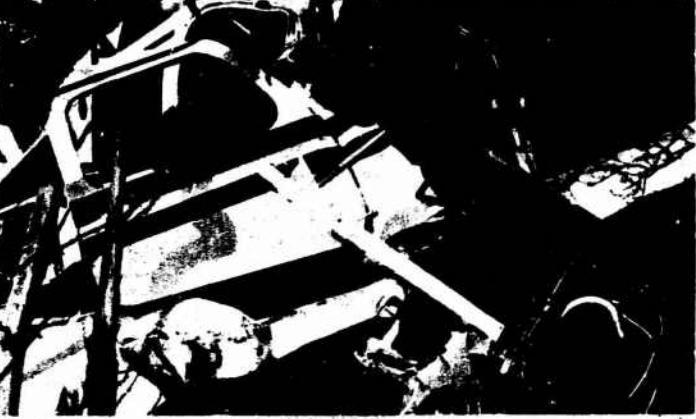
C. Inside the cabin, the tree is almost touching the front edge of the pilot's reat. An octline of a head indicates head impact area on the tree.

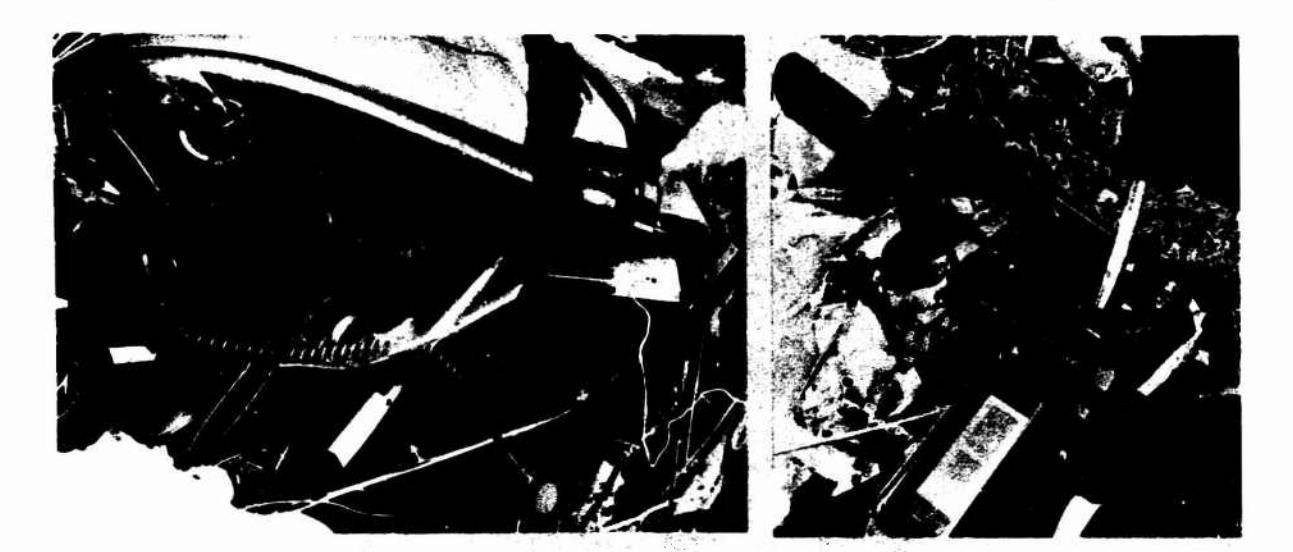
E. Right half of instrument panel sheared off by tree penetration.

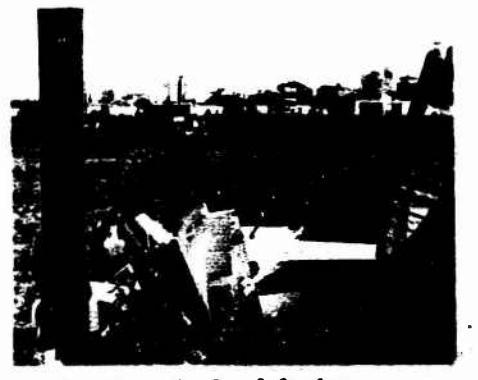
A. Aircraft after left wing impacted telephone pole.

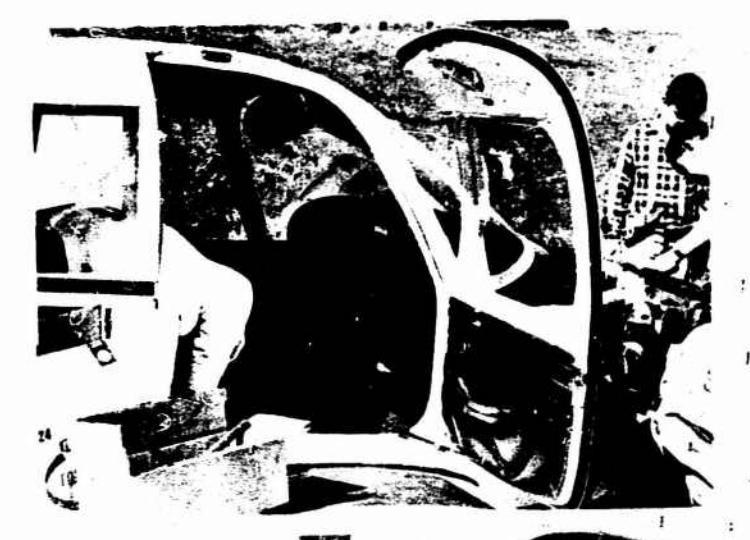
E. Upper left instrument panel. No damage from head impact.

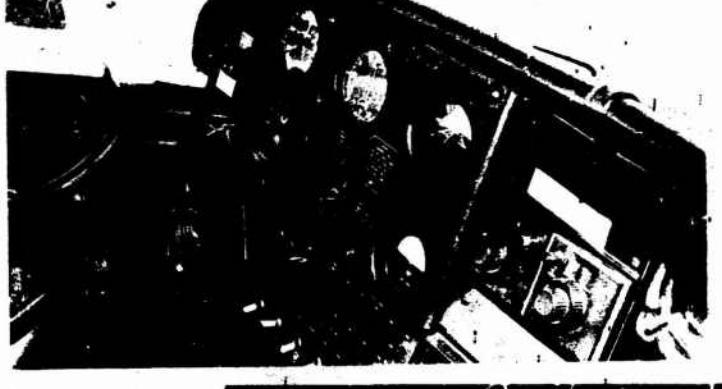
Lower left instrument panel. No damage from knee impact.

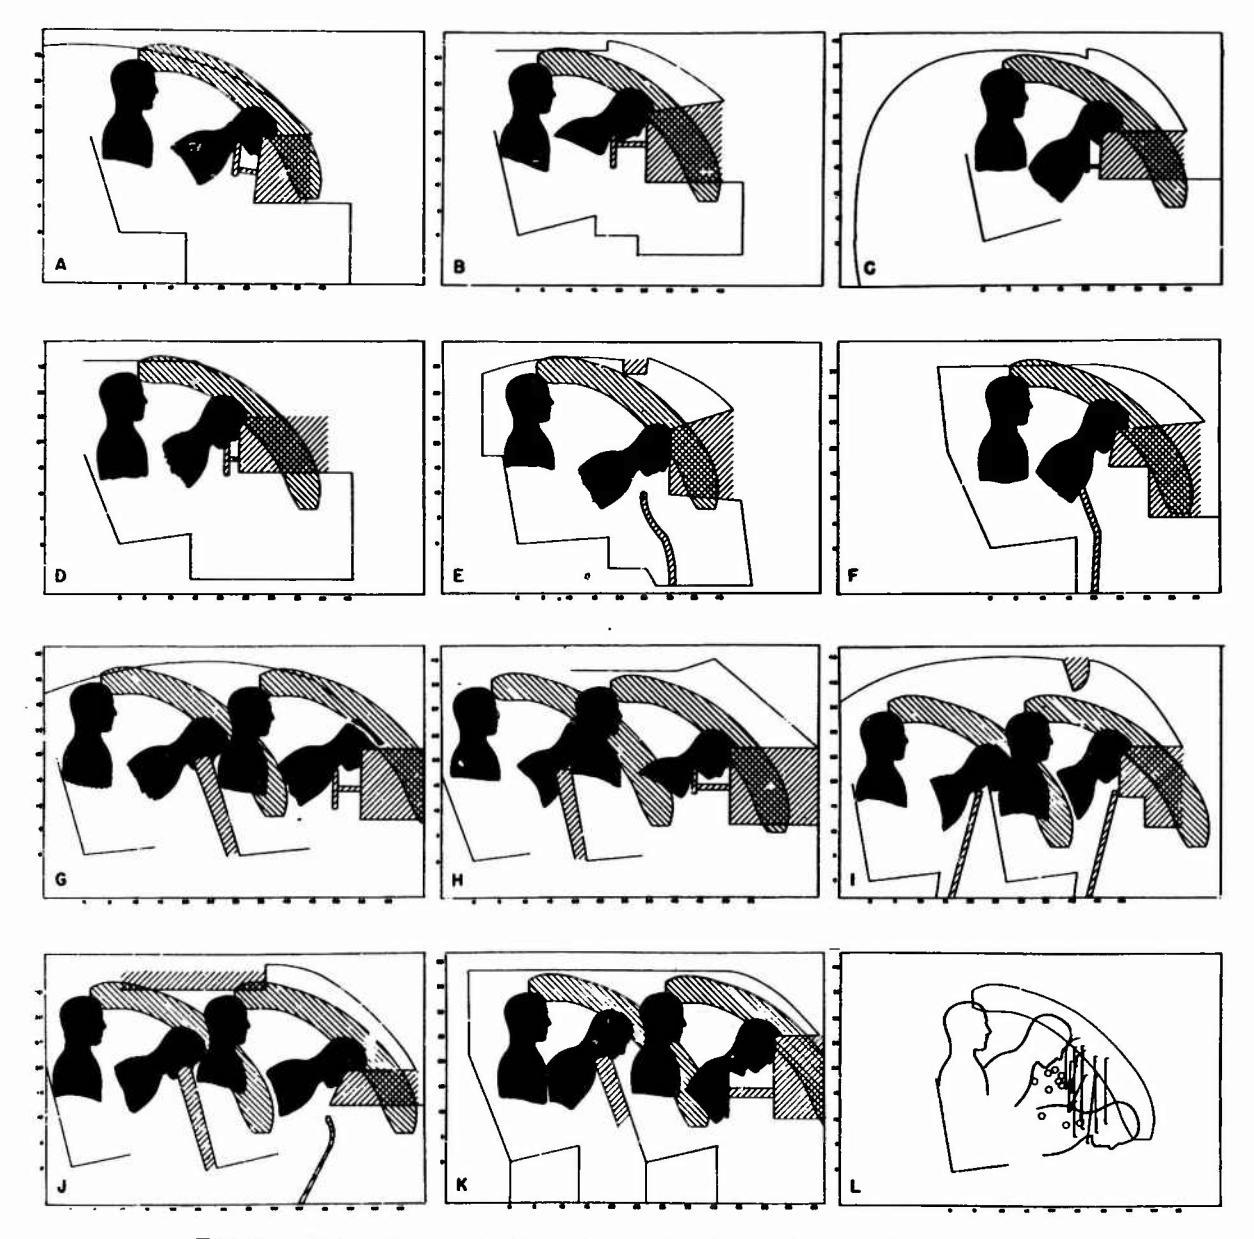
FIGURE 1. Minimum head clearance as related to 11 popular personal type aircraft.

Swearingen 55 has adequately described the kinematics of the body and the head strike areas in numerous general aviation aircraft. Figure 1 shows head clearance area of the path taken by the top of the head (5th to 95 percentile), when the body jackknifes over a seat belt, superimposed on scale size drawings of 11 popular general aviation aircraft (A through K). The composites shown in "L" indicate clearly that all the instrument panels (vertical lines) and top of the control wheels (circles) lie directly in the path of the head. Figure 2 is another, more detailed composite of the same group of aircraft showing forward motion of the body (95th percentile) with seat belt restraint along with arcs swept out by the head, arms, and legs during the flailing motions that accompany crash deceleration. The acceleration forces in these tests on unbraced individuals were less than one "g" and yet the head impact velocity at the point of instrument panel impact exceeded 12 ft./sec.

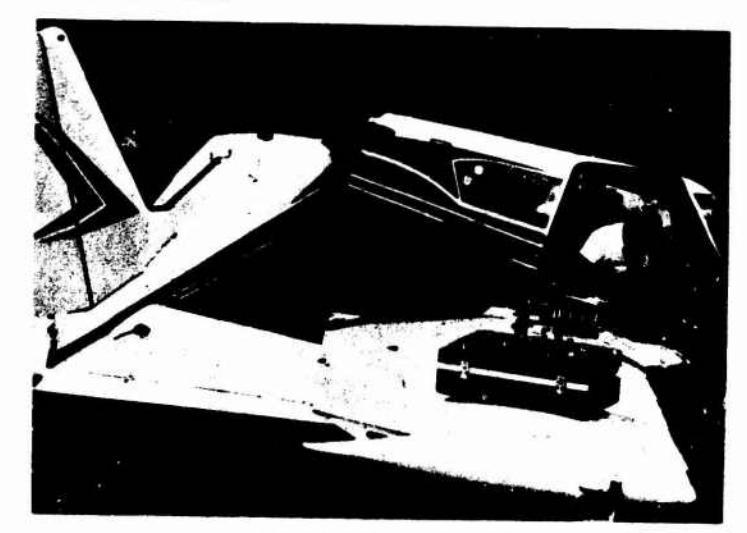
B. Final attitude of aircraft. Tail section separated at the rear of the cabin & turned 90°.

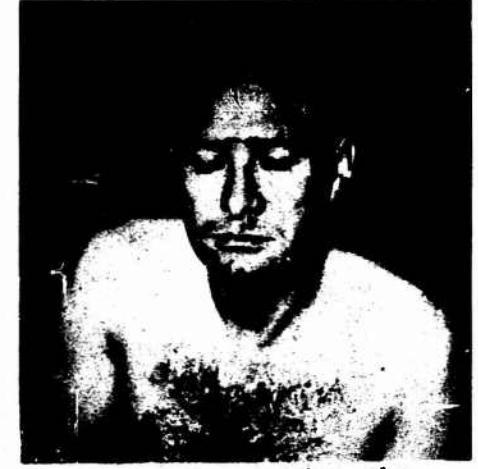
2.5 "g" (reference Case 4), probably during initial impact where the aircraft was changing direction. More severe facial injuries were probably not sustained since the pilot's head hit a relatively flat arc of the instrument panel (Case 5 C), and since a significant portion of the forward force of the head and trunk was dissipated when the chest struck the control yoke fracturing several ribs as well as the horns on the yoke.

D. Pilot with 5-inch laceration from contact with upper in-strument panel.

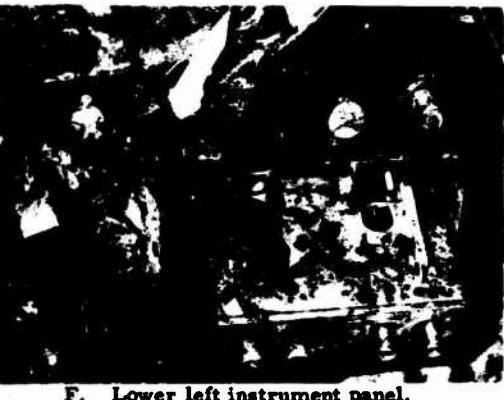
Lower left instrument panel. Heavy radio fractured right leg of copilot shown below.

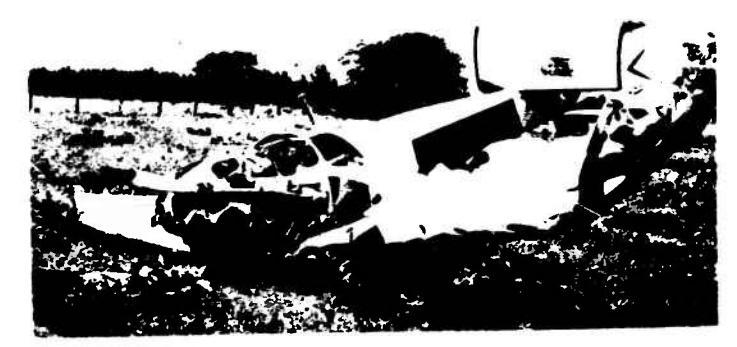
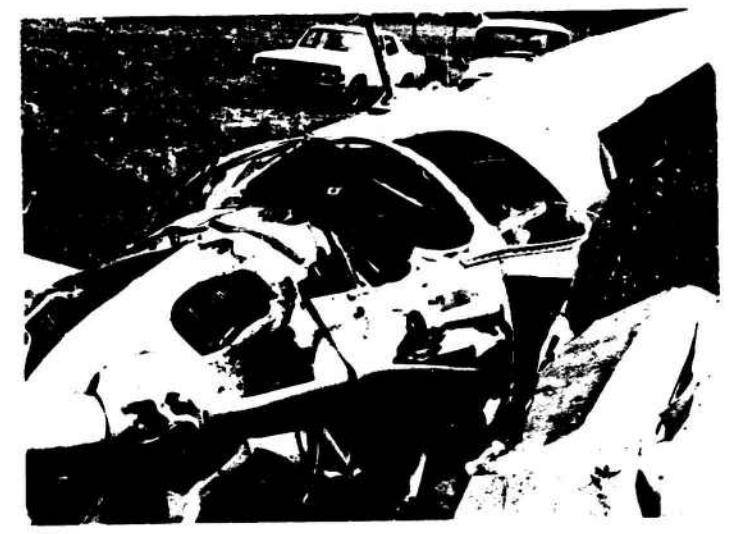
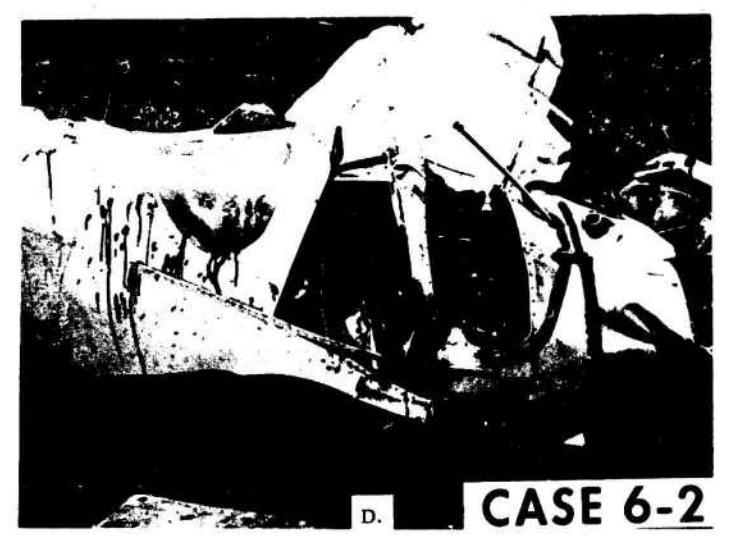
Close-up views of the exterior of the aircraft. The cabin maintained its integrity. The plastic windshield disintegrated & some outward buckling of the sides of the cockpit may be noted.

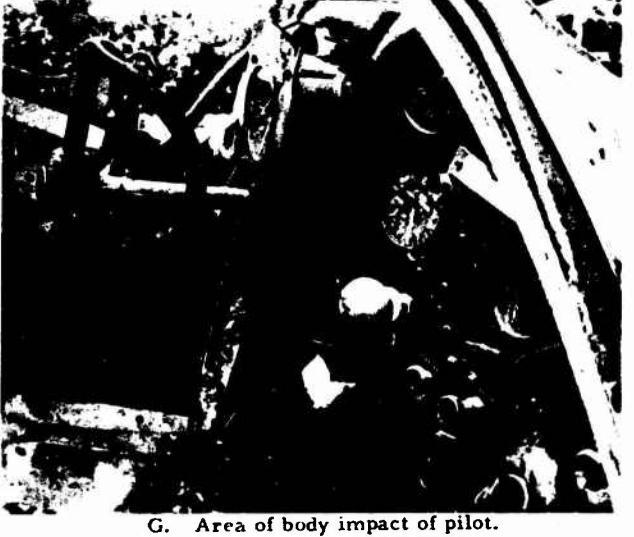
Area of body impact of pilot.

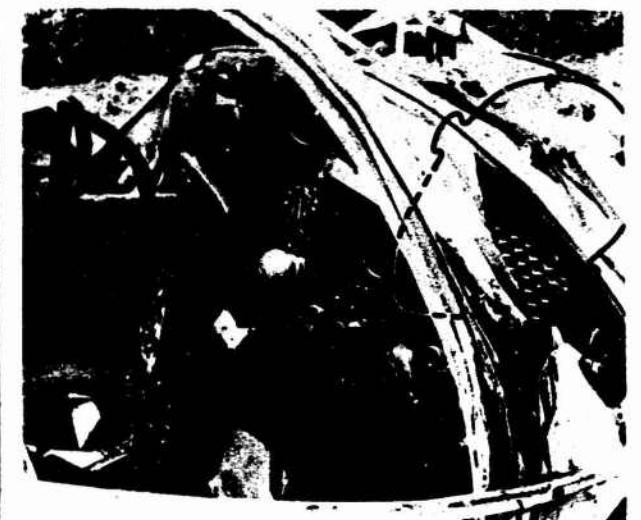
F. Head outline & dent in upper right instru-ment panel indicate head impact of copilot.

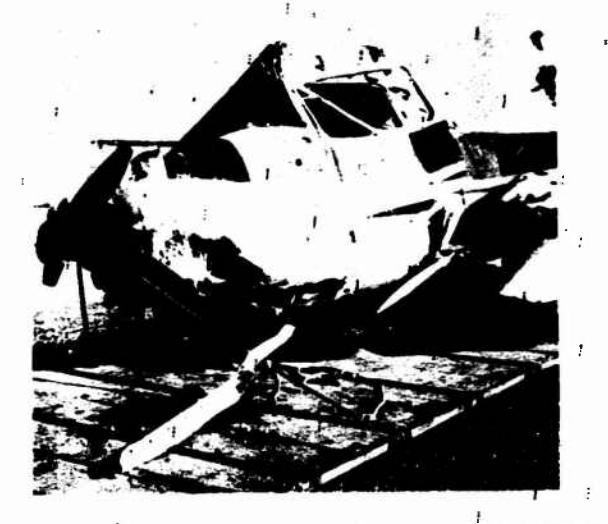
A & B Slight damage to the motor & cabin are indicative of a minor crash impact.

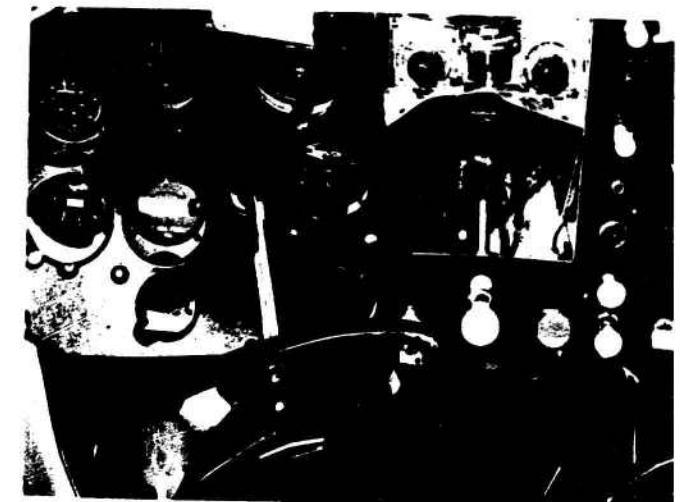
E & F Area in center of instrument panel where pilot's head struck. Note teeth enamel above key insert and sharp edge of radio cover plate.

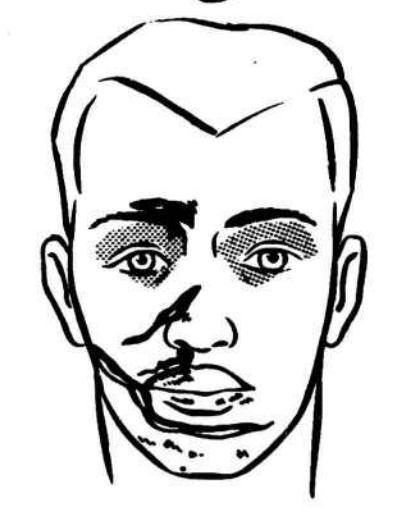
G & H Artist sketch & actual photograph of severe facial injuries inflicted.

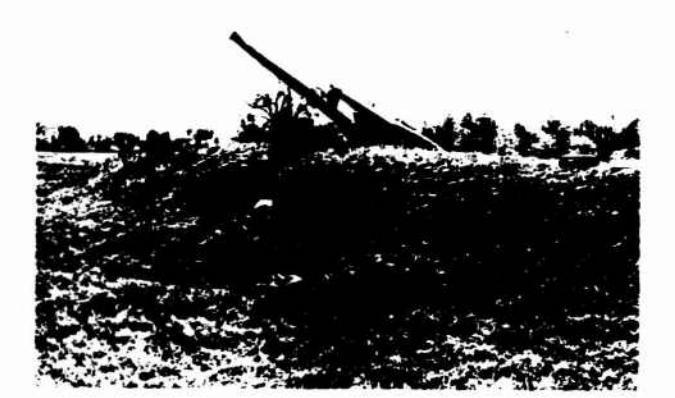
over into the pond.

After traveling 420 feet in the air,

aircraft impacted this dirt embankment, tore off its gear, and slid

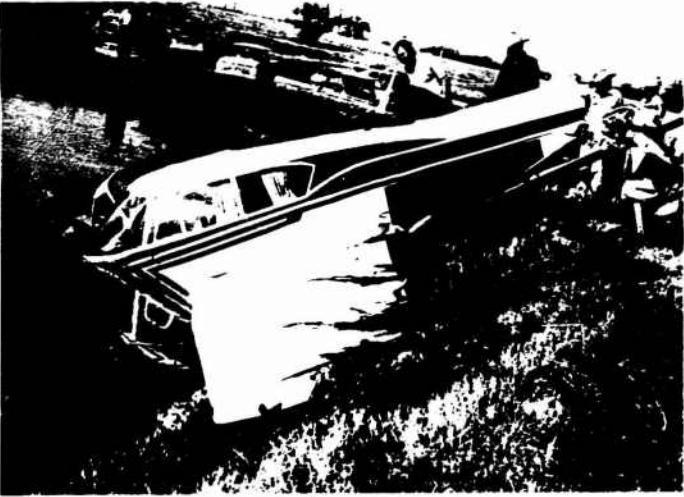
C. View of the aircraft as it was pulled out of the pond. Note cabin is entirely intact.

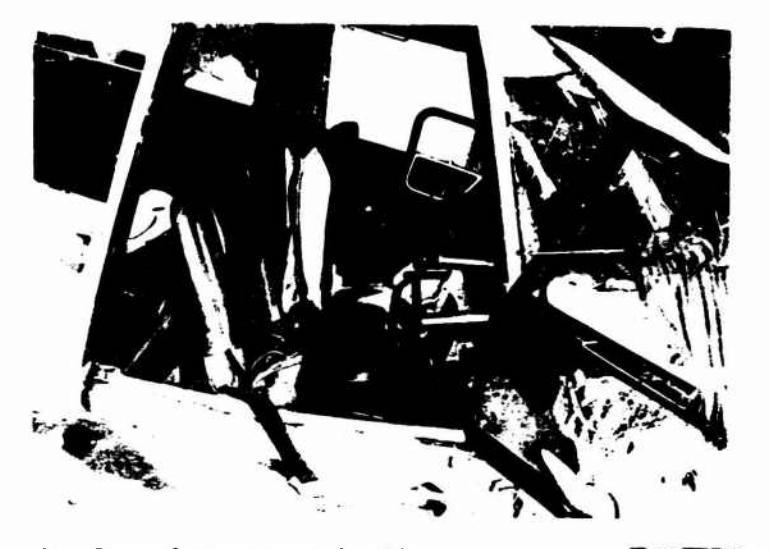
D. General appearance of cabin interior.

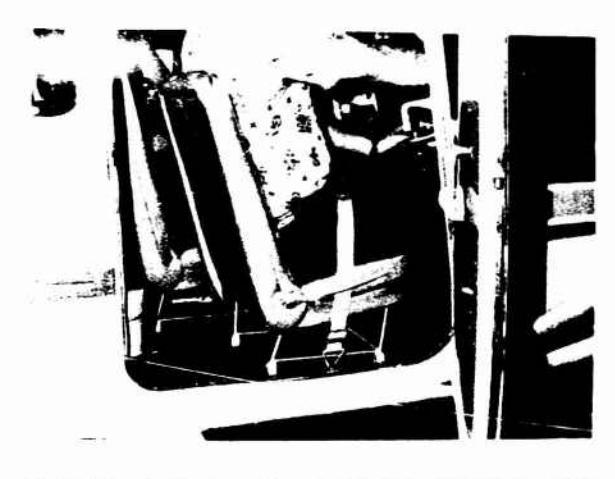
FIGURE 3. Subject wearing seat belt in 1968 Cessna 150.

the lap belts applied around the pelvic structure. The lap belt, if worn and if it does not fail, restrains only the pelvic area and allows the rest of the body to continue in motion until stopped by impacting some portion of the container. In a number of crises in this study it was noted that even the lap belt is an ineffective restraint because of faulty installation. In numerous aircraft the lap belt goes across the thighs and straight down to the floor (Figures 3 and 4) instead of across the iliac crest and then back at a 45° angle to the floor.

During deceleration the occupant is free to move forward until the belt is at nearly a 45° angle with the floor before the belt offers any restraint. By this time he is sliding off the front edge of the seat (Figure 5) and the forward motion added to belt stretch allows him to penetrate the firewall.

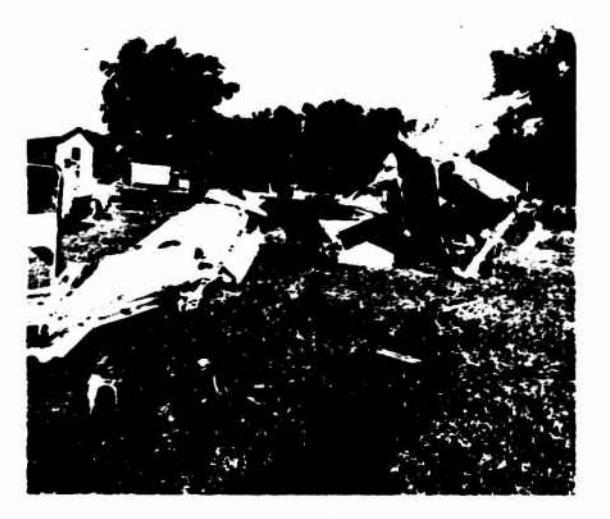
Side shot of wreckage retrieved A. from the lake.

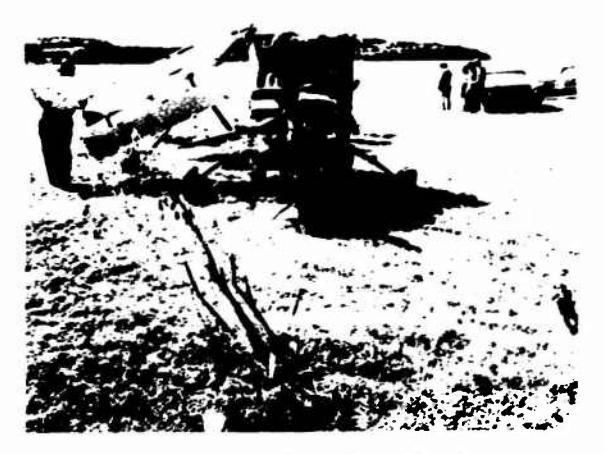
Front view of wreckage showing в. seats & seat belts still in place.

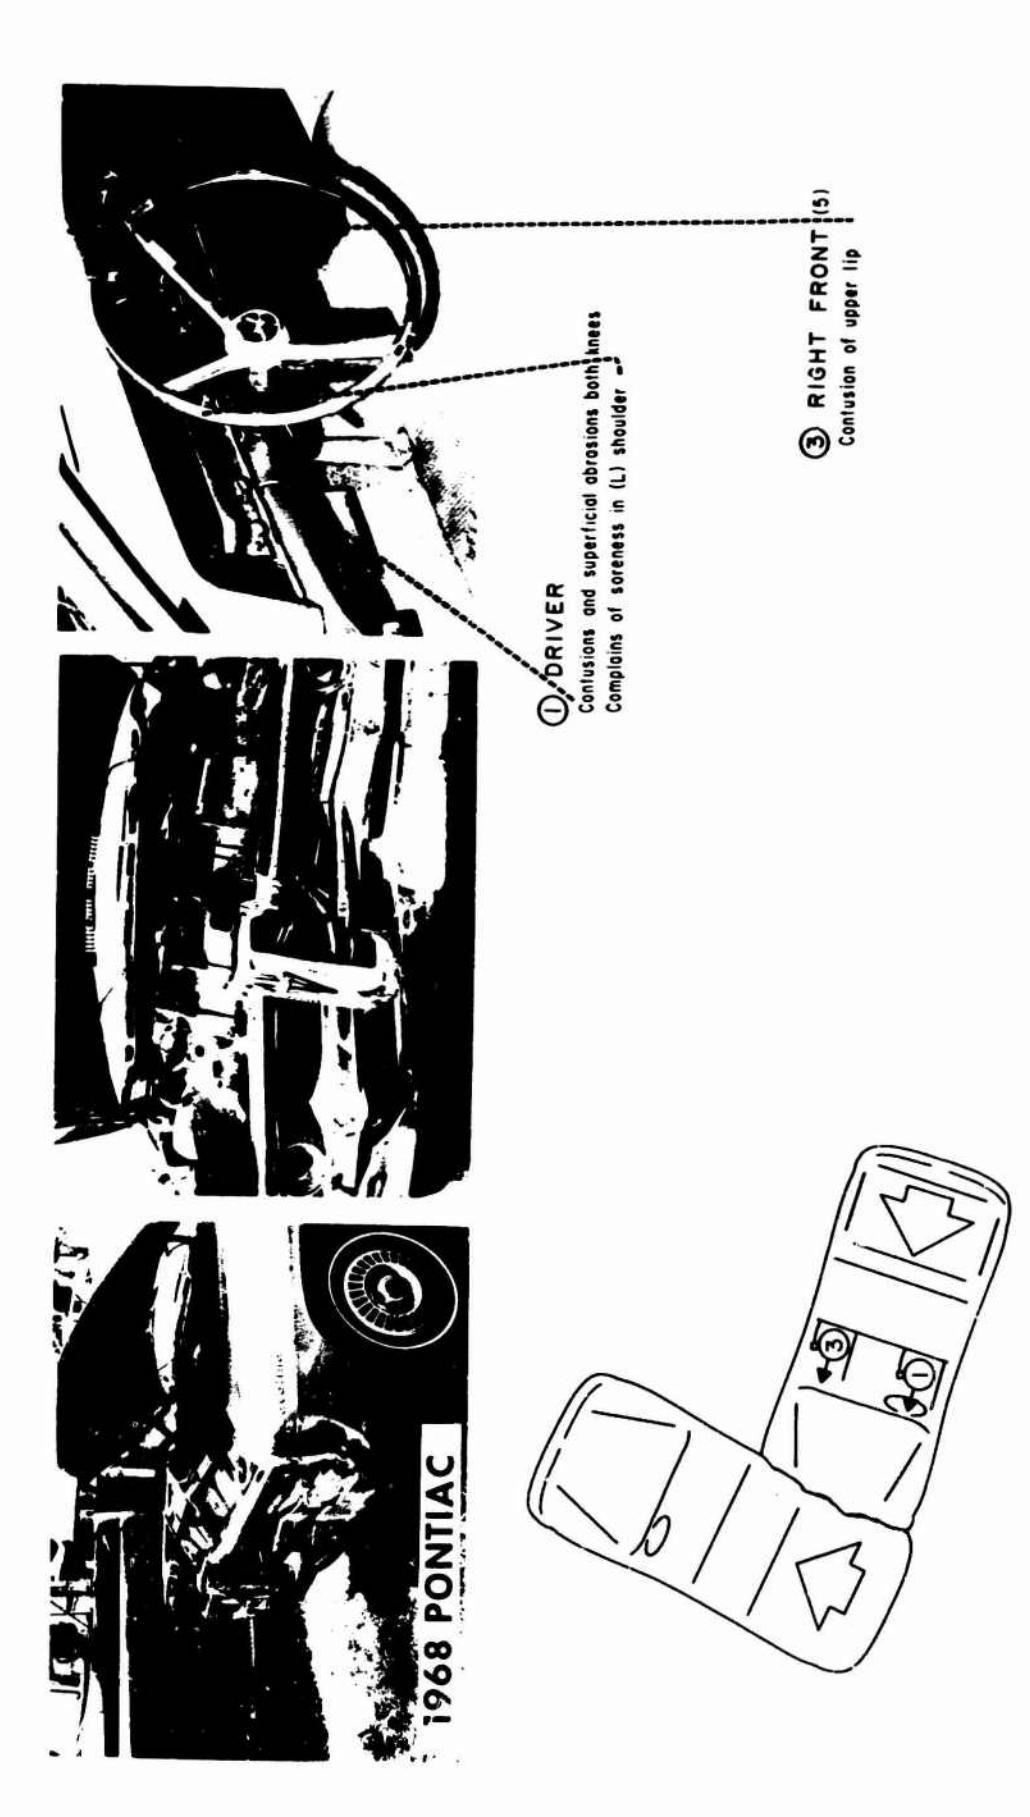
FIGURE 16. Automobile accident-calculated 19 "g".

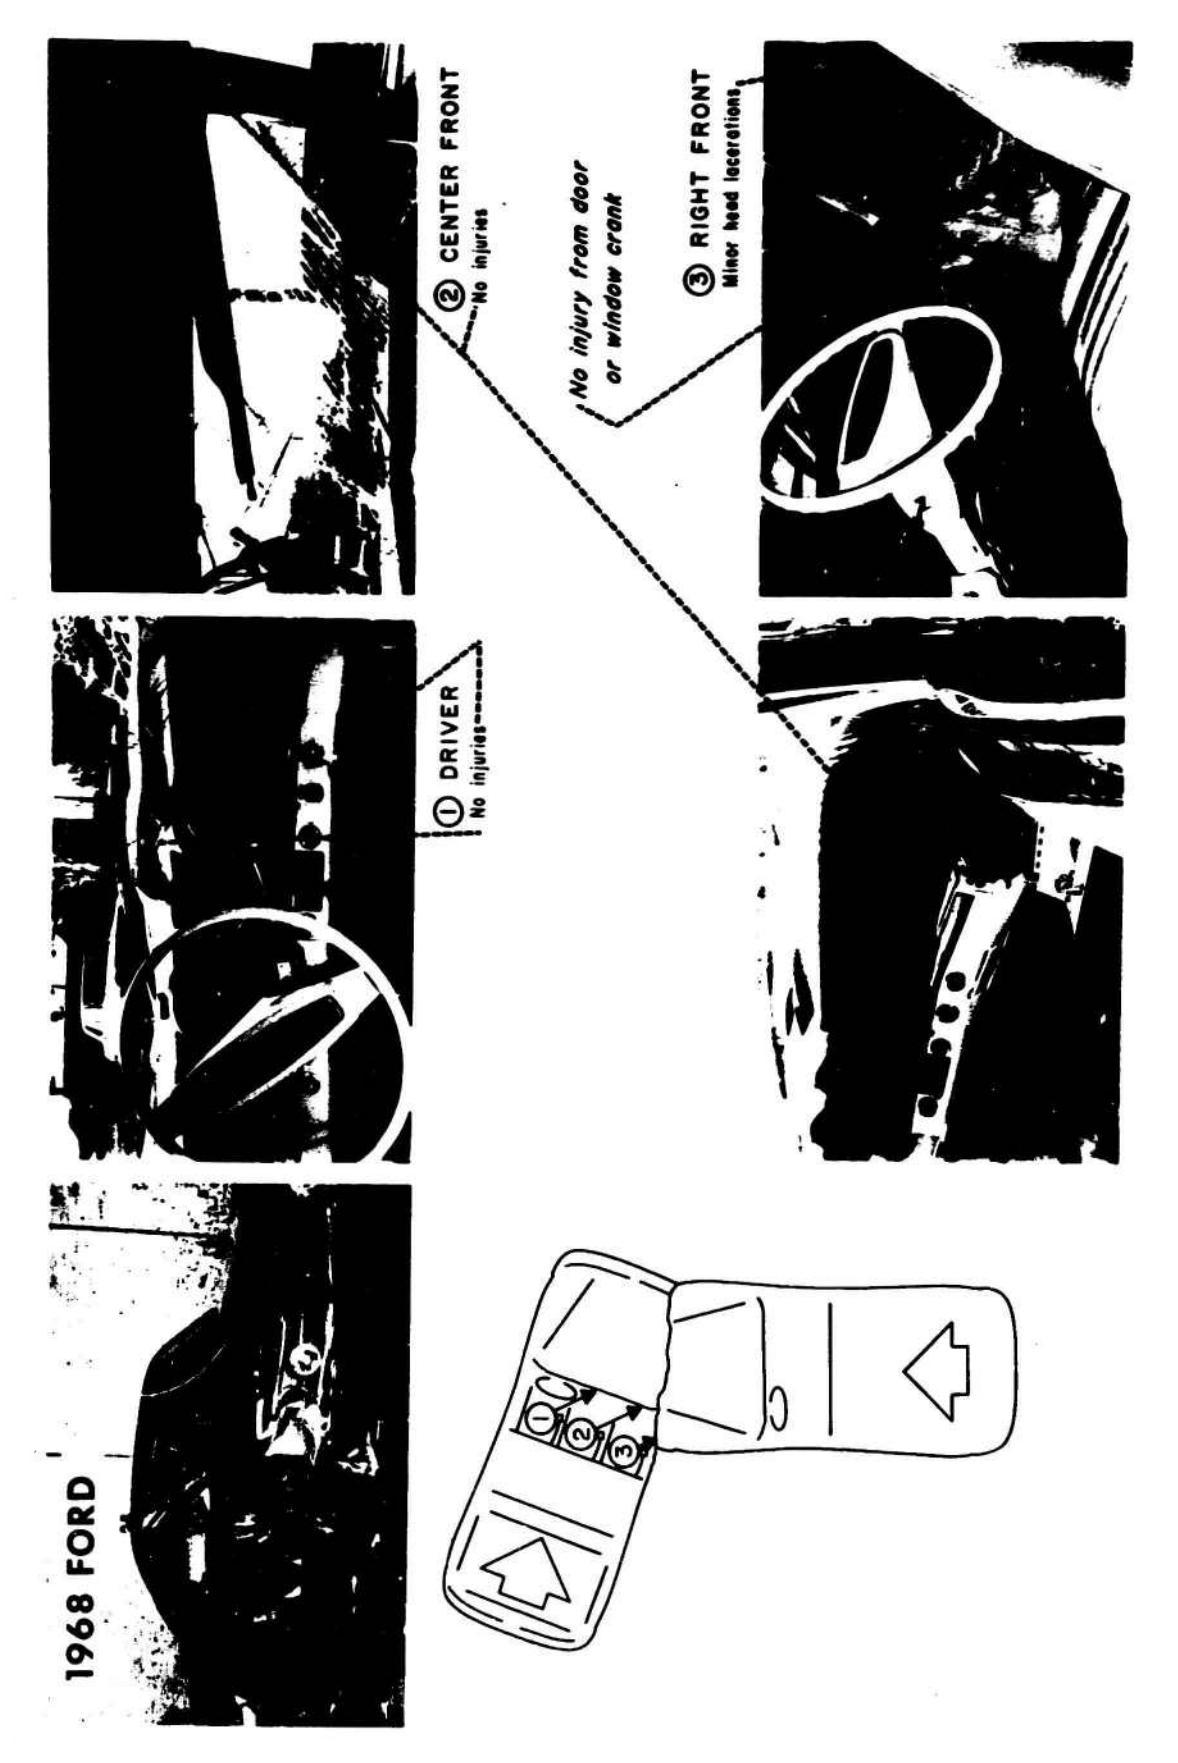
FIGURE 18. 20 "g".

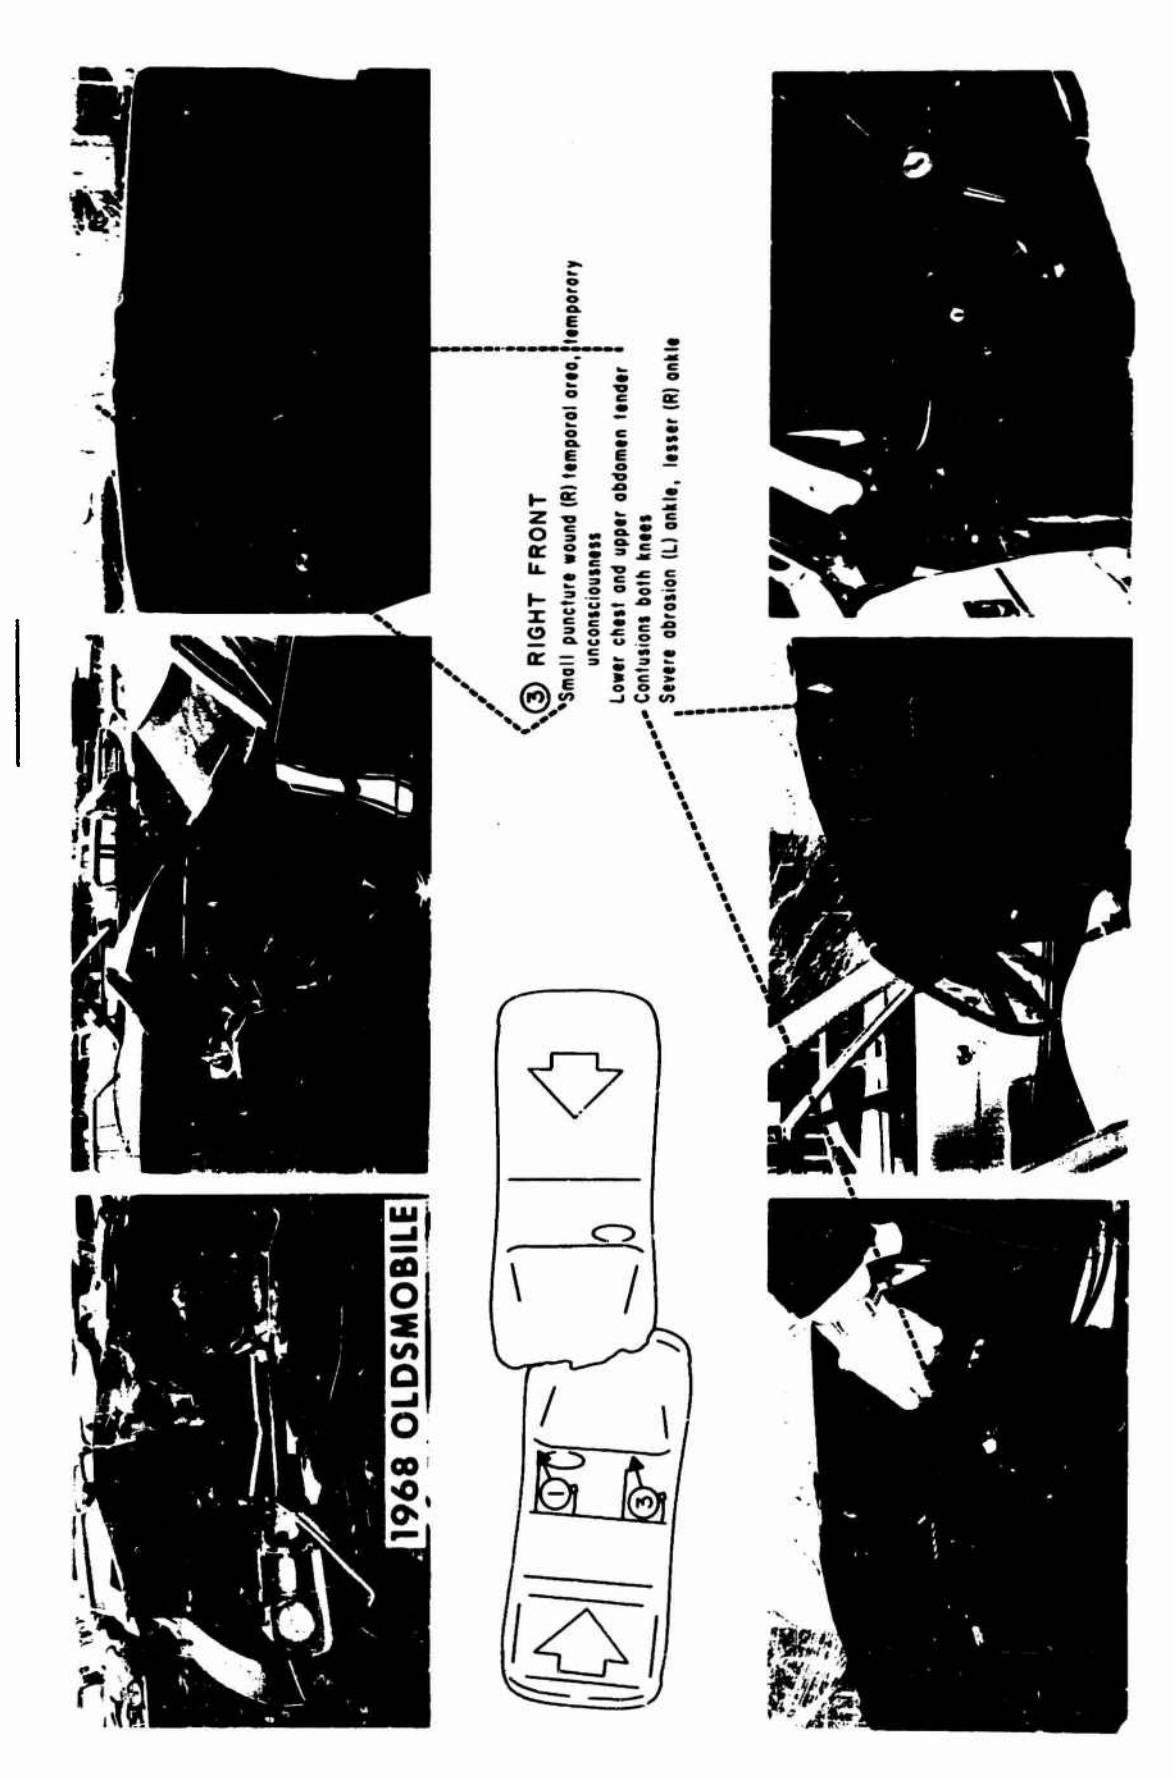
FIGURE 19. Deceleration =22 "g".

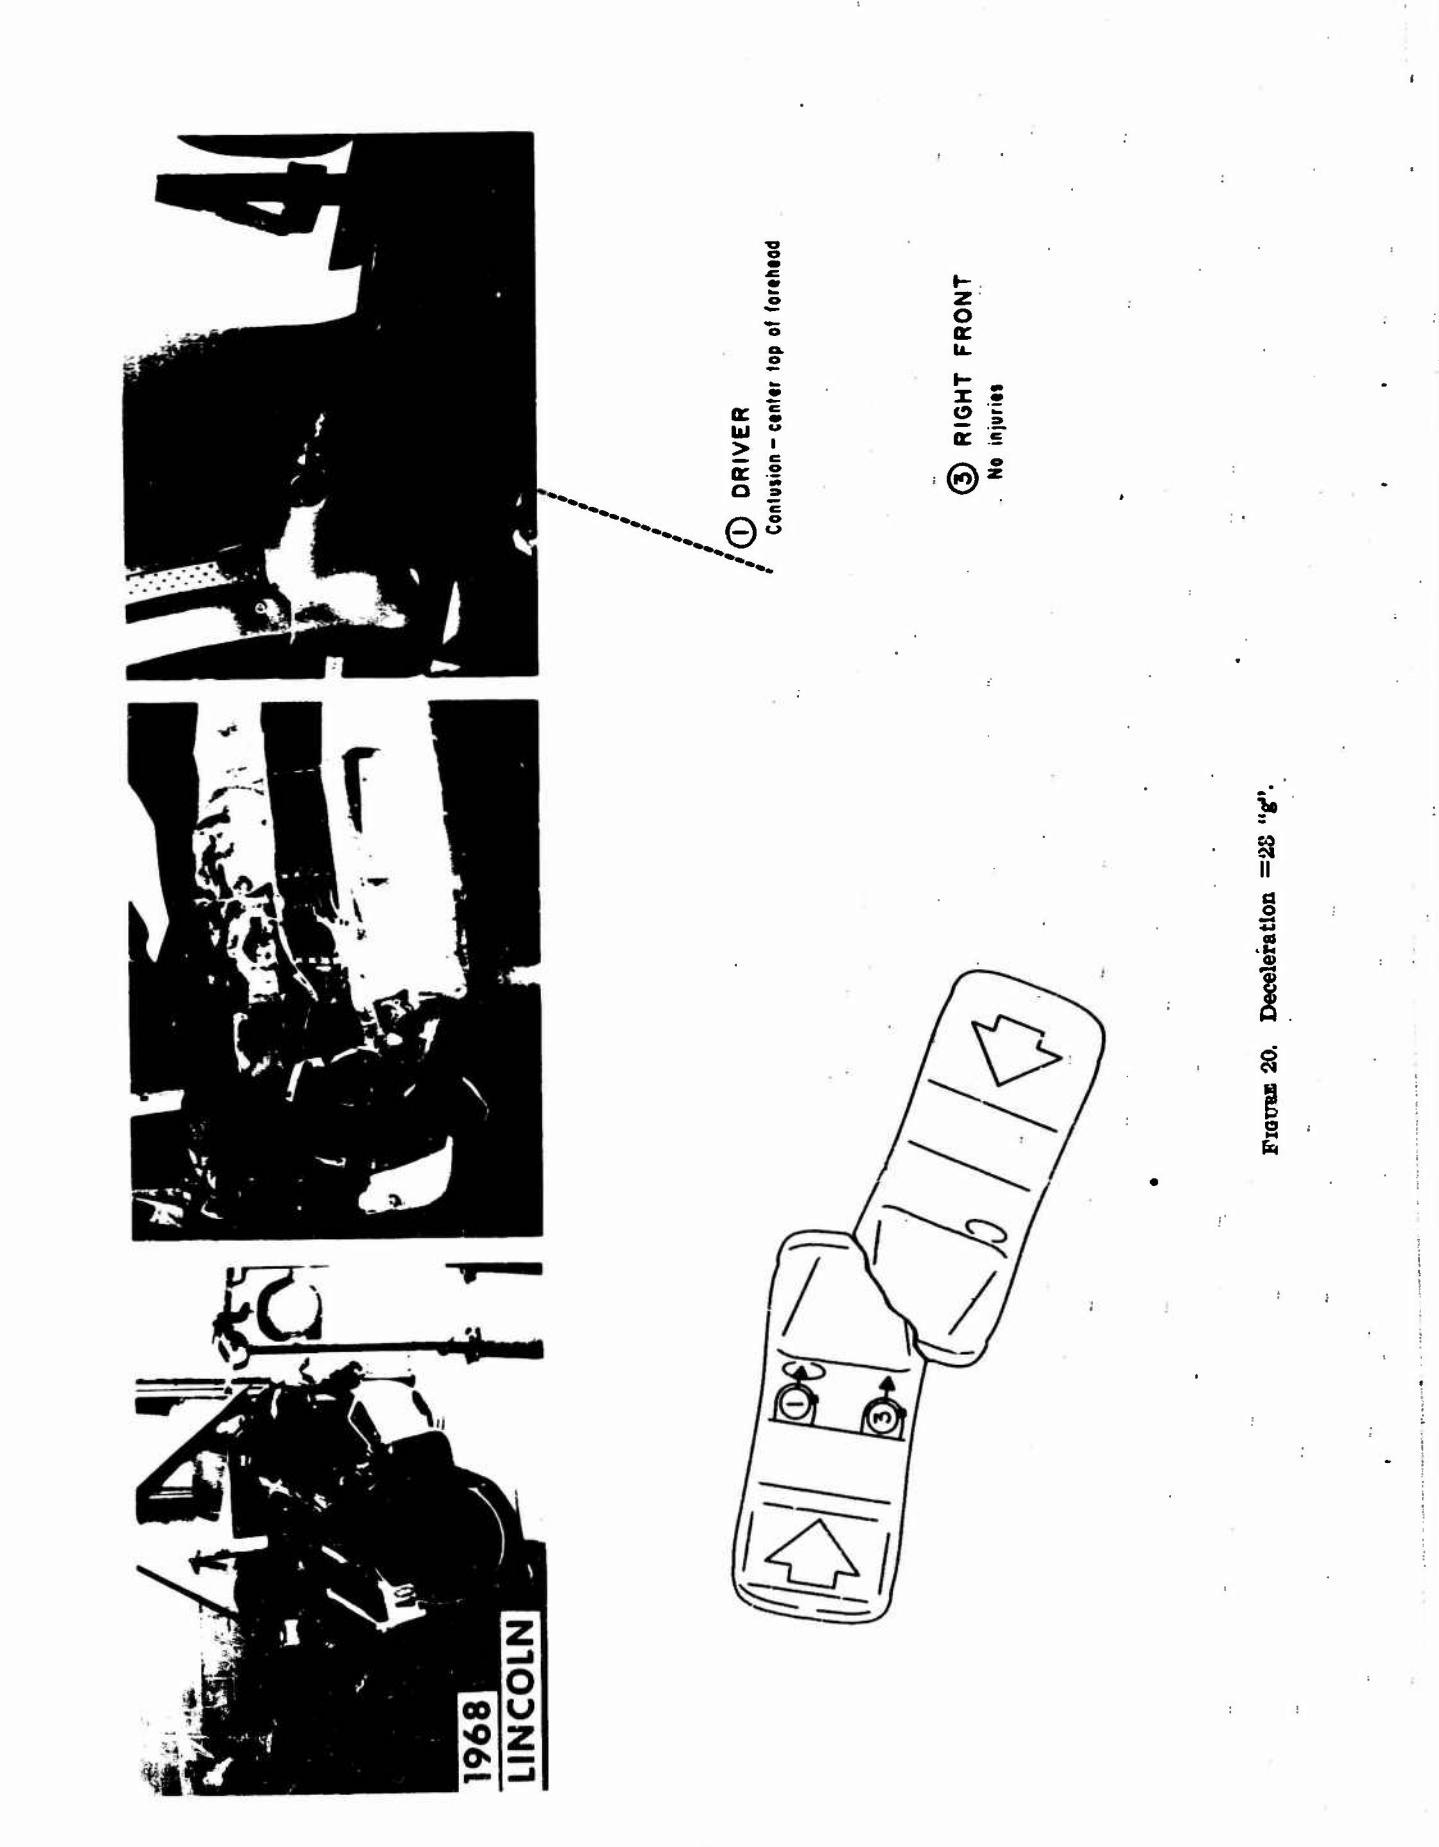
S RIGHT FRONT Fracture (R) clavicle Dislocation (R) shoulder DRIVER Laceration (R) leg below knee FIGURE 21. Deceleration =23 "g". k **1968 CHEVROLET** 6 30 Children of 5 ; 49

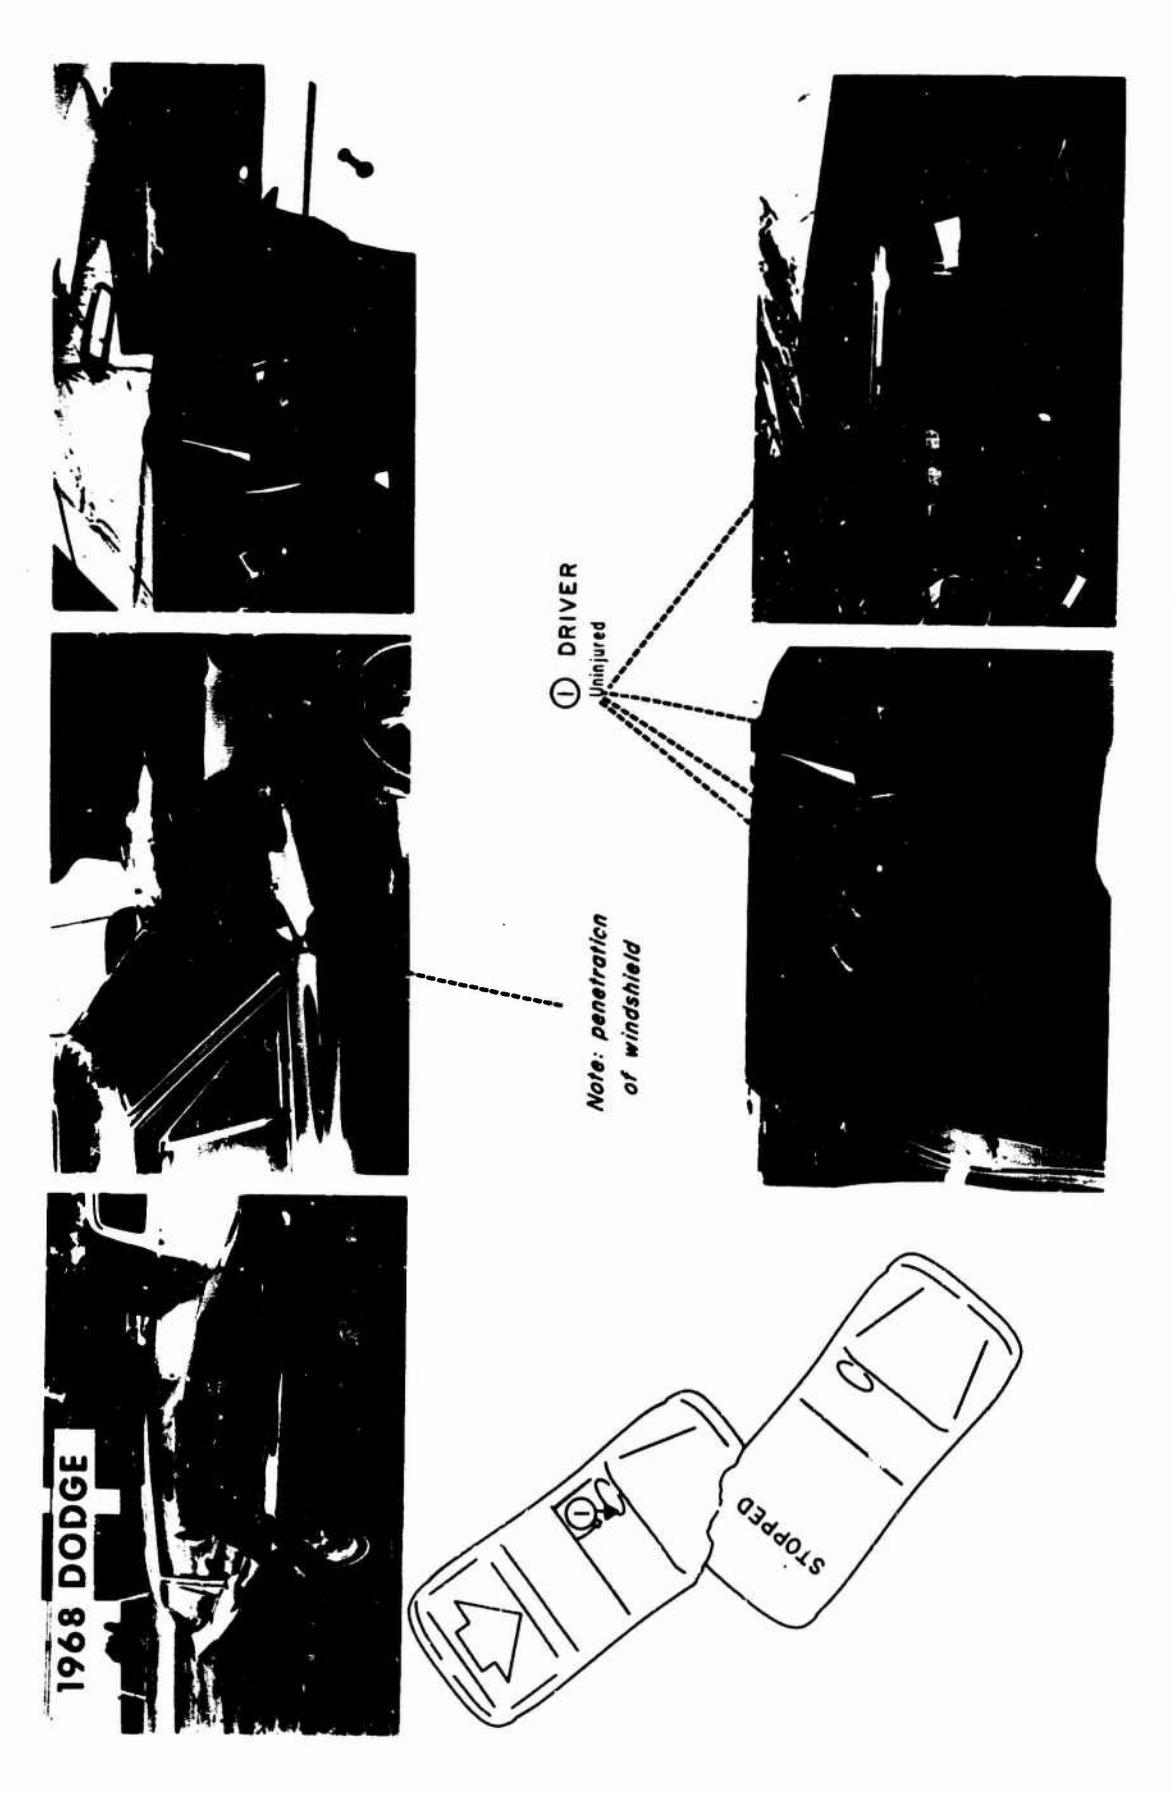
FIGURE 22. Deceleration =24 "g".

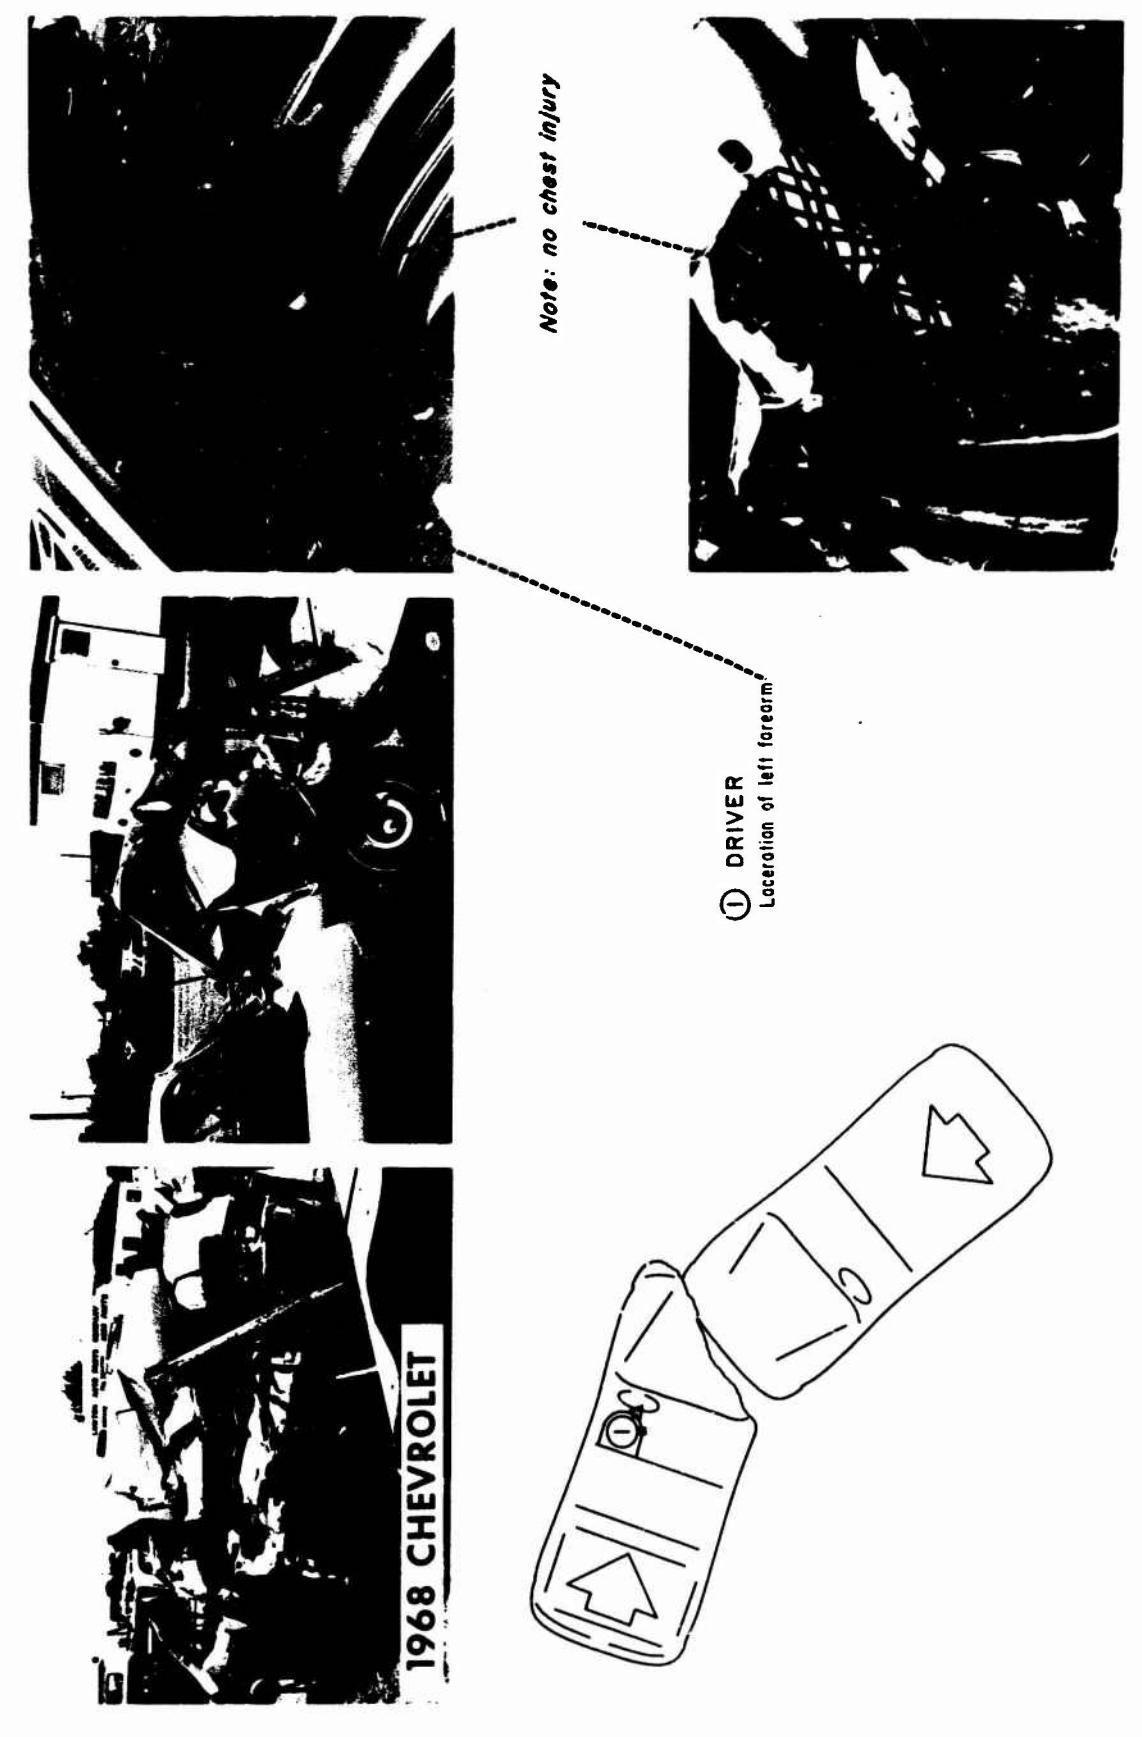
FIGURE 23. Deceleration =26 "g".
