FAA-AM-71-3

GENERAL AVIATION STRUCTURES DIRECTLY RESPONSIBLE FOR TRAUMA IN CRASH DECELERATIONS

SPECIAL REPORT

January 1971

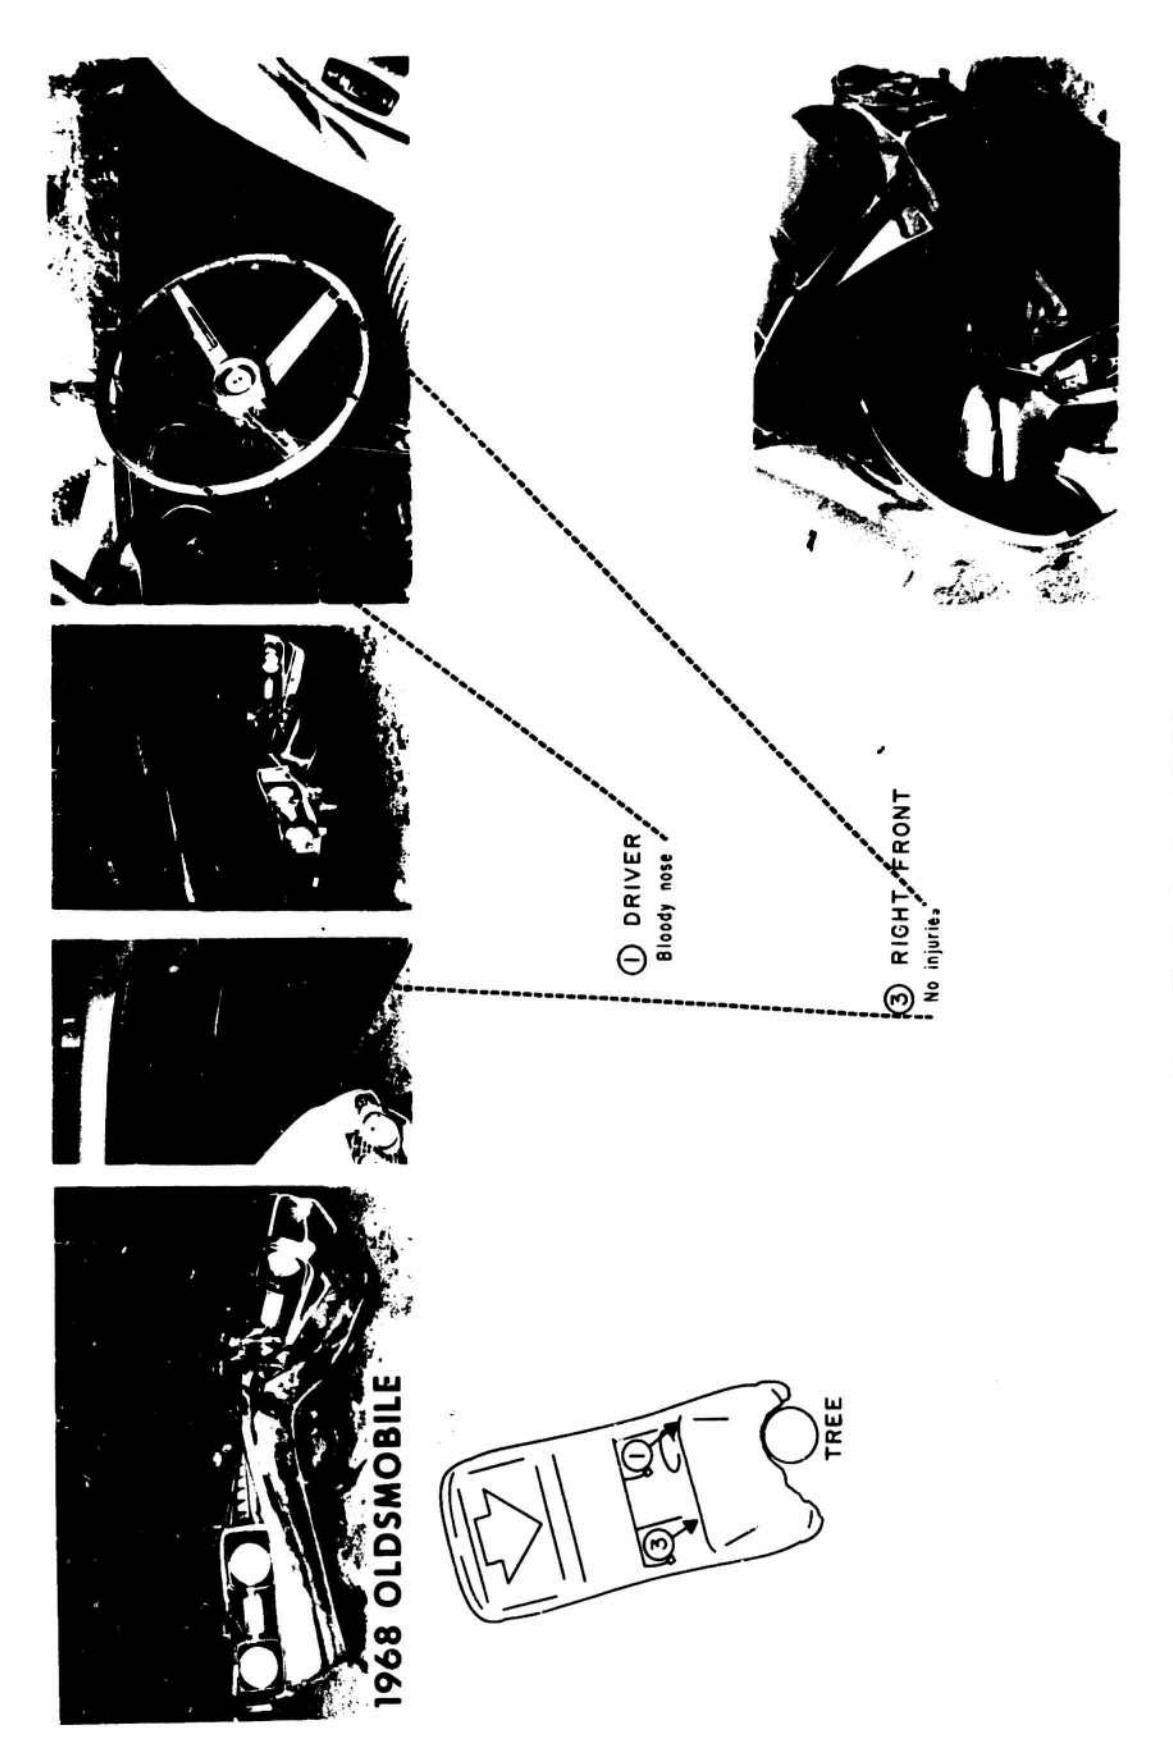
FIGURE 24. Deceleration =26 "g".

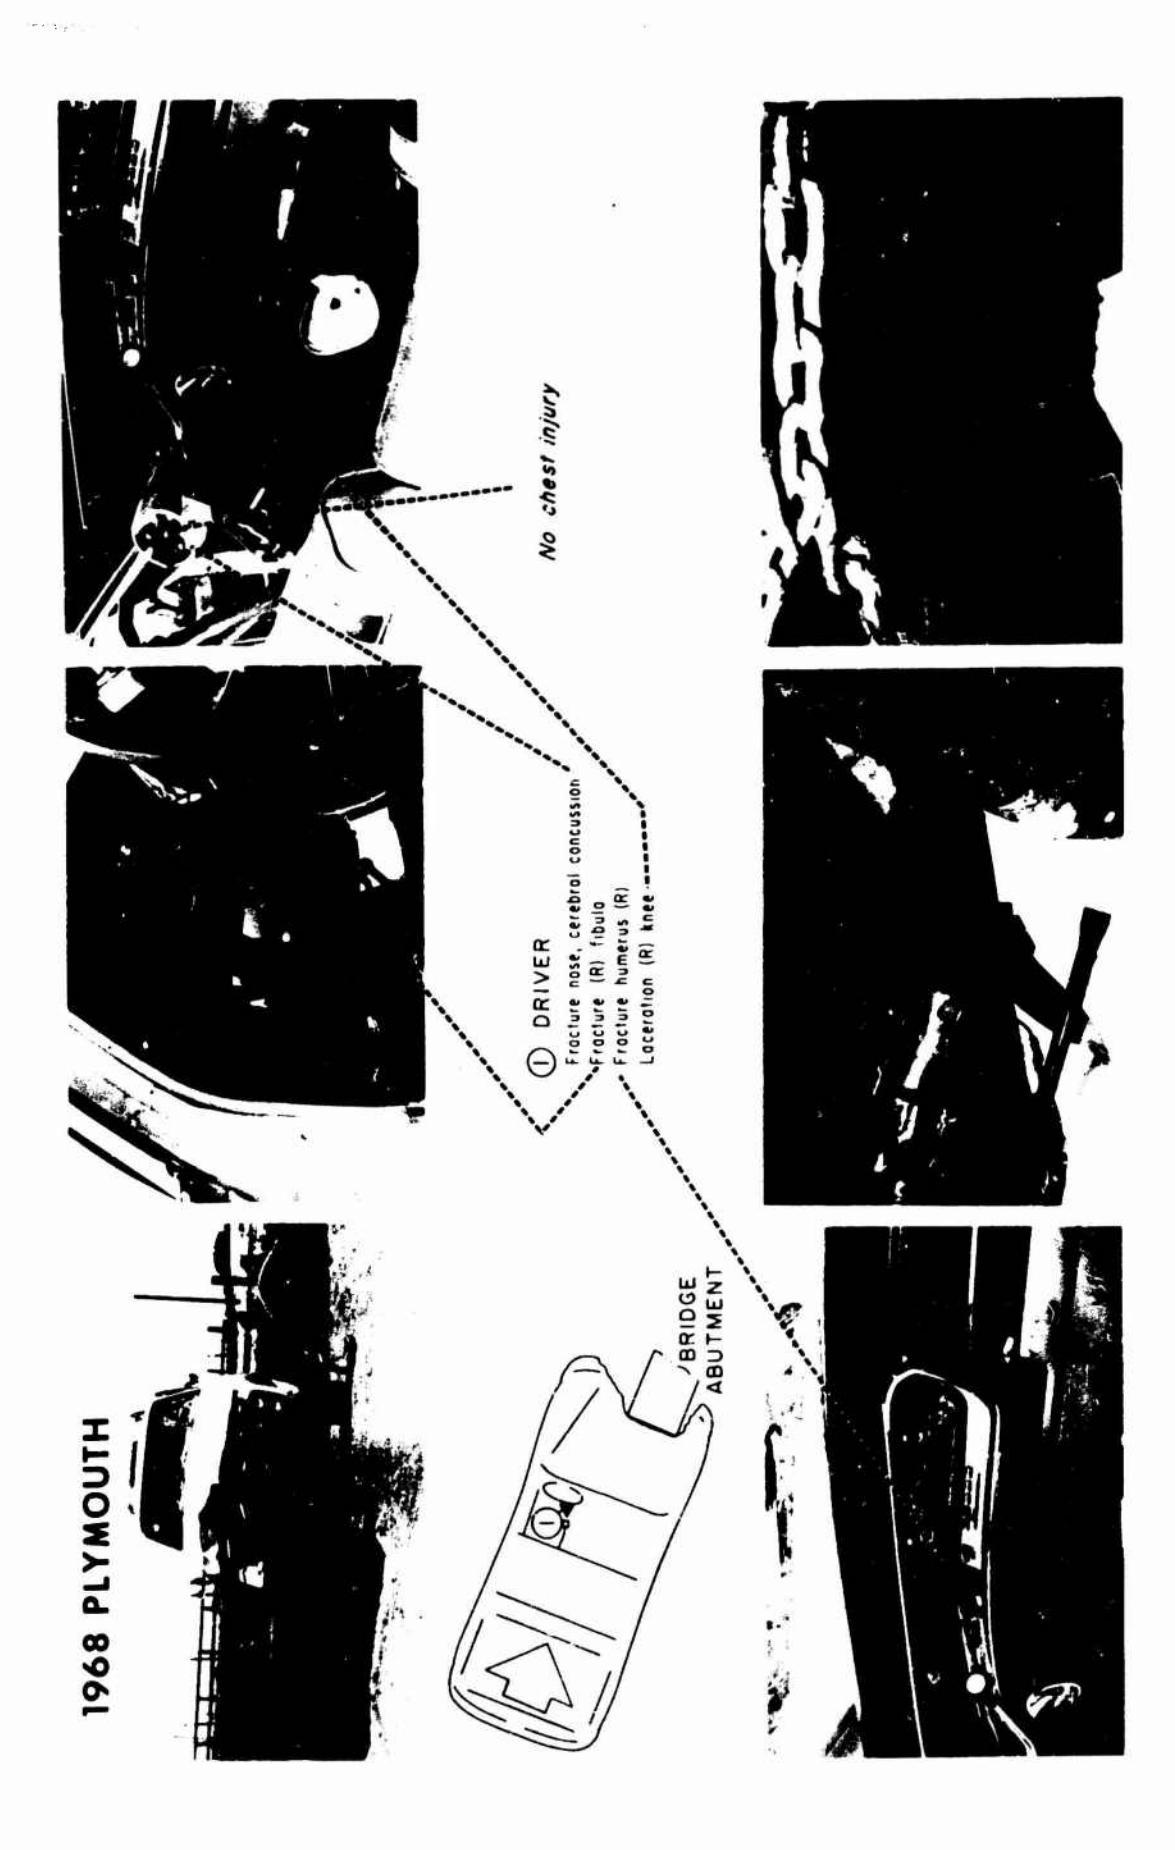
FIGURE 25. Deceleration =38 "g".

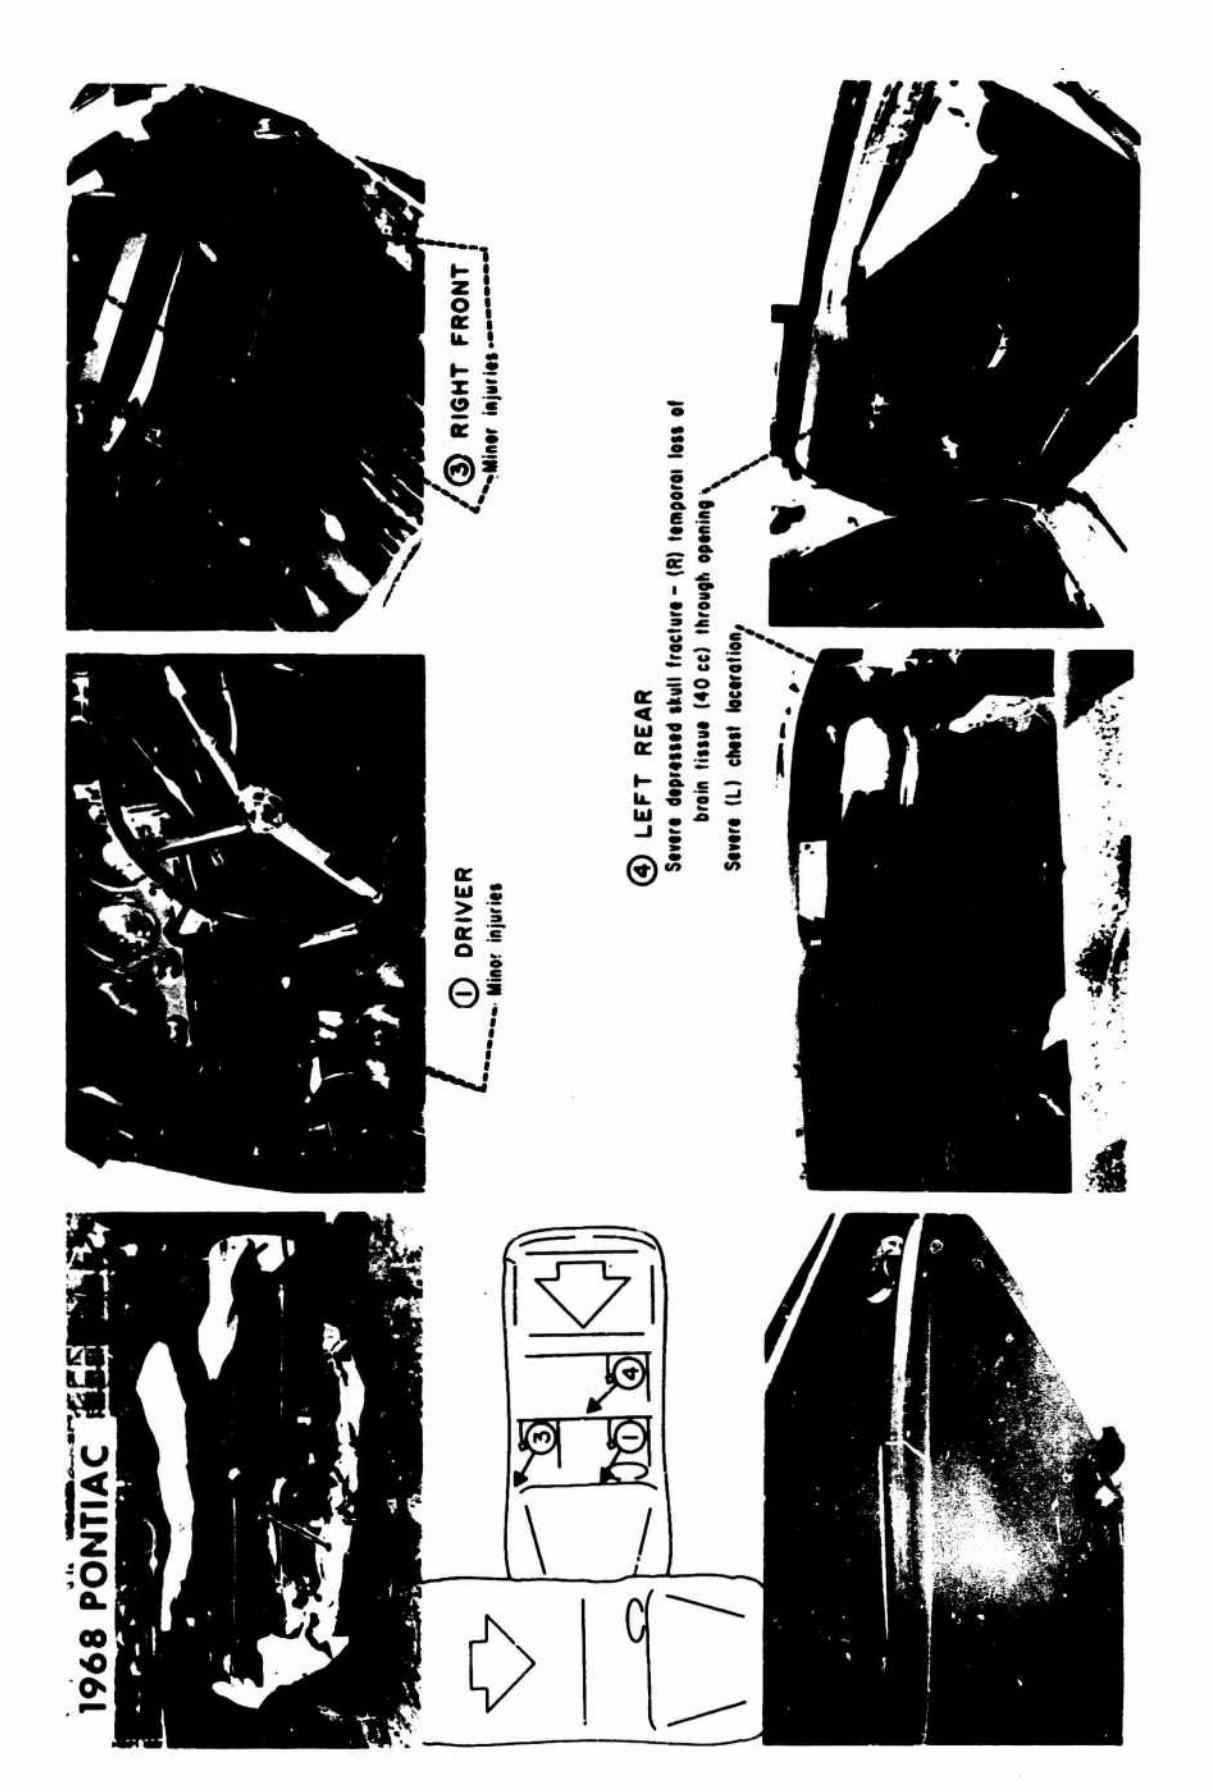
FIGURE 26. Deceleration =42 "g".

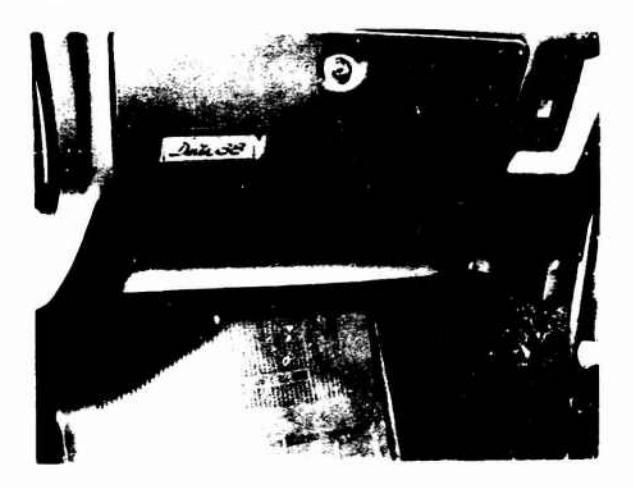
FIGURE 27. Knee impact area in late-model automobile.

peller controls, etc.) on the lower left instrument panel (Case 11 E and G) were directly responsible for a fractured arm, fractured pelvis, and dislocated hip and knee in this accident. The author feels that the manufacturers of general aviation aircraft could significantly reduce leg and pelvic injuries by copying the design trends of the automobile manufacturers (Figure 27).

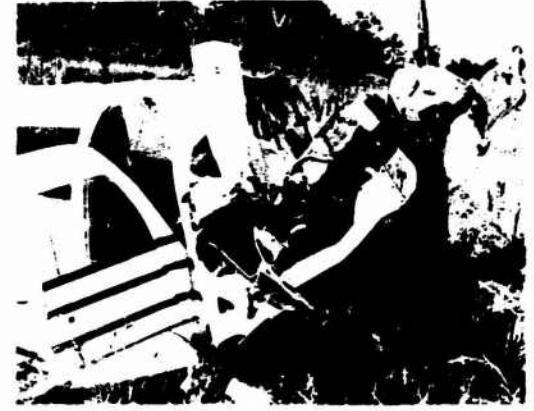
tion forces ultimately transmitted to the cabin and its occupants as long as the cabin area itself is not compromised by penetration of structure. In this case there is evidence (Case 11 A and B) that the engine was forced up during some stage of the deceleration (probably as the aircraft flipped over) until it was at right angles to the axis of the aircraft and pushed the instrument panel back toward the front seat occupants. It should be noted, however, that there is no apparent structural failure with separation at the ends of the instrument panel. It is also worthy of note that the Mooney Corporation has installed a thin layer of padding on the top of the instrument panel (Case 11 C) in this aircraft and they are to be congratulated as it probably saved this pilot from fatal head injuries. On the other hand, the significant contribution of the padding to safety was partly nullified when the heavy compass was mounted on top of the instrument panel. A severe cerebral concussion was caused by this instrument when the pilot impacted it with his head (Case 11 D). In the same figure it is obvious that the pilot received his severe scalp lacerations on the broken plexiglass windshield and a fractured mandible with the loss of several teeth on the right horn of the control wheel which his body had bent up into the facial impact area. These plexiglass windshields have caused numerous severe lacerations, some fatal, as will be seen in other cases presented later in this report. Late-model automobiles are equipped with thin, strong, laminated glass windshields which have greatly reduced the head penetration and severe laceration problems. The control wheel in this aircraft is poorly designed from the standpoint of crash injury prevention. The horns frequently break off and sometimes penetrate the chest. Mounting a heavy protruding instrument with a reset knob protruding even further in the center of the control wheel significantly increases the chance of serious to fatal chest injuries. Beech redesigned their control wheel to fit the chest contour and eliminated the horns and protrusions 20 years ago. Cessna later developed a similar, well-designed control wheel (refer to Case 7). It should be noted, however, that both of these companies have gone back to the horned control wheel in some of their latest aircraft. The heavy radio with protruding knobs in the center of the instrument panel and the row of extended heavy aircraft controls (power, mixture, pro-

B. Motor forced upward, pushing instrument panel inward.

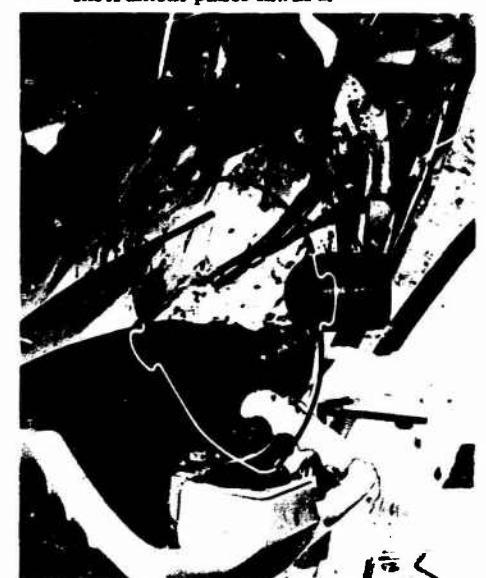
D. Pilot's head struck the broken plexiglass windshield, heavy compass, & right horn of the control wheel.

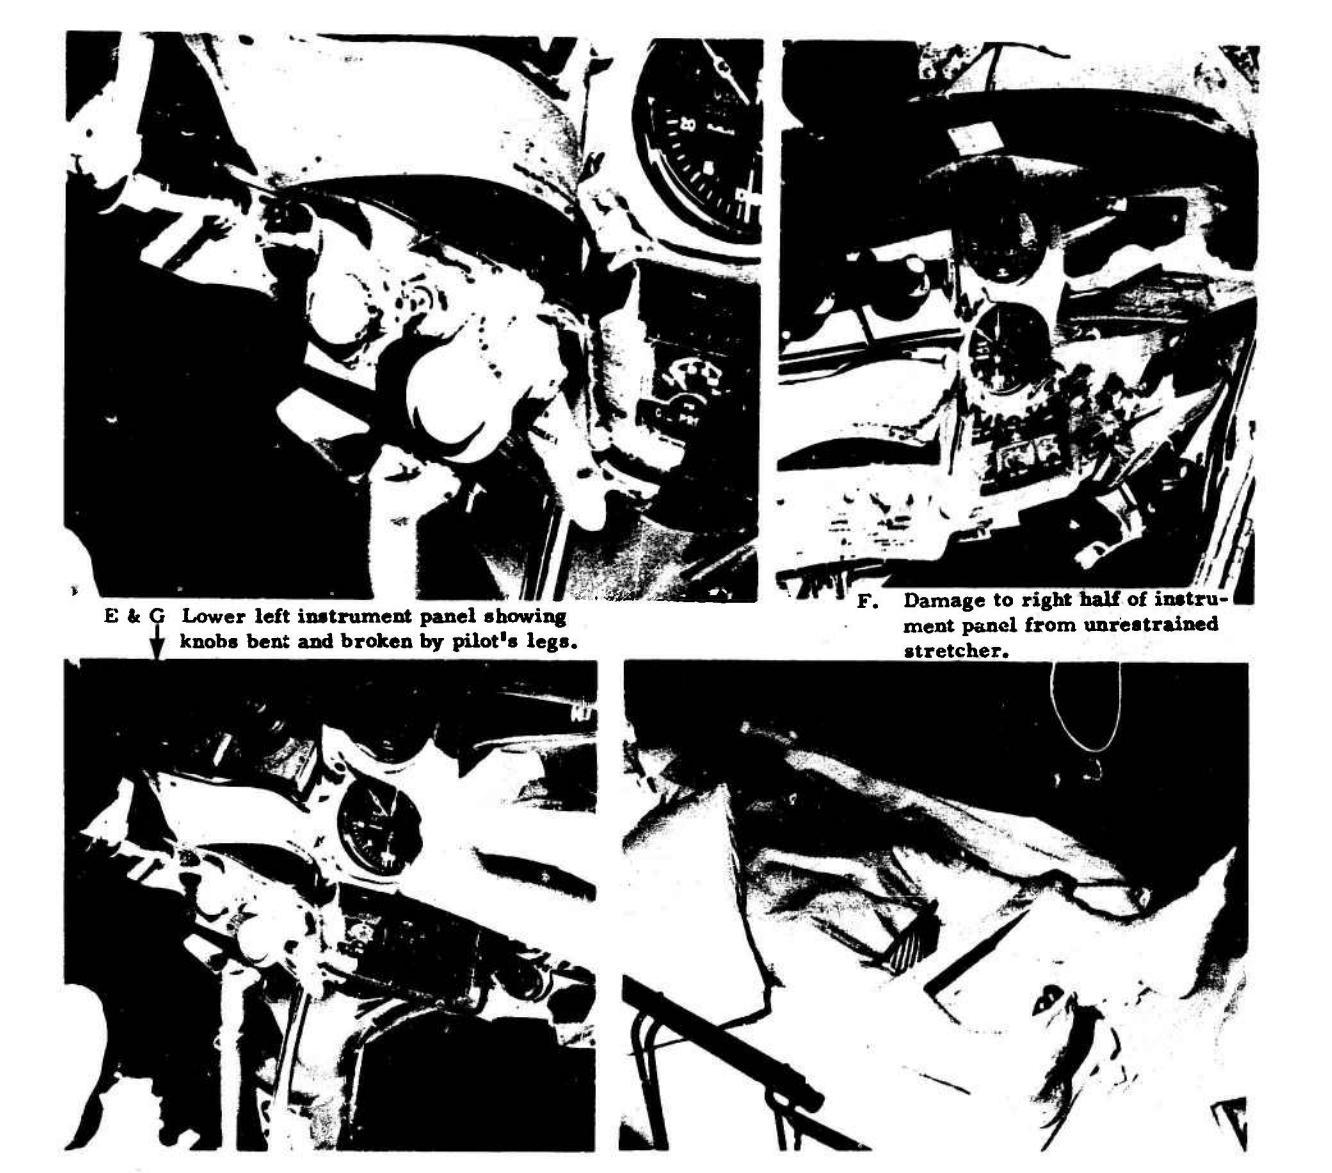
H. Peivic & lower leg injuries.

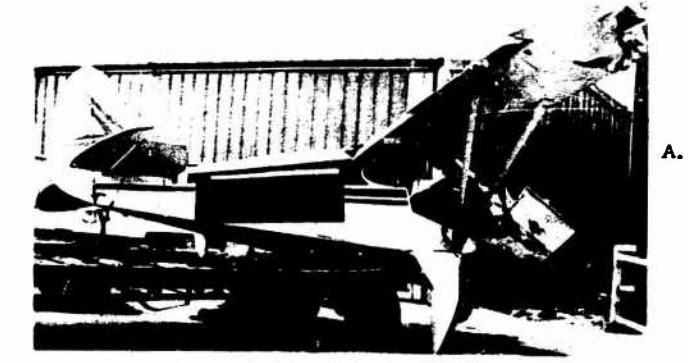
Aircraft from right side after removal from crash site. Note that most of the aircraft appears to be undamaged.

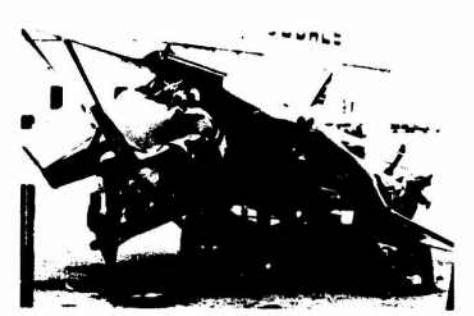
In Case Number 12 there has been a complete separation of the cabin structure at both ends of the instrument panel (Case 12 B and C) as a result of the impact. Since this 1955 Piper Tripacer PA 22-150 has doors on both sides, the only structure preventing the engine and instrument panel from being pushed back into the faces of the front seat occupants is the "A" post on each side of the windshield. The inboard half of each seat belt was attached to the seat while the outboard half was attached to the fuselage. Attaching lap belts to seats loads the seat tie-down attachments unnecessarily, often causing them to fail and the package contents are no longer even partially restrained. Seat attachments in this case did fail (Case 12 I, J. K and L), allowing the two front seat occupants to smash their faces into the formidable structure of the upper instrument panel and their knees and legs into the prong-studded lower panel (Case 12 D). Facial injuries were more severe in this case than in Case 11, partially because there was no padding on the instrument panel and partially because the crash impact force was slightly greater as attested to by the significant increase in lower leg injuries. The bare survival of these two occupants could probably be attributed to welldesigned control wheels for cliest impact without injury. Note in Case 12 F and G these control wheels are smashed flat against the instrument panel and probably slowed the upper bodies just enough to prevent fatal crushing head injuries. Federal Aviation Regulations (FAR) Part 23 requires that all general aviation aircraft have a tie-down strength to withstand a forward static loading of 9 "g". Since this seat did fail at its attachment, one might assume the crash forces involved in this case exceeded 9 "g". However, a recent research report published by the National Aviation Facilities Experimental Center (NAFEC)⁶² shows the unreliability of predicting dynamic strength from static testing and the author believes that the maximum crash force in this case was well below 9 "g" as measured dynamically. A cabin deceleration of 8.5 "g" would have produced head strike velocities in excess of 50 ft./sec. and the head injuries from impacting this instrument panel would have been fatal to both occupants.

B. View from left side of aircraft showing that only the structure between the rear door & motor protected the pilot from being crushed.

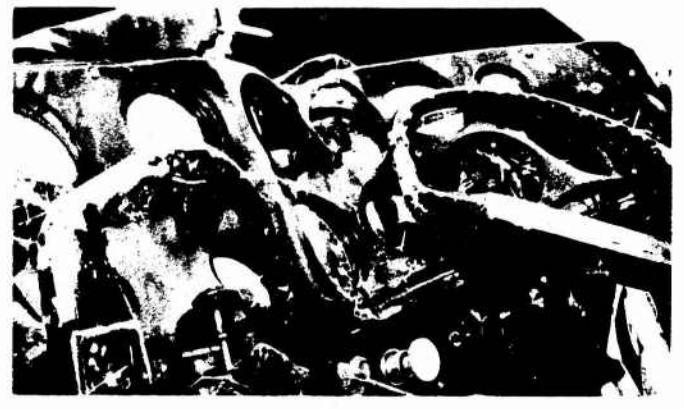
The total weight of the radio equipment in this aircraft was approximately 30 pounds. Radio equipment incorporating miniaturization technology is available today. By substitution of this new equipment, communication weight could be greatly reduced and the pounds saved utilized to strengthen the forward areas of the cabin as Beech Aircraft Corporation did so successfully nearly 20 years ago.

H. Close-up of heavy radio structure on copilot's side causing four lower limb fractures.

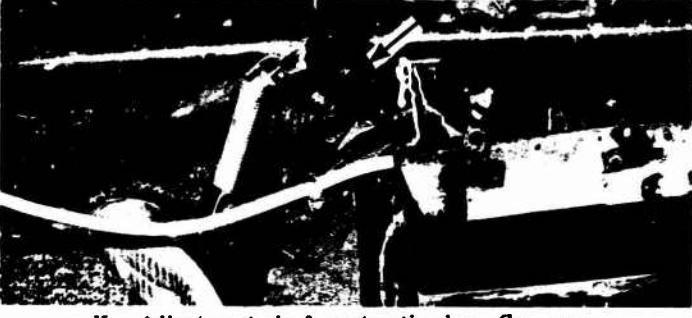
K. Adjustment pin & center tie-down flanges. Notice that the thin tie-down flanges are spread open, allowing the seat to leave the track.

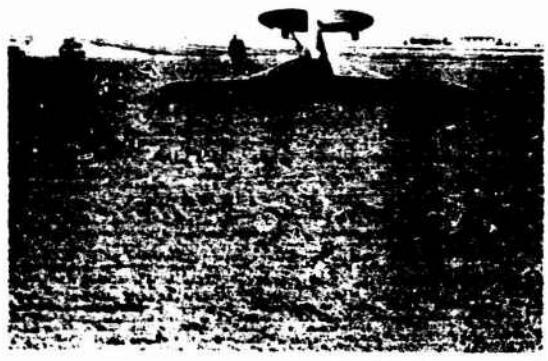
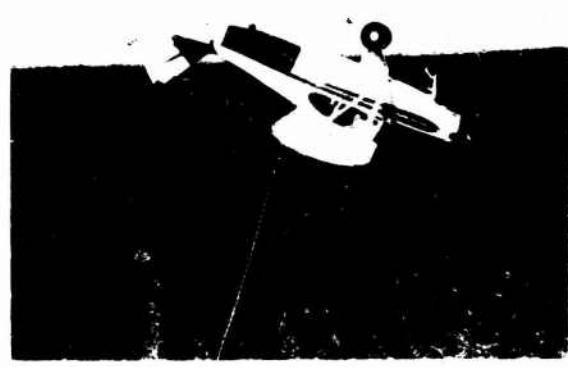
& B Two views of aircraft that simply flipped over onto its back without damage.

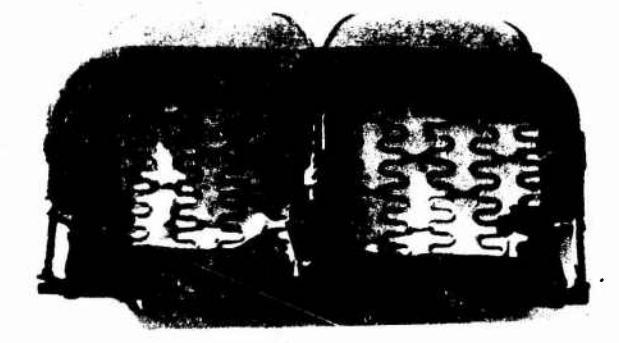
G. and (3) center seat tis-down structure is inadequate.

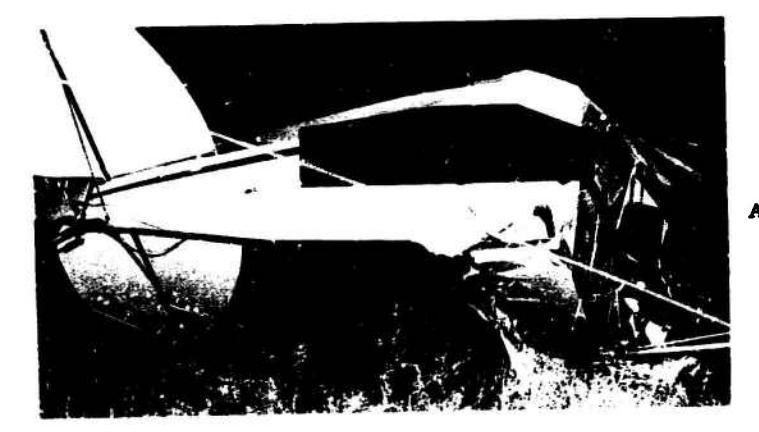
A. Rear view of aircraft wreckage.

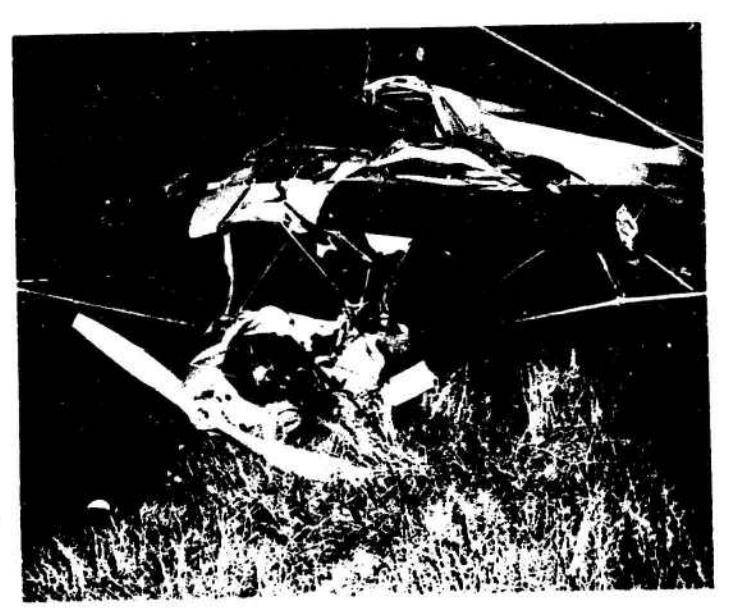
B. Front view showing tubular framework of this aircraft prevented cabin collapse.

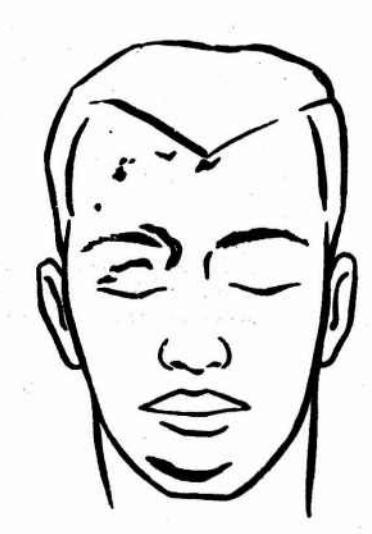
D. Artist sketch of facial injuries.

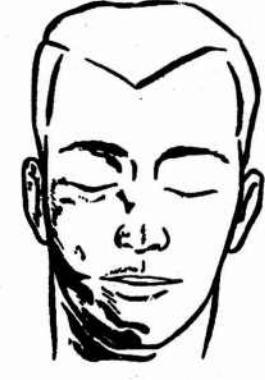
E. Pilot (rear seat) head injuries. Note lacerations from broken windshield.

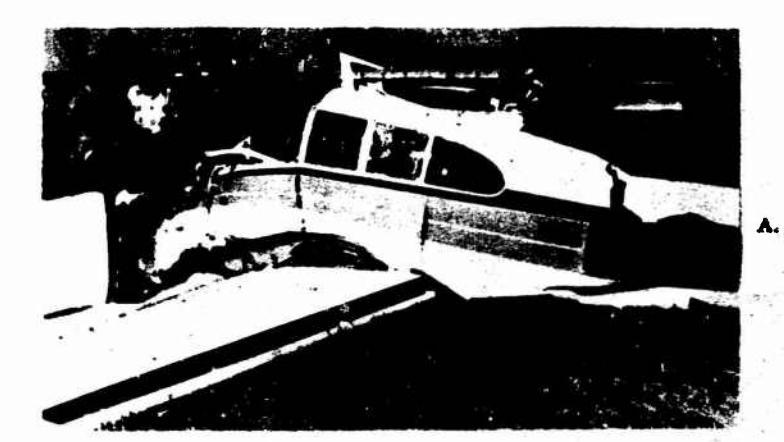
Left side of aircraft after impact.

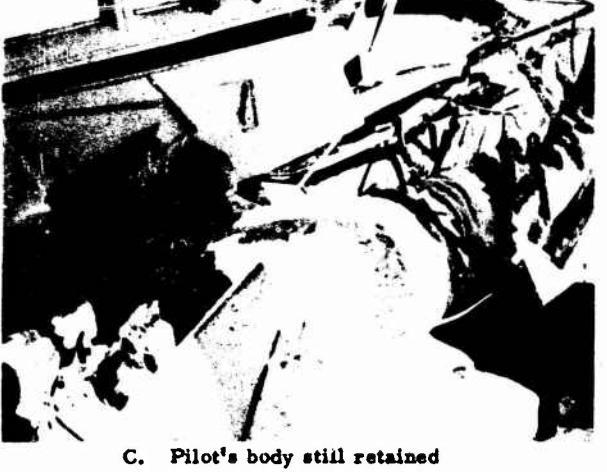
C. Pilot's body still retained by seat belt.

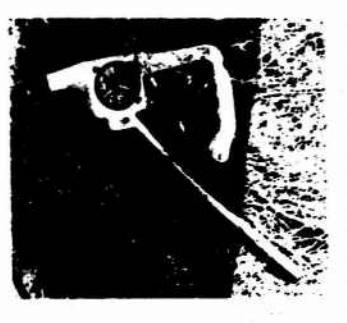
would have exceeded a velocity of 100 ft./sec. (70 mi./hr.). Since the depth of the head imprints measured less than 6 inches, the average deceleration of these two heads was in the order of 10,000 ft./sec.2, or over 300 "g" which approaches the tolerance limits of the human face and head with the load distributed evenly over the facial contours. In this case, the impact loads were concentrated by irregular structures and the crushing injuries inflicted would be expected. Also note that both seat belts and seat attachments did not fail. The author concludes that the crash forces in this case were less than 15 "g" and, since the rear cabin structure is intact, it is likely these two men could have survived this crash had they been wearing shoulder harnesses. Special attention should be called to the head impact areas outlined in Case 16 H. Note that these two depressions are down on the face of the instrument panel, the right one being lower than the left, and not on top as would have been expected, indicating that the instrument panel was moving or had moved away from the front seat occupants before they made their head strikes. In other words, the cabin structure had failed and most of the failure occurred on the right side of the cabin, allowing the right end structure of the instrument panel to fail (Case 16 B). The left side of the cabin of this aircraft does not have a door (Case 16 A) and for that reason has more structural strength. This weakness of cabin structure around the door area has been observed throughout this crash investigation study with the exception of aircraft manufactured by Beech Aircraft Corporation who, through the use of light channel, greatly increased the strength of the Beech aircraft cabins in the early 1950's. Attention was called to the poor design of the control wheel of this aircraft in Case 11. Here we see it again-the protruding clock in the center of the wheel has left its mark and the horns have broken off (Case 16 K and L).

K. Broken control wheel with centermounted altimeter & reset knob.

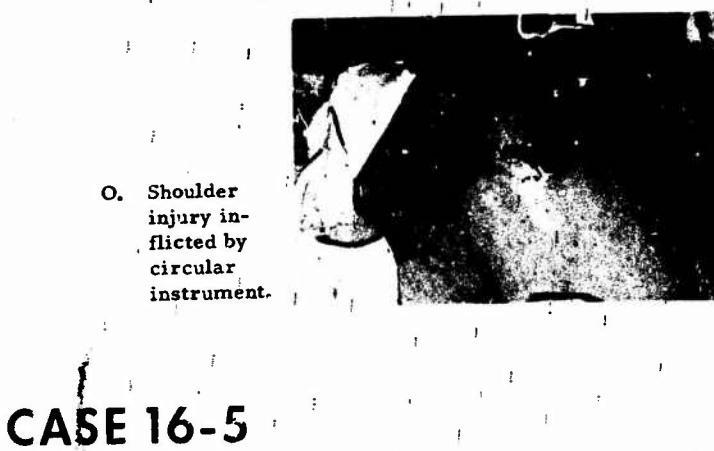
P, Q & R Severe lacerations & fractures inflicted when arms & legs flailed into broken structures.

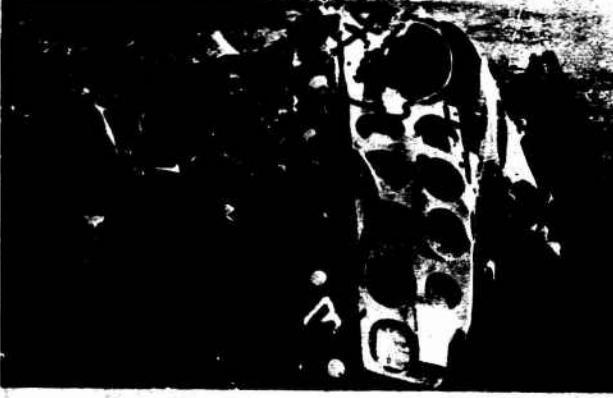
D. The pilot received fatal head injuries when his face impacted the area outlined on the instrument panel. Also note the absence of the pilot's control column & wheel.

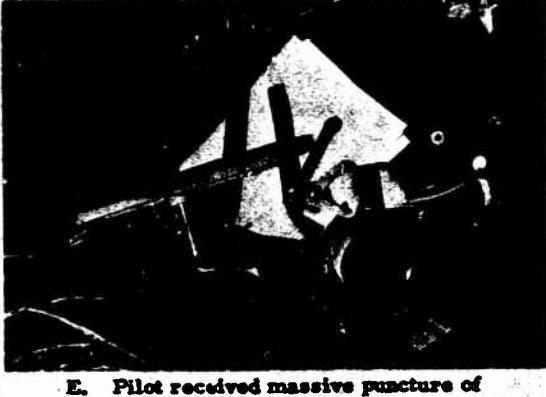
Pilot received massive puncture of all major body viscera when control column bent to form a spear after sezt belt attachment failed.

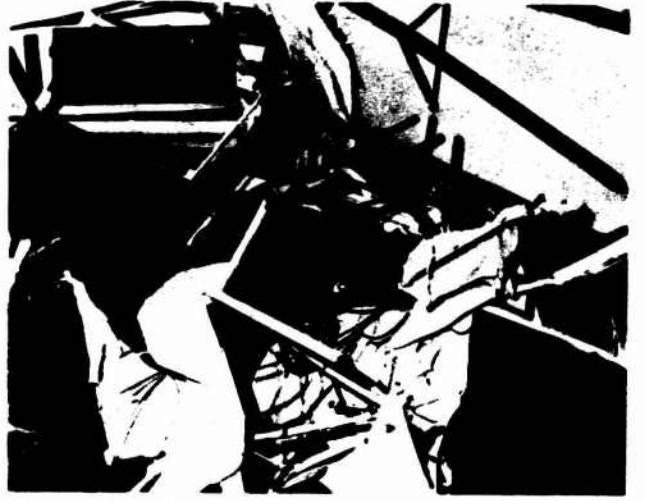
A. Close-up of aircraft wreckage looking into the cockpit area.

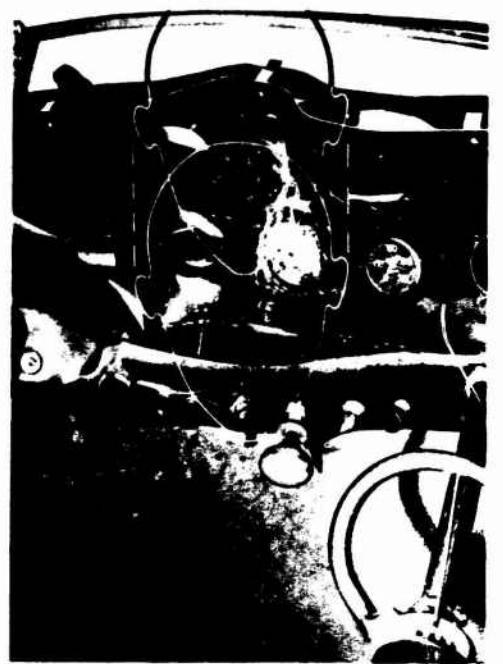
B. Head outlines on instrument panel indicate areas impacted by the pilot's head.

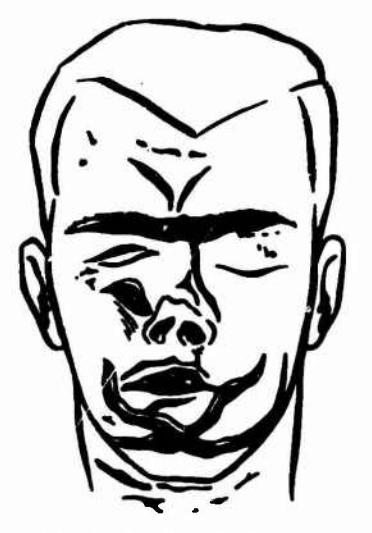
C. Artist sketch of severe lacerations & facial crushing resulting from impact with the instrument panel.

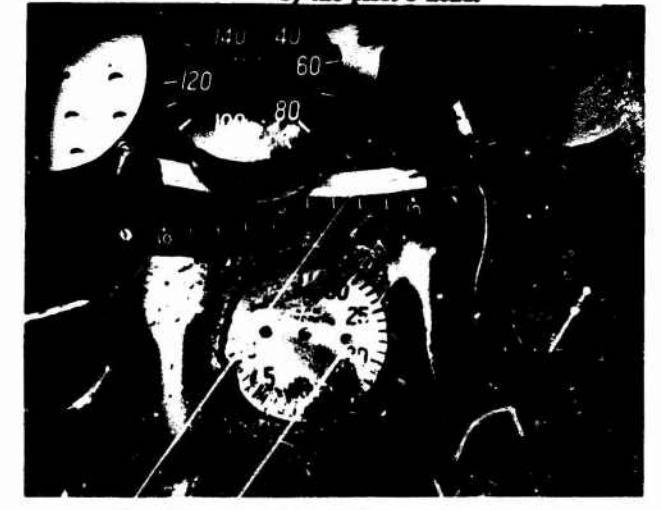
D. Close-up of heavy instruments struck by pilot's head.

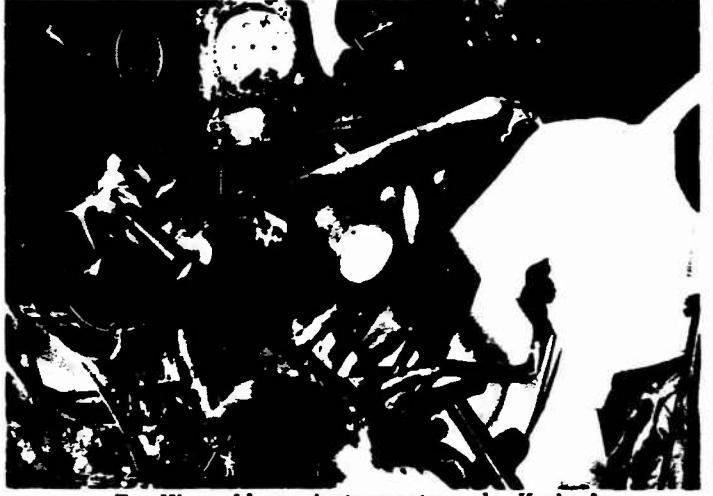
View of lower instrument panel. Knobs & sharp-edged metal produced leg injuries shown in J. Note pilot's control column has been sawed off.

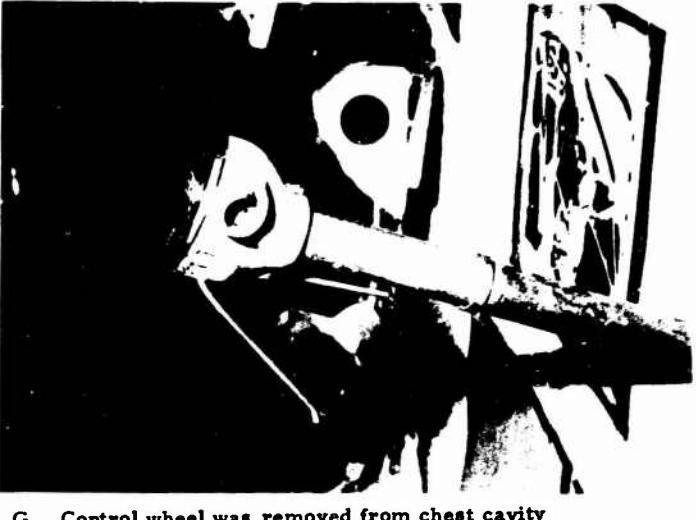
G. Control wheel was removed from chest cavity with difficulty since wire spokes opened up like an unbrella.

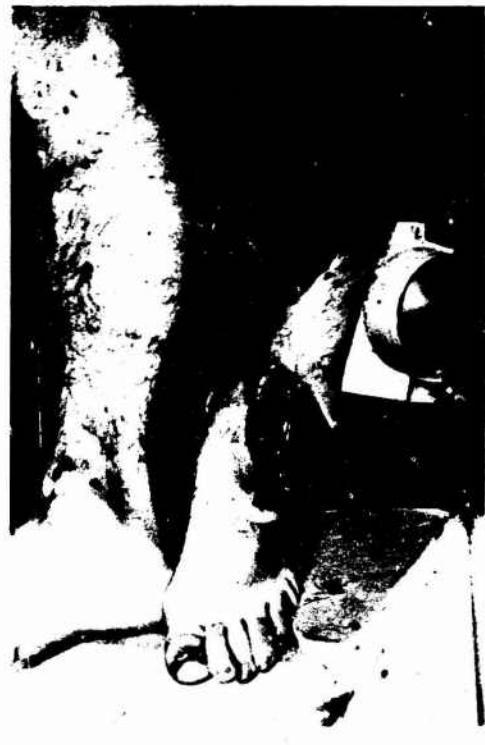
J. Lower leg injuries.

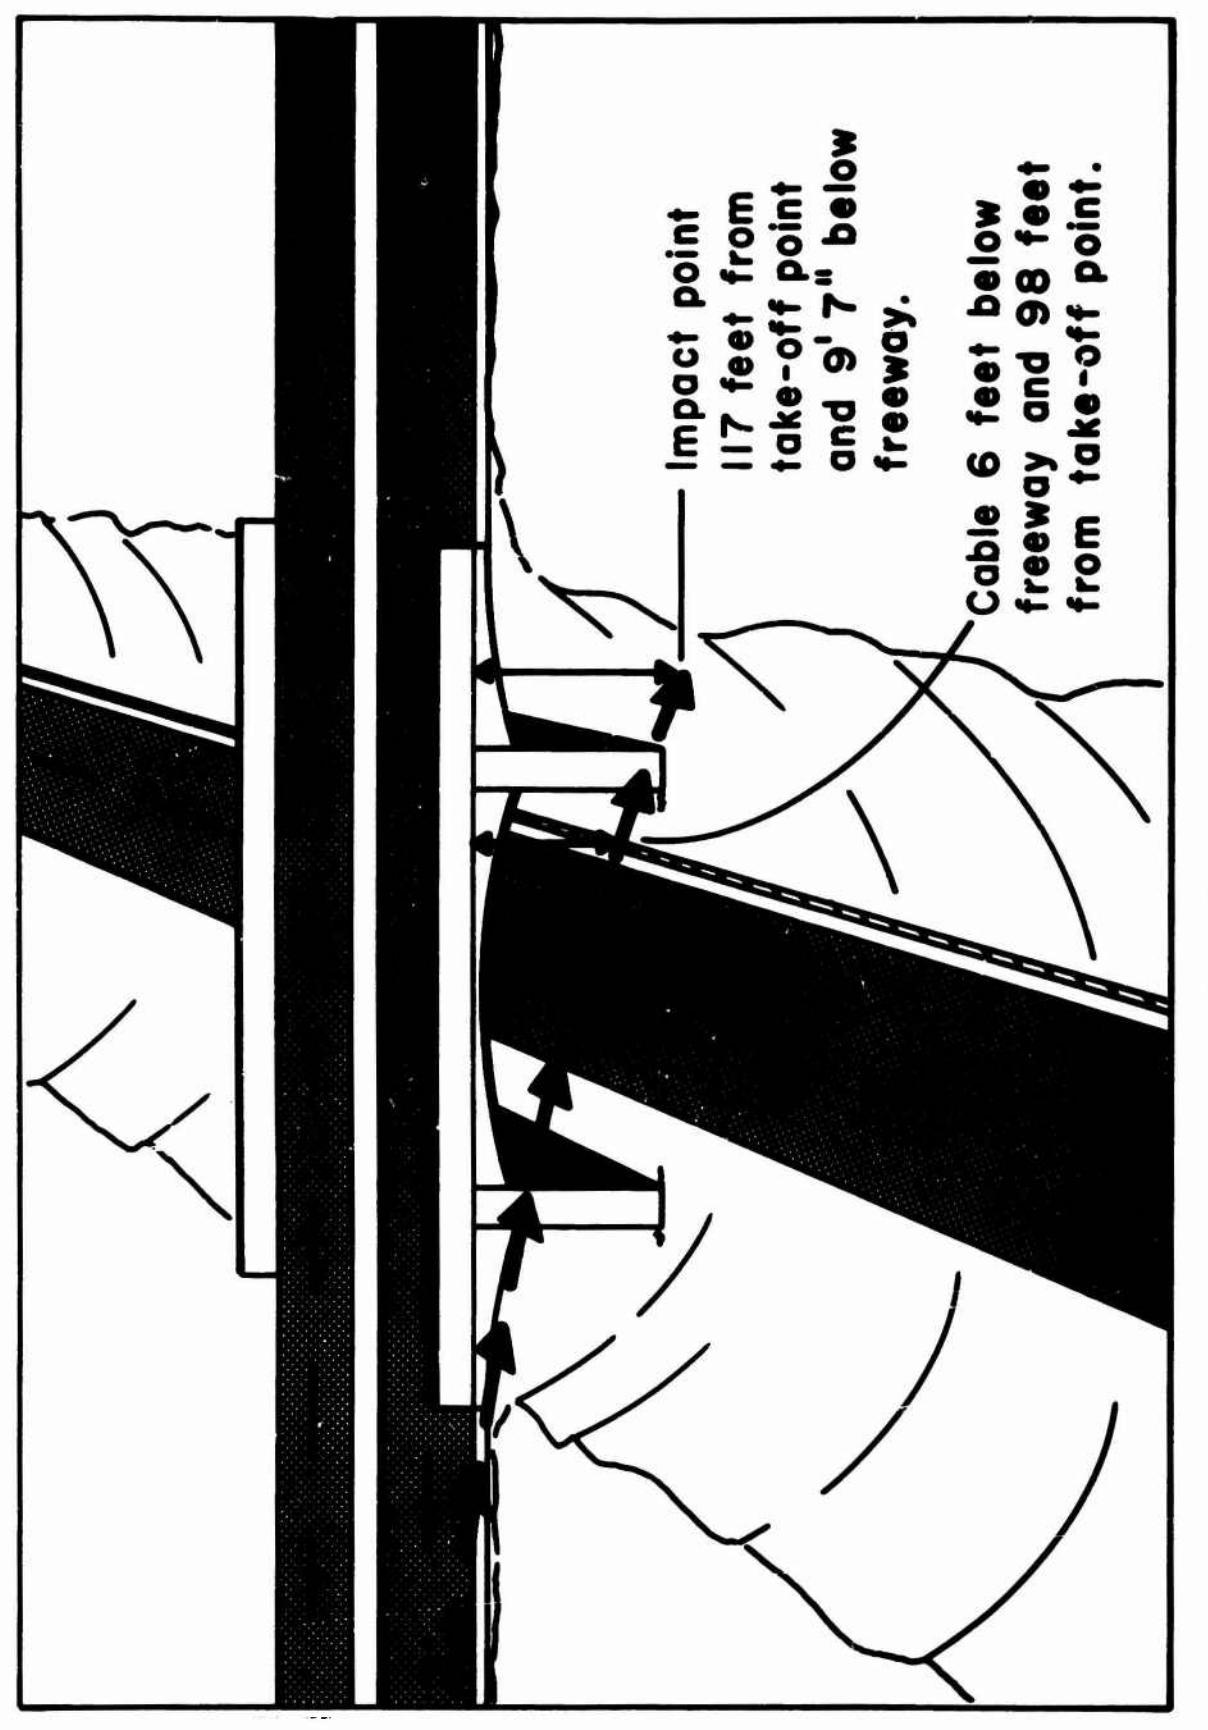
FIGURE 29. Trajectory of an automobile traveling at high velocity after it ran of the freeway.

ing 6 feet below the bridge and about 98 feet from the take-off point. Acceleration due to gravity caused a drop of only 9 feet, 7 inches, during its 117-foot flight. In this instance, one can easily calculate with accuracy that the flight velocity of this vehicle must have been slightly over 100 miles per hour. Crushing of the front of the vehicle was approximately 5 feet (Figure 30) and the depression in the hard earth embank-

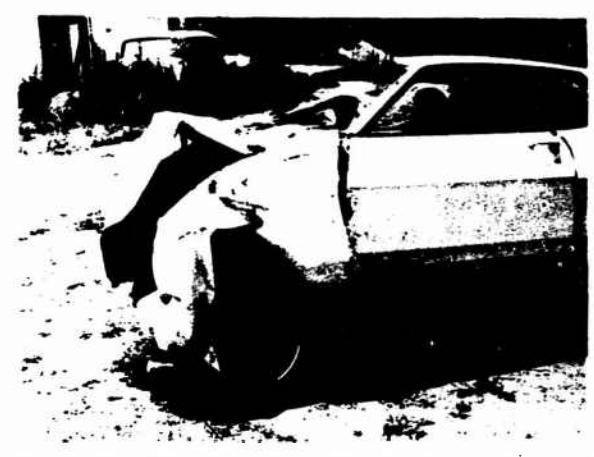
FIGURE 30. Side view of vehicle showing crushing of front end during deceleration.

ment measured 8 to 12 inches. Hence, it can be calculated that the average deceleration of the car was in excess of 50 "g". Even with these very severe impact forces, the shipping container maintained its integrity and the heavy motor was pushed back under the floor board and not into the cabin. While it is doubtful if light aircraft cabins can be designed to withstand "g" forces of this magnitude, their interior certainly could be modified to incorporate some of

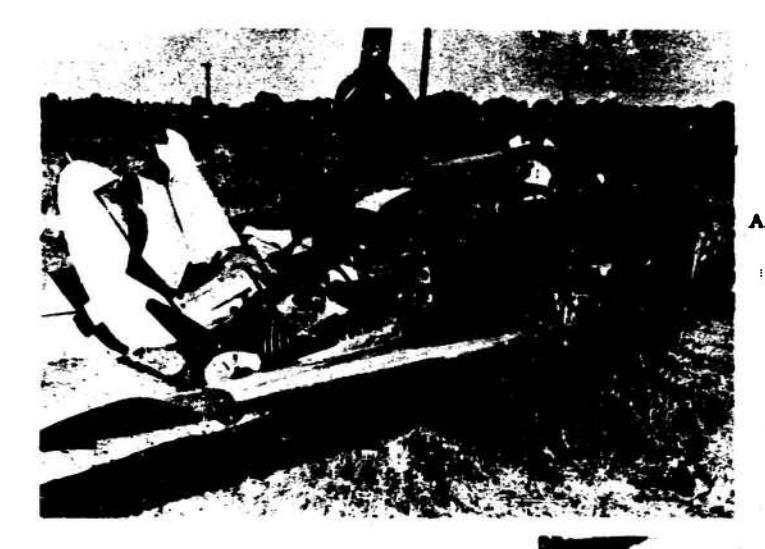
Telephone pole is completely buried in fuselage after side impact by aircraft.

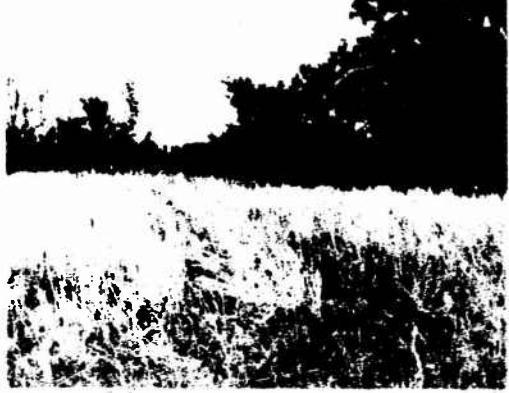
A. Distant view of crash site. Tracks in wheat field were made by rescue personnel as aircraft did not touch the ground before striking the tree.

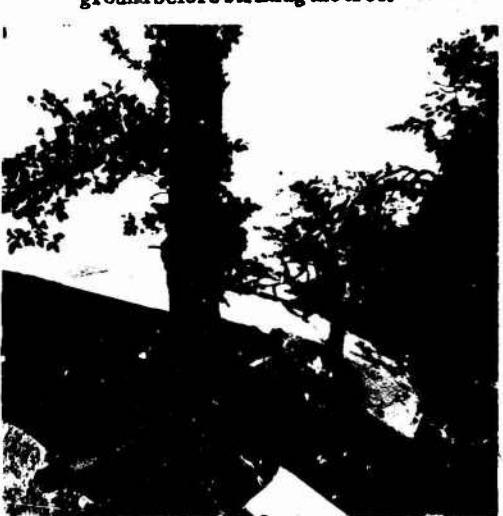
C. Right side of aircraft. Note bark missing from tree & snagged control cable about 5 feet above the ground.

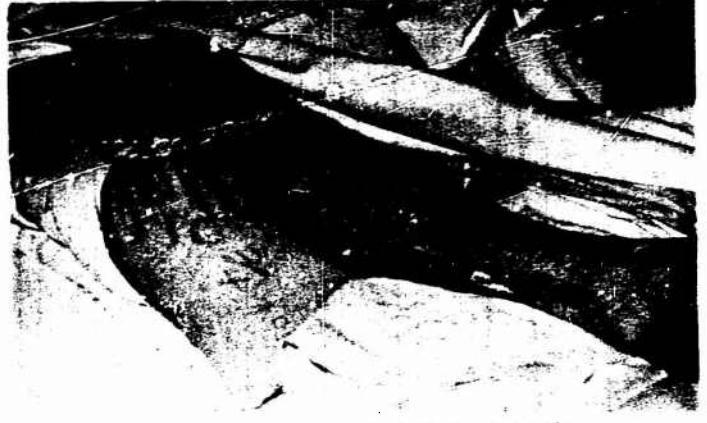
G. Copilot fractured tibia & fibula of right leg.

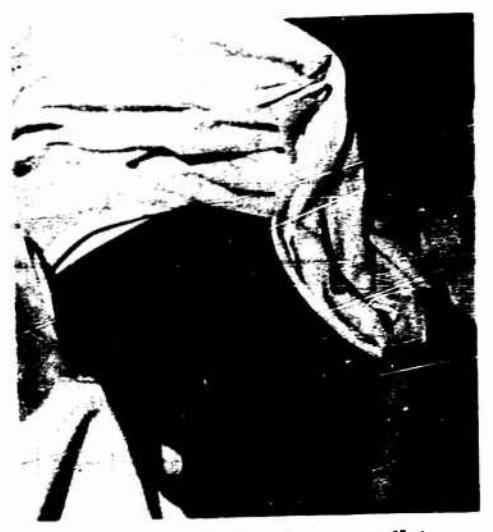
F. Seat belt abrasion on copilot.

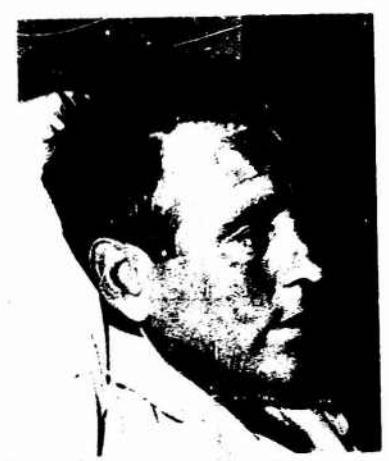
H. Pilot wit'. minor laceration of forehead.
