FAA-AM-71-3

GENERAL AVIATION STRUCTURES DIRECTLY RESPONSIBLE FOR TRAUMA IN CRASH DECELERATIONS

SPECIAL REPORT

January 1971

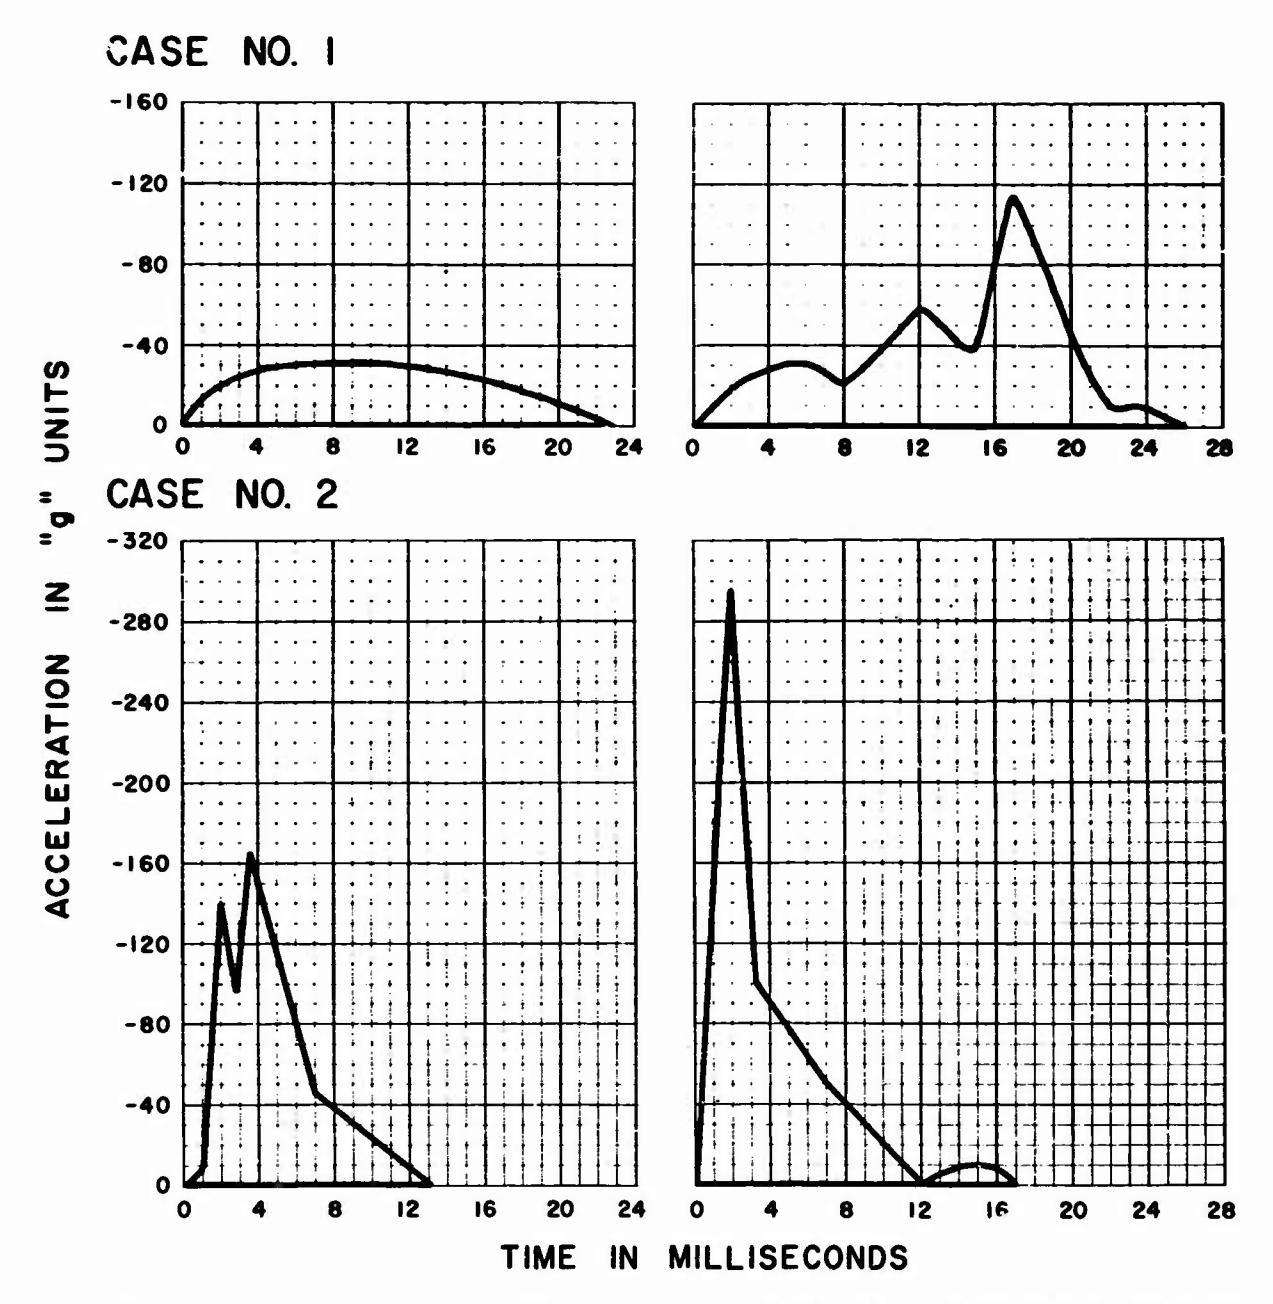
FIGURE 36. Comparison of test results of head impact tests against the Piper Pawnee aluminum ½ cylinder (Case 1), and one of the common rigid instrument panels in general aviation aircraft (Case 2).

similar data for impacts against a rigid instrument panel in common use in general aviation aircraft, are presented in Figure 36. Note that not only does the aluminum roll reduce the peak "g" force at 15 ft./sec. from 160 to 30 "g", but also extends the time for deceleration from 12 milliseconds to nearly 24, while at 30 ft./sec. impact velocity it reduces the force of head impact from 300 "g" to 110 "g" with a doubling of the deceleration time. Decreased impact forces and extended duration times are most important for preventing head injuries, but of even more significance was the distribution of the load over a greater surface area. As the light aluminum

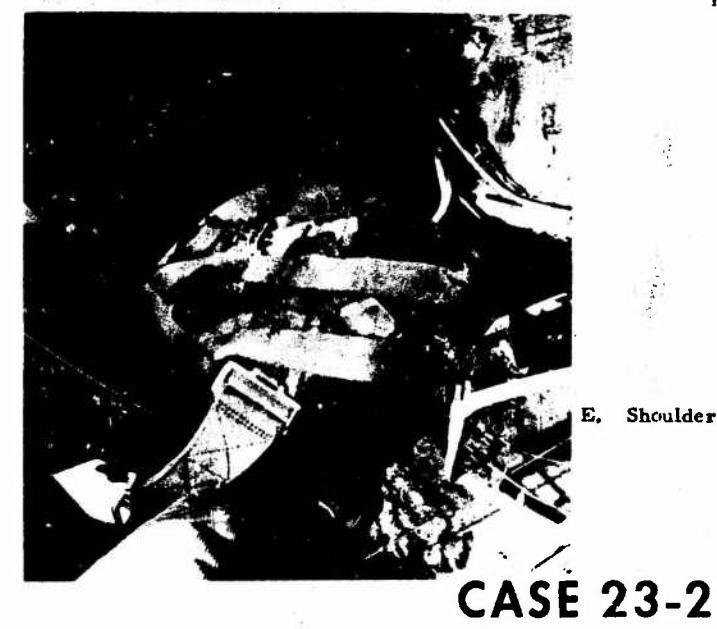
E. Shoulder harness & 3" seat belt broke.

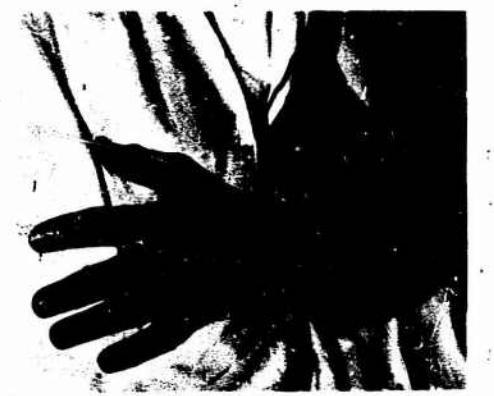
J. Minor laceration of left hand.

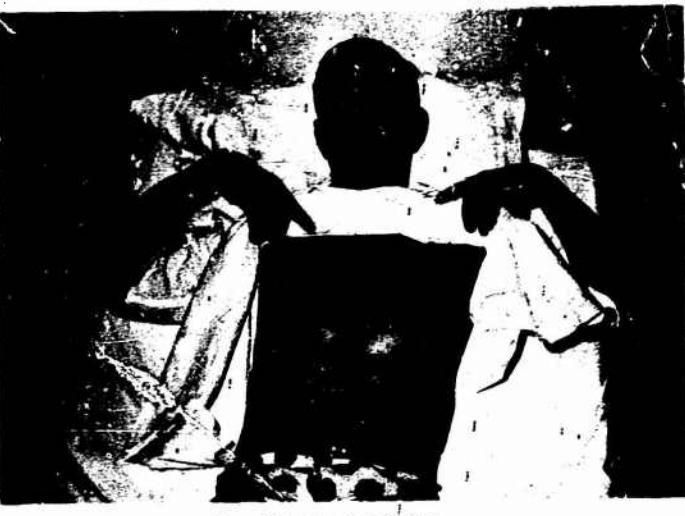
I. No chest injuries.

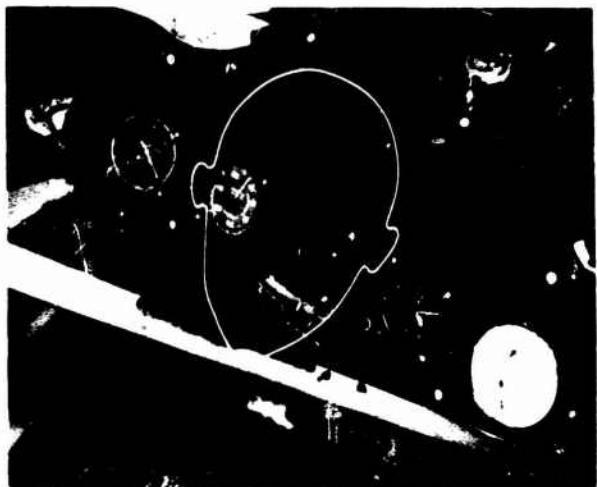
B. Outline indicating area of head impact.

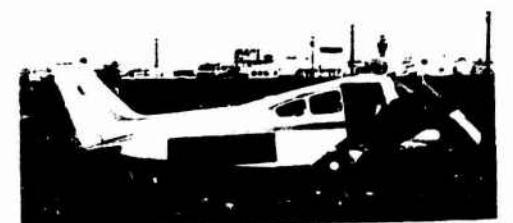
B & C Short 6-foot gouge mark under the aircraft, upward bending of the landing gear, & downward bending of motor all indicate that the aircraft crached nearly flat with heavy vertical loads.

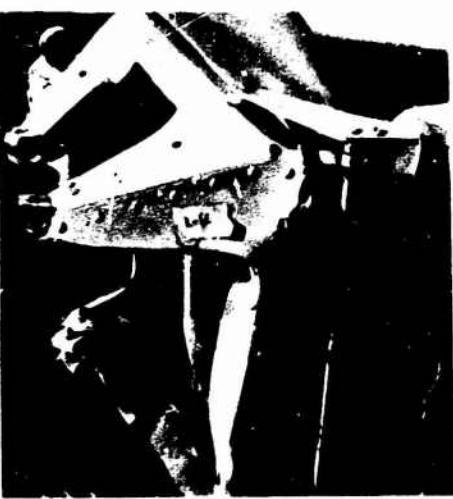
I Heavy seat legs buckled from vertical forces. Vertebral fractures could have been prevented by attenuation in seats.

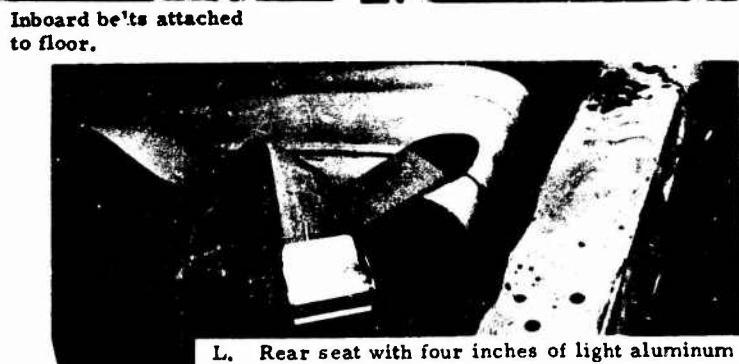
Rear seat with four inches of light aluminum structures beneath it saved rear passenger from spinal injuries.

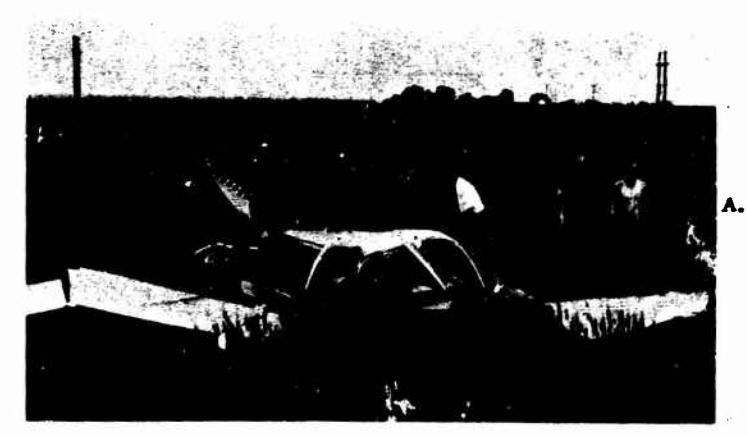
Aircraft crashed flat in a tall wheat field. Note wheat all around aircraft is undisturbed.

B. Motor is bent downward, landing gear pushed up into wings, instrument panel completely undamaged & rear passenger appears to be sitting flat on the ground.

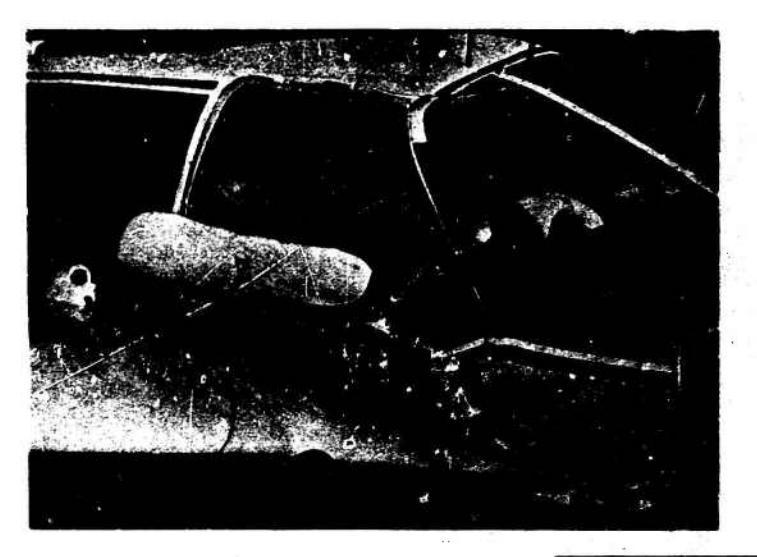
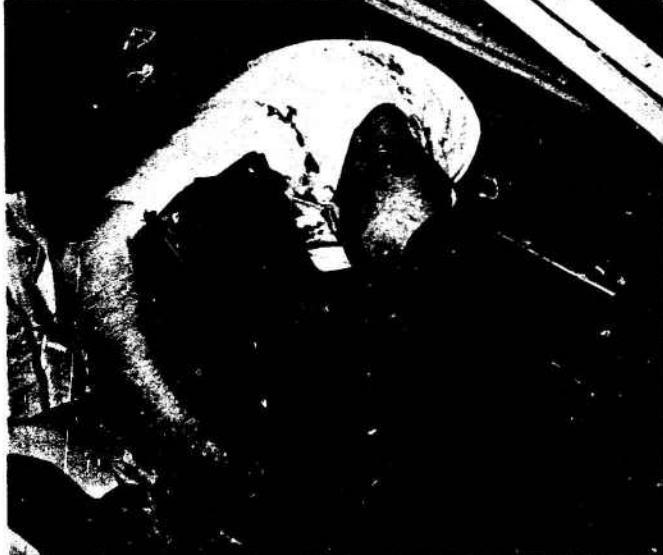
C & D Front seat occupants appear to be uninjured & asleep.

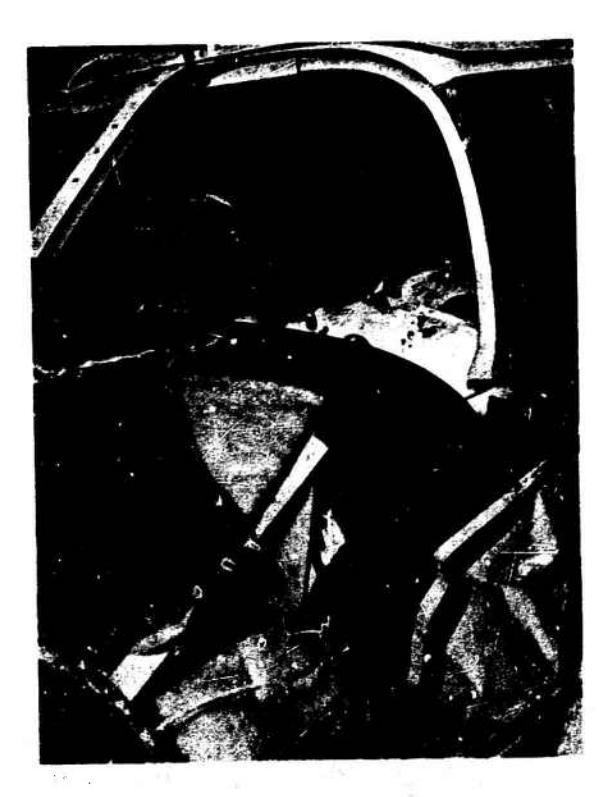
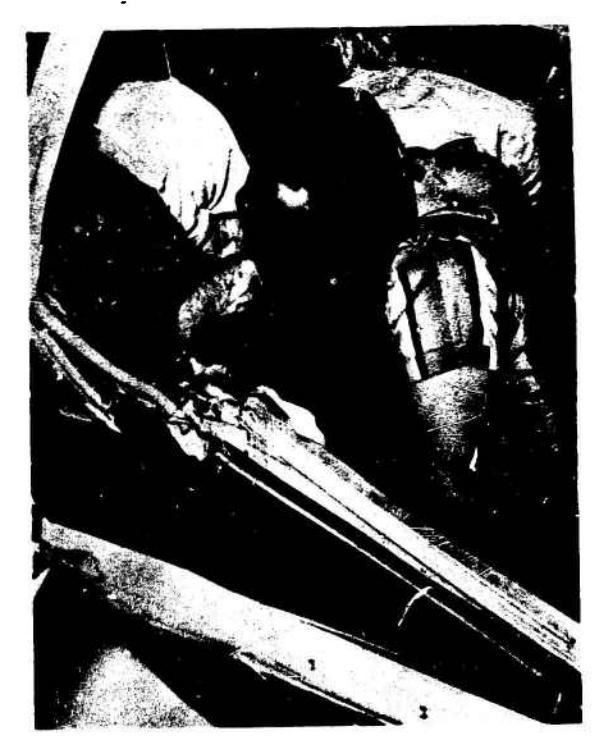
E & F Views of right front & center seat occupants.

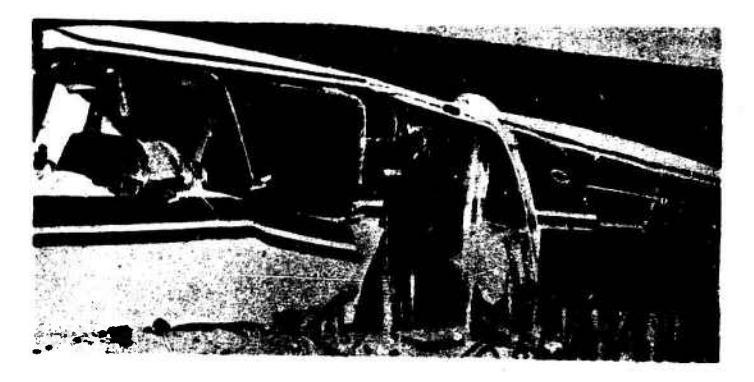
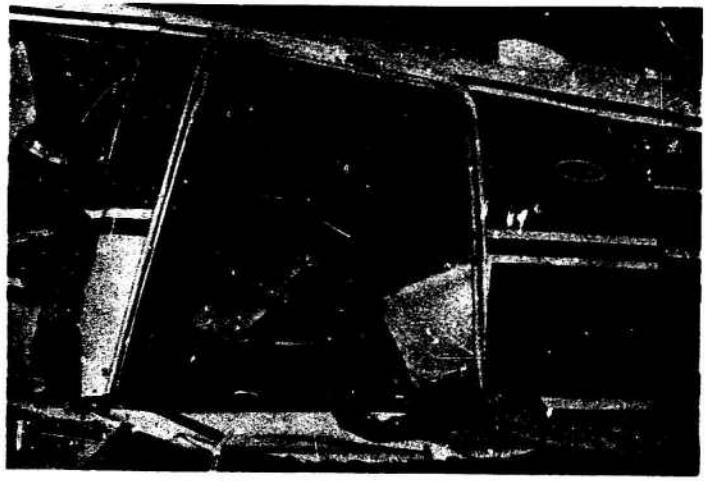
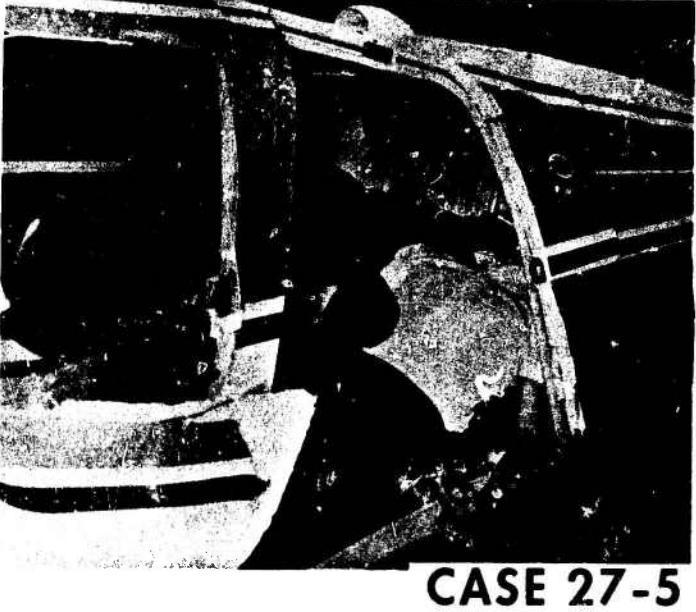
All occupants have seat belts fastened, G, H & I scat belts instened, appear to be sitting on the ground, & died from severe internal injuries produced by verti-cal forces cal forces.

and repaired in time. The author⁷² has experienced vertical decelerations of up to 95 "g" for .0075 seconds with internal injuries corrected by surgery. In the same study, all subjects tolerated 220 "g" for .0065 seconds without injury or pain when the test seat was equipped with 4 inches of crushable foam under the seat pan. Judging from the massive internal injuries of the occupants in the crash case being presented here as compared to those for the fall case presented by Snyder, the peak vertical force generated when the seats bottomed out must have been in the range of 5,000 to 6,000 "g". The significant point to be made here is that the seats must not be of a frail design that allows them to crush, using up valuable deceleration distance while dissipating very little of the impact force and then bottom out against rigid structure and producing very high, intolerable "g" forces. Numerous simple methods for gradual vertical deceleration have been devised and are in use on Army helicopters. Use of energy attenuators in the design of the seats of this aircraft would have allowed the six occupants of this aircraft to survive without injury.

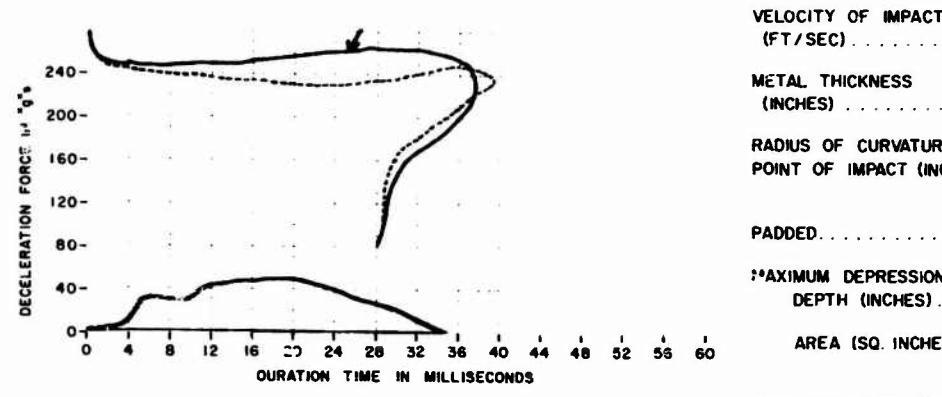
(FT/SEC)	19.0
METAL THICKNESS (INCHES)	.037
RADIUS OF CURVATURE AT POINT OF IMPACT (INCHES)	8
PADDED	NO
*AXIMUM DEPRESSION: DEPTH (INCHES)	3/4
AREA (SQ. INCHES)	81.3
YEAR AND MAKE OF CAR	6I CHEV

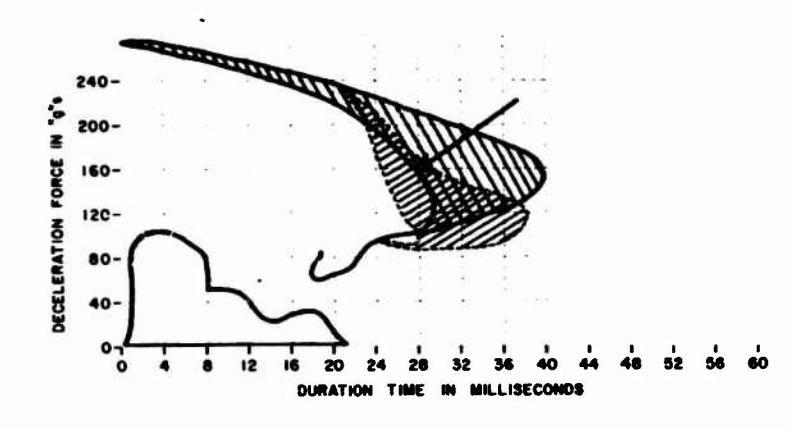
(FT/SEC)	24.1
METAL THICKNESS (INCHES)	.039
RADIUS OF CURVATURE AT POINT OF IMPACT (INCHES)	2
PADDED	YES
MAXIMUM DEPRESSION: DEPTH (INCHES)	3/4
AREA (SQ. INCHES)	19.4
YEAR AND MAKE OF CAR	57 FORD

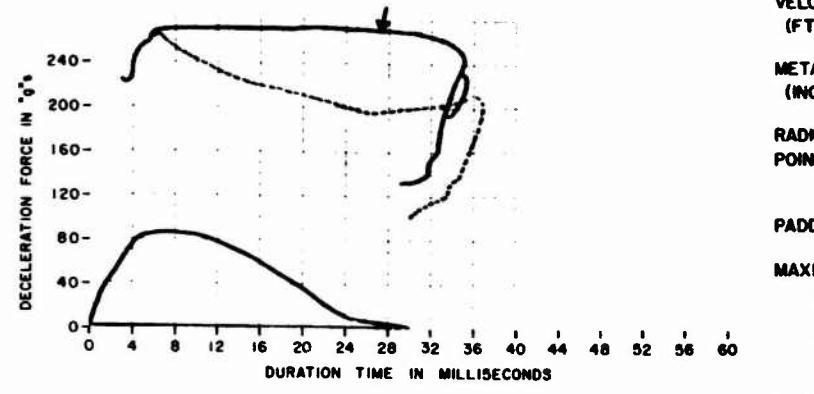
(FT/SEC)	_24.3
METAL THICKNESS (INCHES)	.045
RADIUS OF CURVATURE AT POINT OF IMPACT (INCHES)	10 1/2
PADDED	NO
MAXIMUM DEPRESSION: DEPTH (INCHES) AREA (SQ. INCHES)	1 7/8 79.9
YEAR AND MAKE OF CAR	55 MERC

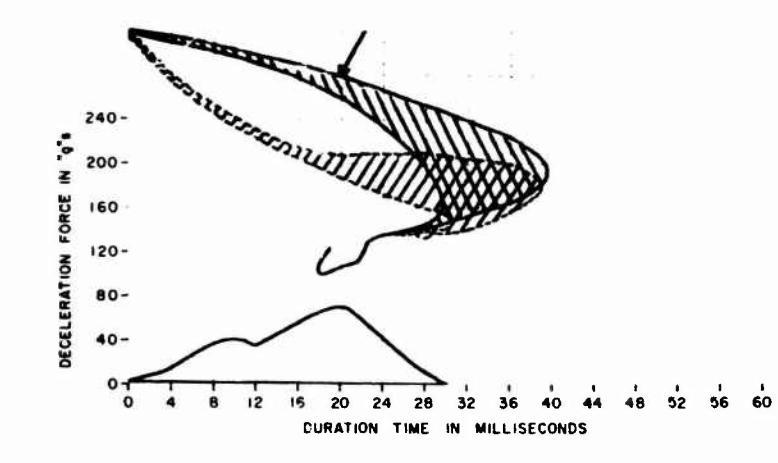
VELOCITY OF IMPACT (FT/SEC)	246
METAL THICKNESS (INCHES)	039
RADIUS OF CURVATURE AT PCINT OF IMPACT (INCHES)	_9
PADDED.	YES
MAXIMUM DEPRESSION DEPTH (INCHES)	13/4
AREA (SQ INCHES)	950
YEAR AND MAKE OF CAR	57 FORD

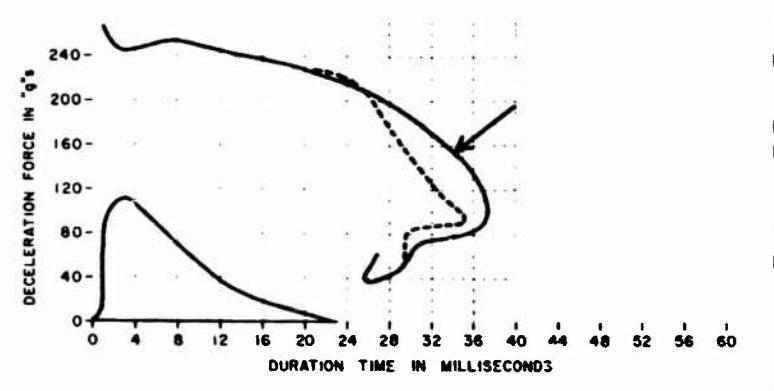
VELOCITY OF IMPACT (FT/SEC)	24.6
METAL THICKNESS (INCHES)	.039
RADIUS OF CURVATURE AT POINT OF IMPACT (INCHES)	43/4
PADDED.	NO
MAXIMUM DEPRESSION: DEPTH (INCHES)	-7 _{/8}
AREA (SQ. INCHES)	26.7
YEAR AND MAKE OF CAR	57 FORD

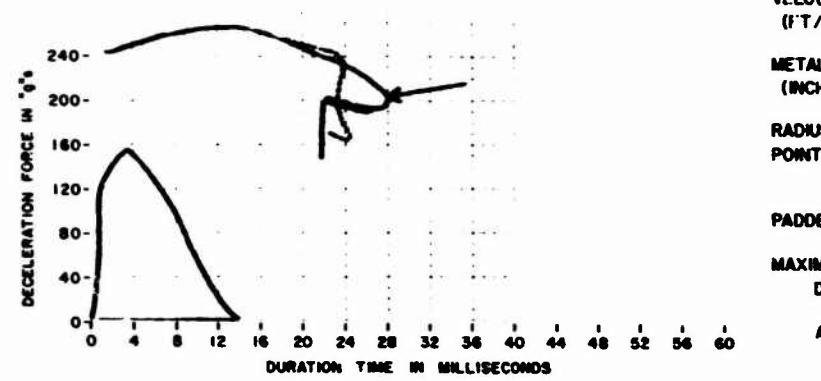
VELOCITY OF IMPACT (FT/SEC)	25.0
METAL THICKNESS (INCHES)	.042
RADIUS OF CURVATURE AT POINT OF IMPACT (INCHES)	<mark>8_</mark> _
PADDED	NO
MAXIMUM DEPRESSION: DEPTH (INCHES)	<u>الە</u>
AREA (SQ. INCHES)	6.0
YEAR AND MAKE OF CAR	55 CHEV

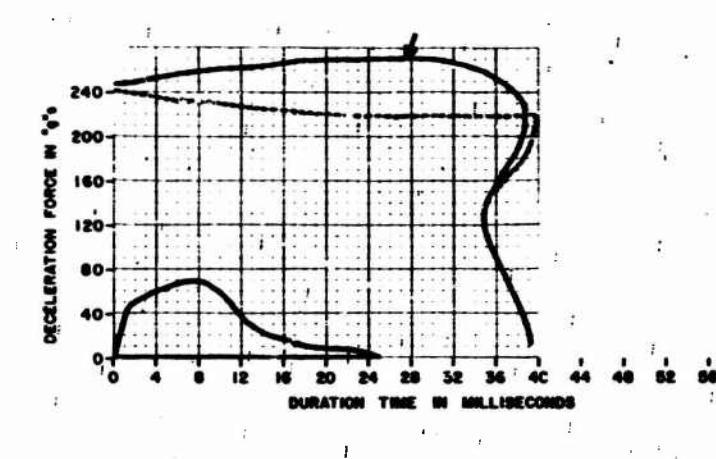
VELOCITY OF IMPACT . (FT/SEC)	25.2
METAL THICKNESS (INCHES)	.037
RADIUS OF CURVATURE AT	1034
PADDED.	NO
MAXIMUM DEPRESSION: DEPTH (INCHES)	14
AREA (SQ. INCHES)	28.7
YEAR AND MAKE OF CAR	FORD P/L

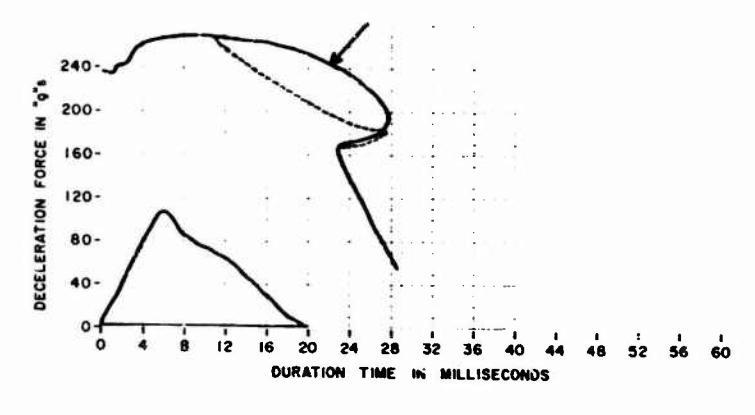
VELOCITY OF MPACT (FT/SEC)	25.6
METAL THICKNESS (INCHES)	.039
RADIUS OF CURVATURE AT POINT OF IMPACT (INCHES)	4/2
PADPED	NO
MAXIMUM DEPRESSION: DEPTH (INCHES)	<u> </u>
AREA (SQ. INCHES)	31.9
	55

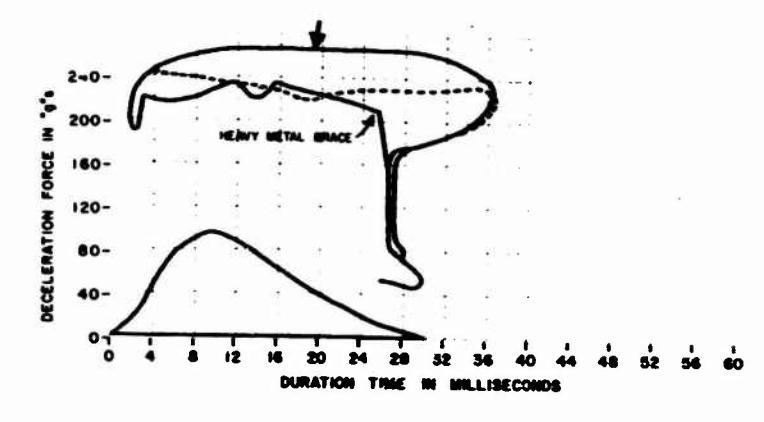
VELOCITY OF MPACT (FT/SEC)	26.0
METAL THICKNESS (INCHES)	.043
RADIUS OF CURVATURE AT POINT OF IMPACT (INCHES)	.19
PADDED.	NO
MAXIMUM DEPRESSION: DEPTH (INCHES)	11/4
AREA (SQ. INCHES)	86.8
YEAR AND MAKE OF CAR	57 OLDS

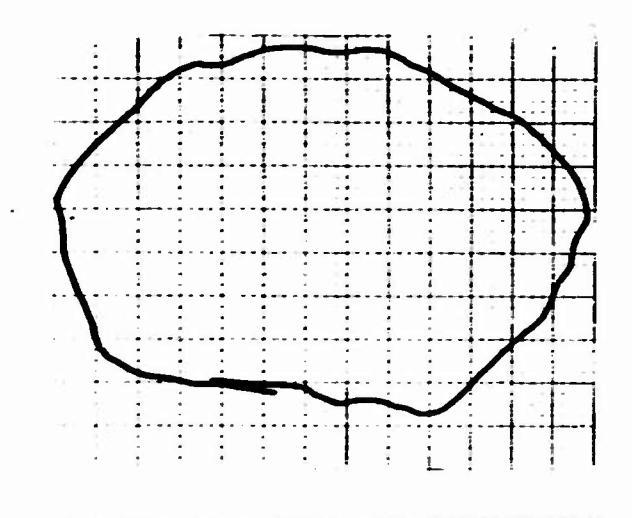
SHAPE AND AREA OF DEPRESSION
