TECHNIQUES FOR OVERLAYING DETERIORATED
LANDING MAT. BARE BASE SUPPORT

MISCELLANEOUS PAPER S-70-23

**TECHNIQUES FOR OVERLAYING
DETERIORATED LANDING MAT
BARE BASE SUPPORT**

Conducted by U. S. Army Engineer Waterways Experiment Station, Vicksburg, Mississippi

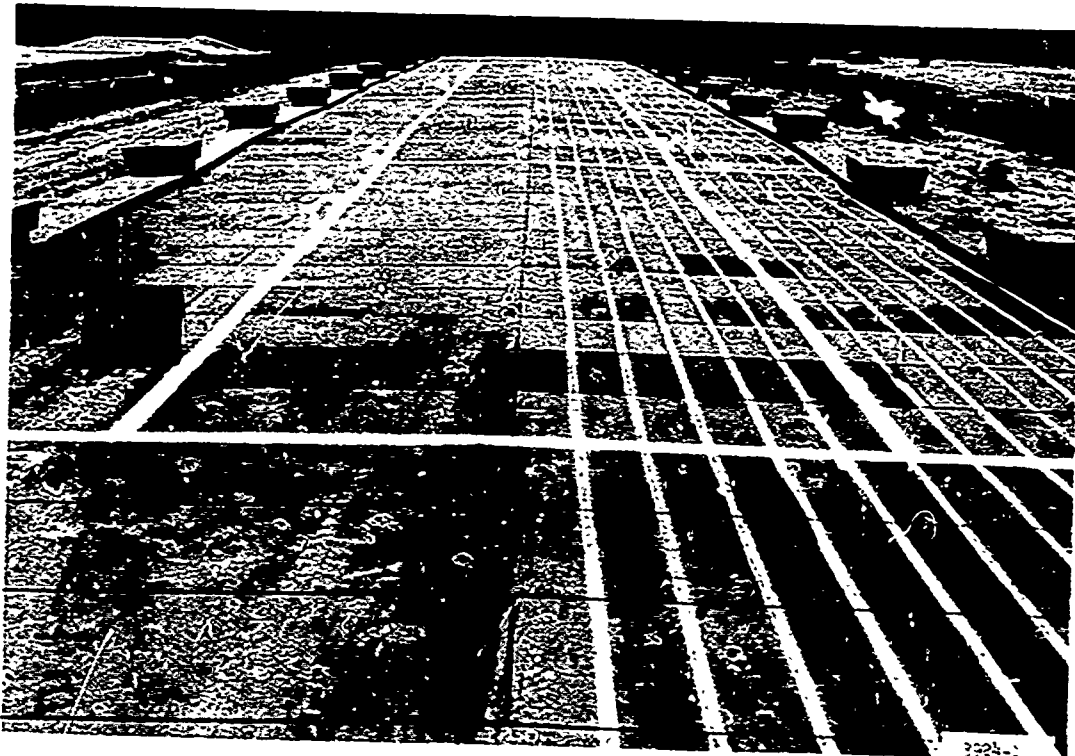
3924-1

23. General. A general view of the test section prior to traffic is shown in photograph 6. As traffic was applied to the test section, the mat deflected considerably, particularly along the test lane center line. During application of the first 26 coverages of traffic, the individual panels shifted laterally and longitudinally due to the apparent instability of the placement configuration used. A closeup view of a mat panel is shown in photograph 7, and a general view of item 2 at 26 coverages is shown in photograph 8. At this point, all the mat was removed from the test section, and the placement configuration was changed so that successive end joints were offset about 6 in. from the center line as shown in photograph 9 and plate 3. This configuration eliminated the tendency for the panels to shift and creep by eliminating the mutual intersection of the

Photograph 6. Completed test section prior to traffic

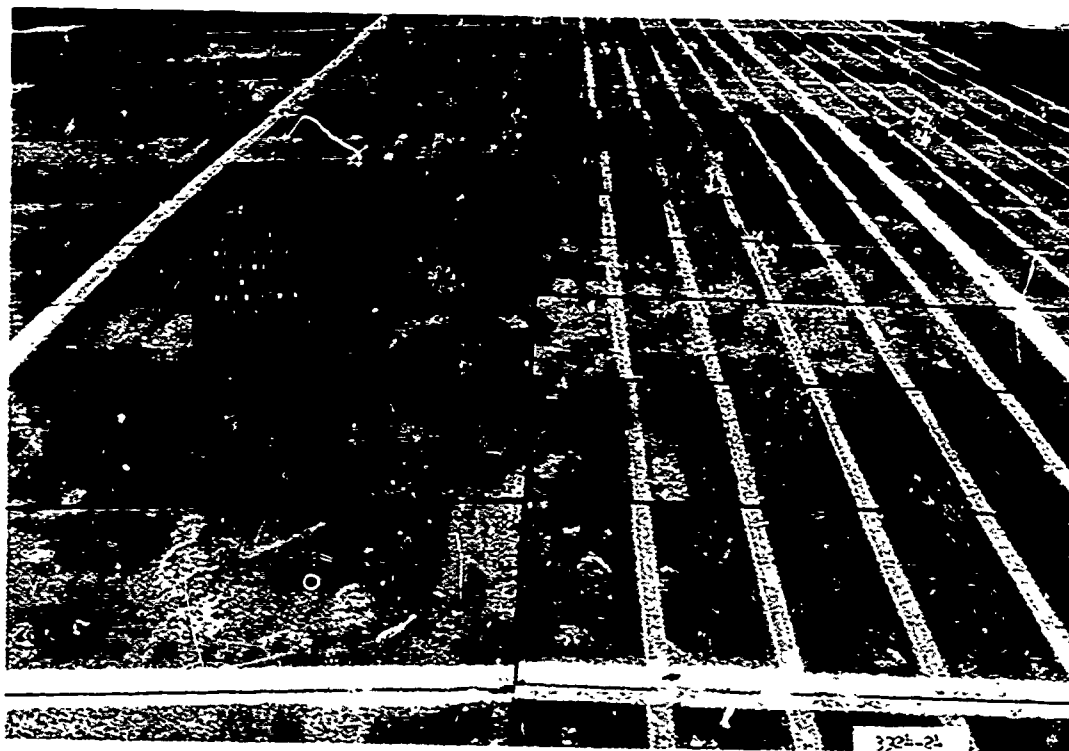
Photograph 8. Item 2 after 26 coverages

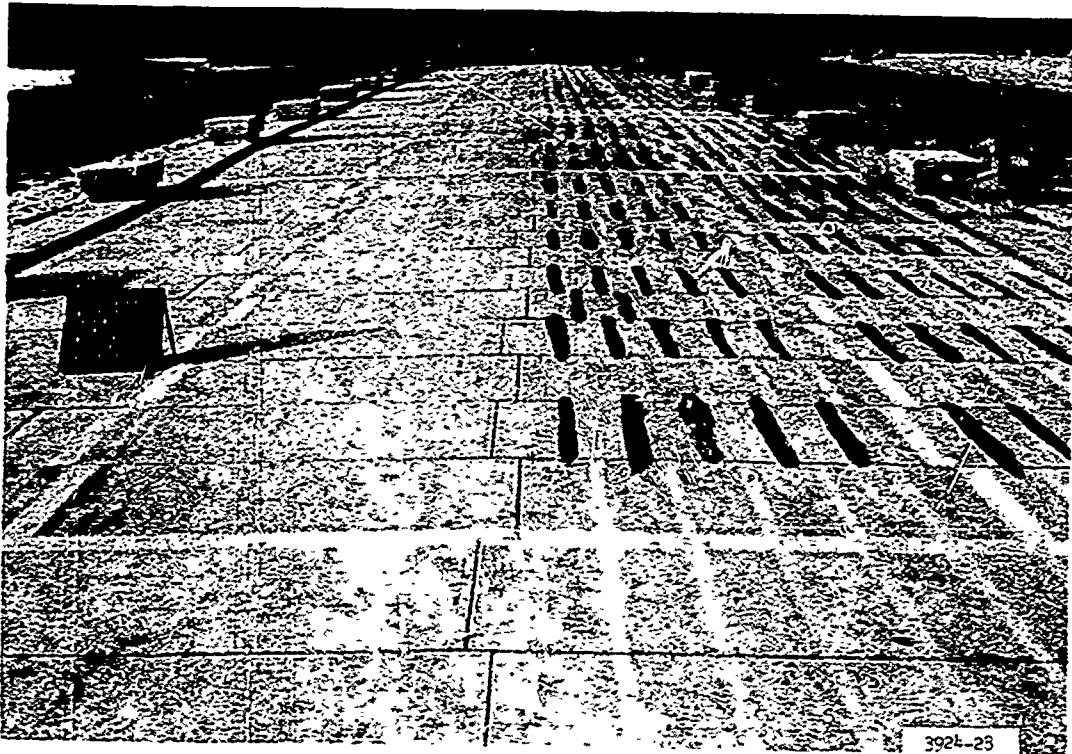
Photograph 9. Test section after center-line joint was staggered

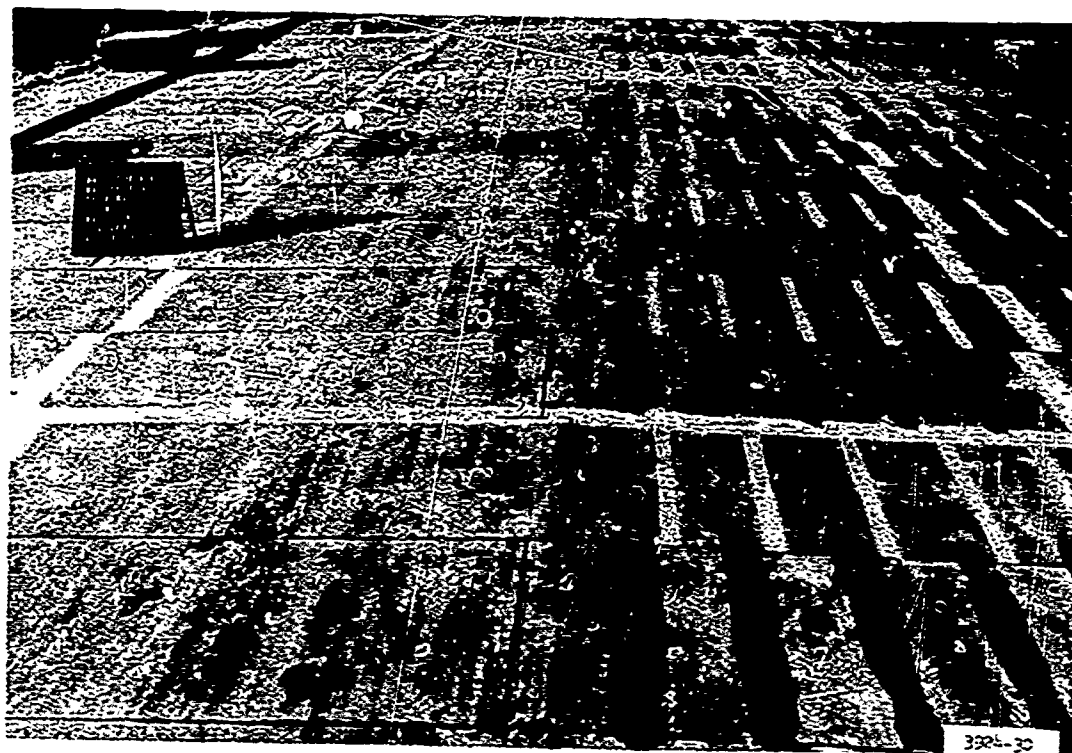
25. Item 2. A general view of item 2 after the mat was rearranged at 26 coverages is shown in photograph 14. Mat breaks developed rather

Photograph 14. Item 2 after rearrangement of mat at 26 coverages

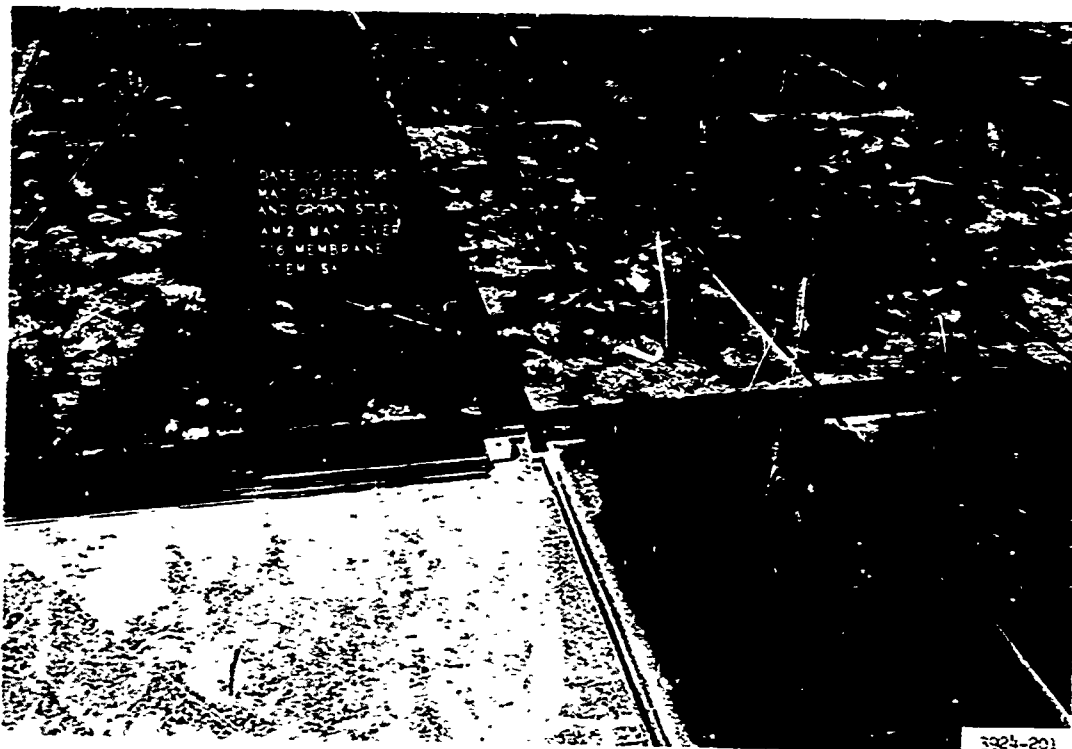
49. In item 5, connection of the panel ends along the center line of the test section was accomplished by means of 90-deg turn adapters, which are described in paragraph 38. This connection is shown in plate 7c. In this method, one side of the narrow bar is compatible with the end connector of the mat on the left side. The narrow bar was connected to the wider bar, the other side of which is compatible with the end connector of the mat on the right. This connection is also shown in photograph 29. The turn adapters are connected end to end with a setscrew, as shown in photograph 29.

Photograph 29. Turn adapter used along center line of crowned subgrade

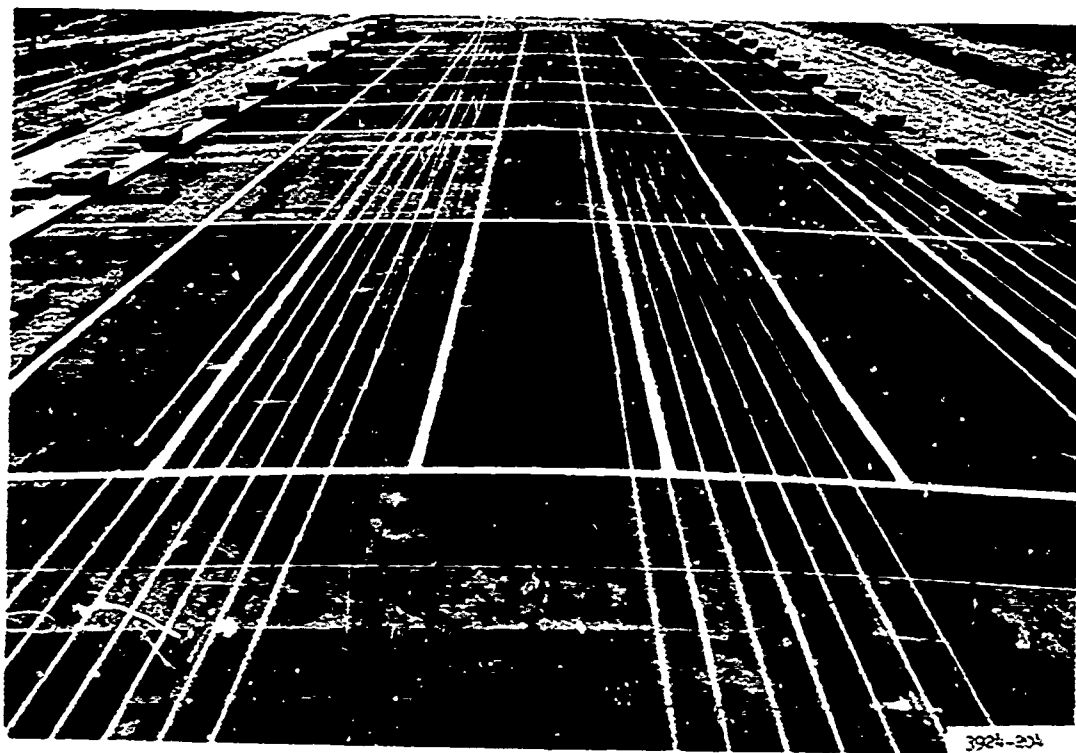
50. As shown in plate 6, items 1 and 2 each consisted of 12 runs of mat, and items 3a-5b consisted of 6 runs of mat each, for a total length of 60 runs, or 120 ft. The average width of the mat surface was approximately 48 ft. After the mat had been placed, traffic lanes and guidelines were painted on the mat. A general view of the completed test section is shown in photograph 30.

Photograph 30. Test section 2 prior to traffic
