EVALUATION OF REDESIGNED XW18 MEMBRANE
AND ACCESSORIES

Army Engineer Waterways Experiment Station
Vicksburg, Mississippi

May 1973

TECHNICAL REPORT S-73-3

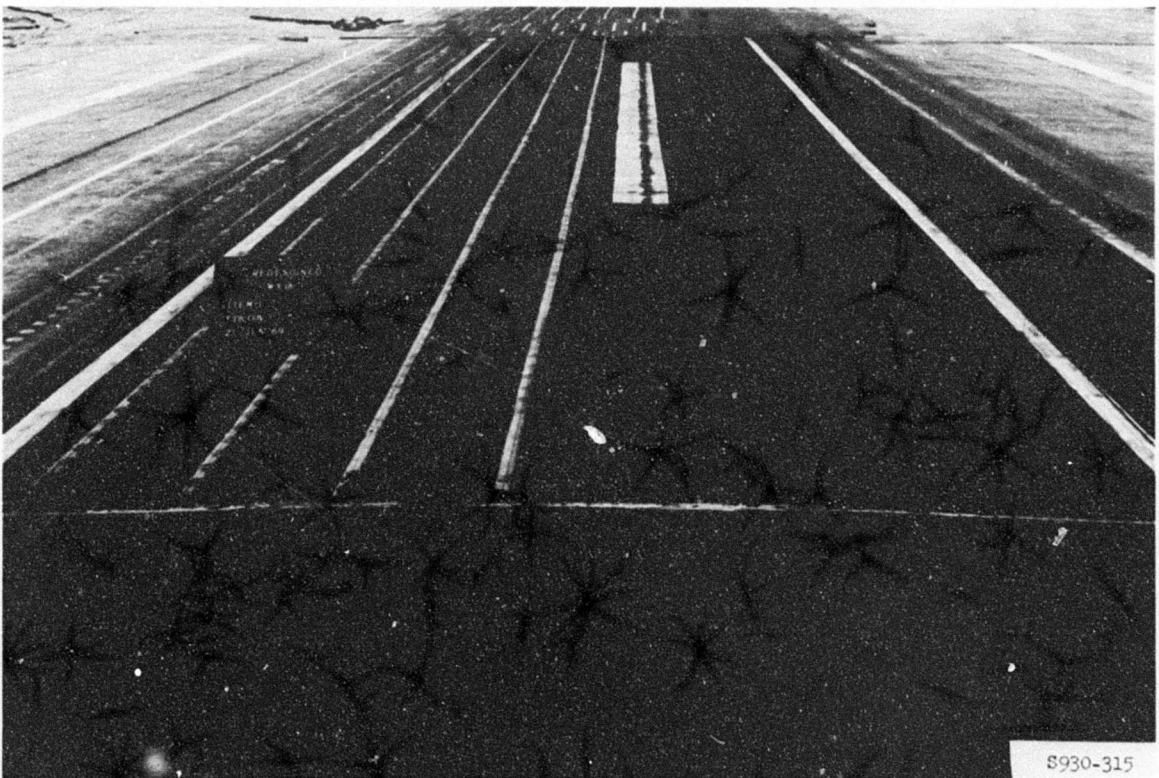
72. With the repair of the subgrade and replacement of sheet 3 completed, trafficking was resumed. At 738 coverages, no rutting of the subgrade was noted. The general condition of sheets 1, 2, and 3 at this time is shown in photos 64-66. The neoprene coating on one run of sheet 1 had worn down to the fabric. Photo 67 is a close-up of this condition showing the top ply of the fabric exposed in most areas except where the nonskid pattern remained. After 738 coverages, an inspection of the nonskid pattern on sheets 1 and 2 revealed that an average of 64 and 86 percent, respectively, of the nonskid remained. After 200 coverages, 84 percent of the nonskid pattern remained on sheet 3A (plate 17). The general condition of both sealants used along the edges of the reinforcing strips was good (photo 68). Both sealants exhibited adequate resistance to the wear of the test wheel, adhered well to the membrane, and provided watertight seals.

Photo 64. Sheet 1 of test section 1 after 738 coverages

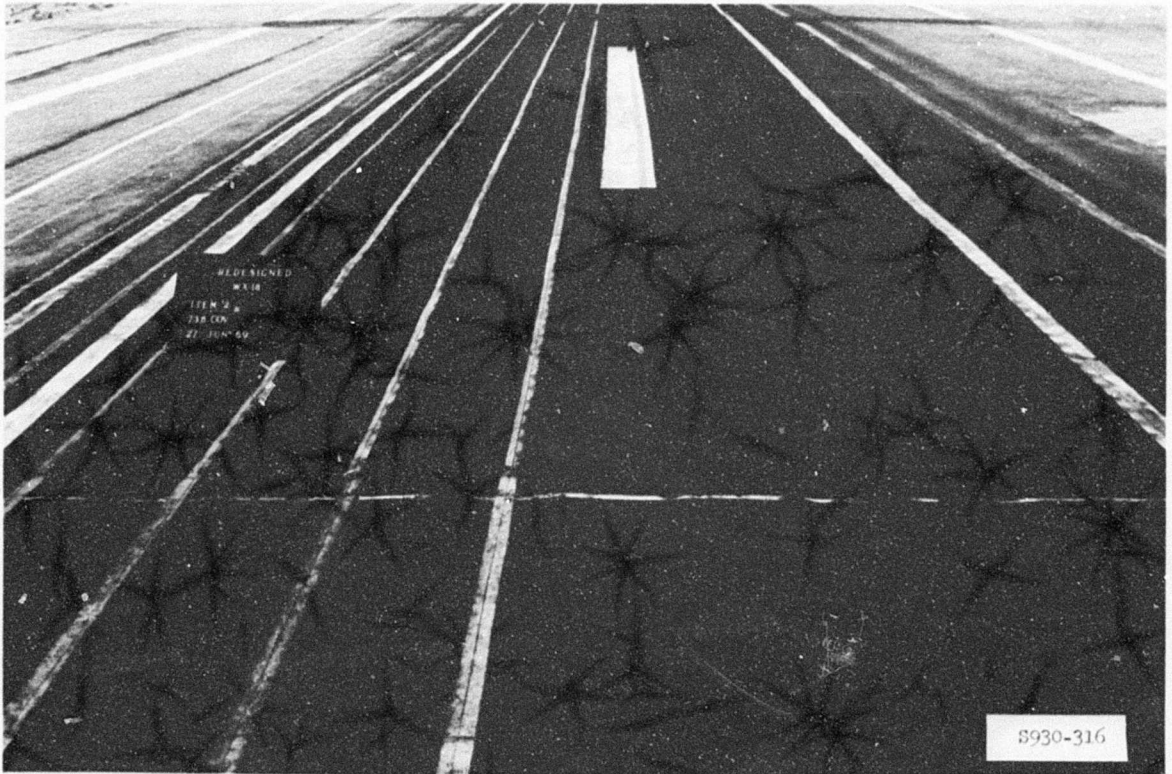
Photo 65. Sheet 2 of test section 1 after 738 coverages

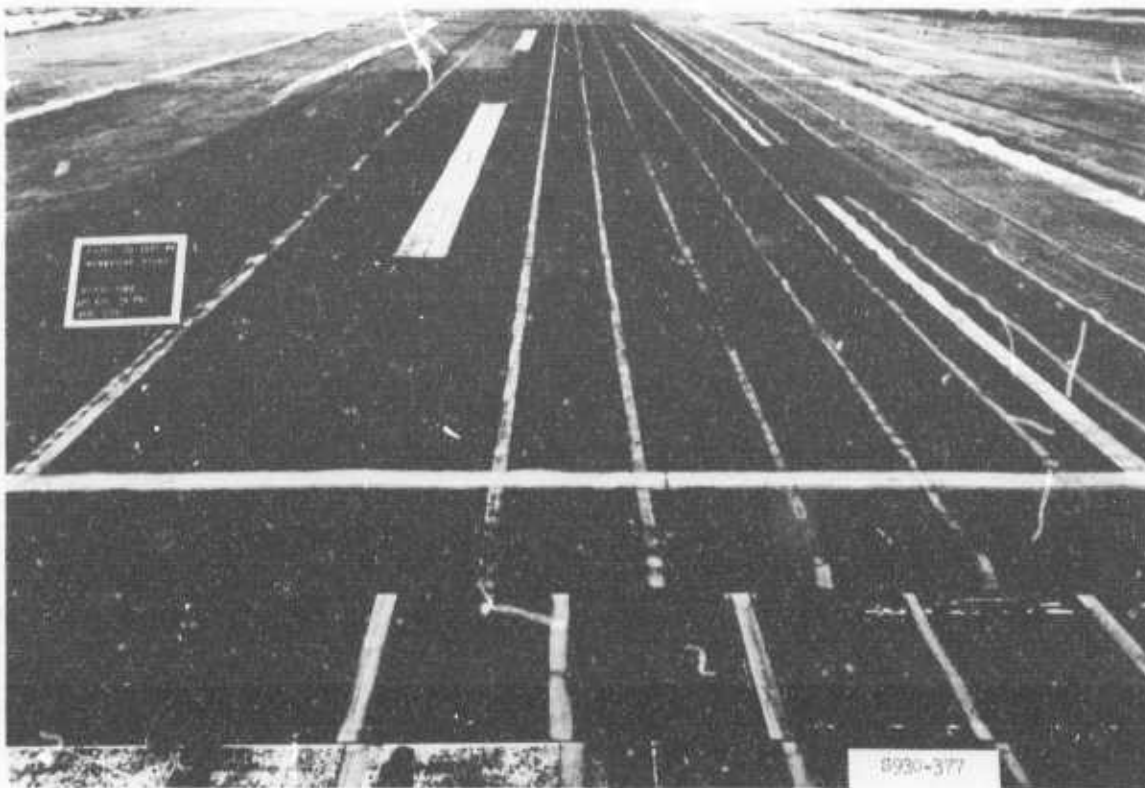
78. Photo 79 shows the general condition of the test section after 200 coverages. At this coverage level, there were no major occurrences, and the membrane showed little wear. Photo 80 shows the condition of the 3-ft-wide reinforcing strip on the joint between the two sheets. The sealant shown along the edges of the strip was wearing well and required no repair at this point. However, several of the 6-in.-wide factory fabrication joints that connected the runs of membrane were beginning to peel loose (photo 81). When the test wheel passed over a joint where a wrinkle resulting from slack in the surfacing was present, the wheel folded the wrinkle over, stressing the adhesive bond between the double layer of surfacing and causing the surfacing to peel loose. The peeled areas extended approximately 1 in. into the 6-in.-wide factory joints and were repaired by use of the MG-180 adhesive. Approximately 12 percent of the nonskid compound on sheet 1 and 5 percent of the nonskid material on sheet 2 had been removed by trafficking of the test vehicle at this coverage level (plate 19).

Photo 79. General condition of traffic test section 2 after 200 coverages

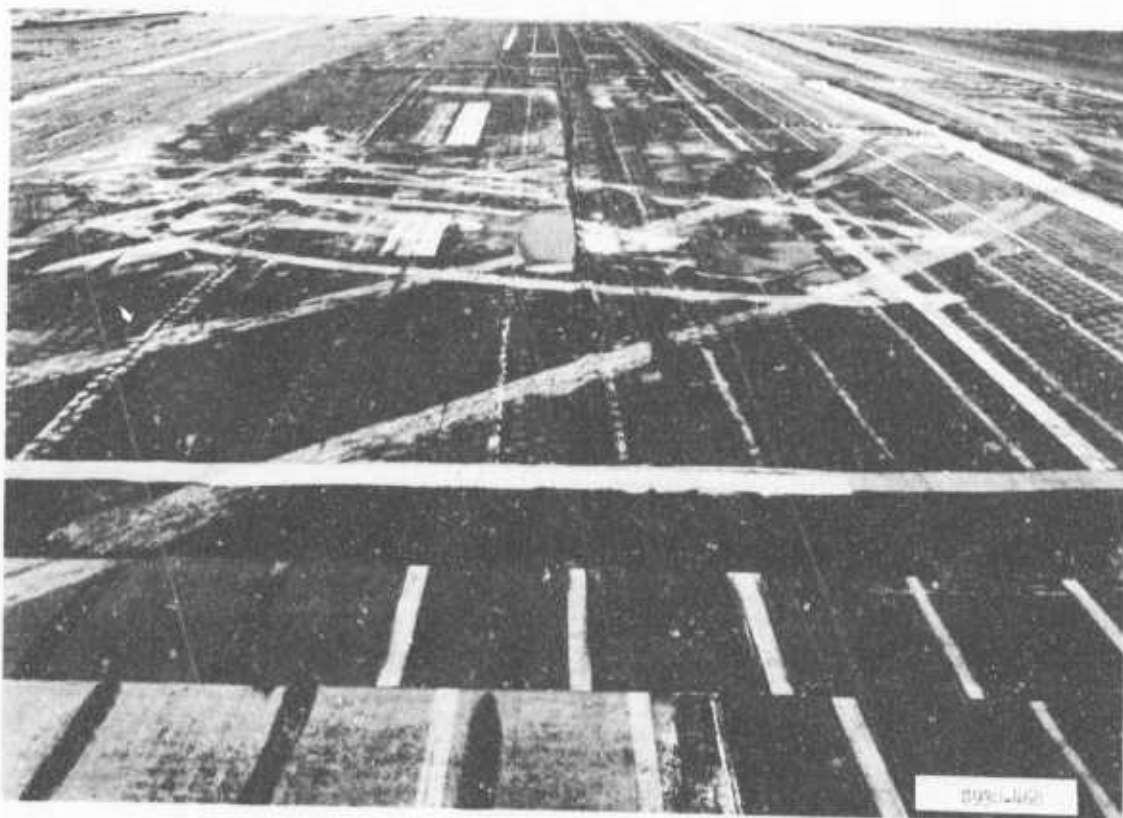
86. An overall view of the test section taken following a heavy rain at 1200 coverages is shown in photo 90. As can be seen by the good drainage of the section, only slight rutting of the subgrade had occurred during trafficking, indicating that the membrane had retained its waterproof seal. (A total of 2.08 in. of rainfall had occurred since the 1000-coverage level.) The good condition of the subgrade was confirmed by cross sections taken at 1200 coverages that indicated only consolidation of the subgrade under the test wheel with no appreciable rutting (plate 20). CBR readings taken at this coverage level indicated a slight increase in soil strength in the area of the traffic lane (table 6).

Photo 90. General condition of test section 2 after 1200 coverages
