11. Mail11 MISSILE 1F INVESTIGATION REPORT This document is subject Run S1-613-14-01 . 1 Controls and to 📬 🖉 🖉 _ .: ioreign ea 🗈 v a station -BOWLFILL --na. i.i. . . be made only Run Date: 13 May 1962 with pror approval of: GENERAL DYNAMICS ASTRONAUTICS Issue Date: 17 July 1962 JUL 20 1962 Attn: SMSD Report No. AC-62-0031 LIBRARY Copy No. 4 WS 107A (ATLAS) CLASSIFICATION CHANGED TO: э UNCLASSIFIED AUTHORIZED BY: AIR FORCE LETTER SAN BERNARDINO AIR MATERIEL AREA (SBAMA) s) J DATED 17 NOVEMBER 1965 э**r** ĴØĹ RECLASSIFIED BY: REE DEPT. 190-1 DATE 12-13 gèr Ass General Dynamics/Astronautics General Dynamics/Astronautics Durgede pluid on dr. by Security Dept., 112/66. An. D. M. McCray A. C. Chase Manager - STL Responsible Representative Sycamore Field Office Rocketdyne Field Office - Sycamore S. R. Simpson Acting Site Manager - Acoustica Associates Acoustica Field Office .. Sycamore meaning of the Esplorage La Marined person is prohibited rs, Title by law. This document centeles informati 18, U.S.C., Soction 793 and 794.

This report presents the findings of the Accident Investigation Board investigating the explosion of Missile IF during static firing S1-613-14-01 at-Sycamore--Canyon

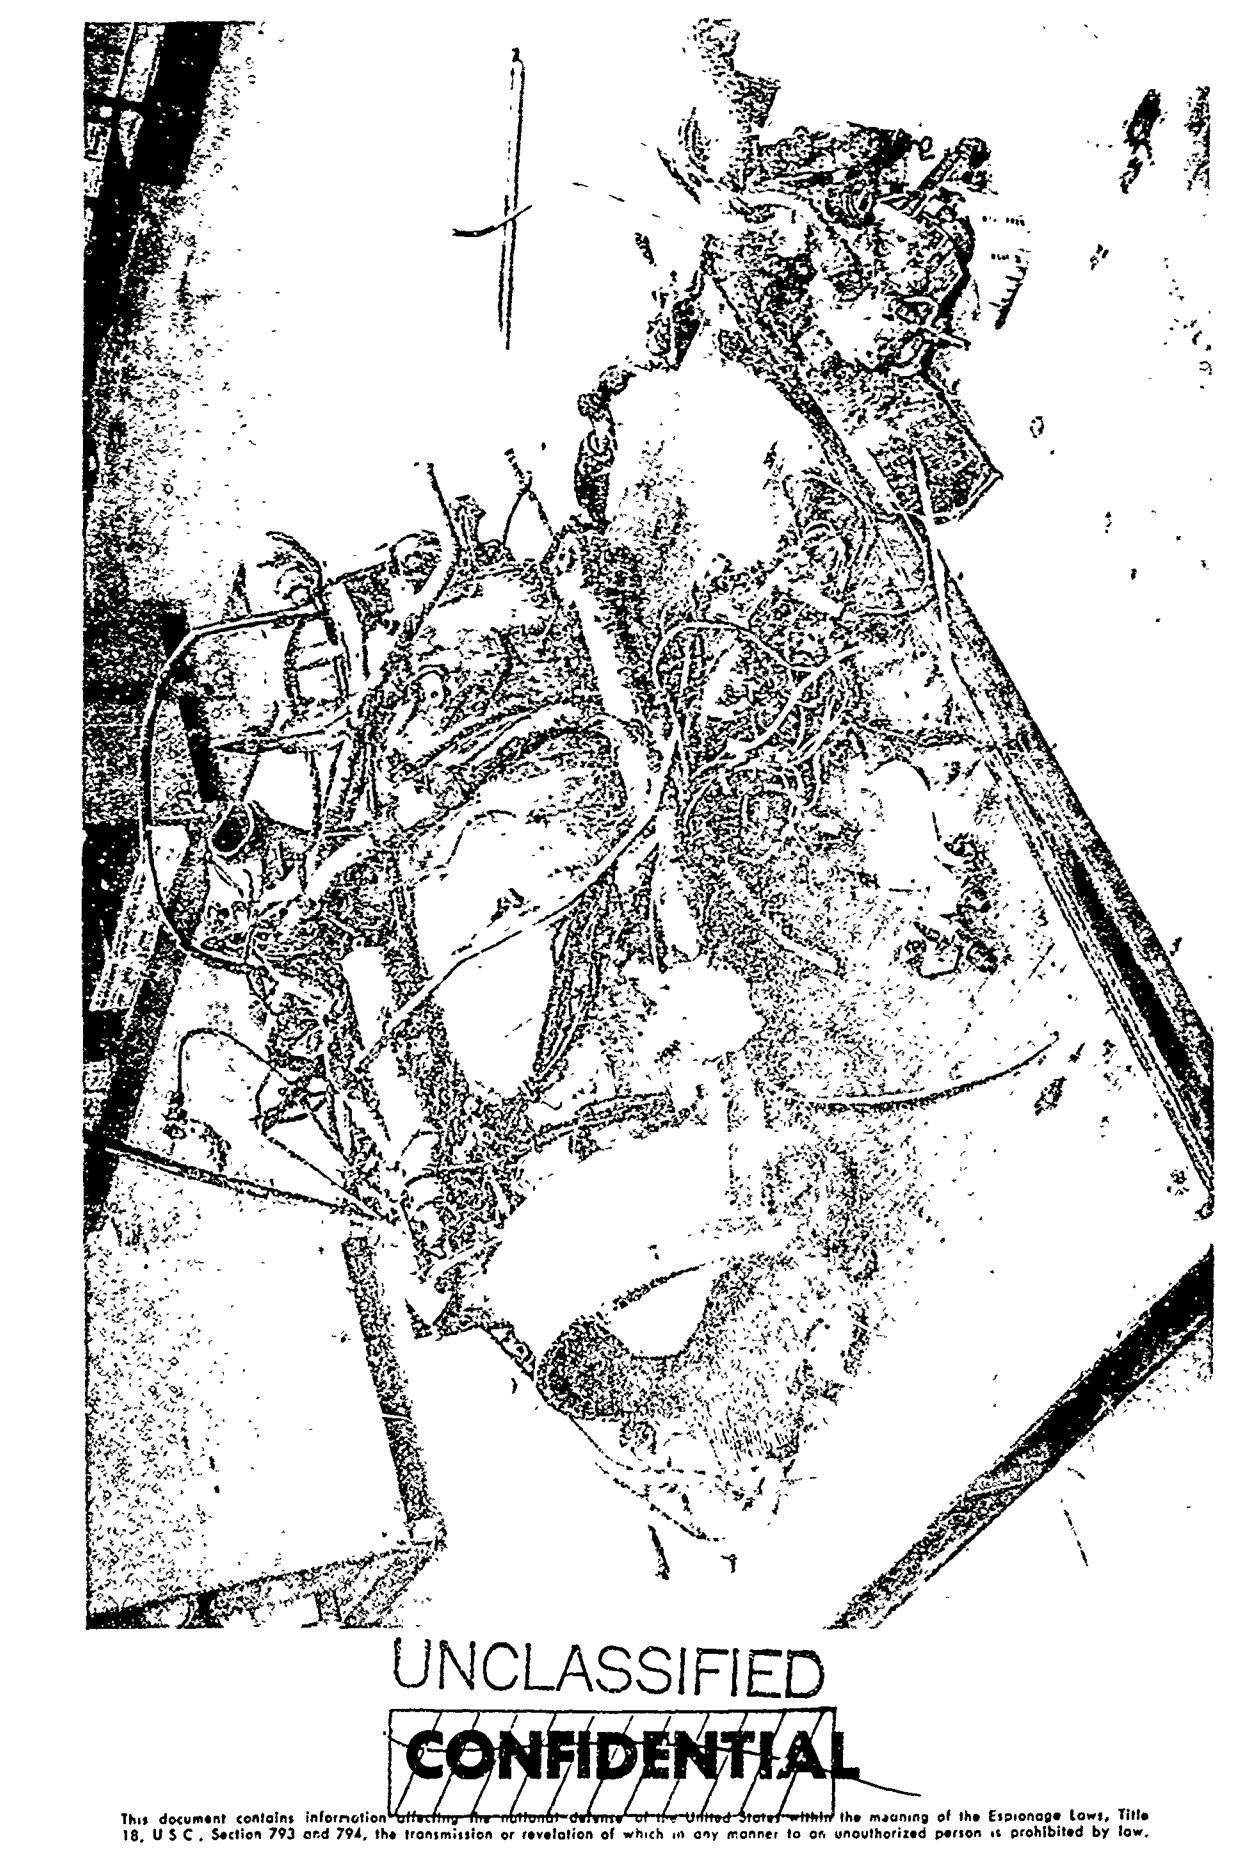
FIGURE 5 AFT THREE-QUARTER VIEW OF SUSTAINER

The sustainer thrust chamber was found with the head suppression (HS) valve body attached by the turnbuckles. The turbopump was torn from the pump mounts and the thrust chamber was separated at a plane just downstream of the throat (Figs 4 and 5). The sustainer engine turbopump assembly was recovered in several pieces. The turbine, gear case, RP-1 pump, approximately half of the LOX pump volute, impeller, inducer, and pump shaft were still joined as an assembly. A portion of the LOX pump volute, wear ring, inlet housing, RACO seal and the mating GD/A LOX duct

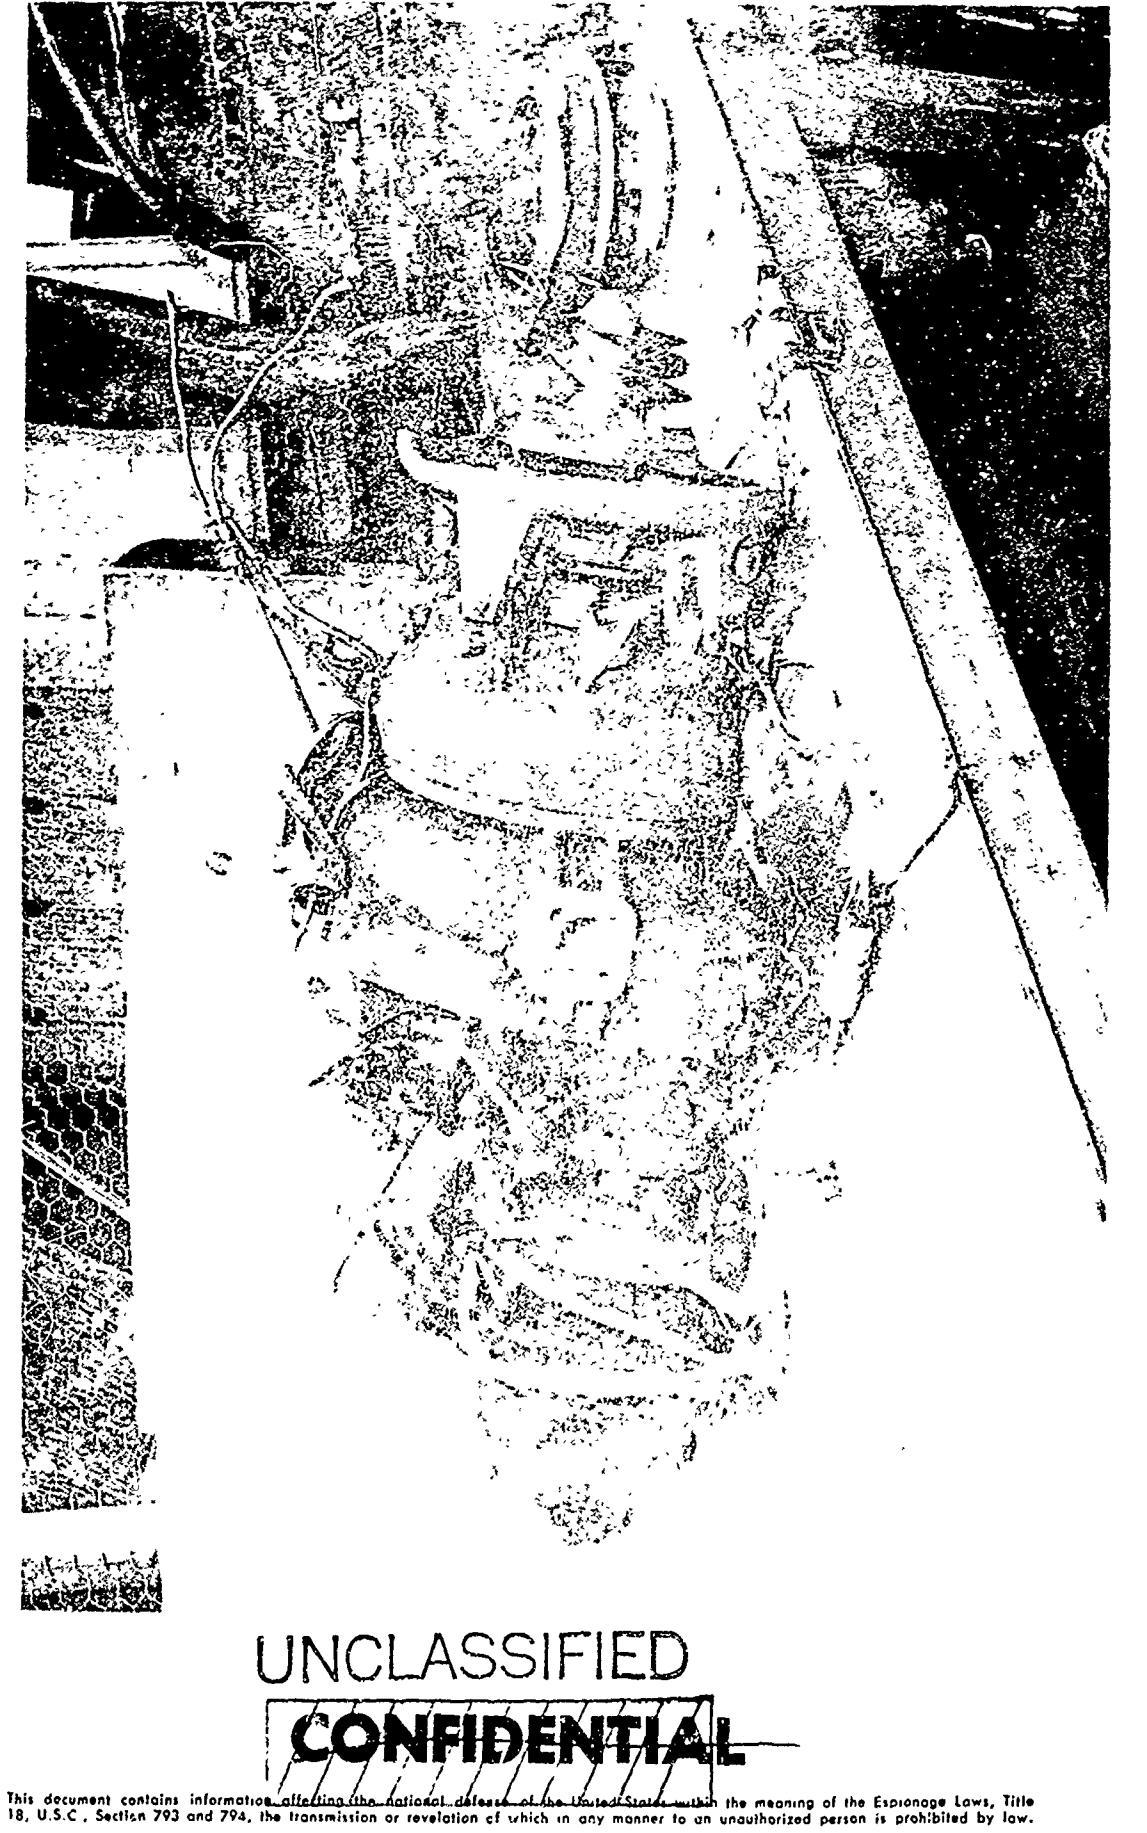
FIGURE 7

flange (with a small piece of the bellows) were found as a unit (Figs 6 and 7). Two additional pieces of the pump volute were recovered segmately (Fig 8). A portion of the LOX pump volute was not recovered.

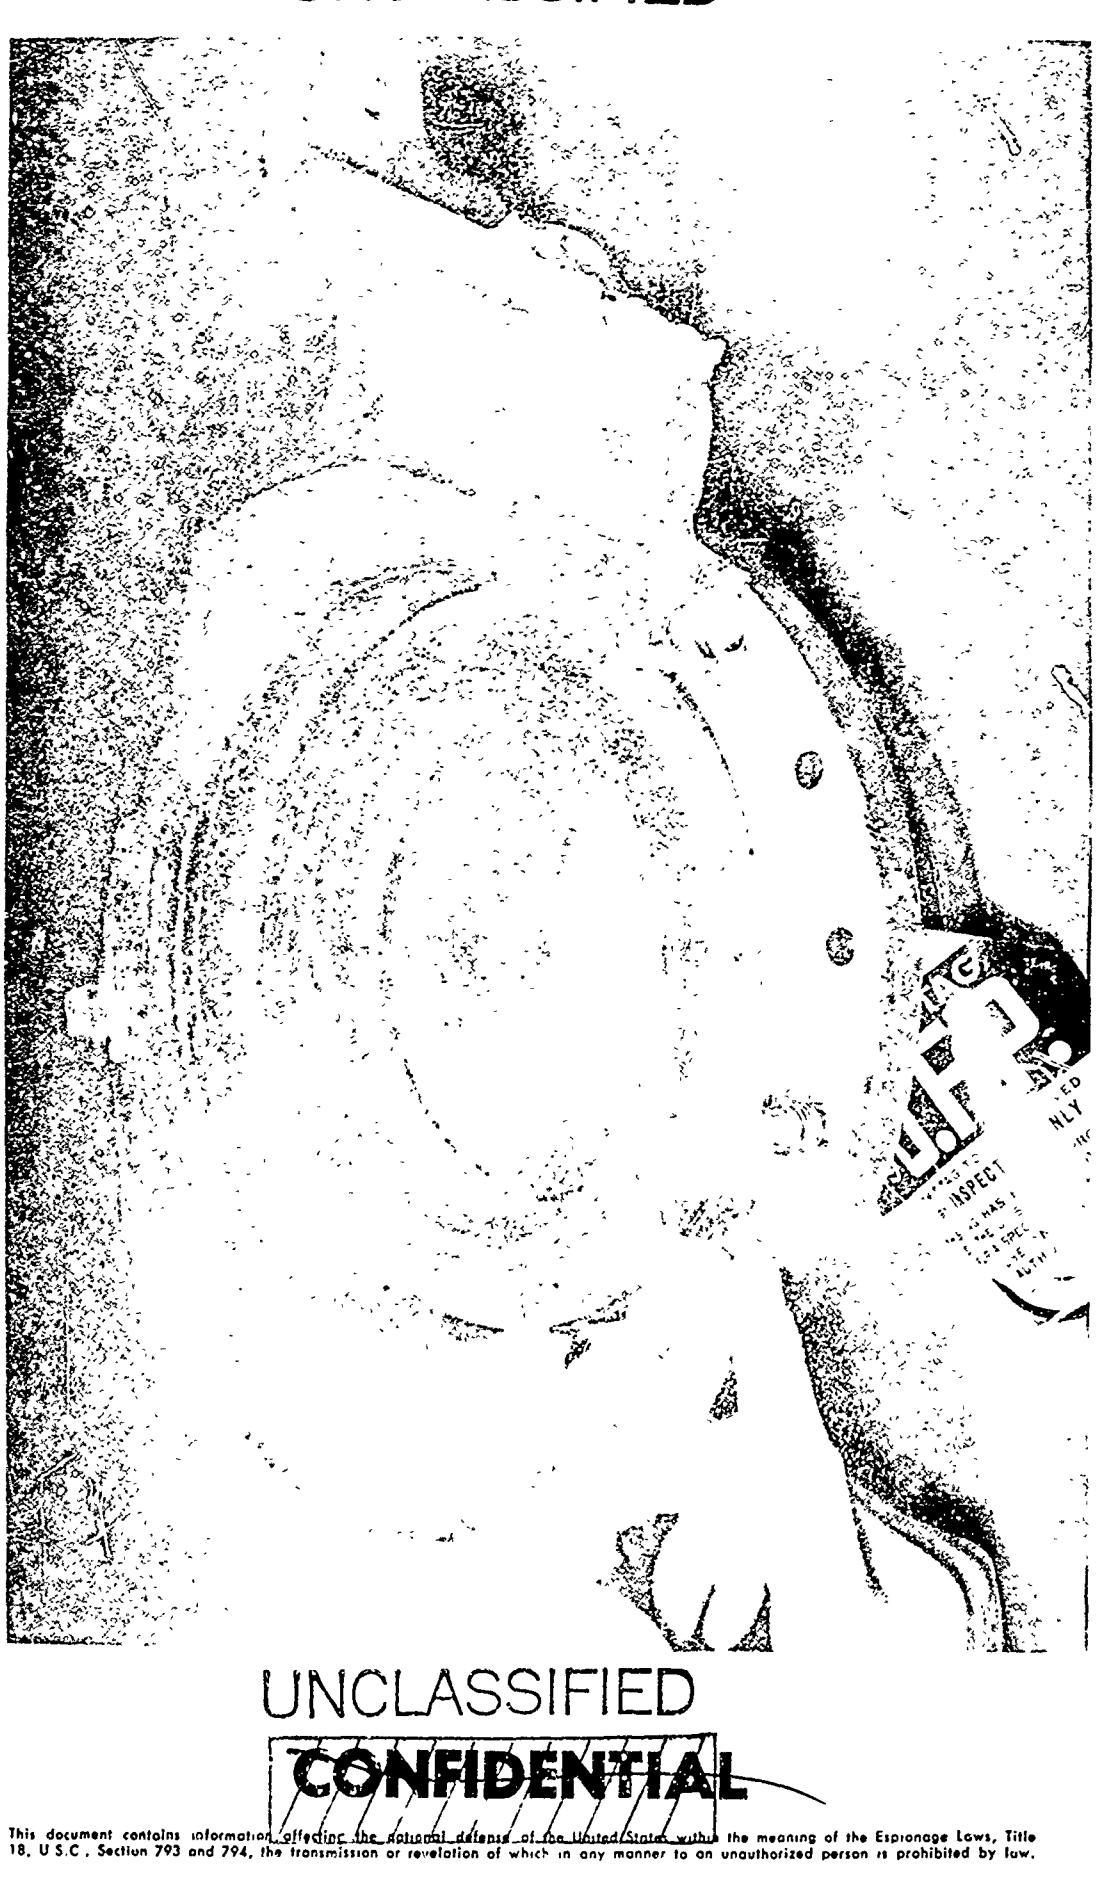
FIGURE 8

RECOVERED PARTS OF PUMP VOLUTE

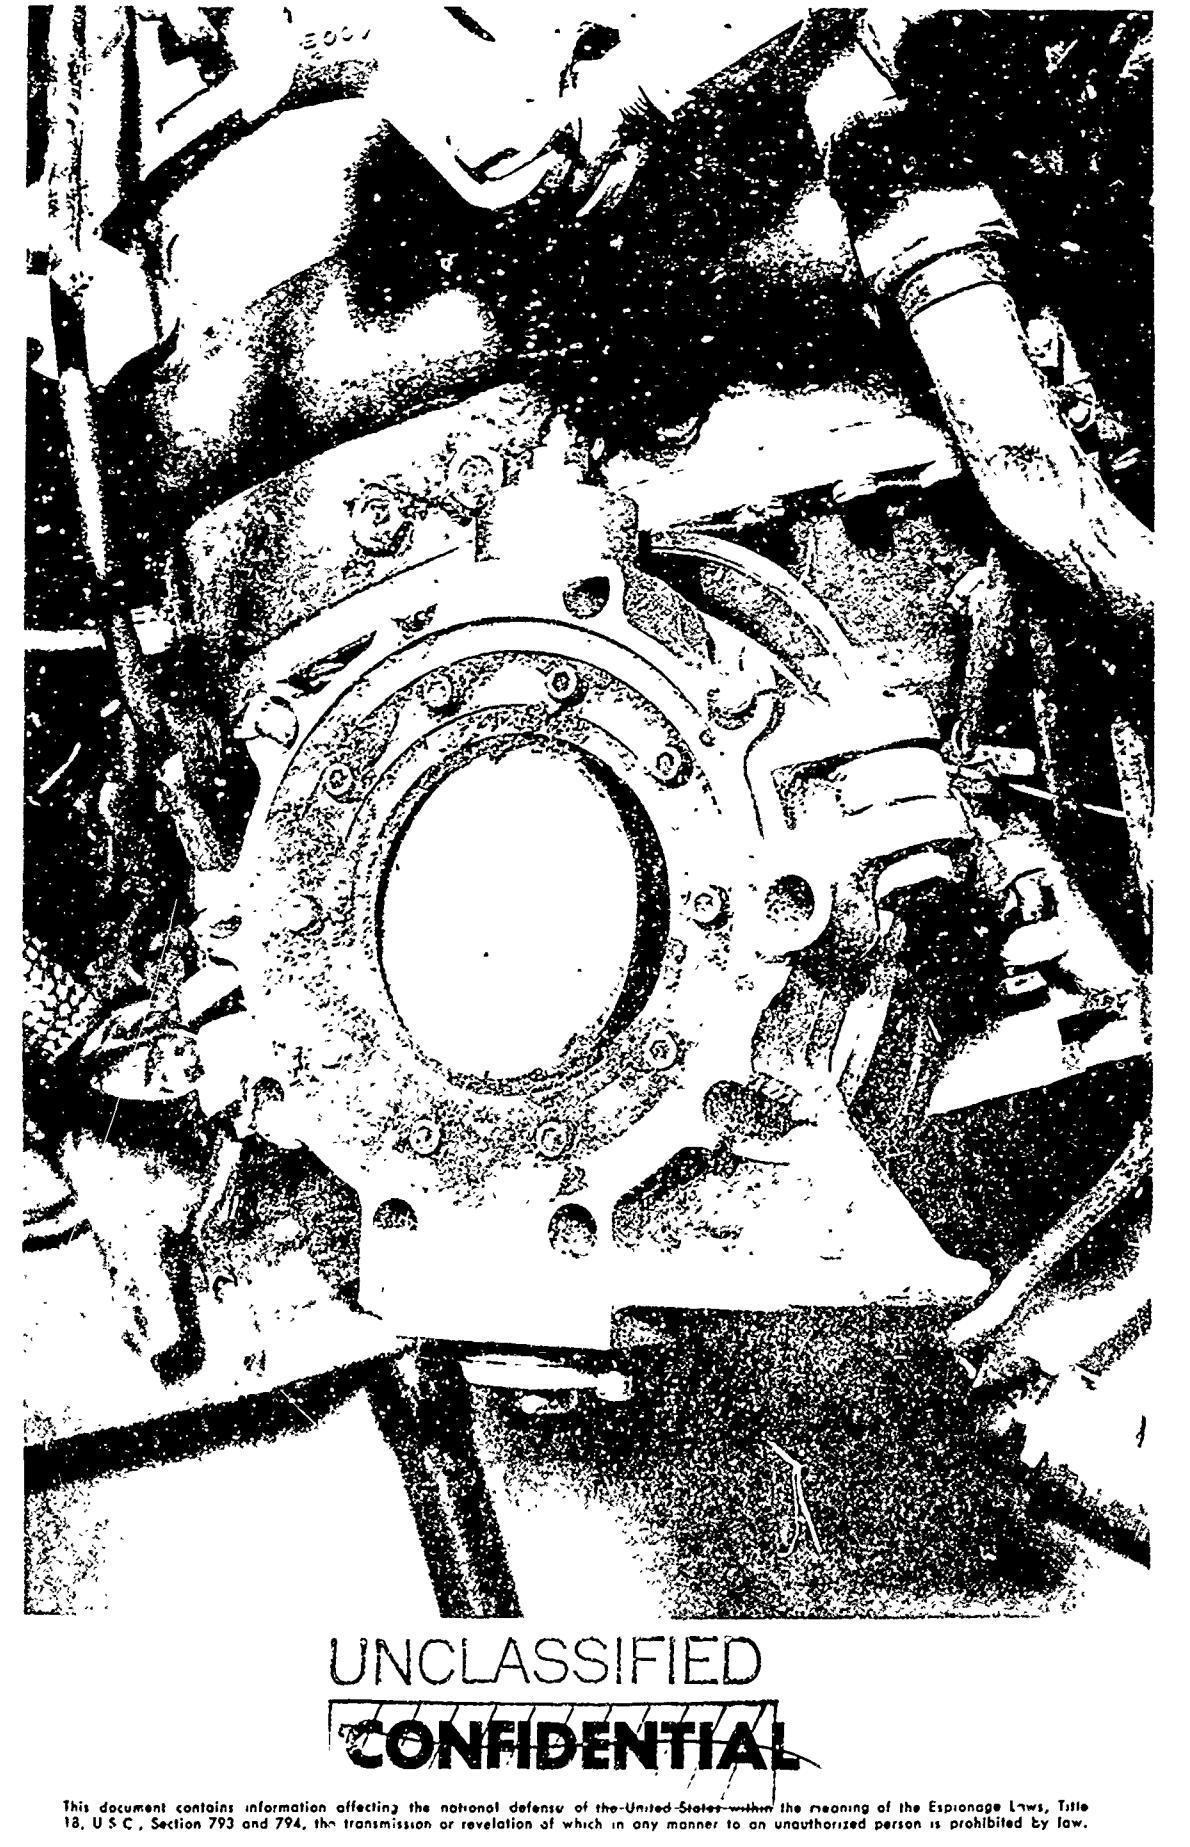
FIGURE 10 RECONSTRUCTION OF HS VALVE DAMAGE

The HS valve actuator was separated from the valve by the forward movement of the front half of the LOX pump volute (Fig 10). The aft side of the actuator housing was deformed inward by the LOX pump discharge flange striking it as evidenced by matching brinelling on the edge of the flange and the deformed portion of the housing. Deformation inward of the actuator housing resulted in the brinelling of the interior of the housing against the fuel igniter valve cam attachment bolt (Fig 11). Comparison of the location of this brinell mark with layout drawings snowed that the head suppression valve was 45 ± 1 degrees open when the actuator housing was deformed during the LOX pump explosion.

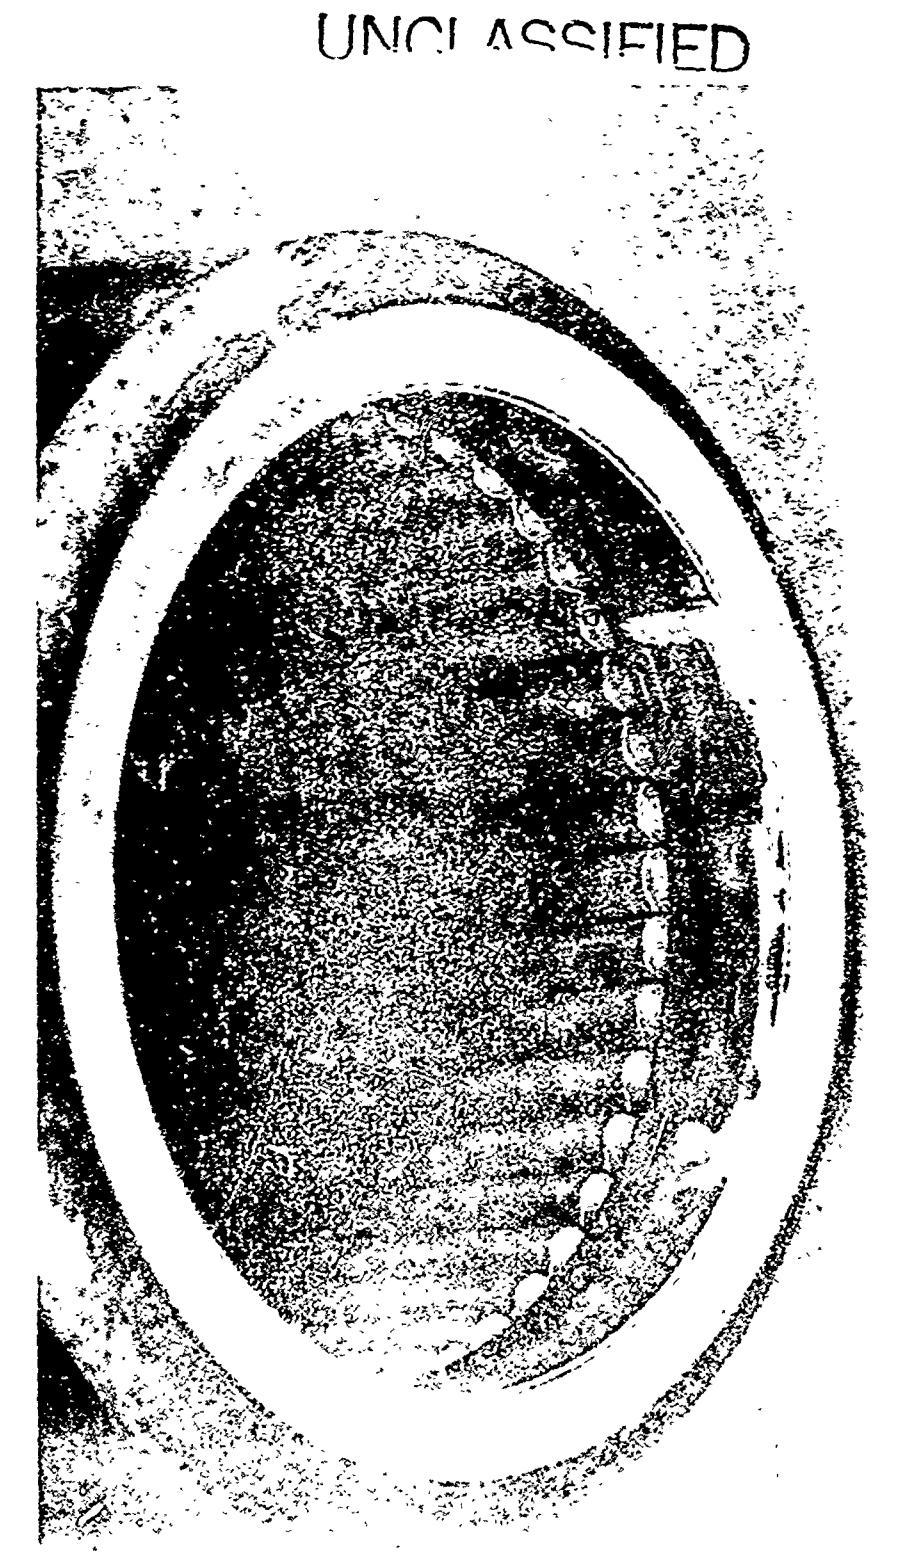
FIGURE 13 HS VALVE IDLER SHAFT BEA' ING

The head suppression valve drive shaft, idler shaft, and gate were disassembled. The bearing assemblies were free on the shaft and withdrew easily. The mylar lip seals used for excluding moisture from the valve drive shaft bearings were partially split in the seal radii. The idler shaft outboard seal was split in the same manner, while the inboard seal was intact at disassembly. It should be noted that the most likely point of moisture entry during a normal test run is through the seal that remained intact. Moisture was observed inside the seal retainer and vent valve assembly which is installed in the idler shaft housing. The idler shaft needle bearing assembly contained water and scaly rust deposits on the needle bearing tapered ends and outer bearing race. Several of the needles were galled on the inboard end (Fig 12). The polished surface of the idler shaft exhibited several types of deformation (Fig 13). Brinelling imprints of the needle bearings occurred on opposing sides of the idler shaft. Build up of metal in the brinelled areas of the idler shaft showed valve gate motion toward the closed position. Marks were also observed on the surface of the idler shaft which showed compression of a hard gritty substance between the needle bearings and the erial around these depressions shaft surface.

- A study be conducted to determine a method for precluding the presence of moisture in the HS valve idler shaft bearing housing. Possible methods are:
 - a) Use of improved lip seal.
 - b) Use of a dessicant plug to absorb whatever moisture is ingested into the housing.

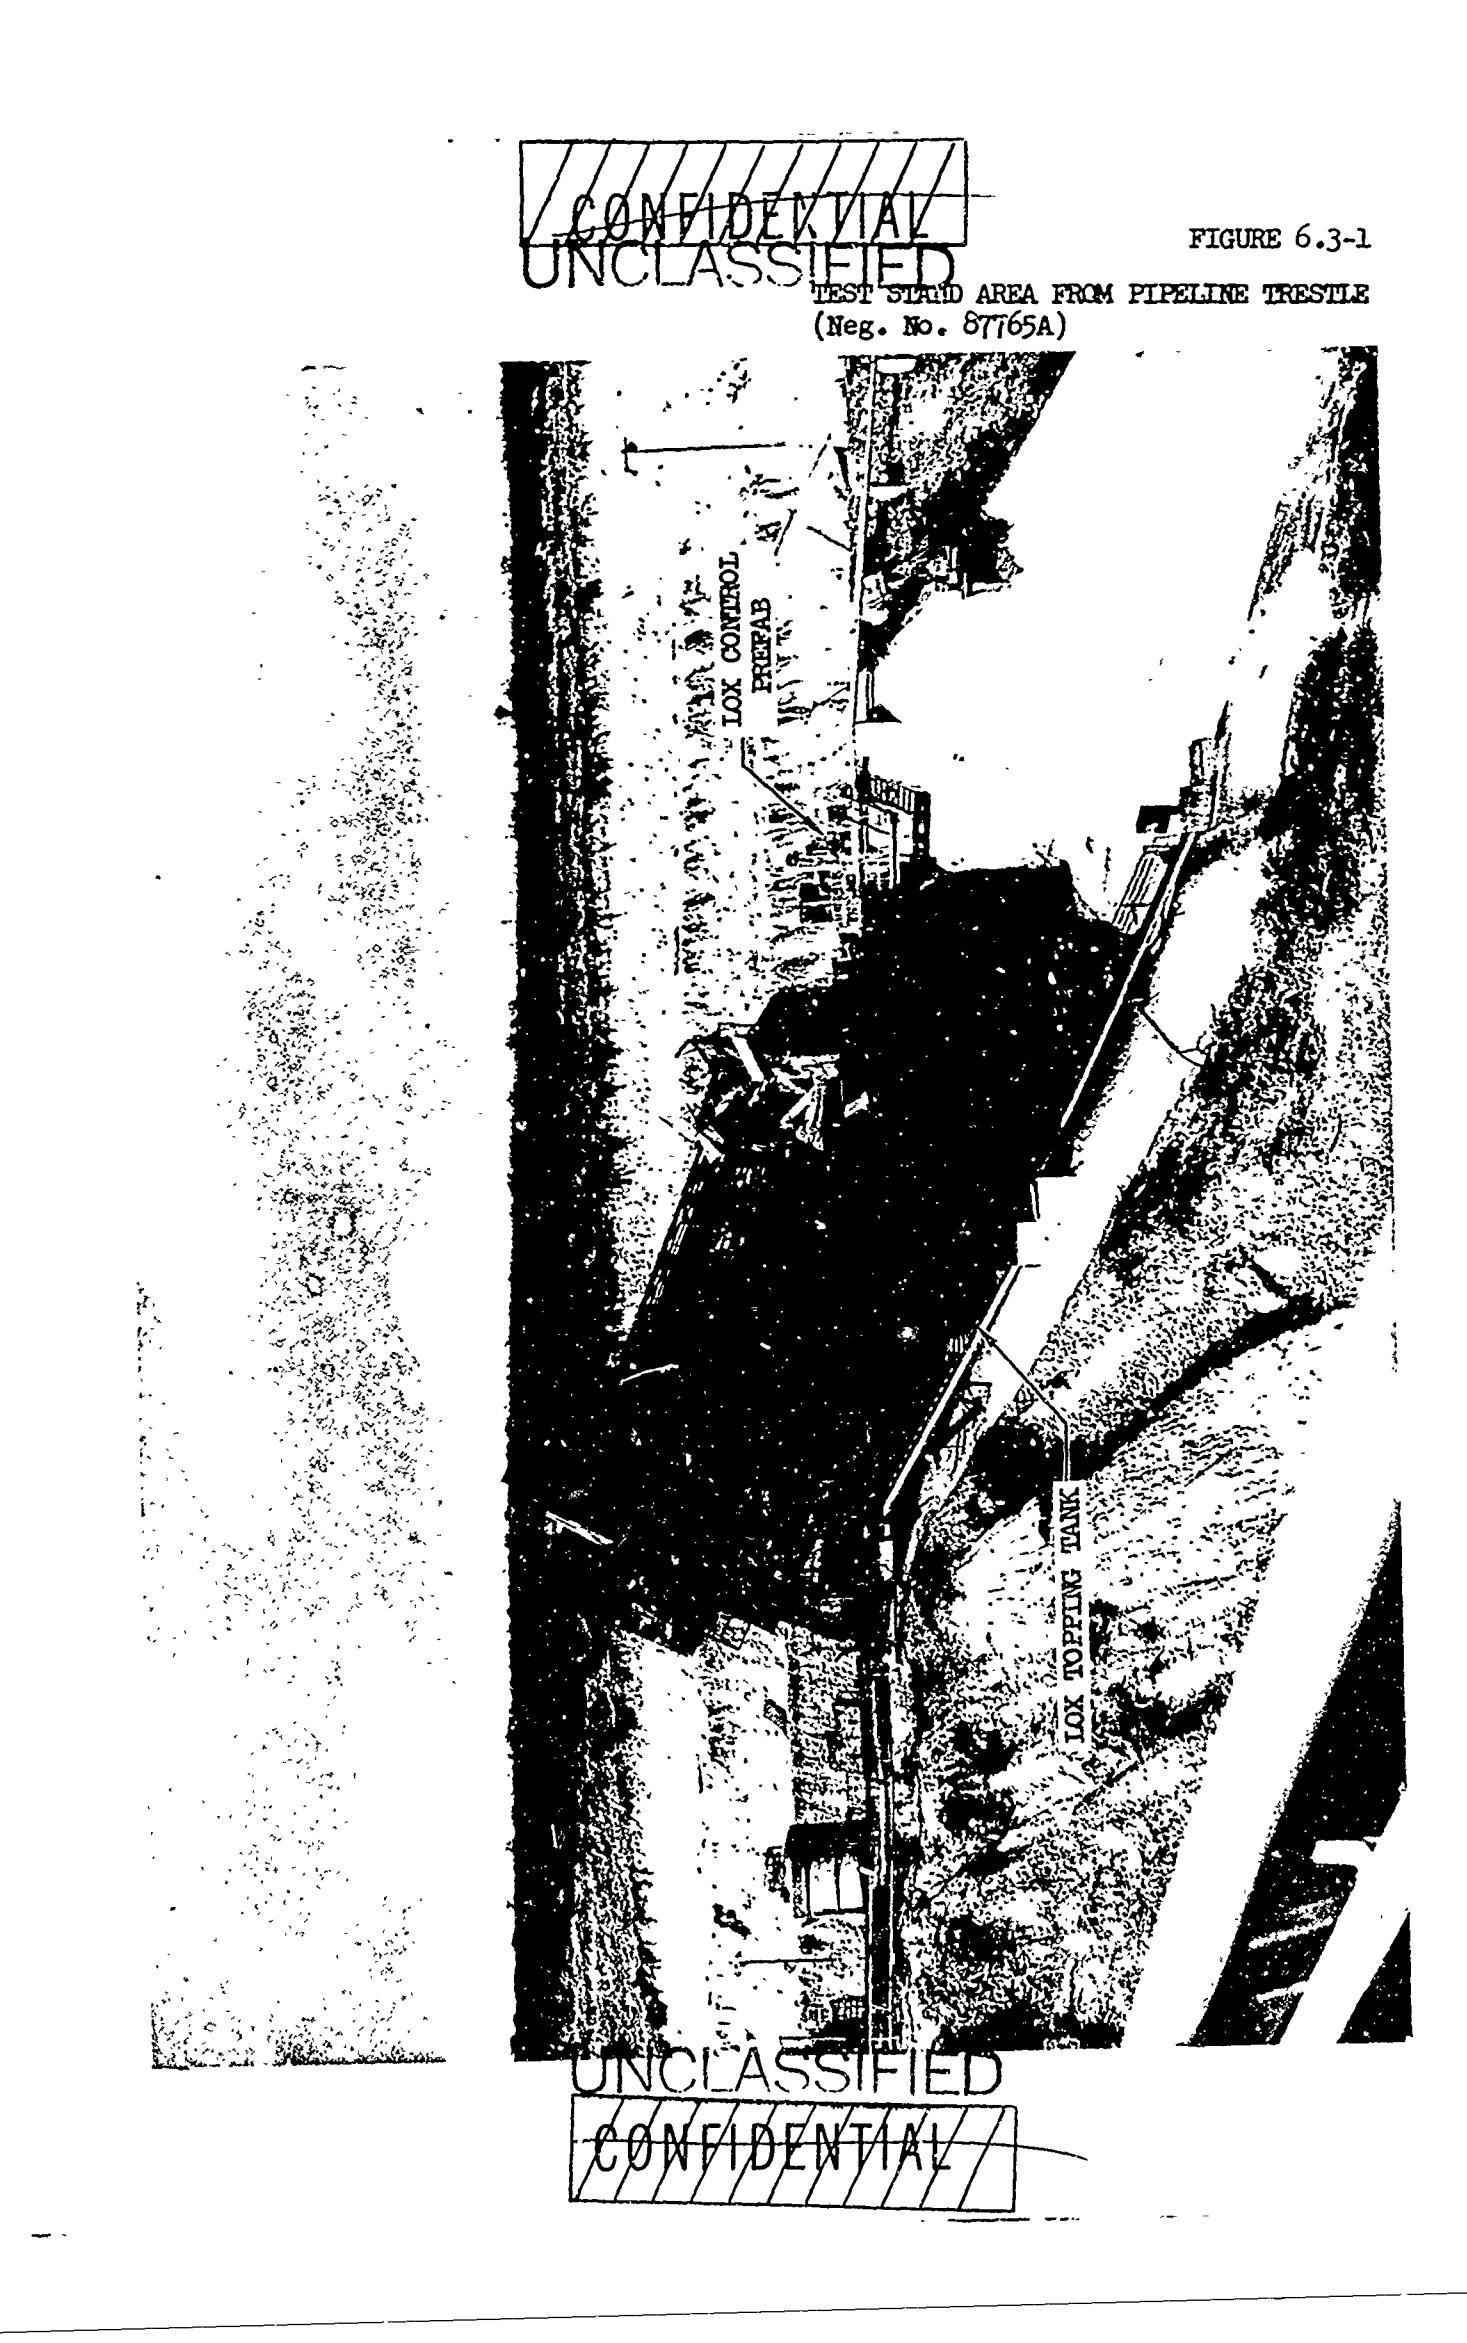
FIGURE 6.3-2

VIEW OF SERVICE TOWER FROM PARKING LOT BEHIND LOX STORAGE AREA (Neg. No. 37779A)

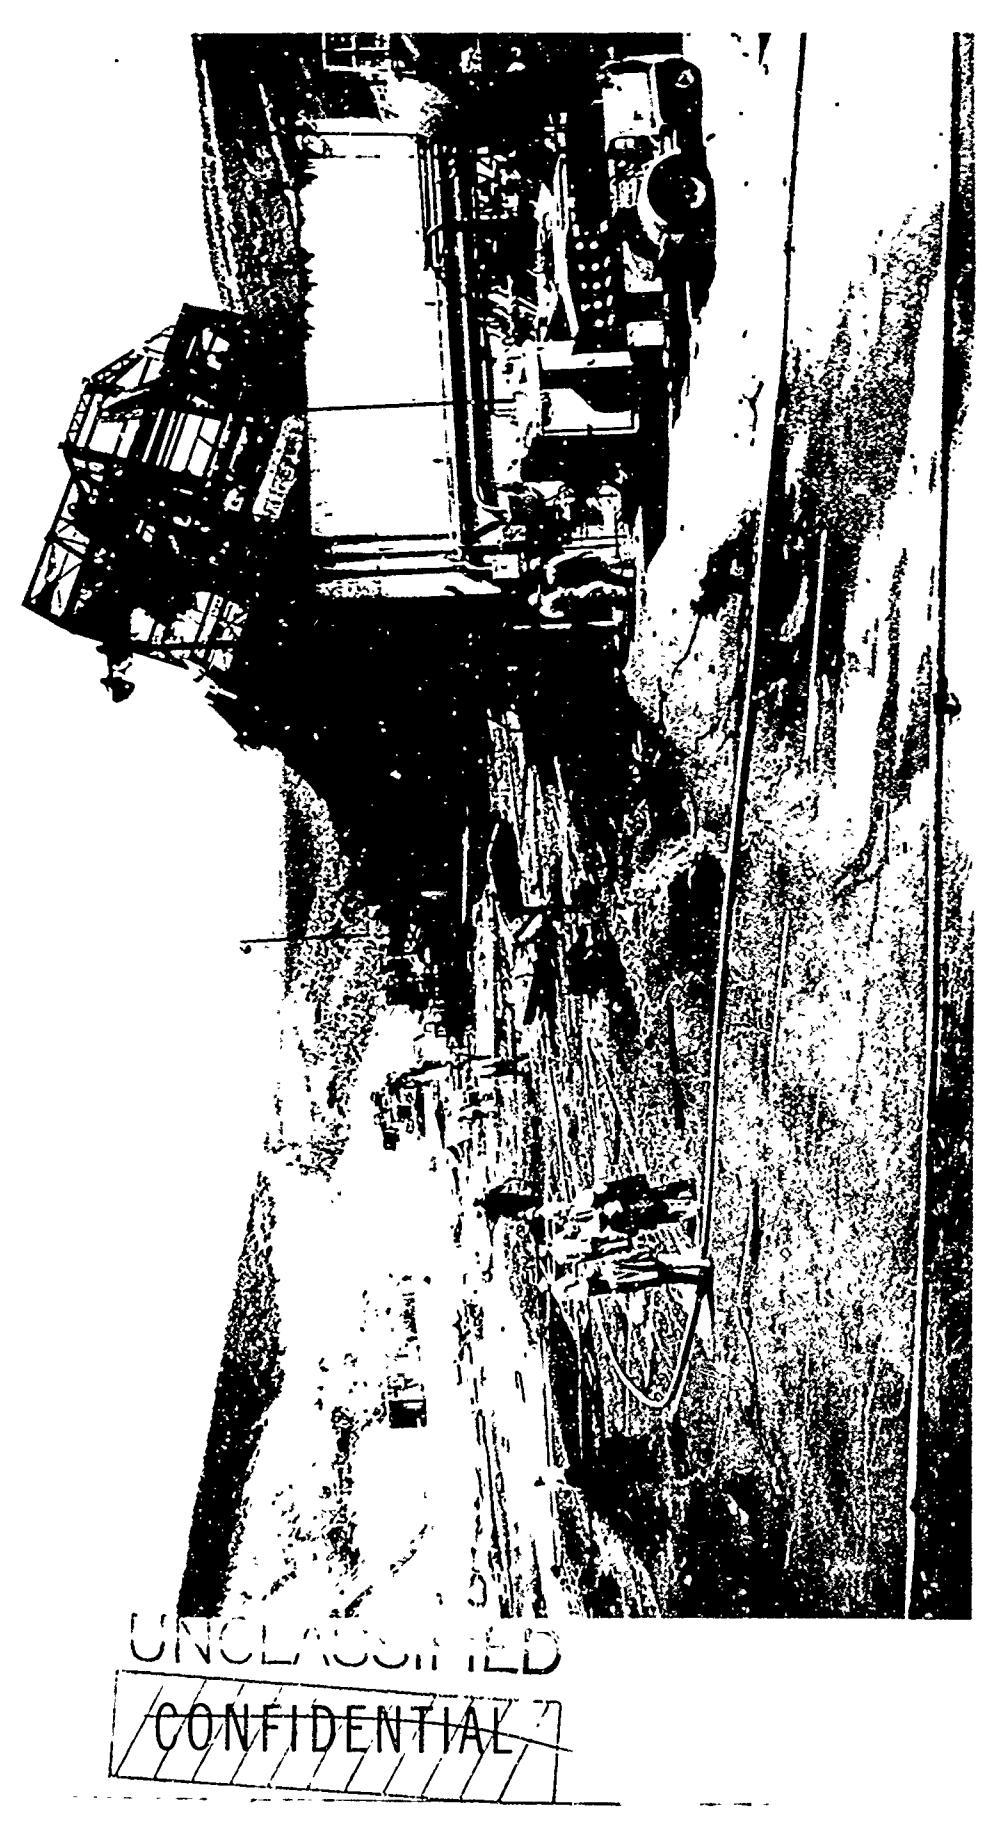
FIGURE 6.3-3

TEST SAND AREA FROM FUEL FARM LOOKING TOWARD BLOCKHOUSE. LOX CONTROL PREFAB VISIBLE NEAR SERVICE TOWER. (Neg. No. 87833A)

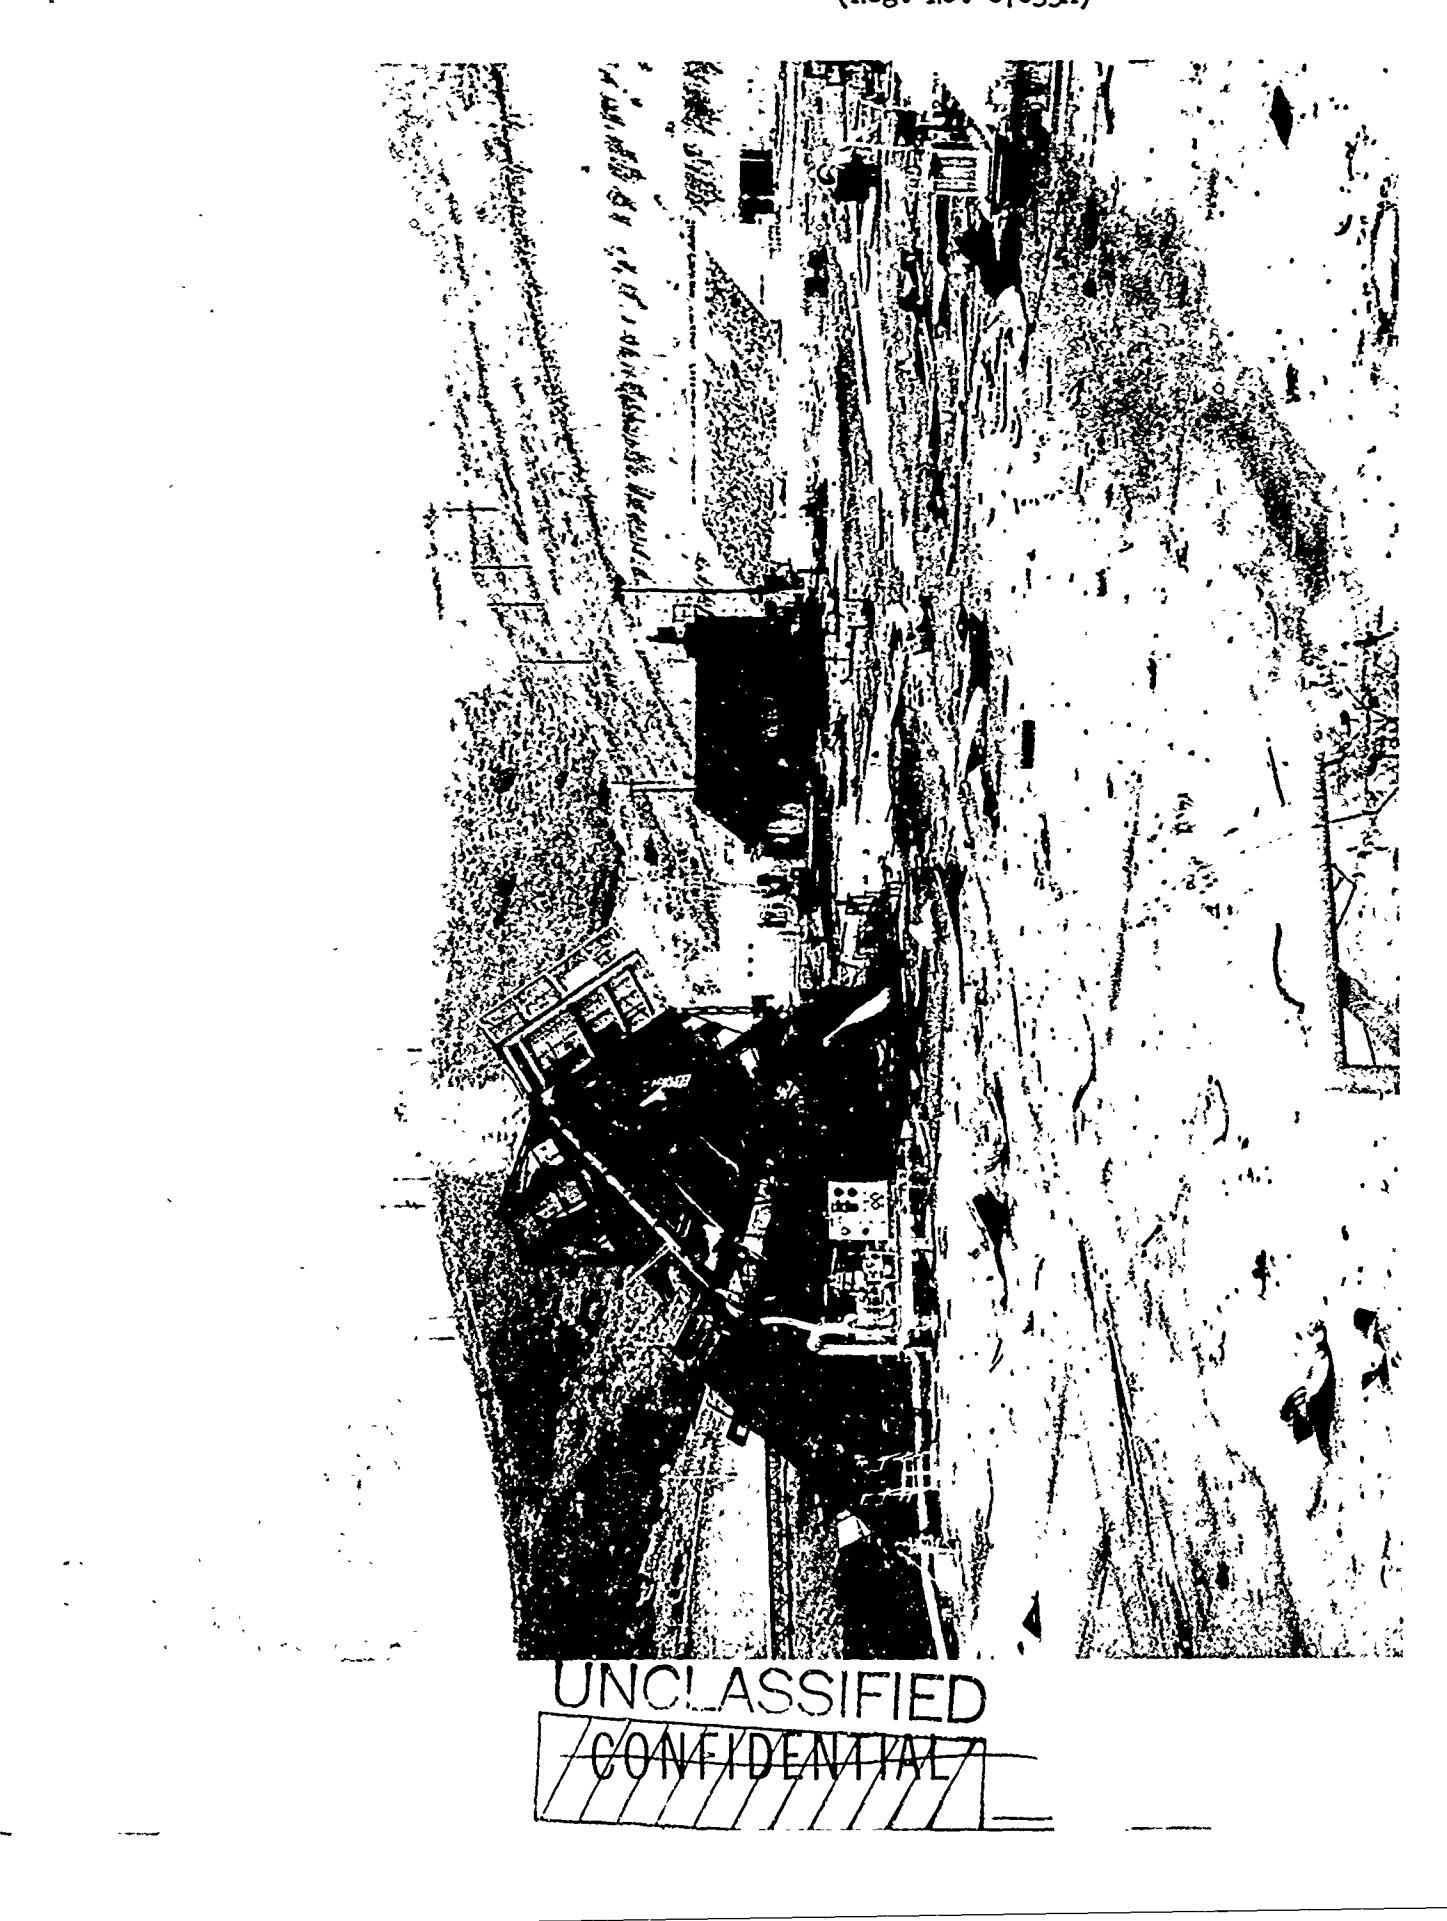
FIGURE 6.3-4

VIEW OF THE SERVICE TOWER AND FACILITY EQUIPMENT (Neg. No. 87773A)

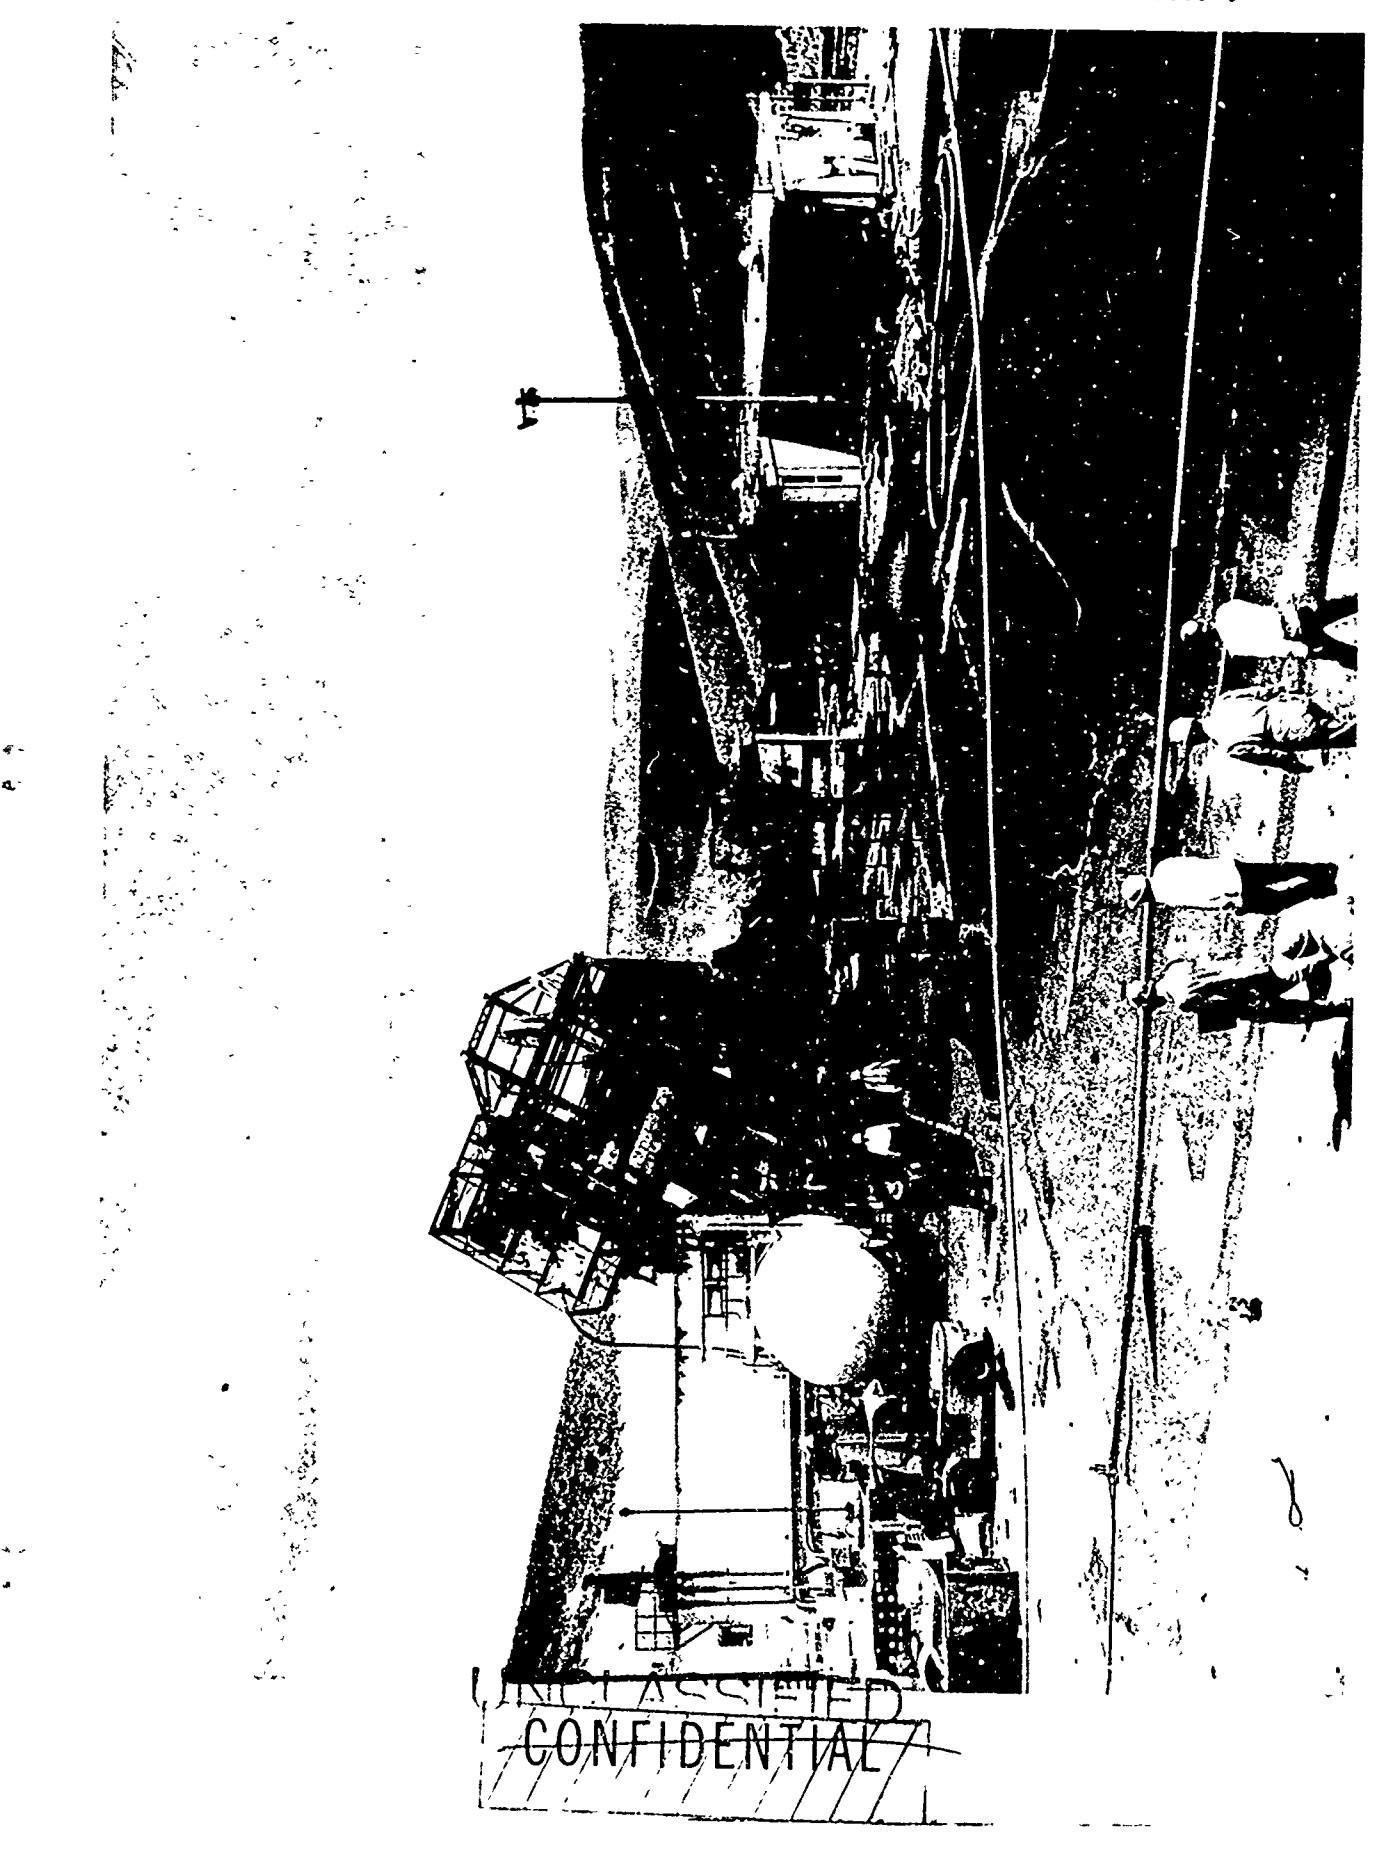
SL BLOCKHOUSE ANNEX INTERIOR (Neg. No. 87642A)
