11. Mail11 MISSILE 1F INVESTIGATION REPORT This document is subject Run S1-613-14-01 . 1 Controls and to 📬 🖉 🖉 _ .: ioreign ea 🗈 v a station -BOWLFILL --na. i.i. . . be made only Run Date: 13 May 1962 with pror approval of: GENERAL DYNAMICS ASTRONAUTICS Issue Date: 17 July 1962 JUL 20 1962 Attn: SMSD Report No. AC-62-0031 LIBRARY Copy No. 4 WS 107A (ATLAS) CLASSIFICATION CHANGED TO: э UNCLASSIFIED AUTHORIZED BY: AIR FORCE LETTER SAN BERNARDINO AIR MATERIEL AREA (SBAMA) s) J DATED 17 NOVEMBER 1965 э**r** ĴØĹ RECLASSIFIED BY: REE DEPT. 190-1 DATE 12-13 gèr Ass General Dynamics/Astronautics General Dynamics/Astronautics Durgede pluid on dr. by Security Dept., 112/66. An. D. M. McCray A. C. Chase Manager - STL Responsible Representative Sycamore Field Office Rocketdyne Field Office - Sycamore S. R. Simpson Acting Site Manager - Acoustica Associates Acoustica Field Office .. Sycamore meaning of the Esplorage La Marined person is prohibited rs, Title by law. This document centeles informati 18, U.S.C., Soction 793 and 794.

This report presents the findings of the Accident Investigation Board investigating the explosion of Missile IF during static firing S1-613-14-01 at-Sycamore--Canyon

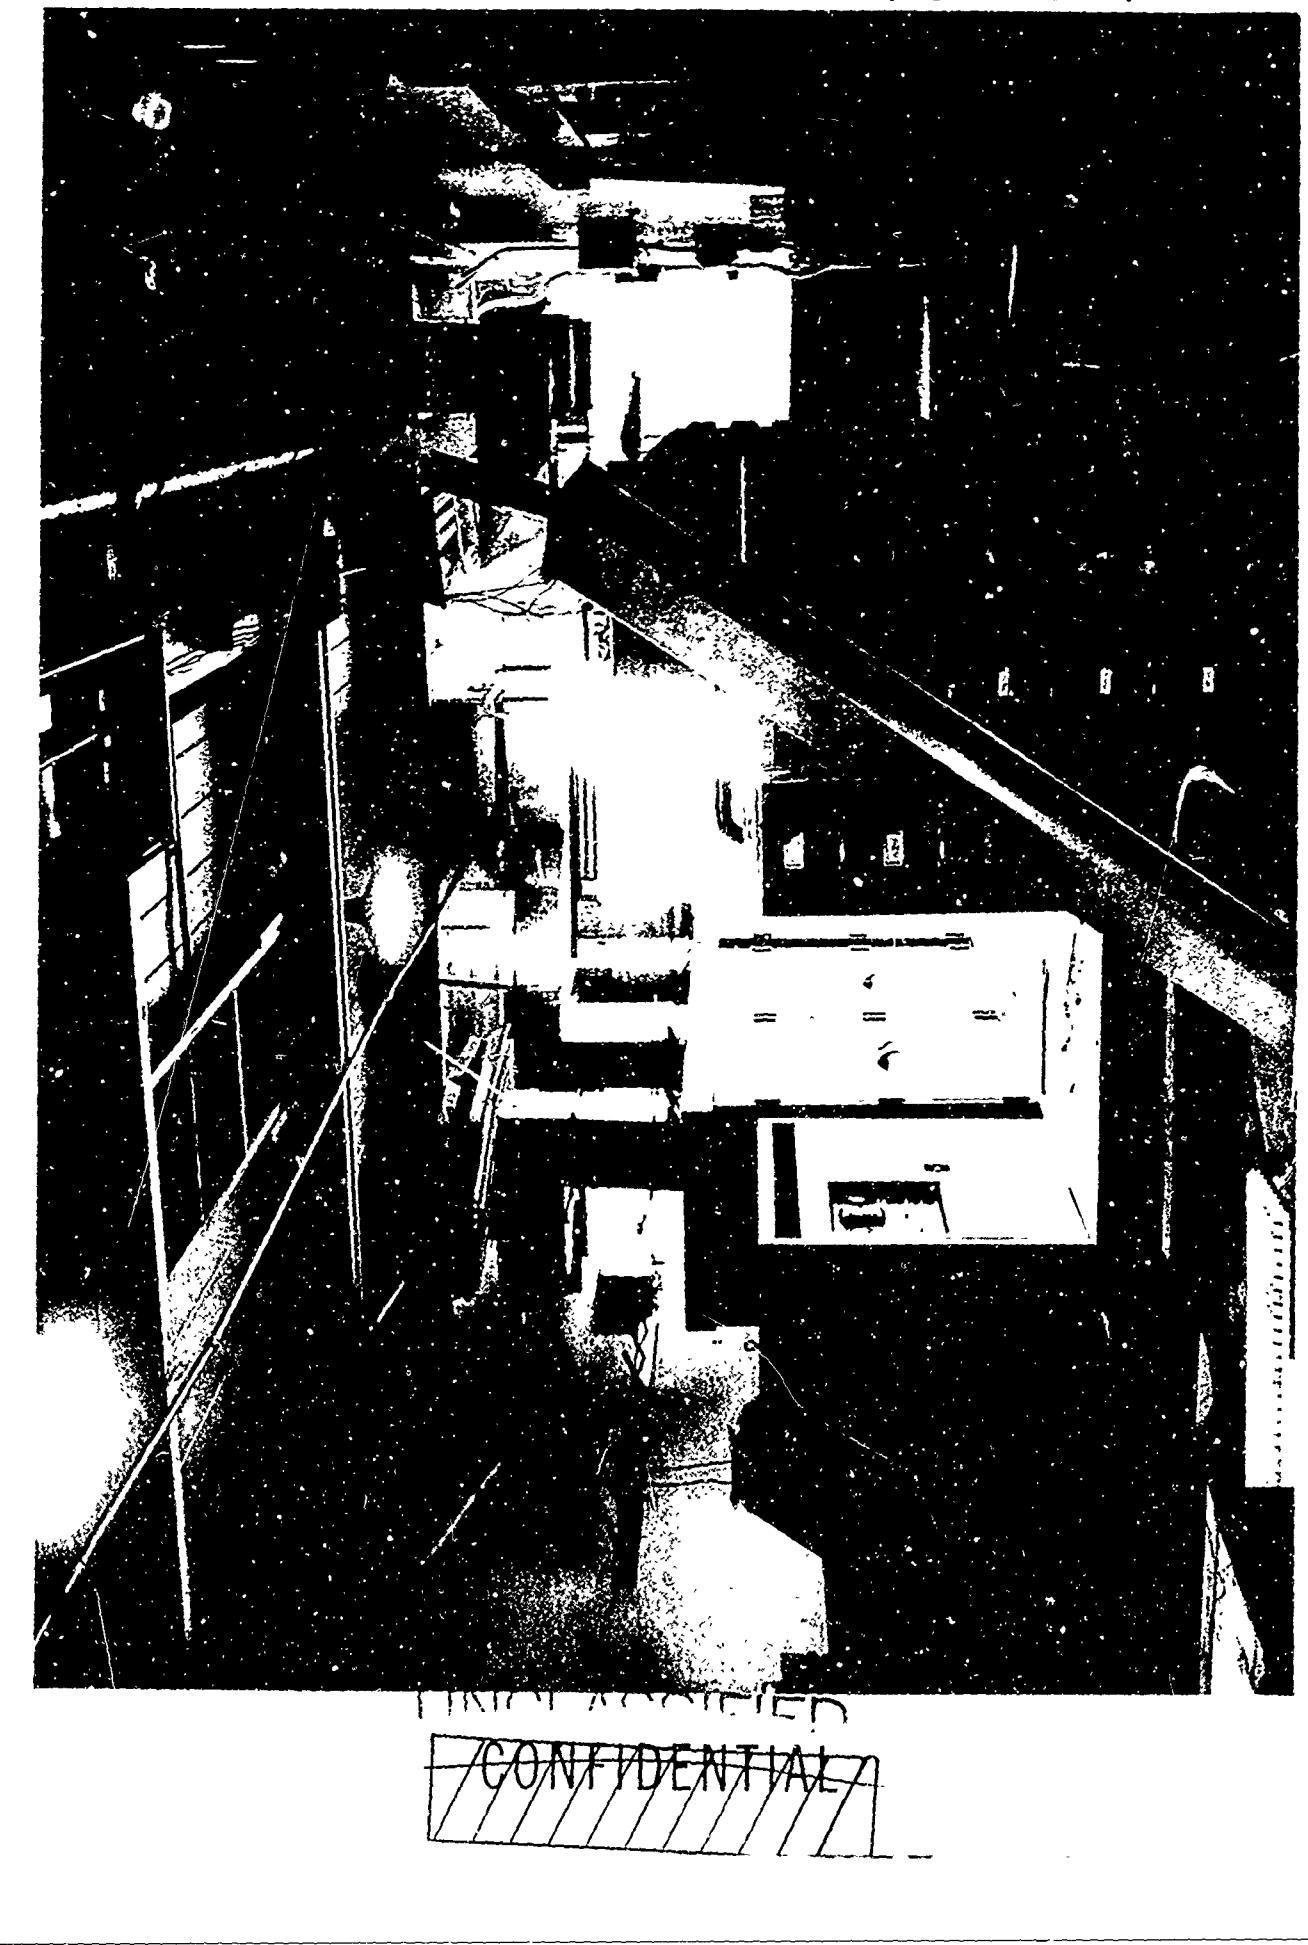
FIGURE 6.3-6

S4 UTILITY BUILDING (Neg. No. 87635A)

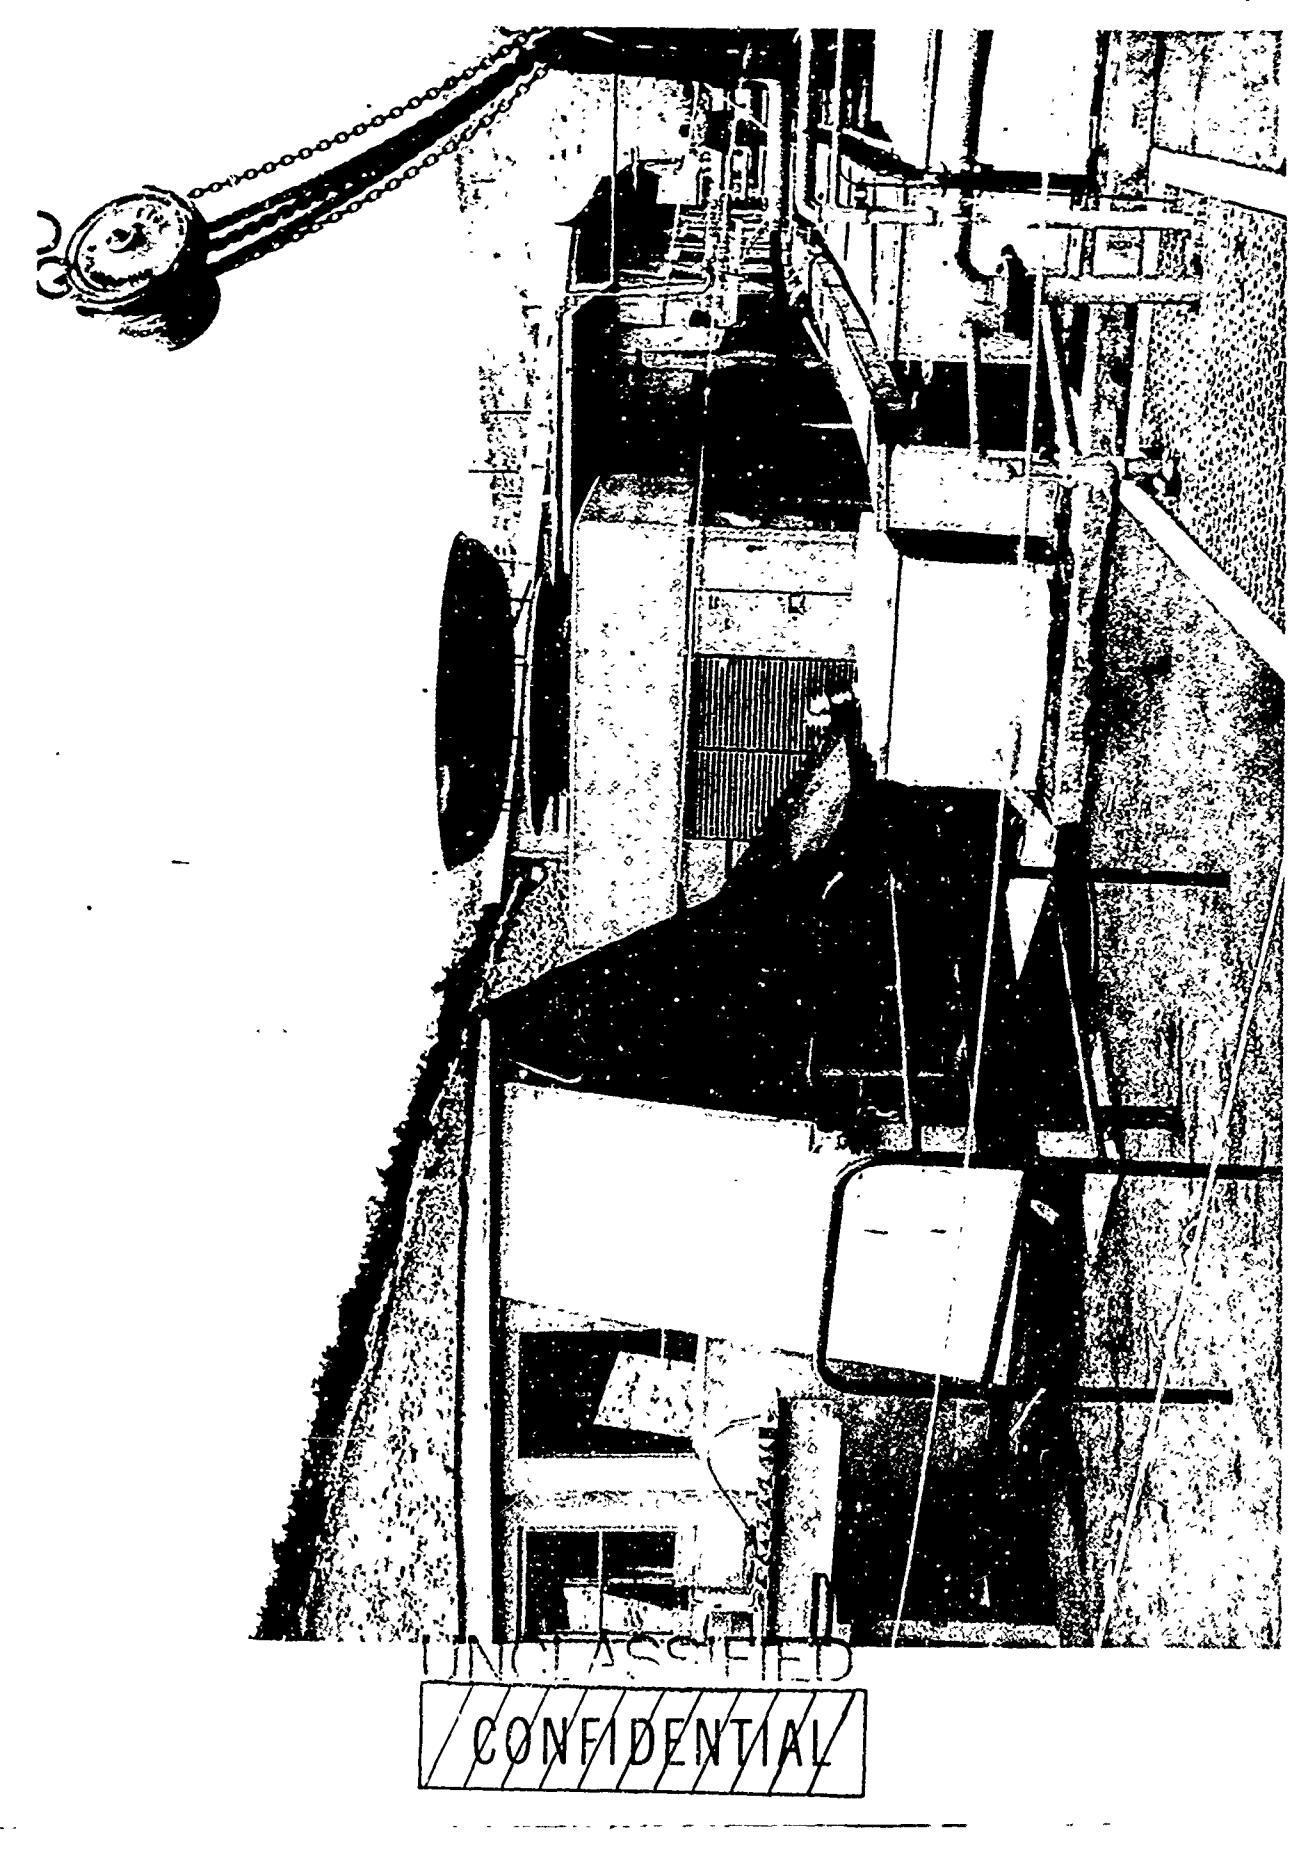
SUSTAINER COMBUSTION CHAMBER AS RECOVERED FROM SKIM POND (Neg. No. 87862A)

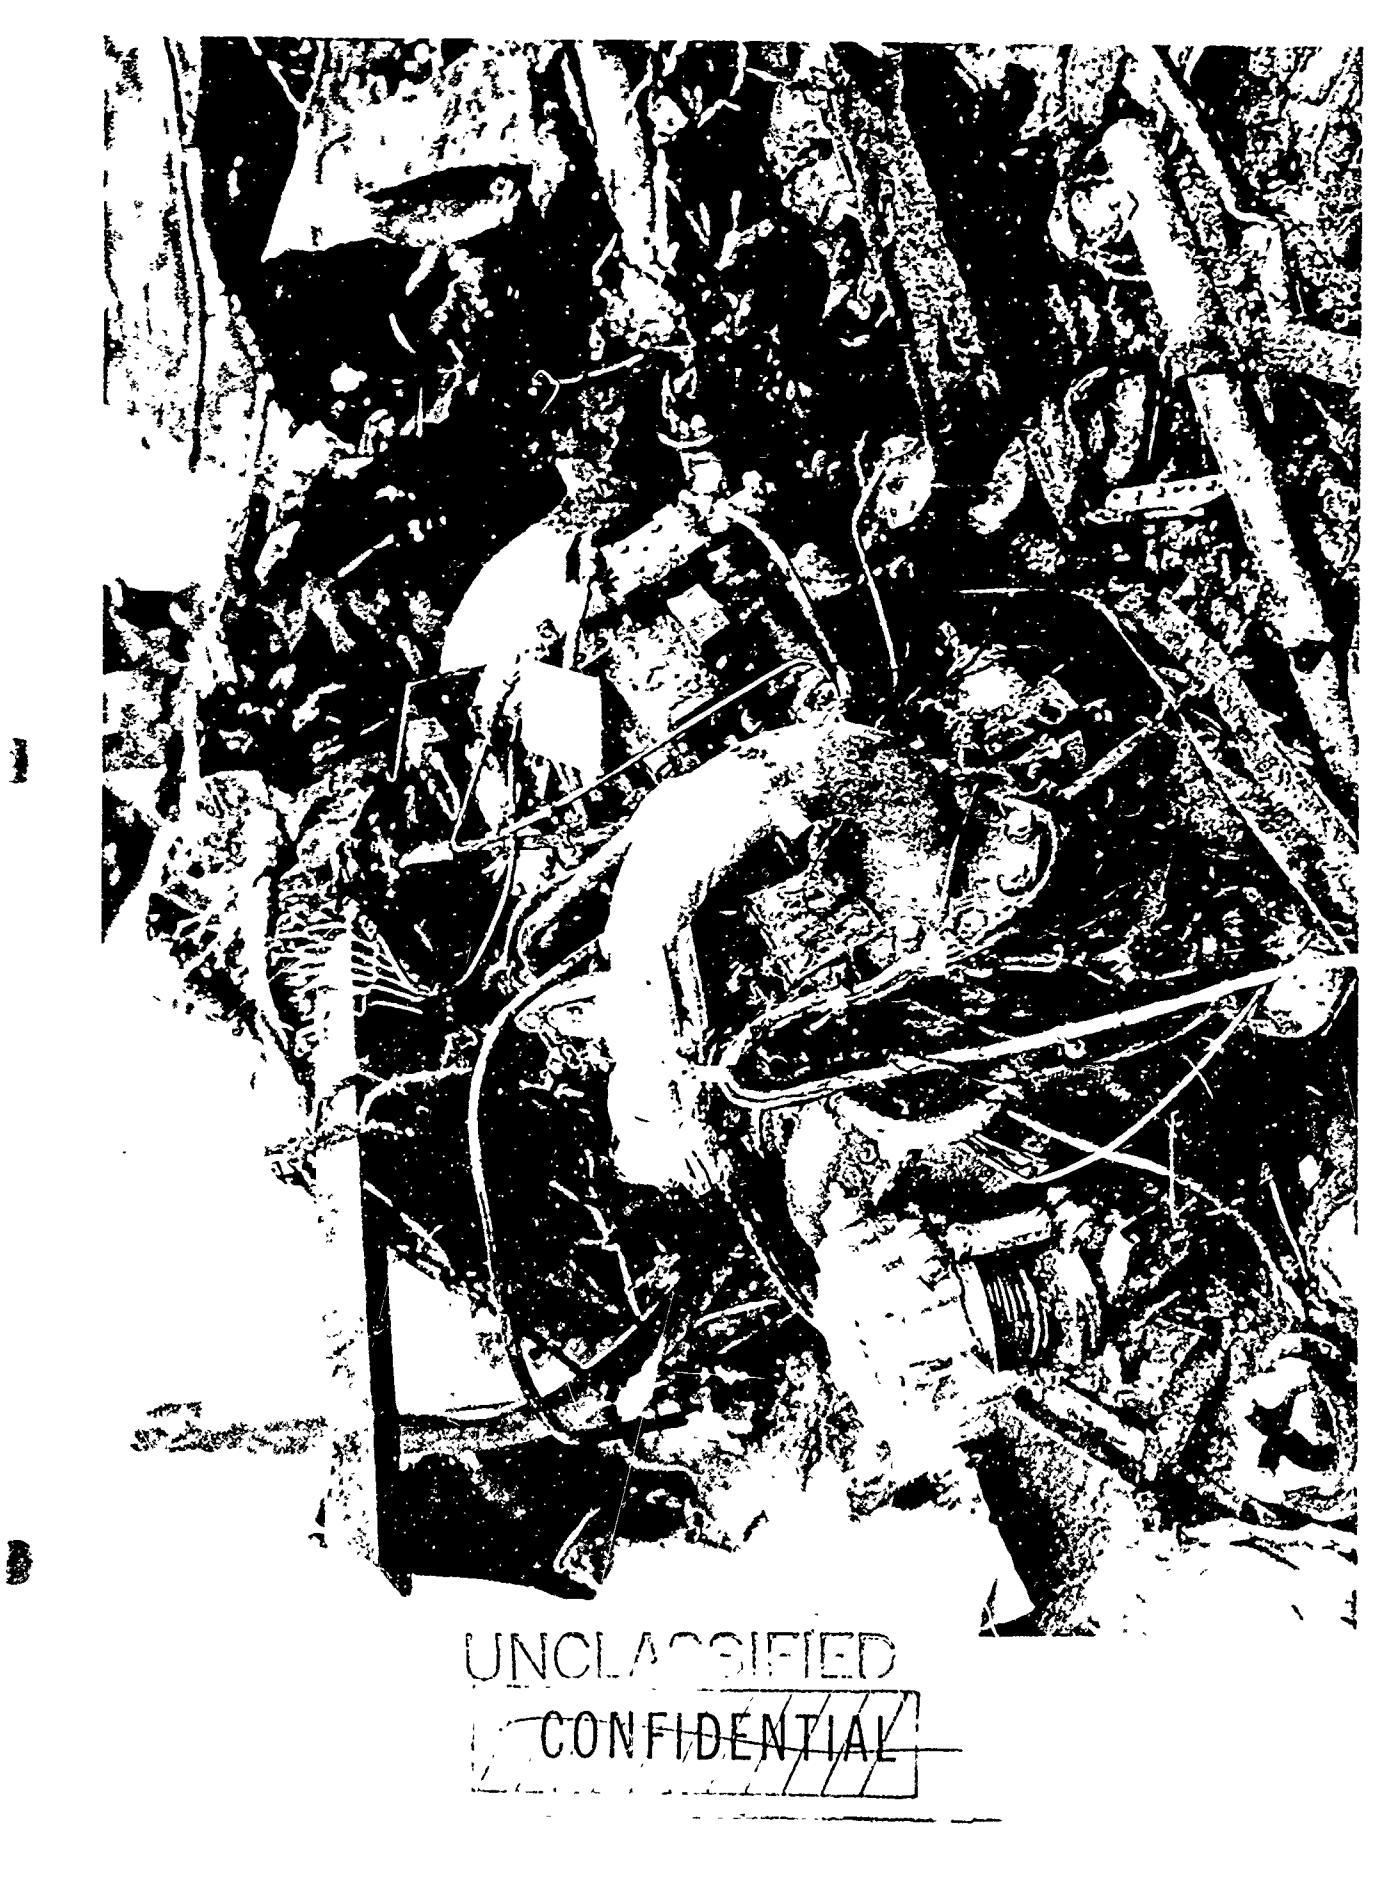
SUSTAINER COMBUSTION CHAMBER AFTER PARTIAL CLEAN-UP (Neg. No. 87864A)

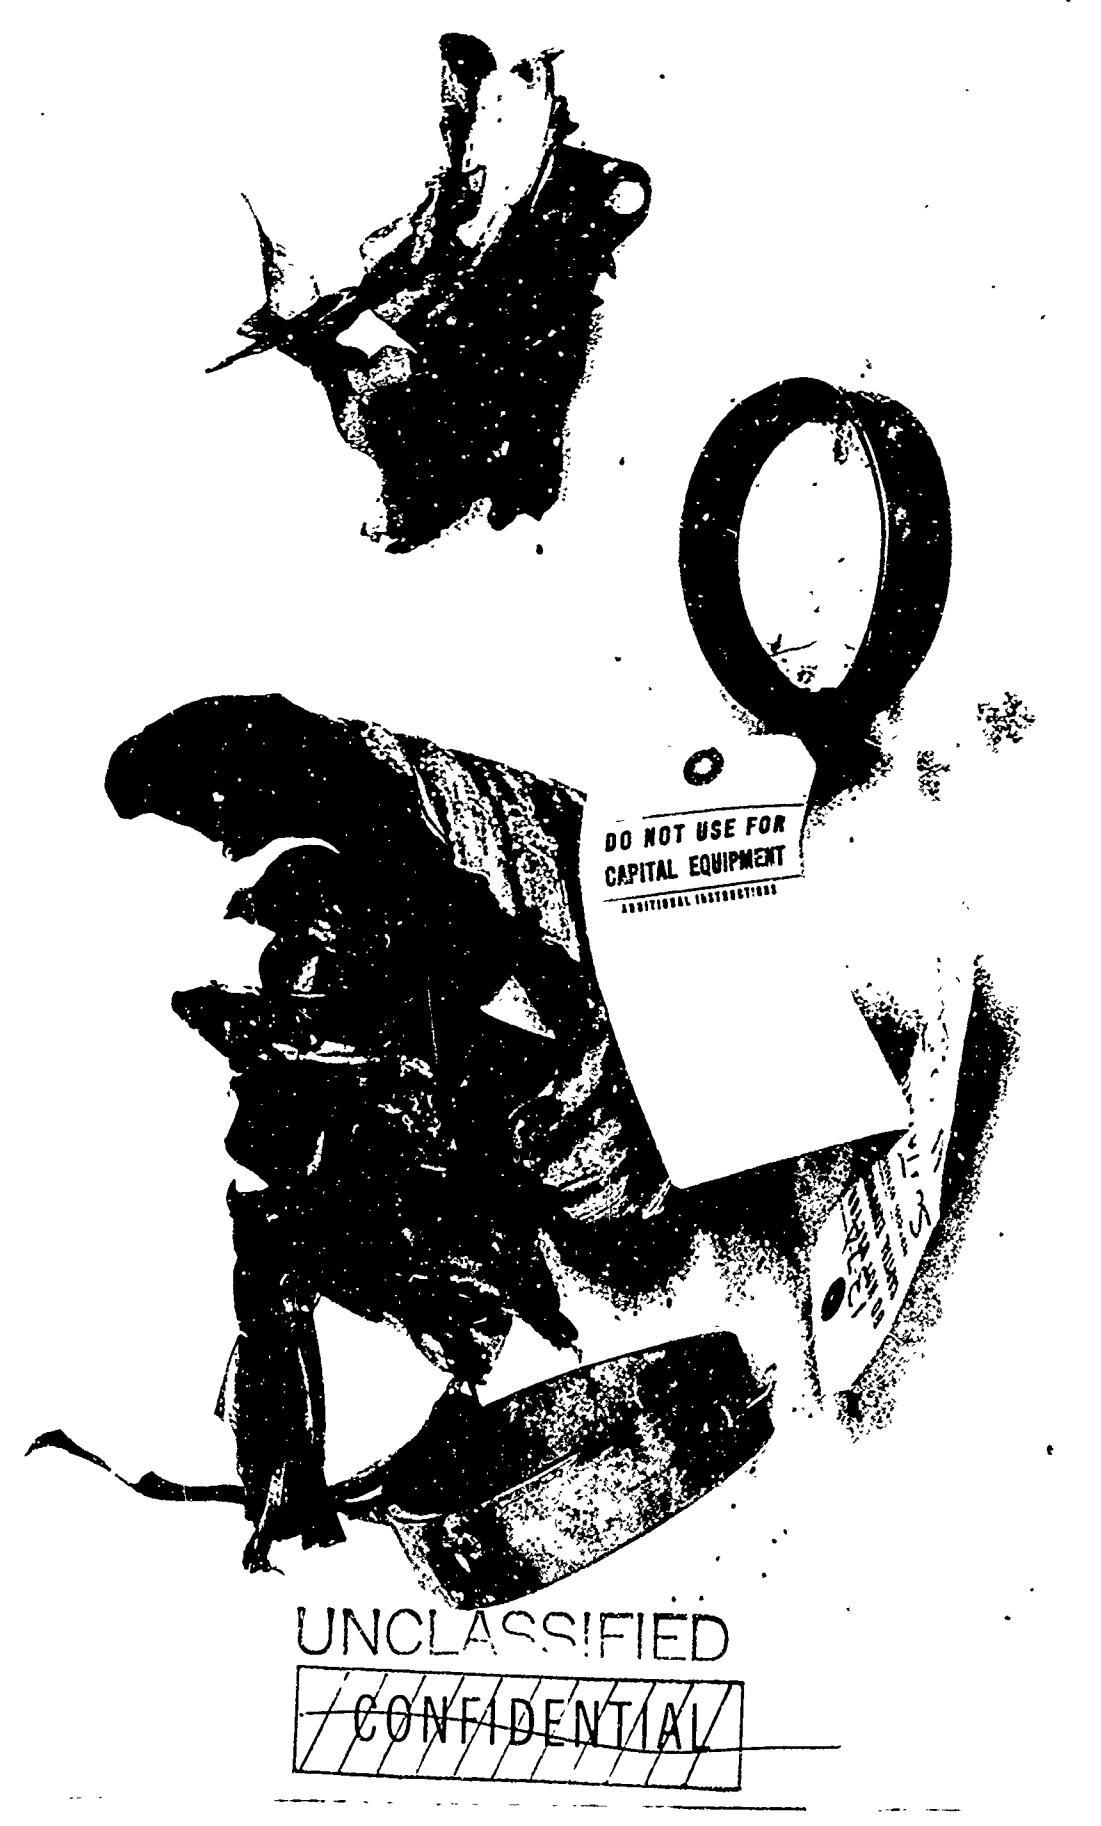
SUSTAINER TURBOFUMP (Neg. No. 88029A)

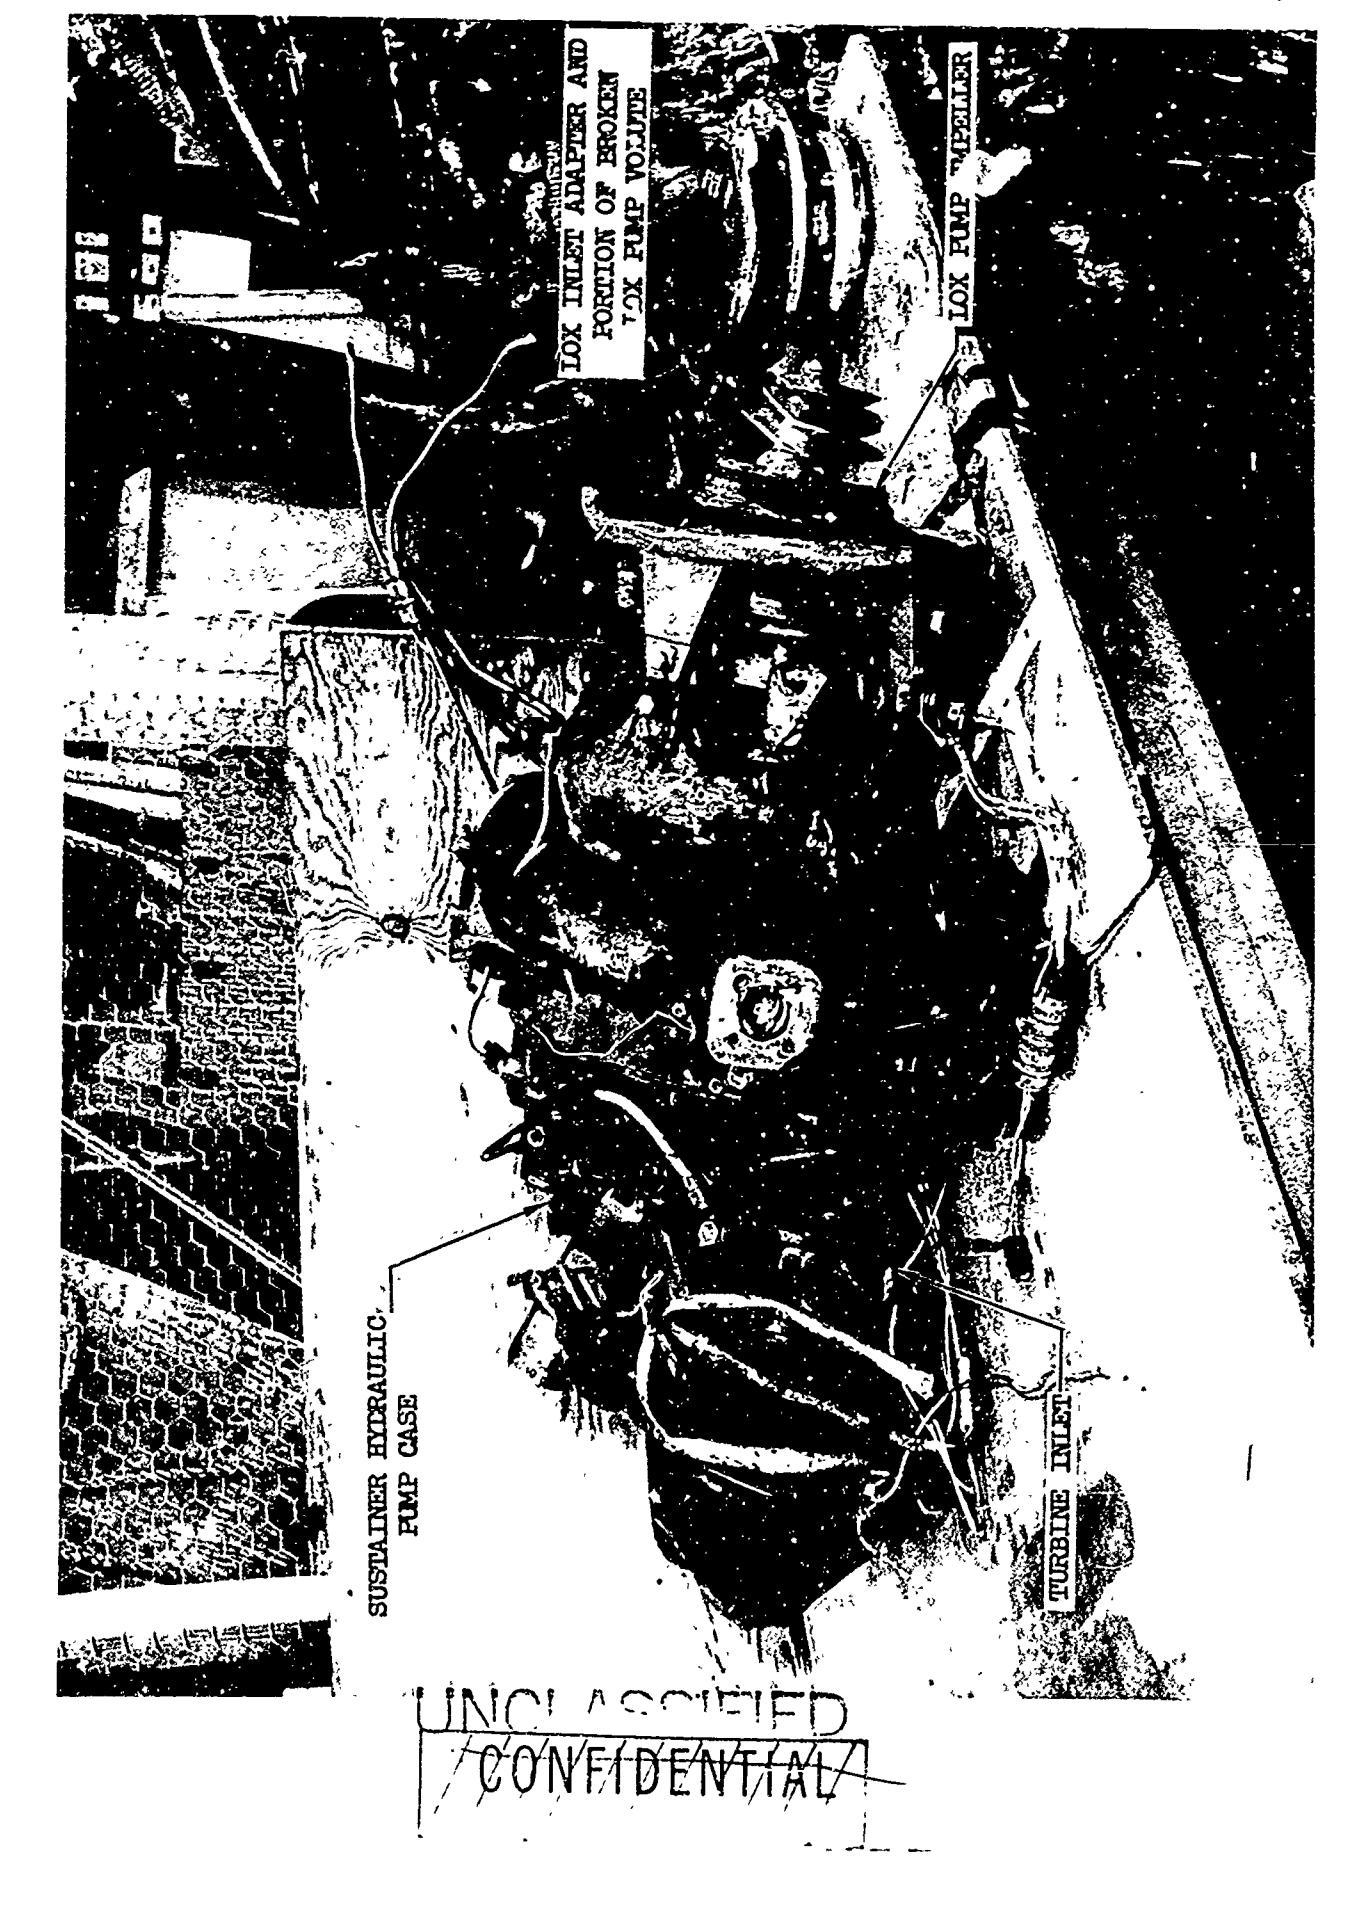
SUSTAINER TURBOFUMP (Neg. No. 88028A)

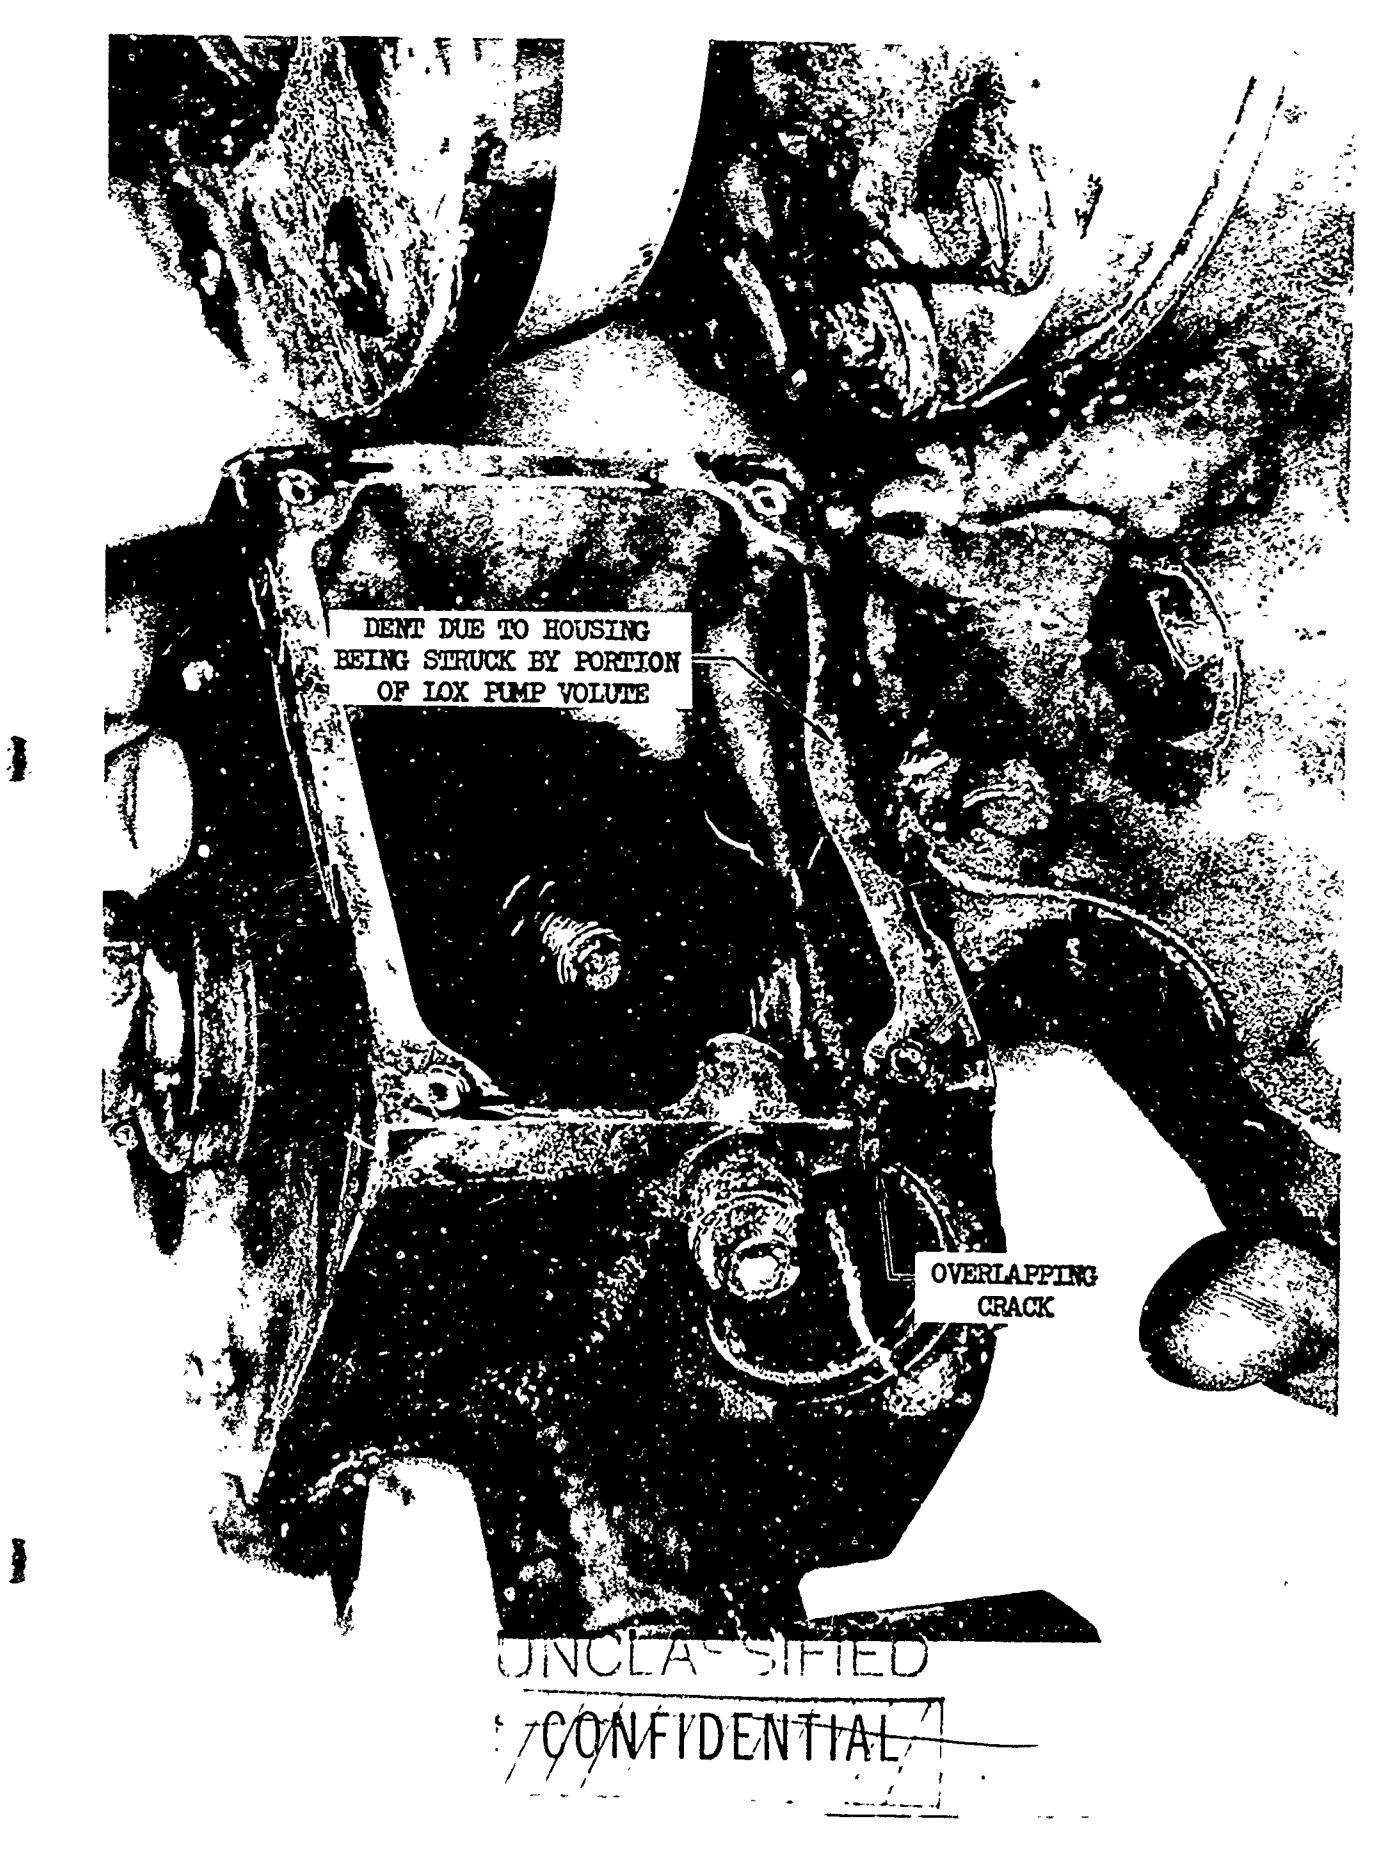
HAD SUPPRESSION VALVE ACTUATOR SHOWN IN FOSITION ON THE THRUST CHAMBER (Neg. No. 88021A)

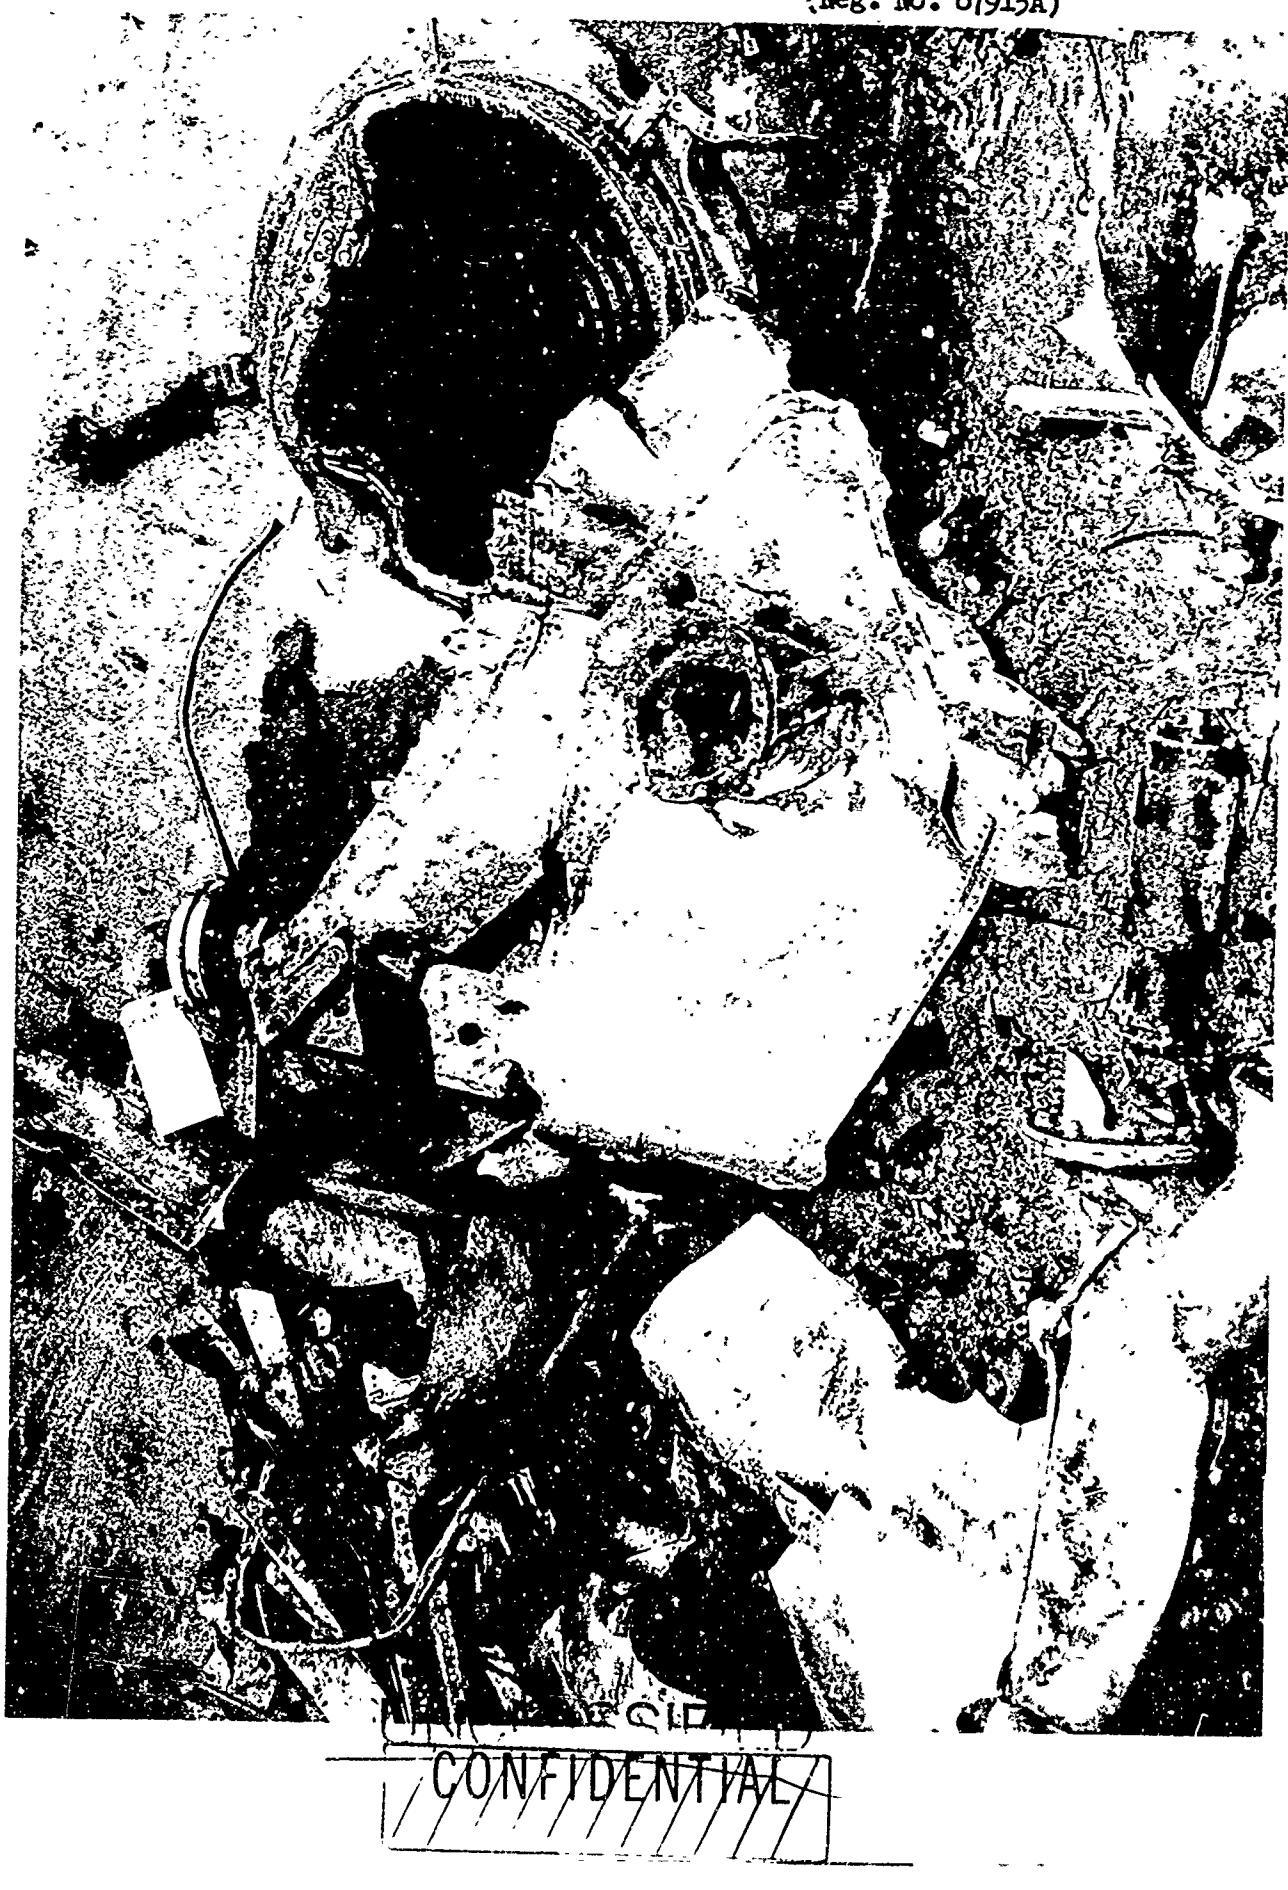
FIGURE 6.3-16

B1 TURBOFUMP ASSEMBLY FOUND WEDGED INTO TOWER STRUCTURE (Neg. No. 87918A)
