AFRPL-TR-70-43

**LONG-TERM STORABILITY
OF
PROPELLANT TANKAGE AND COMPONENTS
INTERIM REPORT #1**

R. B. MEARS, 1st LIEUTENANT, USAF

MAY 1970

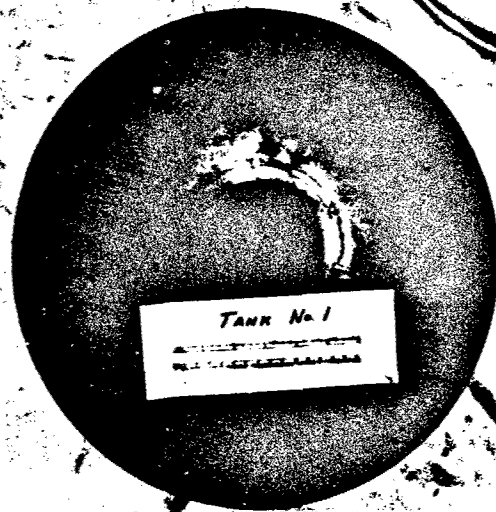
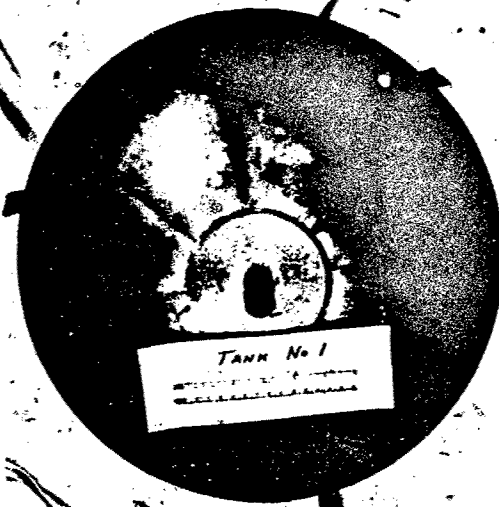
2. Leak Test - The tank was baked at 250°F for one hour. It was then pressurized with 100% helium for 30 hours. The tank was then leak checked by the hand probe method, using a CEC helium mass spectrometer. One leak was found in the bottom of the tank. This leak had a magnitude of 8.4×10^{-6} atm. cc/sec. One leak having a magnitude of 1.6×10^{-9} was also found in the top of the tank, Figure 2.

Figure 2. Leak Areas of Tank No. 1
0.2X (Shown by Arrows)

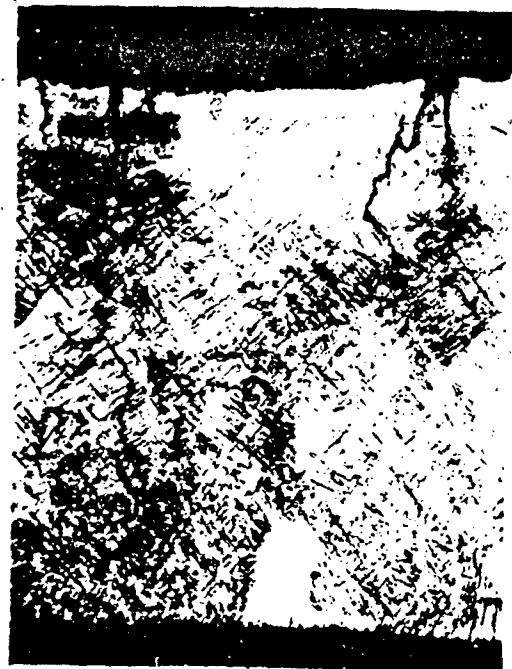
Figure 7. Stress-Corrosion Cracks and Alpha Case in Discolored Area, Unetched and Etched. (100X)

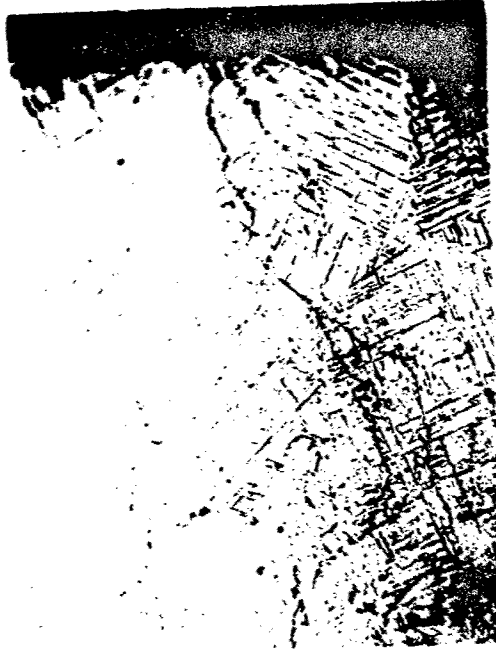
Figure 6. Photomicrograph Showing the Microstructure of the Ti-6Al-4V Titanium Alloy at a Stress Corrosion Crack (250X)

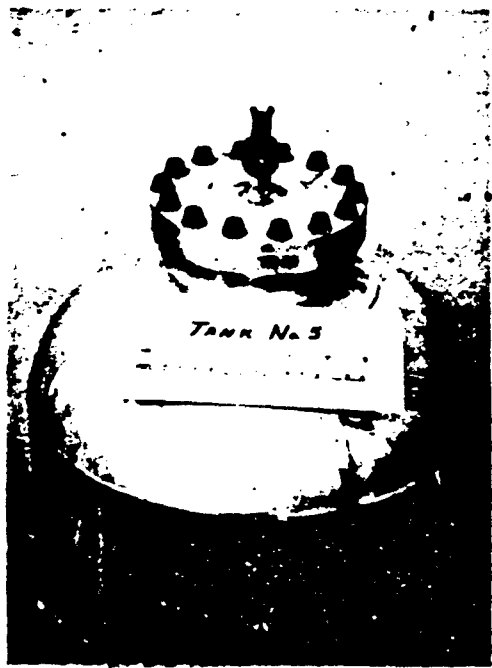
Figure 4. End Views of Small Tank S/N 5 1/4X

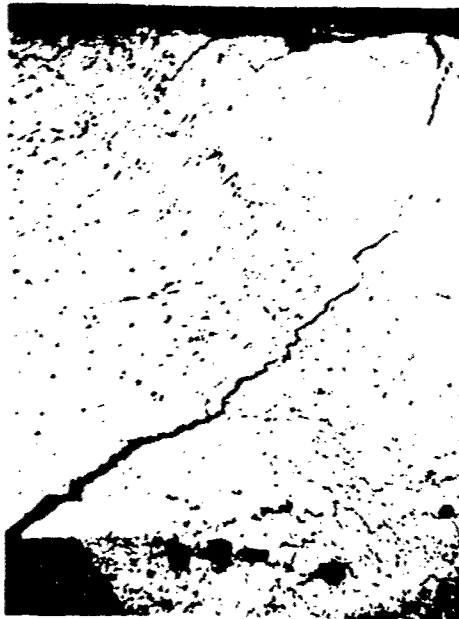
The cracks in the outlet-tube weld area were in the parent metal adjacent to the fillet weld, Figure 7. A microsection through one of these cracks is shown in Figure 8. These cracks were caused by hot-short cracking in the heat-affected-zone of the 7039 cover plate. Another microsection was made through an area that showed crack indication in x-rays of the area. Figure 9 is a photomicrograph of the internal surface of this area. Here a crack running parallel to the weld in the heat-affected zone is visible. This was also a hot-short crack as indicated in Figure 10. Figure 11 is the external surface across from the hot-short crack. Intergranular corrosion and the beginning of stress corrosion are apparent.

Figure 10. Microsection Through Hot-Short Crack in Figure 9. (50X)

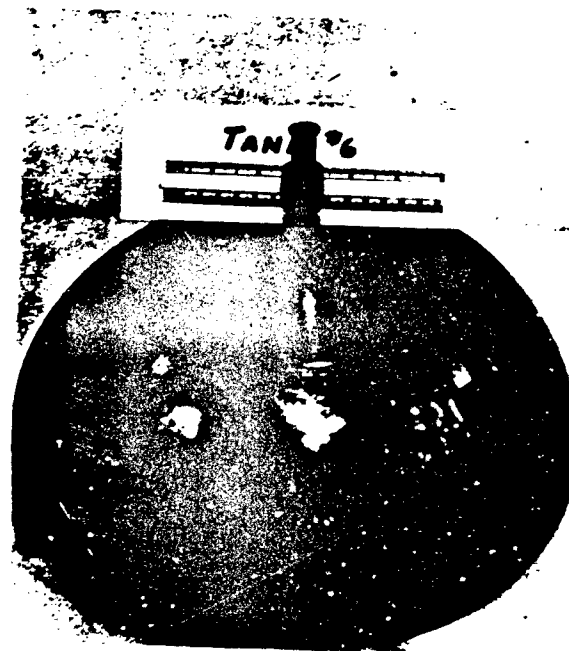
Figure 4. "Eenie" End of Tank No. 6.

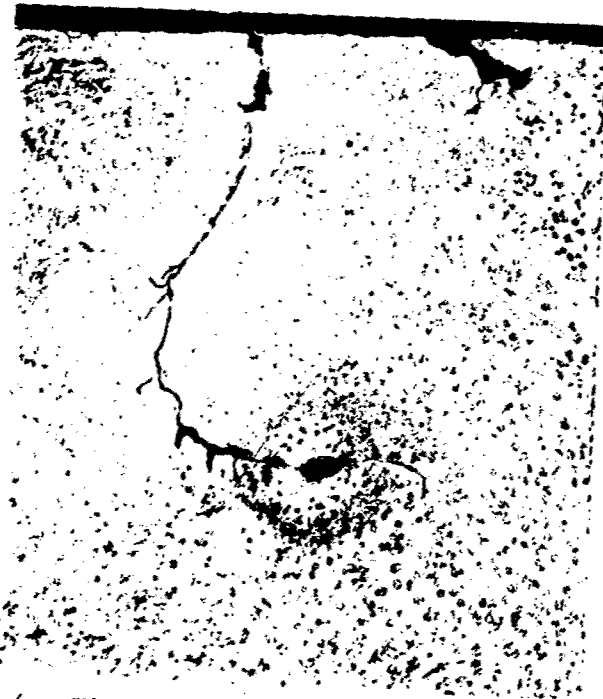
Figure 6. Photomicrograph of Hot-Short Crack in Dome Weld Area of Tank No. 6. 75X

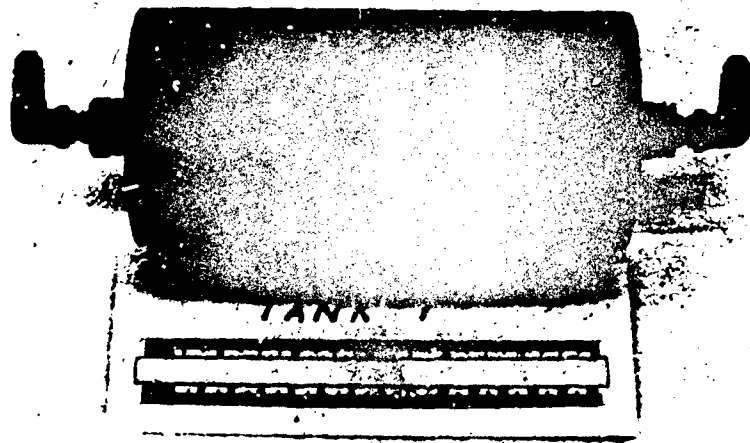
1. Macroexamination - The tank had been lightly etched over its whole external surface, Figures 1 and 2. Numerous stress-corrosion cracks were found in the HAZ of the boss weld on one end of the tank, and severe corrosion pits were found in the weld, Figure 3.

Figure 1. Sideviews of Tank Number 7. 1/2X
Note the Generally Etched Appearance
of the Tank.

1. In this case, the one recommendation is that no propellant tanks should be exposed to oxidizer fumes from leaking vessels while in a humid environment. HNO_3 formed (as occurred in this instance) can cause pitting and stress corrosion of propellant tankage.
2. Provisions should be made in design such that the exposure of short transverse grain direction to corrosive environments is avoided. Plate stock would have been better in this case for a welded-in outlet fitting since on longitudinal and long transverse grains would be exposed.
3. The material should always be in the fully aged -T6 condition for best corrosion resistance.

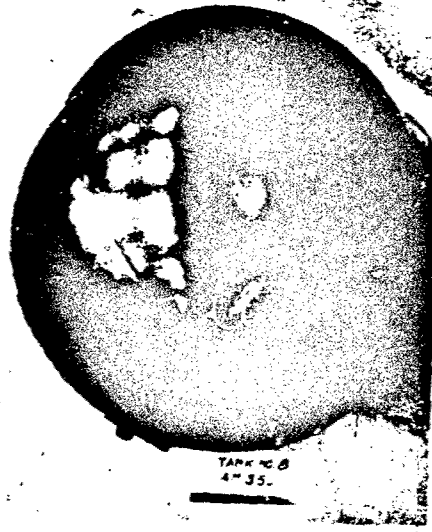
The tank was severely corroded, particularly the bottom half, as shown in Figures 1 and 2. Numerous corrosion pits were found on the bottom portion of the tank, as shown in Figures 3 and 4.

Figure 2. Top and Bottom View of Tank Serial No. 8. Representative Photomicrographs Showing General Corrosion. Approximately 1/4X Magnification.

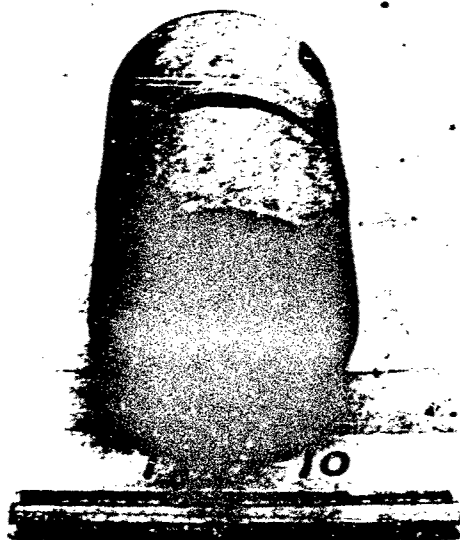
Figure 2. Endviews of Tank No. 10. 1/2X

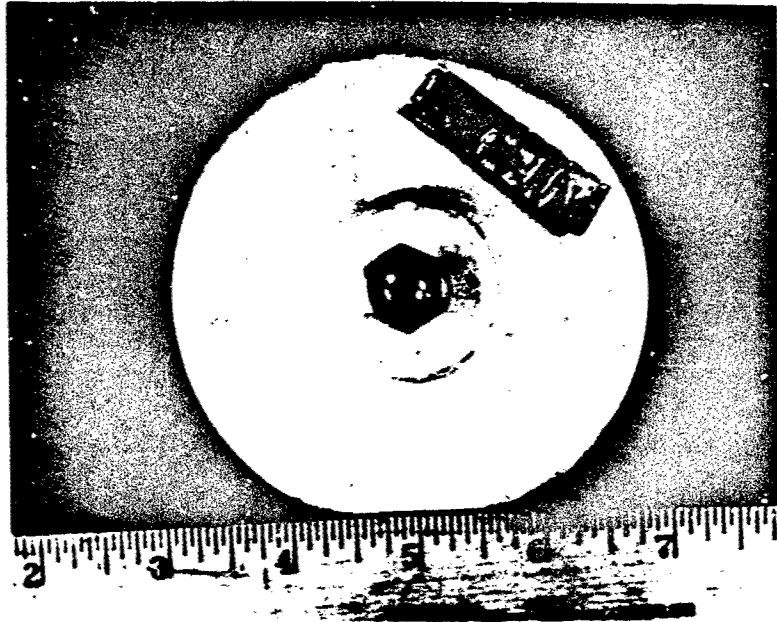
Figure 5. Photomacrograph showing an overall view of the bottom of small tank no. 11 0.75X
