## **Demonstration and Validation of a Lightweight Composite Bridge Deck Technology as an Alternative to Reinforced Concrete**

Final Report on Project F09-AR16

August 2016

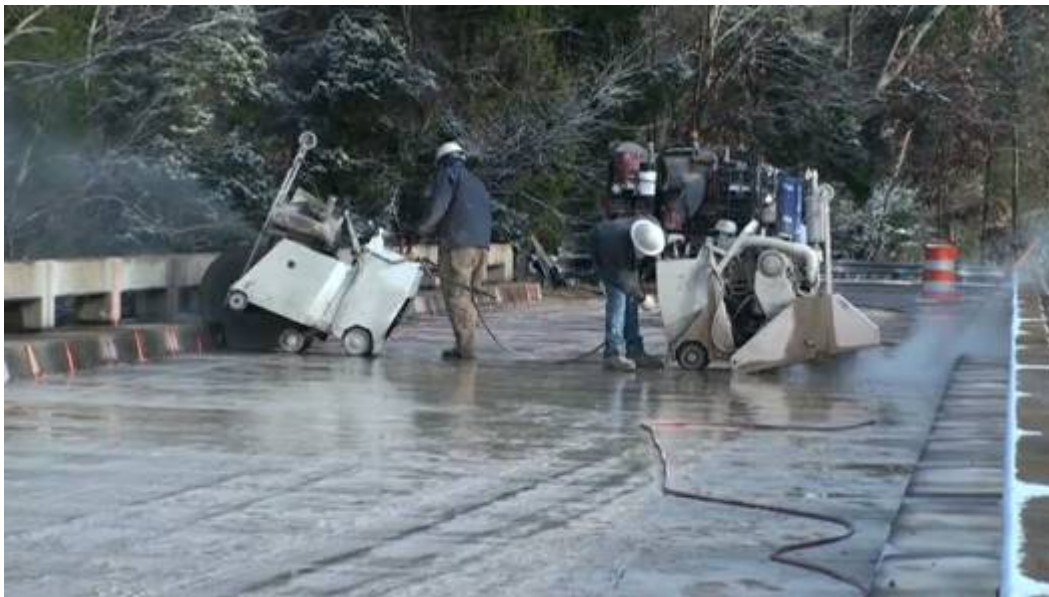
Figure 6. Cutting original bridge deck and barrier rail during demolition.

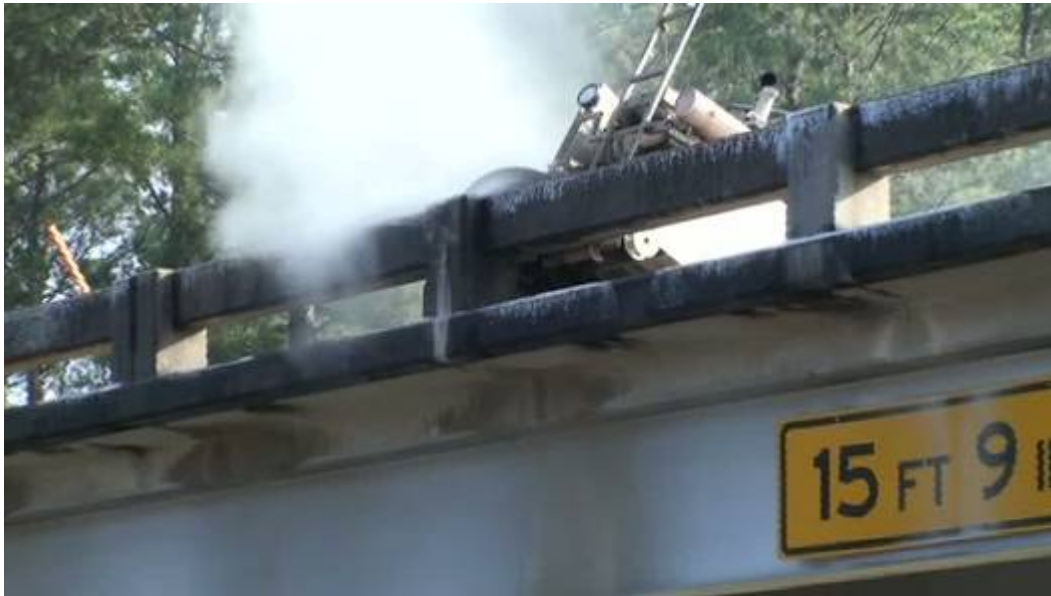
Figure 7. Sectioning of barrier rail.

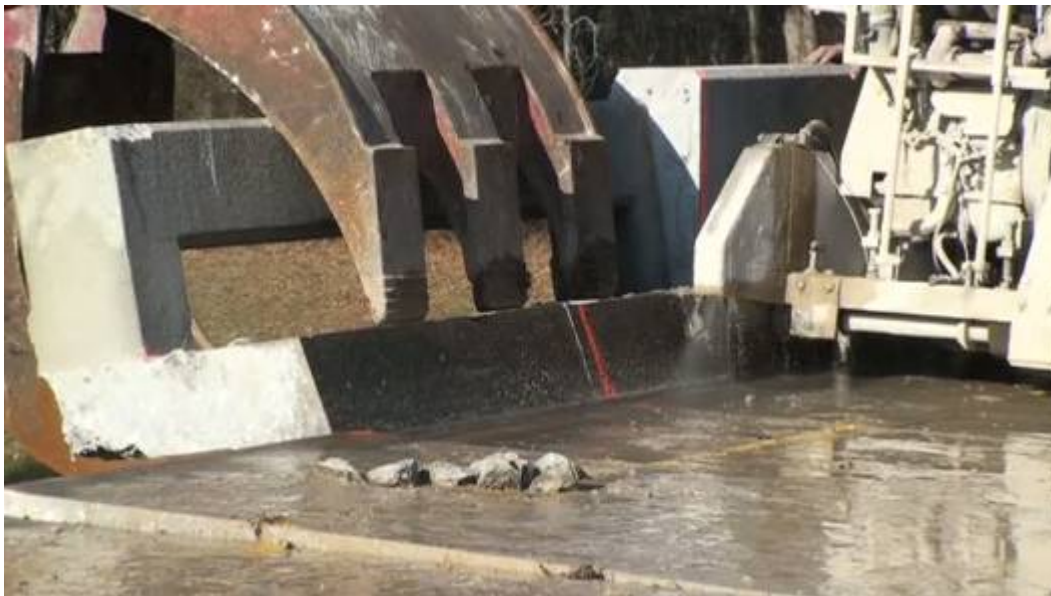
Figure 8. Removal of barrier rail section.

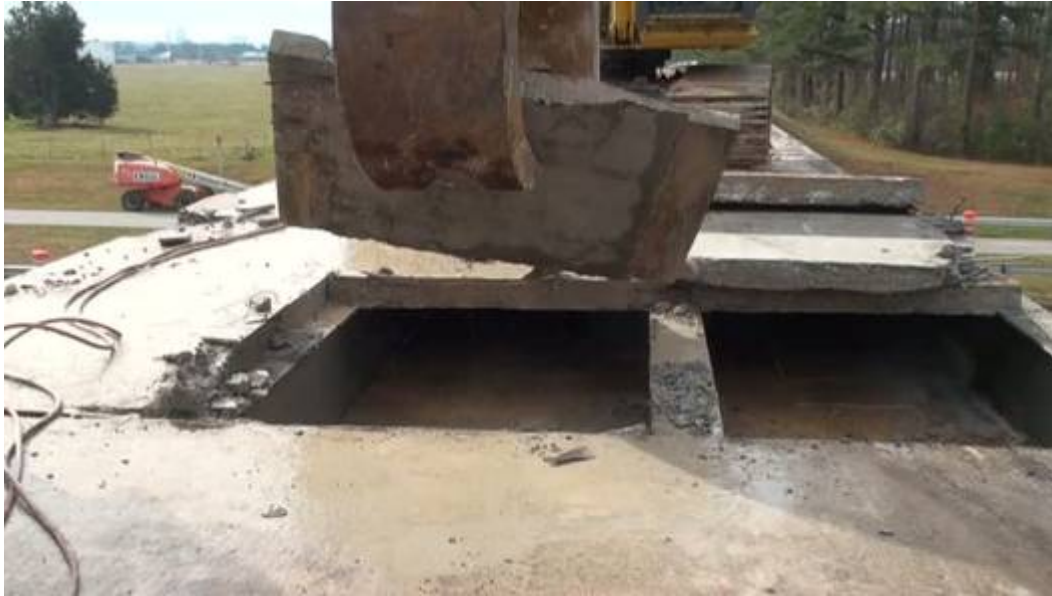
Figure 9. Removal of concrete deck section.

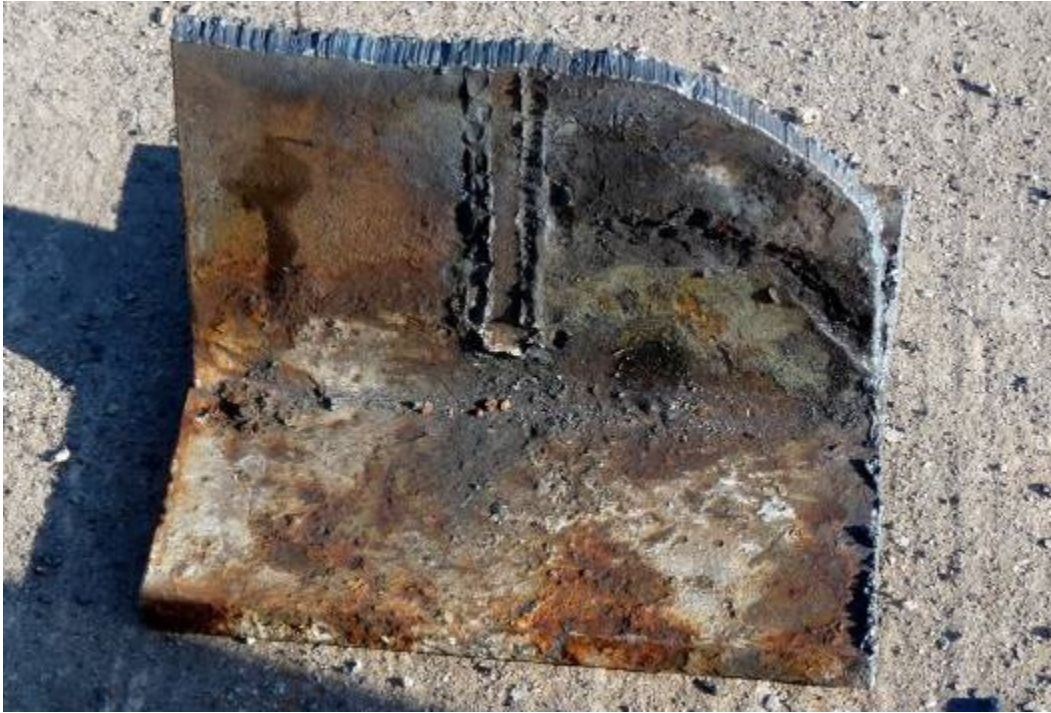
Next the girders were cleaned, inspected and rehabilitated. The inspection revealed that the upper corners of the girder ends needed to be replaced due to extensive corrosion. Figure 10 through Figure 12 show an end of a girder with the section removed, the extent of corrosion damage, and the repaired girder. Also the southeastern-most girder section was replaced in its entirety due to corrosion and impact damage. All girder refurbishment was performed by Redstone Arsenal DPW and was not part of the CPC project.

Figure 11. Removed section of girder shown in Figure 10.

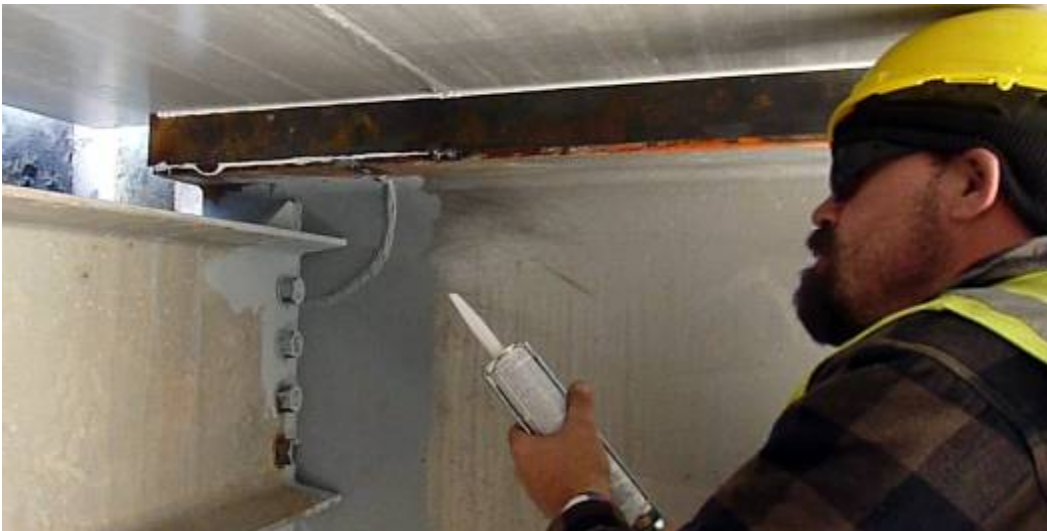
Figure 20. Caulking gaps above and below grout form.

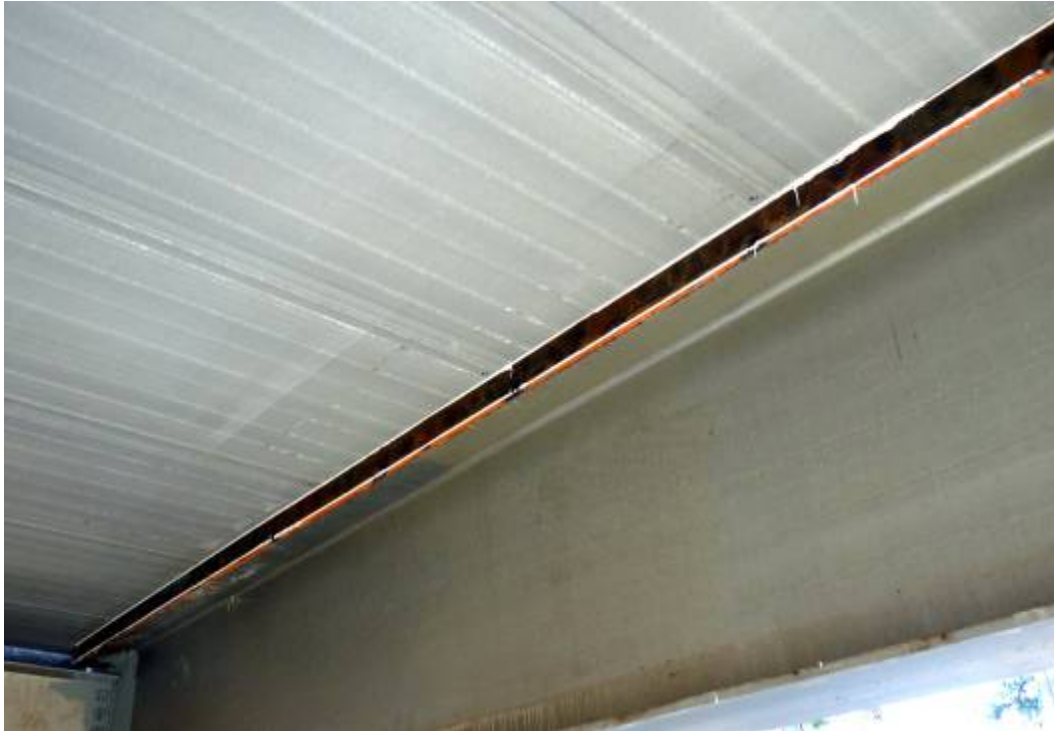
Figure 21. Caulked grout form (between girder flange and bottom of deck).

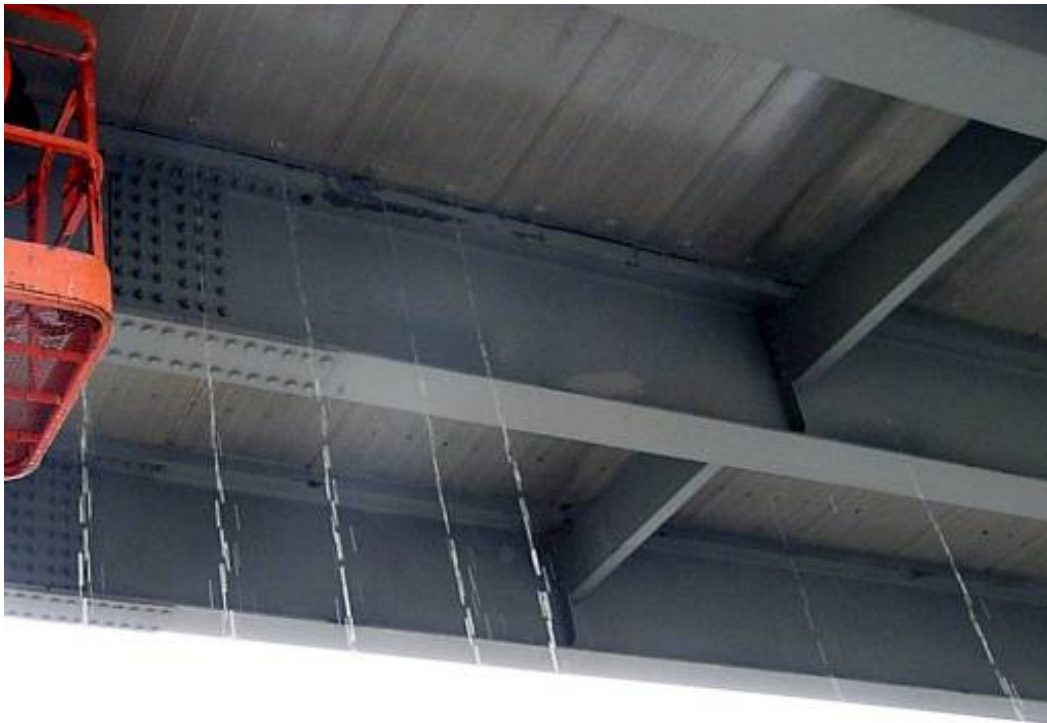
Figure 63. Additional weep hole drilled next to concrete-obstructed hole.

Because of the imminent onset of the winter freeze/thaw cycle in Huntsville, AL, immediate corrective action was undertaken to drill additional weep holes in the bottom of the deck. Overall, approximately 296 additional 0.5 in. diameter weep holes were drilled into the deck. Of those, approximately 90% drained in excess of 2 gallons of retained water (Figure 62). Finally, in locations where concrete was obstructing existing weep holes, MEC drilled replacement holes at higher elevations at 6 in. intervals until an unobstructed weep hole could be established (Figure 63).

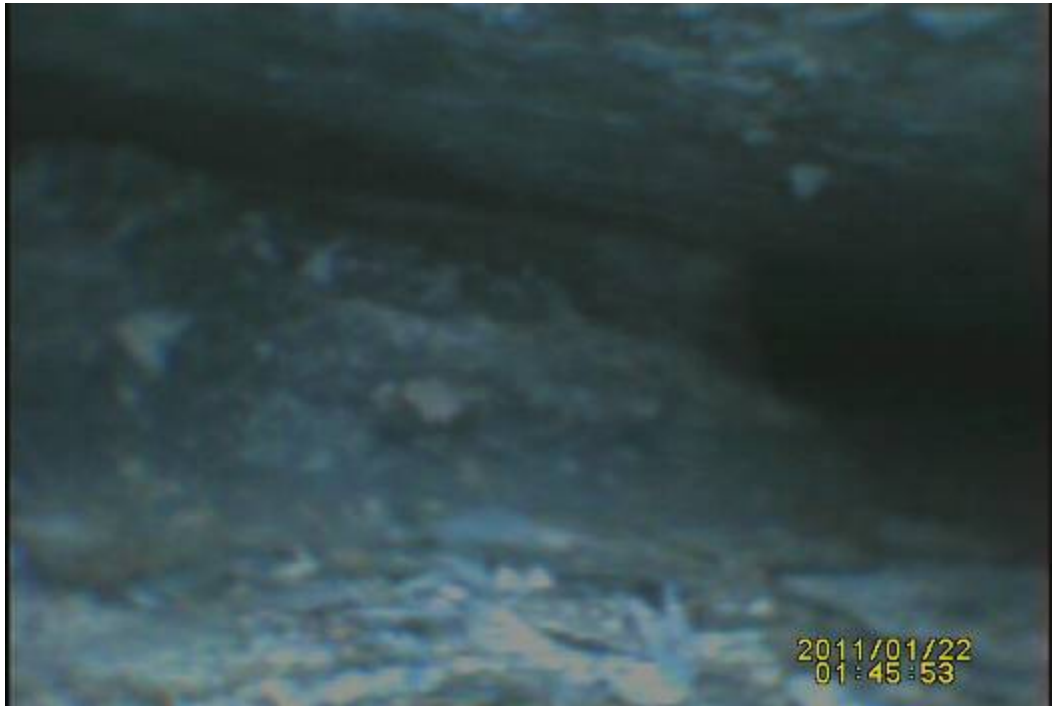
MEC also conducted a borescope inspection of the interior of several voids and several deck channels. During these inspections, no significant amount of water or external debris was observed in either the deck sections or in the voids. Figure 65 and Figure 66 show the interior of two voids. The bottom of the deck can be seen faintly at the top of each figure. Figure 67 and Figure 68 show the interior of composite deck sections. The deck surface and foam dam material for a grout pocket are visible.

Figure 66. Borescope view of void interior.

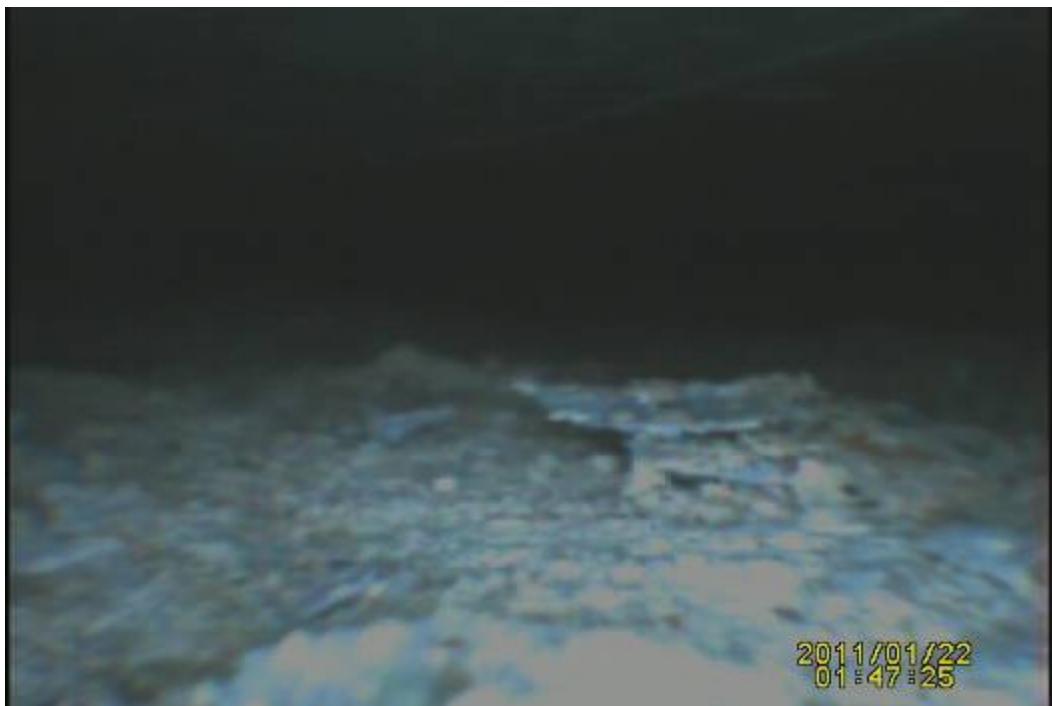
Figure 67. Borescope view of deck section interior.

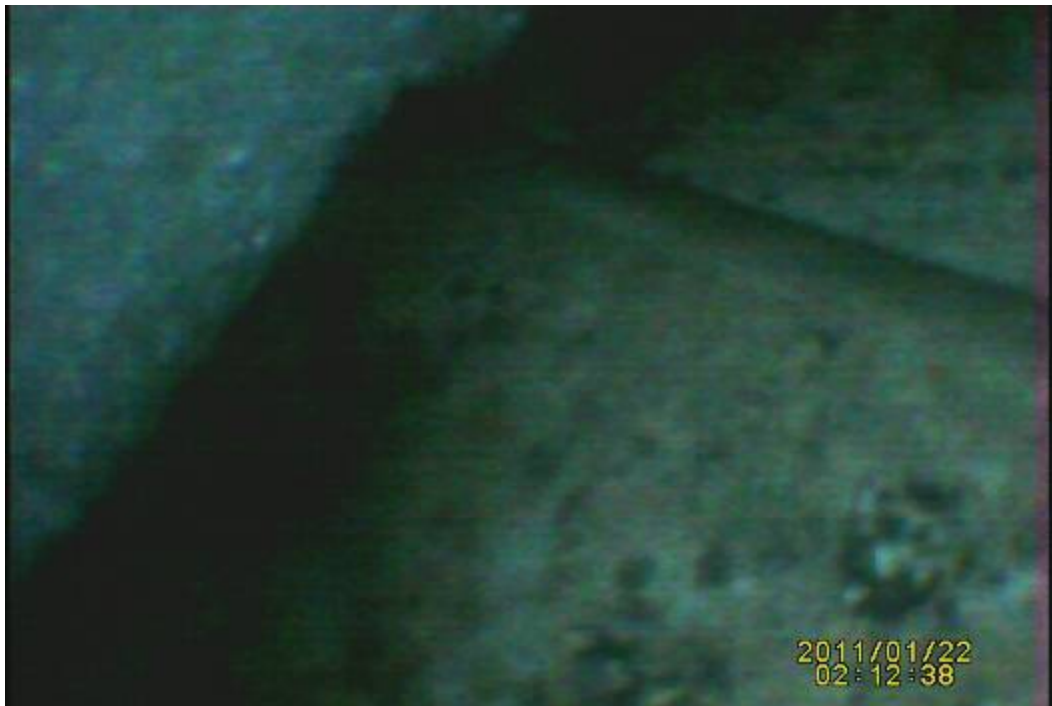
Figure 68. Borescope view of deck section interior.

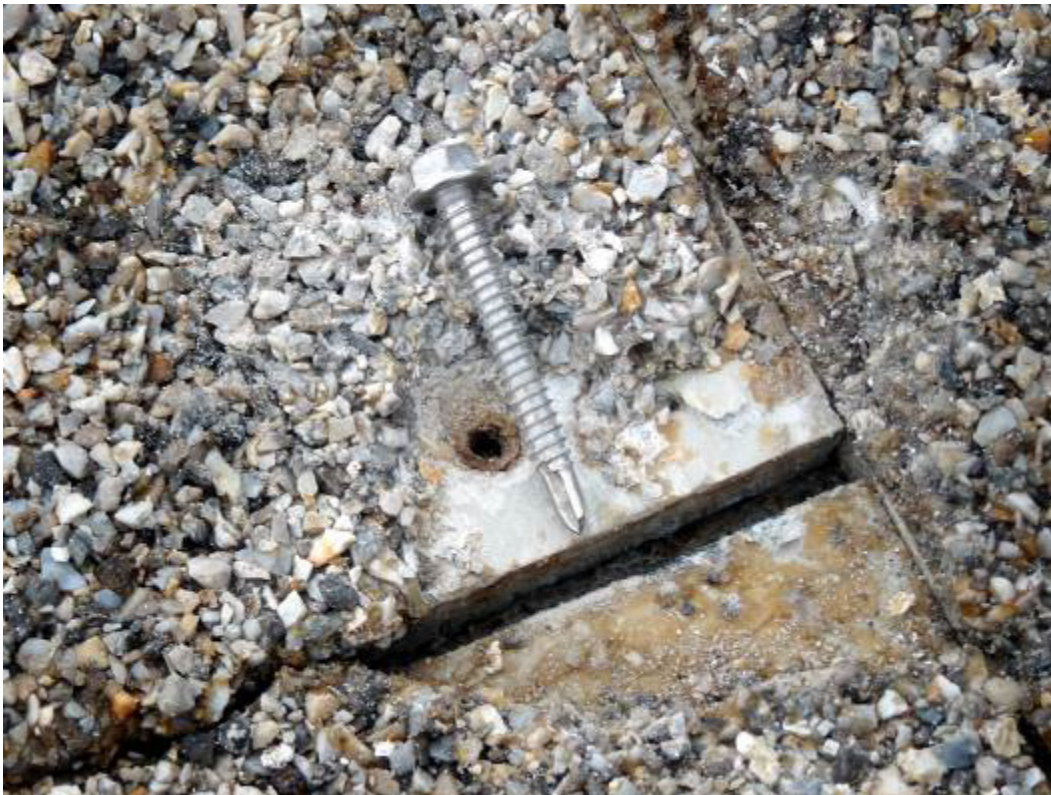
Figure 71. GFRP composite sheets with additional fasteners installed.

Repairs to the wear surface and voids began 16 May 2011. First, dirt and other foreign materials were removed from the cracks adjacent to the raised flat composite sheets supporting the wear surface. The wear surface material was then removed to expose the closest fasteners (Figure 69). The exposed fasteners were removed to check whether the threads had damaged the composite material (Figure 70). Although not visible in Figure 70, in all cases the screws had in fact been overtightened, shearing the composite material and contributing to the panel raising. Replacement fasteners were installed adjacent to the original ones, and fasteners were added to help prevent any future panel lifting (Figure 71, Figure 72, and Figure 73). In all instances, replacing the fasteners returned the composite sheets to sit flush with the adjacent ones. Figure 73 shows two locations where extra screws were added before wear surface repair. The same area after the first application of polymer concrete is shown in Figure 74. The completed repair, before full cure, is shown in Figure 75.

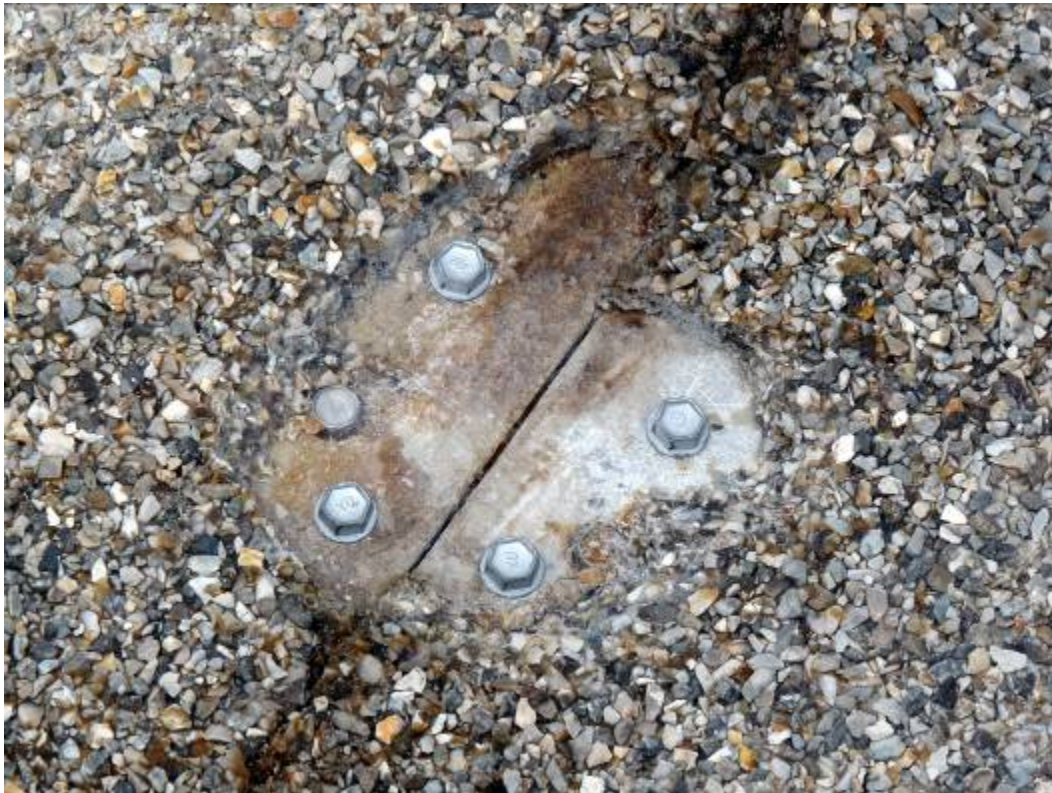
Figure 72. GFRP composite sheets with additional fasteners installed.

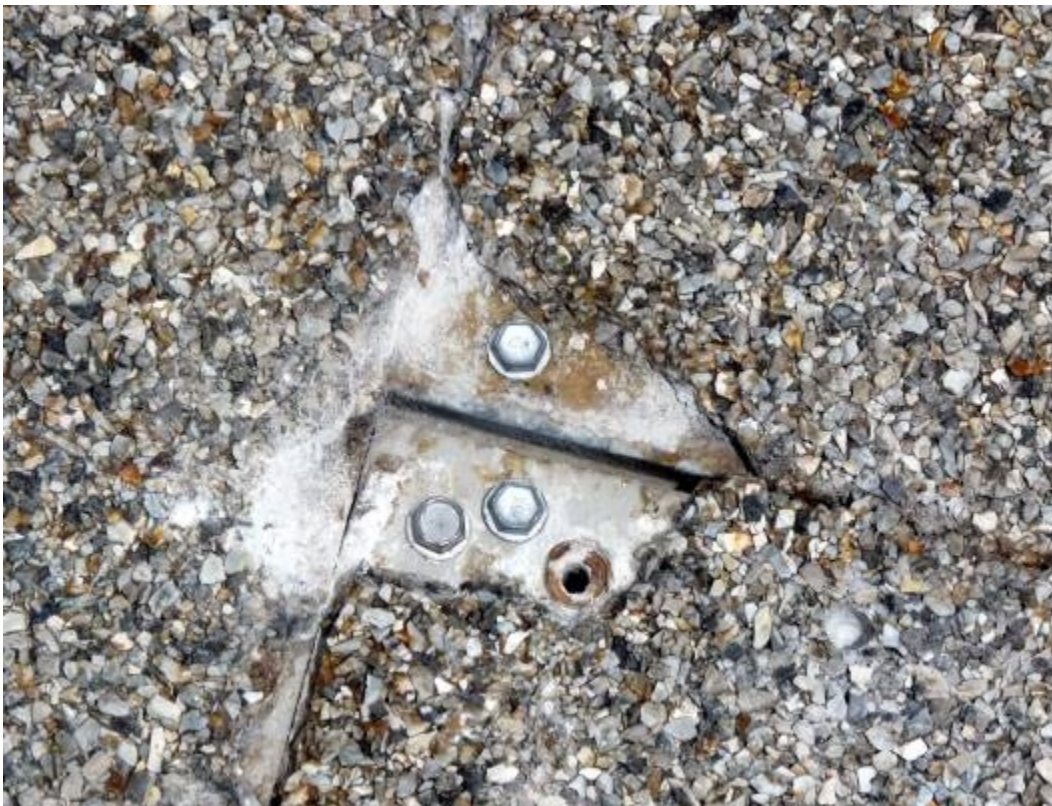
Figure 73. GFRP composite sheets with additional fasteners installed.

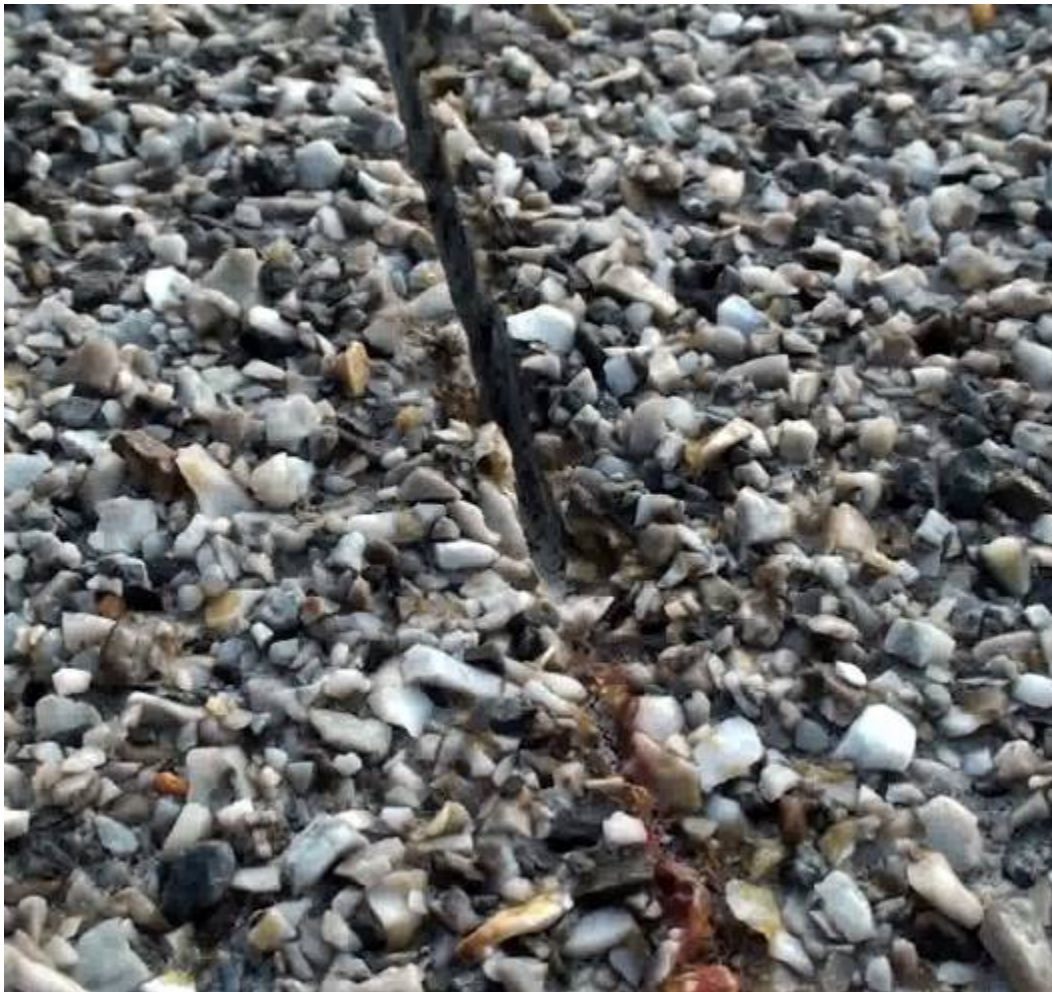
Figure 77. Cutting v-groove.

After these initial repairs to the raised sheets and adjacent wear surfaces were finished, the reflective cracks were repaired. The cracks were cut open to provide a surface to adhere to the sealant. First, a straight cut was made to provide a guide for the second step (Figure 76), which was cutting a v-groove (Figure 77). The completed v-groove is visible in Figure 78. Once the v-groove was cut, the cracks were cleaned of dust and debris using compressed air. Next, a primer (Tremco Vulkem 171) was applied (Figure 79). This material was used at the suggestion of the sealant manufacturer because adhesion testing was not going to be practical for this particular repair, and the GFRP composite-sealant bond is not as common as bonds to other materials. Once the primer cured, the sealant (Tremco THC-901) was applied. The sealant was mixed in accordance with manufacturer's instructions, including the inclusion of a coloring agent to match the wear surface coloring. The sealant was applied with a bulk sealant gun (Figure 80). Before the sealant set, a scraper was used to remove excess material (Figure 81) and to ensure contact between the sealant bead and the top of the wear surface on each side of the joint (Figure 82). The completed repair is shown in Figure 83, and the procedure for the wear surface repair is documented in Appendix B, section B1.

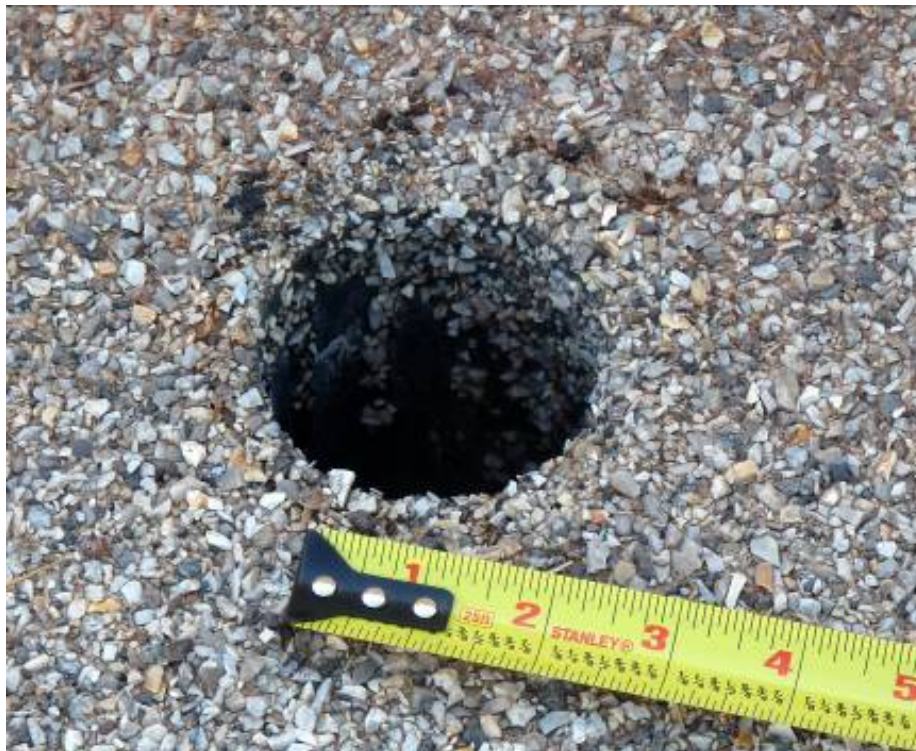
pool on the bridge deck until it was deep enough to flow over into the scuppers (Figure 85). This drainage problem was compounded by the loose aggregate and sand that had migrated to the “downhill” side of the bridge. In order to facilitate drainage of the scuppers, these lips were removed using a grinder (Figure 86), and a slight downward bevel was ground toward the hollow of PVC body in each scupper (Figure 87). Completed repairs on the southwest end of the bridge can be seen in Figure 88. Note that a small fraction of the loose aggregate and sand that had accumulated on the bridge is visible in the upper left corner of Figure 88.

Figure 85. Water pooling on bridge.

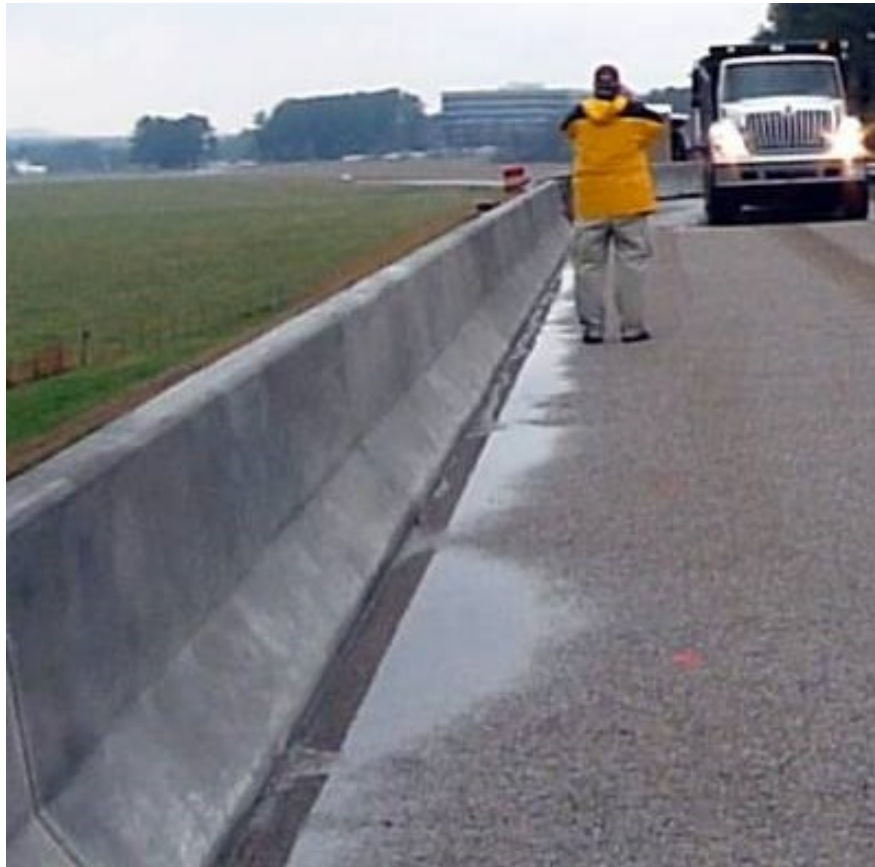
Figure 86. Grinding lip off scupper.

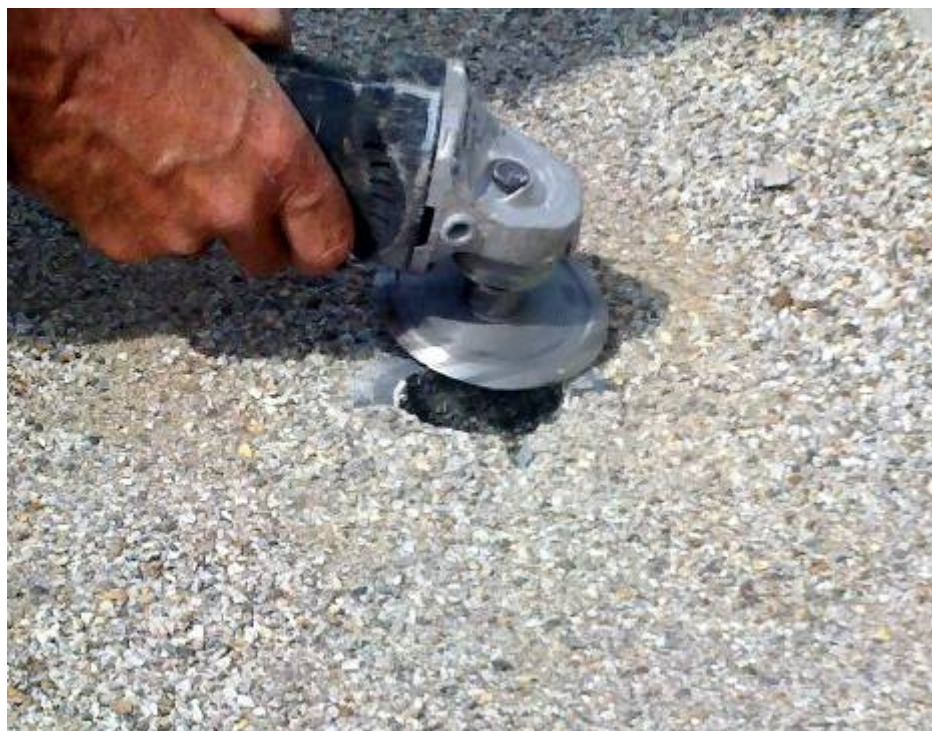
Figure 87. Repaired scupper.

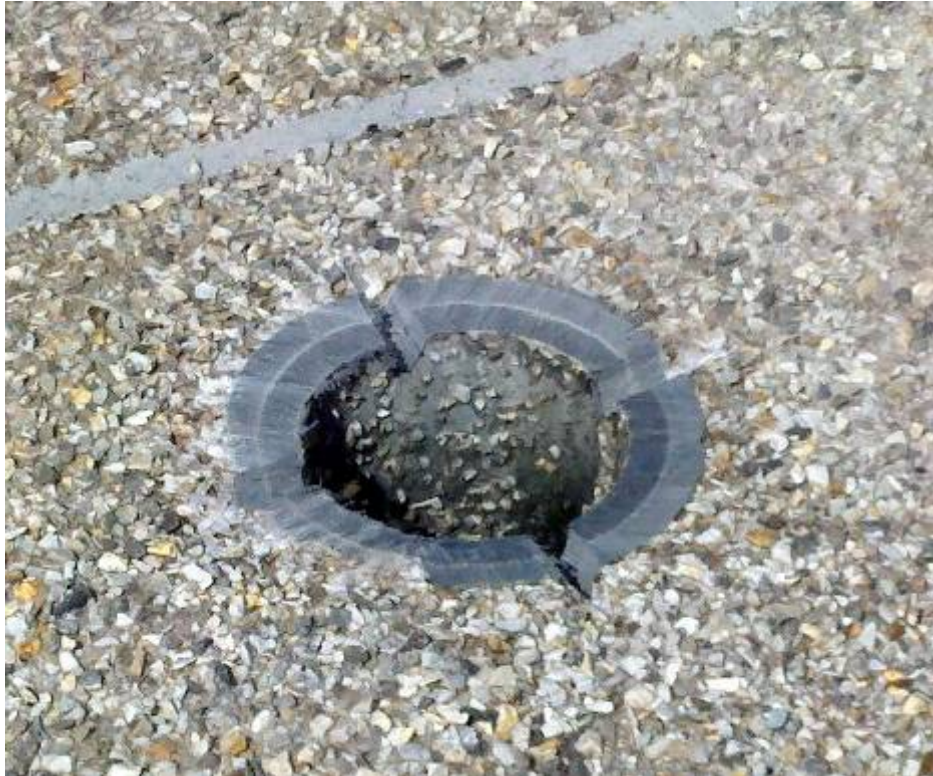
Figure 88. Repaired scuppers.

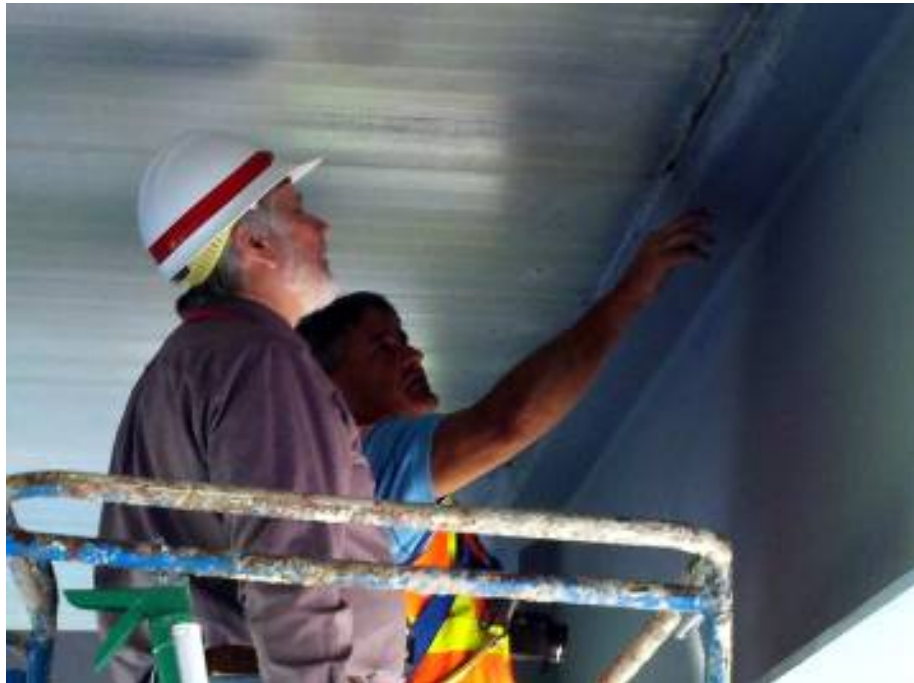
Figure 91. Cleaning surfaces prior to attaching grout form.

Once the voids were identified, forms were attached to contain the repair material. First, mating surfaces on the bridge deck and steel grout haunch were mechanically cleaned using a scraper (Figure 91). Temporary forms to contain grout injected into the voids were fabricated from aluminum siding material bent to a right-angle profile. An injection hole was drilled in the “uphill” side of the form, where all of the voids were detected. In cases where the width of the void extended across the entire girder, aluminum containment forms were added to both sides of the girder, and a vent hole was drilled in the “downhill” side of the form in order to indicate the complete filling of the void and to avoid air entrapment. In cases where only one side of the girder allowed access to the void, vent holes were drilled on both sides of the injection hole to prevent air entrapment. In all cases, the mating surfaces for the aluminum containment forms were caulked using TremCo 626 sealant (Figure 92), and then the forms were

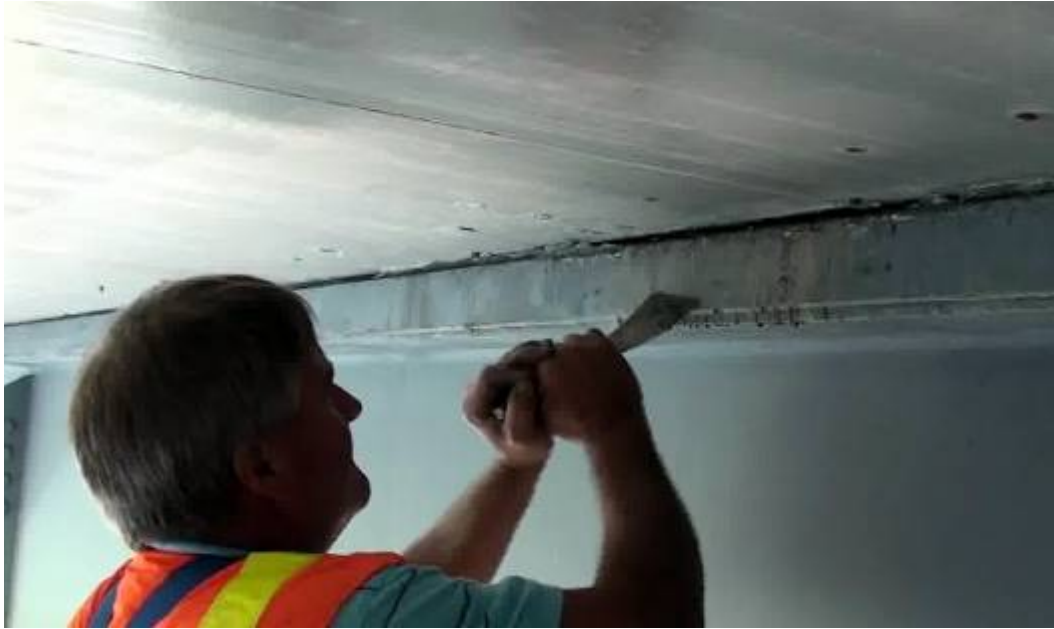
Figure 92. Caulking form joints.

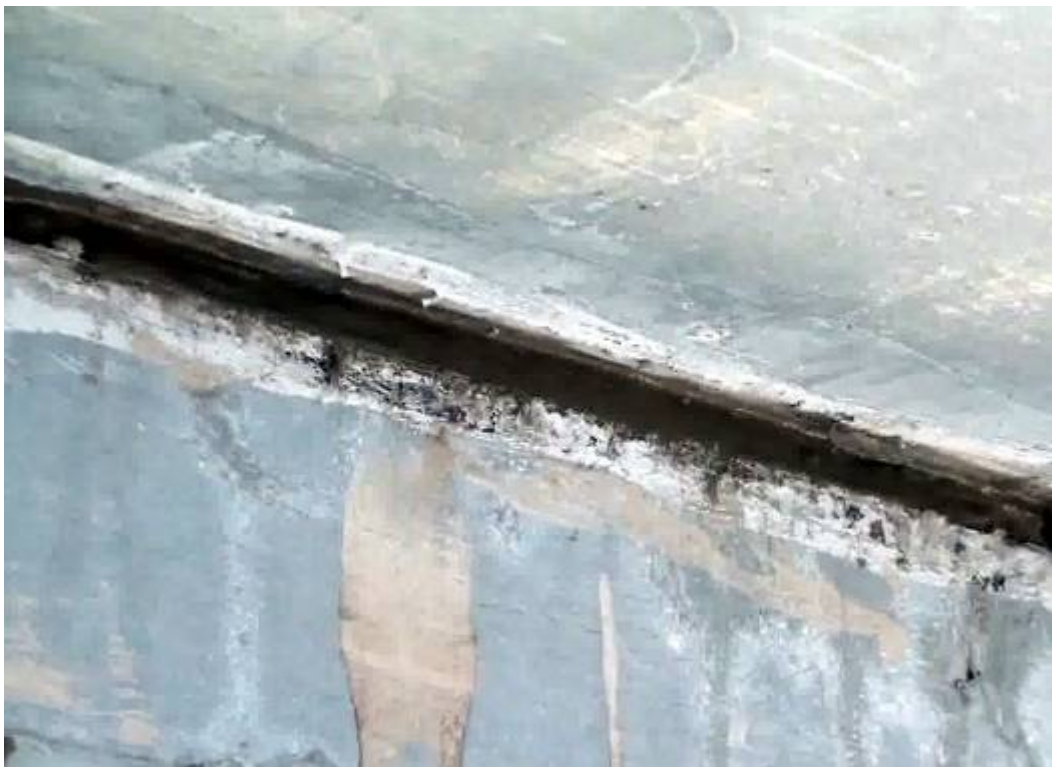
During an inspection of the bridge in March 2012, areas of active corrosion were evident in places where the steel form for the grout haunch was attached to the top girder flange (Figure 101). Because the steel form provided no structural purpose after the grout haunch cured, sections affected by corrosion were cut out in order to evaluate the problem. As shown in Figure 102, red iron oxide corrosion had formed on the edge of the girder's top flange. When water is trapped behind inside the grout haunch form, this steel becomes electrochemically connected with the steel in the girders, evidently creating localized galvanic corrosion cells. To eliminate this condition, a contract was awarded through the Redstone DPW to remove the steel grout form from the entire bridge and to have the corroded areas of girder cleaned, surface-prepared, and painted.

Figure 101. Corrosion on top flange where steel strip attached to form grout haunch.
