## **Demonstration and Validation of Reactive Vitreous Coatings to Prevent Corrosion of Steel Fixtures Attached to Masonry Walls**

Final Report on Project F10-AR12

Under Project F10-AR12, "Use of Reactive Vitreous Coatings on Steel Fixtures for  
Masonry Wall to Prevent Corrosion at Fort Stewart, GA"

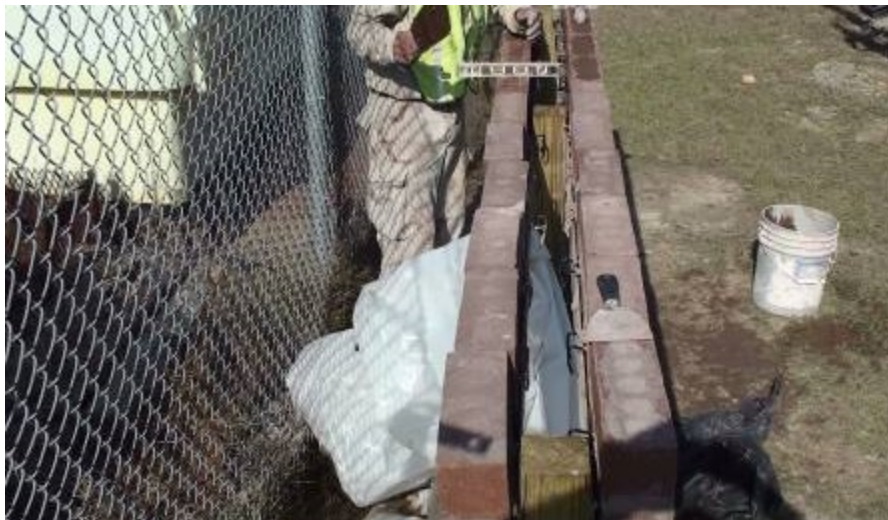
Figure 18. Fort Stewart coupon test rack.

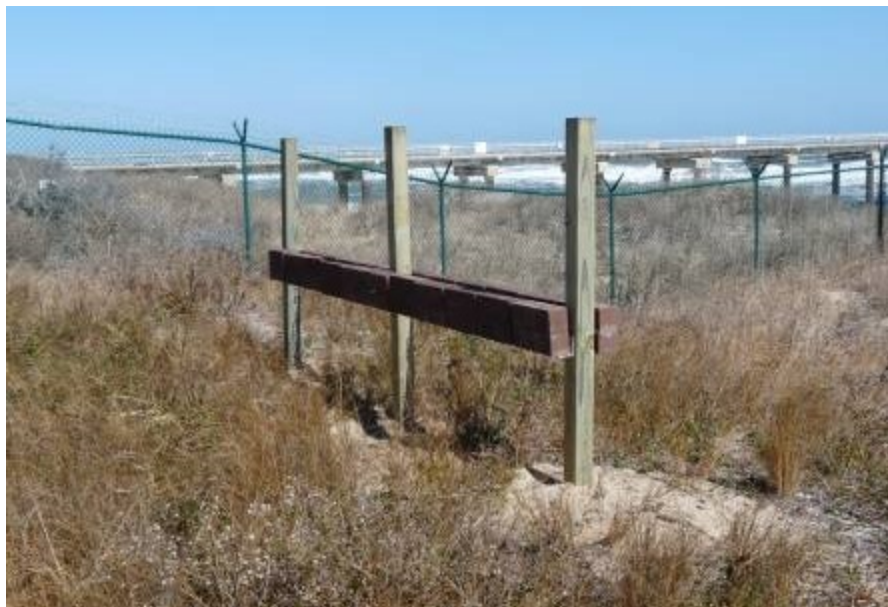
Figure 19. Duck, NC, coupon test rack.

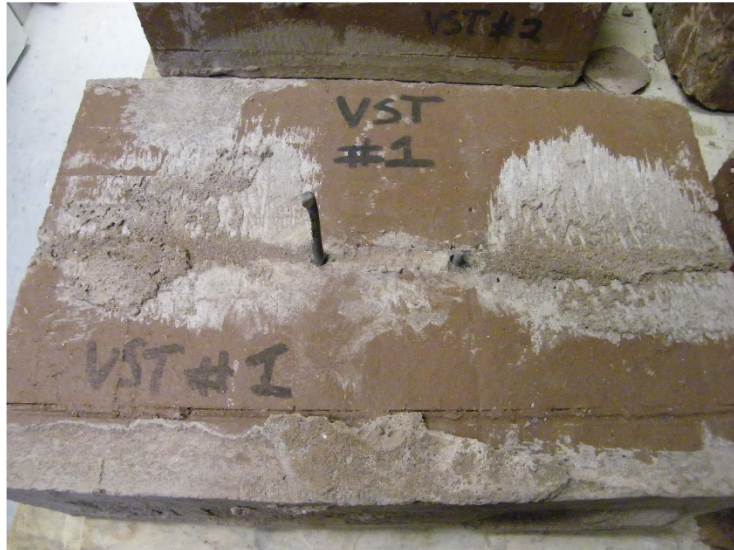
Photo 2 – Mode of Failure – VST #1

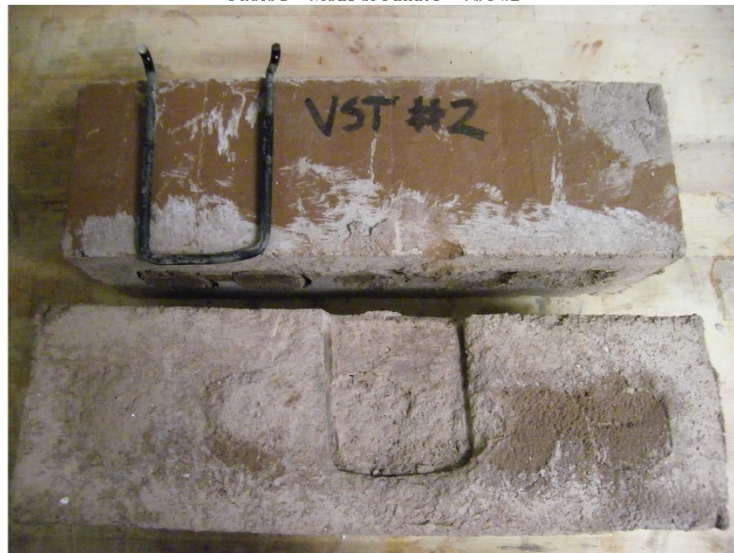
Photo 3 – Mode of Failure – VST #2

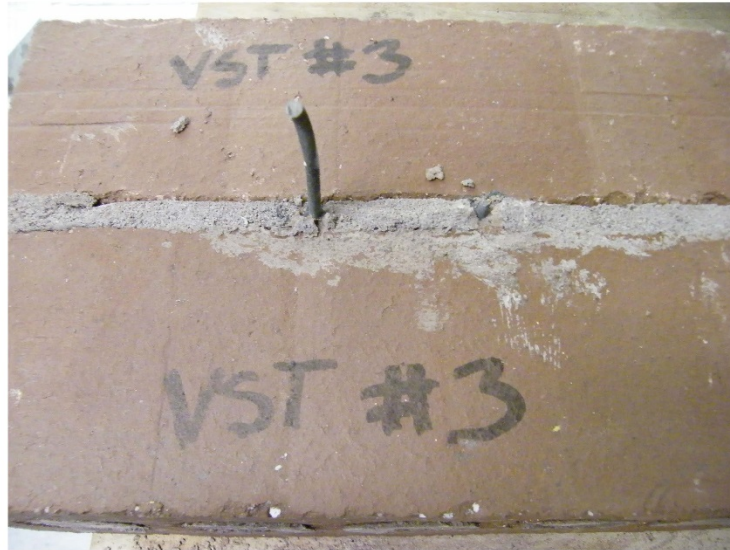
**Photo 4 – Mode of Failure – VST #3**

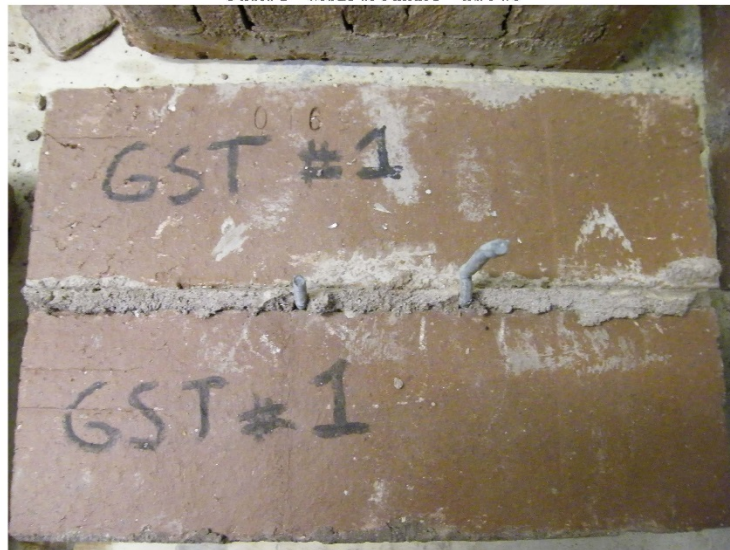
**Photo 5 – Mode of Failure – GST #1**

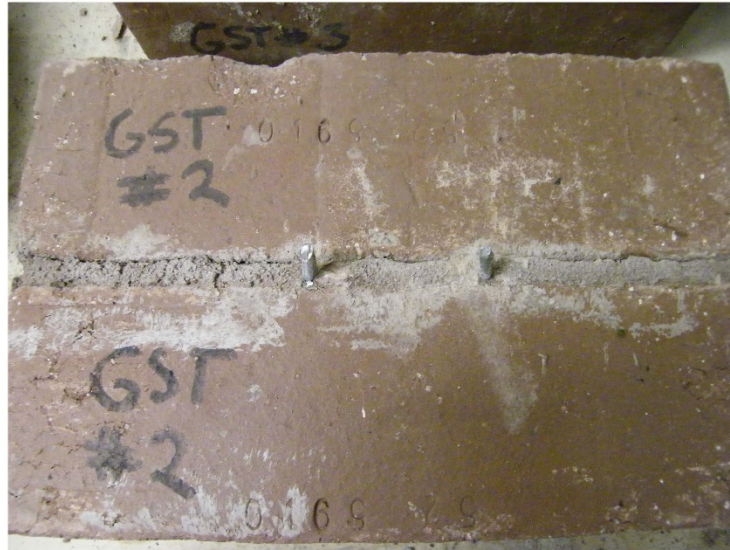
Photo 6 – Mode of Failure – GST #2

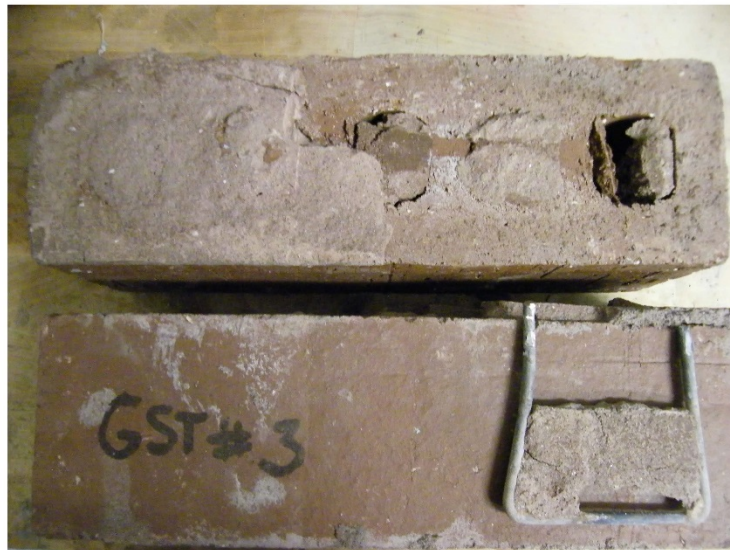
Photo 7 – Mode of Failure – GST #3

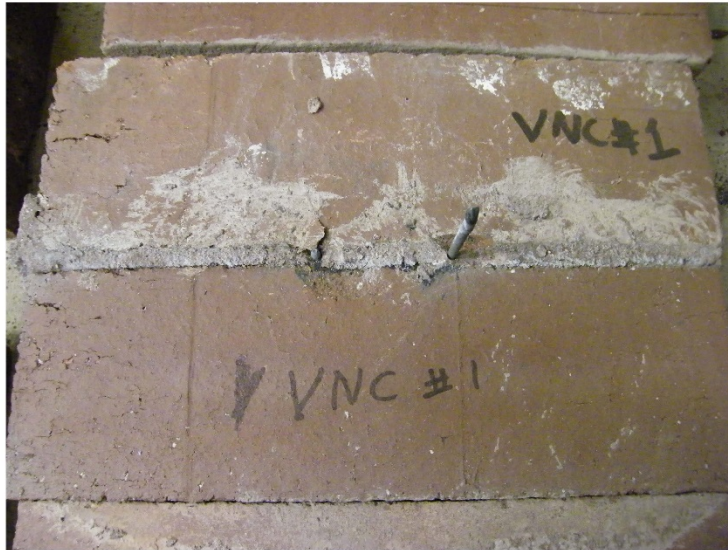
**Photo 8 – Mode of Failure – VNC #1**

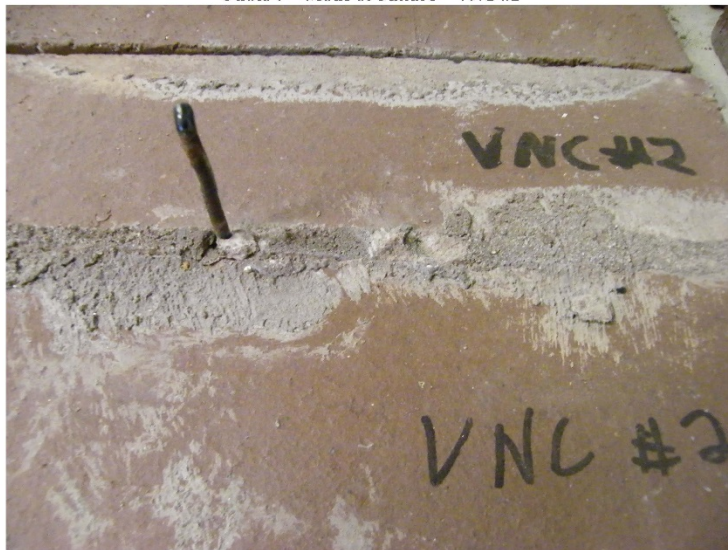
**Photo 9 – Mode of Failure – VNC #2**

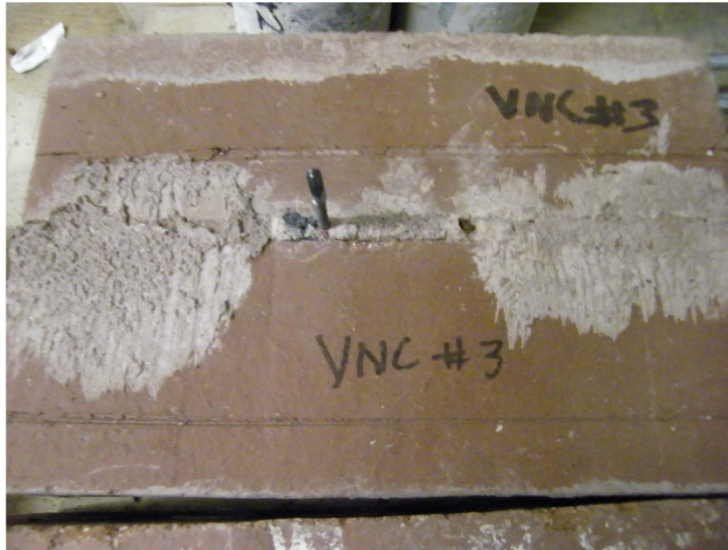
**Photo 10 – Mode of Failure – VNC #3**

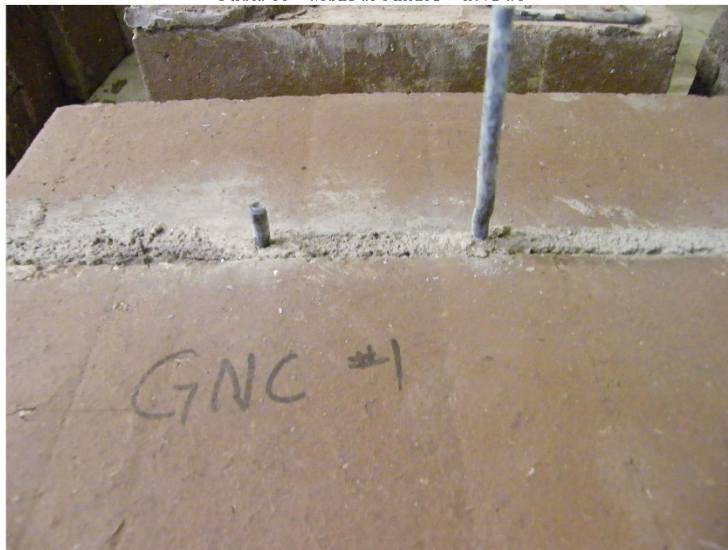
**Photo 11 – Mode of Failure – GNC #1**

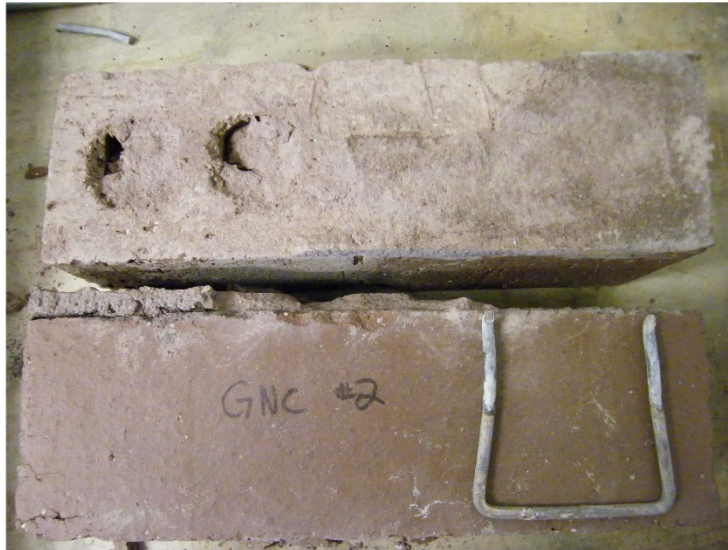
**Photo 12 – Mode of Failure – GNC #2**

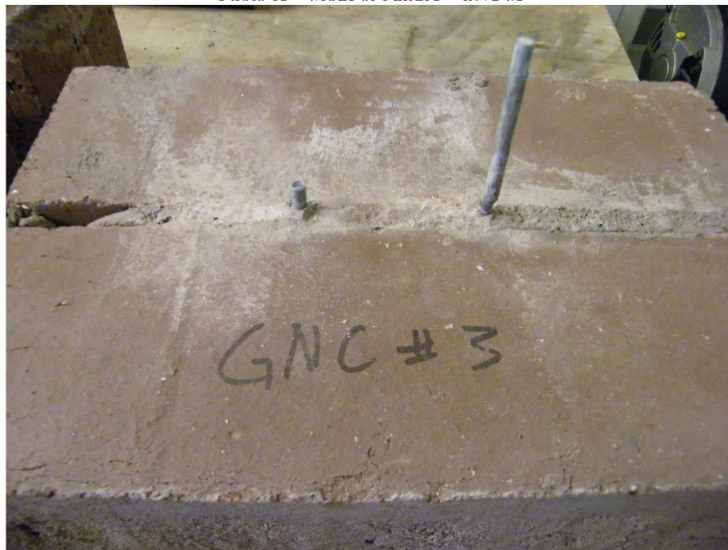
**Photo 13 – Mode of Failure – GNC #3**

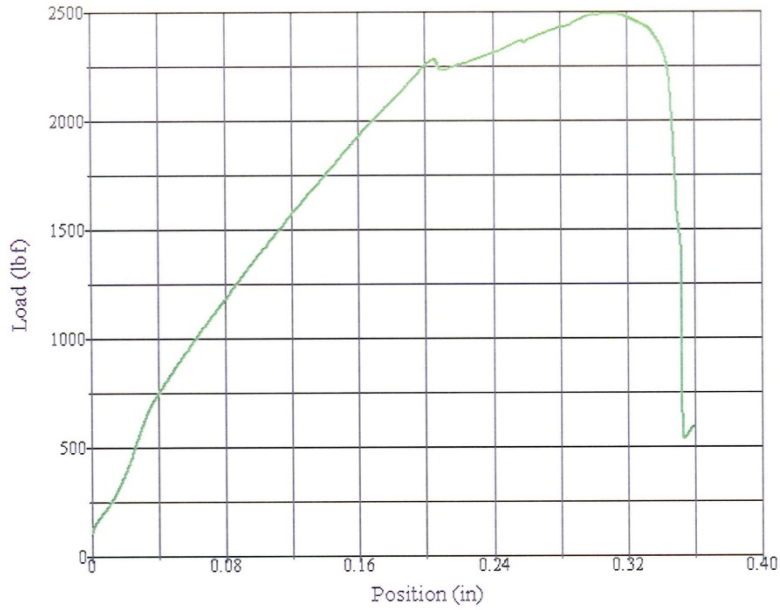
Counter: 9498  
 Elapsed Time: 00:03:39  
 Procedure Name: ASTM E754 - Masonry Anchor Pull Out  
 Start Date: 8/10/2012  
 Start Time: 10:42:55 AM  
 End Date: 8/10/2012  
 End Time: 10:46:34 AM  
 Workstation: INSTRON2  
 Tested By: McCants  
 Specimen Identification: GST 6  
 Date Made:
