APPENDICES A THROUGH BB - Individual Accident Investigation Reports

CAPSIZING/SWAMPING ACCIDENT INVESTIGATIONS FOR 1976 SEASON

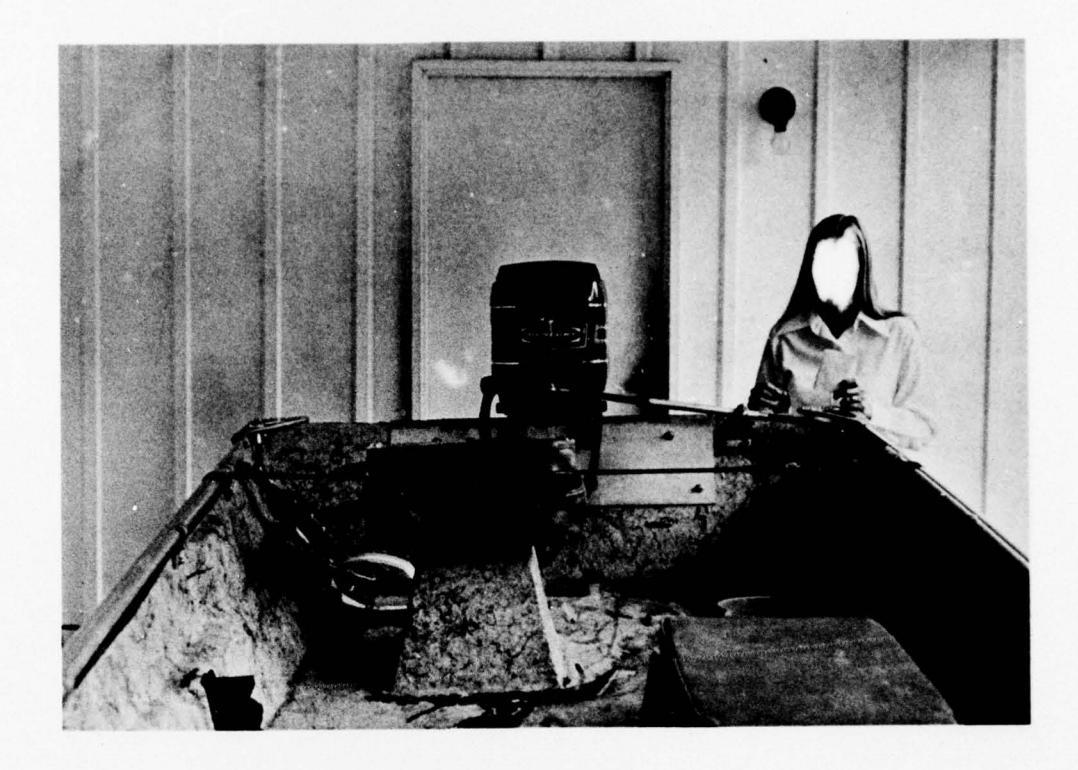
FIGURE 7. TRANSOM AND MOTOR

Refer to Figures 4, 5, and 6 for overall boat views, and Figure 7 for transom and motor view.

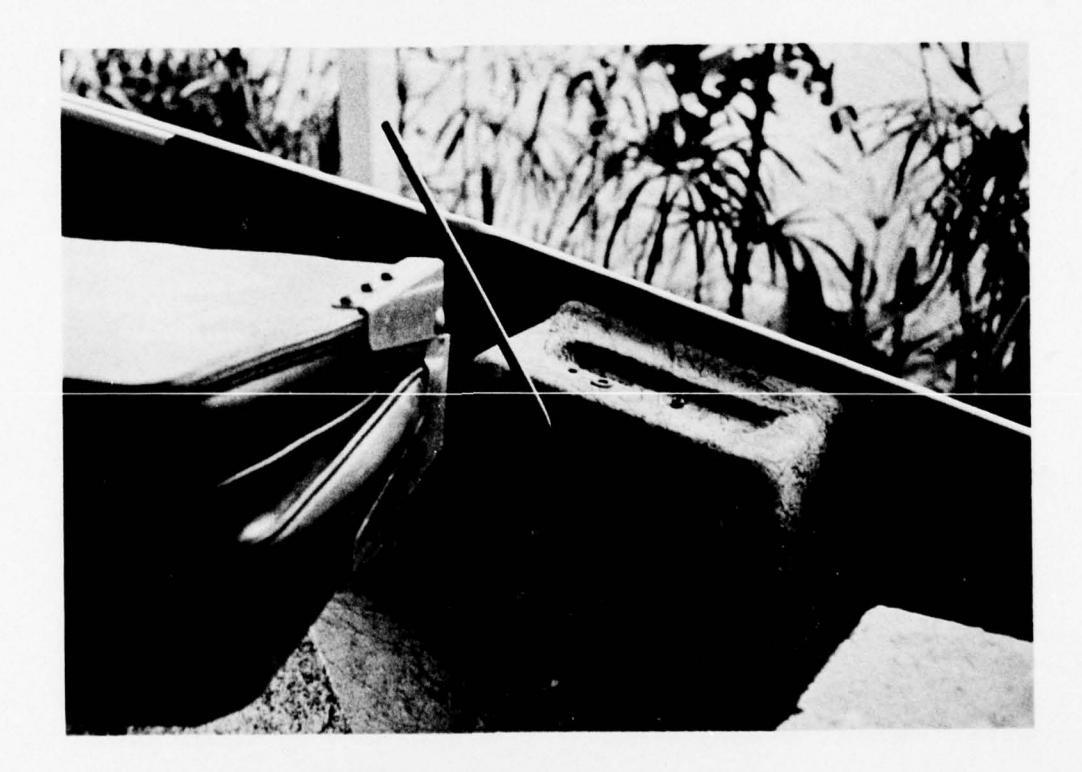
FIGURE 8. DEFORMED STEERING STICK

turn. The control stick was bent aft which would strongly indicate that the stick went forward and hit the deck with enough force to cause the bend. It is very unlikely that the operator could have exerted sufficient rearward force on the steering stick to cause the deformation. This is considered a likely factor in causing this accident. Refer to Figure 8 for deformed steering stick and Figure 9 for plastic ball location.

Considering the statements of the occupants and the deformation of the steering lever, it is the opinion of the investigators that the accident was caused by a material failure in the steering system. Whether the inexperience of the operator prevented him from reacting to the emergency situation properly is unknown.

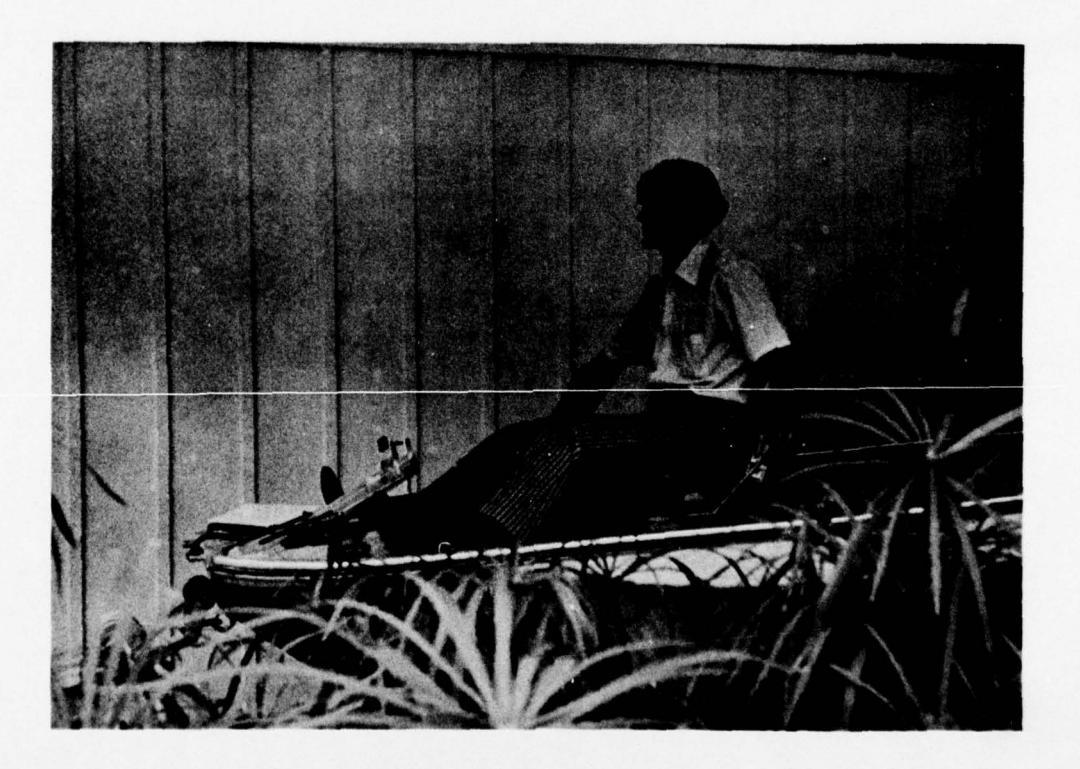
FIGURE 10. STICK STEERING POSITION FOR ZERO MOTOR ANGLE AFTER ACCIDENT

The boat entered a hard turn to starboard and, due to the hull design, began to skid to the outside of the turn. As the turn continued, the skidding action caused the keel to ride up over the bow wake. The boat then rolled to port (tripped), and the port chine dug in, causing the skidding motion to abruptly stop. Sufficient momentum had been generated in the turn, so that when the lateral motion of the boat was stopped, the momentum of the occupants caused them to be thrown out of the boat on the port side. The operator stated that he always kept his hand on the throttle when traveling full speed. Seated in the normal operating position (see Figure 10), the normal reaction of the operator would be to hold to the throttle for support when being thrown over the port side. The throttle position for full speed is down and forward; therefore, if the operator held to the throttle, the force exerted would cause the lever to come up and aft, reducing the engine rpm. This would account for the slower speed the boat was traveling after the occupants were thrown overboard. Figure 10 shows the stick steering position for zero motor angle after the accident. Figure 11 shows the approximate normal zero motor angle position prior to the accident.

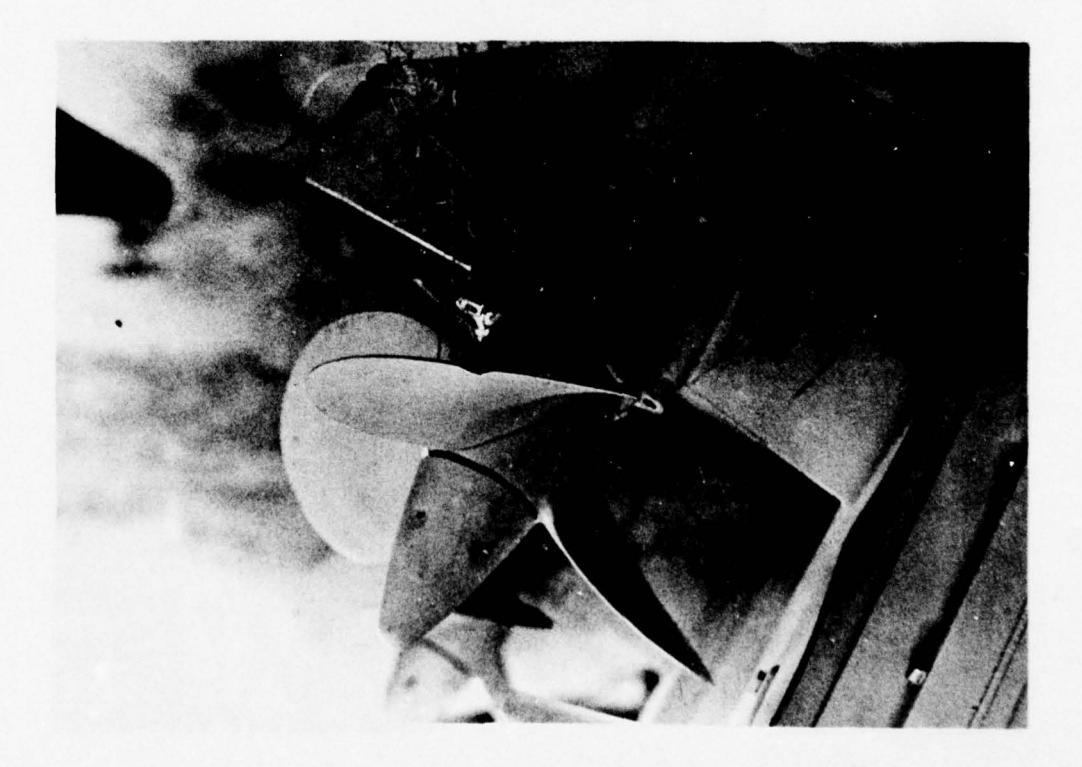
FIGURE 7. PORT ENGINE. NOTE FISHING LINE IN PROPELLER

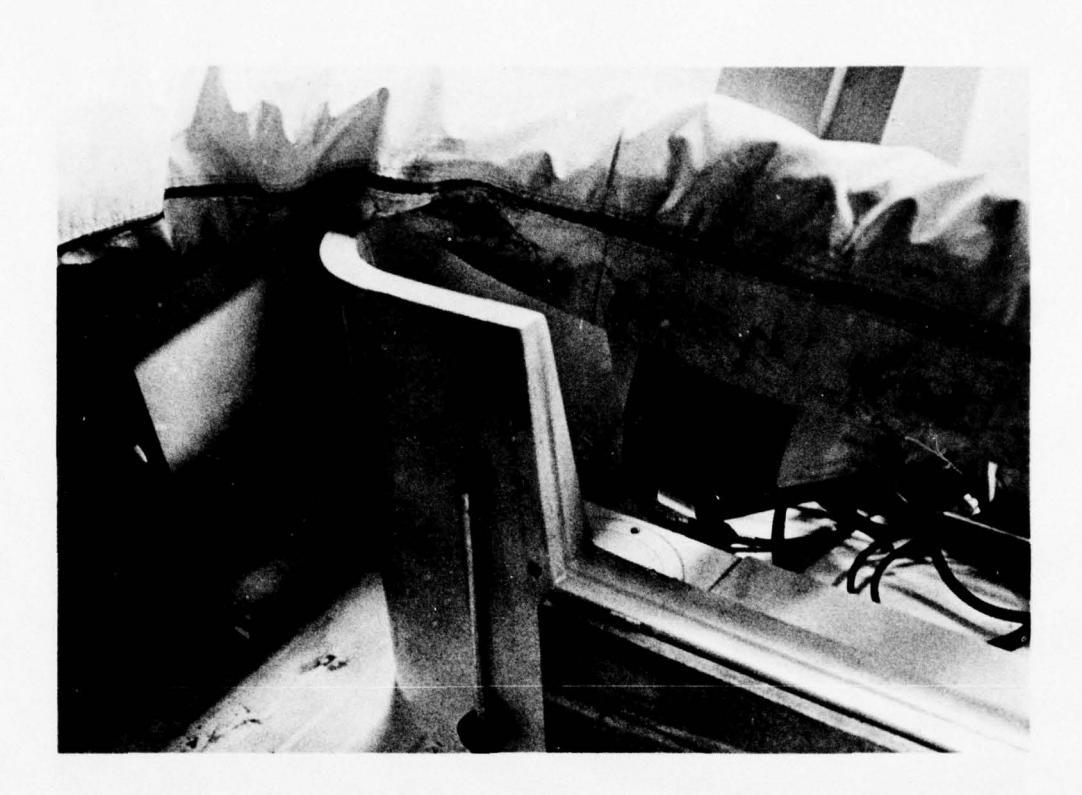
FIGURE 8. NOTE FOLDED DOWN MOTORWELL BULKHEAD

The boat's load of persons, motor, and gear was well below its capacity plate limitation. There is some possibility, however, that enough water was shipped over the transom (and hence into the bilge, because the owner modified the motorwell such that any benefit it may have provided was cancelled) to make the boat more prone to being swamped. This effect would have depended on the extent to which the electric bilge pump was used, which was not able to be clearly determined.

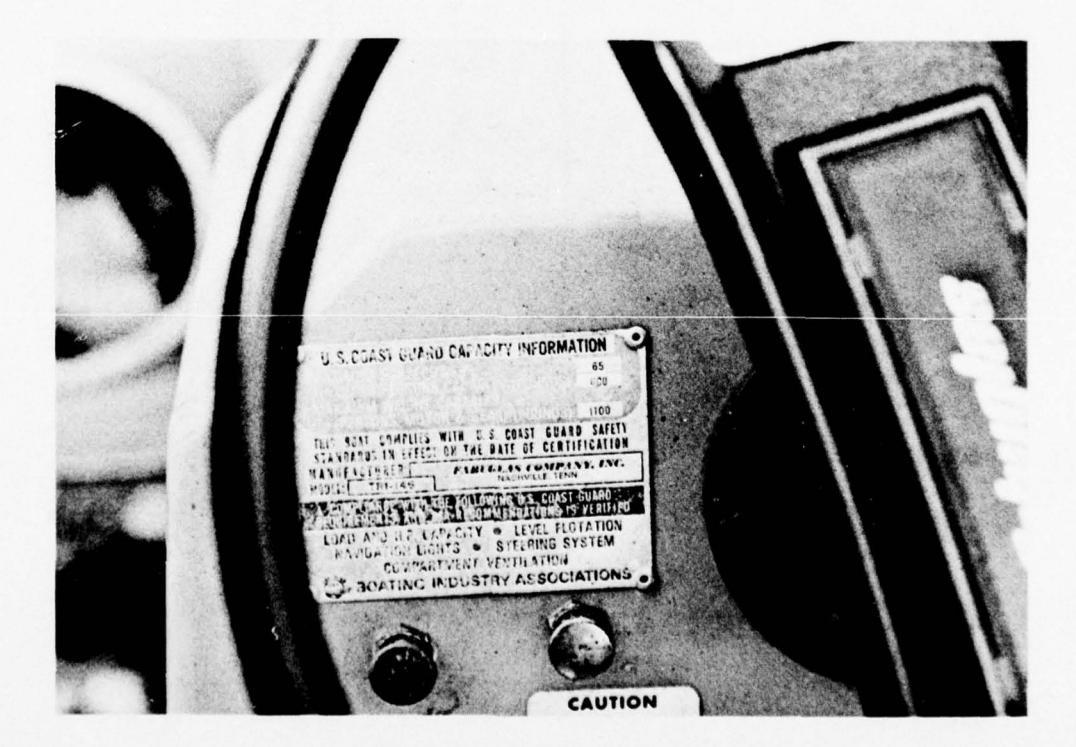
FIGURE 4. CUTOUT FOR BILGE PUMP OR DRAIN

There was very little damage to the boat as a result of the accident. The helm seat had been removed and replaced with a folding lawn chair to provide more room for fishing. A two in. x four in. (5.1 cm x 10.2 cm) hole had been cut in the deck on the left side of the steering console by the previous owner. The hole was either cut to install a forward bilge pump or to provide a drain for the forward section of the passenger compartment (see Figures 4 and 5). Overall boat views are shown in Figures 6, 7, and 8.

According to the operator, the inner hull plugs were out at the time of the accident. He stated that he purposefully removed the plugs to allow the water in the inner hull to drain to the stern where it could be pumped out by the bilge pump. Water that came over the transom ran into the inner hull through the drain holes, helm seat mounting holes, and the cutout at amidships. When water became visible in the aft section of the boat, the inner hull contained enough water to significantly reduce the transom freeboard. Waves continued to break over the stern until the freeboard was reduced to the point that water flowed freely over the transom, completely swamping the boat. As the boat started to sink, the flotation material installed in the inner hull caused the boat to have a natural tendency to roll. There was no flotation material installed above deck level. With all the flotation material in the bottom, the boat became very stable in an upside down attitude.

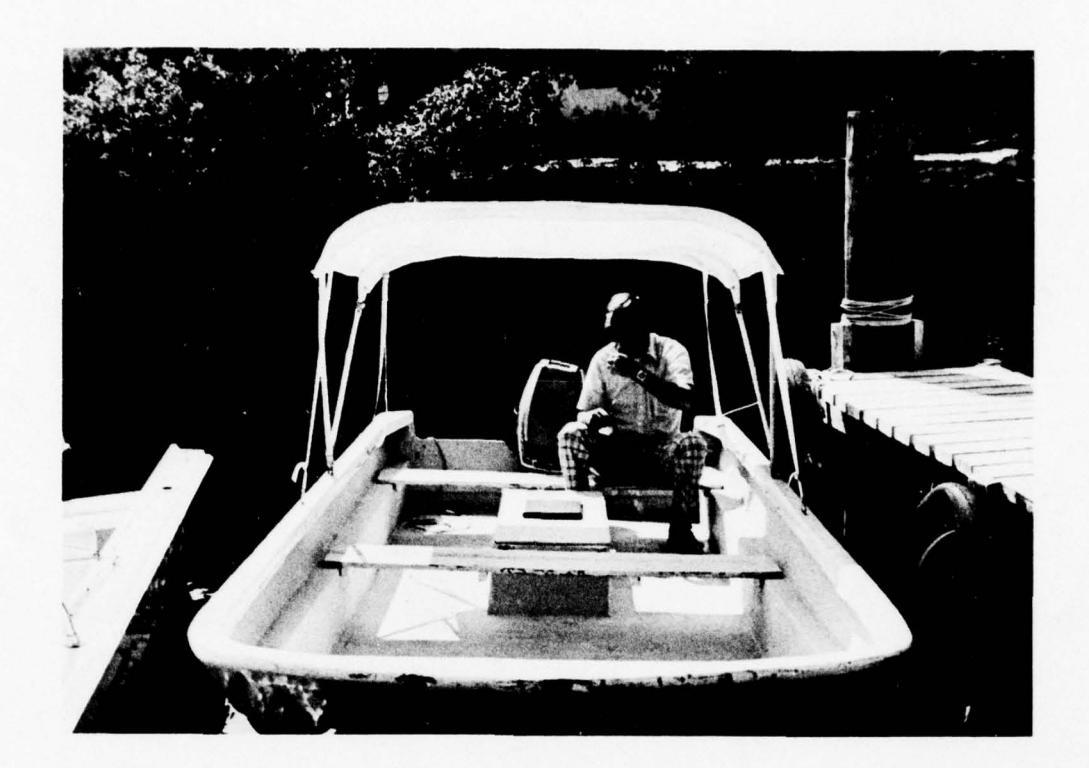
FIGURE 3. FRONT VIEW

The boat appeared to be in very good condition and no evidence of damage resulting from the accident could be found. Refer to Figure 3-6 for overall boat views.

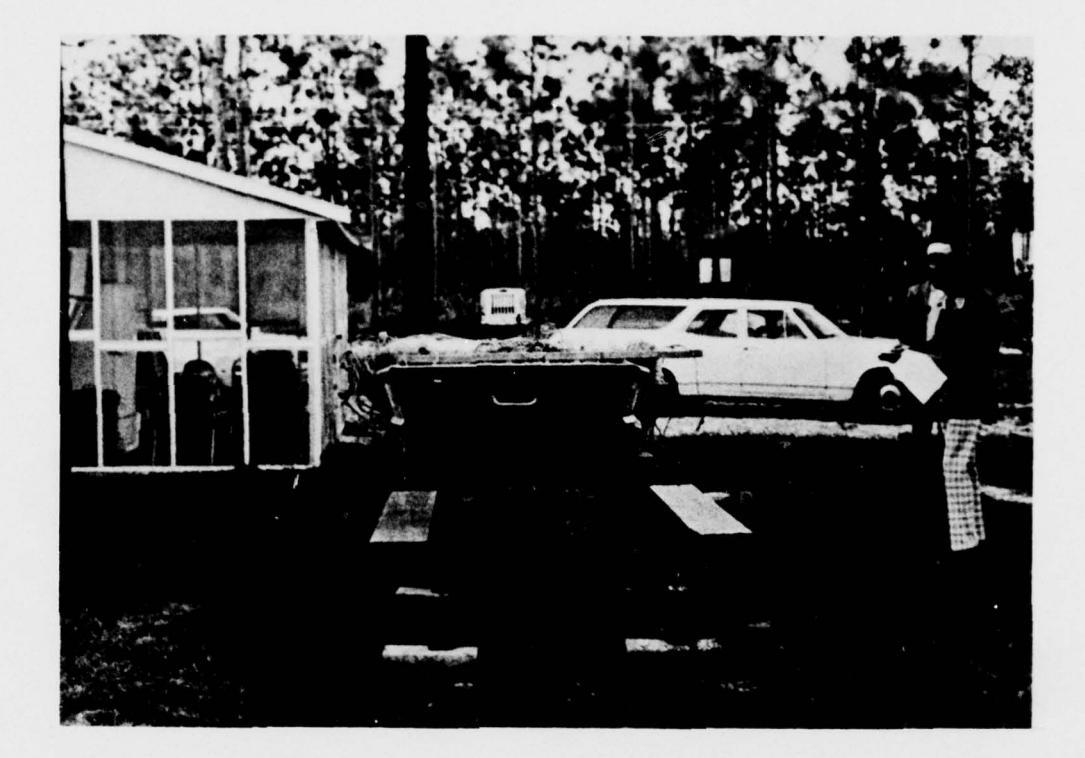
FIGURE 3. BOW VIEW

No evidence of damage as a result of the accident could be found. Refer to Figures 3-5 for overall boat views.

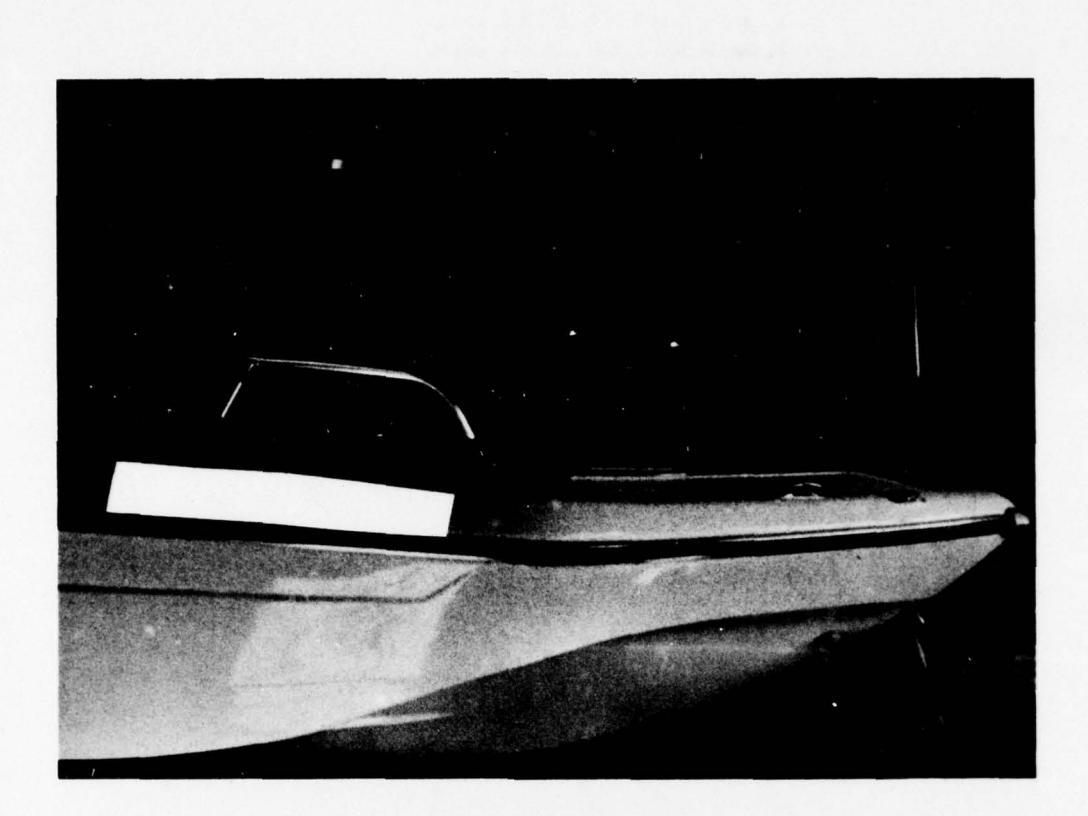
FIGURE 3. BOW VIEW

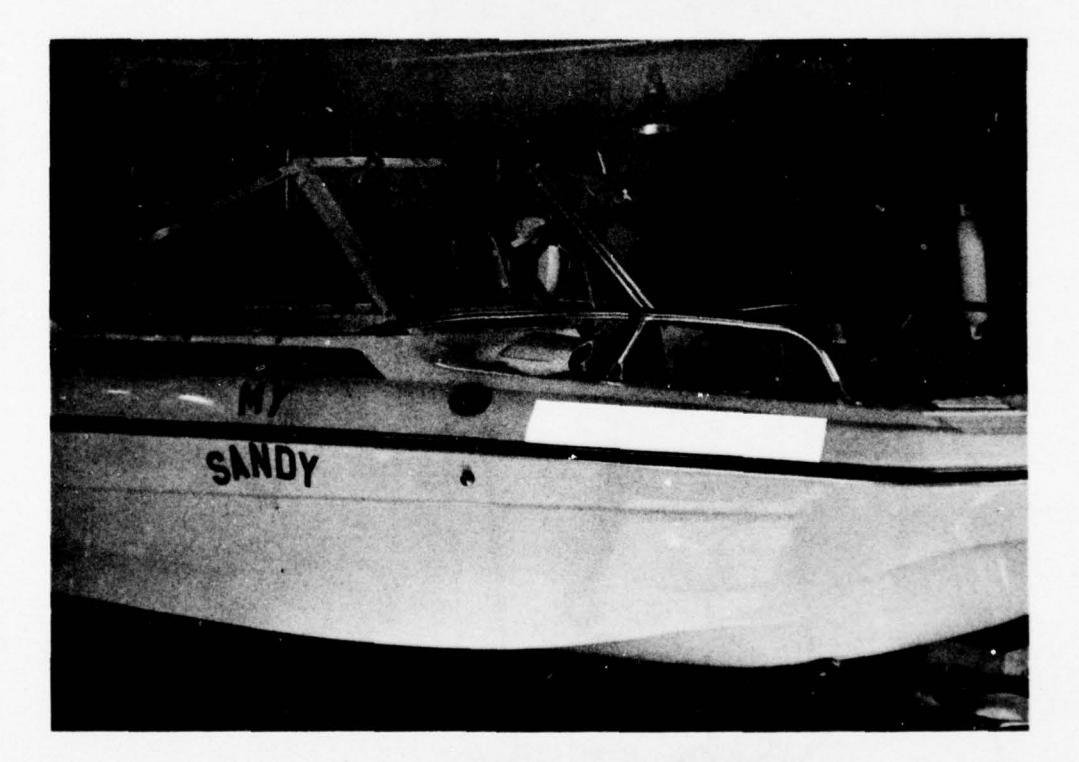
FIGURE 4. SIDE VIEW

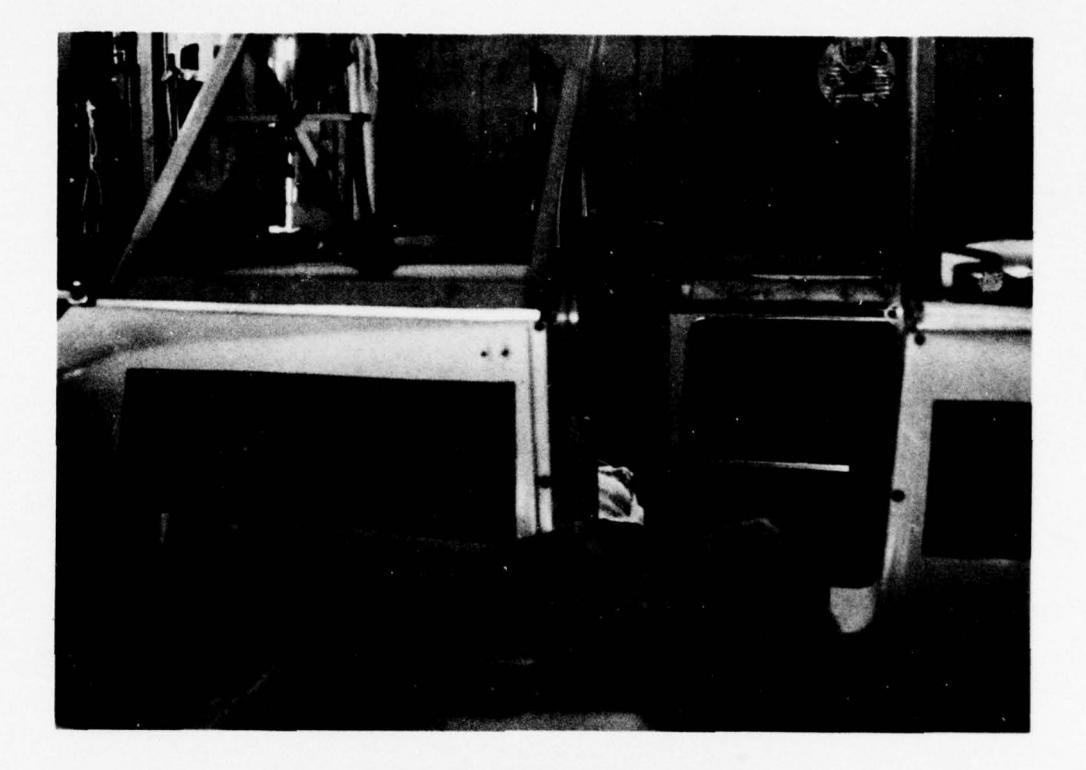
FIGURE 5. INTERIOR VIEW (BOW TO STERN)

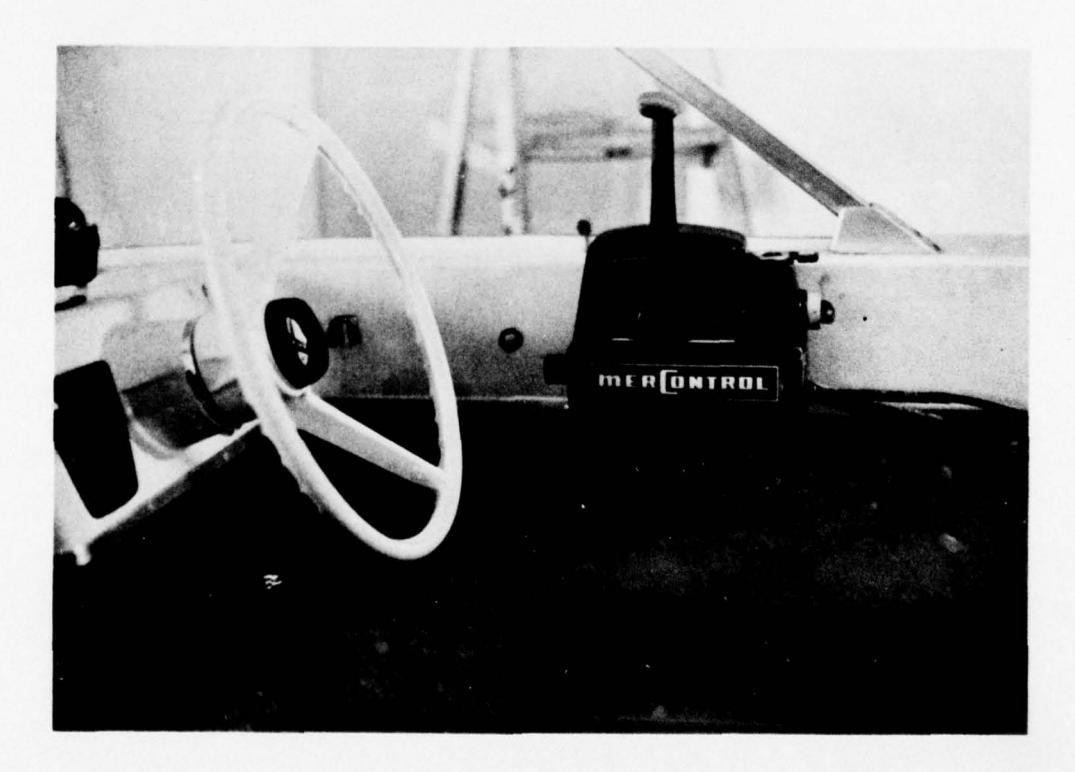
FIGURE 6. HELM U-11/12

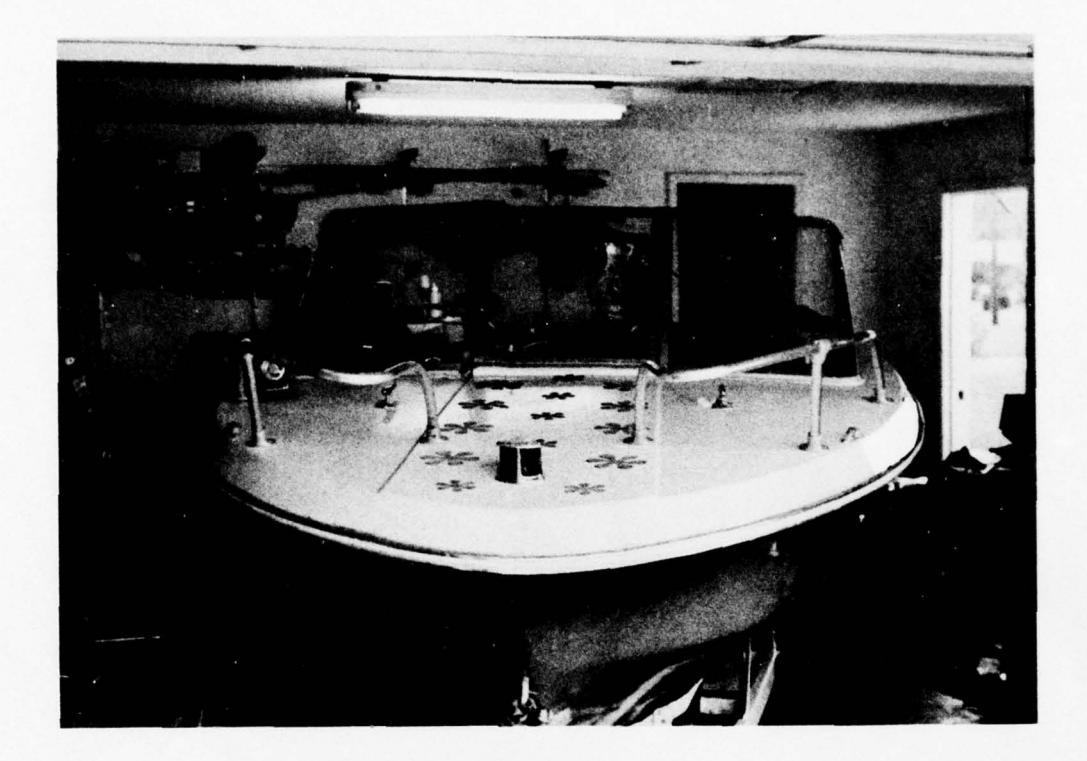
FIGURE 3. BOW VIEW (UPPER)

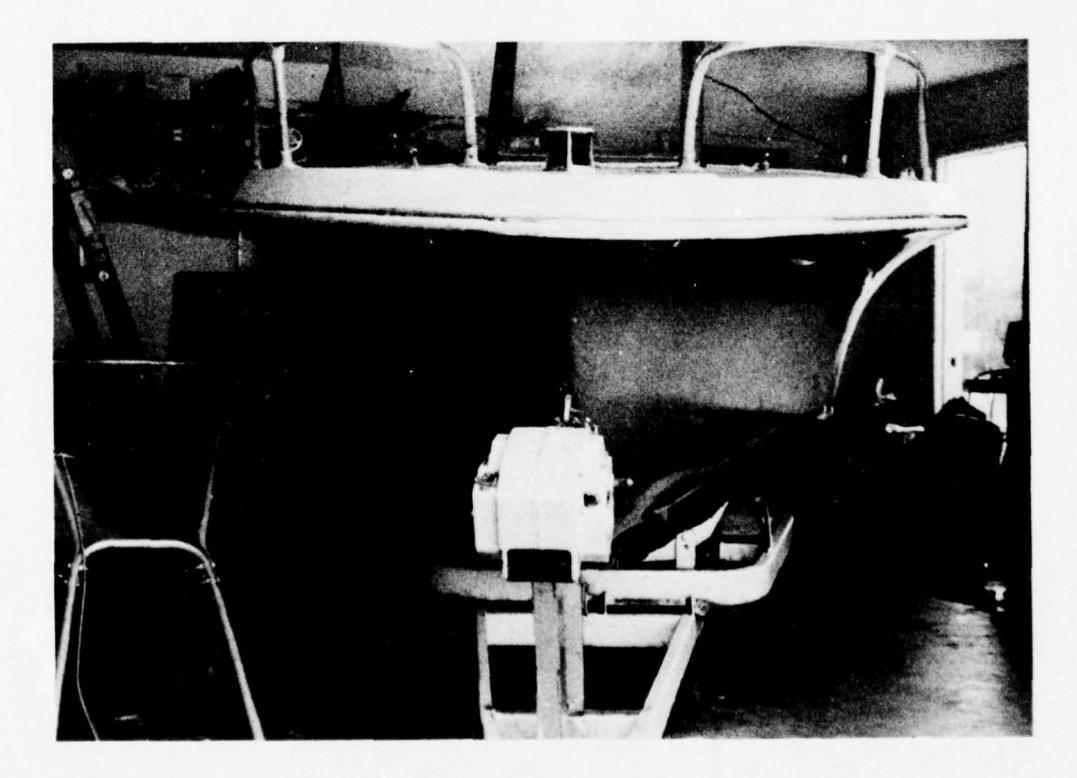
FIGURE 4. BOW VIEW (LOWER)

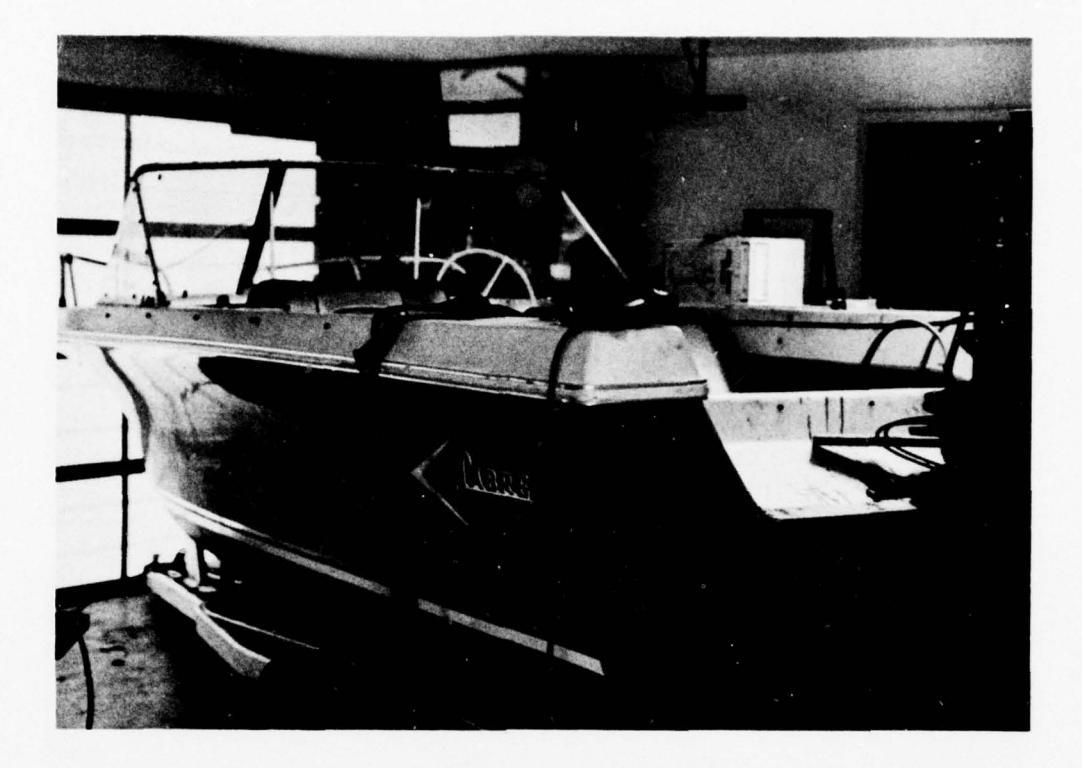
FIGURE 5. STERN VIEW

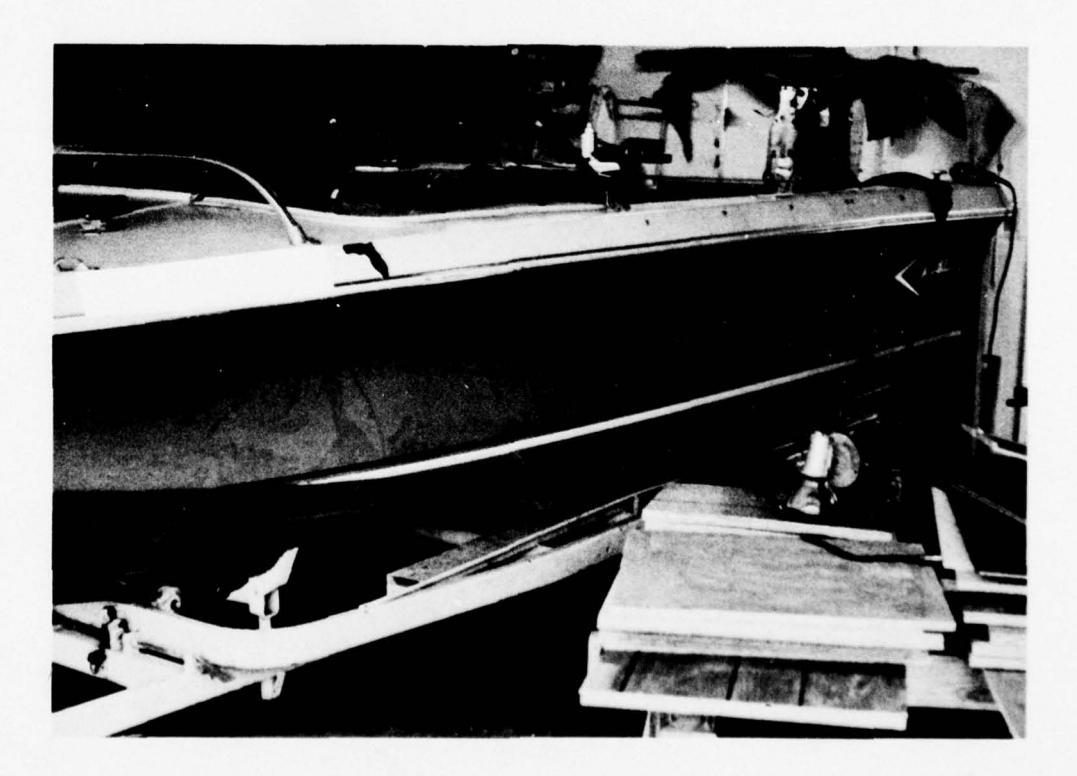
FIGURE 6. SIDE VIEW

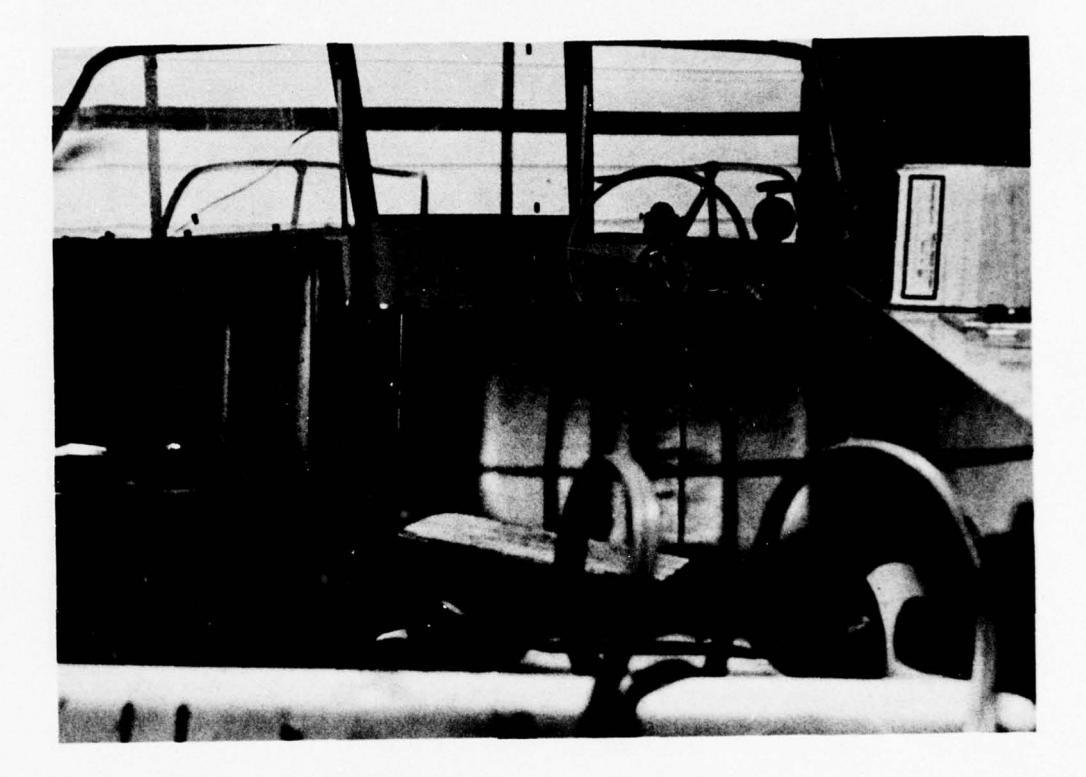
FIGURE 7. INTERIOR VIEW

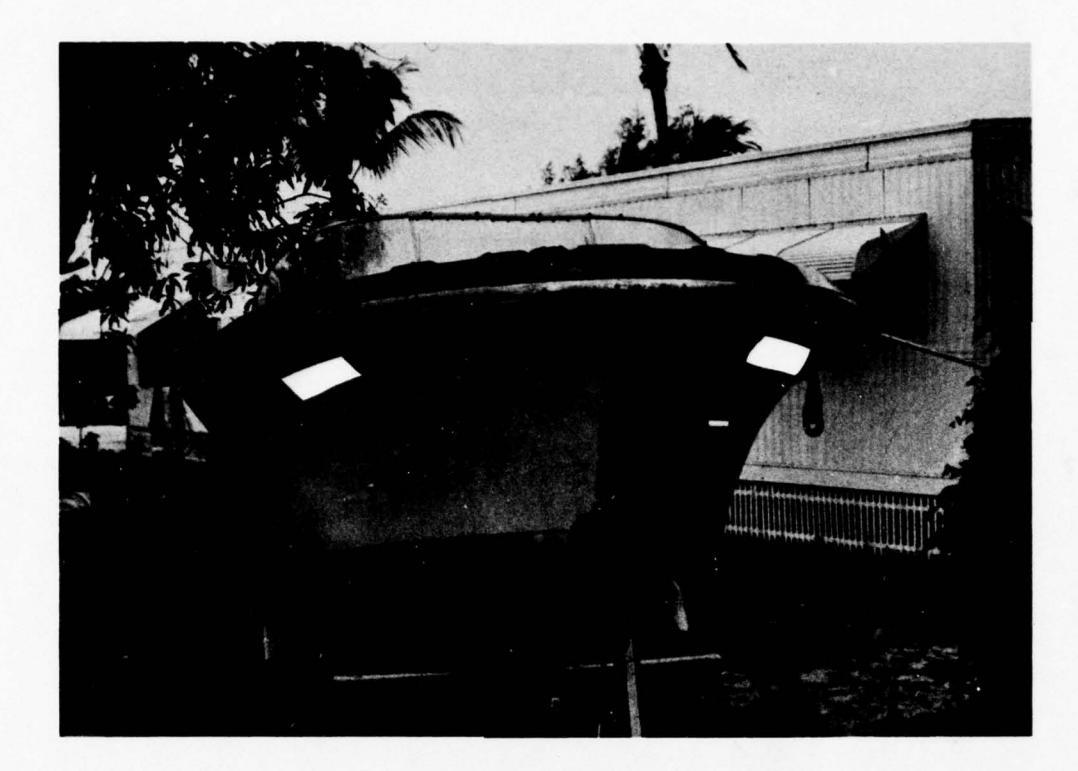
FIGURE 3. BOW VIEW

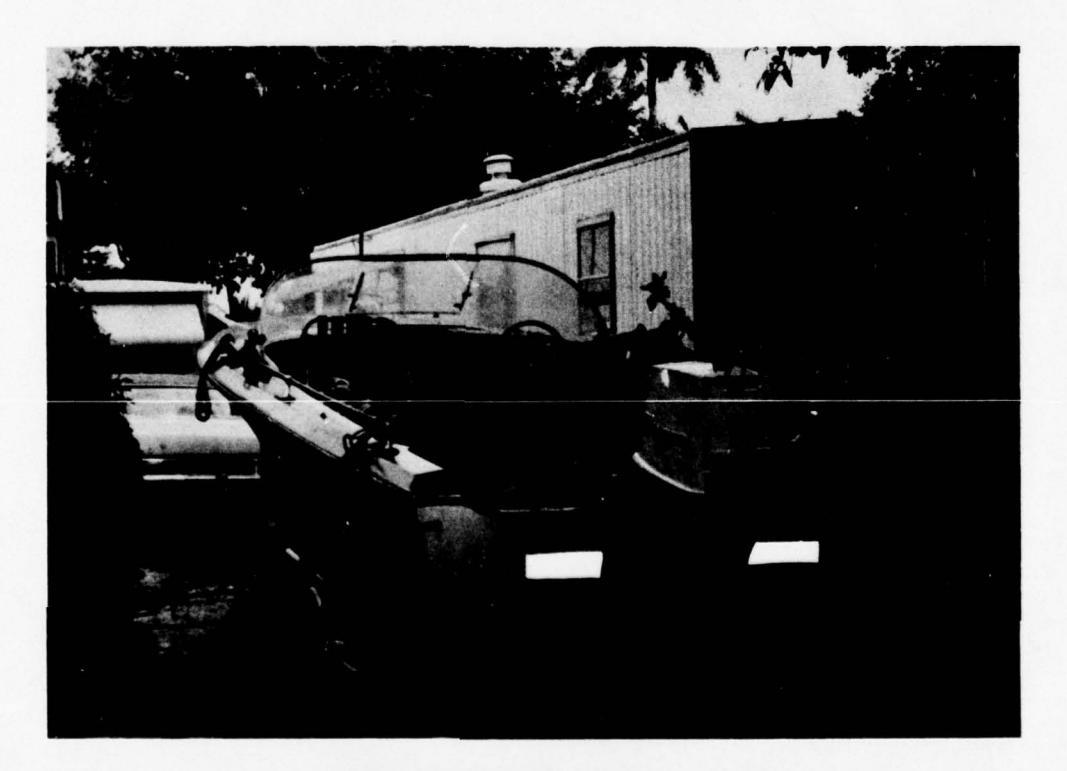
FIGURE 4. STERN VIEW

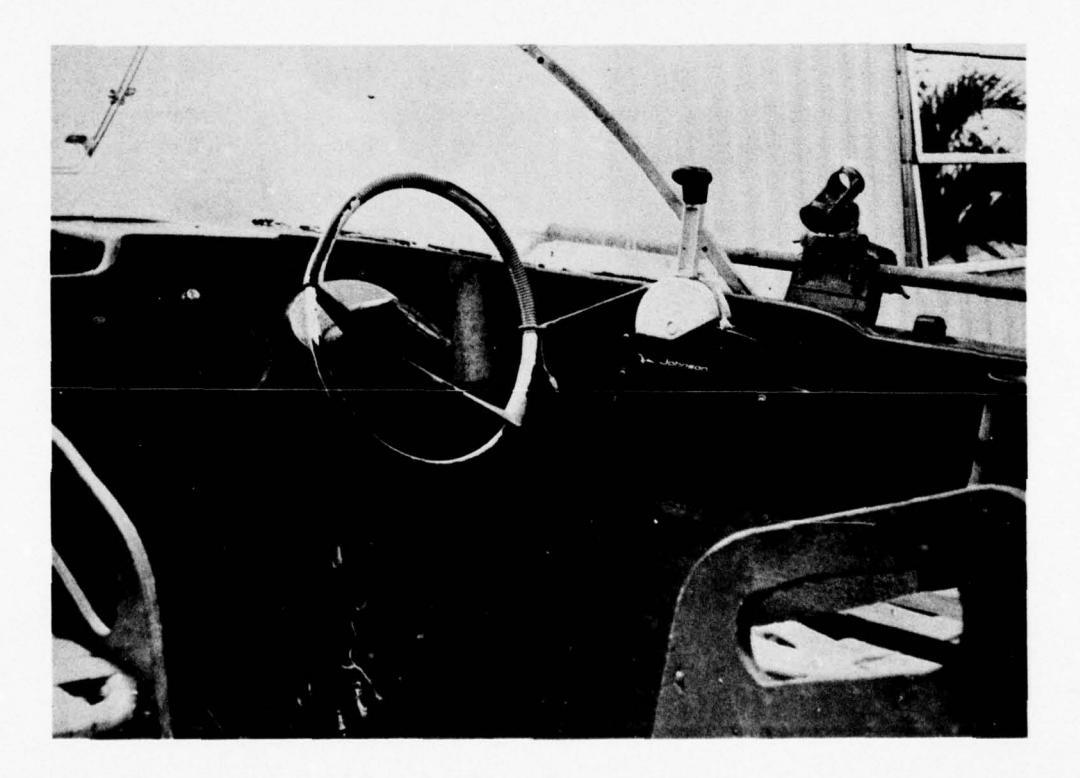
FIGURE 6. HELM STATION

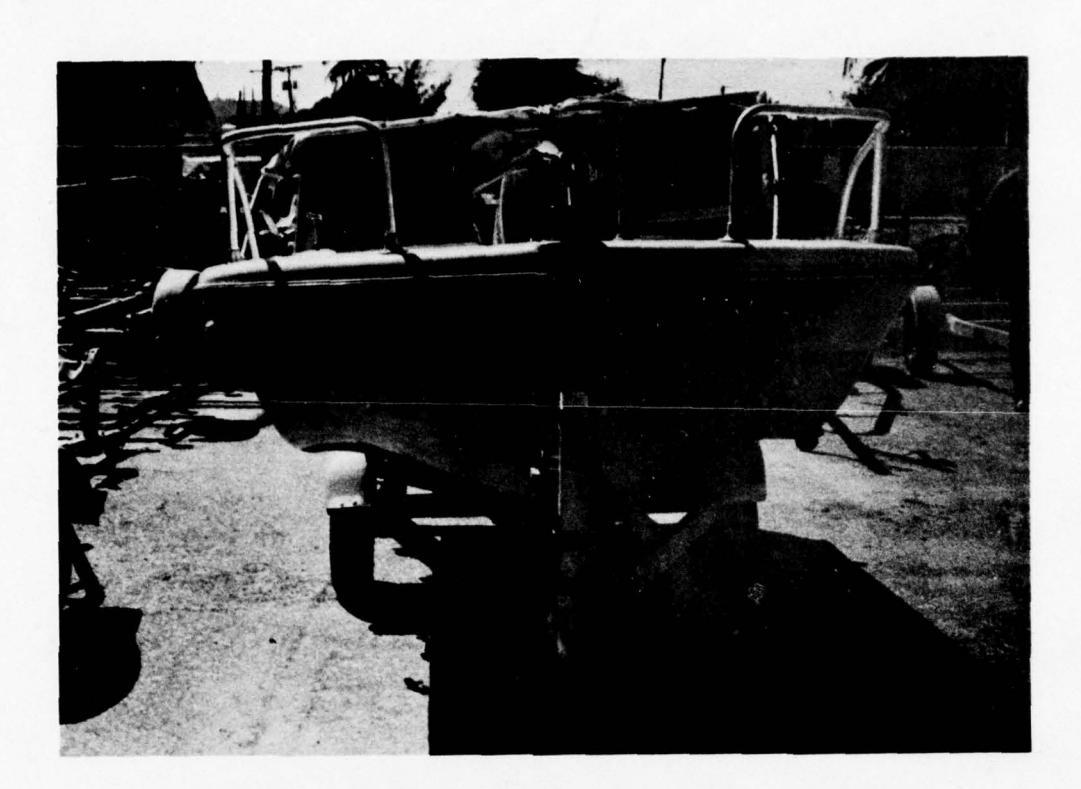
FIGURE 3. BOW VIEW

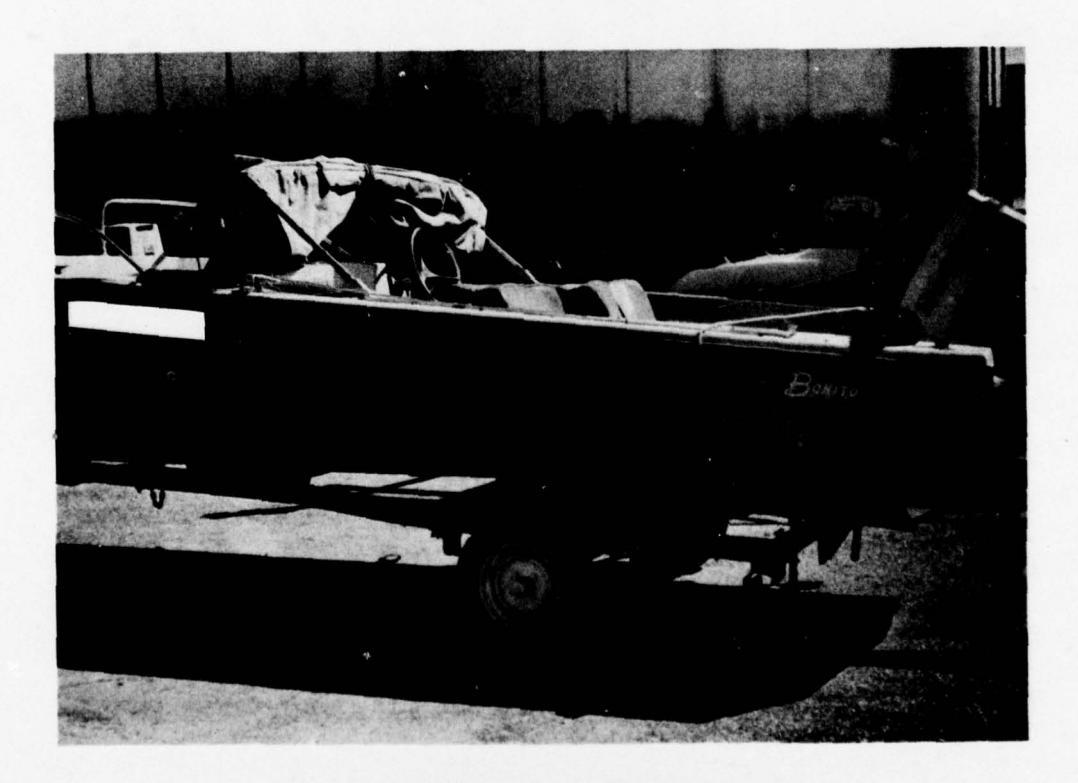
FIGURE 4. SIDE VIEW

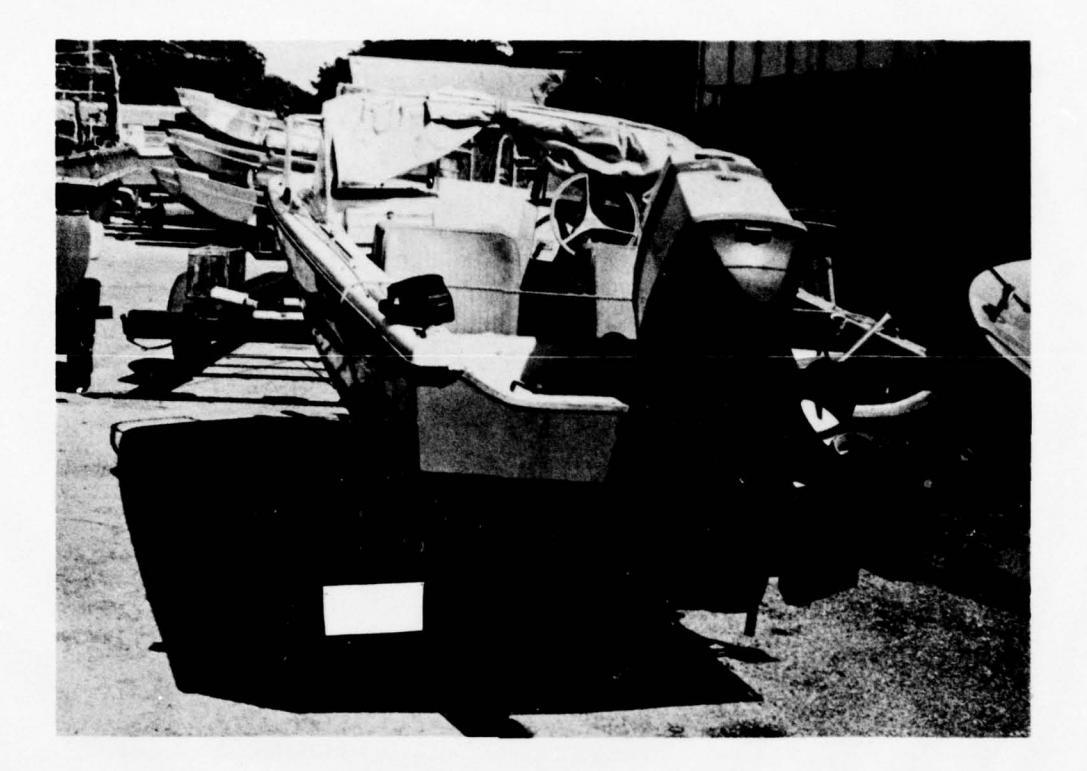
FIGURE 5. STERN VIEW

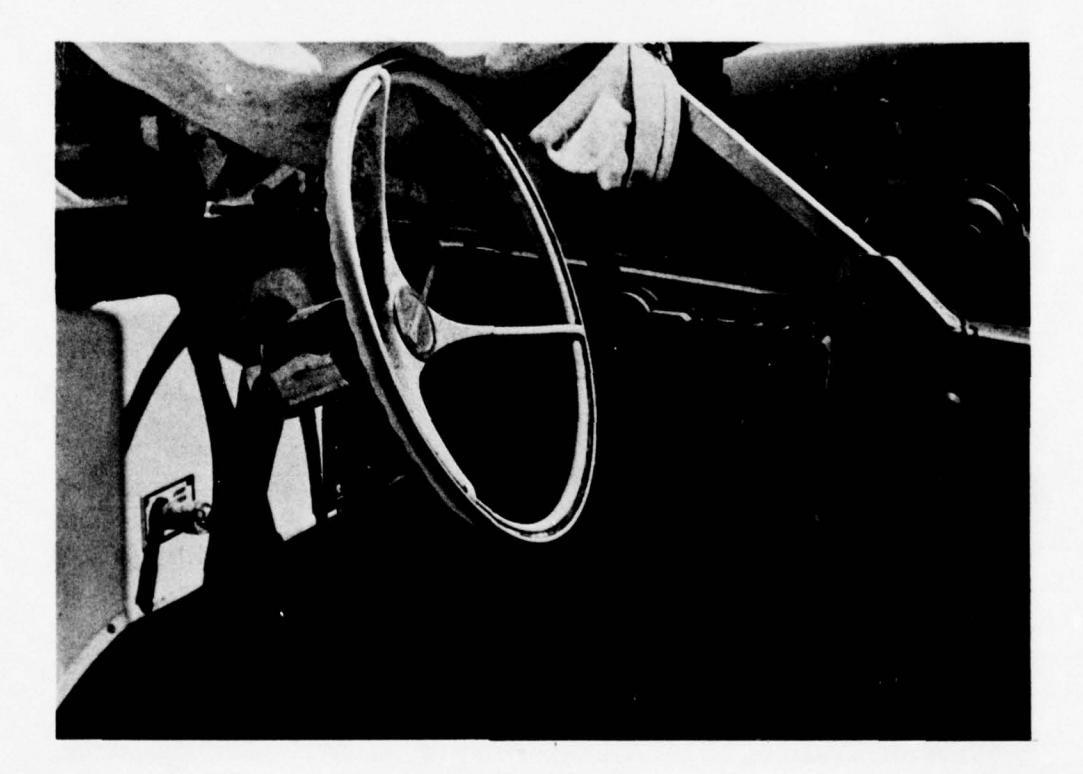
FIGURE 6. VIEW OF HELM
