APPENDICES A THROUGH BB - Individual Accident Investigation Reports

CAPSIZING/SWAMPING ACCIDENT INVESTIGATIONS FOR 1976 SEASON

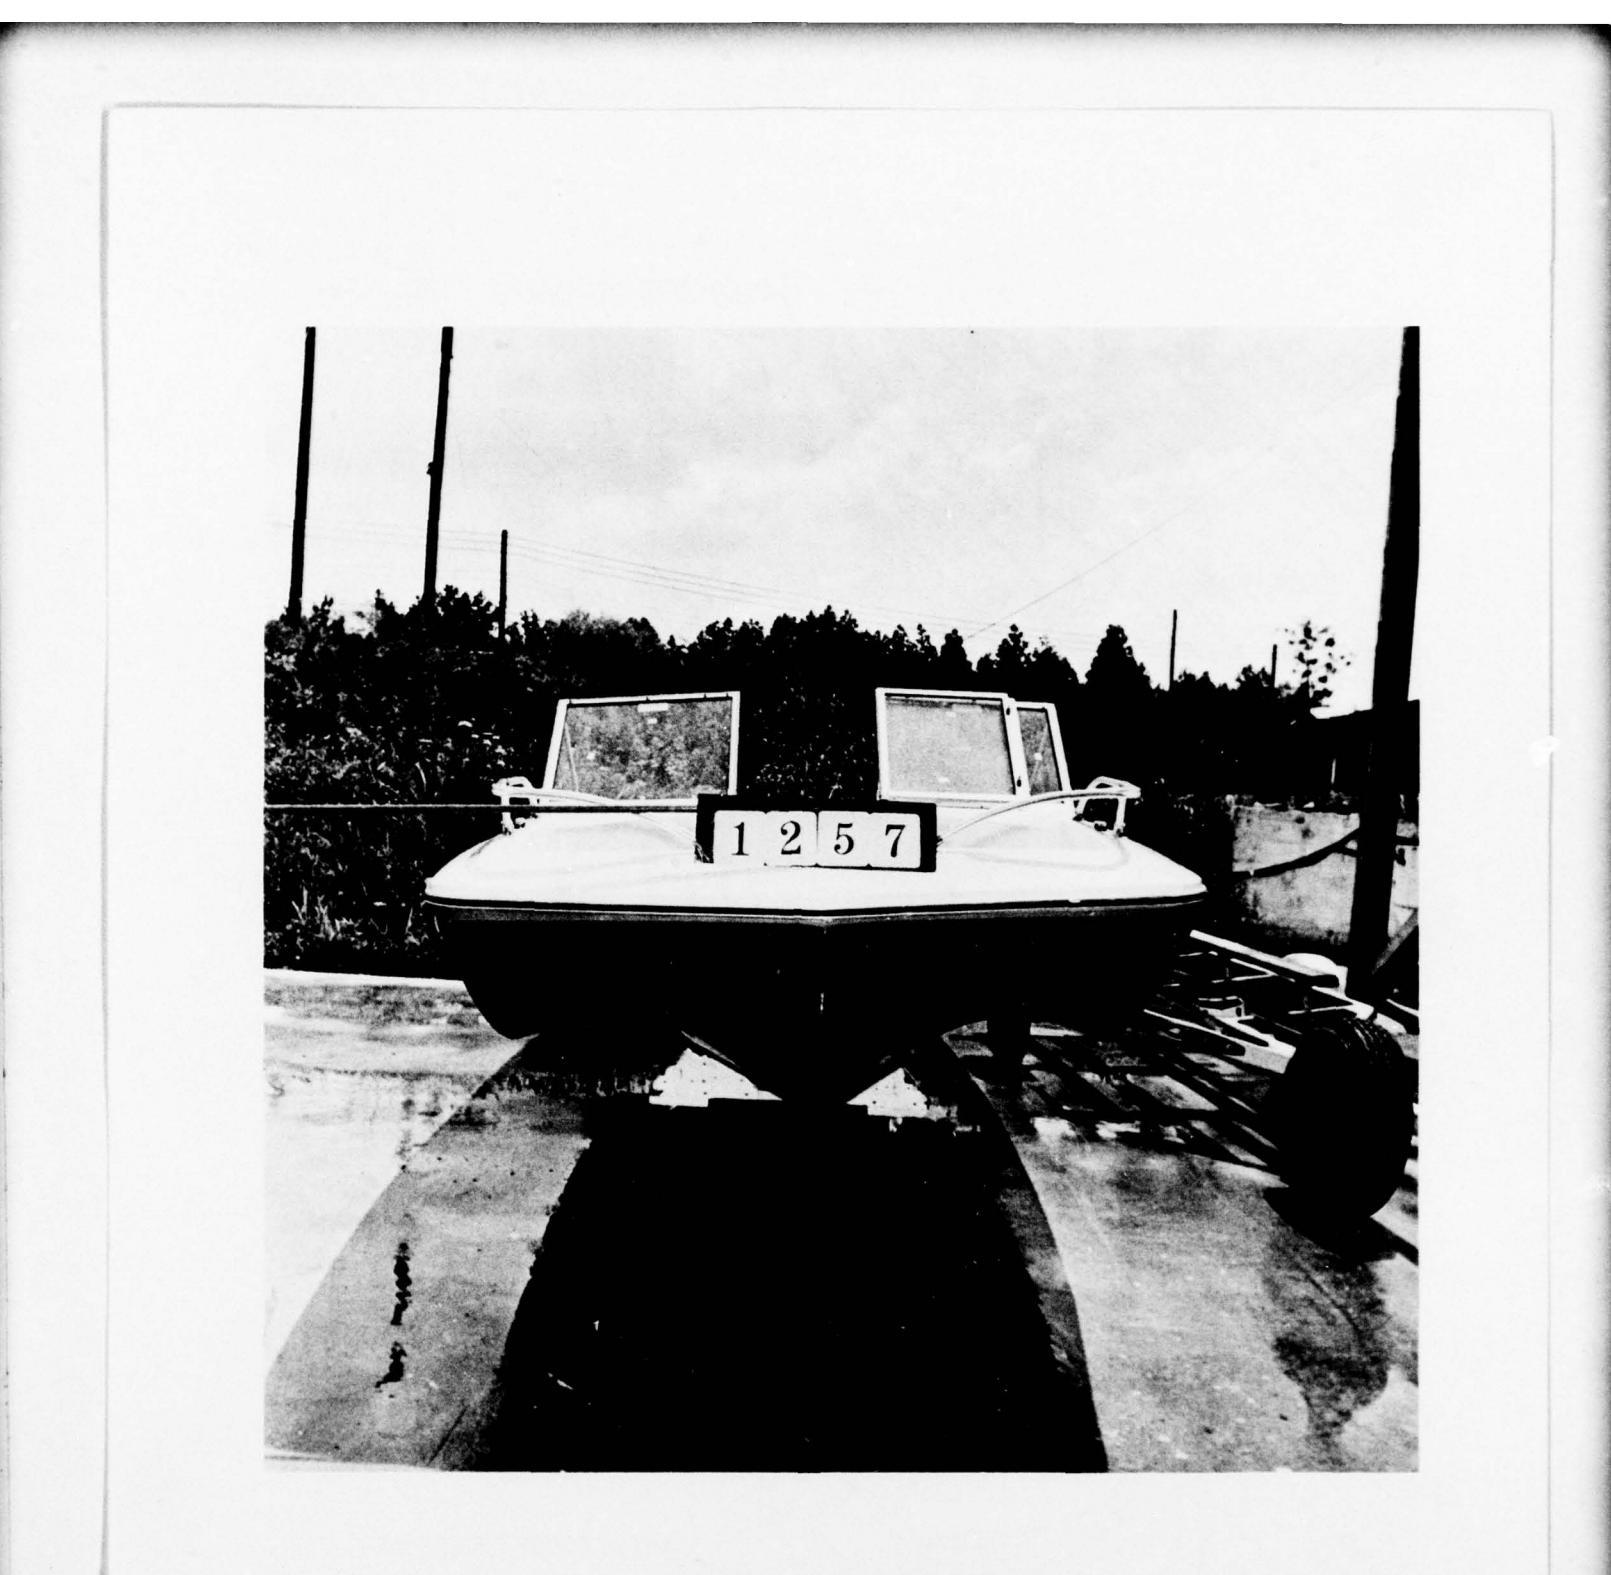
FIGURE 3. BOW VIEW

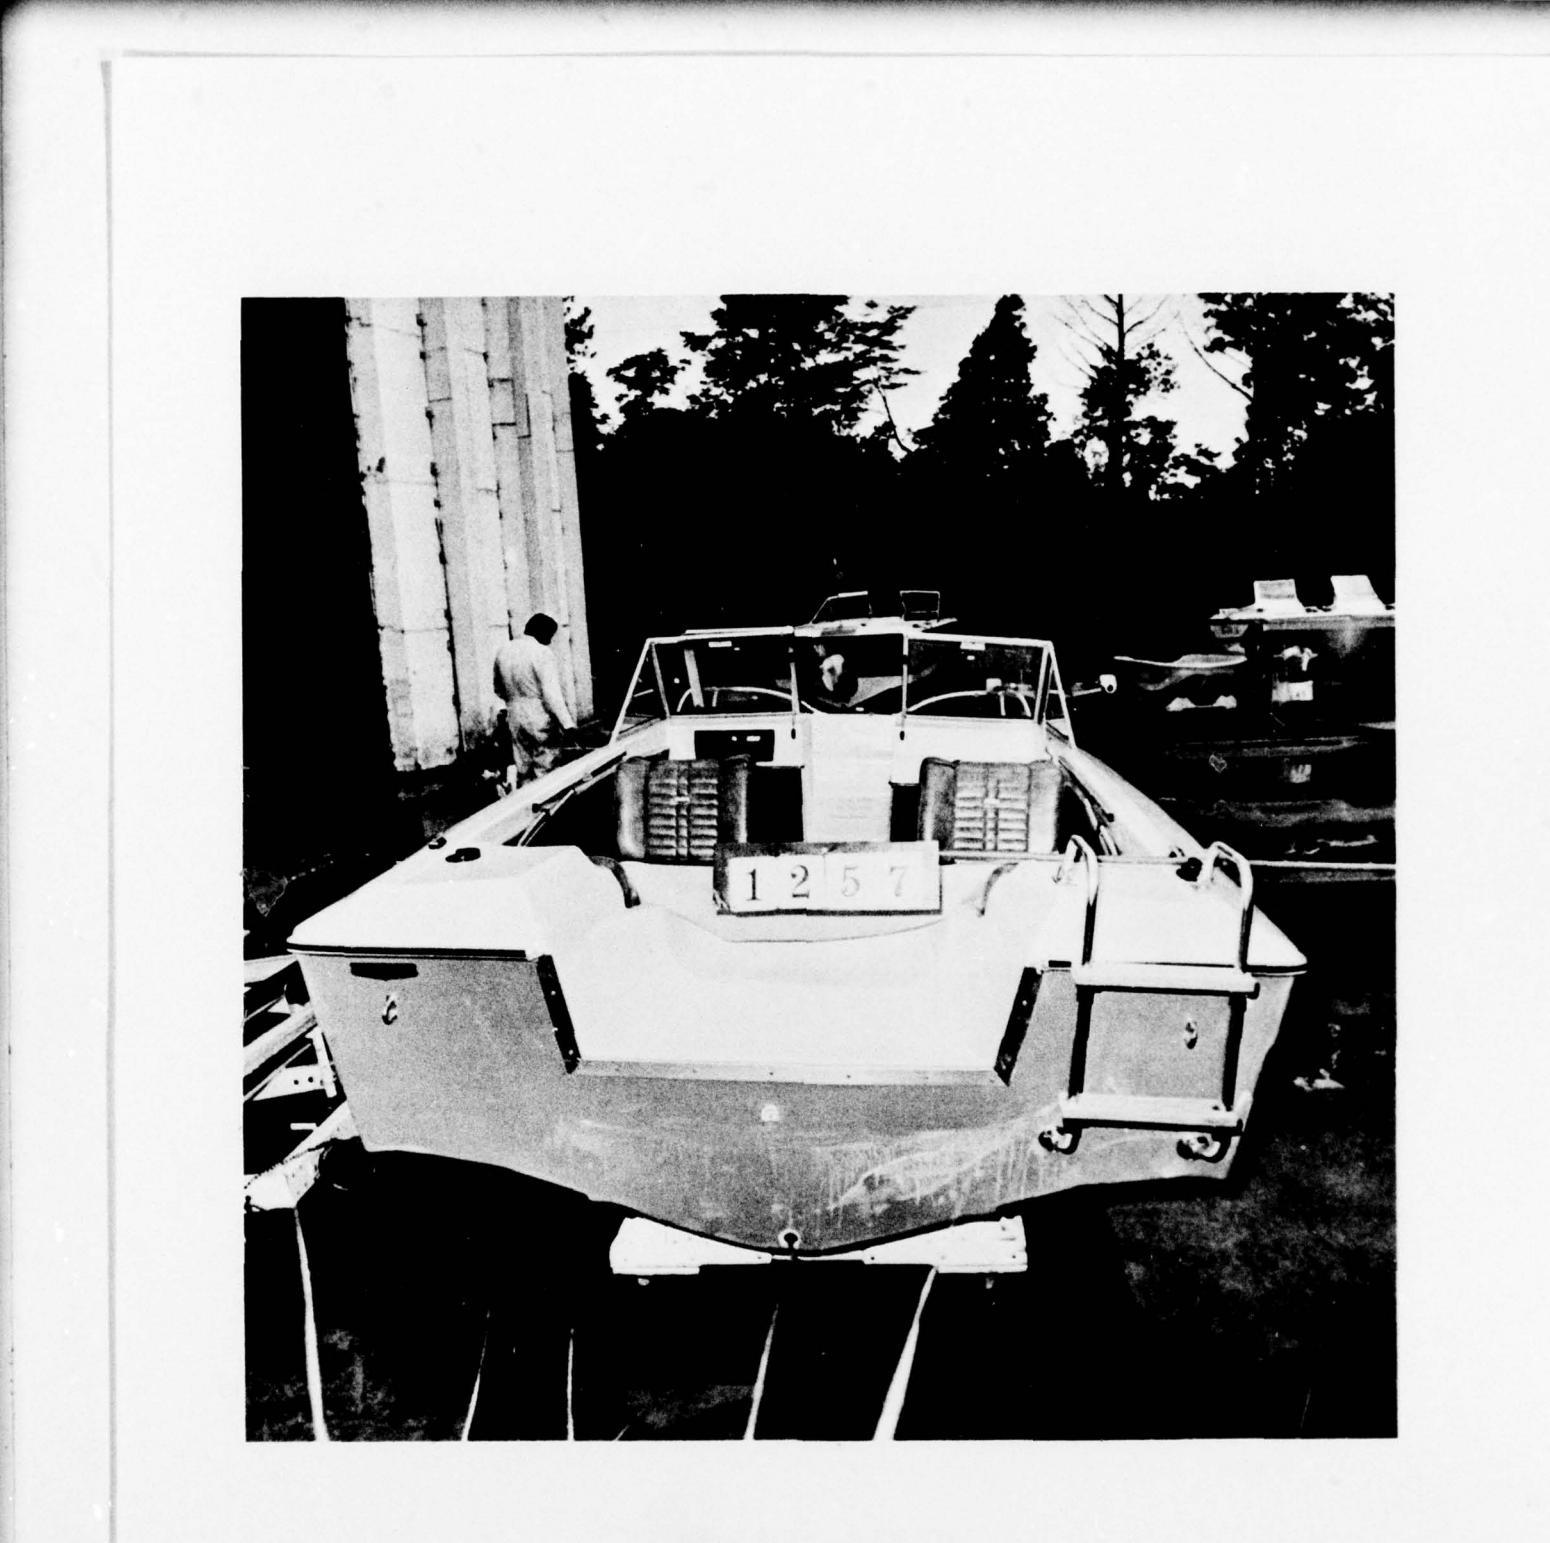
FIGURE 4. STERN VIEW

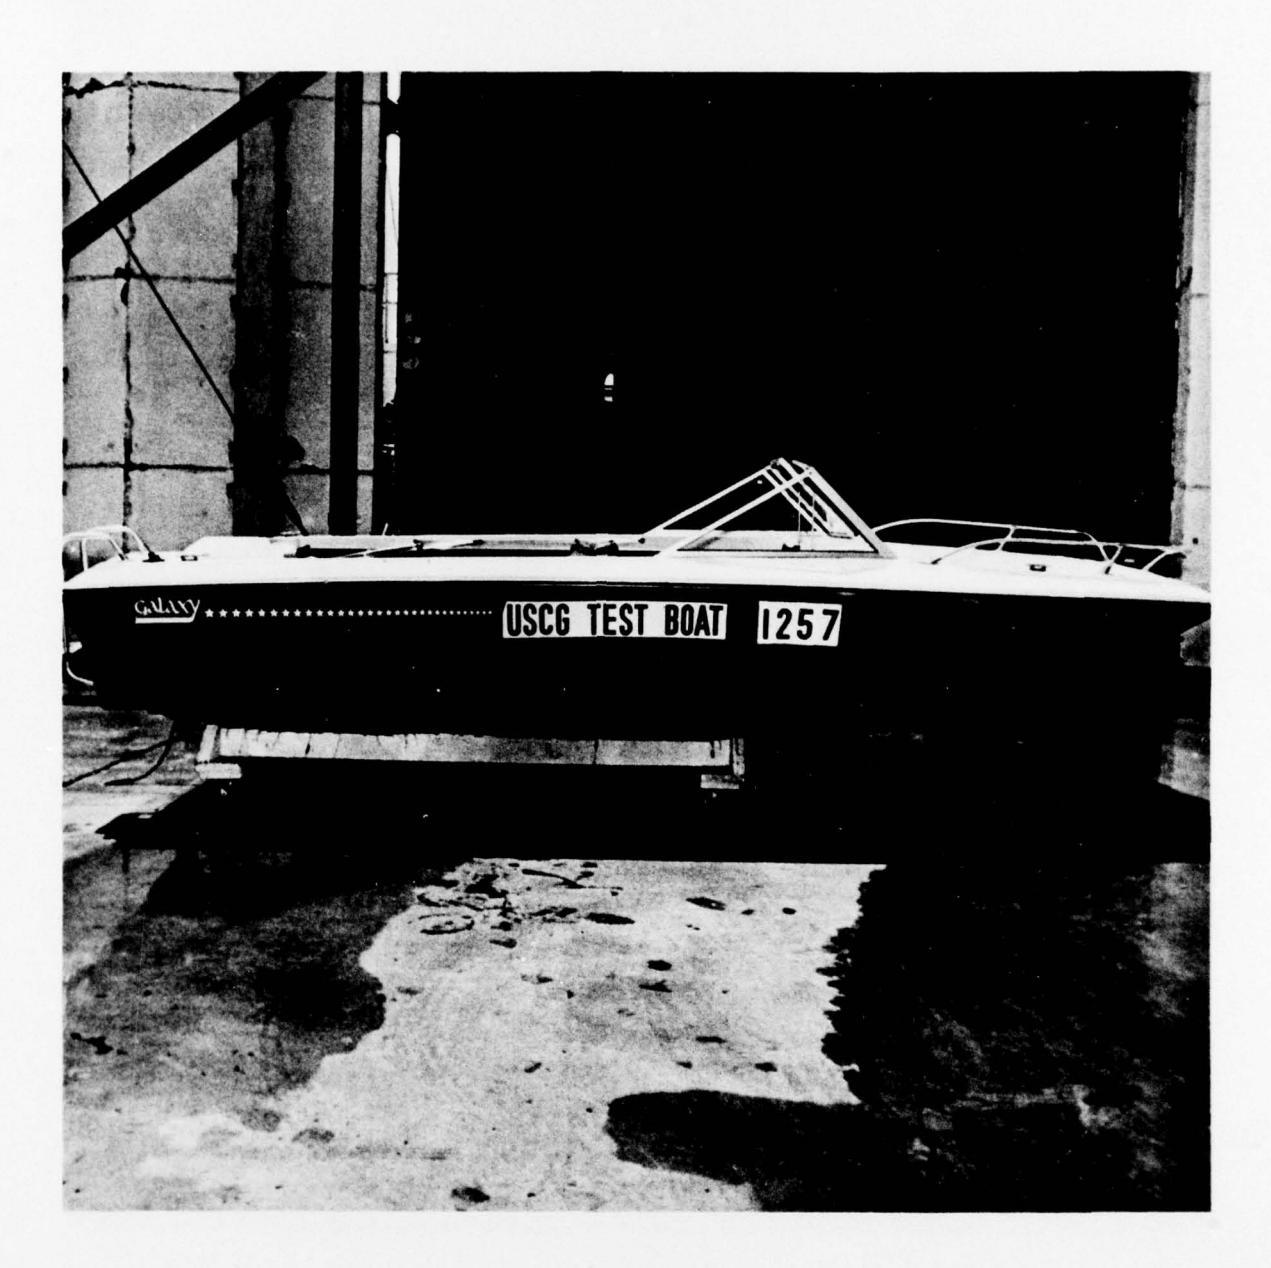
FIGURE 5. SIDE VIEW
