PASSAIC RIVER BASIN
DEN BROOK, MORRIS COUNTY
NEW JERSEY

INDIAN LAKE DAM

PHASE I INSPECTION REPORT
NATIONAL DAM SAFETY PROGRAM

NJ 00167

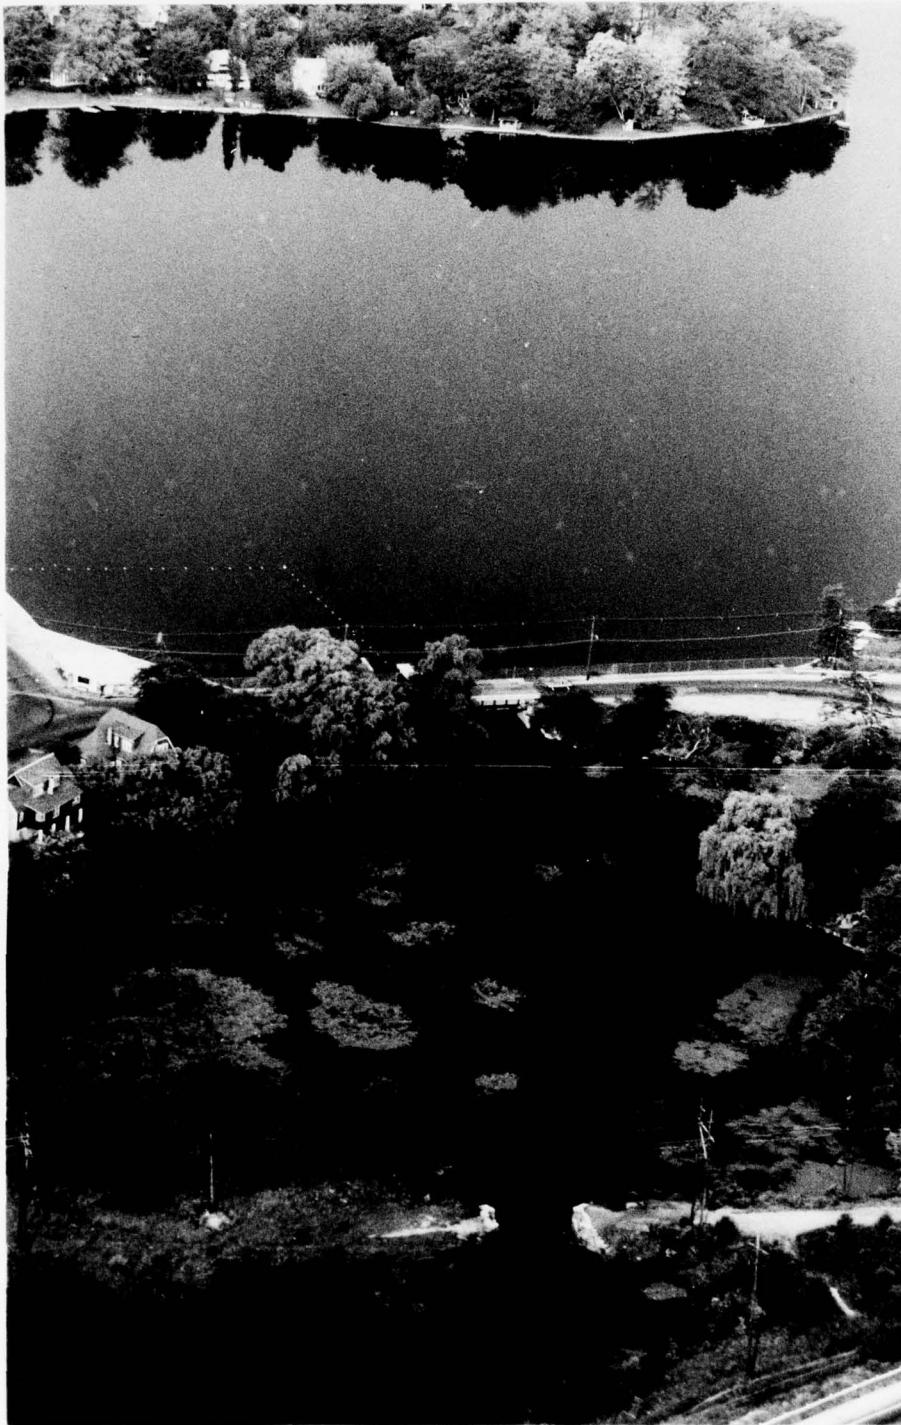
OVER VIEW

INDIAN LAKE DAM
21 June 1978
