Special Report 78-17

September 1978

EFFECTS OF WINTER MILITARY OPERATIONS ON COLD REGIONS TERRAINS

COLD REGIONS RESEARCH AND ENGINEERING LABORATORY
U.S. ARMY CORPS OF ENGINEERS
HANOVER, NEW HAMPSHIRE

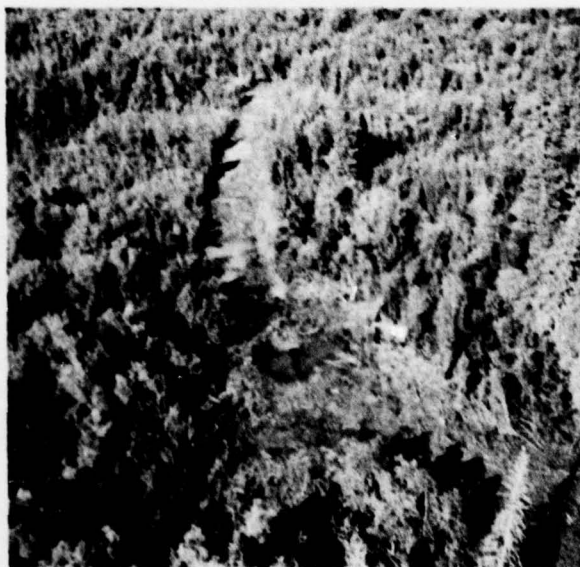
17

Figure 19. Aerial view of site 17.

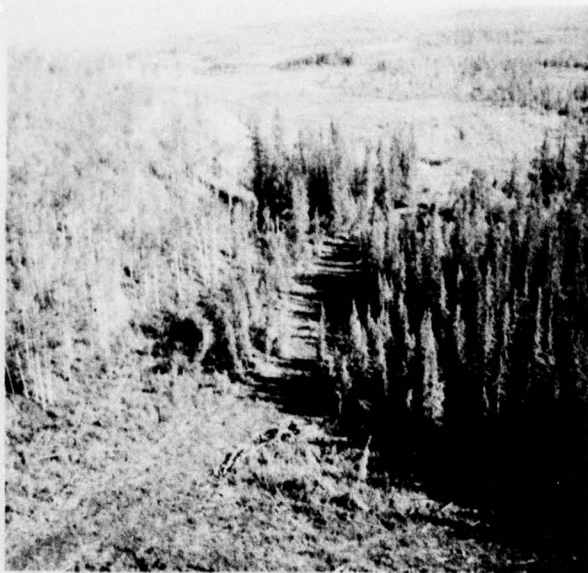
An aerial view of site 18 is shown in Figure 24, and of site 19 in Figure 25.

Figure 24. Aerial view of site 18.

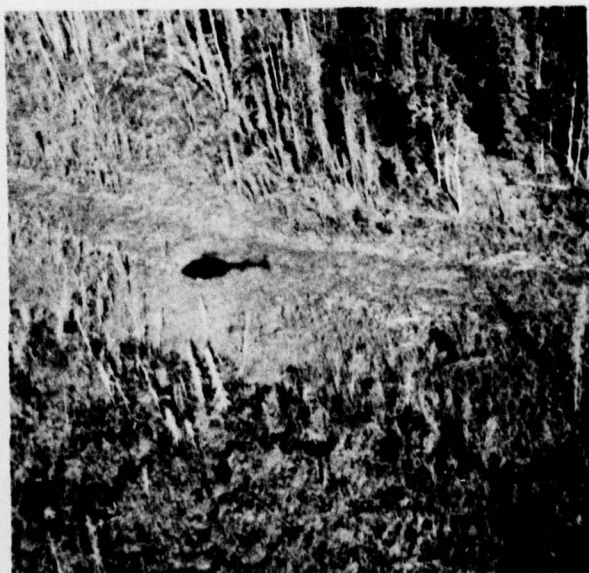
19

Figure 25. Aerial view of site 19.

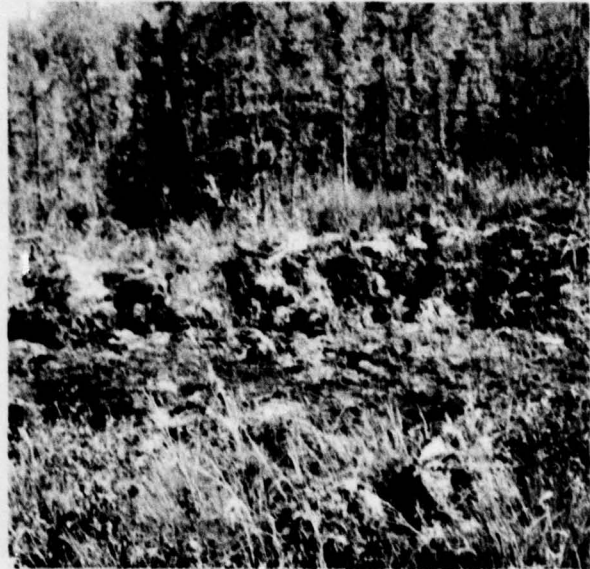
Figure 33. Area adjacent to site 20
(looking E).

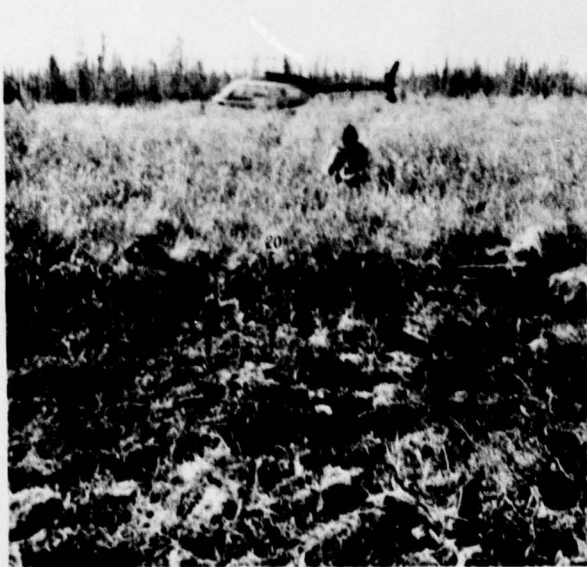
Figure 34. Area adjacent to site 20
(looking W).

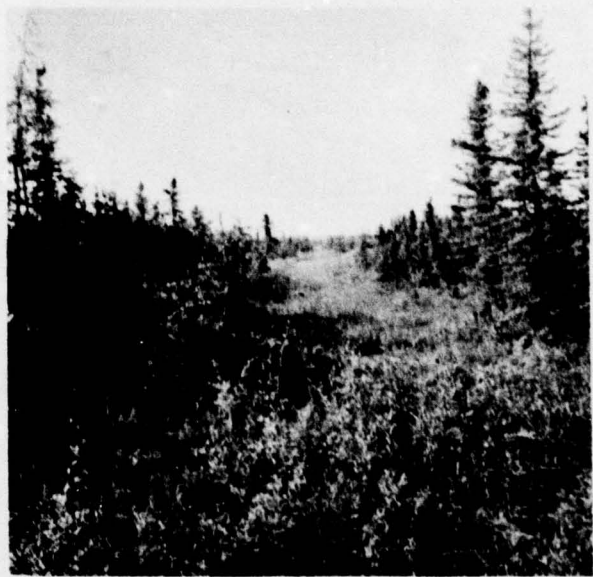
Figure 37. Trail at troop
concentration (artillery)
area (looking W).

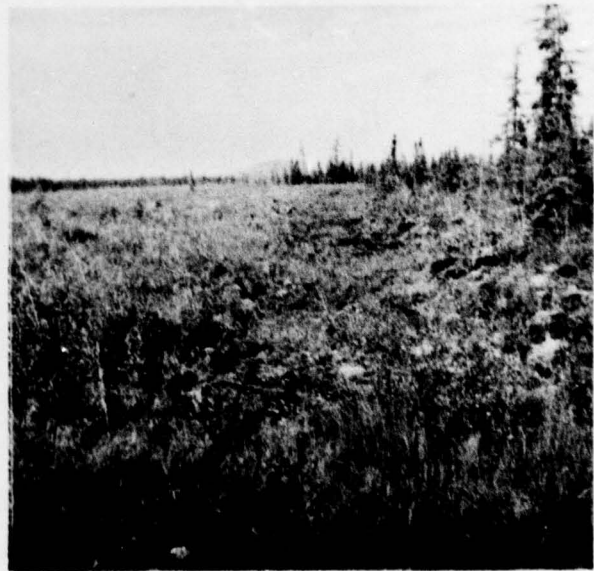
Figure 39. New trail
(looking N).

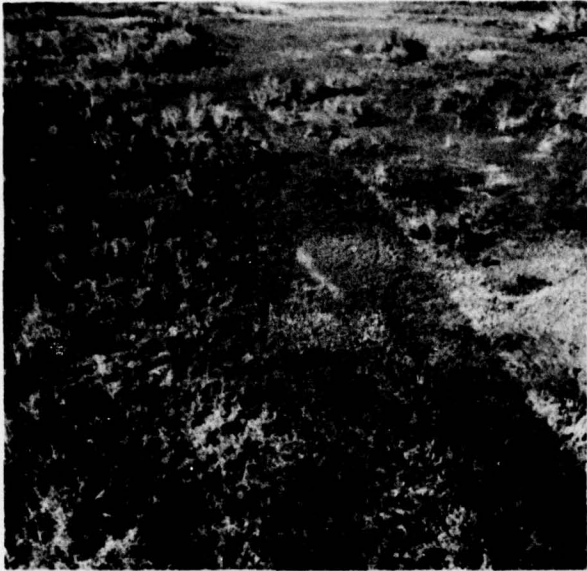
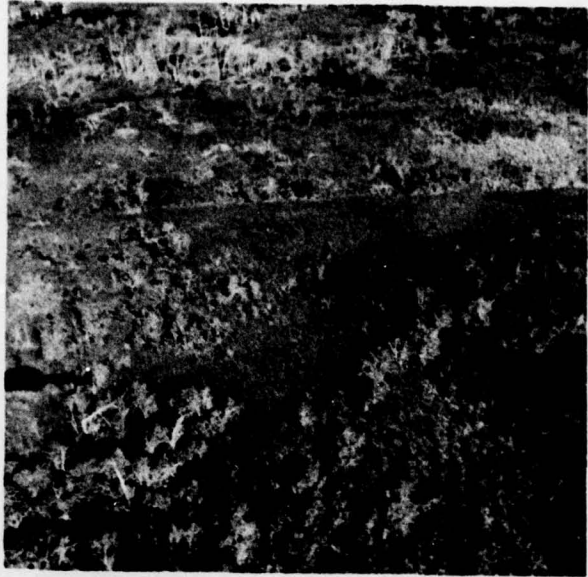
Trail over bog (Figs. 40 and 41; refer also to Fig. 70a). An open bog, with sedge and horsetail as dominant species and willows on moss covered high points, the vegetation mat floating on standing water 0.6 to 1 m deep.

Figure 40. Trail with minor disturbance south of Clear Creek Butte (looking N).

Figure 41. Same trail (looking E).

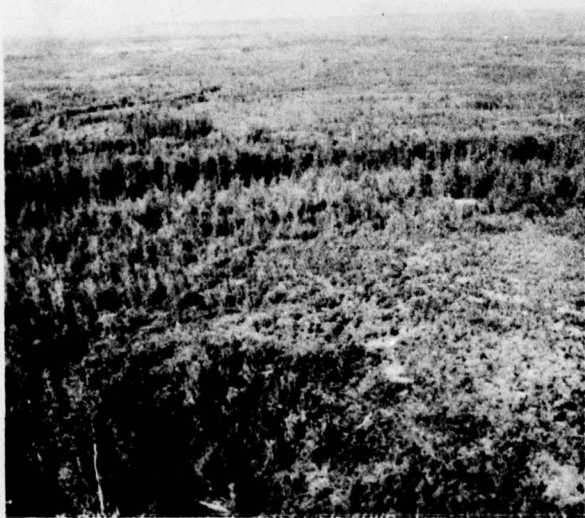
Figure 42. Command post location north of Clear Creek Butte (looking N).

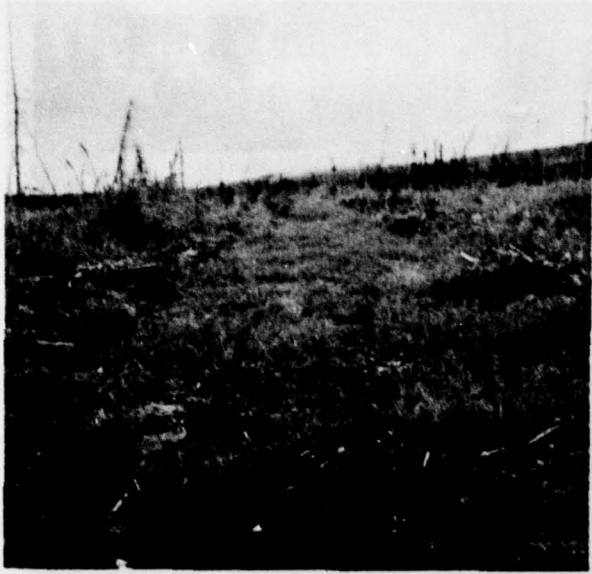
Figure 50. New trail
(looking SE).

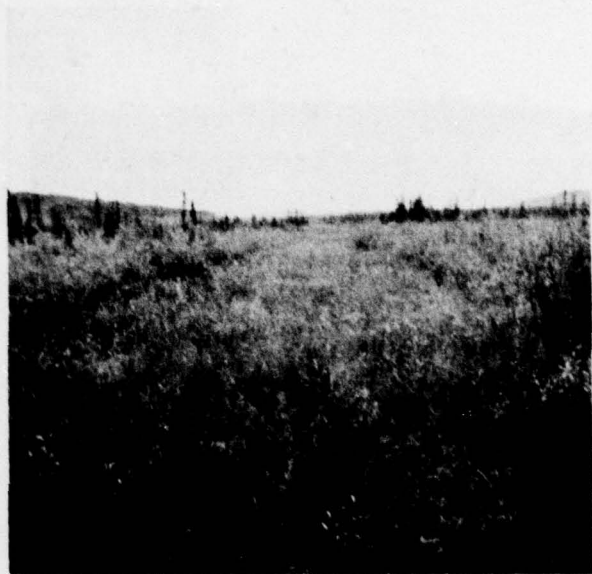
Figure 51. Old trail
(looking E).

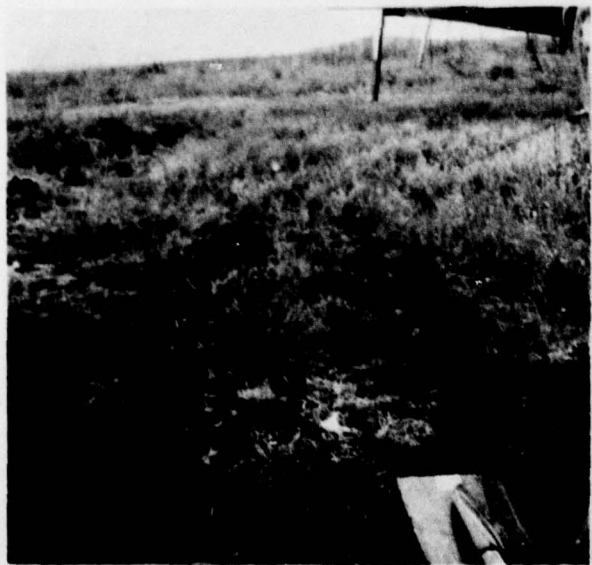
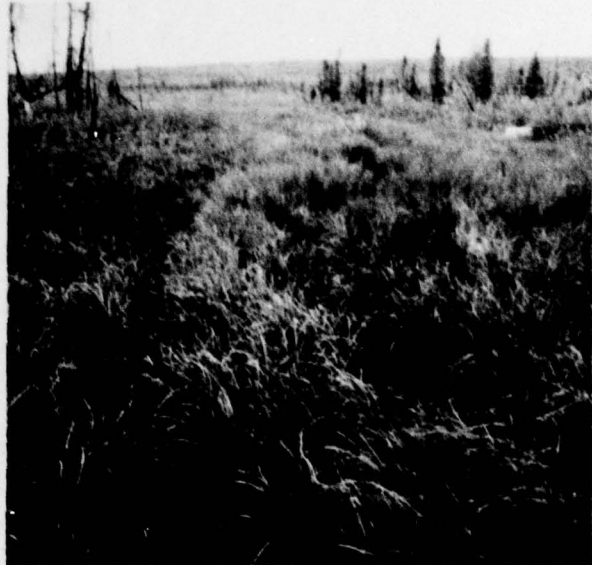
Troop concentration (Blair Lakes) (Figs. 44-57). The area contains an unpaved landing strip, a new trail (Fig. 50) and several old trails (such as shown in Fig. 51). Some vehicle tracks are visible on an old trail (Figs. 52 and 53), which are also detectable in the aerial view (at the intersection of the trails) in Figure 49.

Figure 52. Vehicle tracks in old trail
(looking E).

Figure 53. Vehicle tracks in old trail
(looking S).

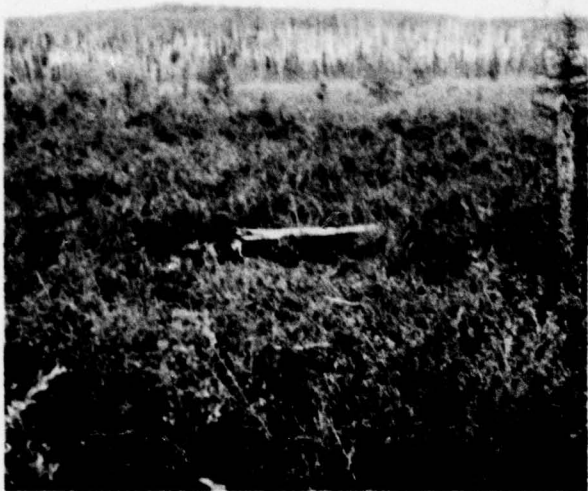
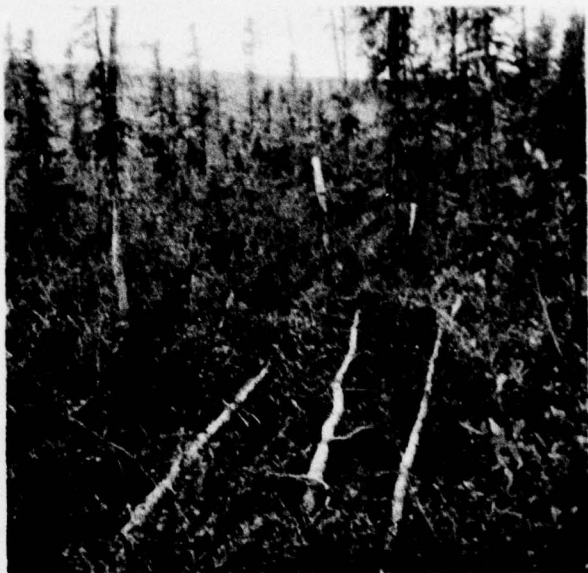
Figure 54. Bivouac site,
north of trail.

Figure 55. Bivouac site,
south of trail

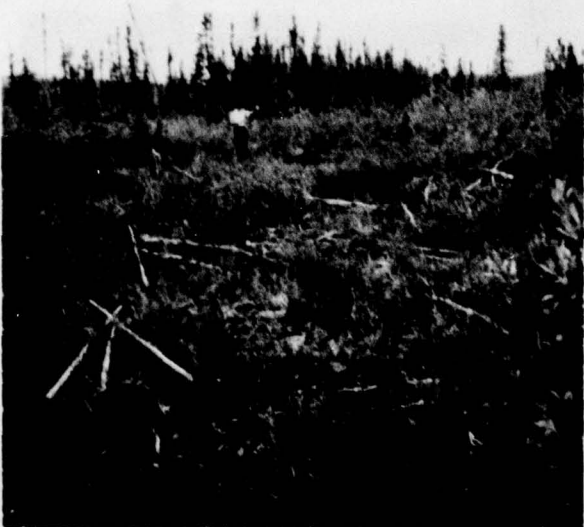
Figure 56. Dump site.

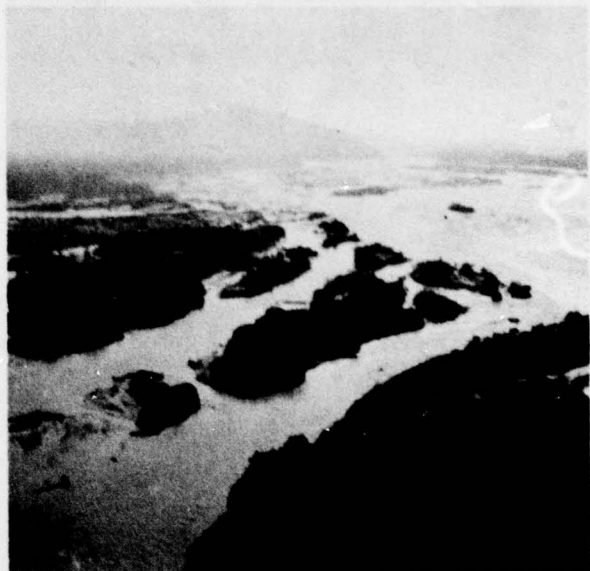
Figure 59. View of Tanana River
S of Eielson AFB (looking S)

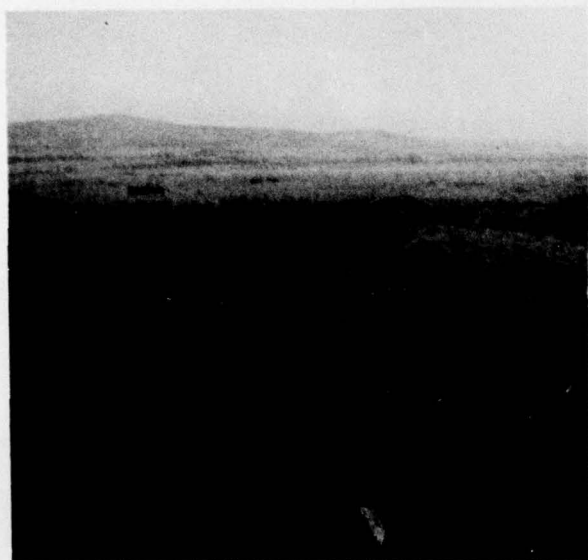
Figure 64. Trails east of Blair Lakes (looking NE).

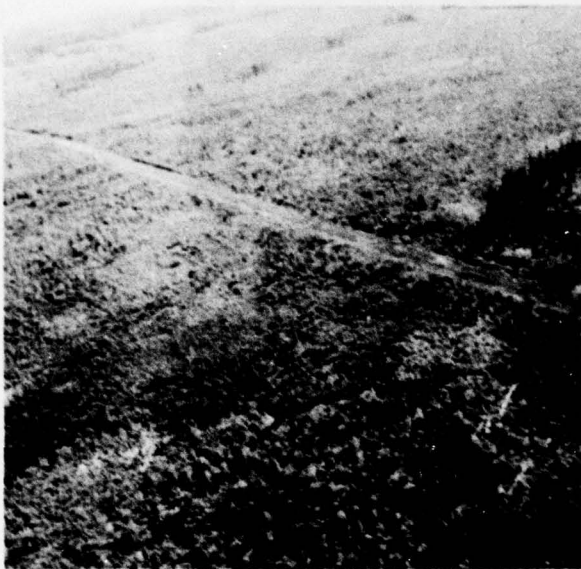
Figure 66. Tanana to Blair Lakes trail (looking SE).

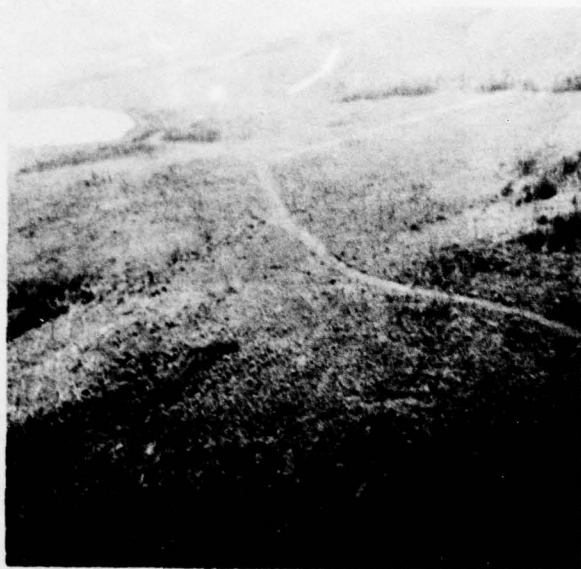
Figure 67. Tanana to Blair Lakes trail (looking SE).

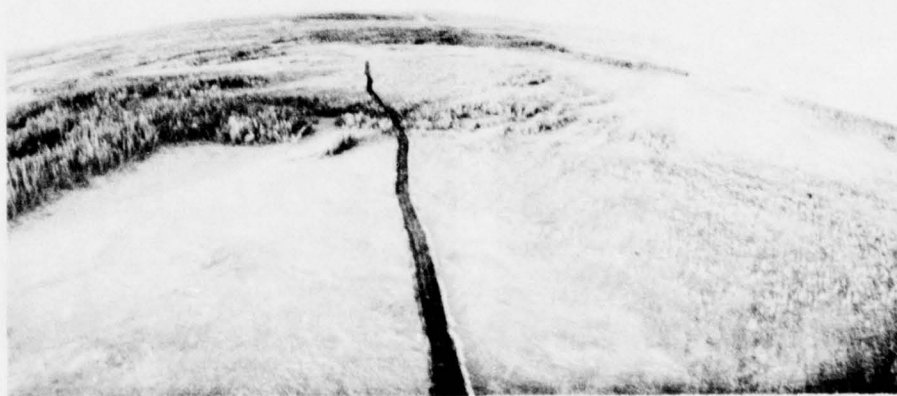
Figure 70 shows aerial views of 3 sections of the new trail SE of Clear Creek Butte shortly after the trail had been cut. Figure 70a shows the bog area where the bulldozer blade did not penetrate into the soil. This view contains the area shown in Figures 40 and 41. Figure 70b contains sites 14 and 15, where considerable vegetation and soil removal had occurred (refer to Fig. 5). Figure 70c includes sites 10 through 13 (refer to Figure 4).

c) Area including sites 10 through 13 (Fig. 4)
