Report to the Test Director

RESPONSE OF DUAL-PURPOSE REINFORCED-CONCRETE MASS SHELTER

Ammann & Whitney New York, New York April 1961

Project 30.2 was conducted to test a reinforced-concrete dual-purpose underground parking garage and personnel shelter designed for a long-duration incident pressure of 40 psi. The shelter was exposed to shot Priscilla, an approximately 37-kt 700-ft balloon burst (June 24, 1957), at a ground range of 1600 ft (predicted 35-psi peak incident-pressure level). The recorded peak incident pressure at the shelter was approximately 39 psi.

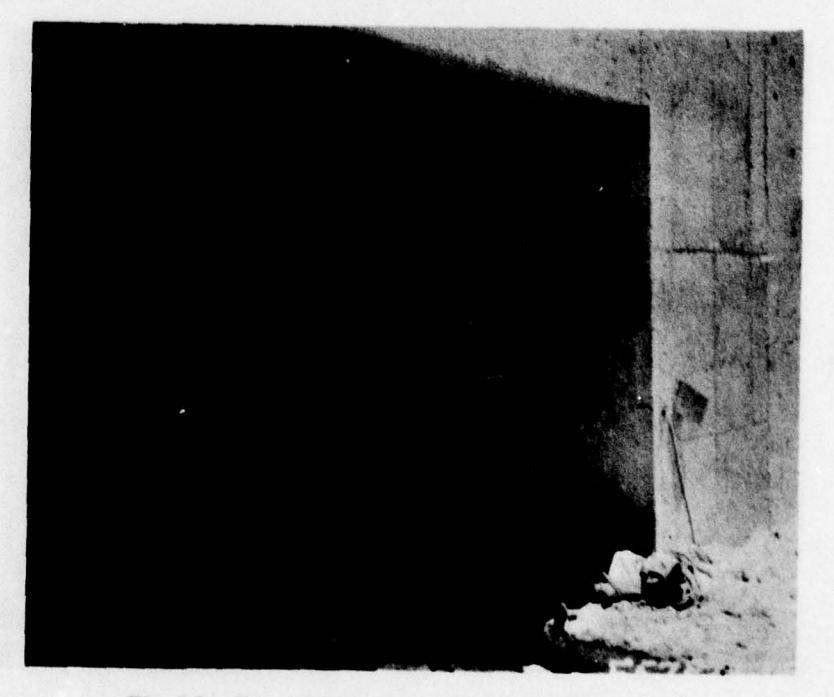
Fig. 3.8-View of door showing locking bolts (postshot).

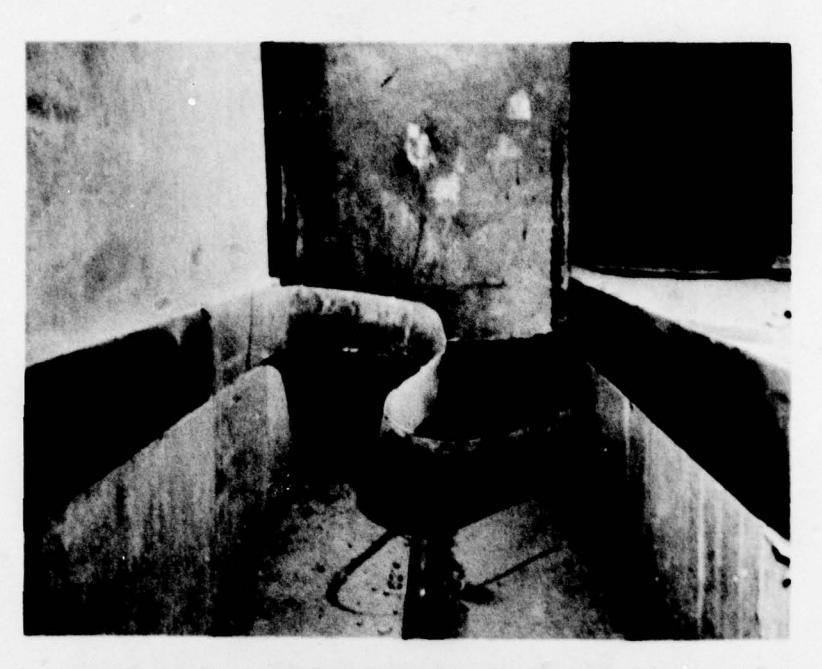
Fig. 3.9-Torn guide plate before removal to allow opening of door (postshot).

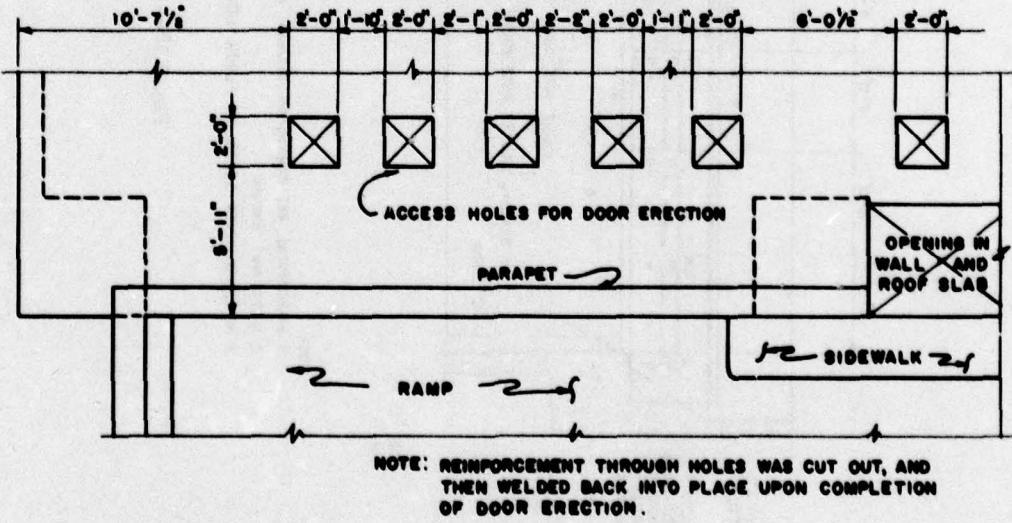
Fig. B.38 - Access holes for door erection.

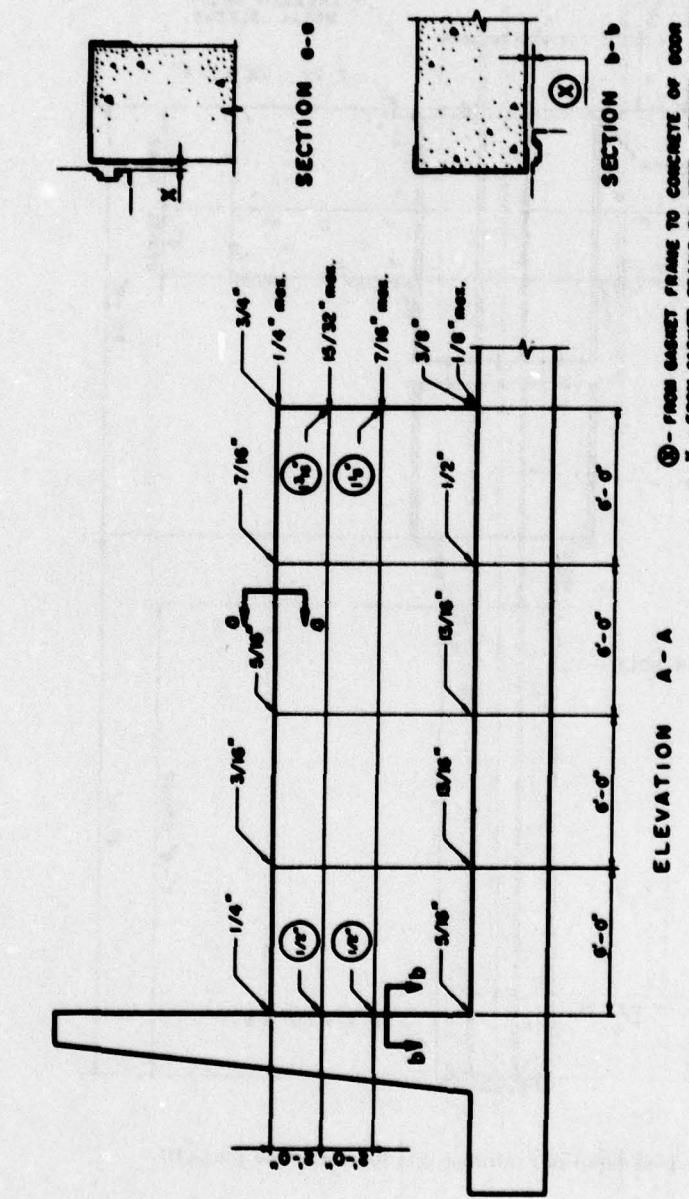
Fig. B.40 - Door clearances, door closed.
