MODIFICATION AND LABORATORY EVALUATION OF A SHIPBOARD
MULTIFUNCTIONAL MAS... (U) NAVAL SURFACE WEAPONS CENTER
DAHLGREN VA J A BYRNE ET AL. MAY 82 NSWC/TR-82-71

4. TITLE (and Subtitle) MODIFICATION AND LABORATORY EVALUATION OF A SHIPBOARD MULTIFUNCTIONAL WASTE INCINERATOR (MFI), PHASE II	5. TYPE OF REPORT & PERIOD COVERED Final

6. PERFORMING ORG. REPORT NUMBER	
7. AUTHOR(s) J. A. Byrne W. W. Jones	8. CONTRACT OR GRANT NUMBER(s)	
9. PERFORMING ORGANIZATION NAME AND ADDRESS Naval Surface Weapons Center (G51) Dahlgren, VA 22448	10. PROGRAM ELEMENT, PROJECT, TASK AREA & WORK UNIT NUMBERS 63721N 21484

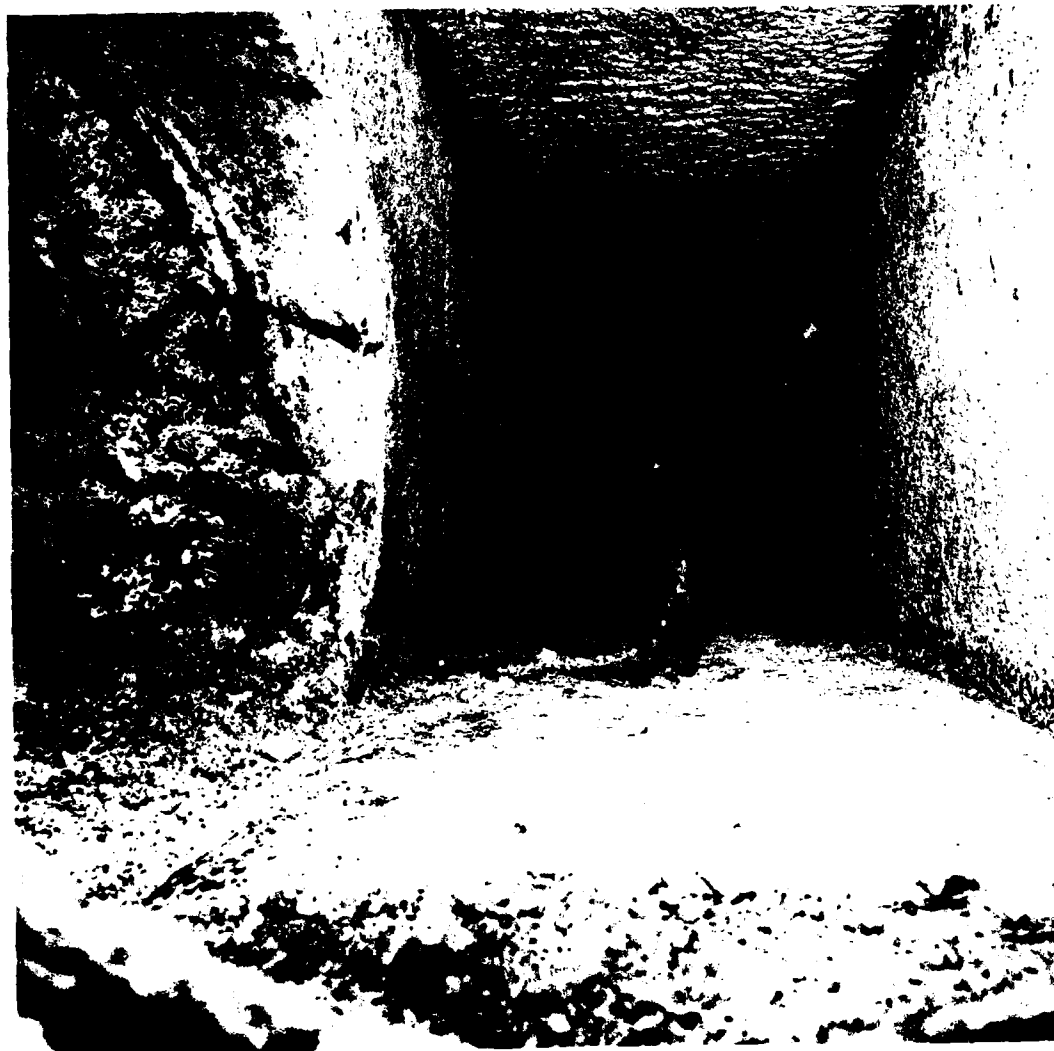
The unit was allowed to cool only 24 hr before it was moved so that the mount supports could be changed for the transverse 90° axis. A photographic inspection of the refractory was made, but due to scheduling difficulties, it was a limited one. This documentation is shown in Figures 67 through 71. Figures 67 and 68 are views of the main chamber. There was some additional peeling of the protective mortar, but there was no significant damage. Figures 69 and 70 show the sewage chamber. Figure 69 is a view of the exhaust port. The white material is excess refractory that was dropped into the sewage chamber when the joint between the sewage and cooling chambers was made. Figure 70 shows the sewage nozzle port at the left and a single vertical crack in the opposite wall. This crack is considered very minor and would not affect MFI operation. Figure 71 is a view of the cooling chamber. No visible change could be seen in the refractory. From this assessment, the MFI met all requirements for normal operation while enduring the transverse 0° axis vibrational environment.

Figure 71. Horizontal Cooling Chamber After Transverse 0° Axis Test

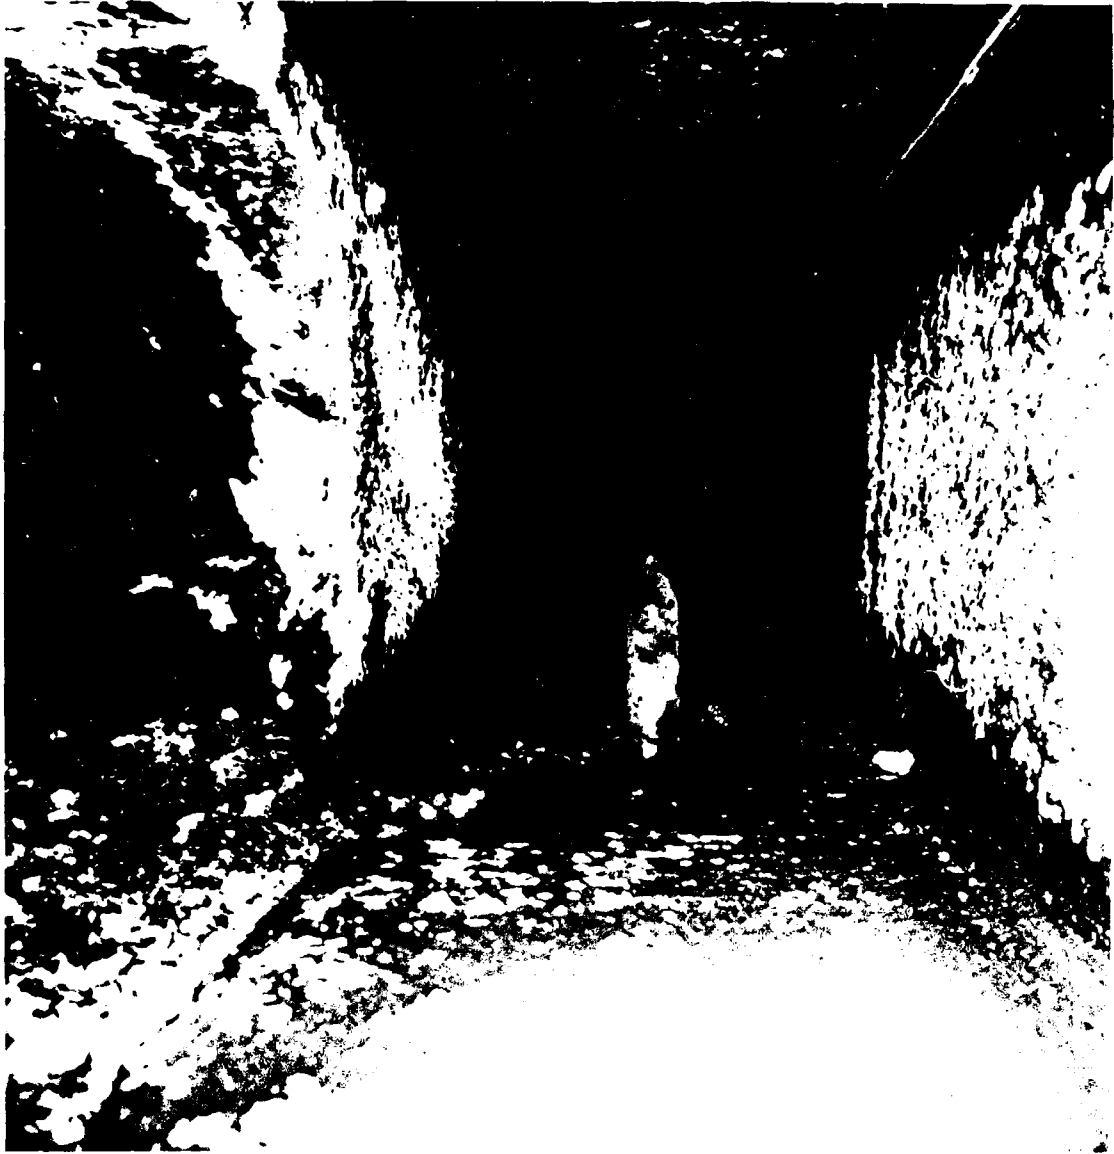
Figures 74 through 83 are the photographs of the refractory after the third axis vibration test. Figure 74 is the view from the feed door of the main chamber. Some additional loss of an approximately 1/2-in. layer of mortar and refractory can be seen on both side walls. This loss would not affect the solid waste process rates. Figure 75 details loss of the refractory layer in the lower right corner of the figure, with the viewing port shown in the upper left corner of the figure. Figure 76 shows that no additional cracking occurred in the front wall. The loss of a small, thin section of the burner is shown in Figure 77; and, again, this refractory loss is very minor. The ash door overhead structure and the rear grout are shown in Figure 78. The right rear grout has been damaged. This damage, though easily repaired, would not affect the MFI's operation, since the castable insulating refractory behind the grout refractory would protect the metal wall. Figures 79 and 80 are views of the sewage chamber from the ash cleanout hatches. As shown, no visible changes or damage could be detected. Figures 81 and 82 are views of the sewage chamber from the sewage nozzle port, and again, there were no discernable changes in the refractory. Figure 83 shows the cooling chamber. Other than the heavy layer of soot, there was no damage to the chamber. Thus the MFI, with only minor refractory damage, successfully passed the transverse 90° axis vibration test. The MFI subsystems functioned as required and were capable of incinerating waste materials.

Figure 83. Horizontal Cooling Chamber After Transverse 90° Axis Test
