LIBBY DAM AND LAKE KOOCANUSA PROJECT, MONTANA

LEFT BANK SLOPE

LIBBY DAM-LAKE KOOCANUSA PROJECT

EXECUTIVE SUMMARY

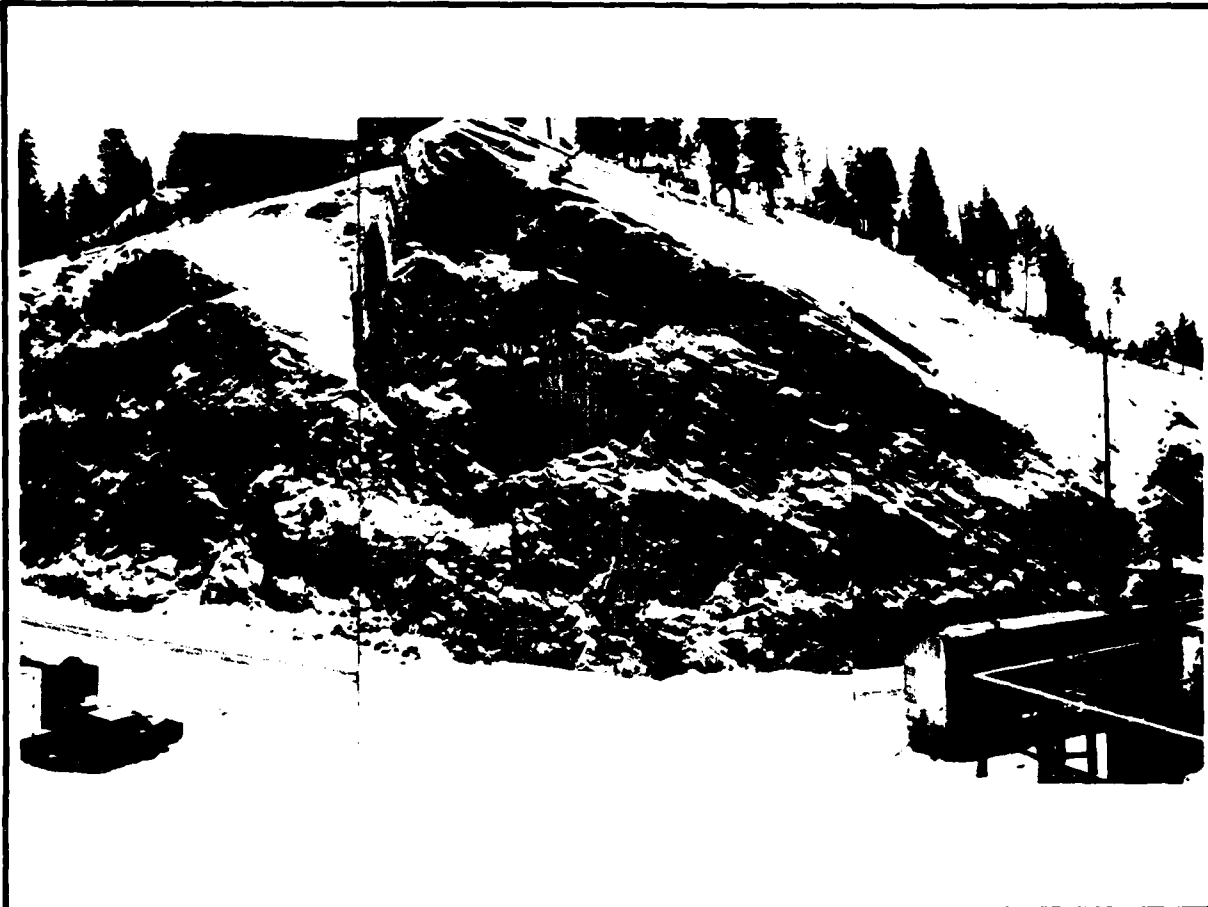
FIGURE 3.1

COMPOSITE PHOTOGRAPH OF MSH 37 CUT
ADJACENT TO LEFT ABUTMENT, WINTER 1968.

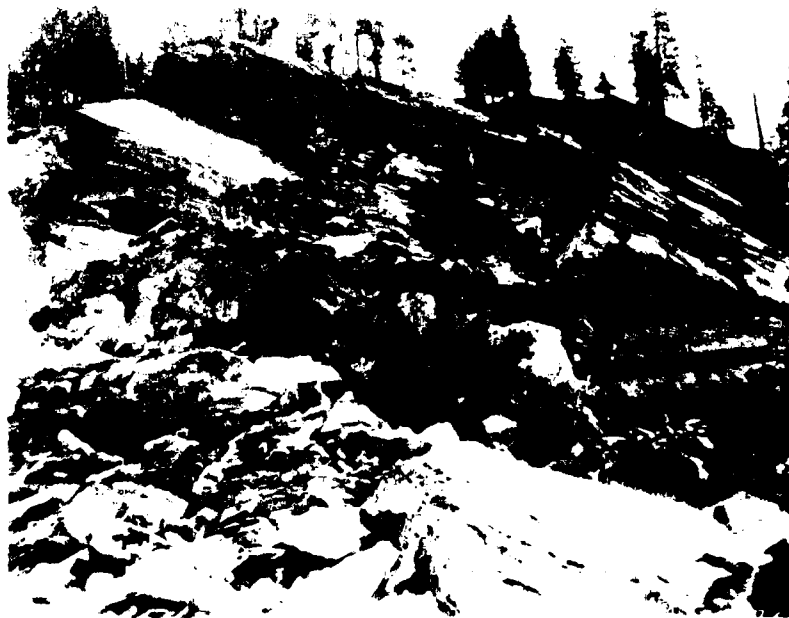
3.11b View upslope to face of slide (moved block) from surface of rubble pile.

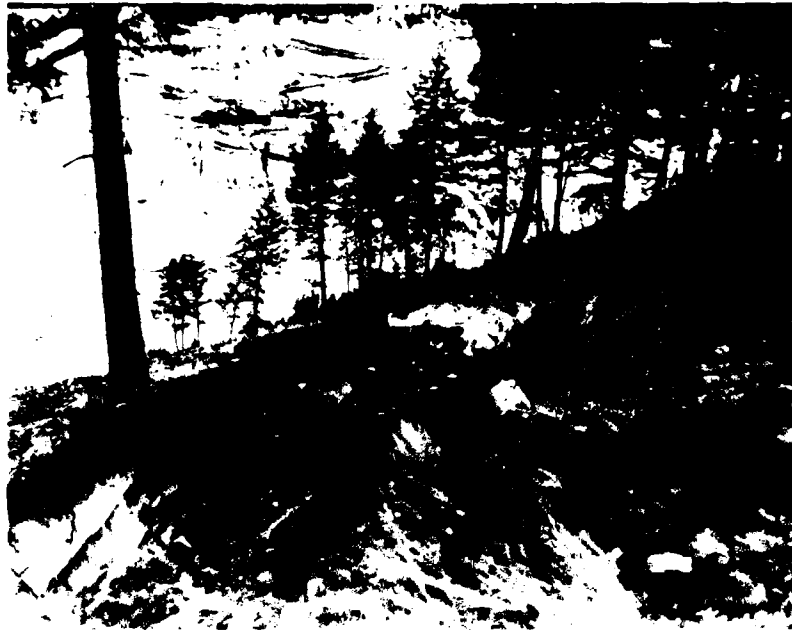
3.13a View upstream of pullaway at head of moved block.
Note north-south joints dipping into slope.
