AFWAL-TR-84-2048

DAMAGE CAUSED TO POLYURETHANE FOAMS BY AGING,
SIMULATED SUNLIGHT EXPOSURE, HEAT AND FIRE

JULY 1984

FINAL REPORT FOR PERIOD 15 JANUARY 1983 - 30 SEPTEMBER 1983

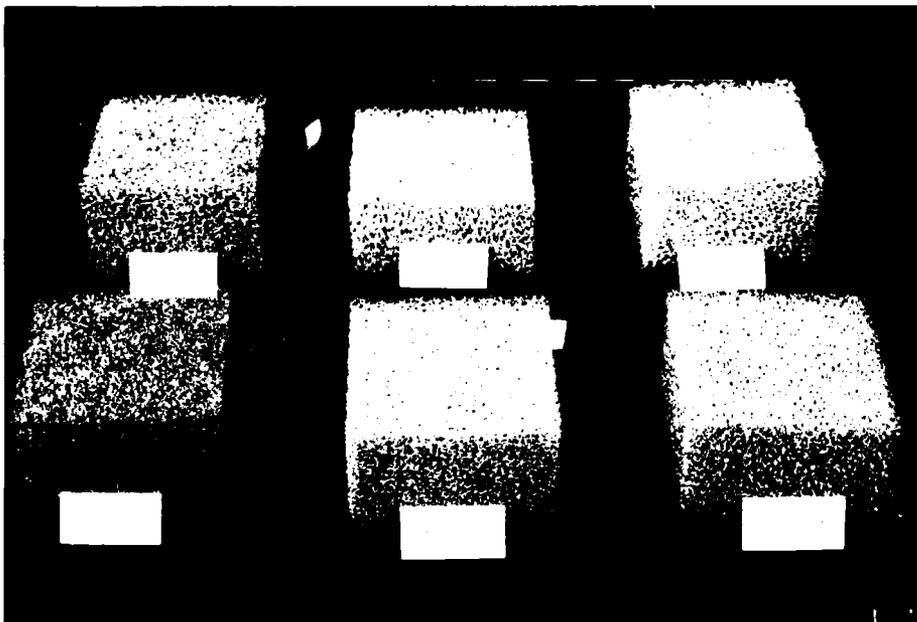
Figure A1-5. Specimens of blue foam, subjected to accelerated aging in air at 200°F (93°C) for one to five weeks. (Reference sample of unexposed foam is also shown.)

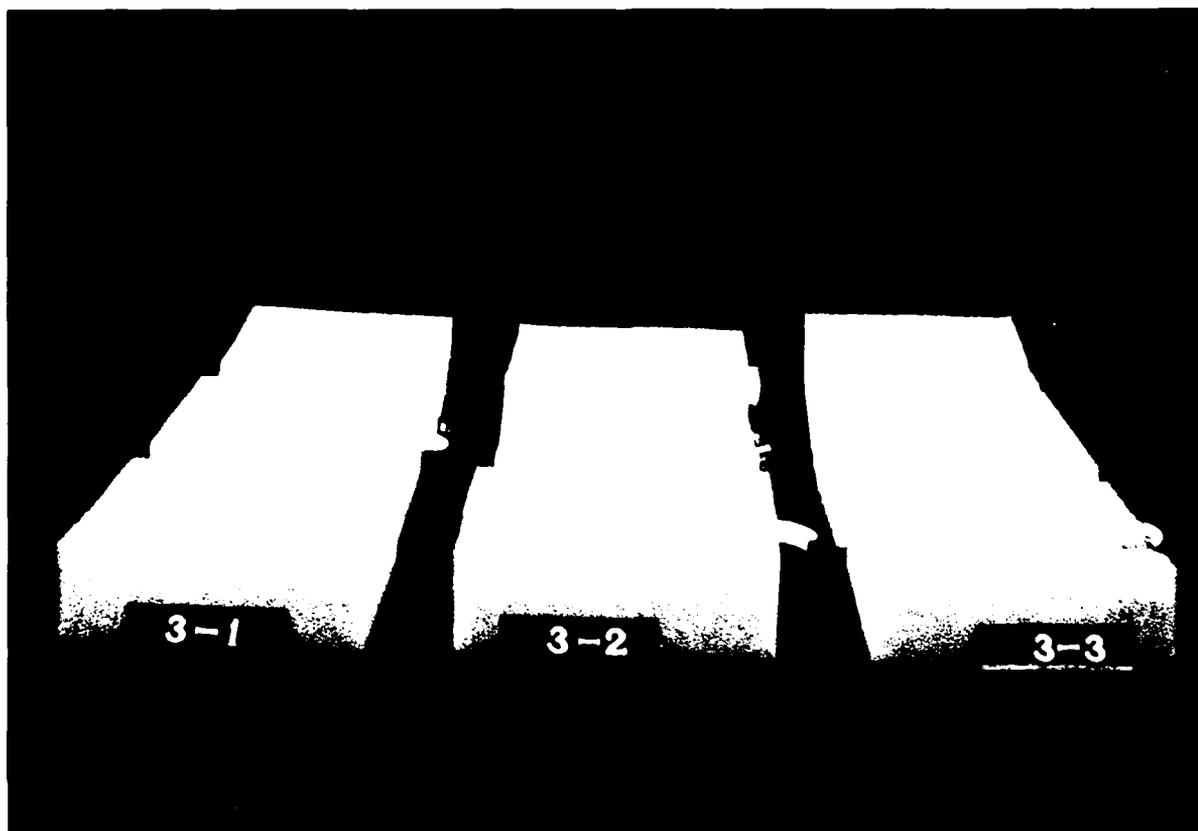
Figure A1-107. Perspective view of yellow foam specimens, subjected to brief flame impingement from top while in horizontal position, and from bottom while in vertical and horizontal positions, respectively.
