CONNECTICUT RIVER BASIN
WARE, MASSACHUSETTS

WINSOR DAM MA 00588
QUABBIN SPILLWAY MA 00589
GOODNOUGH DIKE MA 00590

PHASE I INSPECTION REPORT
NATIONAL DAM INSPECTION PROGRAM

SEPTEMBER 1978

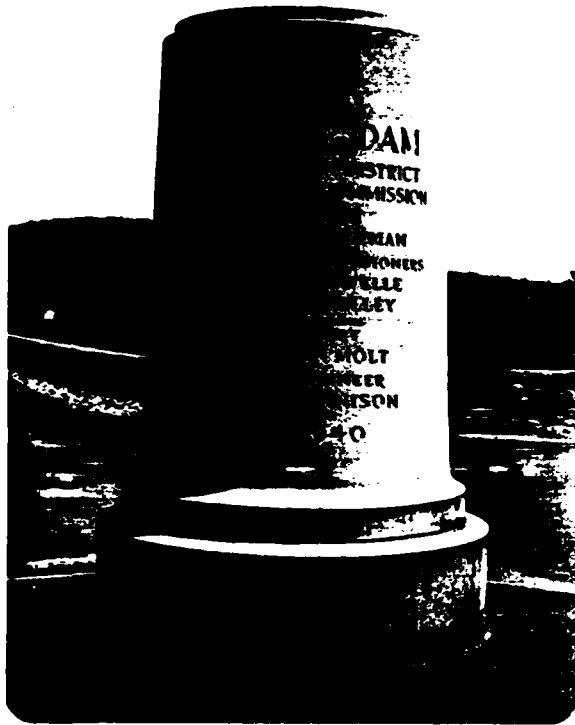
1. Winsor Dam Monument, Located at Right Abutment

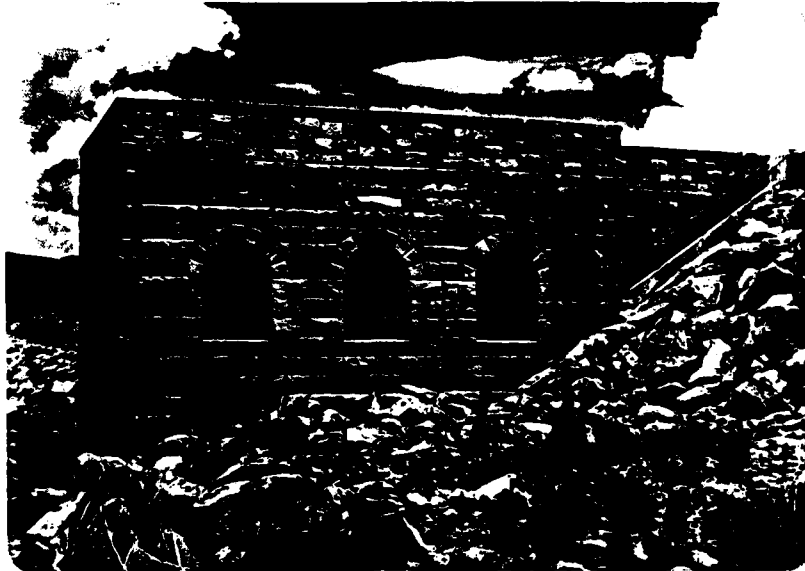
8. Stone Masonry Wall Left of Intake Structure

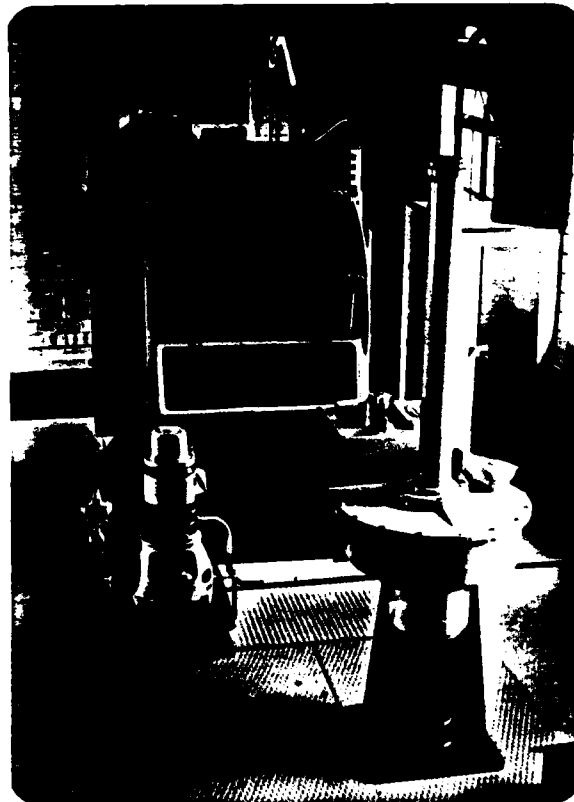
9. Intake Structure

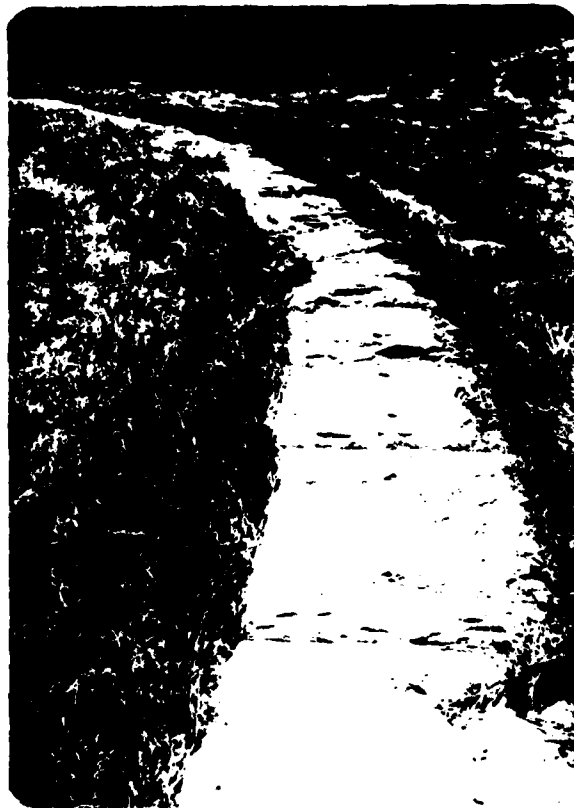
11. Auxiliary Spillway and Approach Channel, Looking
Toward Quabbin Reservoir

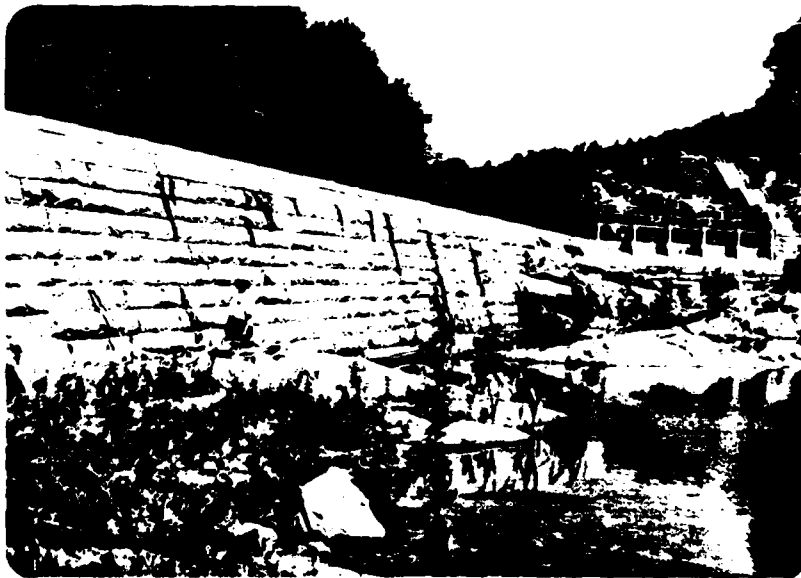
Evidence of Seepage Minor seepage noted on main spillway dropwall

15. Spillway Weir and Bedrock, Water Flowing From Drill Holes
