CLAM LAKE DAM
MA 01052

PHASE I INSPECTION REPORT
NATIONAL DAM INSPECTION PROGRAM

DEPARTMENT OF THE ARMY
NEW ENGLAND DIVISION, CORPS OF ENGINEERS
WALTHAM, MASS. 02154

FEBRUARY 1980

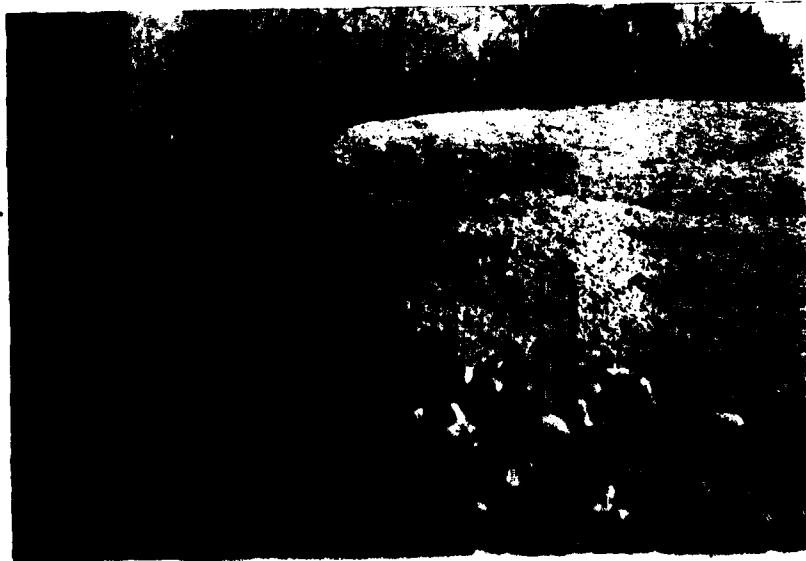
Photo 17

Left slope of emergency spillway.
Note slope failure and erosion.
