## BOMB CRATER REPAIR TECHNIQUES FOR PERMANENT AIRFIELDS

TECHNICAL REPORT GL-81-12

Report 2  
SERIES 2 AND 3 TESTS

Report 2 of a Series  
October 1985

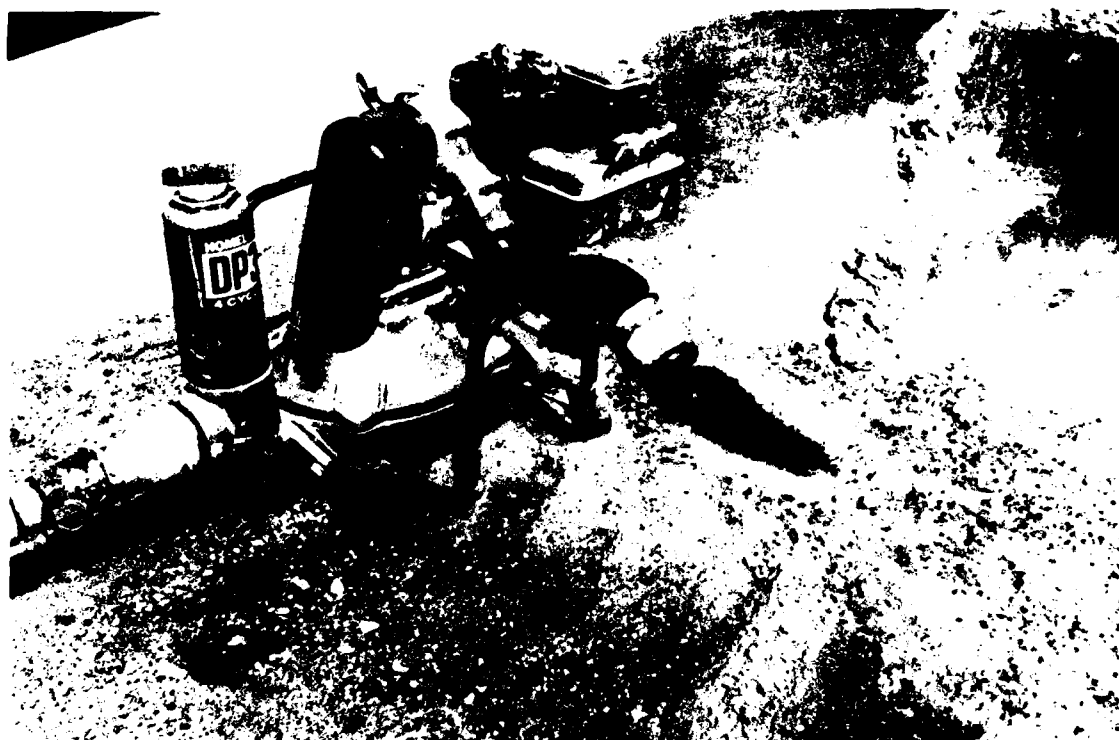
Photo 25. Water being pumped from crater 3
