UNDERWATER FACILITIES AND INSPECTIONS AND ASSESSMENTS

NAVAL AIR STATION

PENSACOLA, FLA.

JANUARY 1983

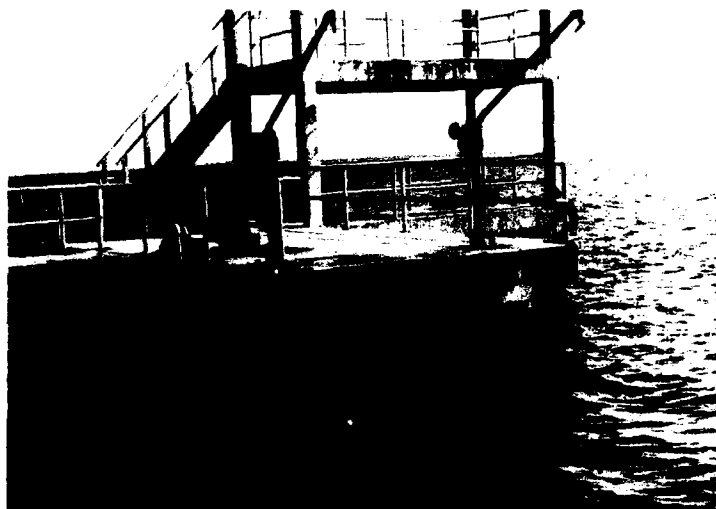
PHOTO NO. 17

Pier 3238 - Perspective view of platform  
for sea survival training exercises.

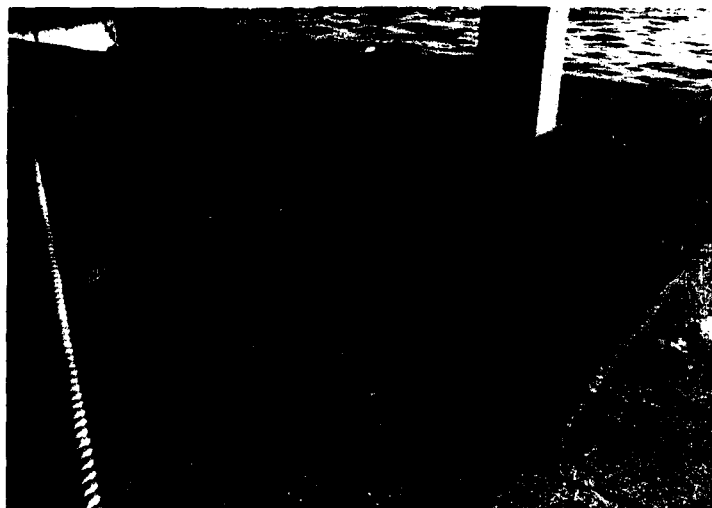
PHOTO NO. 21

Bulkheads 177,178 - Collapsed asphalt pavement  
at station 71+50.

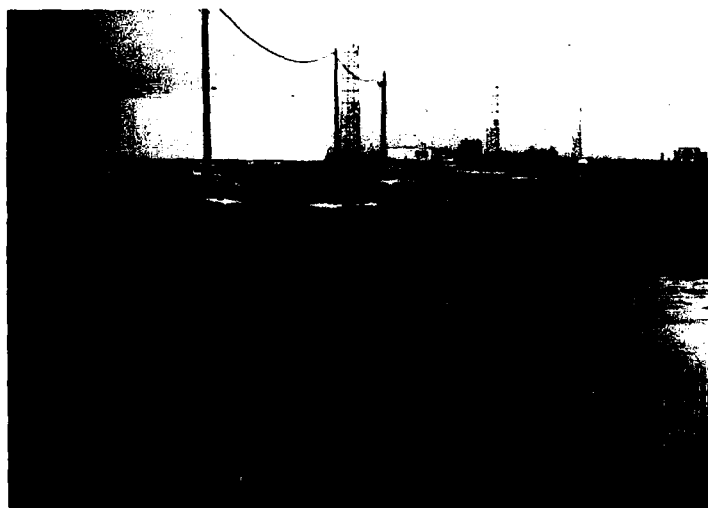
PHOTO NO. 22

Bulkheads 177,178 - View of wetface of bulkhead  
above waterline opposite Finger Pier 303.

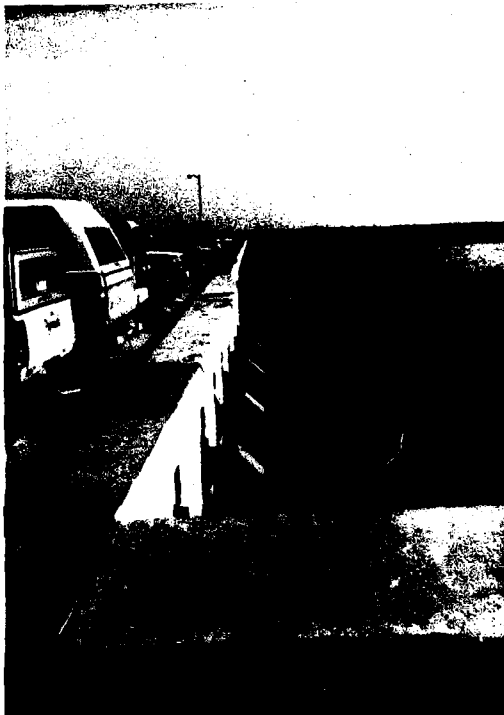
PHOTO NO. 46

Pier 302 - Perspective view showing automobile parking in proximity of bulkhead.
