TECHNICAL REPORT GL-86-17

TECHNICAL EVALUATION REPORTS OF AIRFIELD DAMAGE REPAIR SOLUTION

October 1986

Final Report

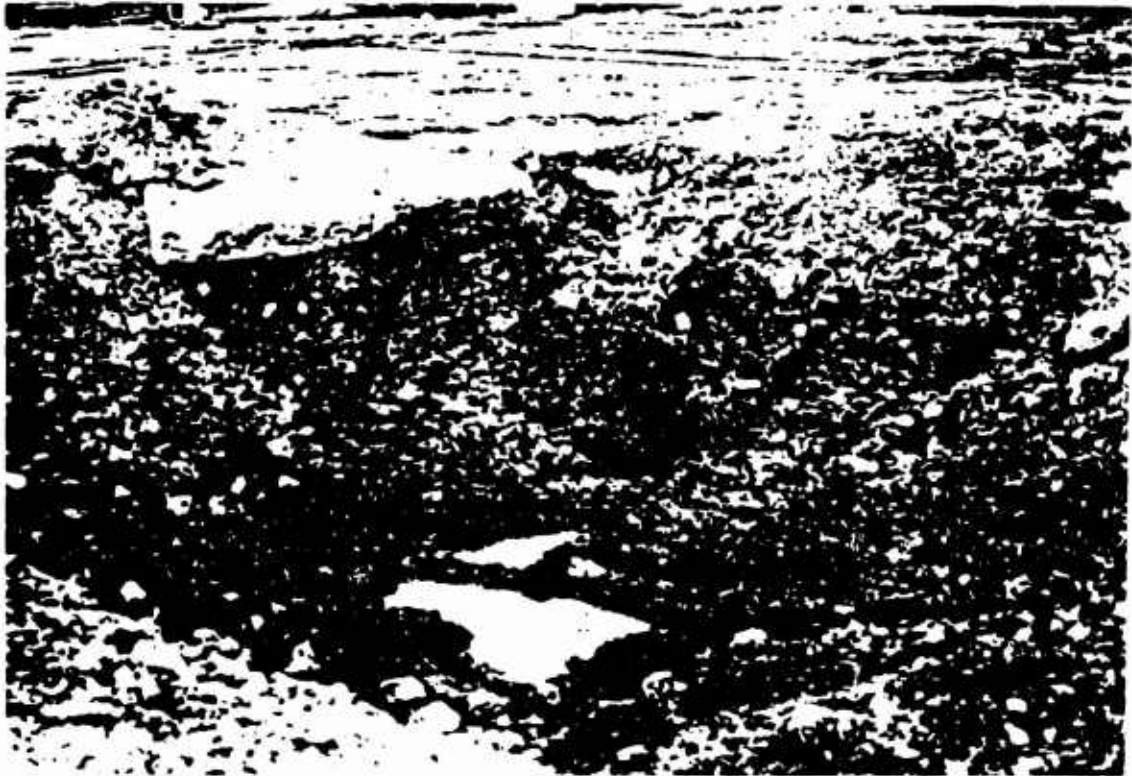
Photo 1. Simulated crater

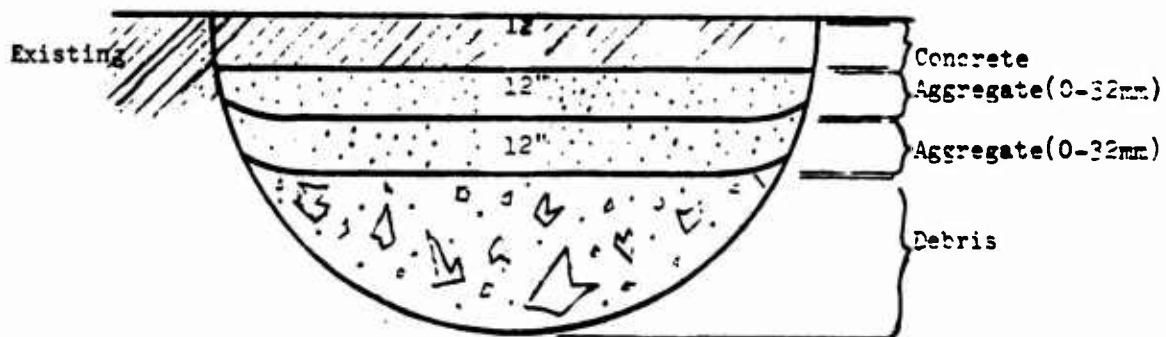
Figure A2. Actual construction of crater

Test strip 1A-1R (Figures A1 and A3) completed 50 passes. A depression formed at each end of the test strip where the new cap met the existing surface. The concrete became a soupy mixture and had little aggregate within it. The depression stopped where aggregate was located. Along the path of the test vehicle's tire, a slurr of about 1/8-3/16 in. depth formed. This slurr was caused by frost action over the night, therefore curing did not take place. A high moisture content was found in the top 3/16-in. layer. No deflections or cracks were observed. Figure A2 shows the actual construction of the crater.
