GILLHAM LAKE

COSSATOT RIVER, ARKANSAS

EMBANKMENT CRITERIA AND PERFORMANCE REPORT

OCTOBER 1987

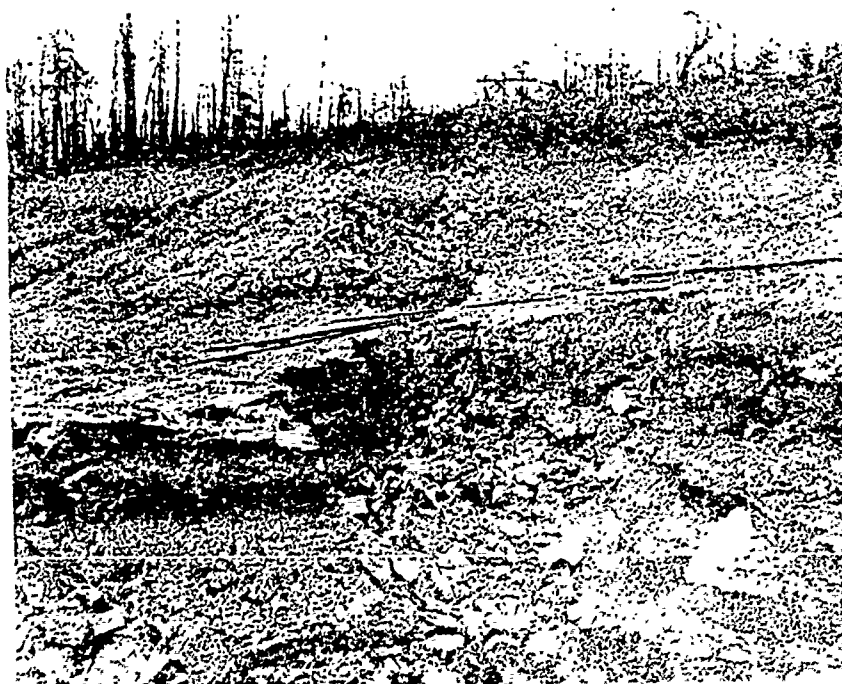
Photo, No 2

View of the upper end of the slide looking I/S from Sta 24+00.
Judy Company (grouting subcontractor) is removing water and air lines.

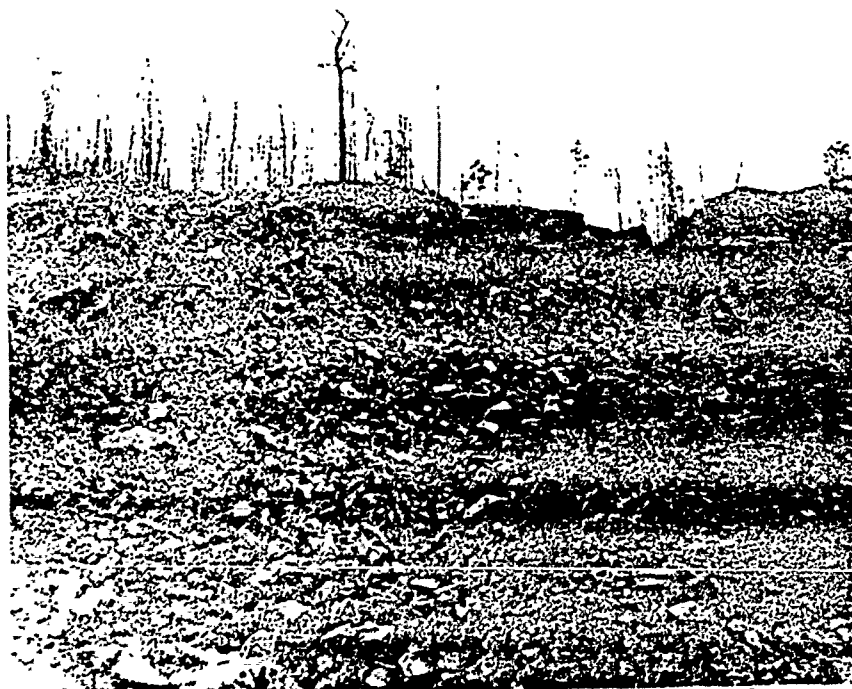
Photo. No. 4

The slide area as viewed from Sta 27+00 looking uphill.

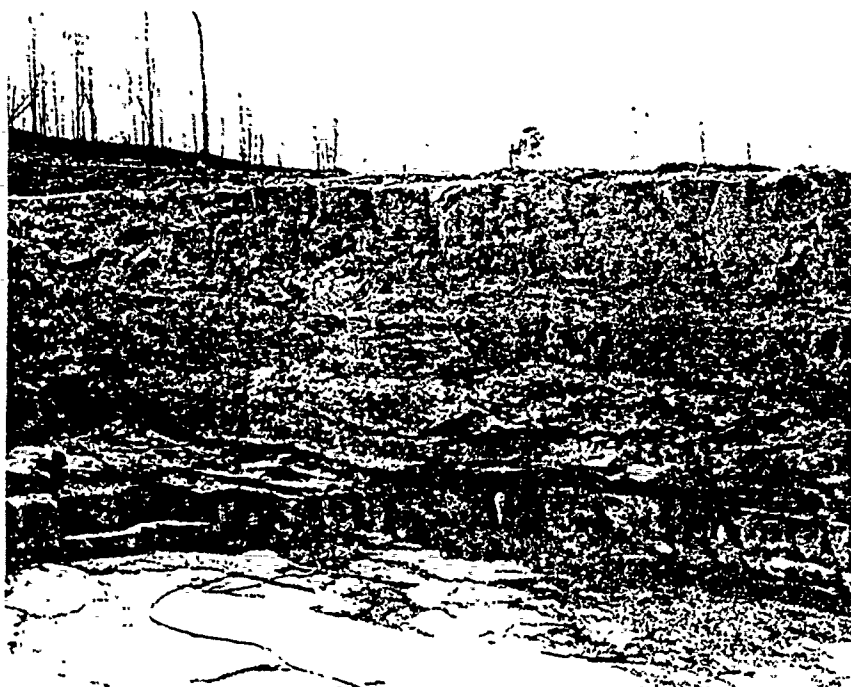
Photo. No. 26

D/S half of the step face at Sta 25+80± prior to placing concrete to eliminate the overhang.

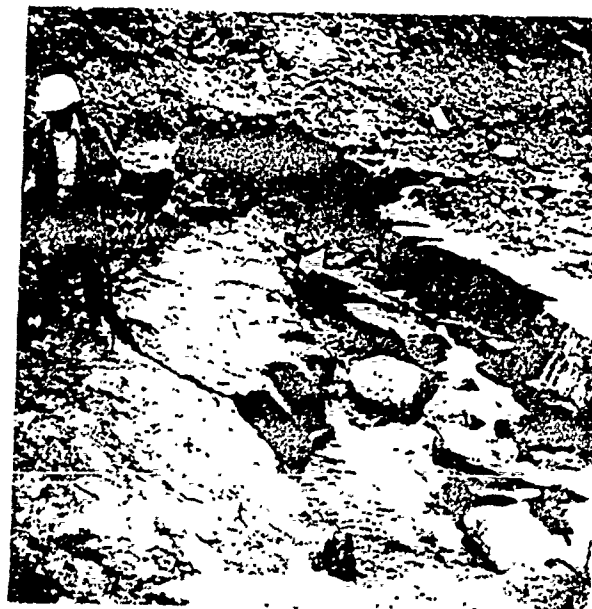
Photo. No. 33

This view (looking U/S from centerline) of the fracture at Sta 26+40 to 26+60 shows partial filling with grout at the lower right. This area was backfilled with concrete.

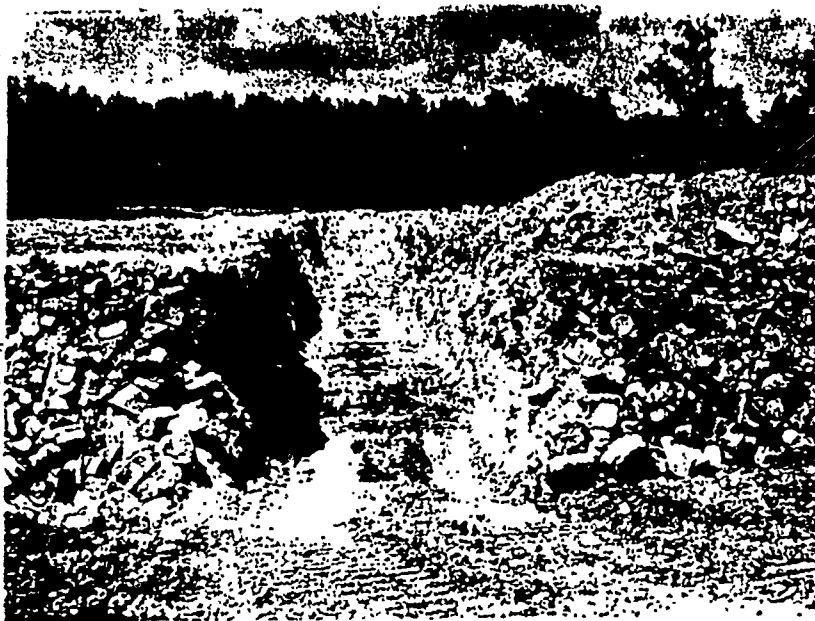
a. View north, inspection trench excavation

- (4) Inspection trench. Visual examination of the inspection trench confirmed the tightness and unusually high degree of stability of all compacted material. No mention was made of any segregated or stratified zones or that any evidence of poor bonding between lifts was found. Two views of the inspection trench are shown in the photographs in fig. 15.
