Technical Report GL-93-20  
August 1993

## **Effects of Variable Tire Pressure on Road Surfacing**

### **Volume I: Design, Construction, Behavior Under Traffic, and Test Results**

Prepared for U.S. Department of Agriculture Forest Service

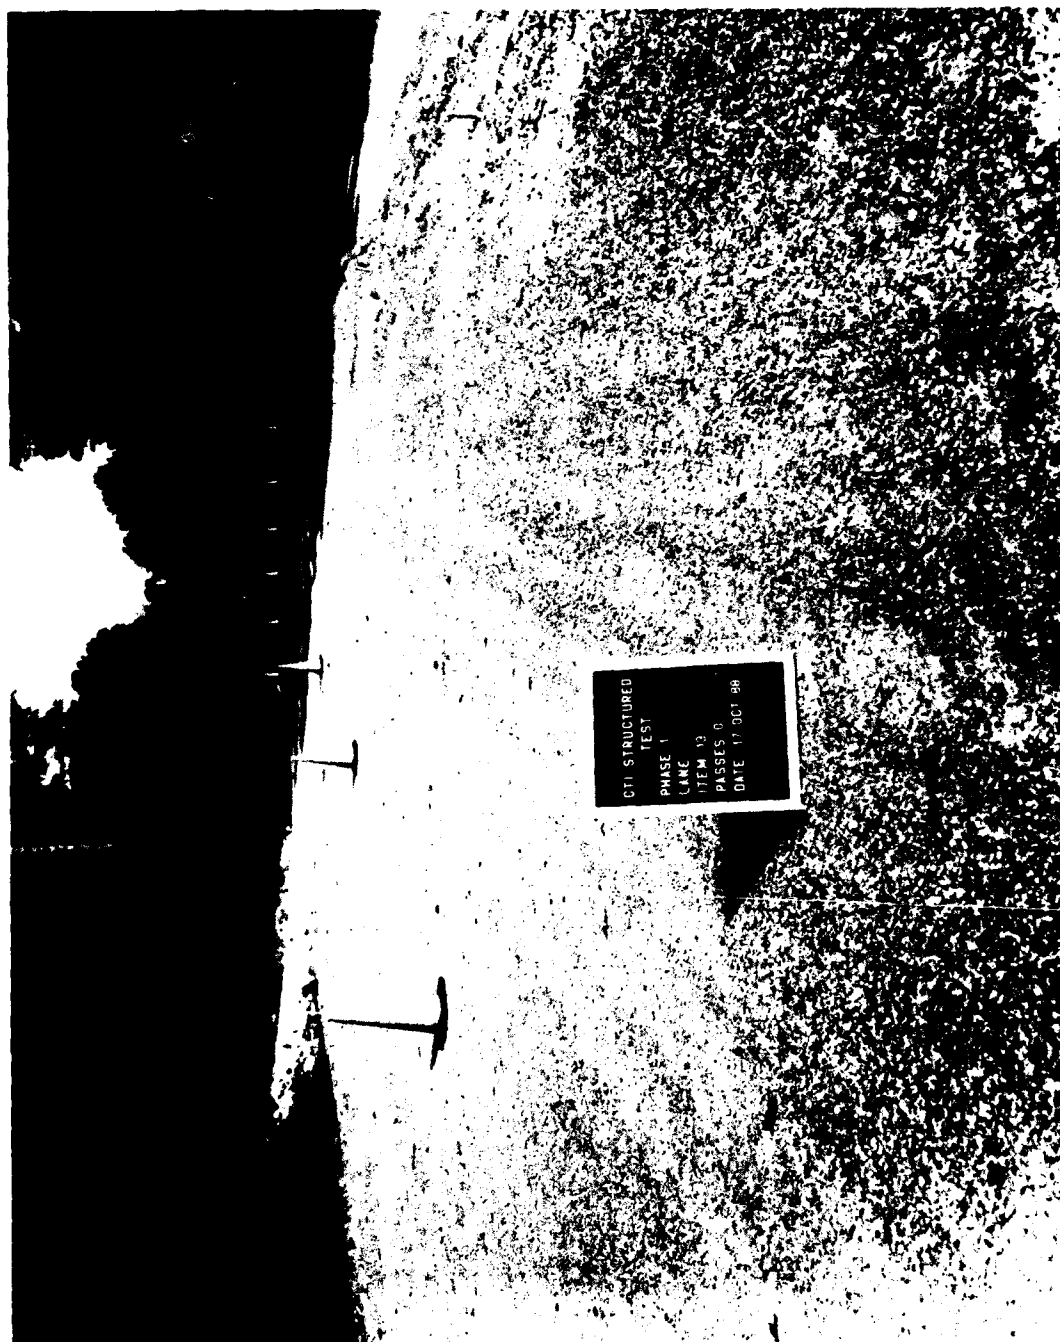
Photo 38. Item 13, general view before traffic

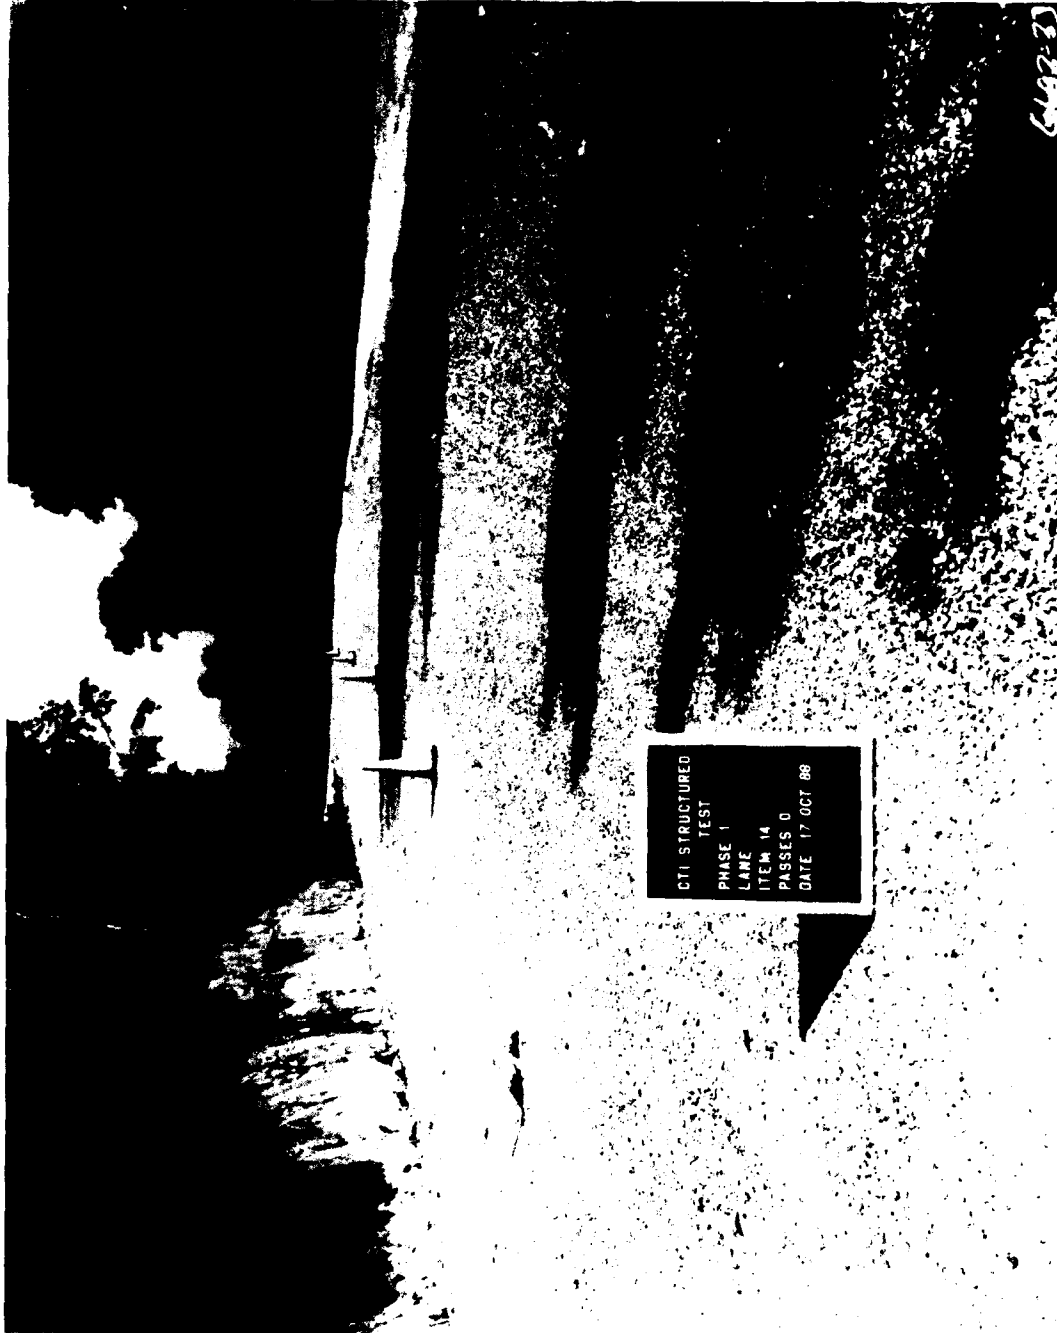
Photo 39. Item 14, general view before traffic
