CULTURAL RESOURCES SURVEY

LONG BRANCH LAKE

Macon County, Missouri

HISTORIC ARCHITECTURAL RESOURCES

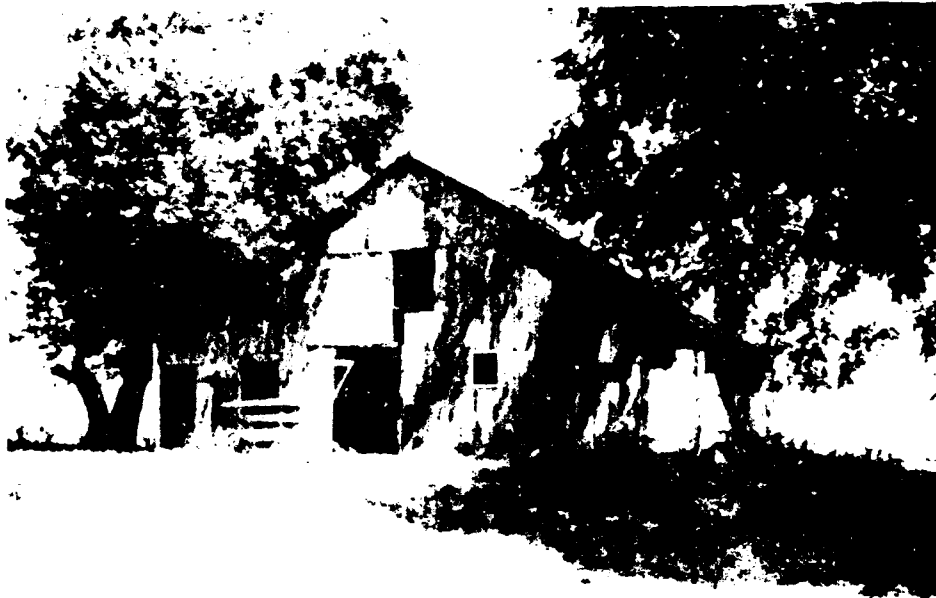
West front of barn

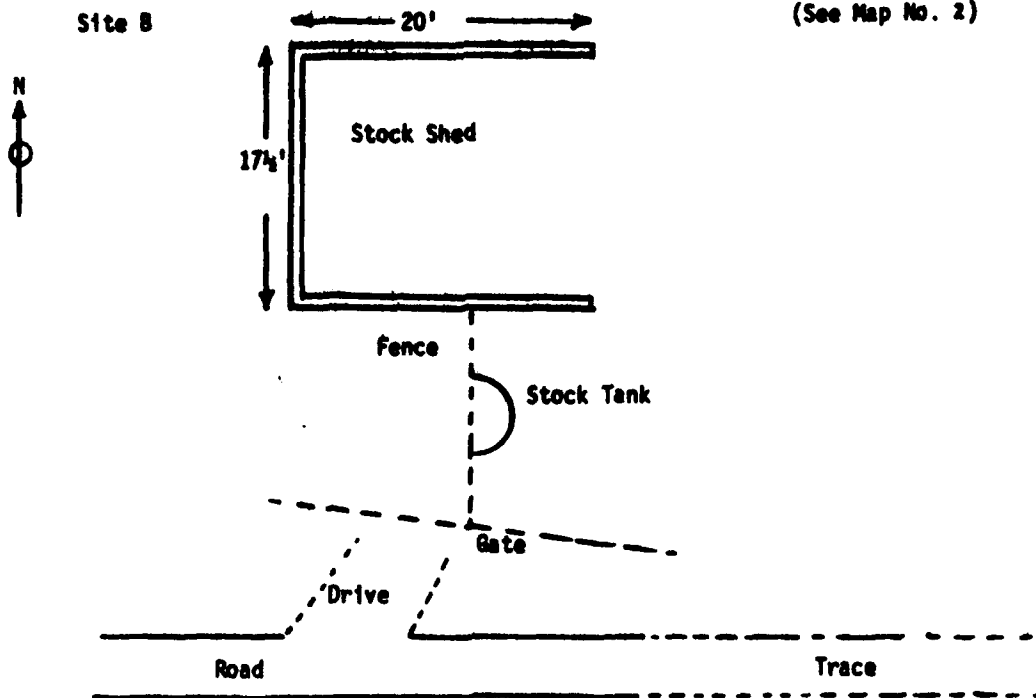
Tract 101-2
Site B

The stock shed and a few fences were all that remained at this site. The fields beyond the shed had been allowed to grow up into tall field grass. The stock tank was battered and probably useless. Fences were in good repair, however, indicating that at the time of inspection, some use was still being made of the fields in that vicinity.

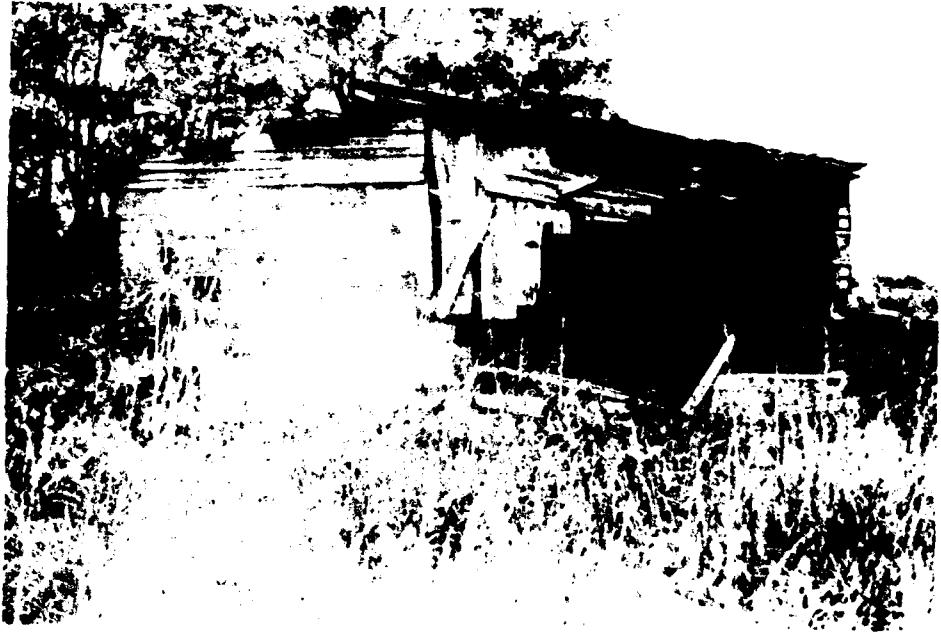
Remains of stable, facing west

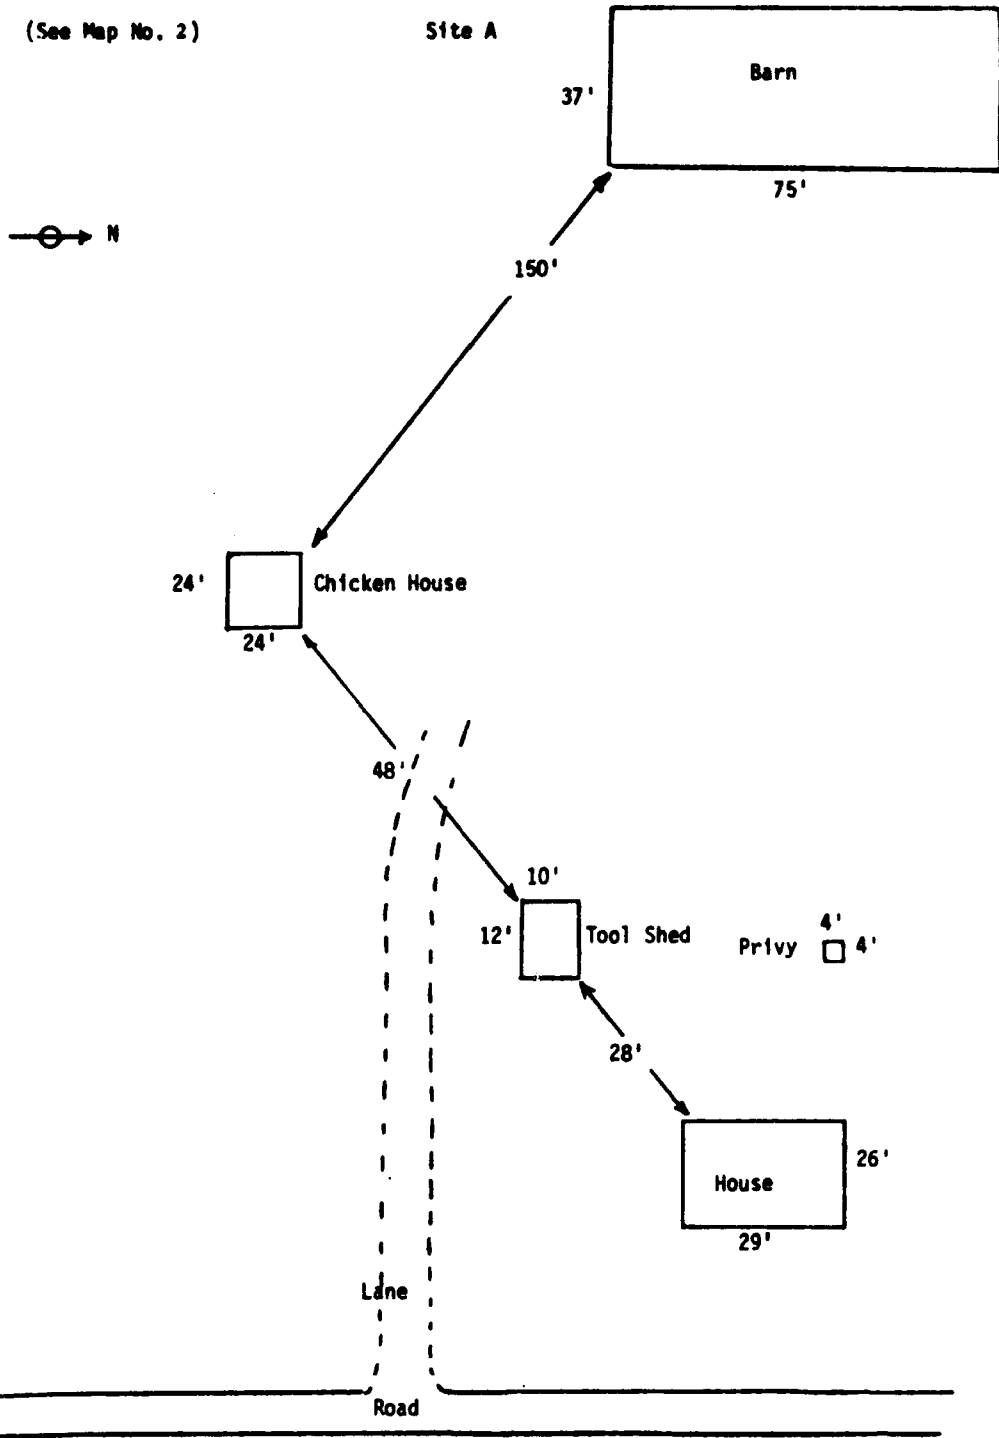
Tract 105
Site A

The house on Tract 105 A had been partially dismantled, and some of its lumber retrieved by the owner. What remained at the time of inspection showed the typical balloon frame construction, with lath and plaster walls.

Evidences of age were shown in the several layers of wallpaper, the newer shingle siding over the older structure, and the re-roofing on the porch.

One porch column of the type commonly found in houses of the 1920s remained as sole evidence of any stylistic pretensions. It was impossible to guess what the roof line might have been but tradition would favor the simple gable roof for houses of this type.

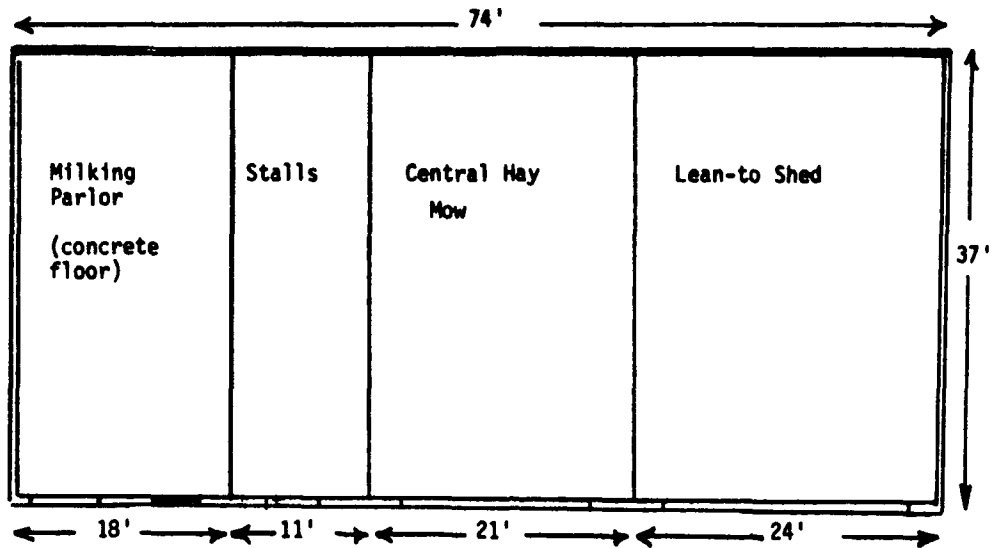
The barn on Tract 105 presented an interesting outline, with its asymmetrical lean-to sections flanking the central area. Largely in a falling-down condition, the barn retained enough of its original shape to reconstruct its appearance as above.

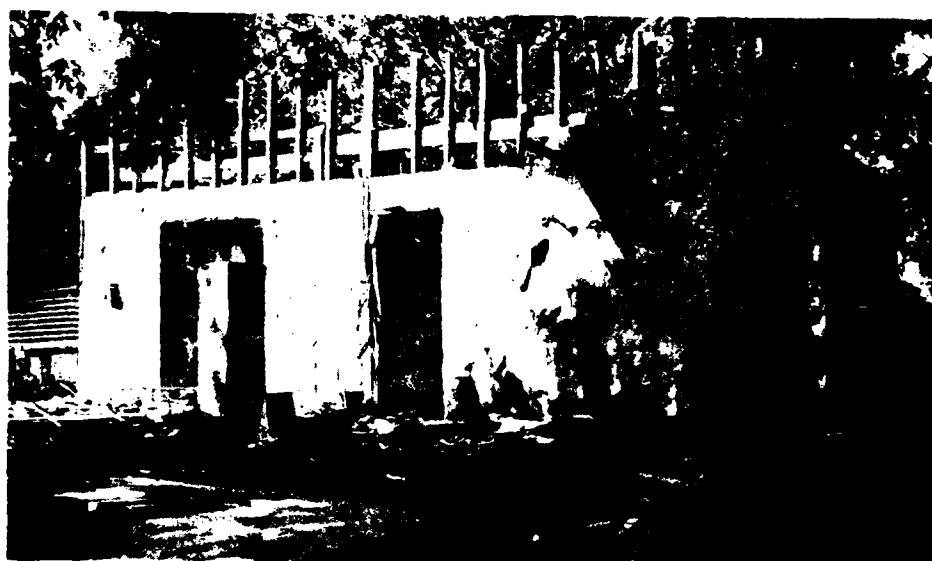
Remains of house, facing Southwest

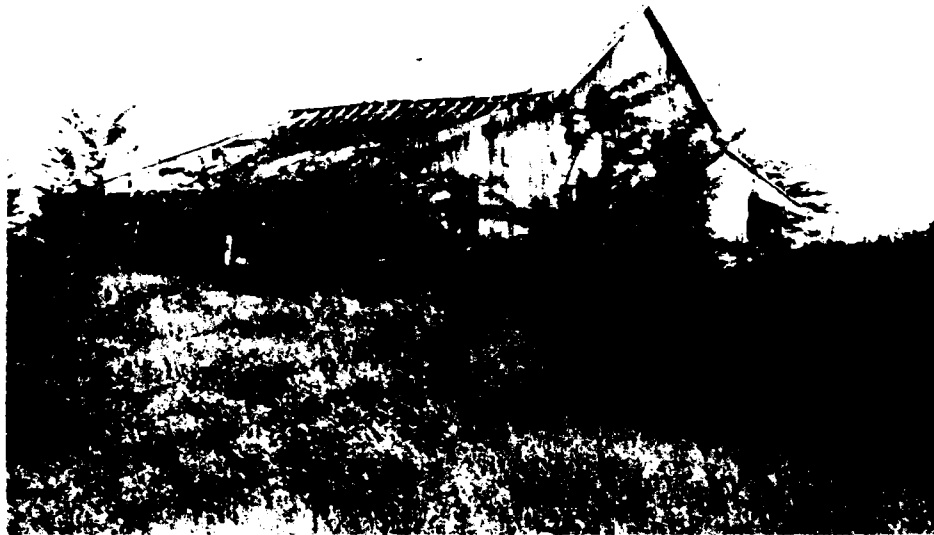
Barn, facing Northwest

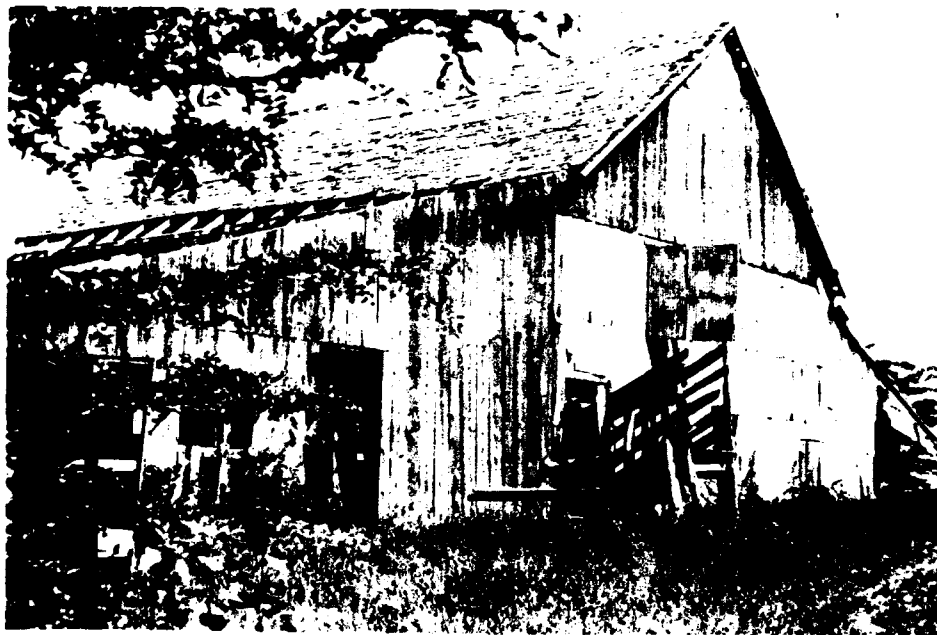
Front of barn, with stock chute

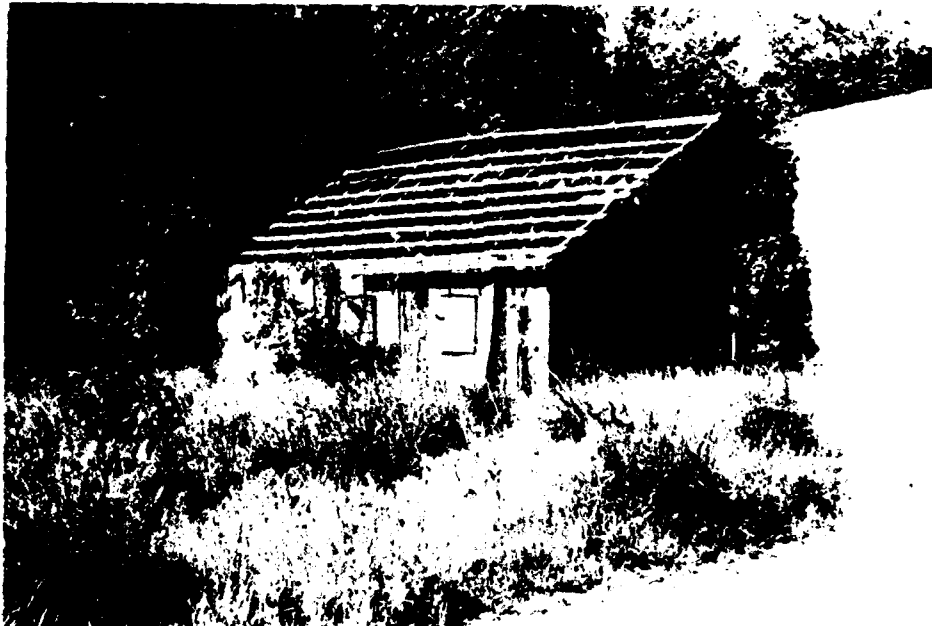
Chickenhouse, viewer facing Southwest

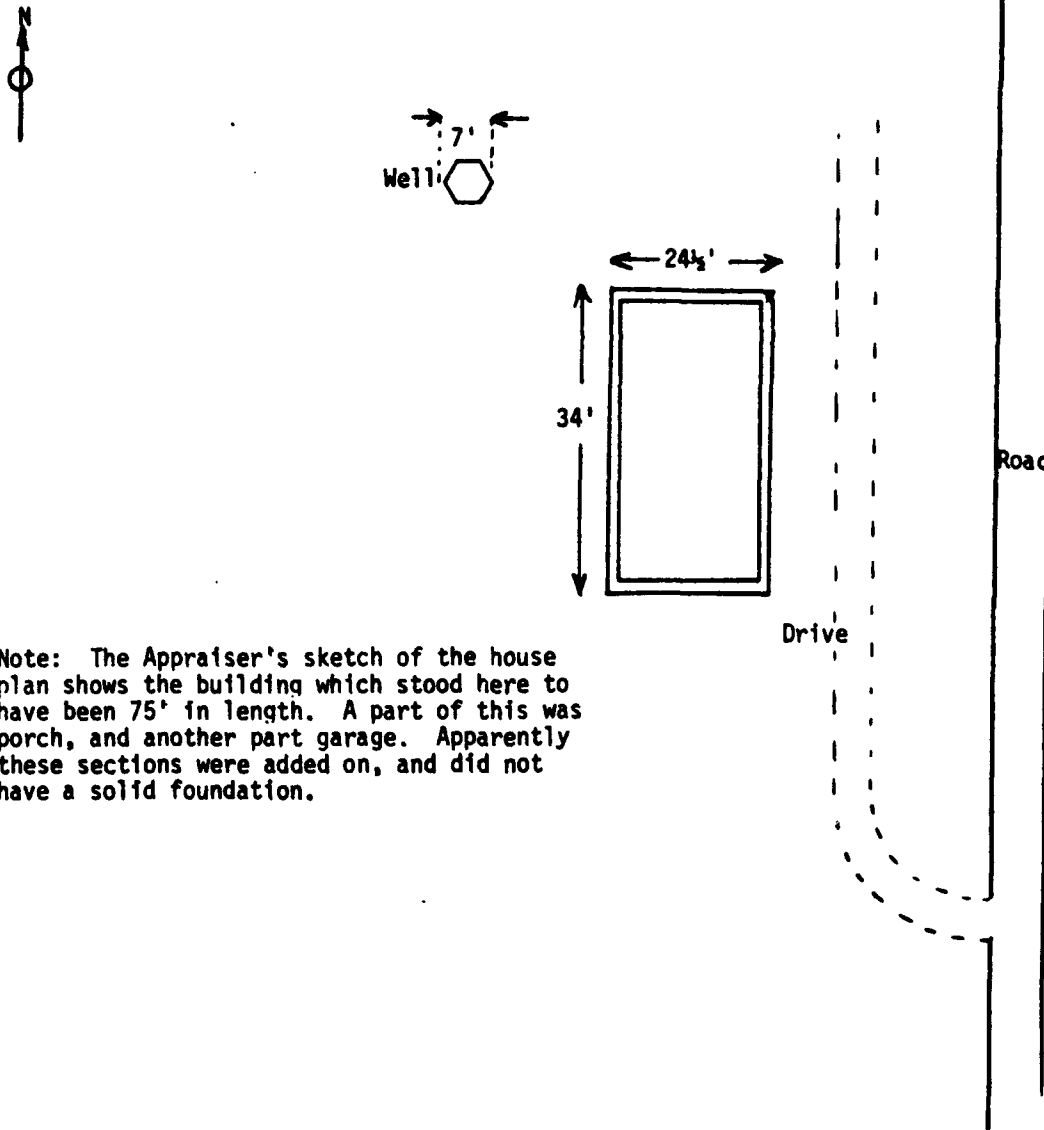
Originally occupied by a three bedroom home, the lot area now has only a foundation where the house once stood. Close to it is a capped well.

Note: The Appraiser's sketch of the house plan shows the building which stood here to have been 75' in length. A part of this was porch, and another part garage. Apparently these sections were added on, and did not have a solid foundation.

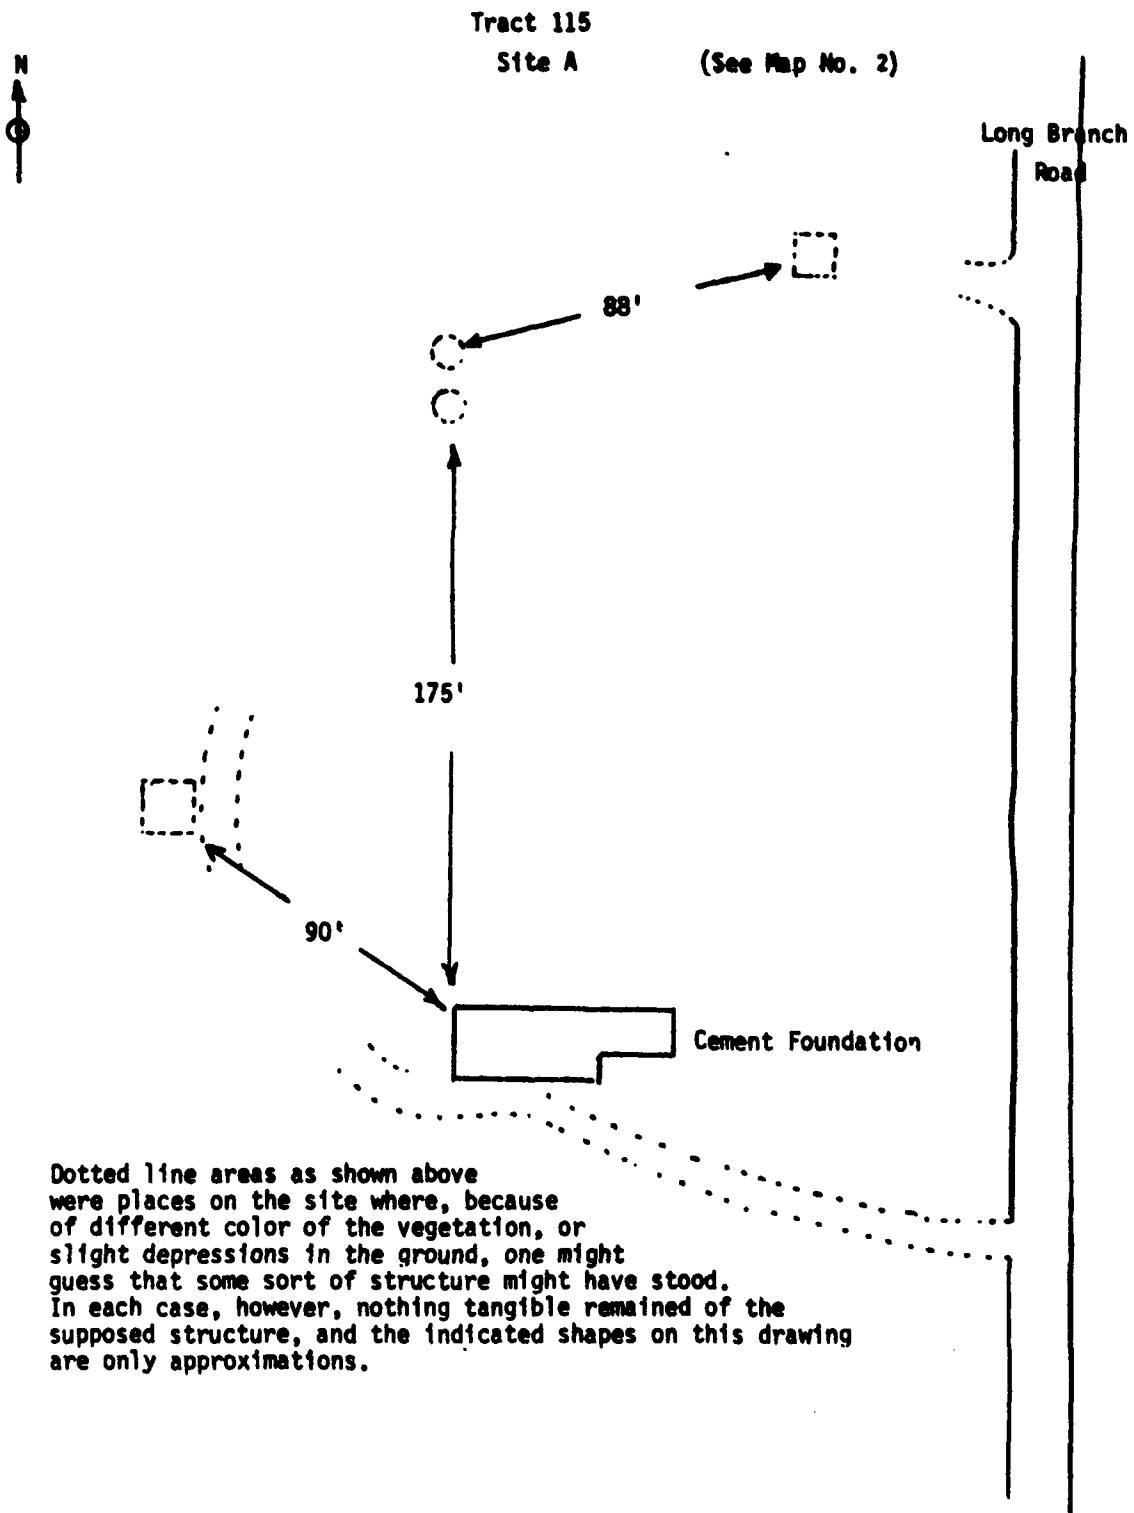
Tract 115 contained the poured cement foundation and walls of what had been an office building of some sort. There were indistinct evidences of a gravel drive, places where various structures, perhaps mobile units, had been located.

The north side of the cement structure was set into the hillside, with about two feet of it above ground. The south side was open from floor to ceiling height.

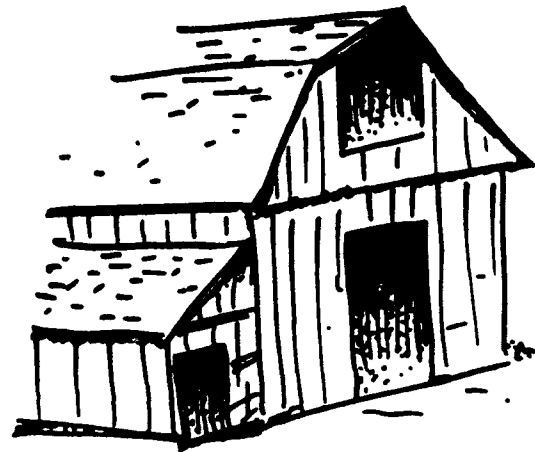
The interior of the barn had the usual hay-storage facilities overhead, with a rail conveyor for the hay fork. The whole structure had partially collapsed, but enough of the structural features were there to show how the barn had looked and functioned.

Earlier photos show it to be in an upright position but with the

roof sagging.

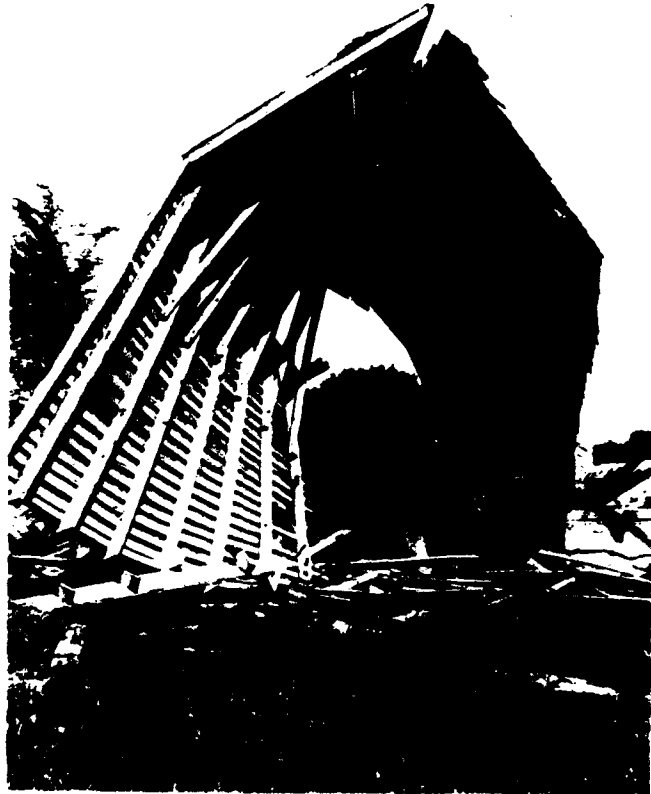
Collapsed barn roof, facing Southwest

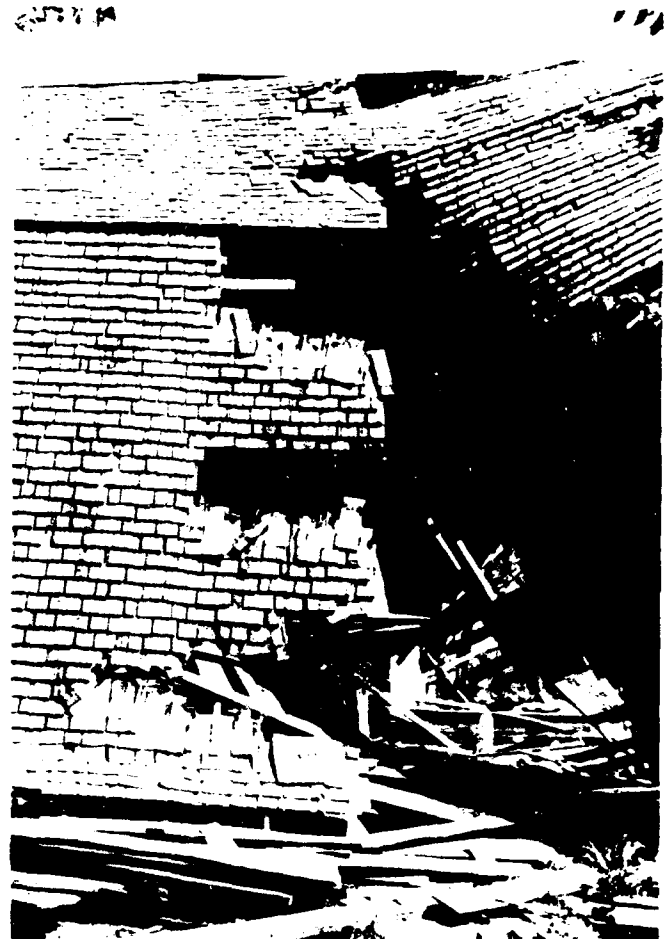
Collapsed
barn roof,
facing South

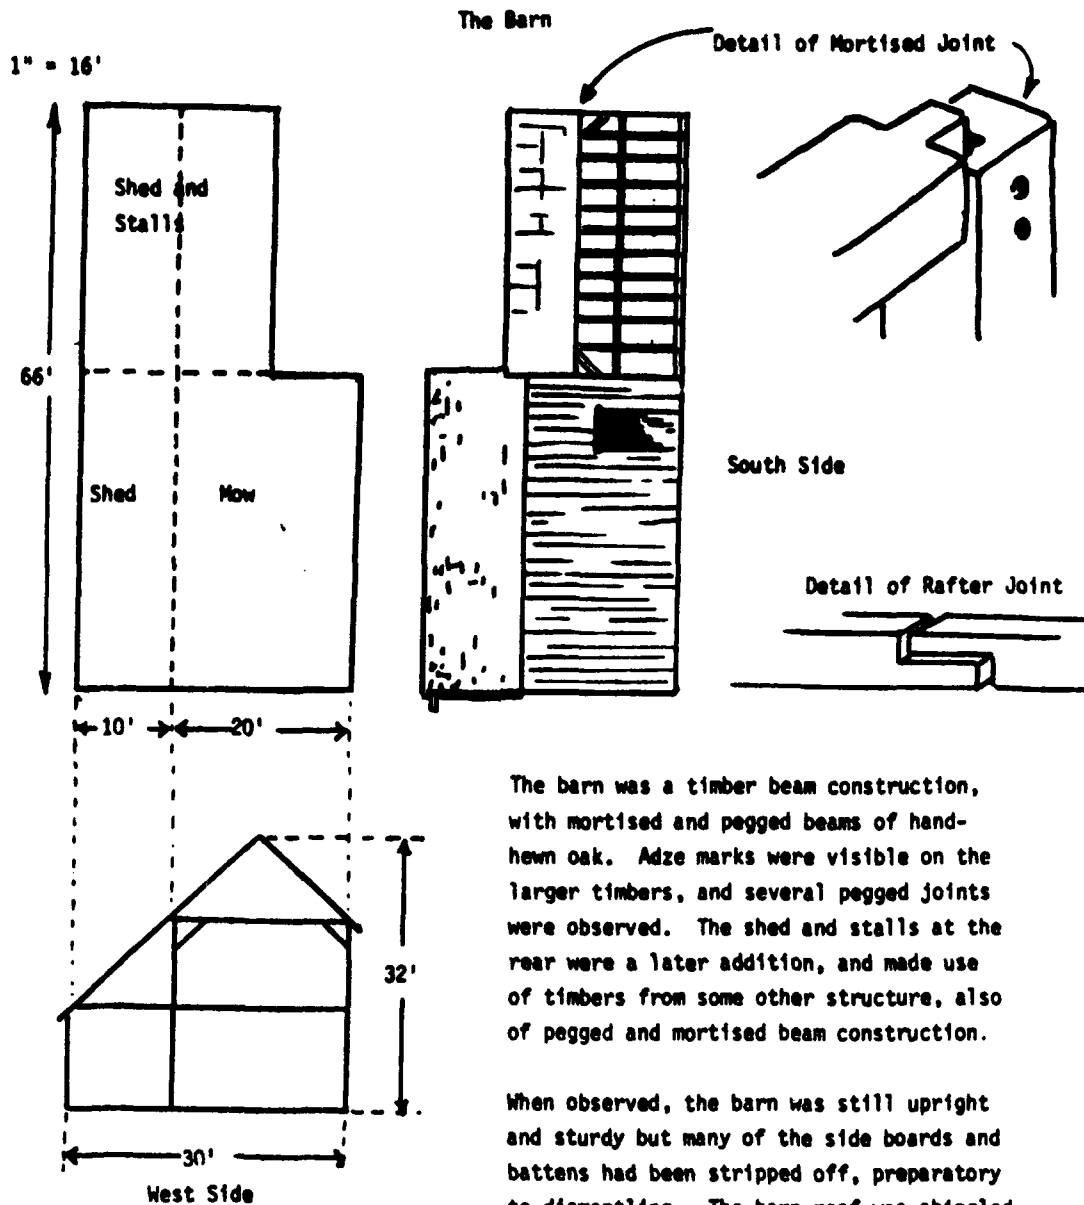
When observed, the barn was still upright and sturdy but many of the side boards and battens had been stripped off, preparatory to dismantling. The barn roof was shingled

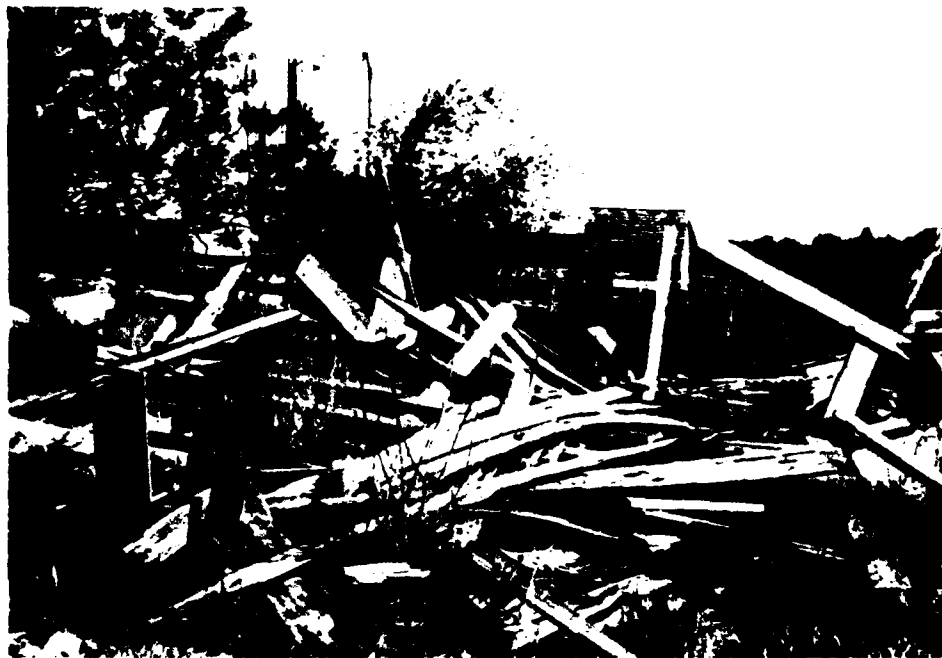
Facing west, two silos and shed in background.
Shed rubble in foreground

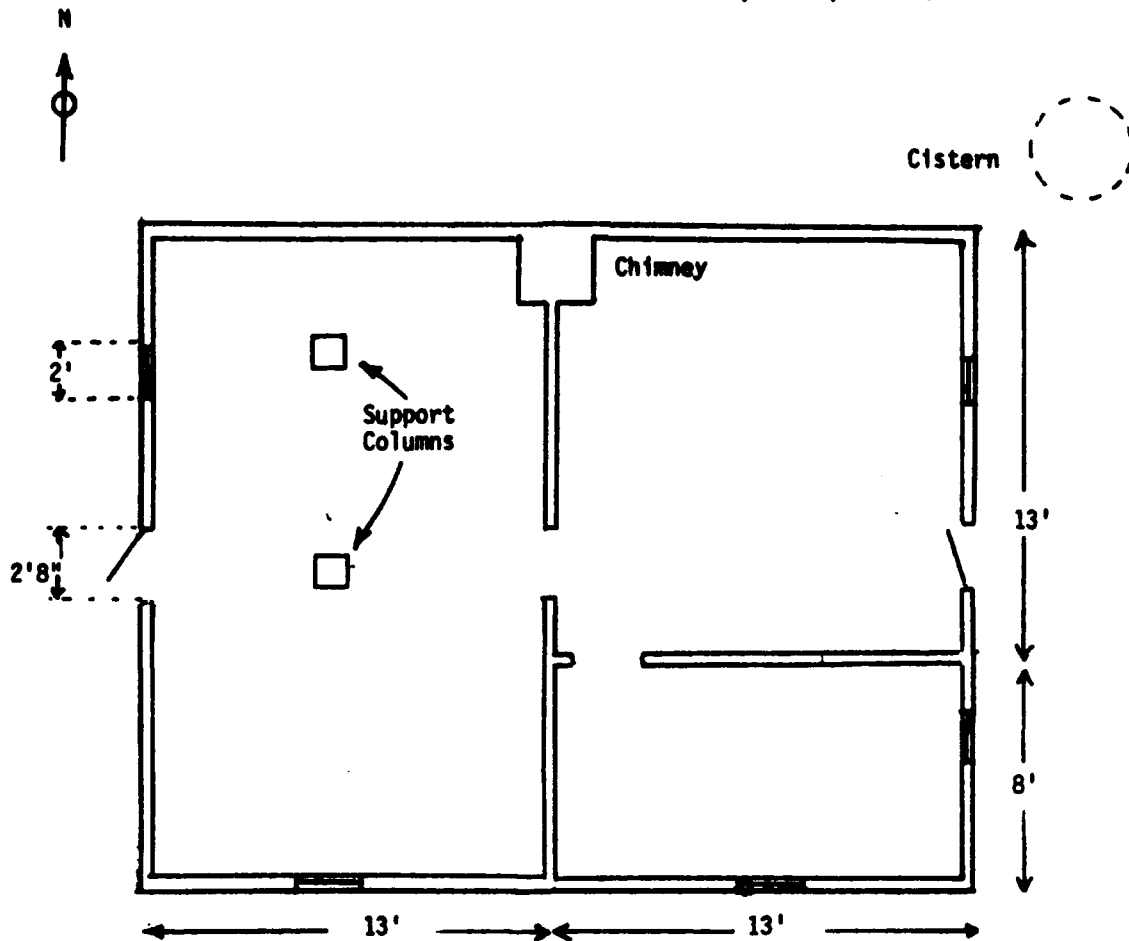
Tract 119
Site E (See Map No. 2)

This house was not listed among the acquisitions of the Corps of Engineers, nor was it shown on any map. It lay a few yards west of the Bee Trace Road, in what was probably the far northern end of Tract 119. The house was completely surrounded by thick undergrowth, and had long been abandoned. Part of the floor at the northwest corner of the house had been ripped up, exposing the supporting concrete posts beneath.

An open cistern lay at the northeast corner of the house. Approximately 100 feet to the southwest lay the remains of what appeared to be a shed four feet square.

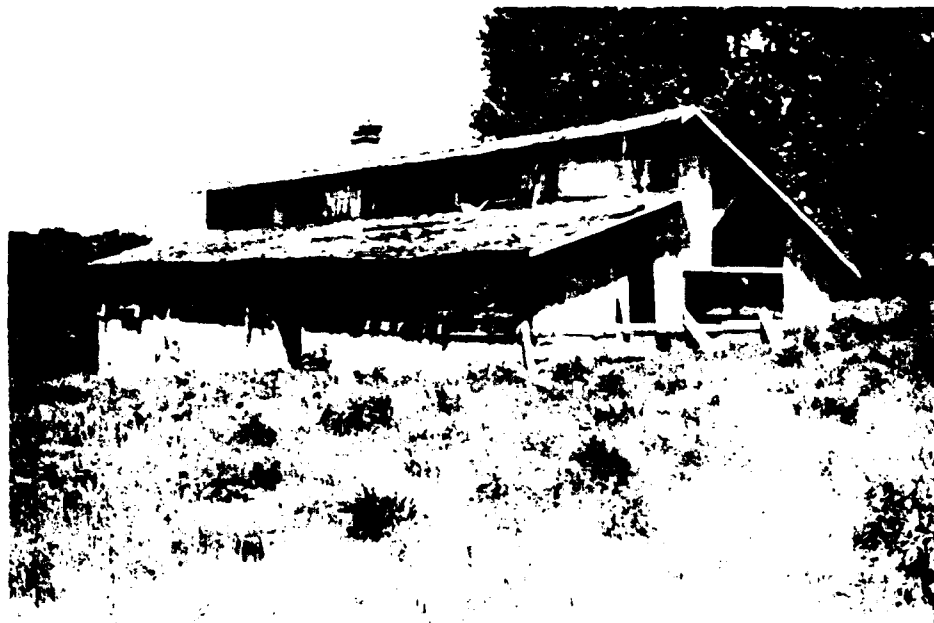
Chicken house

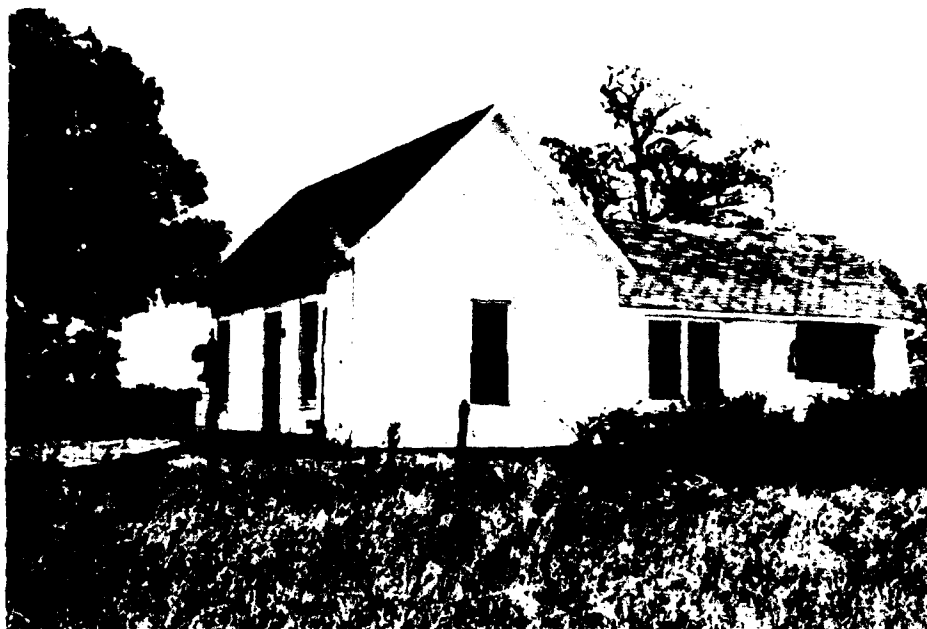
House, viewer facing East-southeast

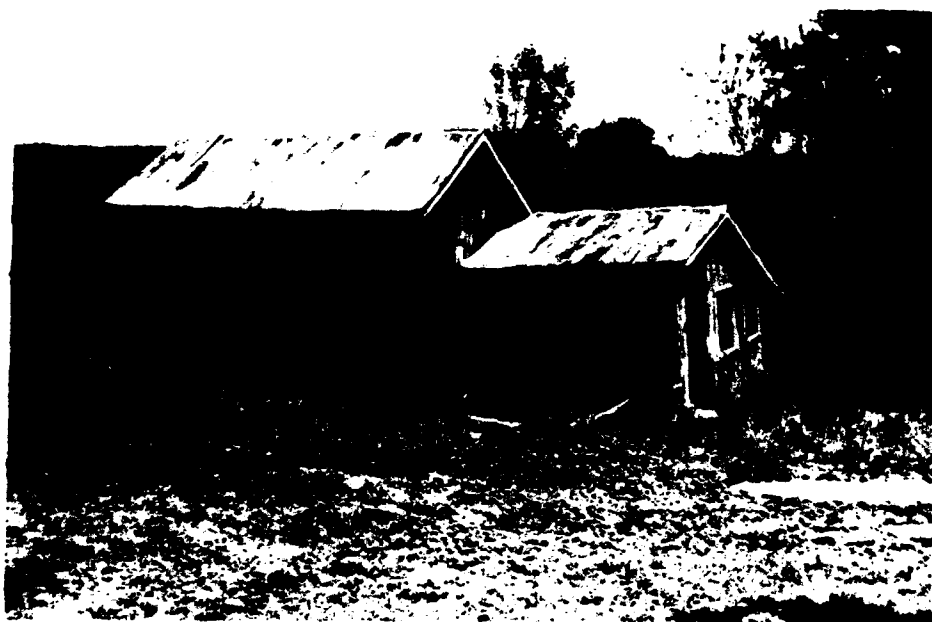
Chicken House, viewer facing East-northeast

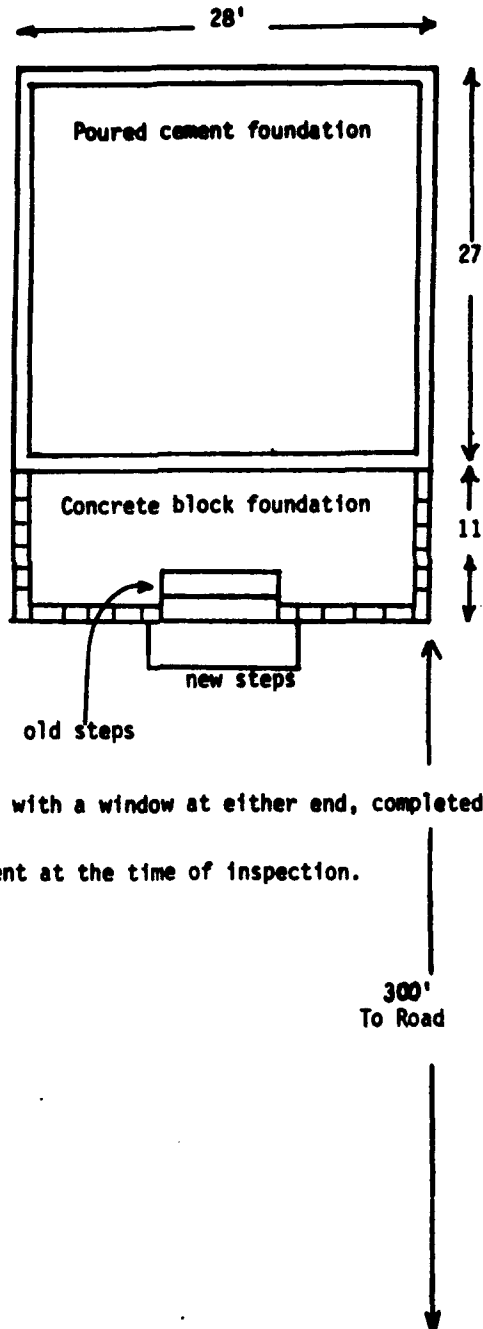
Only the foundation was evident at the time of inspection.

Remains of house foundation

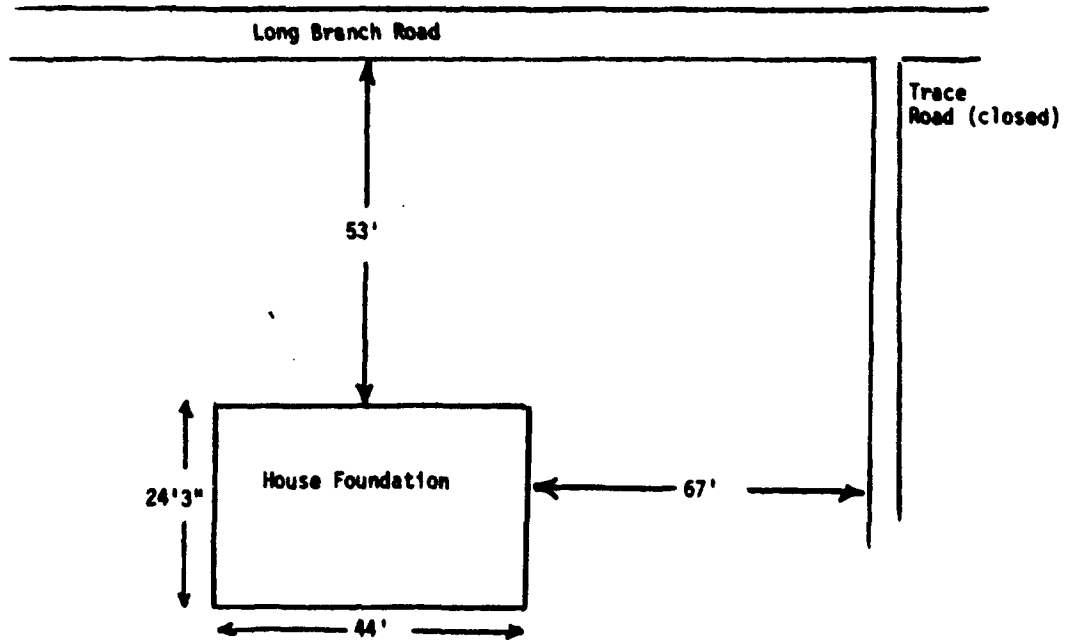
Details of House Foundation

This site was marked by the remains of a poured cement foundation and nothing else. Although photos on the appraiser's report indicated a barn nearby, no trace of it could be found.

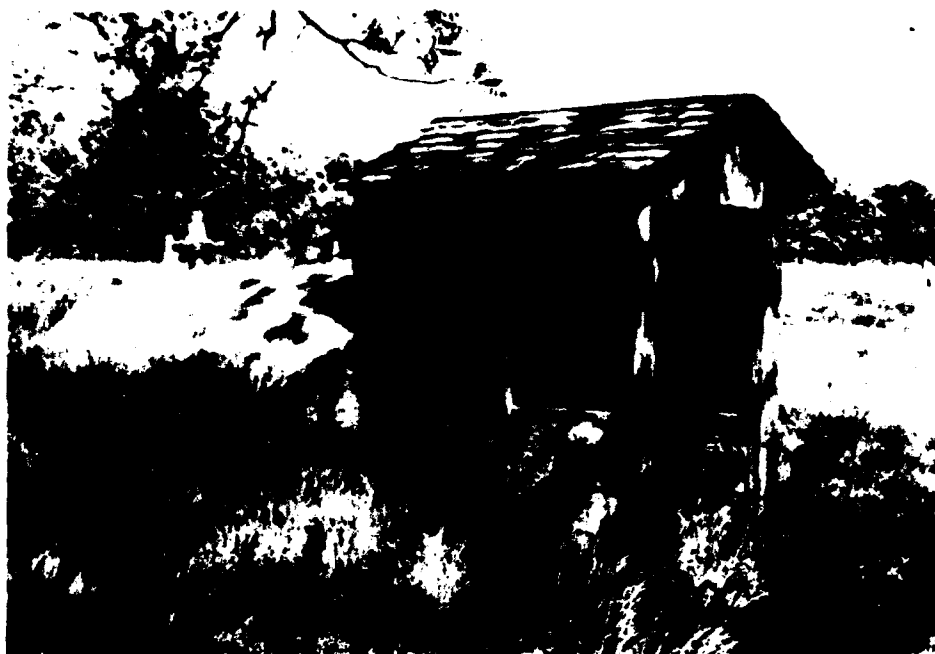
The storm cellar lay slightly lower than the house, with a sharp drop just to the southeast of it. This cellar was the best preserved of the buildings. The cement barrel-vaulted roof was fronted by a native oak entryway (see accompanying photo) still in good repair. Evidences of shelving were found inside, though the interior was choked with debris.

Exterior of storm cellar

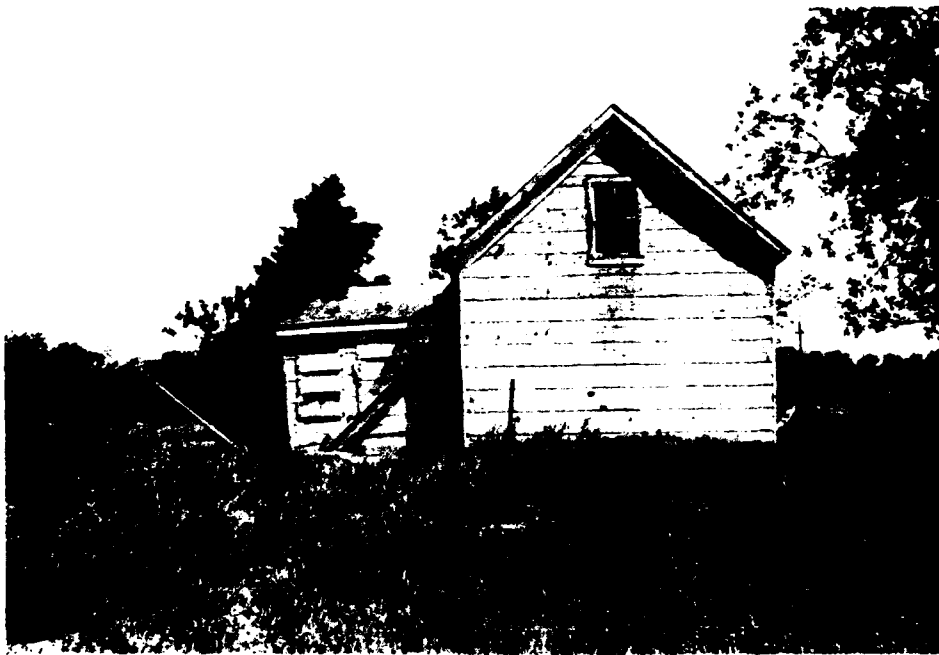
Log cabin house, viewer facing North

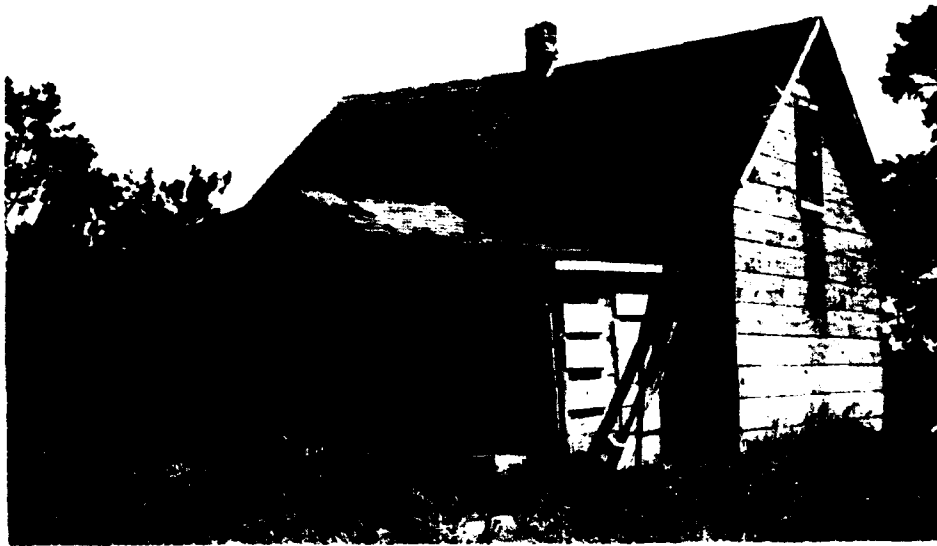
Log cabin house, viewer facing Northeast

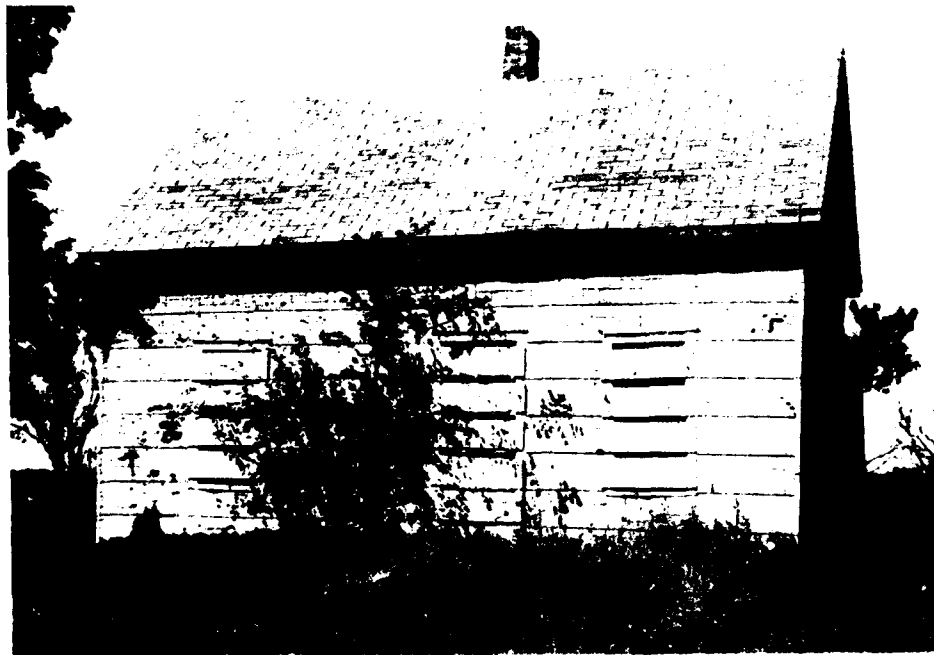
Log cabin, viewer facing West

At the present time, this last addition has been removed, and the remaining structure is fenced in by barbed wire and warning signs. At the time of inspection, the house had been broken into, and evidences of a drinking party were seen, together with minor vandalism, such as writing on walls, and the like.

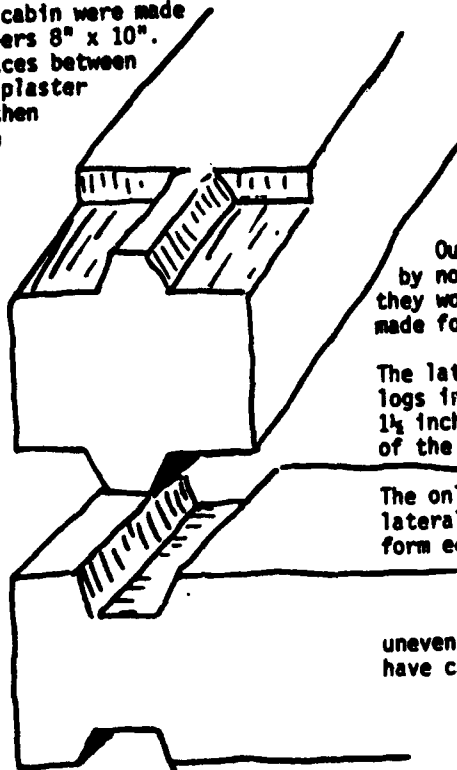
Details of Log Construction

The walls of the cabin were made of hand hewn timbers 8" x 10". The irregular spaces between were filled with plaster originally, and then covered over with cement.

Outside corners were made by notching the logs so that they would interlock. This made for increased stability.

The lateral distance between logs in the walls varied from 1½ inches to 4 inches because of the variations in log sizes.

The only logs that were sawed laterally, so as to form a uniform edge, were those in the topmost course of the wall, where the rafters rested. An uneven log at this point would have caused an uneven roof line.

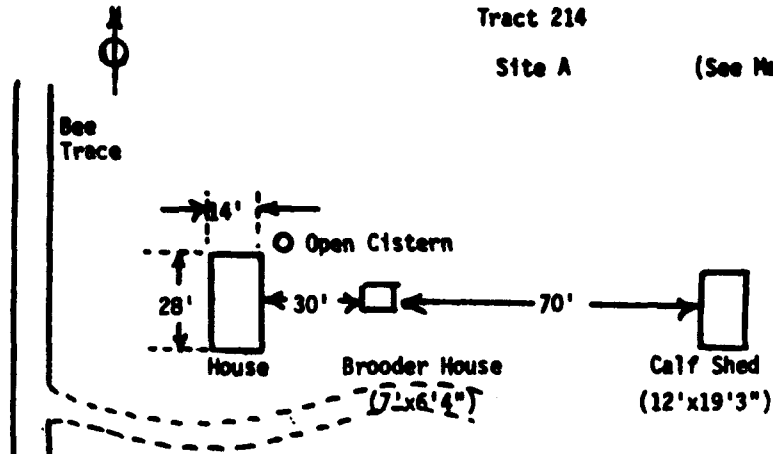
The three buildings on this tract were in a delapidated state, and had obviously been abandoned for a year or more. The house had asphalt shingle siding, and an asphalt shingle roof. The house was of the "saddlebag" style, though the rear was not symmetrical. It had double hung windows, all of them broken out, lath-and-plaster interior walls, a brick chimney, and tongue-and-groove flooring. All windows were 24"x60" in size.

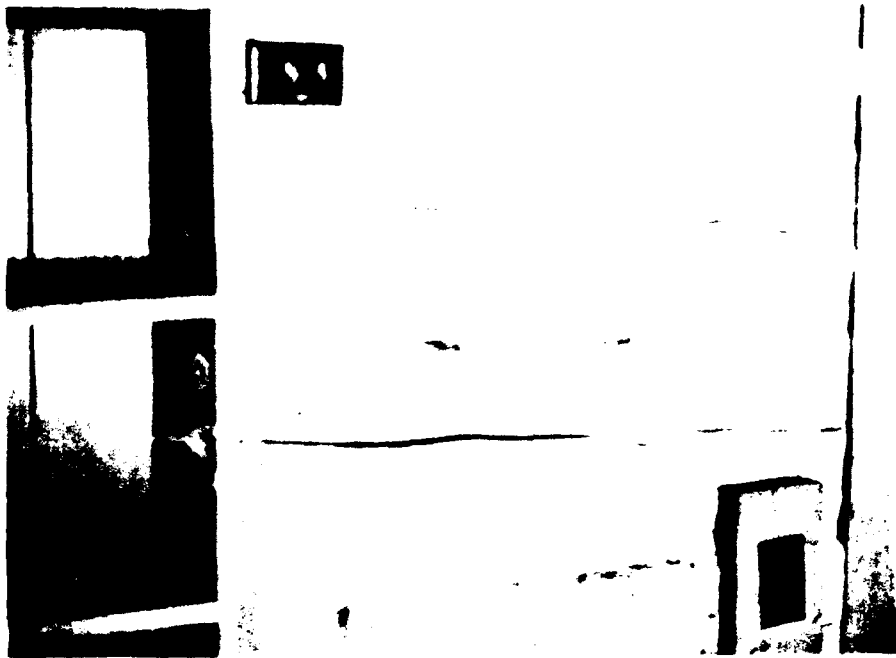
Log cabin house, detail of wall, first floor

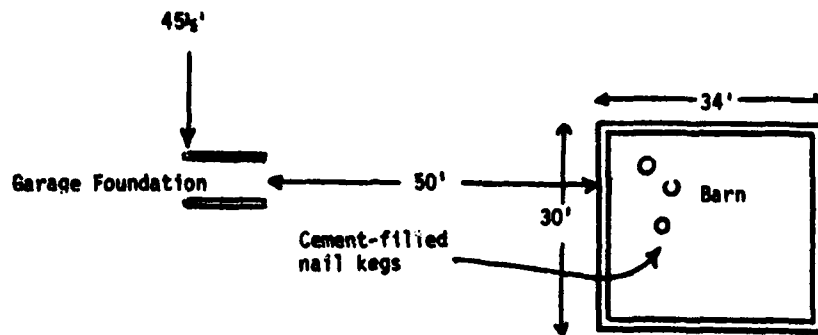
The openings set into the barn foundation (see drawing below) may have served as access to crawl space below the floor, or to assist in removal of waste.

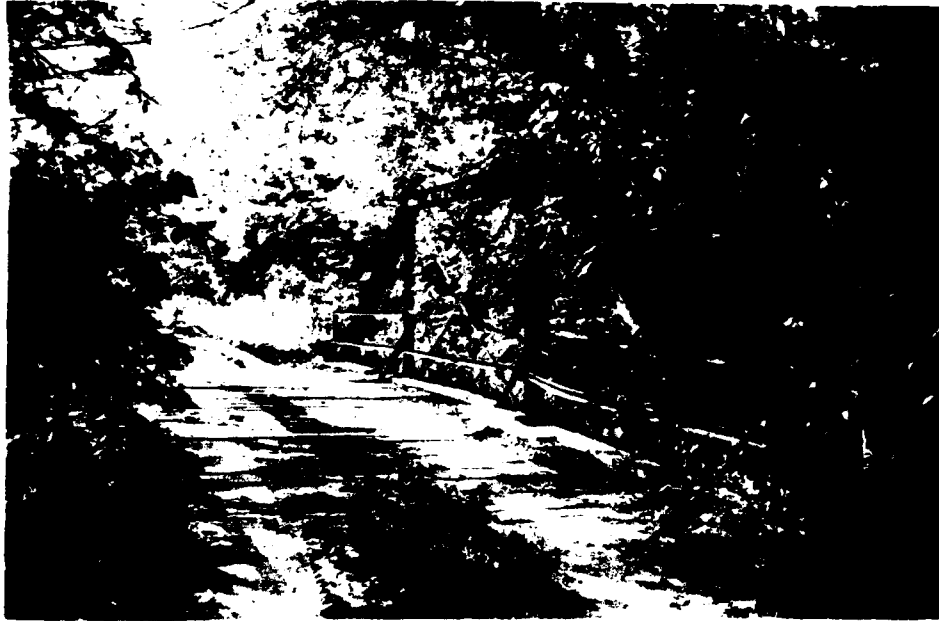
At time of inspection, bridge was in fair condition, loose planking, rusty.

The bridge was in a good state of preservation.

Secondary road bridge, iron frame construction
