CULTURAL RESOURCES SURVEY

LONG BRANCH LAKE

Macon County, Missouri

HISTORIC ARCHITECTURAL RESOURCES

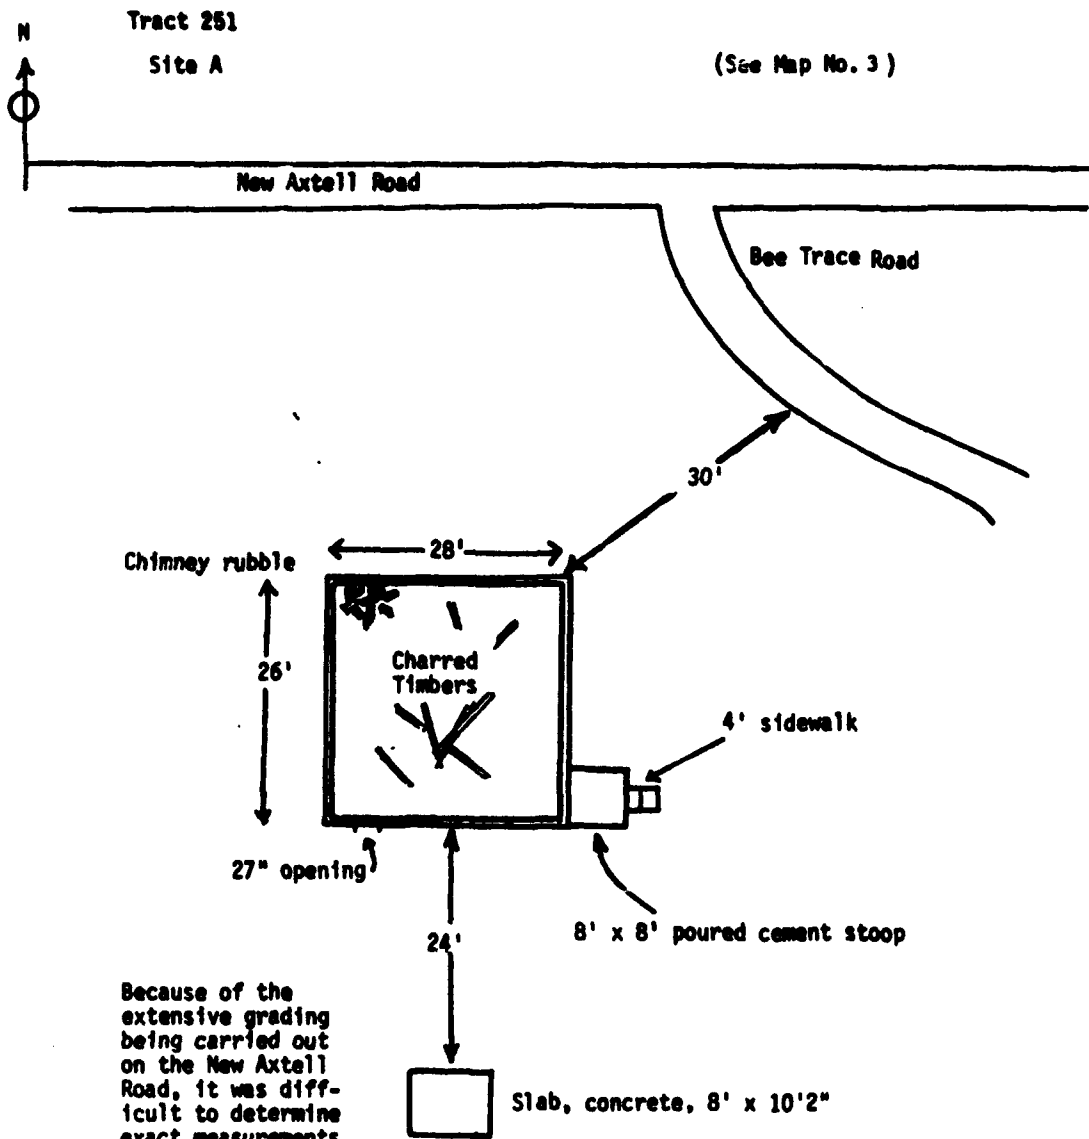
Because of the extensive grading being carried out on the New Axtell Road, it was difficult to determine exact measurements at this site. However, it is likely that this was the site of the New Fairview School.

From the evidence remaining at the time of the inspection, there was no way of determining the construction of the building, other than that it made use of wood timbers and rested on a cement foundation. Bee Trace Road was subsequently widened, and two months after the site was inspected not a trace of the building remained.

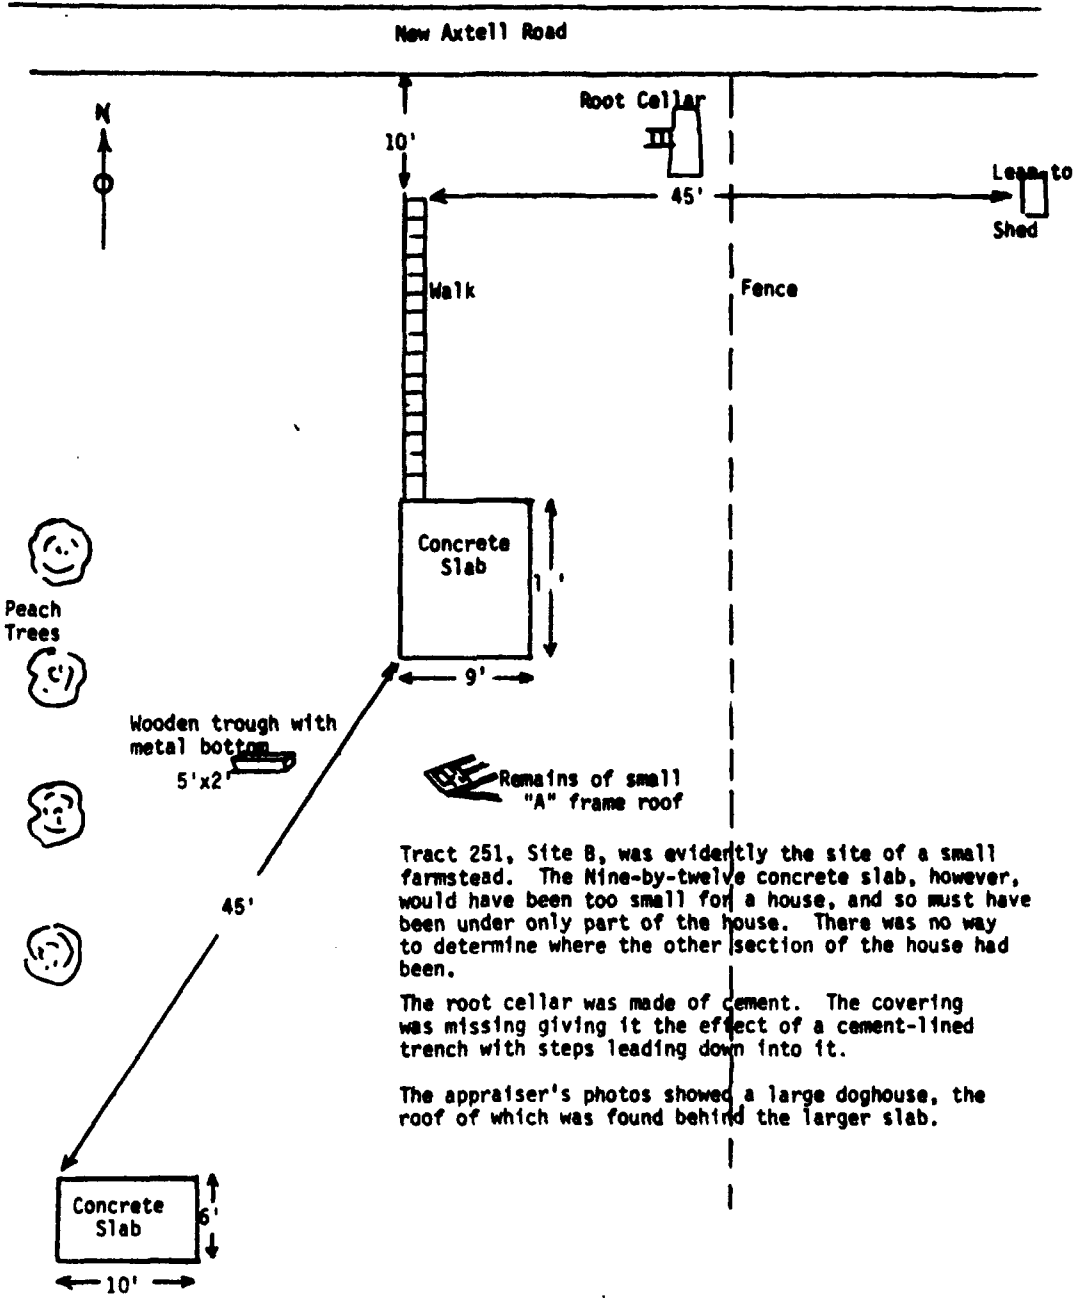
Tract 251, Site B, was evidently the site of a small farmstead. The Nine-by-twelve concrete slab, however, would have been too small for a house, and so must have been under only part of the house. There was no way to determine where the other section of the house had been.

The root cellar was made of cement. The covering was missing giving it the effect of a cement-lined trench with steps leading down into it.

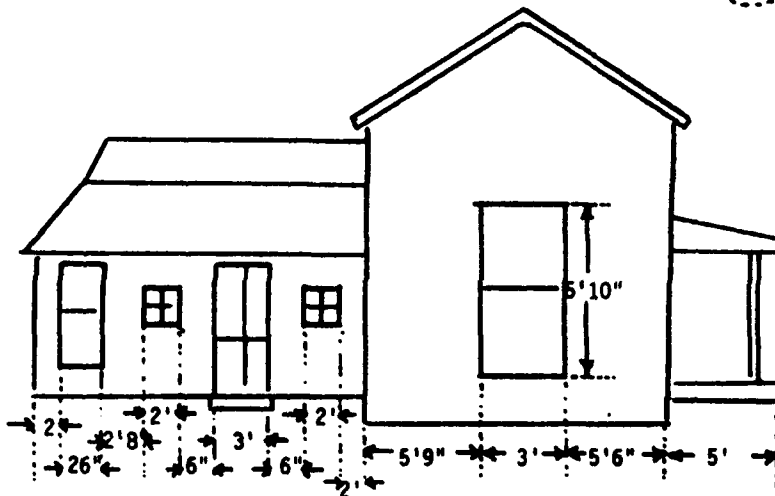
Details of House (east view)

The house was covered with asphalt shingles which had been laid over the original clapboard siding. It was built on a foundation of native lumber (8x8 beams) set on stone piers.

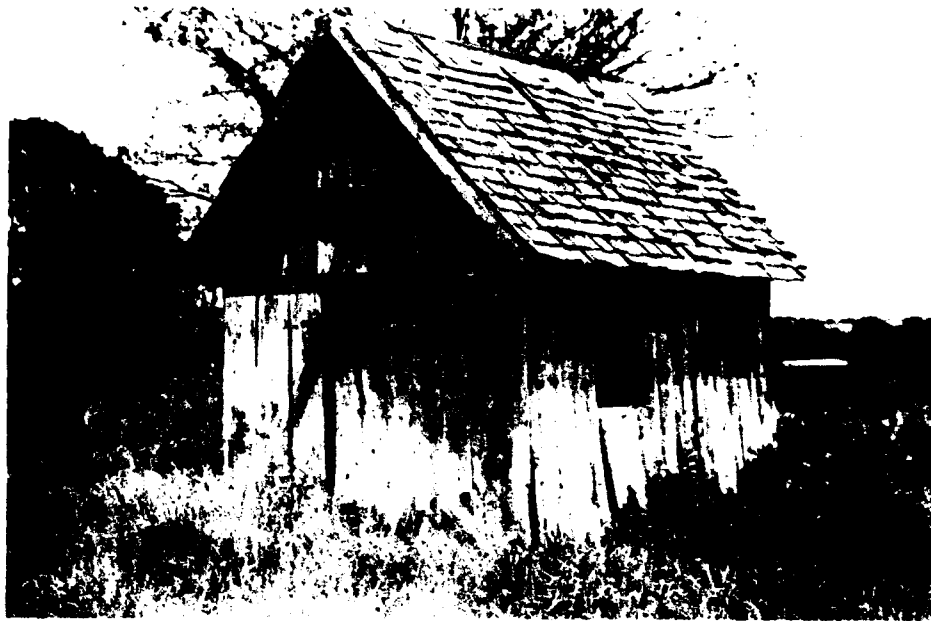
Larger shed, possibly used as smokehouse

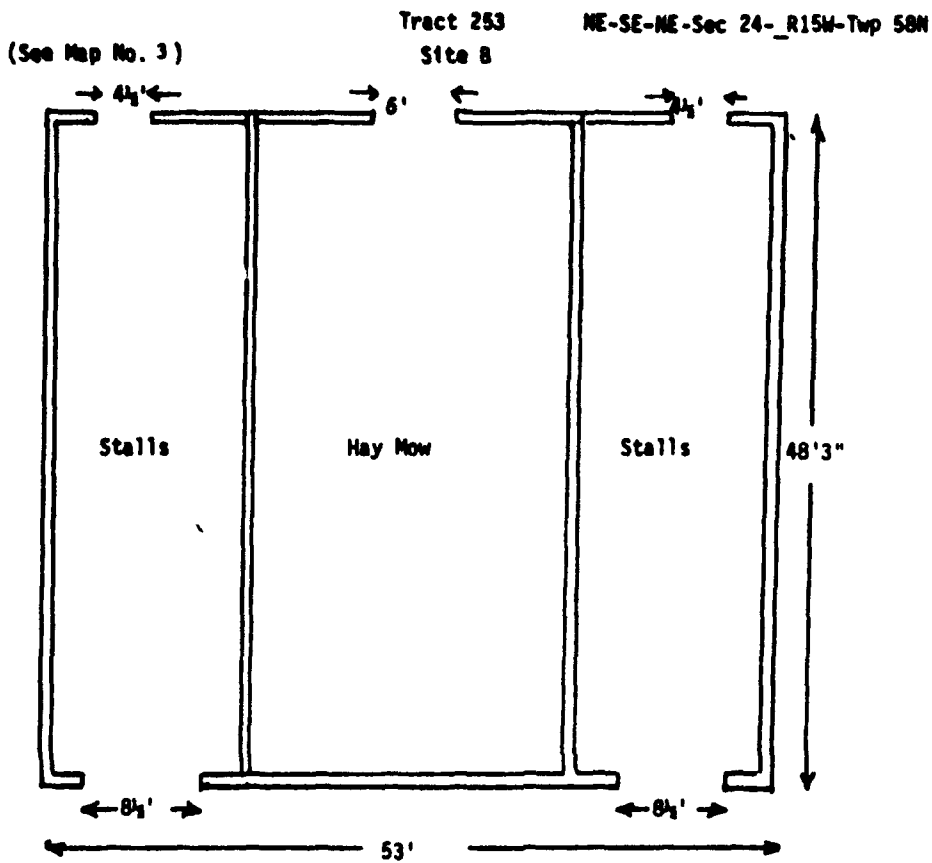
The barn on Tract 253 was of modern construction, using all native lumber. A poured cement foundation supported the structure, which was held together by bolts and nails.

On both sides of the barn, there were numerous large stones piled against the foundation, probably to keep hogs from rooting and wallowing there, and thus damaging the foundation boards.

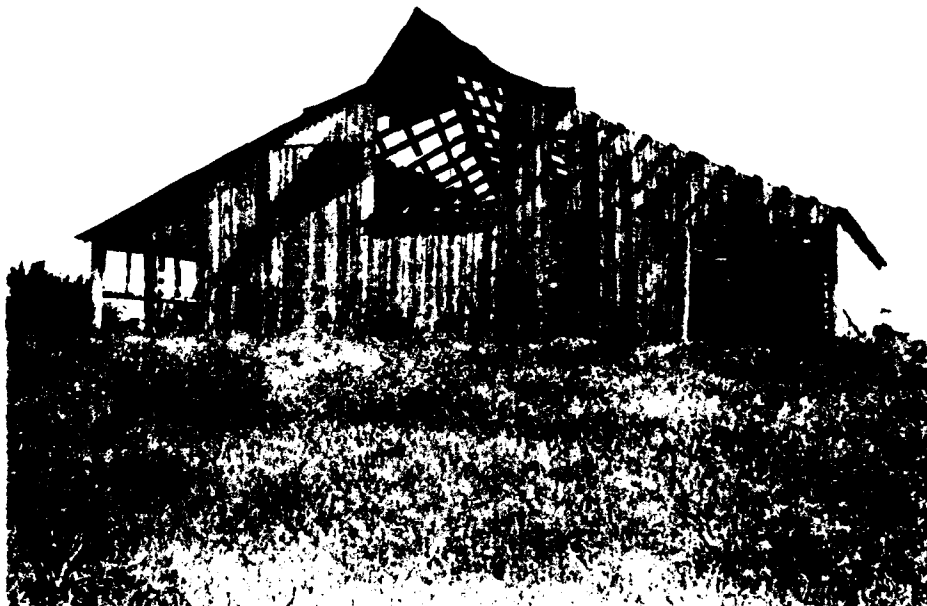
Barn front, viewer facing North
