EFFECT OF MATRIX RESIN ON THE IMPACT FRACTURE CHARACTERISTICS
OF GRAPHITE-EPOXY LAMINATES

NASA Contractor Report 165784

P. E. Hertzberg, B. W. Smith, and A. G. Miller

Boeing Commercial Airplane Company
Seattle, Washington

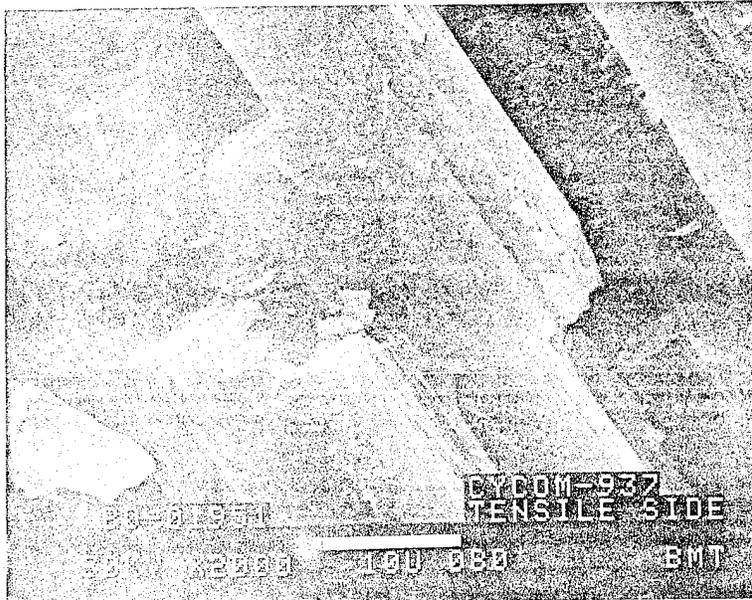
Figure 18. Interlaminar Fracture, Cycom 937 (2000X)

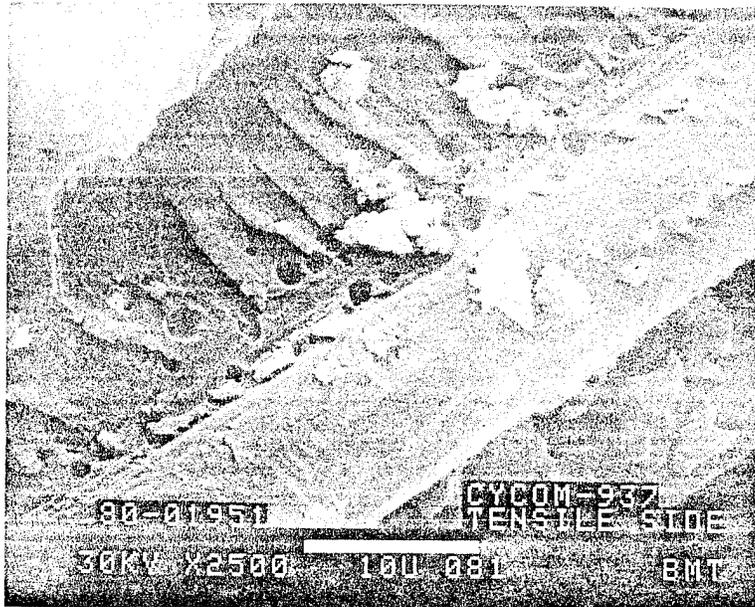
Figure 19. Resin-Fiber Bonding, Cycom 937 (2500X)

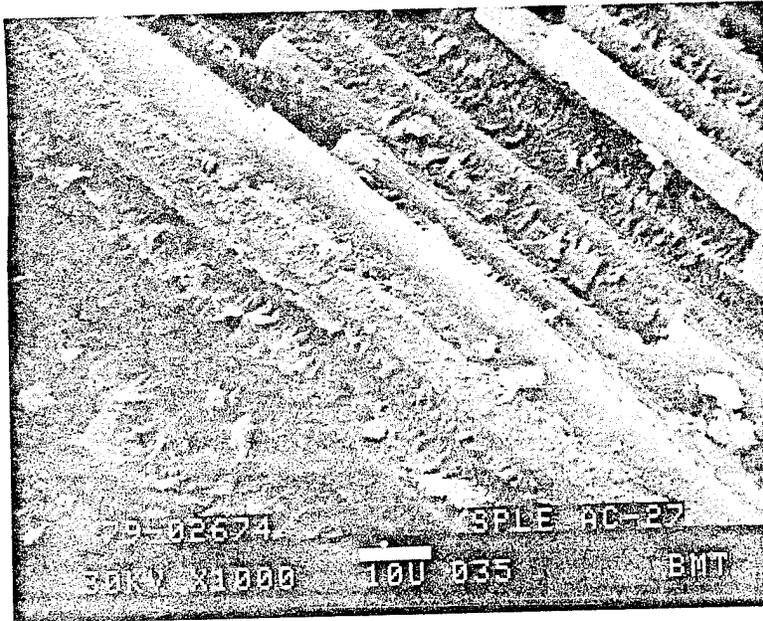
Figure 21. Static Notched Shear Failure, Propagation Zone, Cycom 937 (1000X)

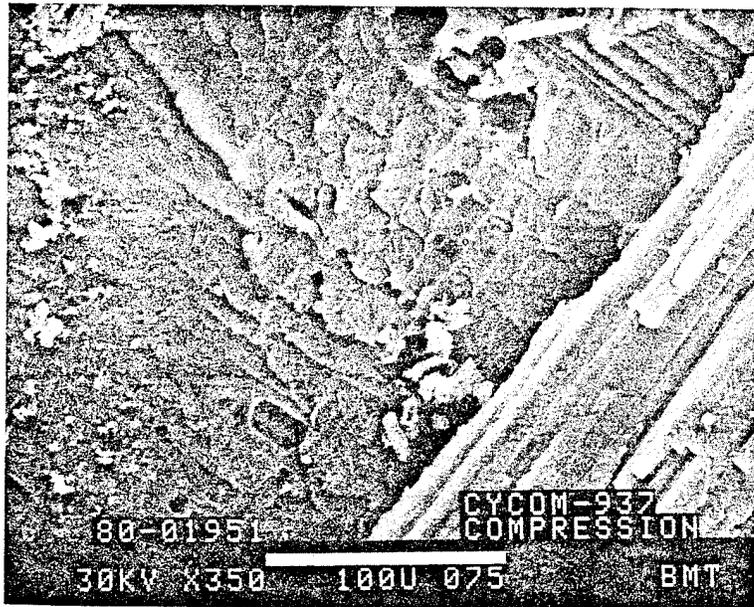
Figure 24. Compression Shear Delamination (Note Voids), Cycom 937 (350X)

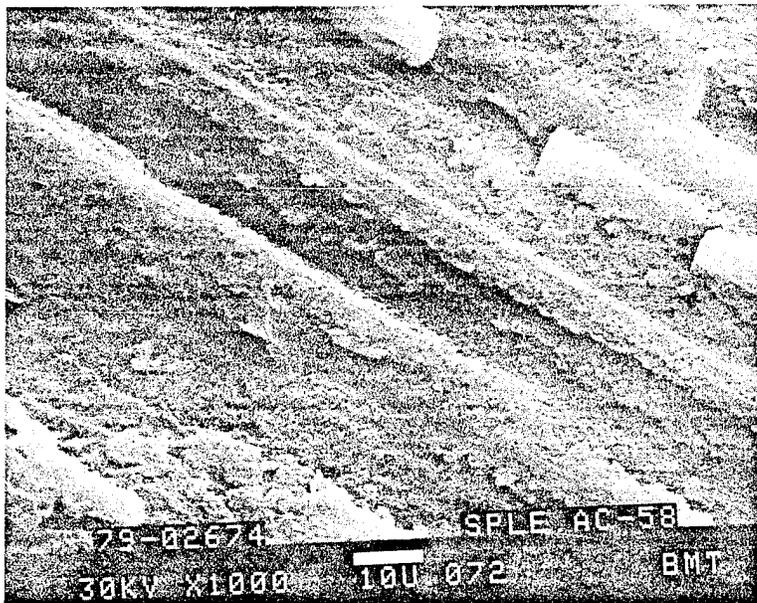
Figure 27. Static Notched Tension Failure, Origin, Cycom 937 (1000X)

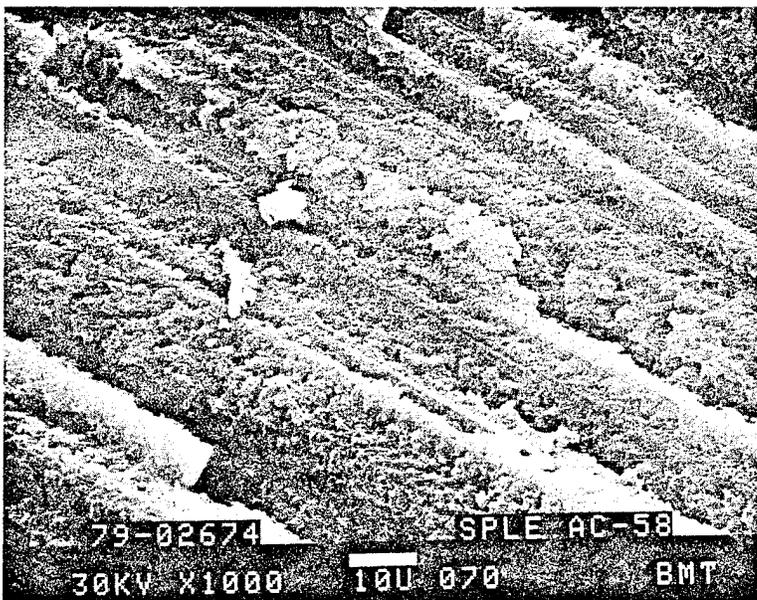
Figure 28. Static Notched Tension Failure, Propagation Zone, Cycom 937 (1000X)

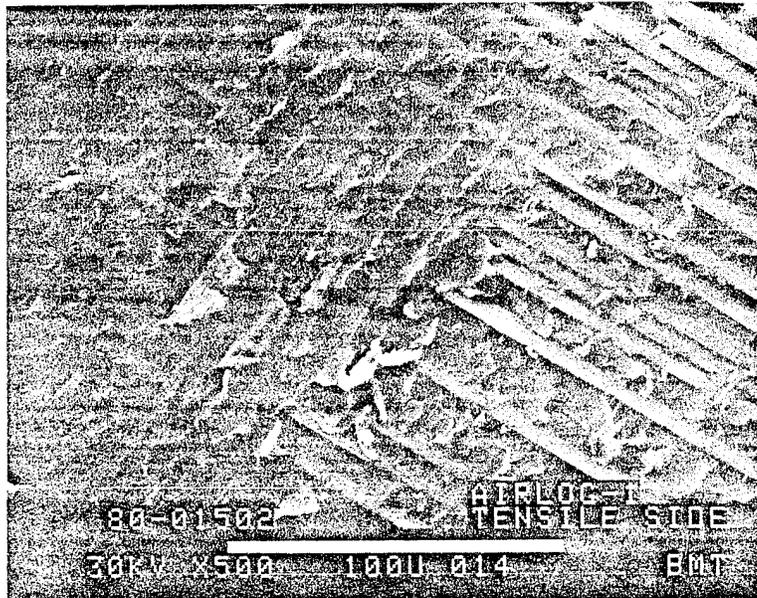
Figure 31. Plastic Deformation of Resin Around Fibers, Air Logistics 1 (500X)

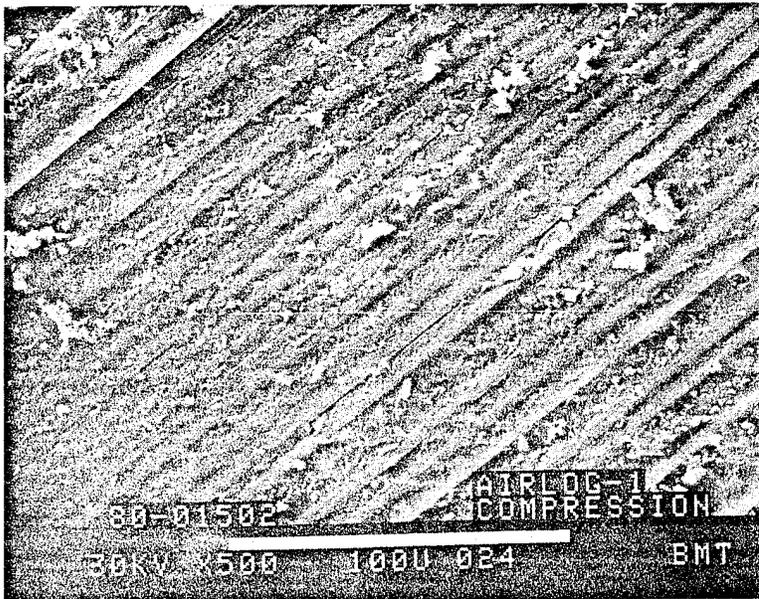
A transverse compression failure is shown in Figure 37, and another view of a compression shear interply fracture is shown in Figure 38. Examination of Figure 37 shows that resin deformation seems to be more restricted in the intraply regions and, in fact, is not substantially greater than in some of the more brittle systems. However, Figures 36 and 38 show that interlaminar resin regions are able to support high flow in a manner similar to the tension side.

Figure 38. Compression Shear With Large Plastic Flow, Air Logistics 1 (500X)

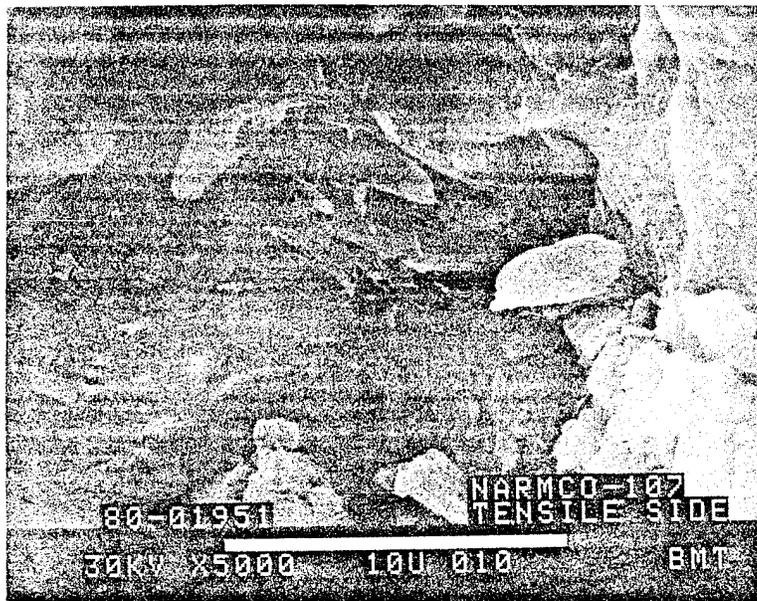
Note flow lines in resin

Figure 43. Flow of Resin Under Shear Loads, Narmco 107 (5000X)

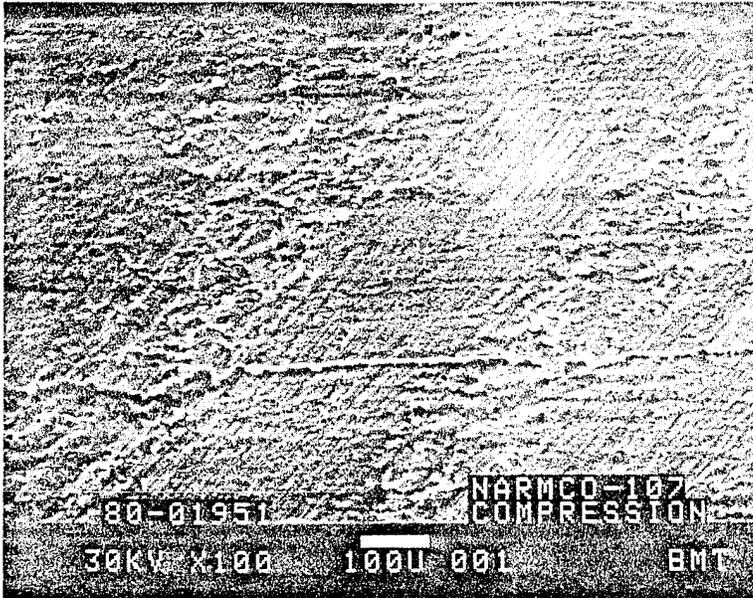
Compression and compression shear faces are shown at comparative magnifications in Figures 47 through 50. These photographs show that the shear deformations, compared to the tension side of the fractures, are caused by the same basic mechanism and produce the same type of fracture appearance. The transply deformations, when viewed in a broken 90-deg ply, show characteristic compression features on the macroscopic level. Figure 51 shows a rare patch of undamaged compression failure surface in the center-right side of the photograph. It is interesting to compare the area of well-defined hackles and the stretching of the broken resin in the area of nonsmeared fracture, to the far more typical appearance of the rest of the photograph. This smoother, flowed appearance is characteristic of neat resin composite compression failures and is a result of separated ply movement after crack formation. The direction of gross separated ply movement in this photograph is to the left, while the actual crack propagated to the right.

Figure 47. Compression-Loaded Shear, Narmco 107 (100X)

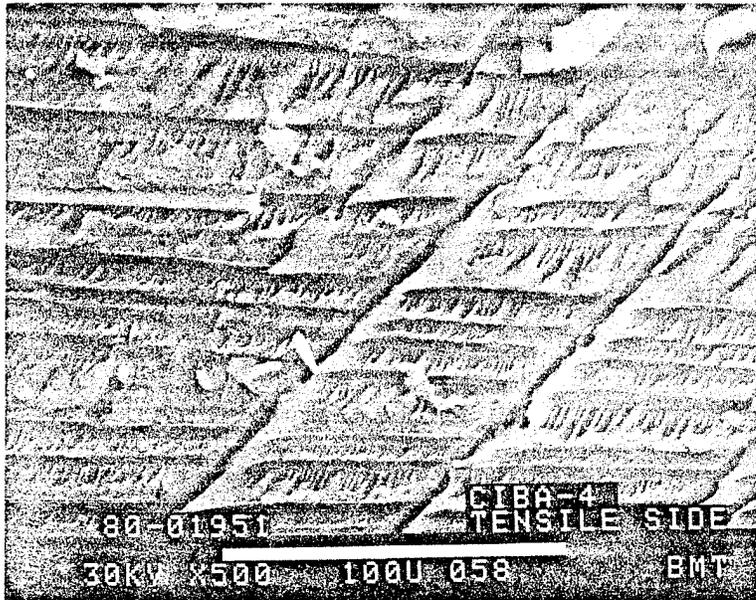
Figures 55 and 56 show higher magnification views of this brittle deformation in two separate areas. For comparison, Figures 57 and 58 show typical shear failures of a brittle resin system, Narmco 5208, in a graphite composite manufactured using tape in a ± 45 -deg layup and failed in tension. Note the similarity of resin fracture features between the fibers of Figures 57 and 58 and the resin fracture of Figures 55 and 56. Recognition must be given to the scale of the features. The brittle cleavage formations of Ciba 4 are much larger and do show some slight rounding, indicating that limited plastic deformation has occurred. This would be expected, since the photomicrographs suggest that Ciba 4 is considerably tougher, based on apparent impact damage, than Narmco 5208.

Figure 55. Apparent Brittle Fracture, Delamination Face, Ciba 4 (500X)

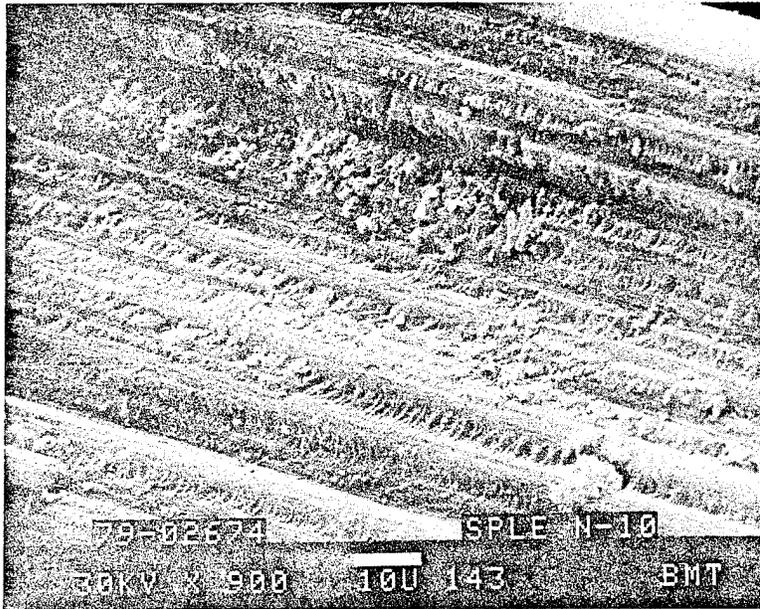
Figure 57. Notched Shear Static Failure, Narmco 5208 (900X)

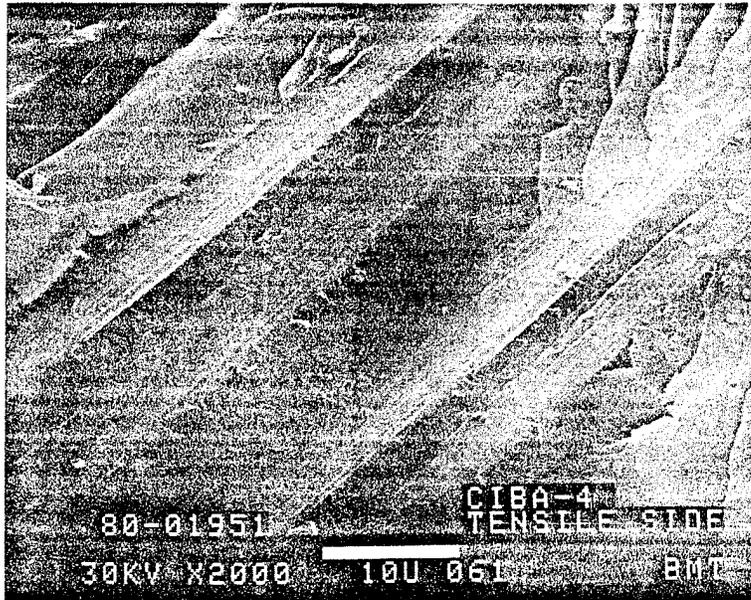
Resin tension fracture, viewed from a transverse crack in a tension-loaded 90-deg ply, is shown in Figures 59 and 60. As in the case of the shear appearance, the ultimate separation mechanism is cleavage. However, plastic flow of the bulk materials appears to have occurred before separation. This is evident when Figures 59 and 60 are compared to Figures 61 and 62, a 90-deg tension failure of Narmco 5208. Care must be taken when making comparisons due to the different magnifications, but the similarity of features is evident.

Figure 59. Resin Tension Fracture, Ciba 4 (2000X)

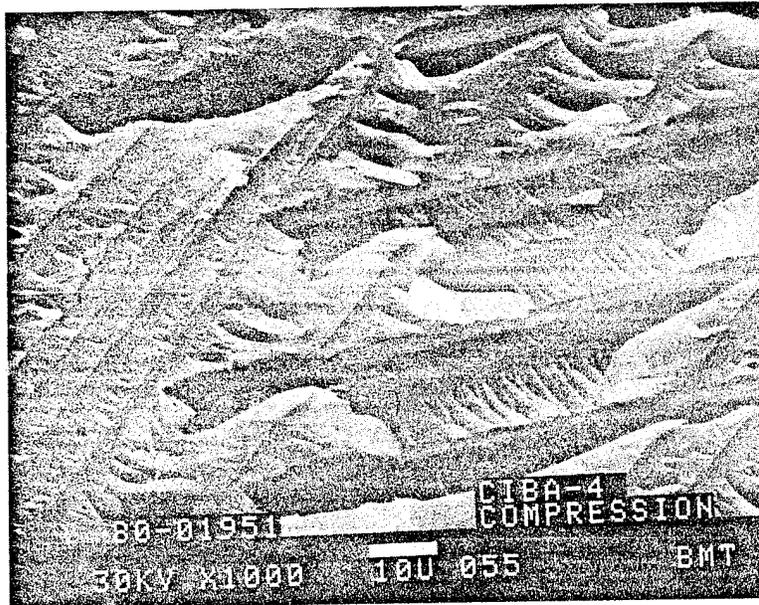
Figure 66. Compression-Loaded Interlaminar Shear Failure, Ciba 4 (1000X)

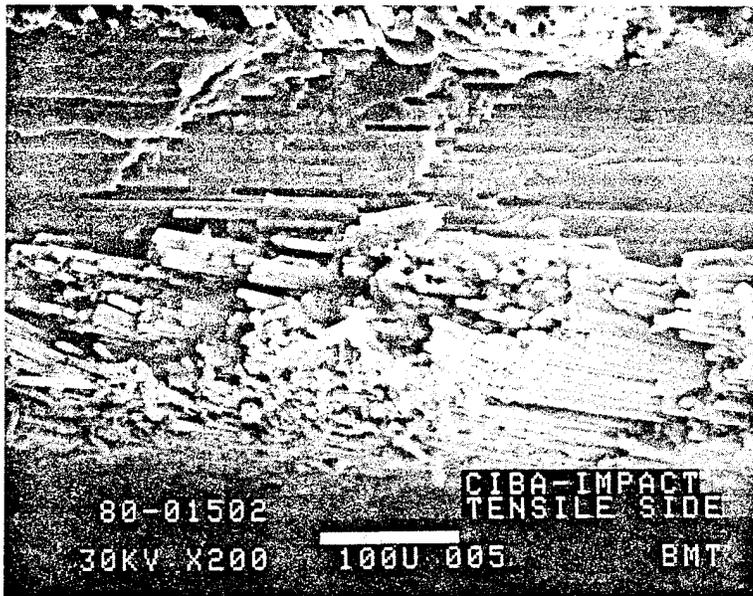
Figure 68. Typical Crossply Failure, Significant Pullout, Ciba 1M (200X)

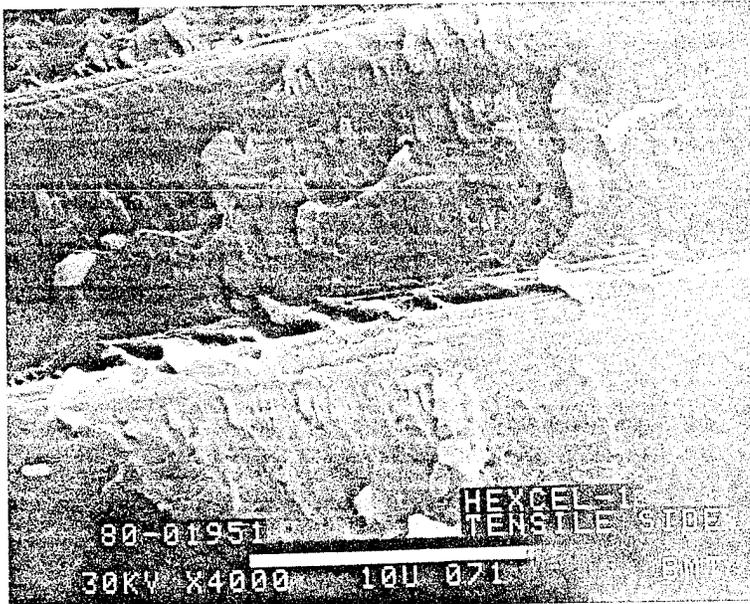
The pit size distribution remains narrow throughout the specimen, as can be seen by comparing Figures 79 and 80 with Figures 81 and 82, which are photographs of a corresponding shear plane from the compression side of the specimen and exhibit the same pitted appearance. The pits conform to the plastic flow directions of the base resin, which supports the supposition that the pits are voids, or at least were created before the ultimate separation of the fracture faces.

Fiber-matrix bonding of Hexcel I seems to be adequate for the impact case. This is shown in Figures 79 and 81. The conditions shown in these photographs are typical of the entire fracture appearance.

Figure 79. Good Resin Ductility, Transverse Tension Loading, Hexcel 1 (4000X)

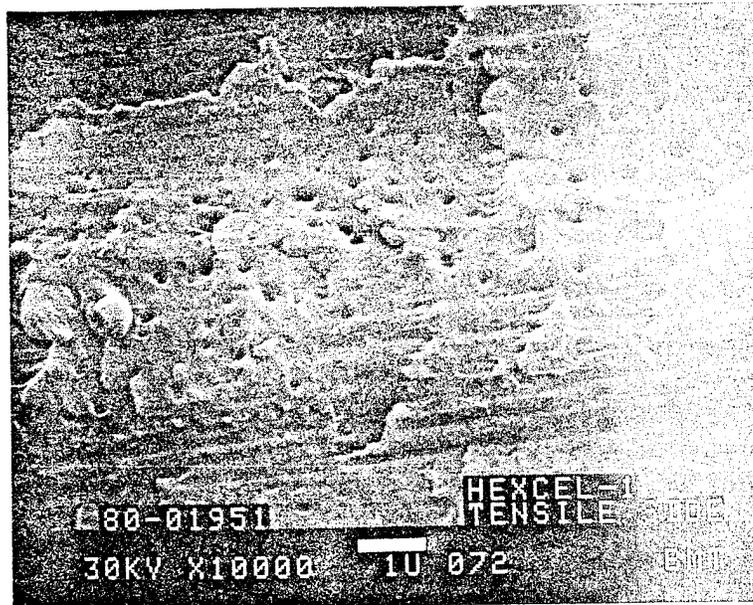
Figure 80. Resin Flow With Pits, Hexcel 1 (10,000X)

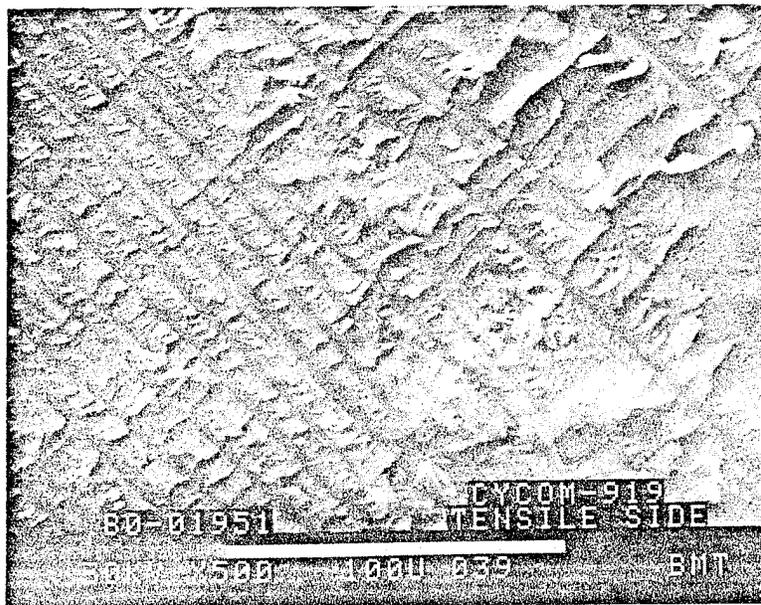
Cycom 919 appears to fail in a brittle fracture mode when viewed at low magnification, as shown in Figure 85. Figure 86 is at higher magnification and is still dominated by a brittle appearance. However, small patches in the center have the hairy appearance of Narmco 107, discussed earlier. A higher magnification photograph of

Figure 86. Apparent Brittle Fracture, Cycom 919 (500X)

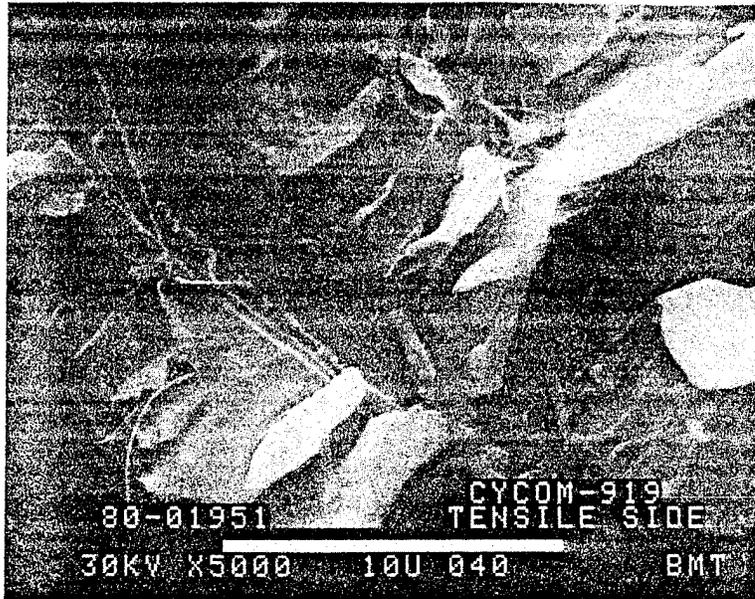
this feature is shown in Figure 87. This magnification reveals the fact that plastic deformation of the resin does occur in this material. This deformation is similar to that of several other specimens used in this study and consists of stretching and feathering of the hackles formed by the intersection of opposing cleavage facets. Several different areas are shown in Figures 88 and 89.

Figure 87. Hairy Appearance, Resin Whiskers, Cycom 937 (5000X)

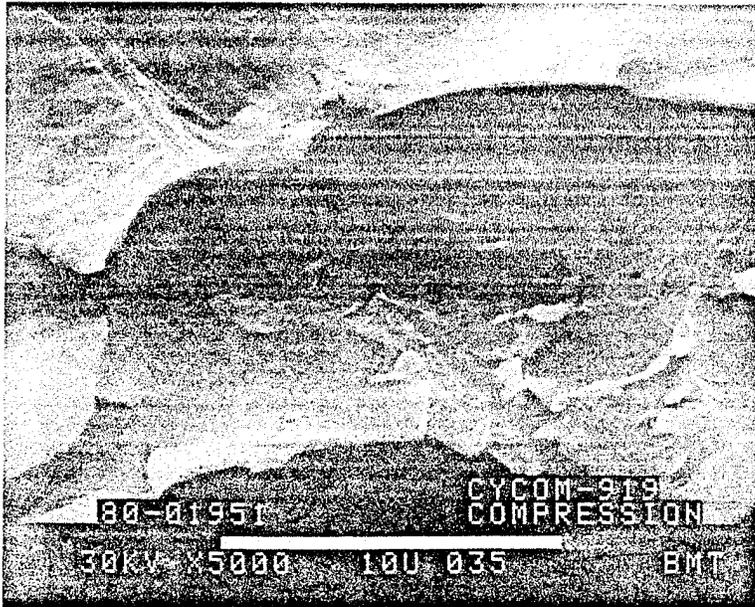
Fiber-matrix bonding is adequate in Cycom 919, as shown in Figures 90, 91, and 92. The fiber surfaces shown in this figure are coated with a thin layer of resin, some of which is plastically deformed.

Figure 91. Resin-Fiber Bond, Cycom 919 (5000X)

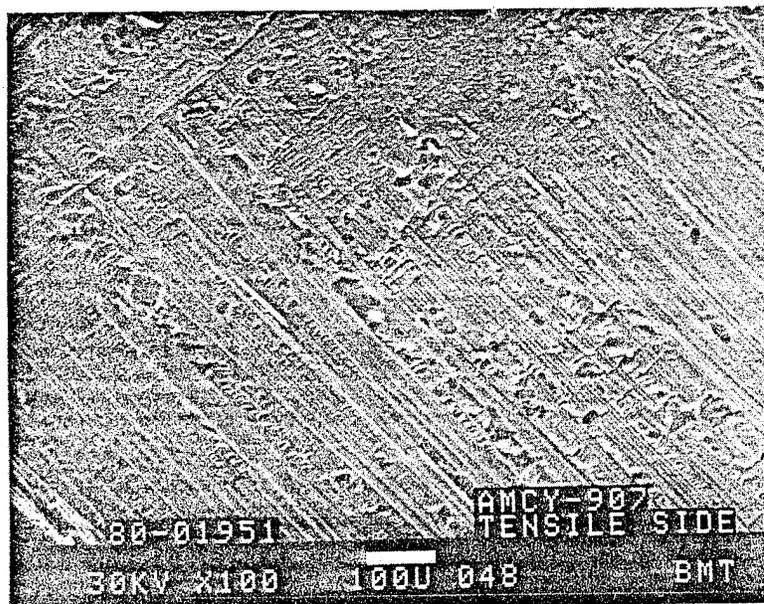
The presence of voids on the shear planes is shown in Figures 93 and 94. The greater number of voids is clearly evident in Figure 94. As in previously discussed specimens, the voids do not act as crack initiators, but serve as free surfaces.

Figure 94. Similar Delamination Face, BP-907-LR (100X)

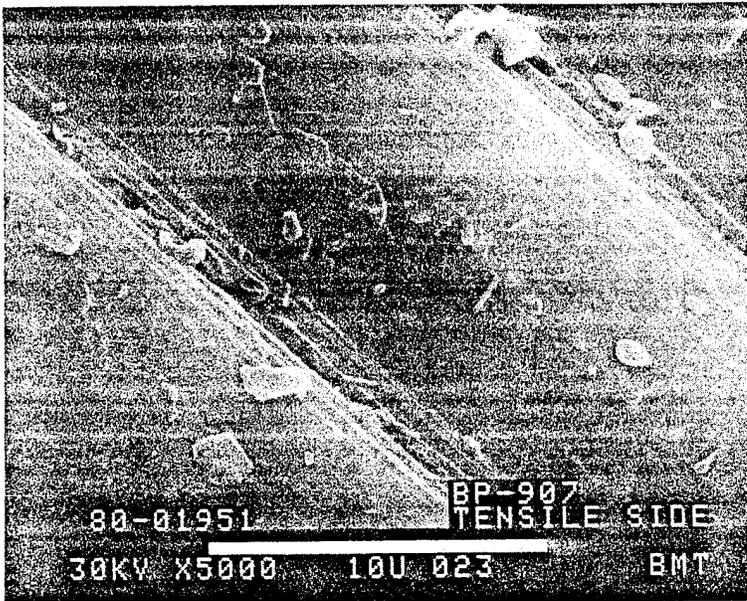
The basic microscopic fracture mechanism appears to be the same in both the high- and low-resin-content materials. This conclusion is based on comparison of the two photographs in Figures 99 and 100. However, the fact that insufficient material may be available for the complete operation of this fracture mechanism may impair its efficiency as a toughening agent, as shown by Figures 101 and 102. The elongation of the resin under stress is clearly shown by Figure 102, but the formation of the large, deformed bodies seems to require the presence of greater amounts of resin. This would be manifested in an apparent increase of impact toughness, since the energy required to deform greater amounts of resin would necessarily be higher than that required for a lesser amount of the same resin.

Figure 99. Microscopic Fracture Mechanism, BP-907 (5000X)

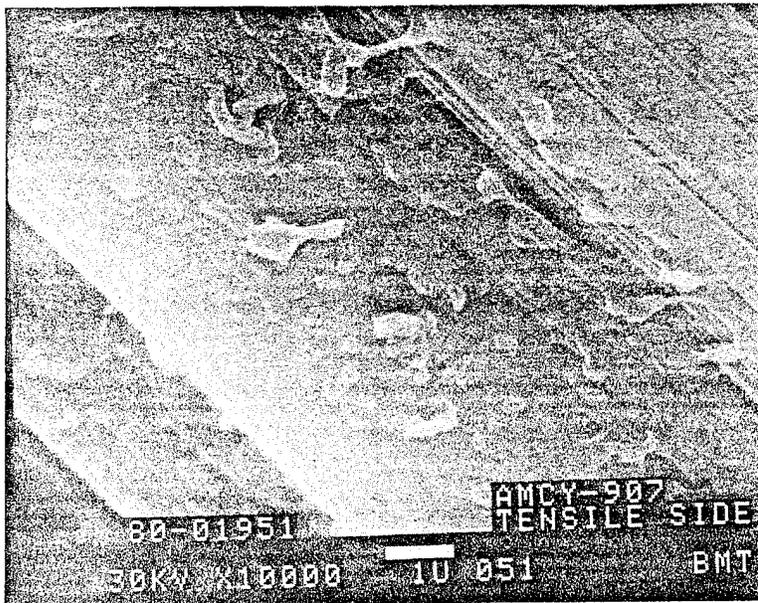
Figures 101 and 102 also show that the interface properties of BP-907 are not affected by resin content and that complete wetting of the fibers occurs despite the lower resin content of BP-907-LR.

Figure 102. Resin-Fiber Bond, BP-907-LR (10,000X)

Note lack of large ductile flow.
