Technical Report SL-97-9  
September 1997

# Durability of Posttensioned Concrete After 33 Years of Marine Exposure

by *Morris Schupack, Schupack Suarez Engineers, Inc.*  
*Edward F. O'Neil, WES*

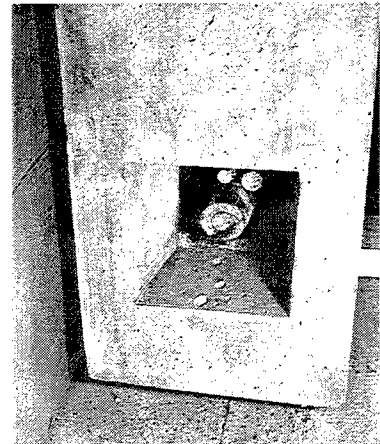
Fig. 4F

- Exterior - anchorage placed on surface of concrete and protected by casting on a cover of concrete after post-tensioning (Fig. 4A to 4E).
- Flush - anchorage recessed into a pocket within the end of the beam, which is filled with protective material after post-tensioning (Fig. 4F).

Flush  
No surface prep.  
(High strength bar)

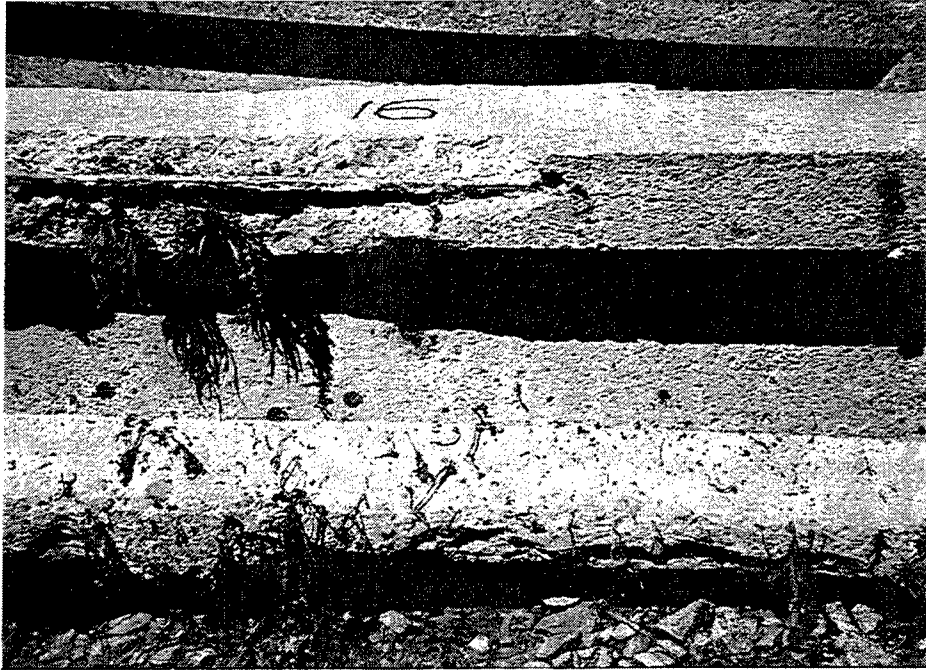
Fig. 8-4M

Beam 16 - 1990

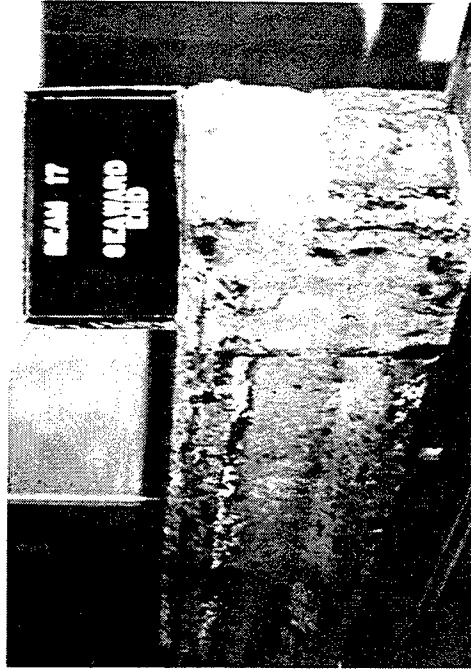
Beam 17 - Seaward end - 1984  
Prior to autopsy  
Fig. 9-2F

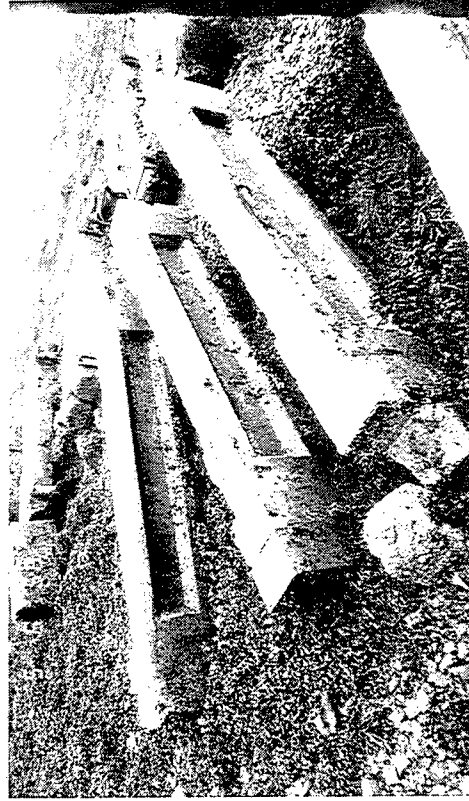
Beam 4, land end, had an epoxy-resin concrete exterior protection. It was in good condition in 1983 when it was autopsied. Figure 10-1B shows the Freyssinet anchorage after removal of the epoxy-resin concrete.

Beam 4 - Landward end - 1982  
Fig. 10-1D
