Little Goose Dam Radial Gate Inspection and Testing

US Army Corps of Engineers, Walla Walla District

13. ABSTRACT (Maximum 200 words) This report is an evaluation of the overall condition of the spillway tainter gates at Little Goose Lock and Dam, Snake River Washington.

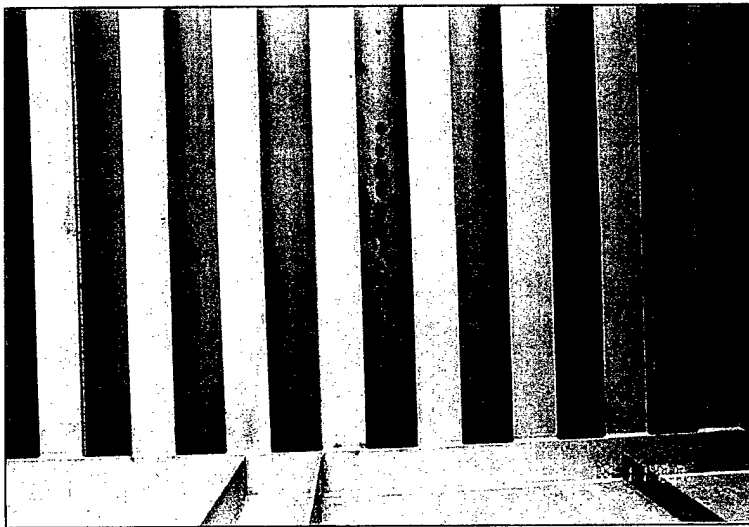
- There is a line of light to moderate corrosion on the downstream side of the skin plate just above the top horizontal girder approximately 10 feet from the left side of the gate.

Photo. 25: Moderate corrosion on downstream surface of skin plate.

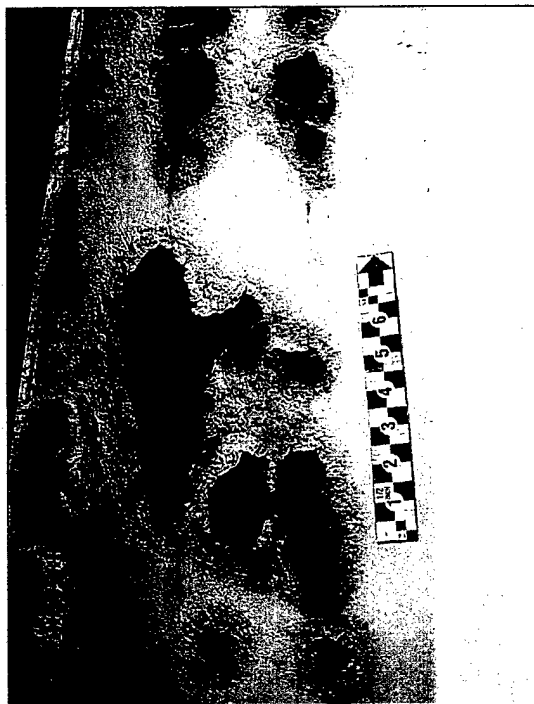
Photo. 26: Moderate surface corrosion on downstream surface of skin plate.

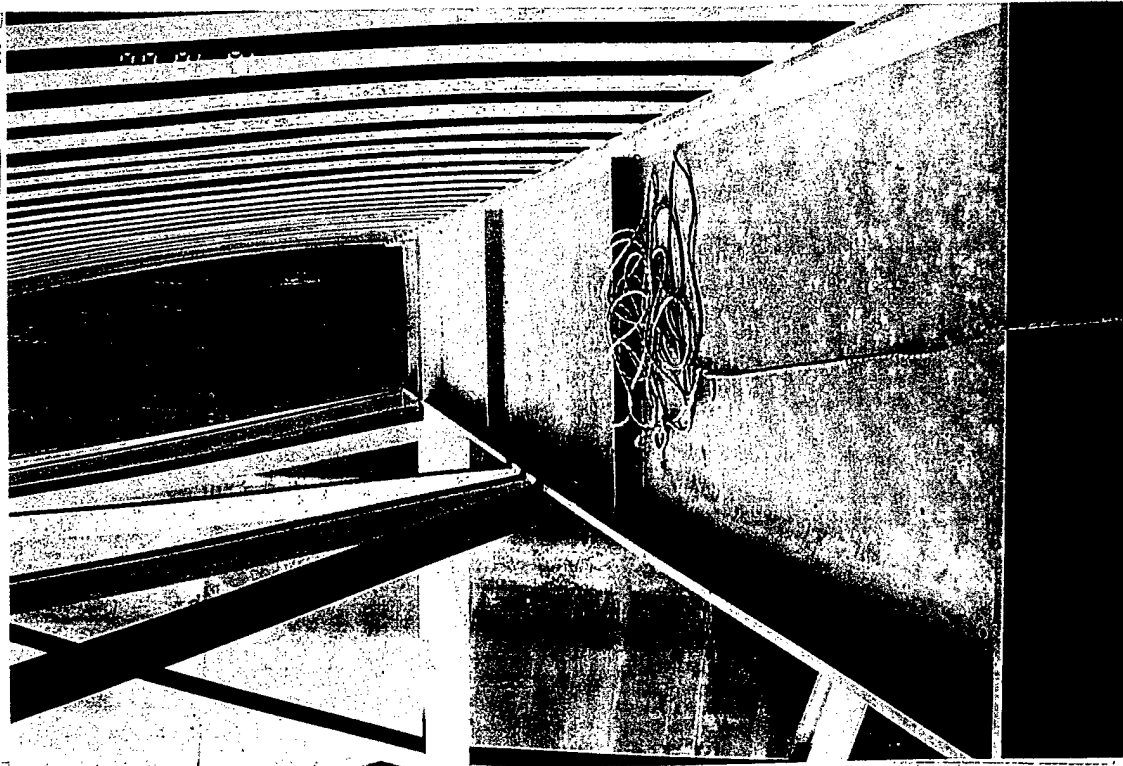
1-11

Gate 1
Middle horizontal girder looking
toward right frame, typical.

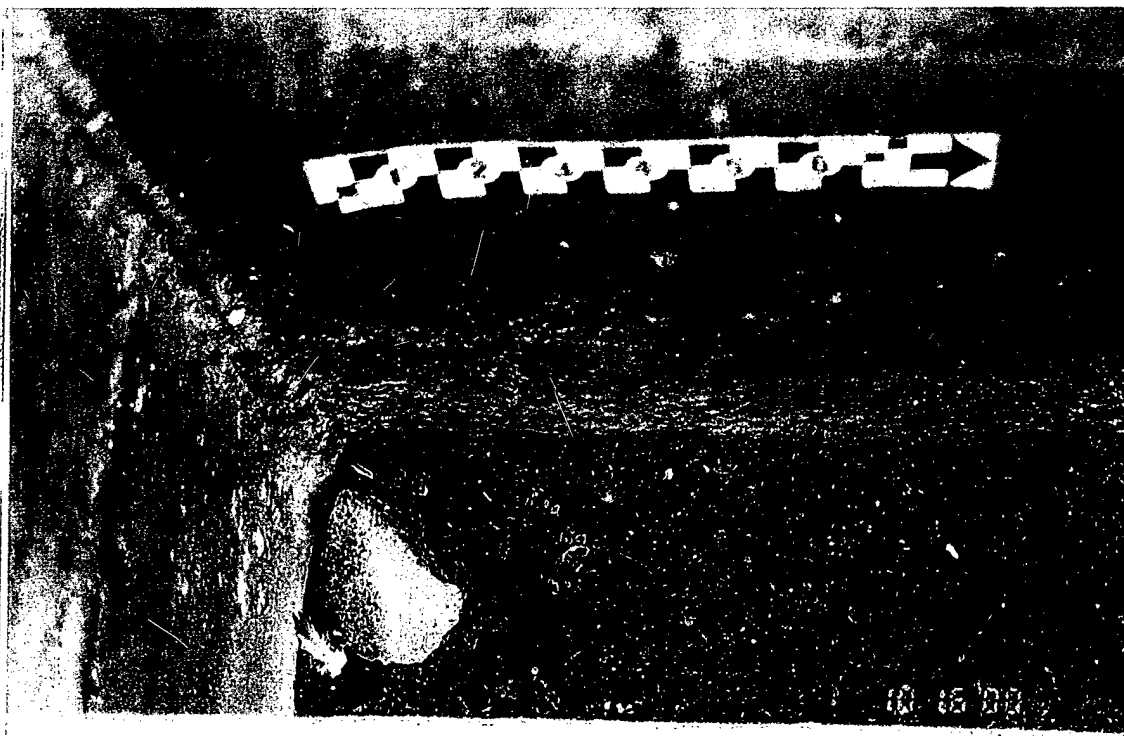
Little
Goose
Dam
10/16/00
1-15

Gate 1
Bottom horiz. girder. Standing
water, no drainage between multiple
stiffeners, typical.

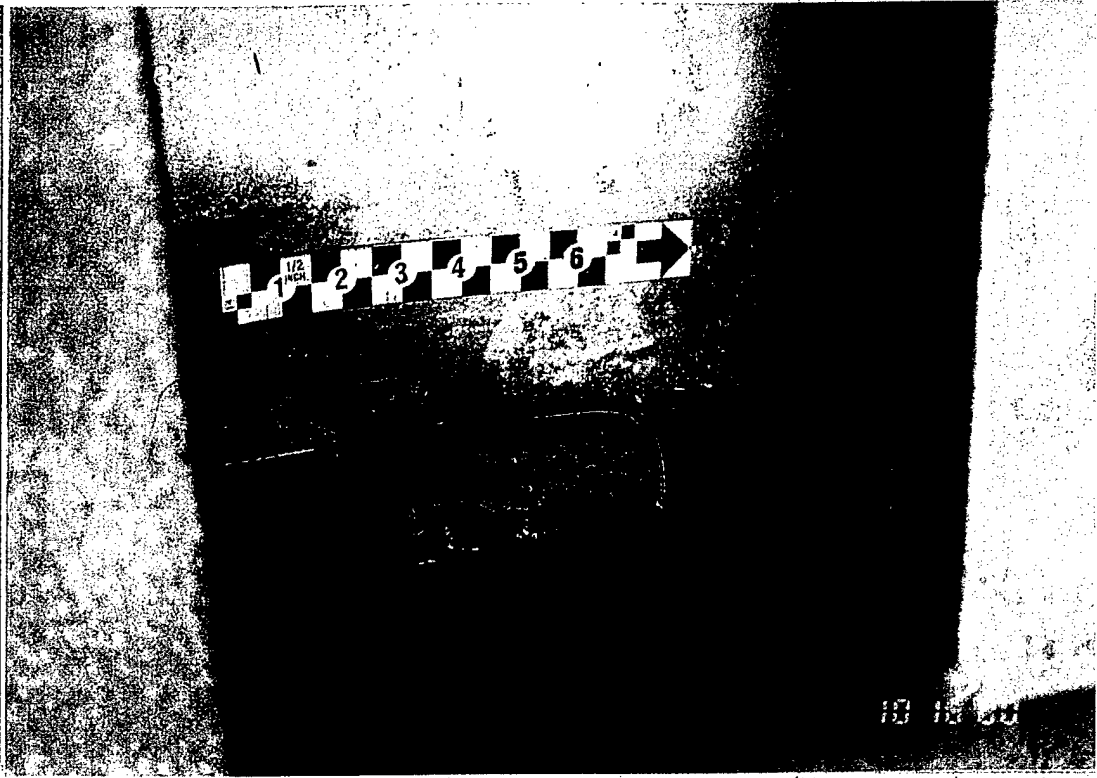
Little
Goose
Dam
10/16/00
1-17

Gate 1
Bottom seal closure plate looking
upstream. Standing water between
closure plate, purlin webs and
skinplate. Typical.

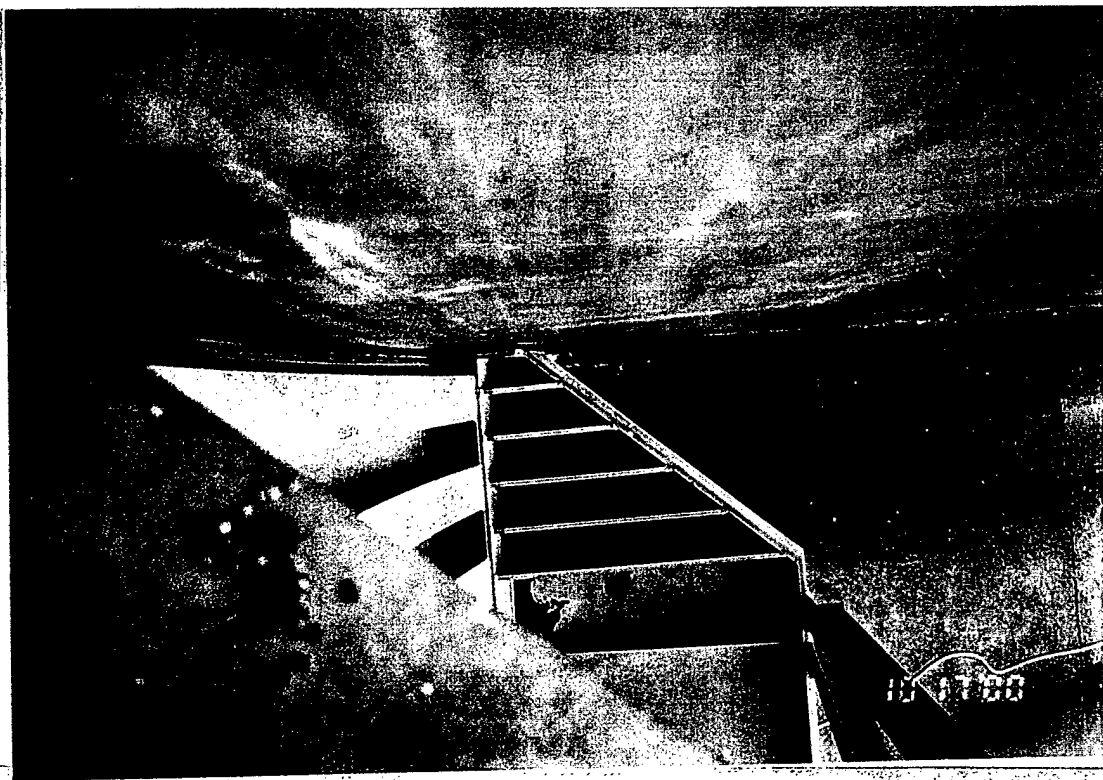
Little
Goose
Dam
10/17/00
2-5

Gate 2
Bottom horizontal girder, left end.
Standing water, no drainage between
multiple stiffeners, typical.

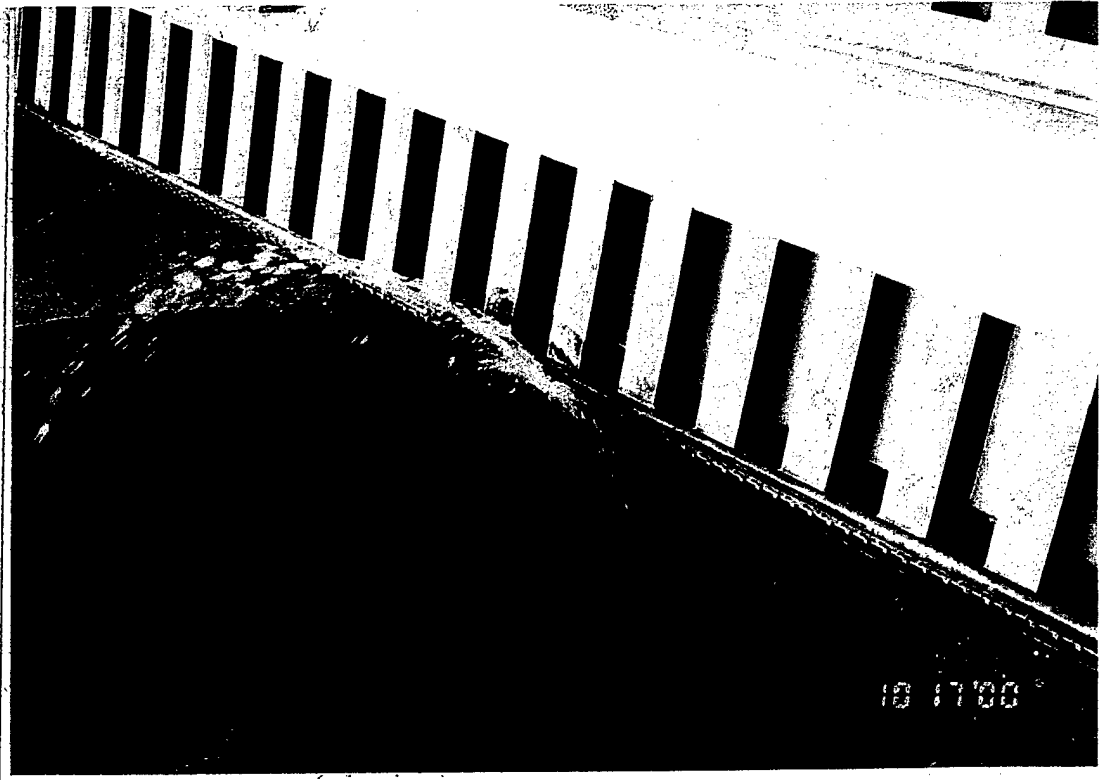
Gate 2
Leak at center construction joint in
spillway monolith.

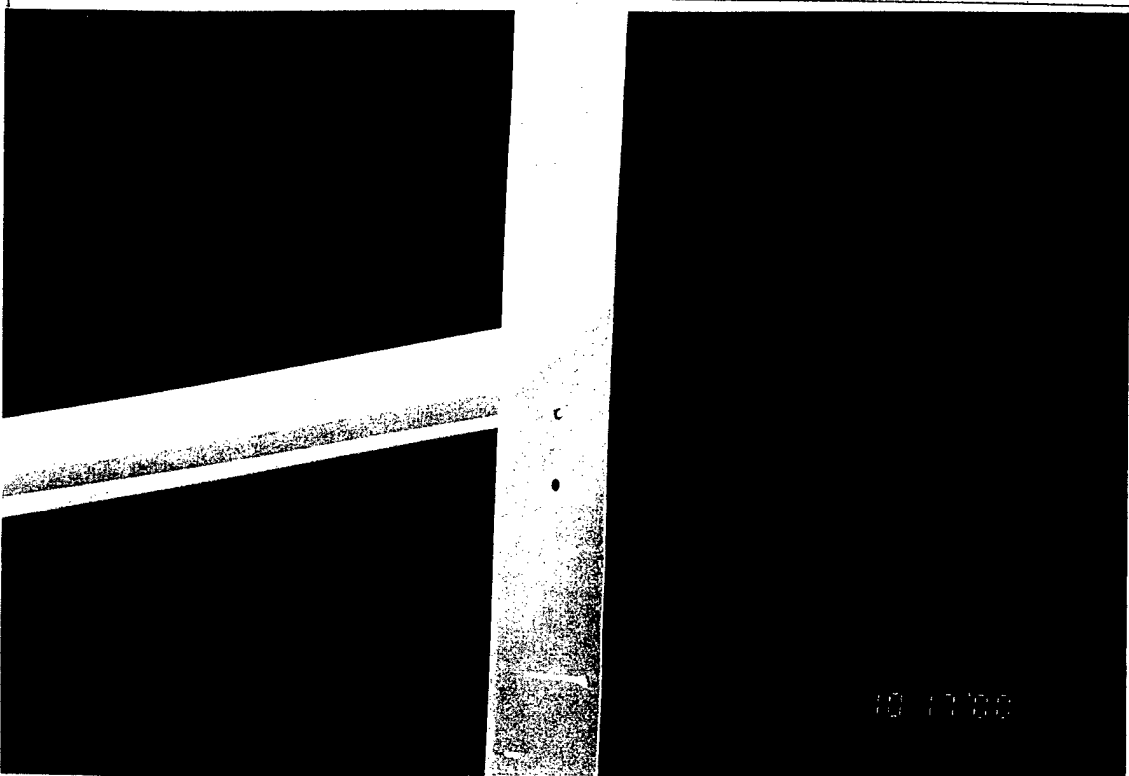
Gate 2
Extraneous holes, top plate at
purlins.

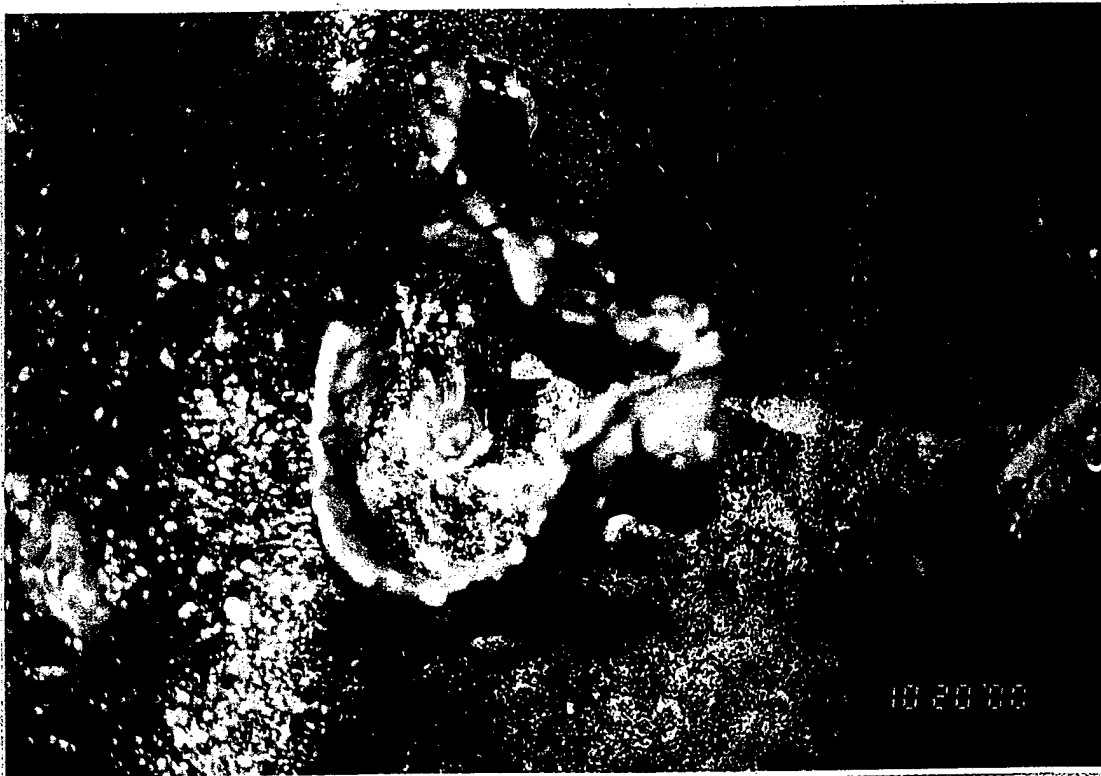
Gate 2
Unidentified metal clamp near hoist
connection.

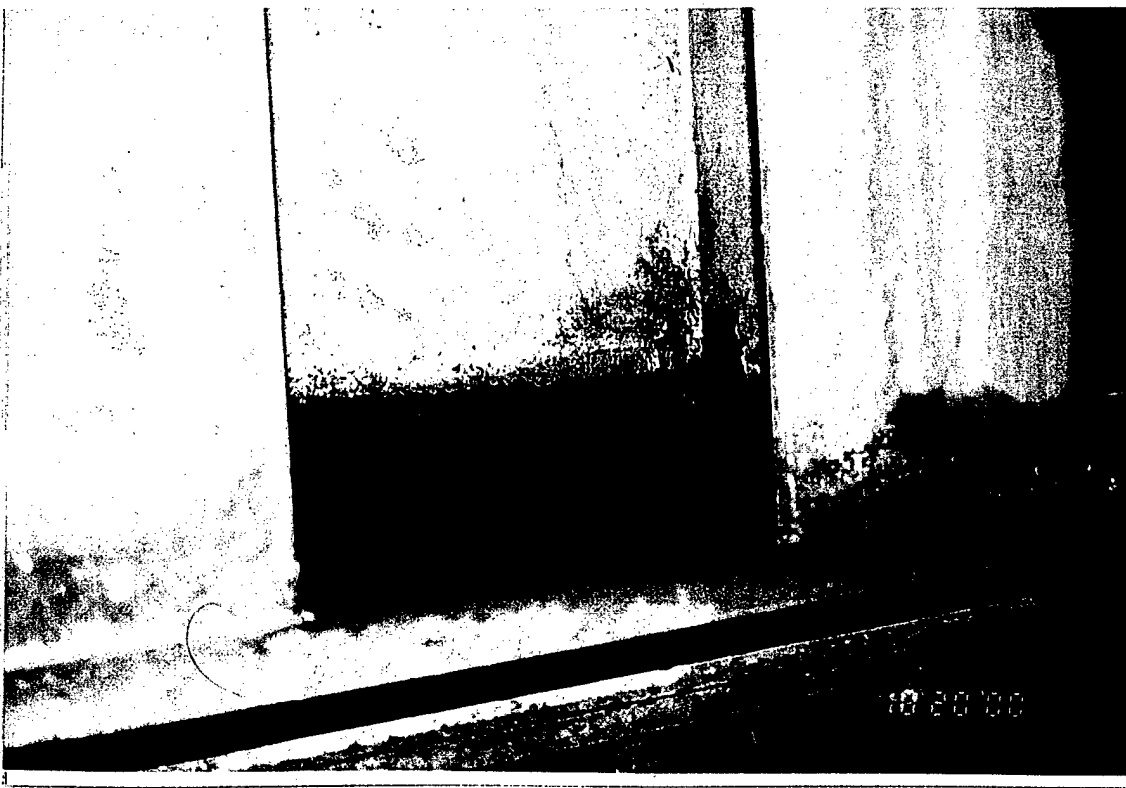
Bottom seal closure plate looking upstream. Standing water between closure plate, purlin webs and skinplate. Typical.

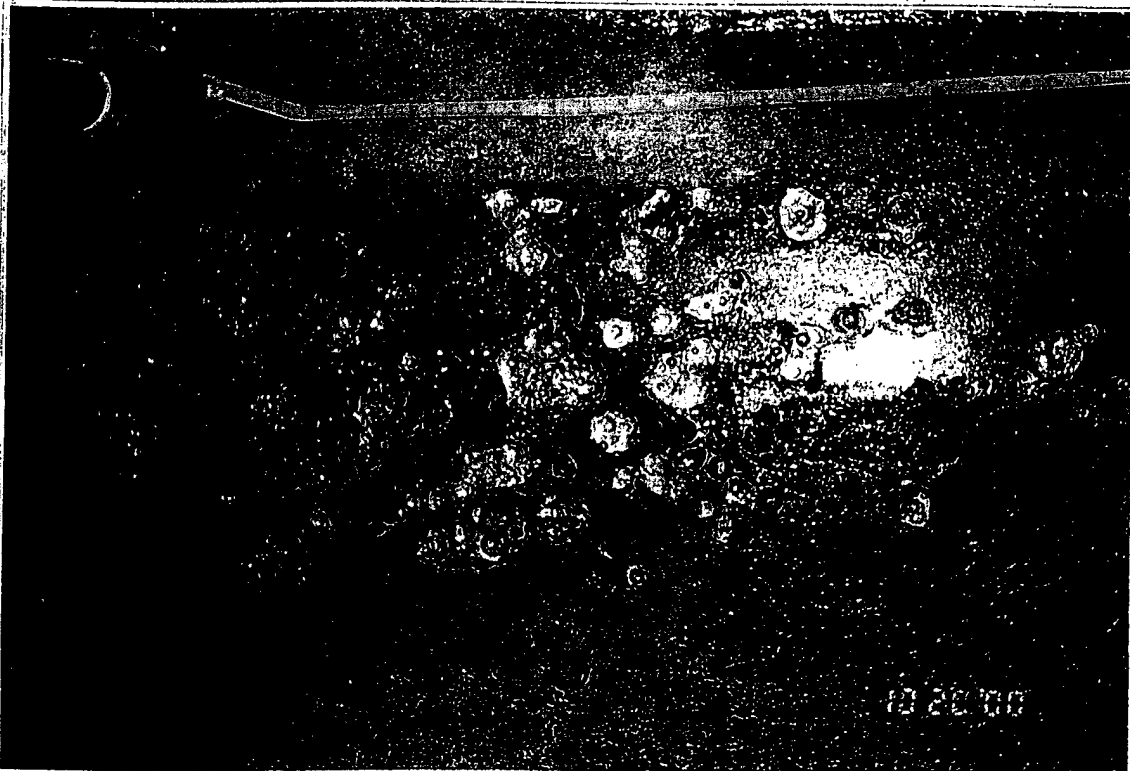
Skin plate pitting, typical.

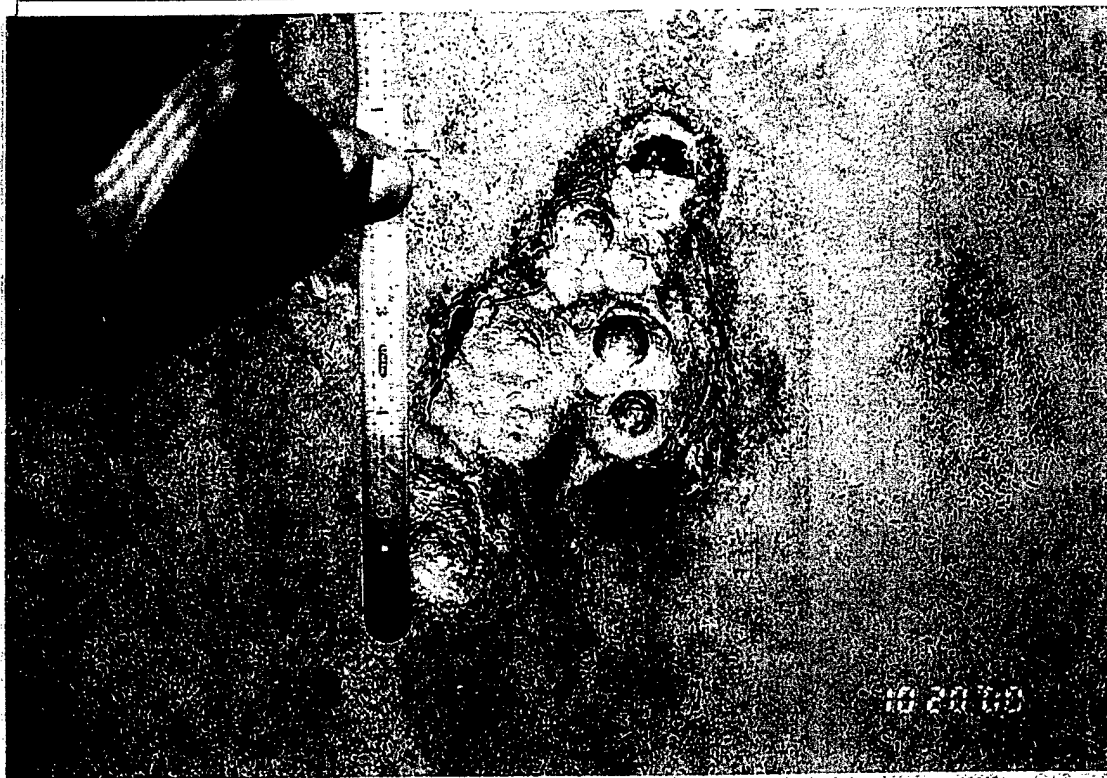
Gate 2
Skin plate pitting, typical.

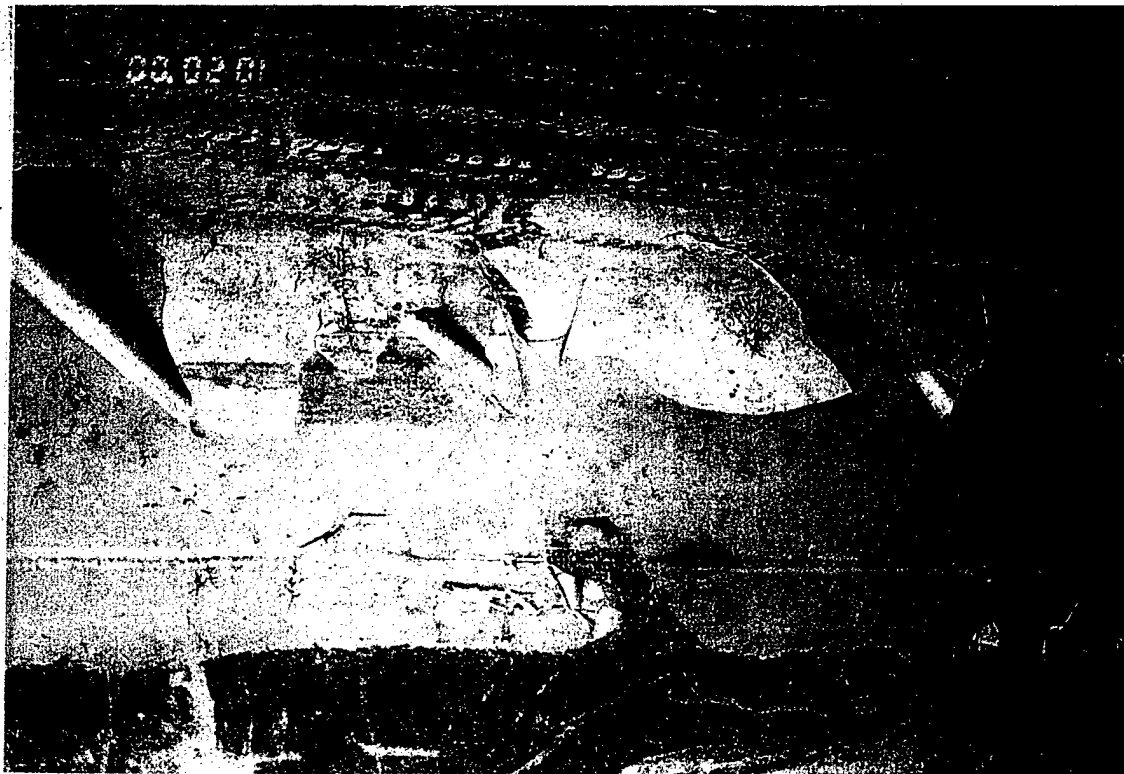
Little
Goose
Dam
10/20/00
2-33

Gate 2
Delaminates vinyl, right side of wear
plate, just below skin plate transition
from 3/8" to 1/2".

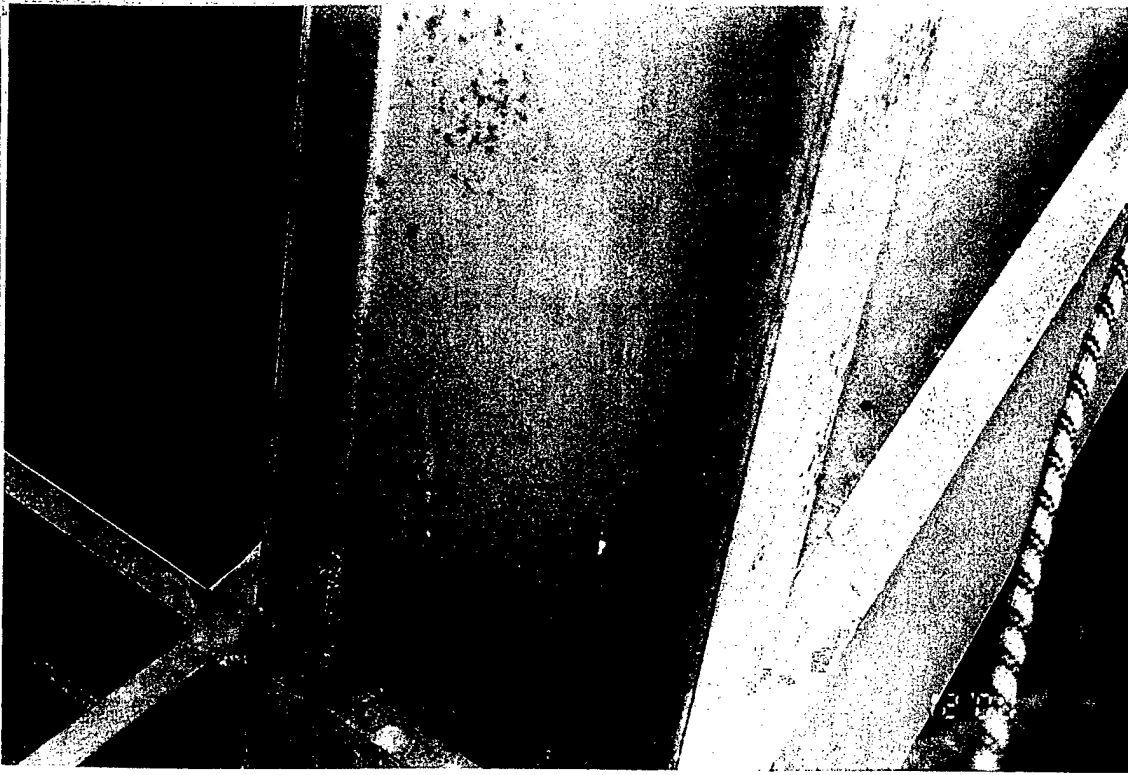
Gate 3
Left frame, Brace A. Light corrosion
on upstream side.

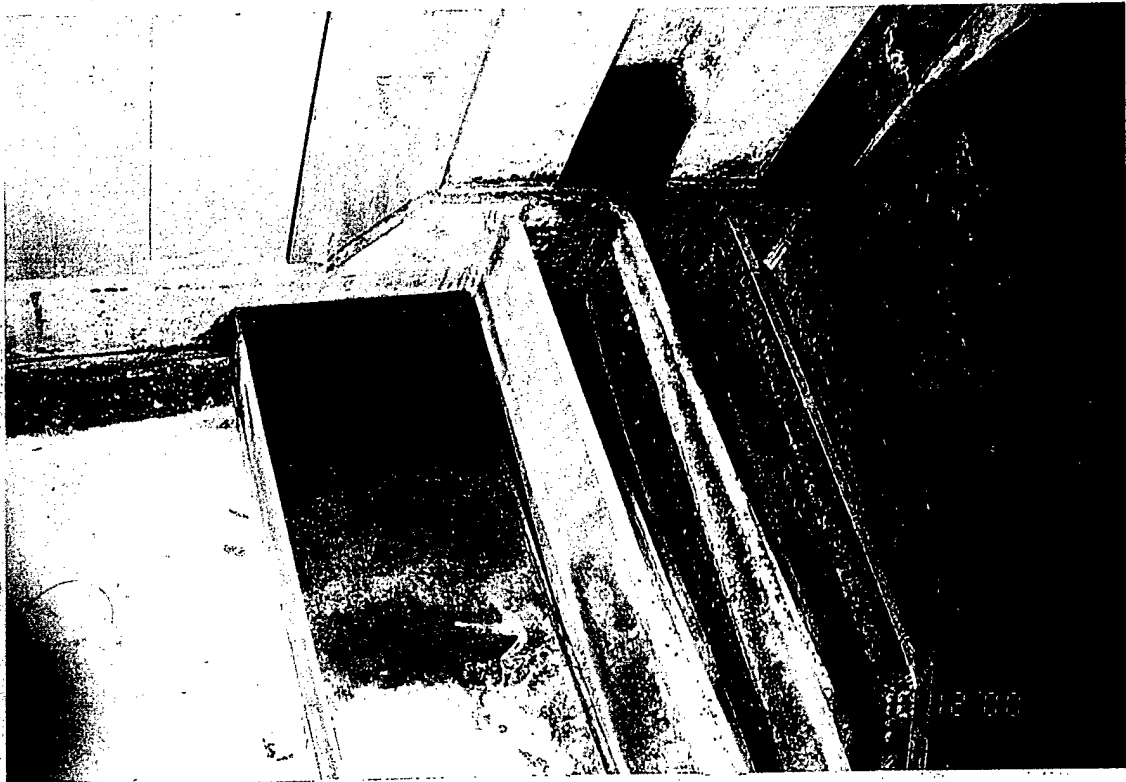
Bottom horiz. girder, left end.
Standing water, no drainage between
multiple stiffeners, typical.

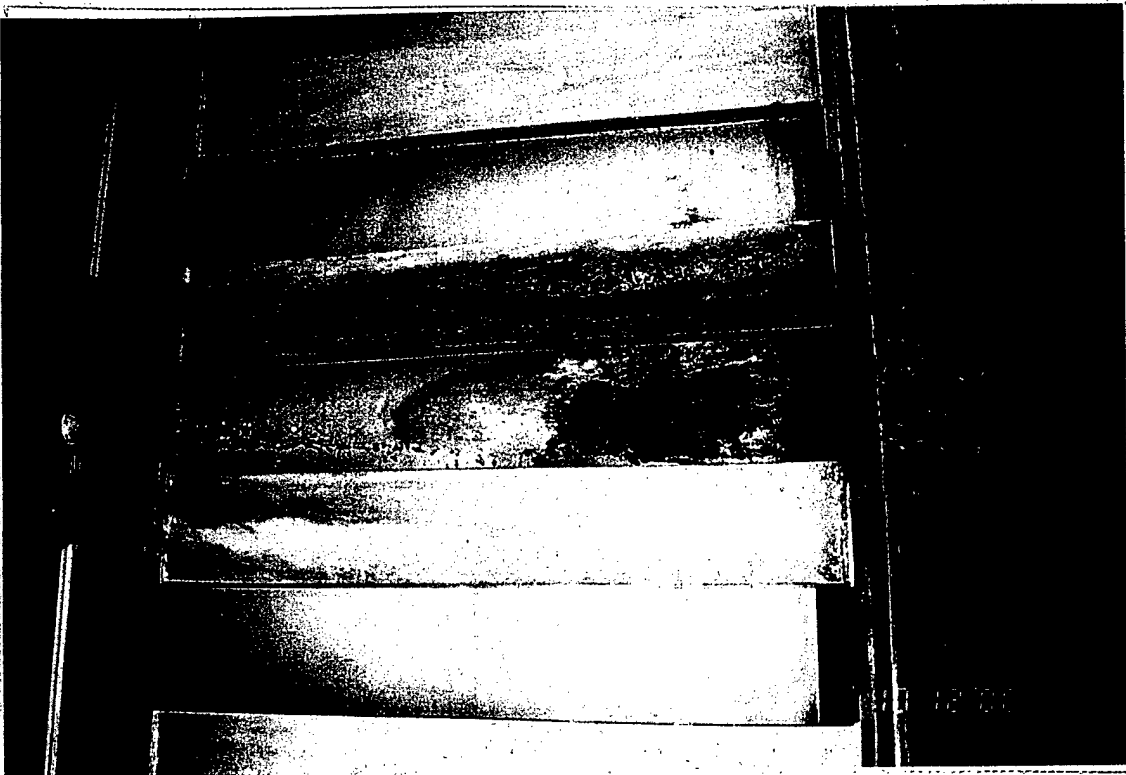
Standing water between closure plate,
purlin webs and skinplate, typical.
Light corrosion around drain hole at
upstream side of bottom radial strut.

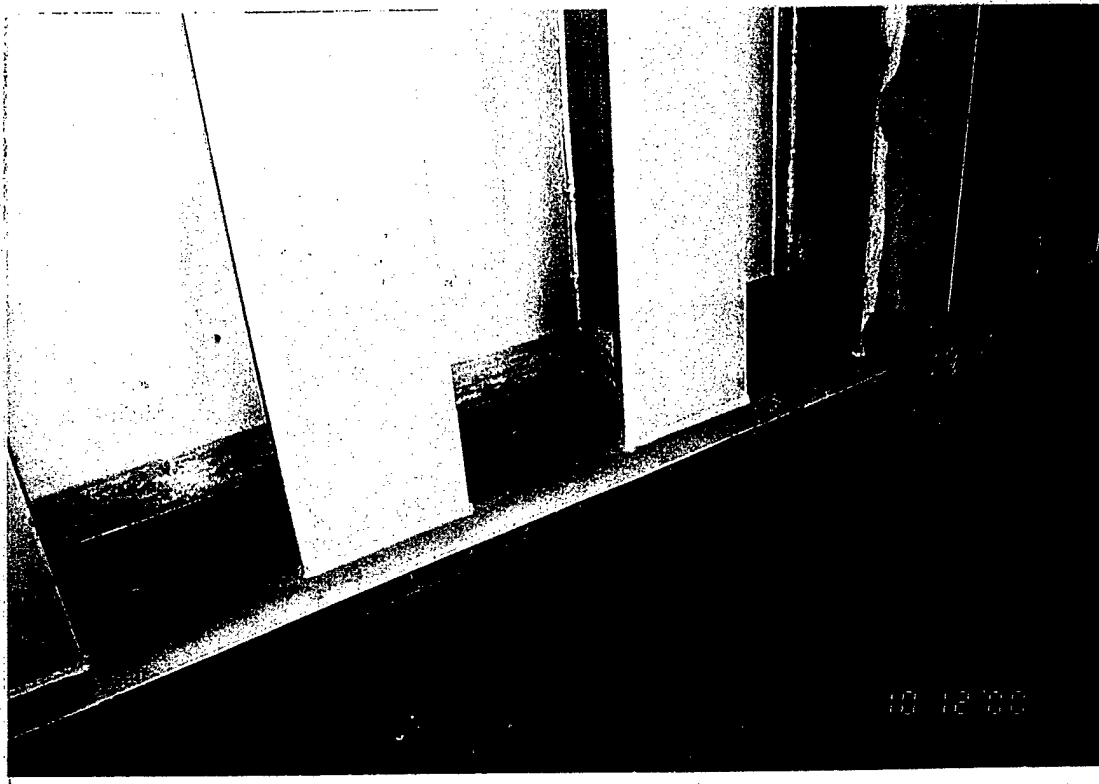
3-10

Gate 3
Standing water between closure plate, purlin webs and skinplate, typical.

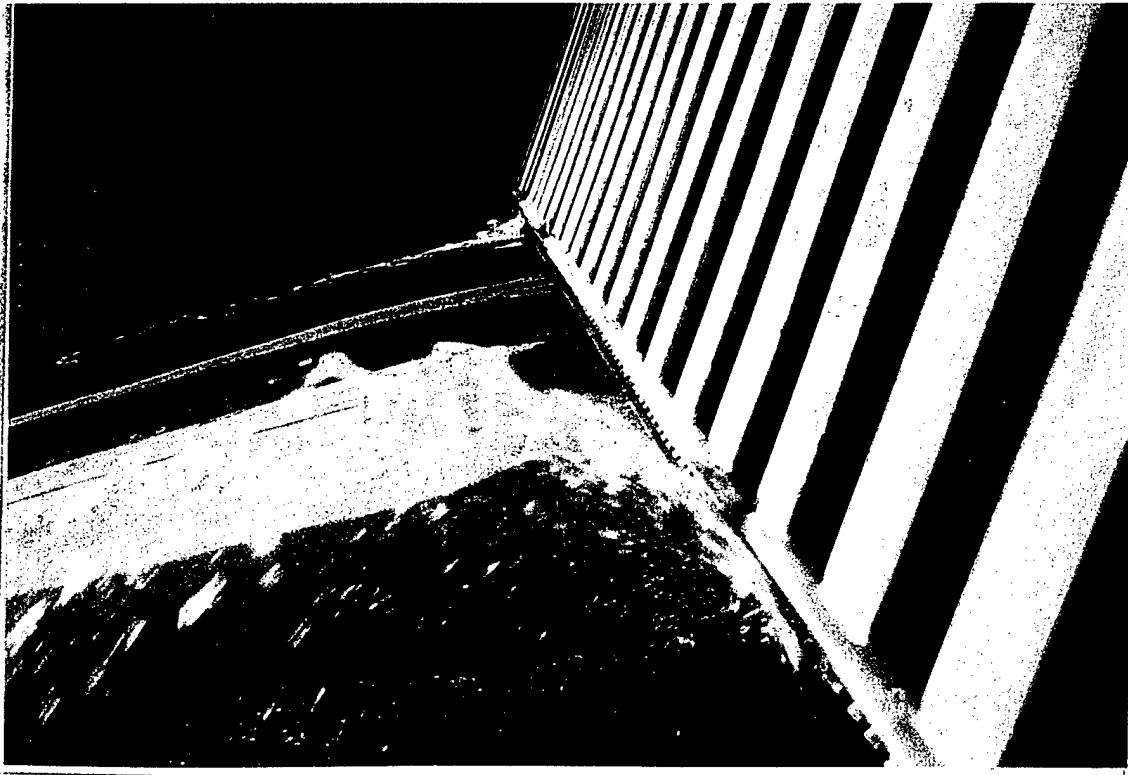
3-11

Gate 3
Leak at center construction joint in
spillway monolith.

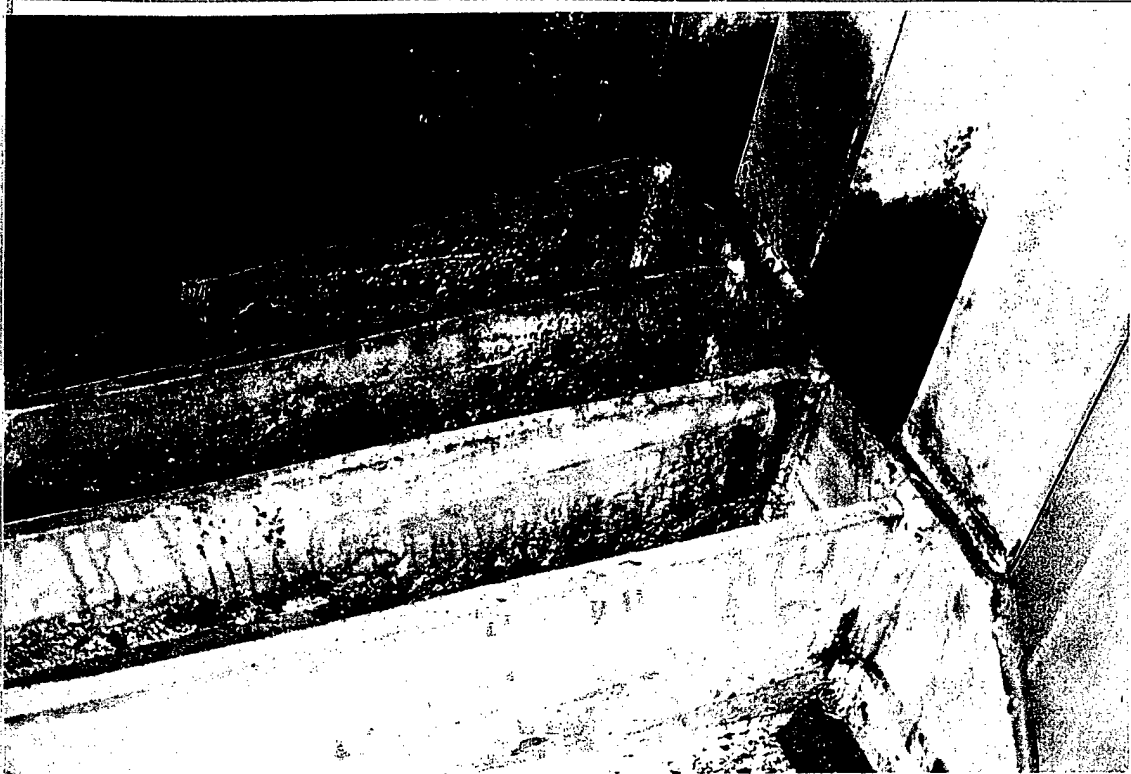
3-12

Gate 3
Bottom horizontal girder, right end.
Standing water, no drainage between
multiple stiffeners, typical.

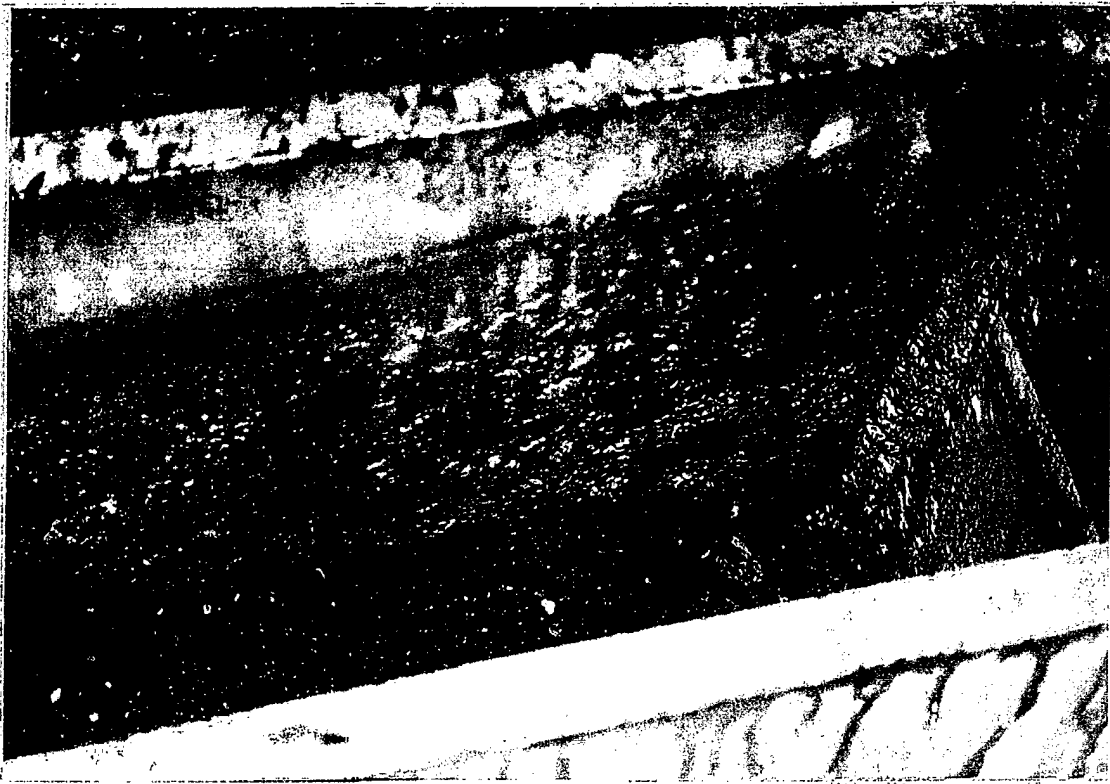
Close-up, bottom horizontal girder.
Standing water, no drainage between
multiple stiffeners, typical.

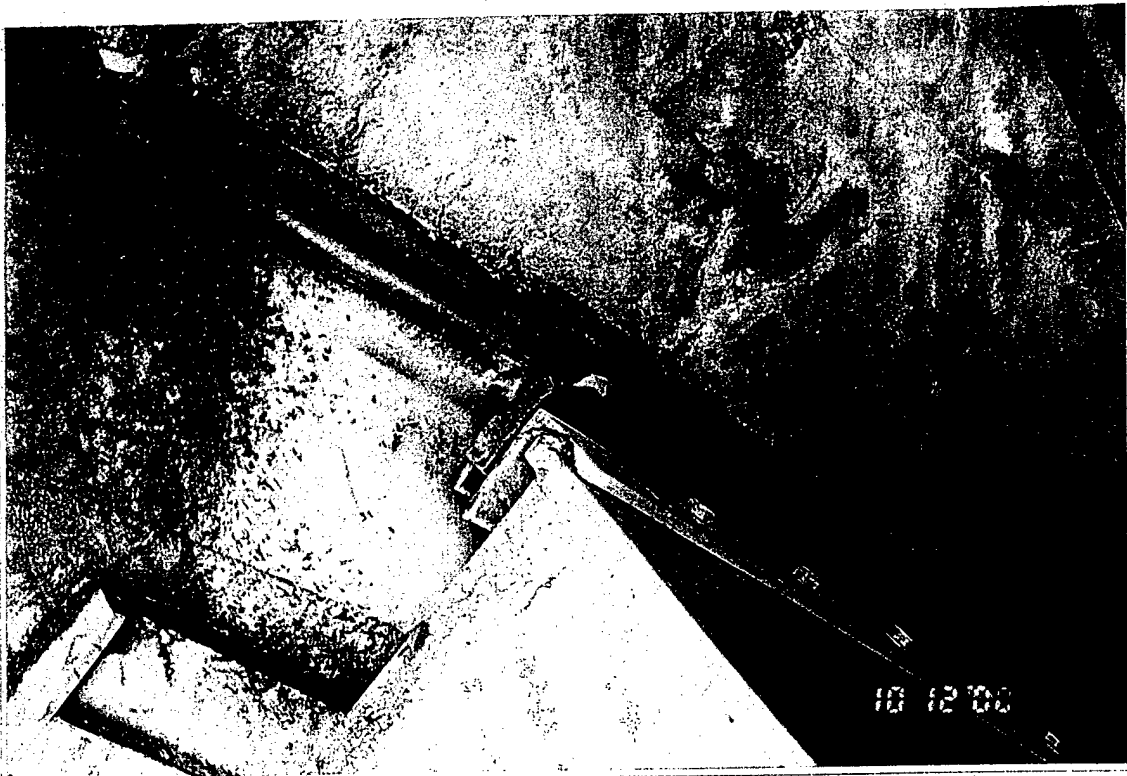
Gate 3
Top of side seal, typical.

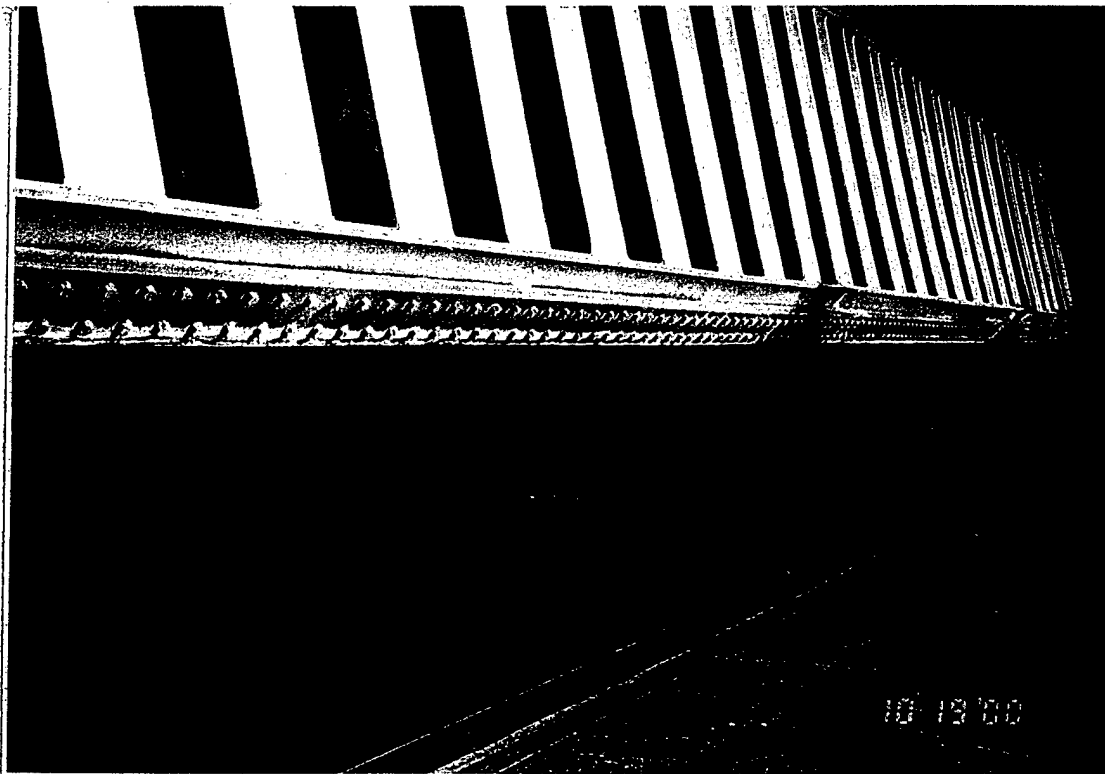
Bottom of left side of gate at 3' open.
Note: Heavy falling water due to stop log leakage precludes inspection of hoist connections.

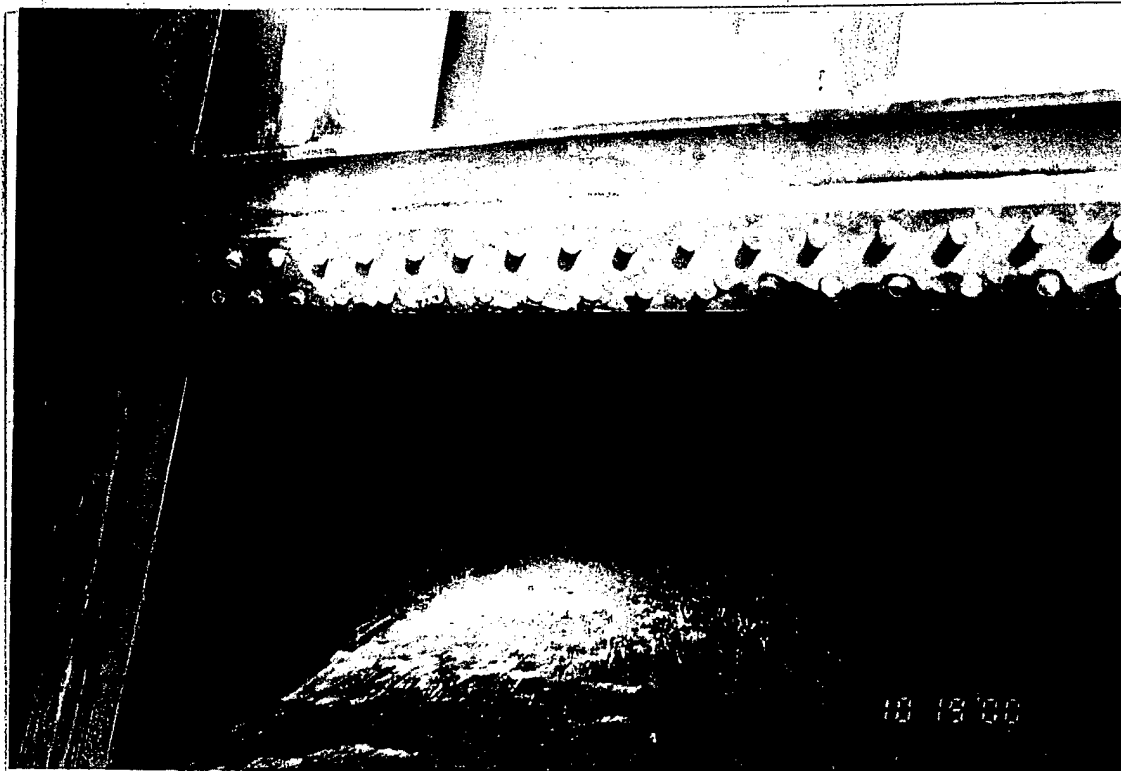
Bottom of right side of gate at 3' open. Note: Heavy falling water due to stop log leakage precludes inspection of hoist connections.

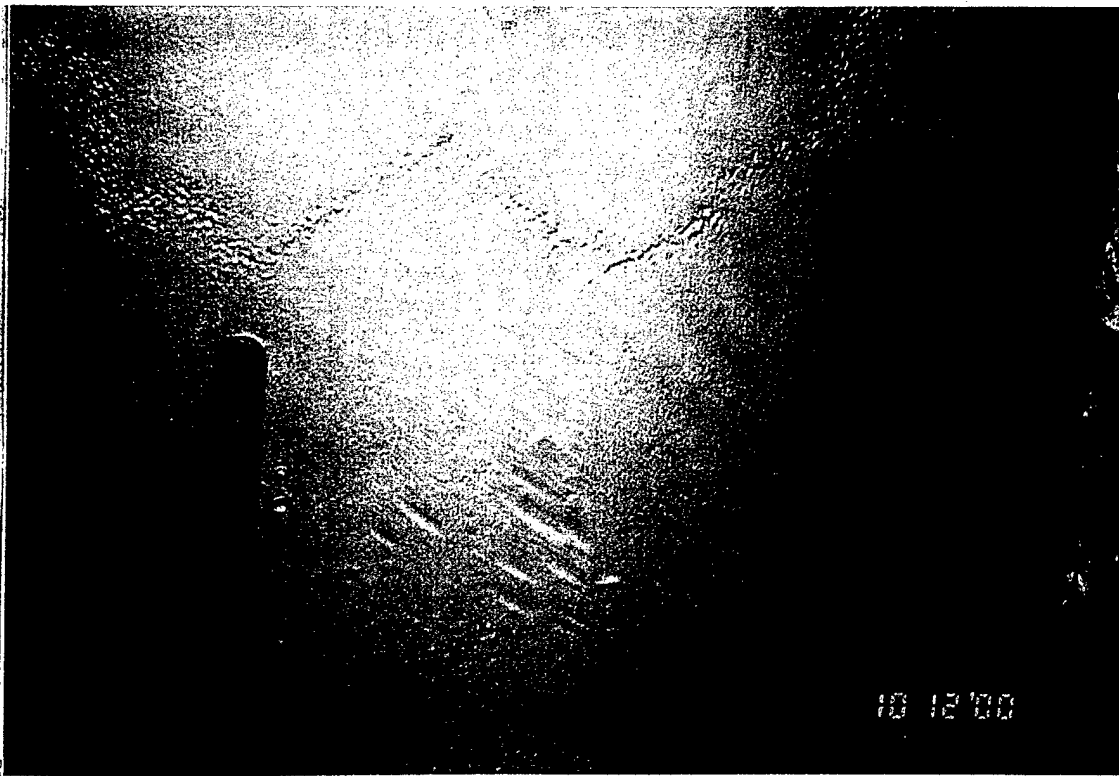
Downstream side of skin plate, right side of gate above top horizontal girder. Possible previous skin plate repair.

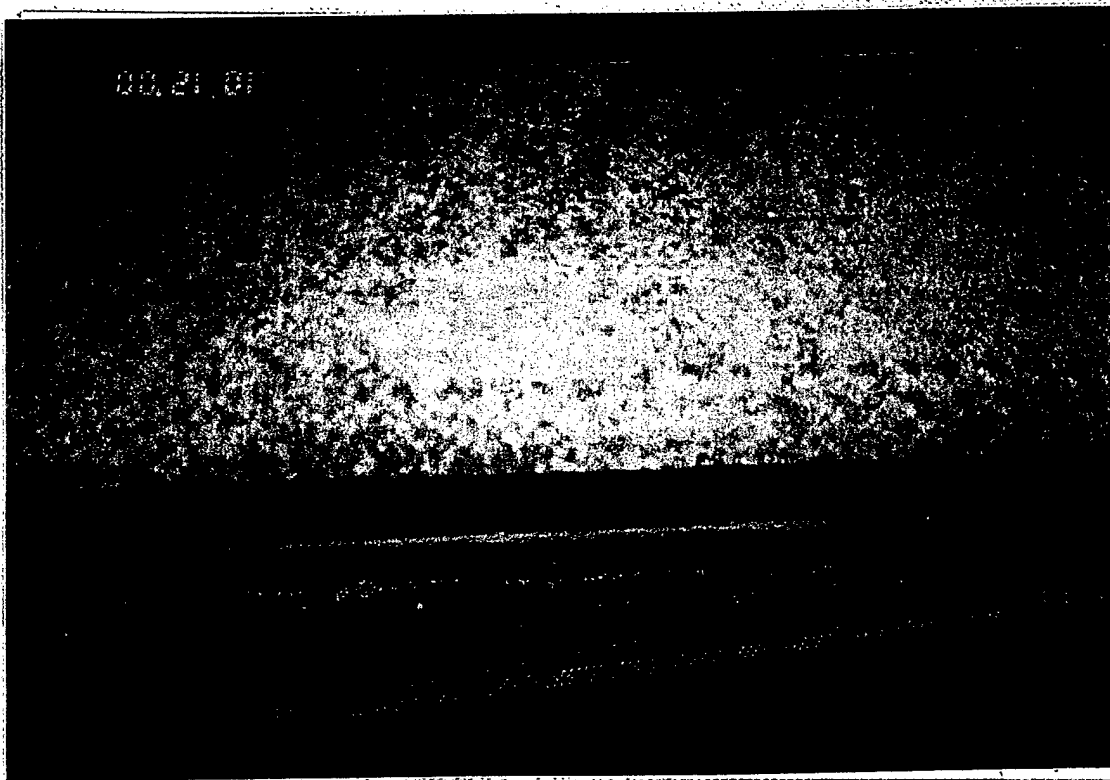
4-6

Gate 4
Downstream side of skin plate, above
middle horizontal girder, right side of
gate. Small circular protrusion in
vertical line on skin plate.

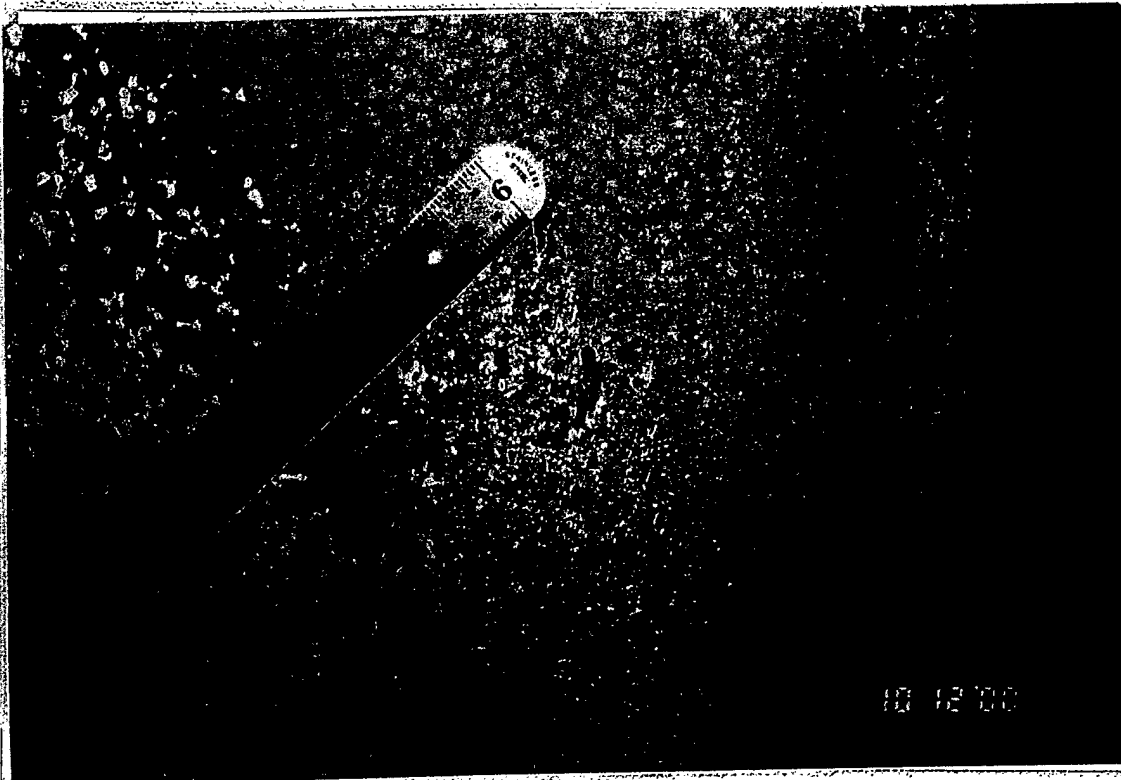
4-8

Gate 4
Brace J, left frame. Small scratches
on web.

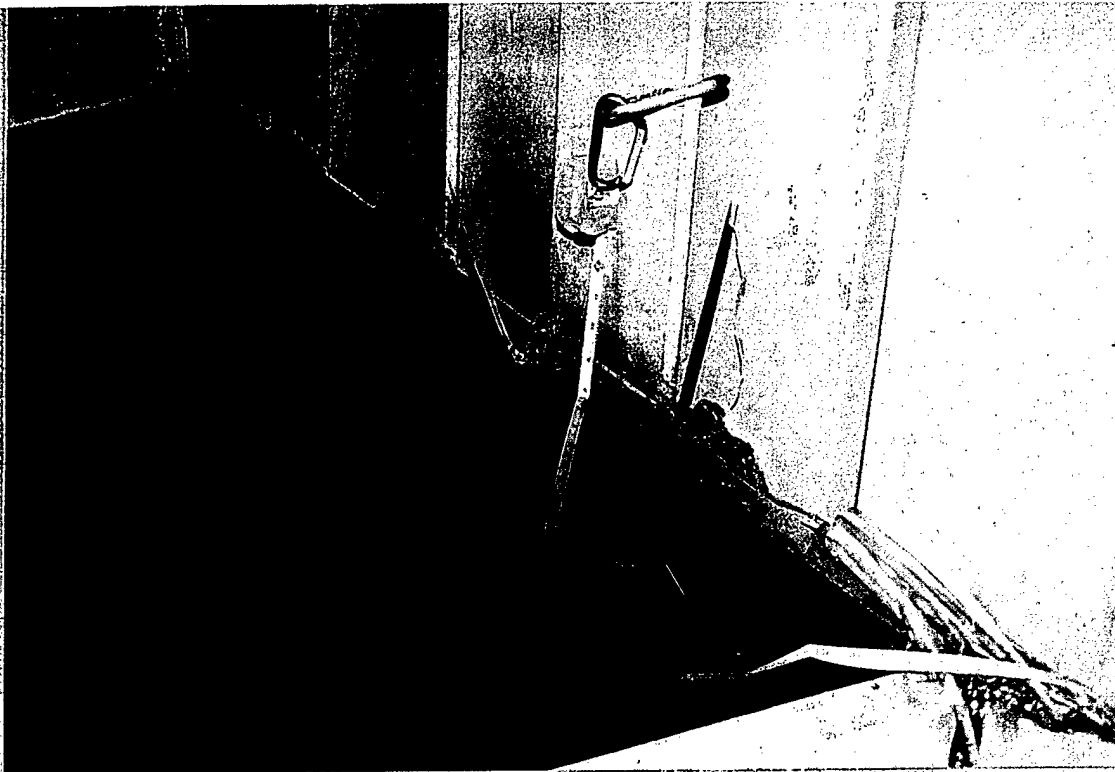
Bottom horizontal girder, right side.
Standing water, no drainage between
multiple stiffeners, typical. Side seal
leak.
