Little Goose Dam Radial Gate Inspection and Testing

US Army Corps of Engineers, Walla Walla District

13. ABSTRACT (Maximum 200 words) This report is an evaluation of the overall condition of the spillway tainter gates at Little Goose Lock and Dam, Snake River Washington.

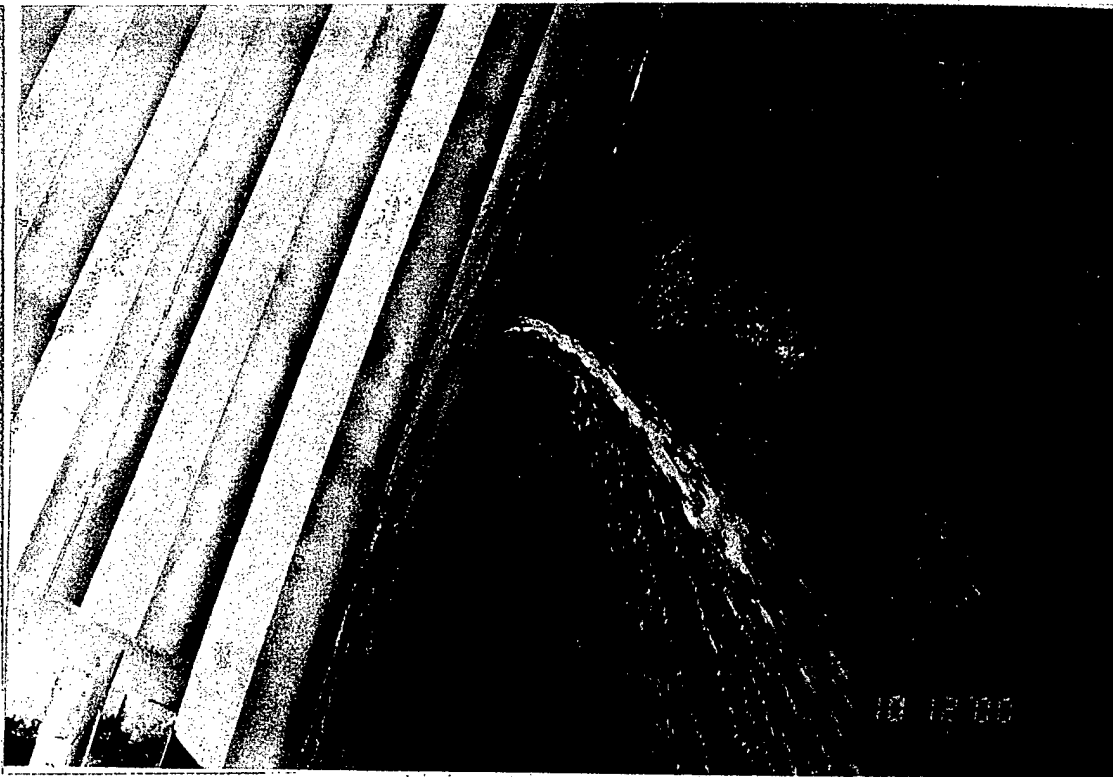
4-21

Gate 4
Side seal leak, left side of gate.

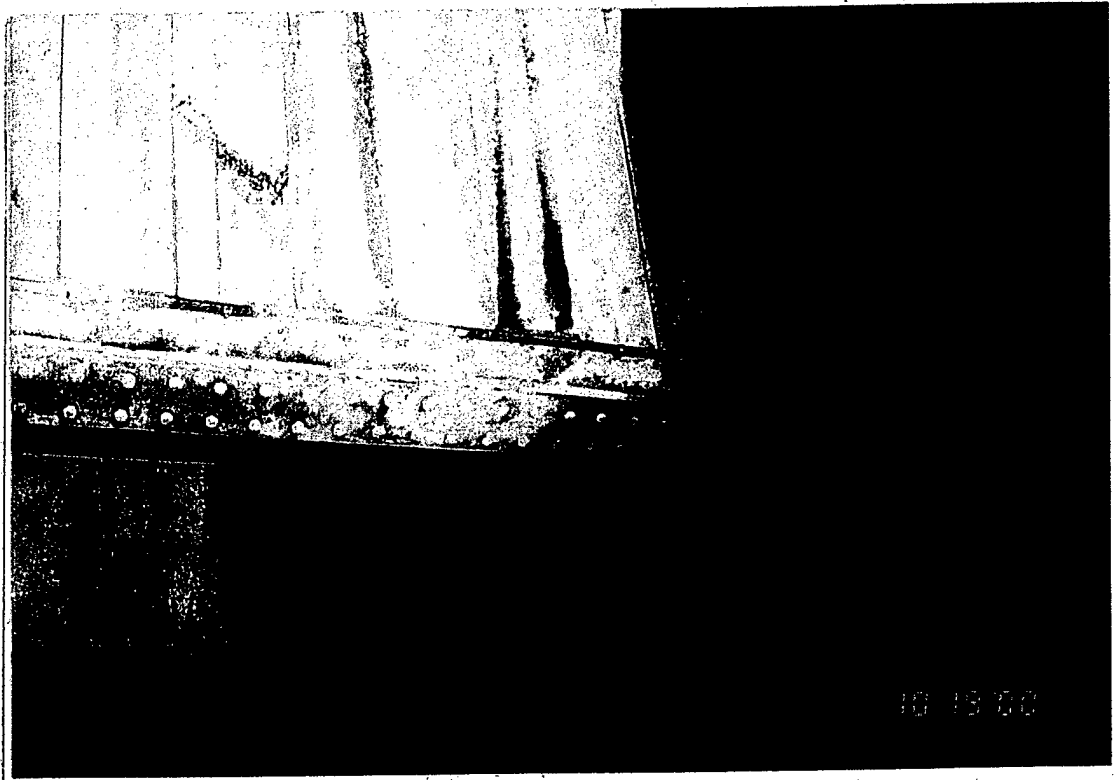
4-26

Gate 4
Bottom left corner of gate, typical.

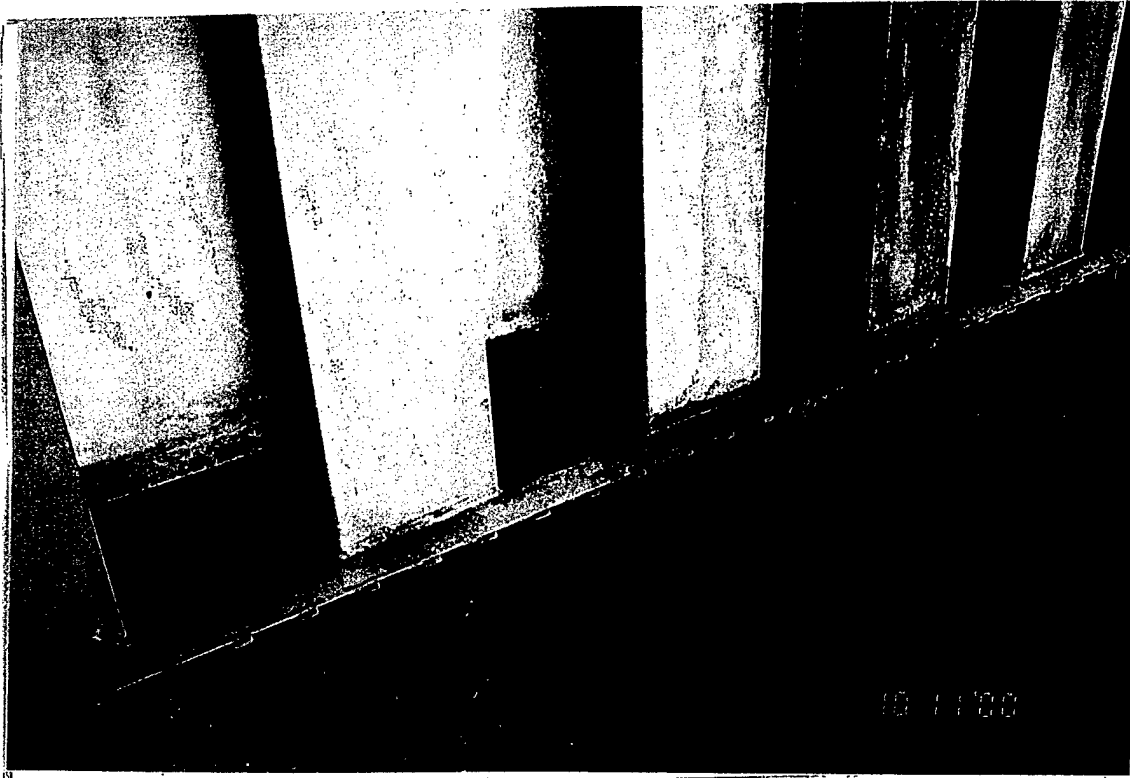
Gate 5
Bottom seal closure plate. Standing
water between closure plate, purlin
webs and skinplate, typical.

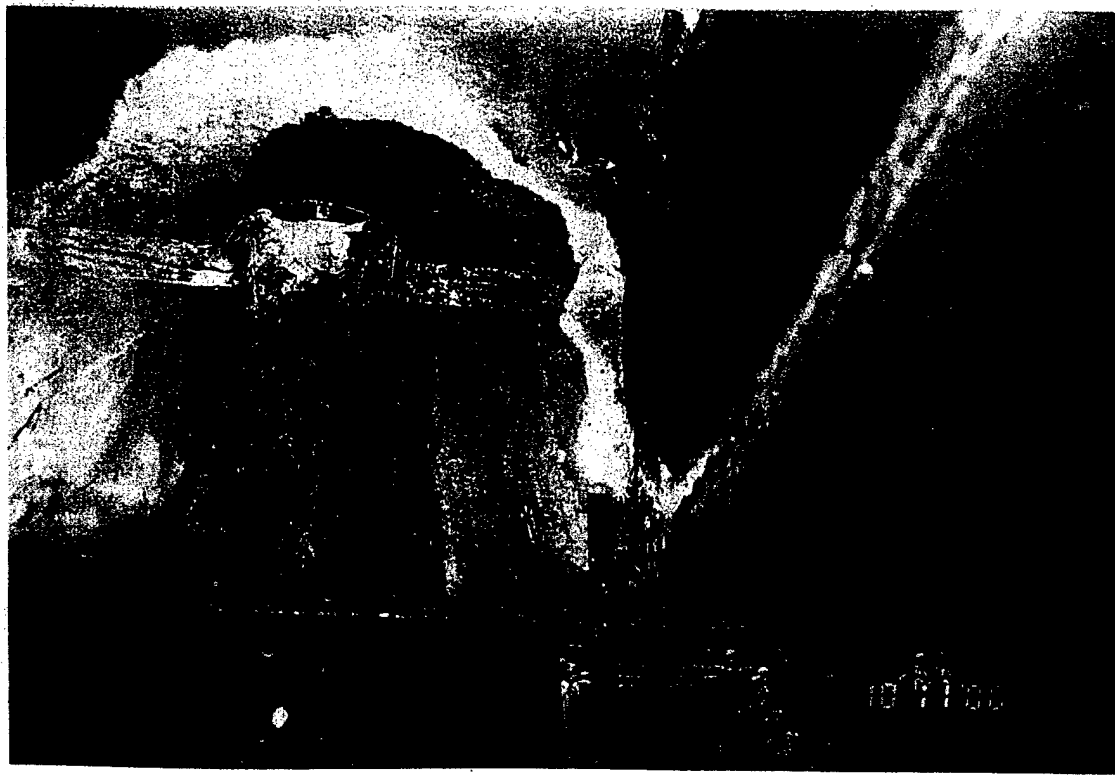
Bottom of bottom horizontal girder
at radial strut connection and girder
drain hole. Light corrosion on girder
web and stiffeners.

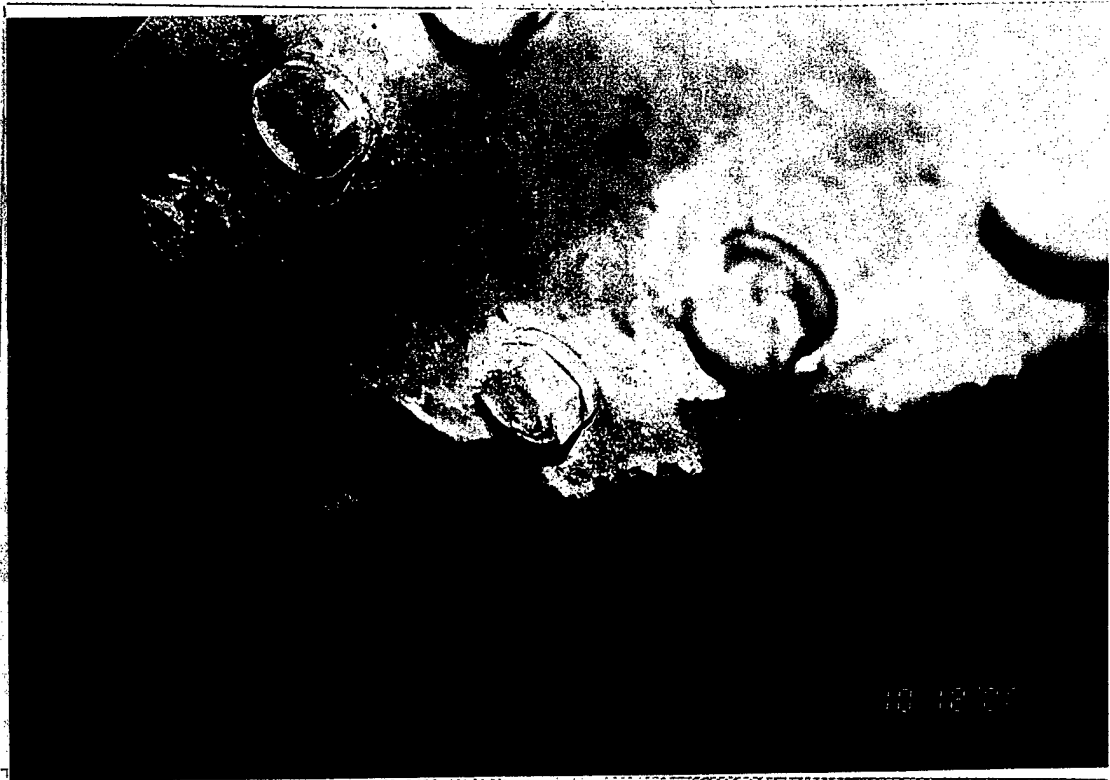
Gate 6
Bottom seal keeper plate, typical.

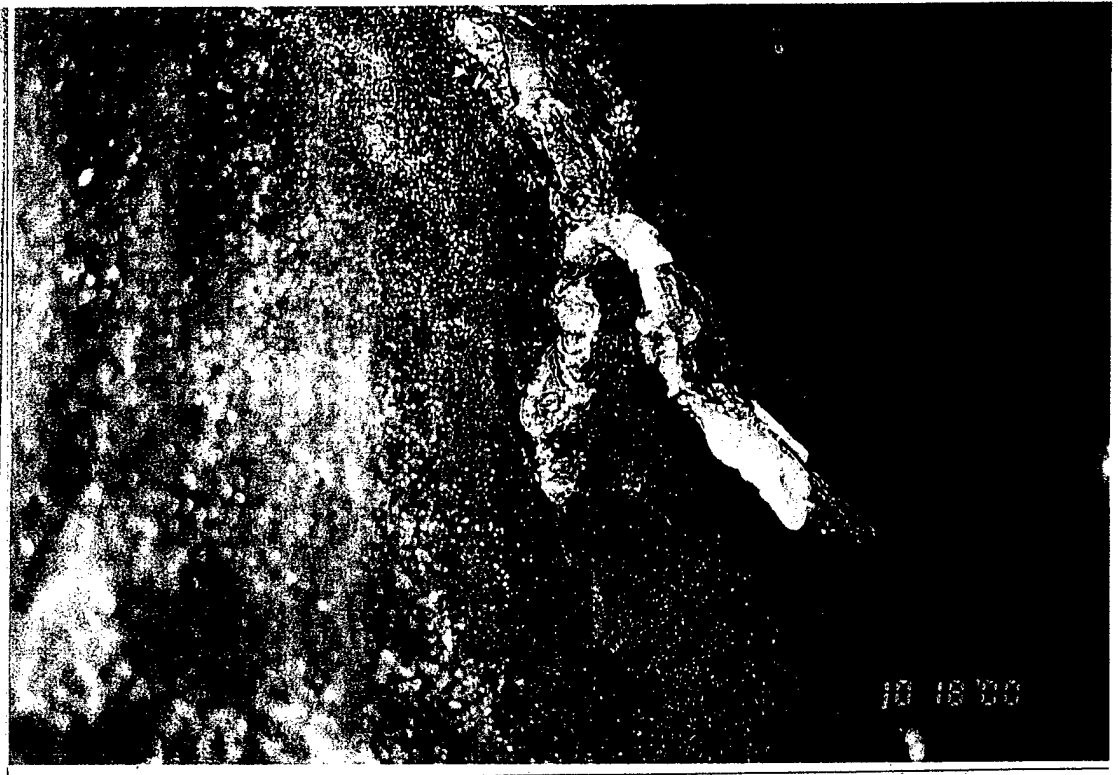
6-33

Gate 6
Apparent previous anode bracket.

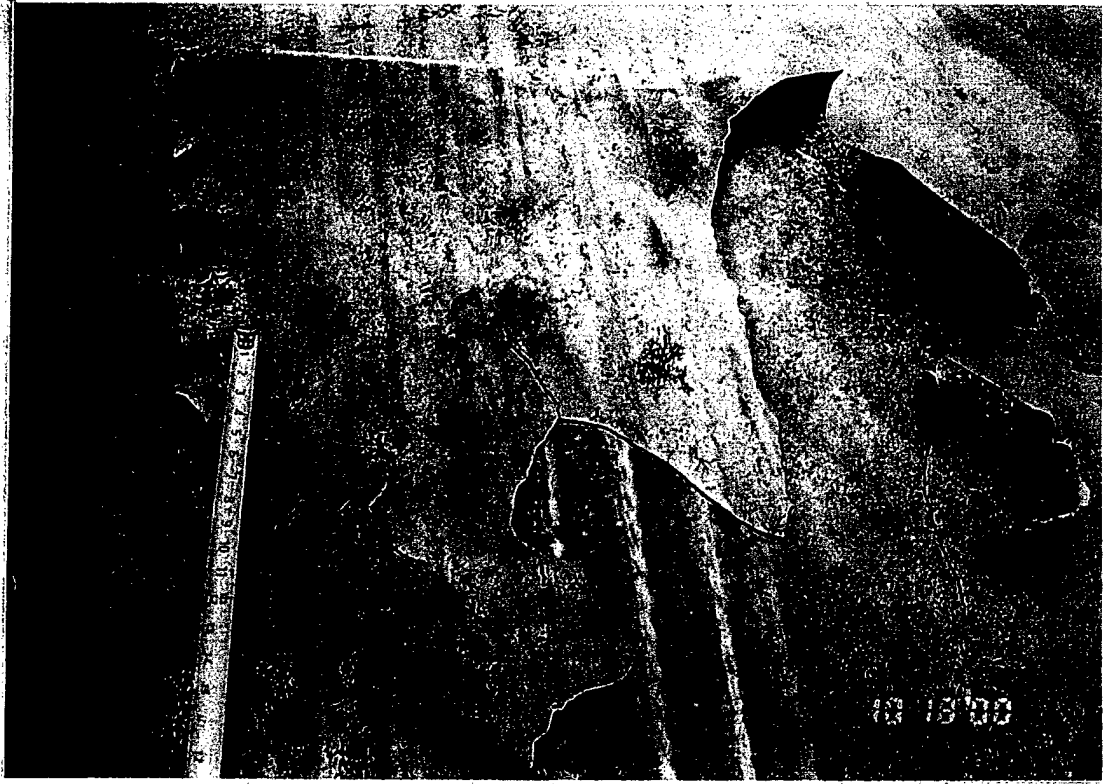
6-37

Gate 6
Left wear plate. Delaminated vinyl
coating.

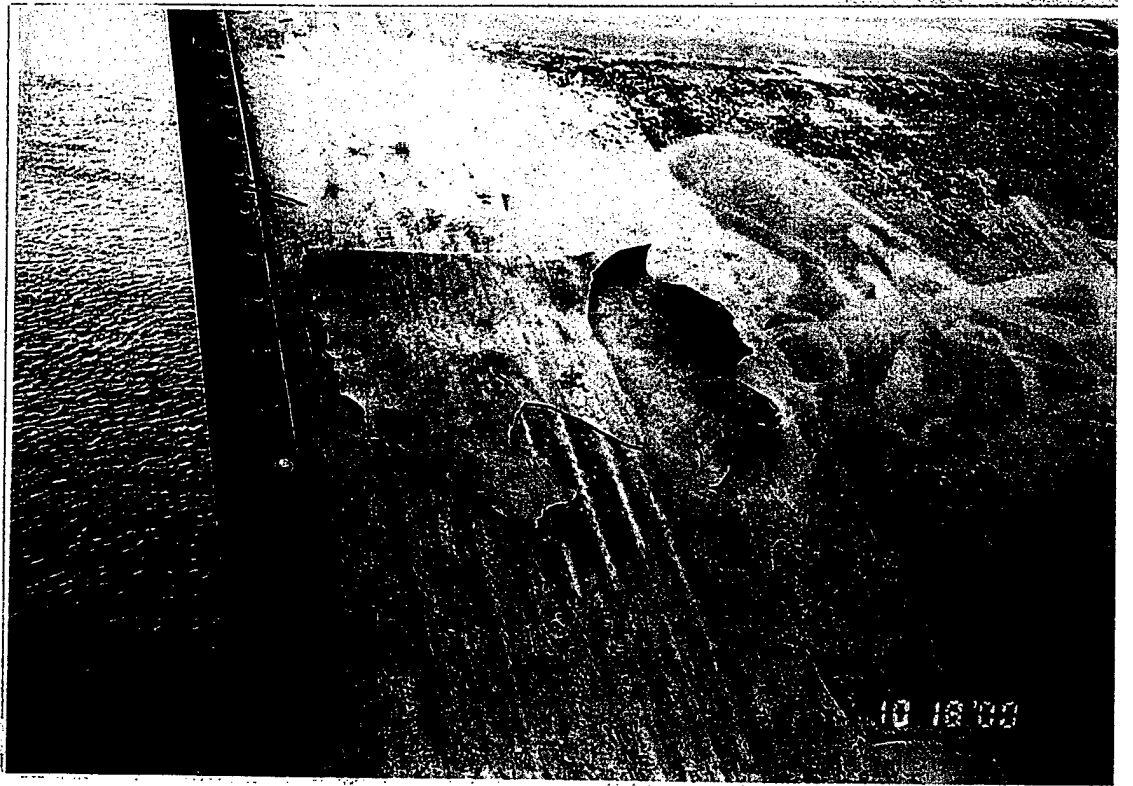
6-38

Gate 6
Left wear plate. Delaminated vinyl
coating.

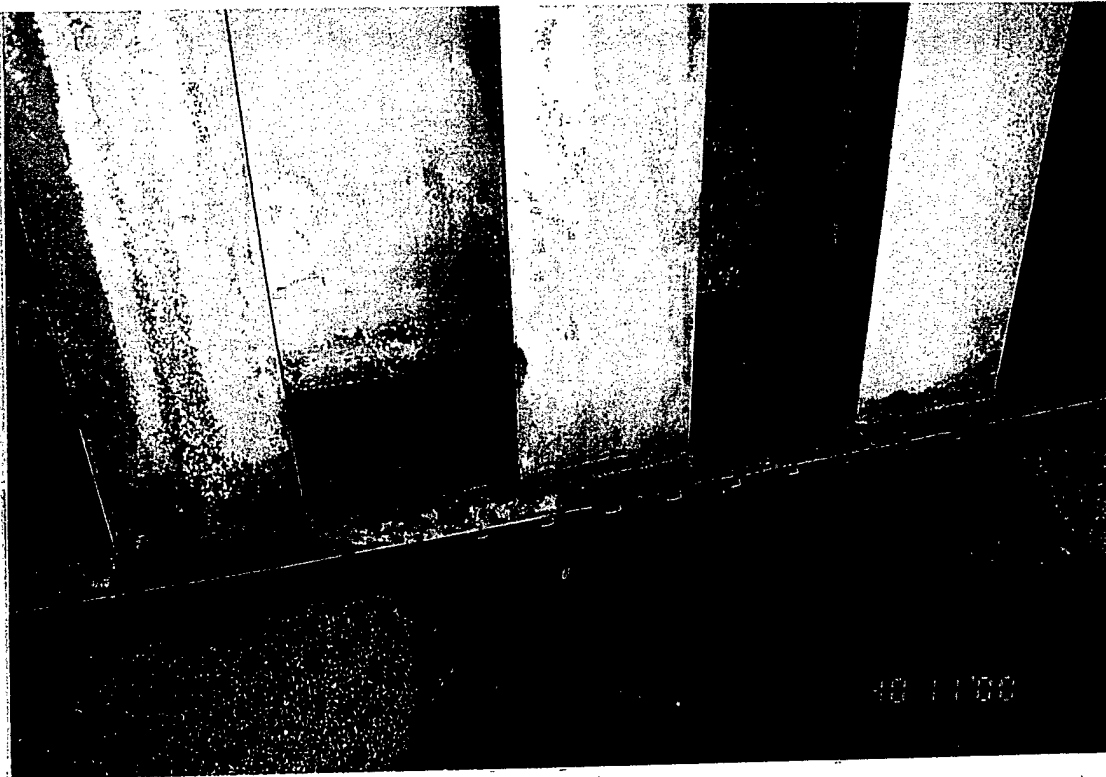
Gate 7
Bottom seal closure plate looking
upstream. Standing water between
closure plate, purlin webs and
skinplate. Typical.

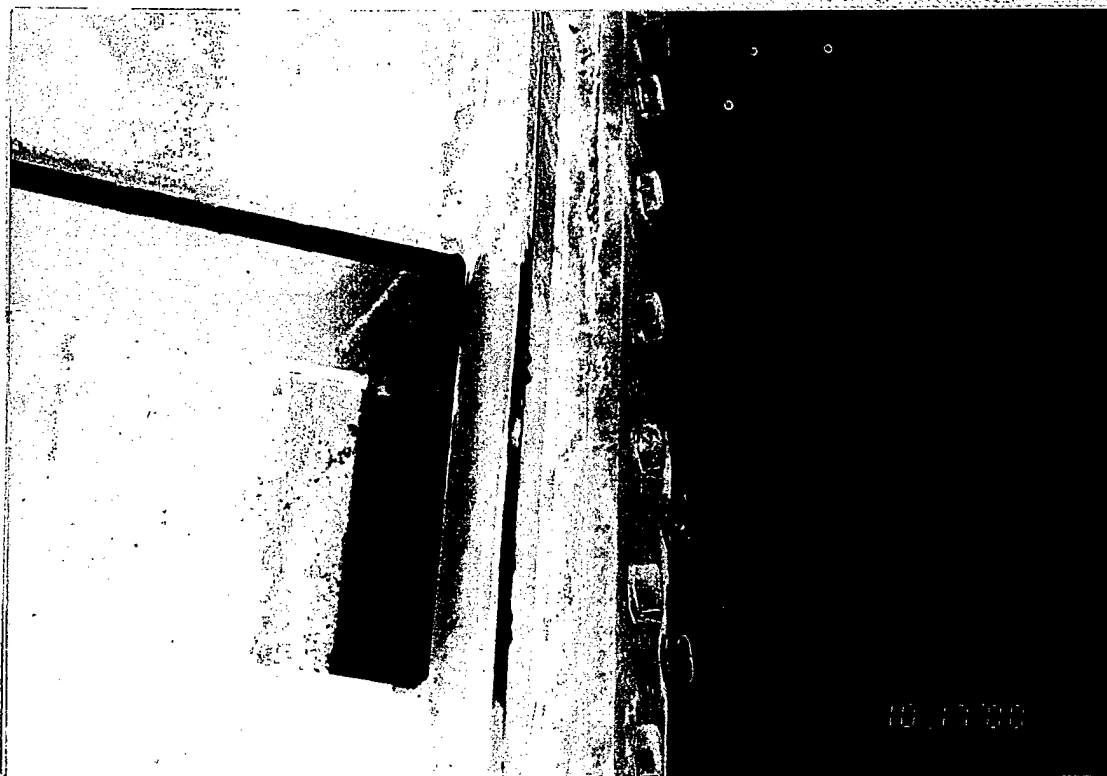
7-14

Gate 7
Bottom seal closure plate. Standing
water between closure plate, purlin
webs and skinplate, typical.

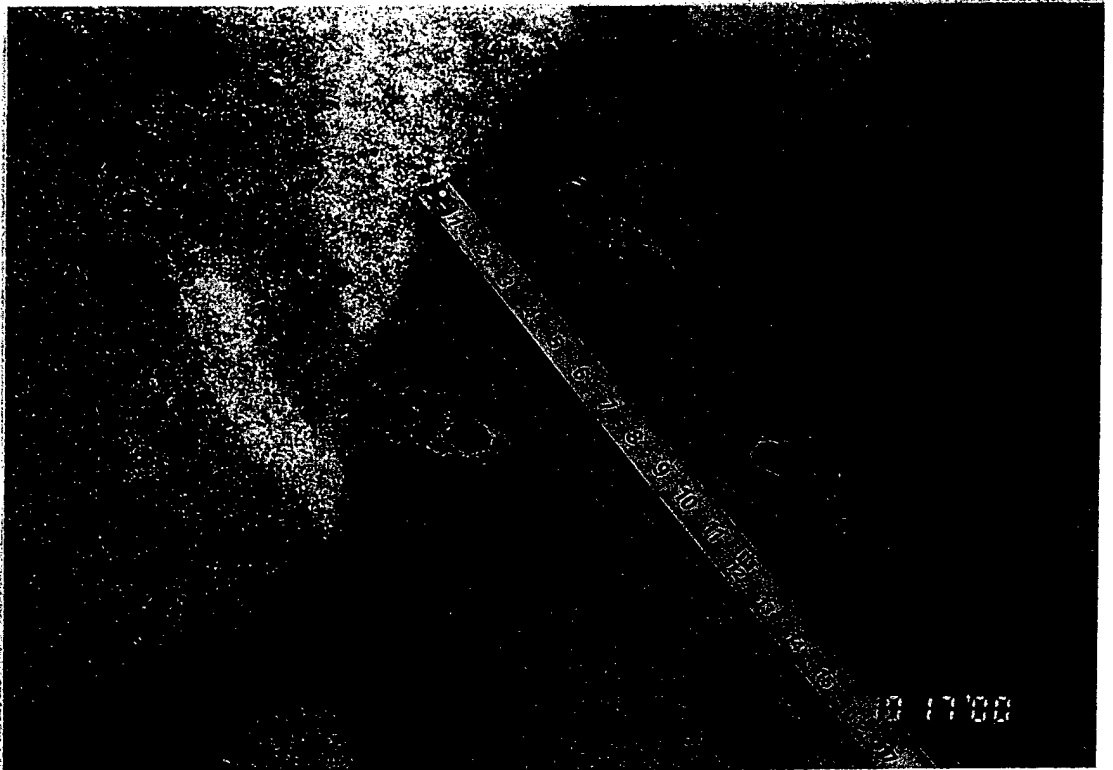
7-22

Gate 7
Skin plate pitting, typical.

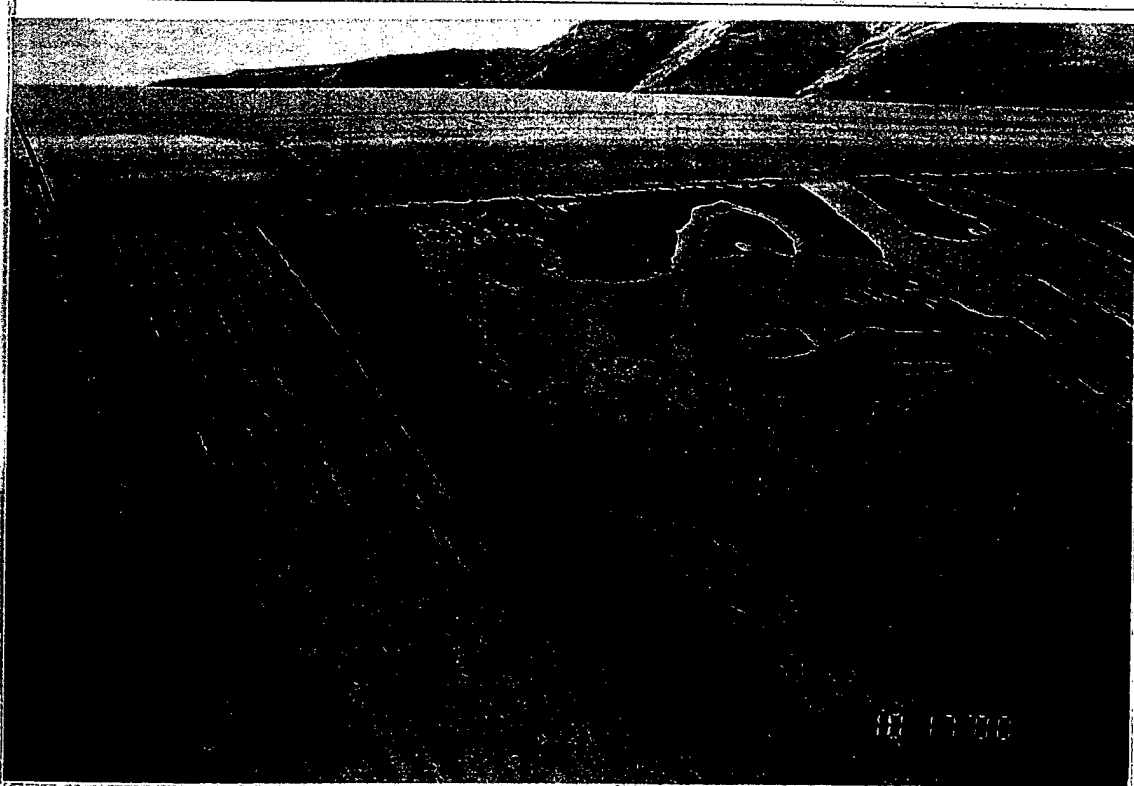
7-24

Gate 7
Wear plate condition, typical.

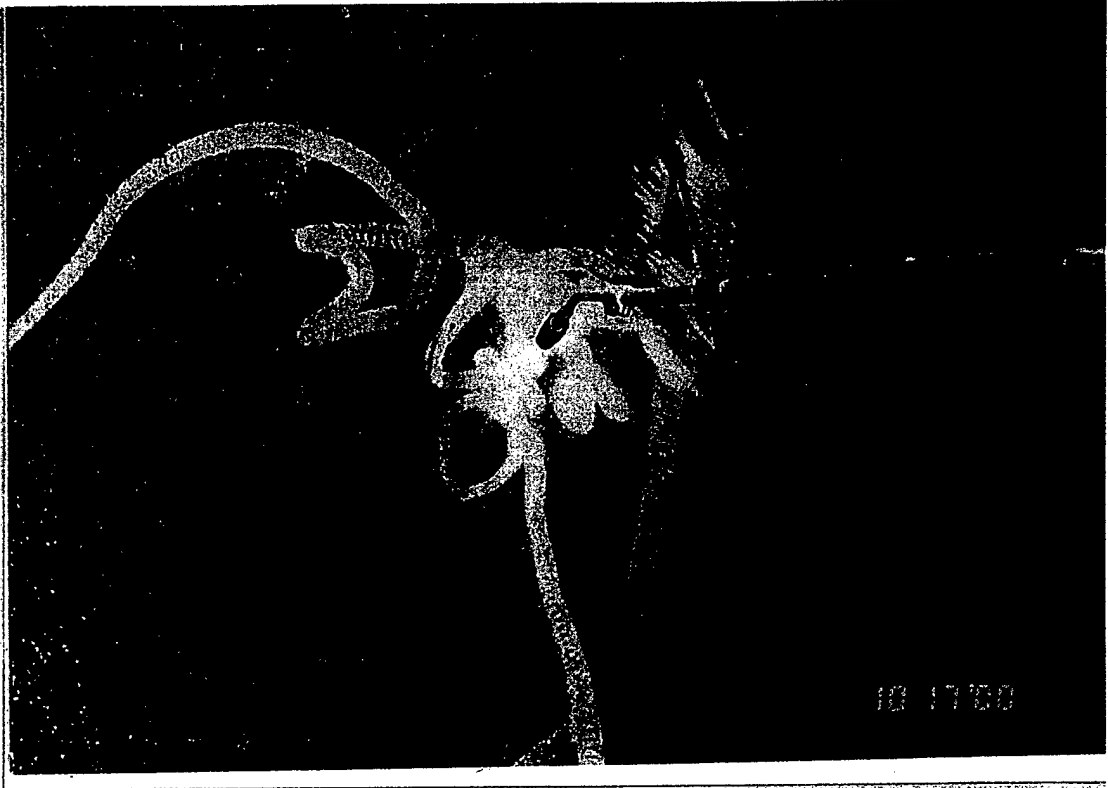
7-25

Gate 7
Waterblasting skin plate.

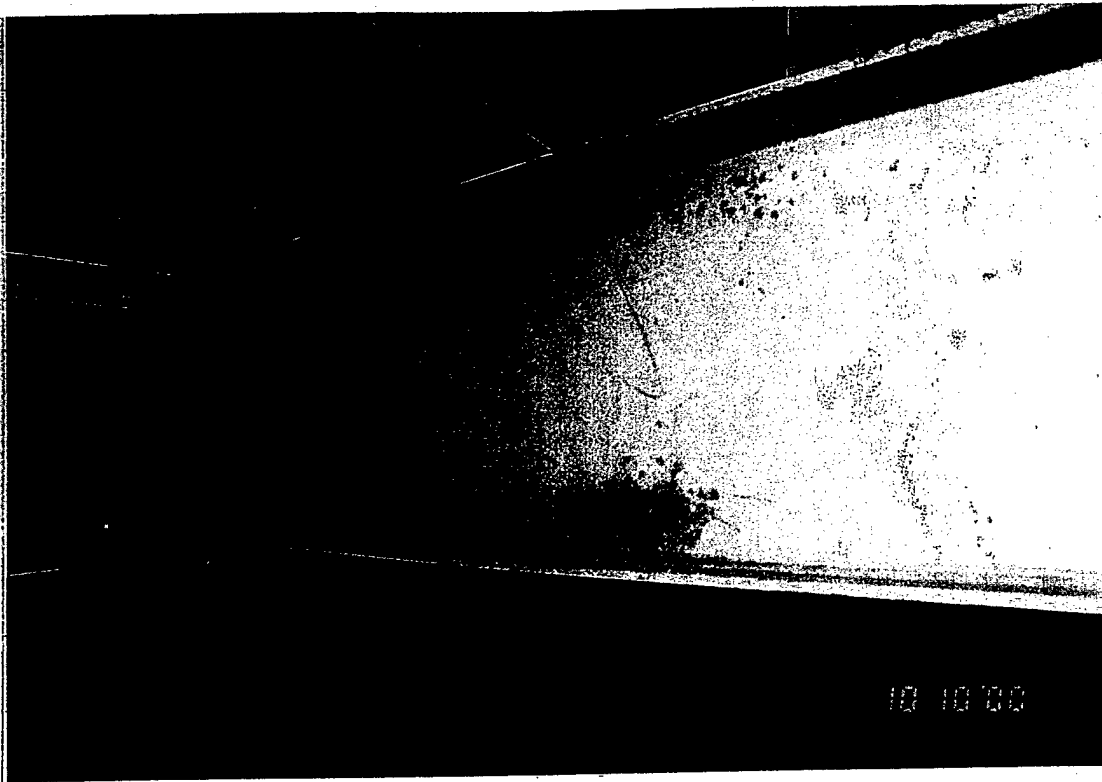
8-1

Gate 8
Left frame Brace C. Light corrosion
on brace, typical.

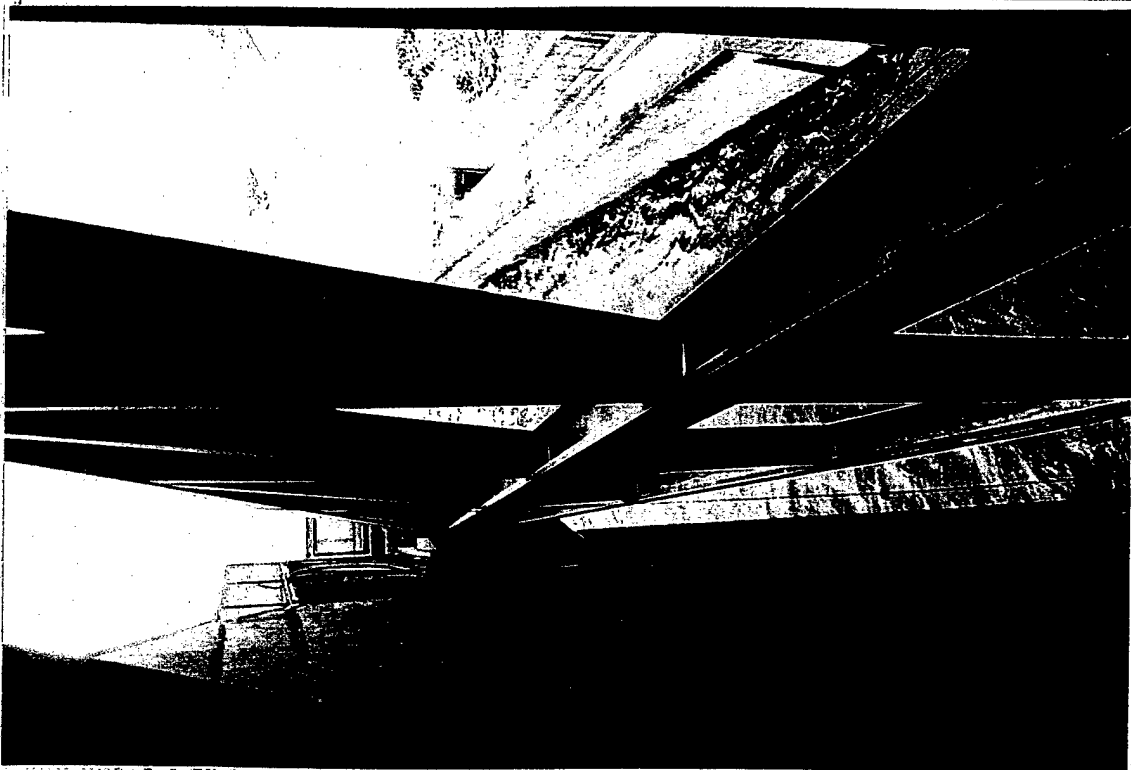
8-4

Gate 8
Outside of left frame, typical.
