<b>13. ABSTRACT (Maximum 200 words)</b> This report is an evaluation of the overall condition of the spillway tainter gates at Lower Granite Lock and Dam, Snake River Washington.				
<b>14. SUBJECT TERMS</b> Spillway tainter gates inspection testing			<b>15. NUMBER OF PAGES</b> 250	
			<b>16. PRICE CODE</b>	
<b>17. SECURITY CLASSIFICATION OF REPORT</b> Unclassified	<b>18. SECURITY CLASSIFICATION OF THIS PAGE</b> Unclassified	<b>19. SECURITY CLASSIFICATION OF ABSTRACT</b> Unclassified	<b>20. LIMITATION OF ABSTRACT</b> UL

February 2001

# Lower Granite Dam Radial Gate Inspection and Testing

US Army Corps of Engineers, Walla Walla District

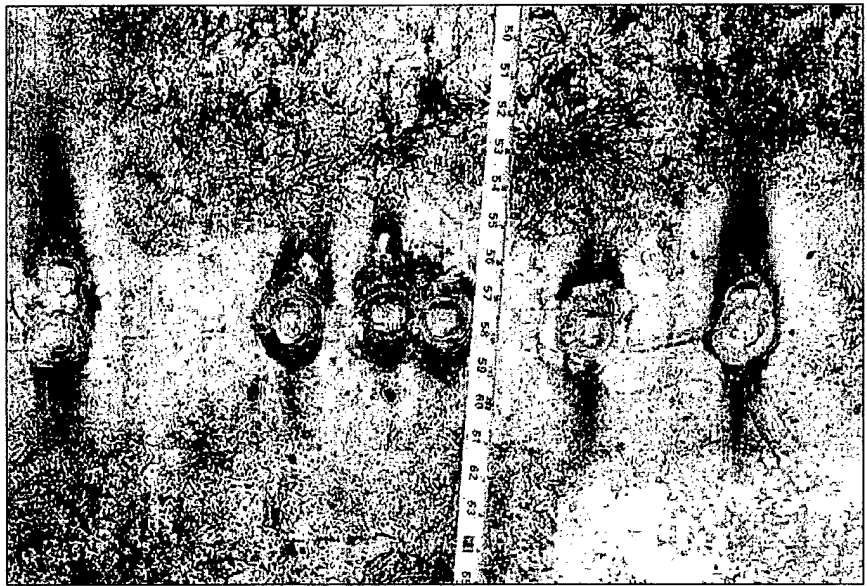
*Photo. 6: Pitting, typical.*

- Repair pitting on skin plate and repaint (or recoat) upstream surface of gate face.
- Install sacrificial anodes on upstream side of gate. Based on the condition of the skin plate at Little Goose Dam (which has sacrificial anodes) sacrificial anodes will significantly reduce the amount and severity of pitting of the skin plate. A corrosion expert should be consulted to determine the number and location of anodes required.

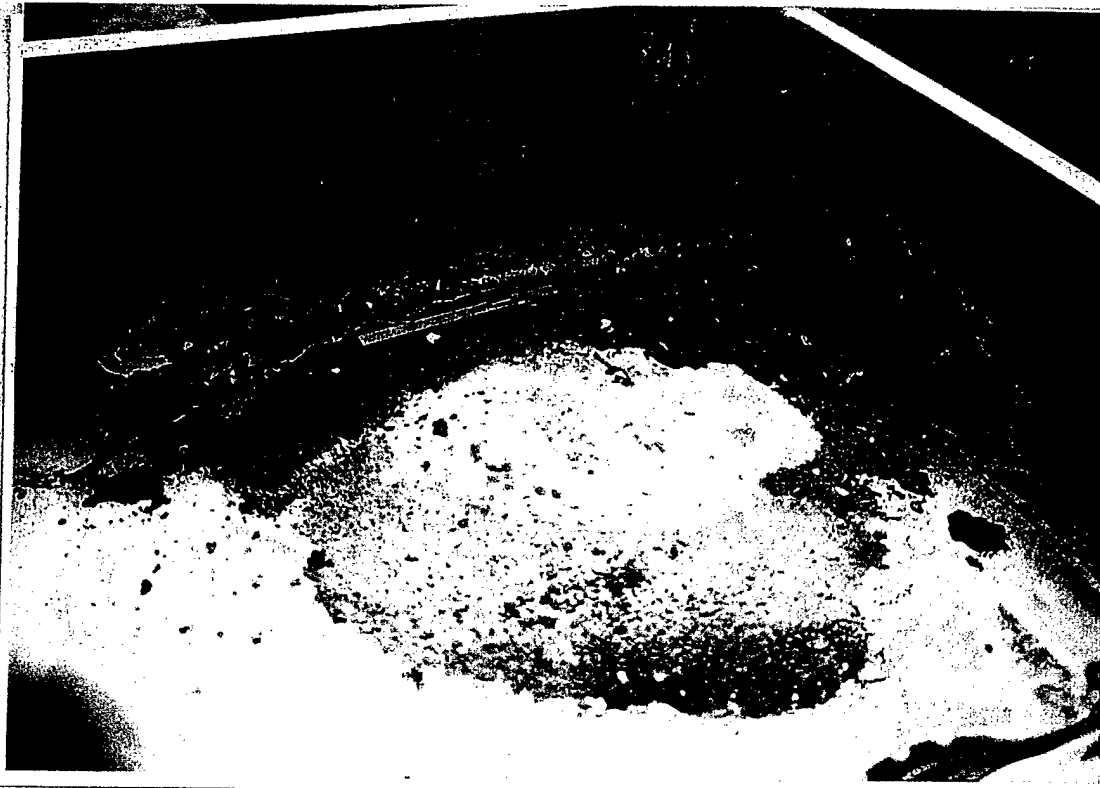
**Gate 1**

Top horizontal girder, right side,  
between stiffeners at radial strut  
connection. Delaminated paint and  
light corrosion due to poor drainage.

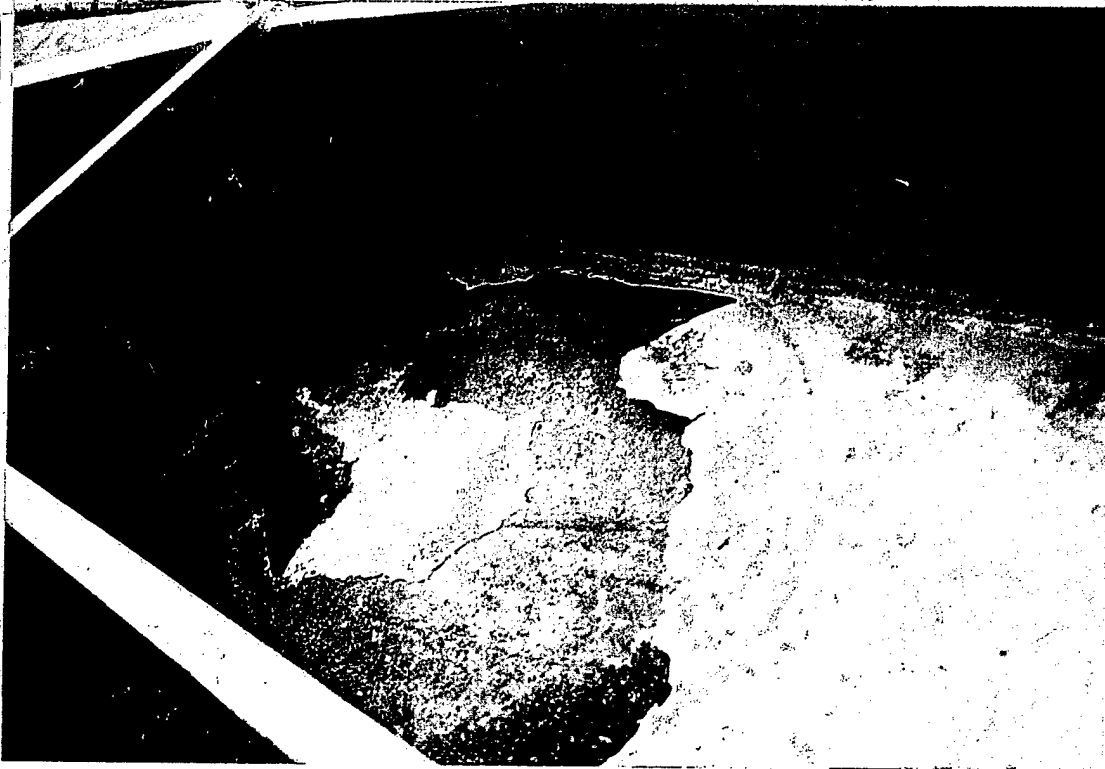
**Gate 1**

Top horizontal girder, right side,  
between stiffeners at radial strut  
connection. Delaminated paint and  
light corrosion due to poor drainage.

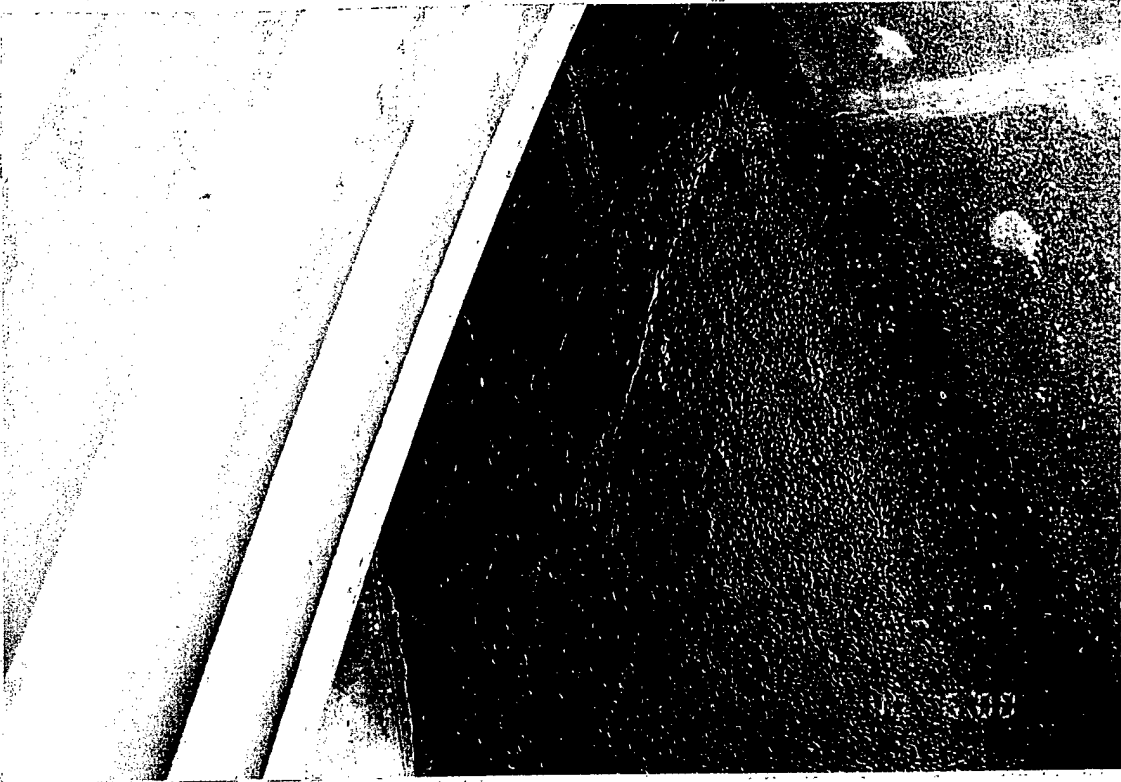
Gate 1  
Side seal leak, left side.

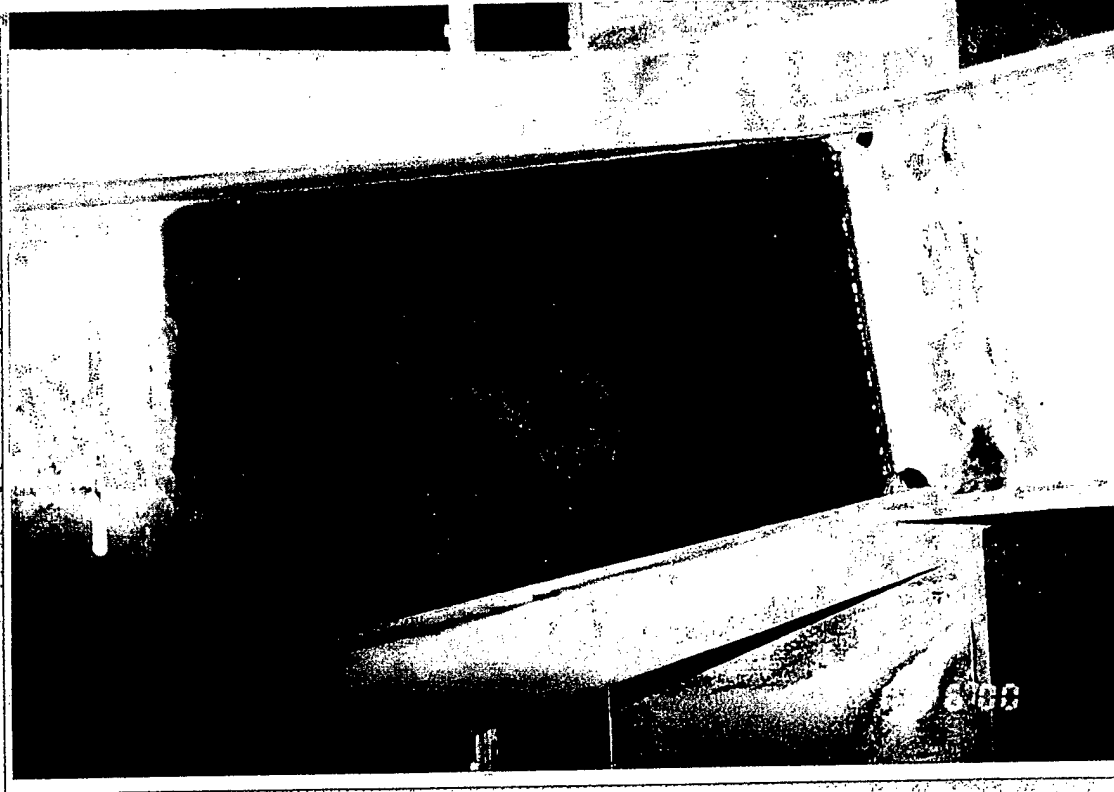
Gate 1  
Upstream end, bottom radial strut.  
Ponding water between strut flanges  
and horizontal girder flange due to  
poor drainage.

- Enlarge the drain holes at upstream end of lower radial struts. The recommended size for these drain holes is 1 1/2 - inch in diameter.
- For all new and enlarged drain holes, the holes should be drilled, not flame cut, to reduce jagged edges which snag debris. If drilling holes is not feasible, then the edges of the flame cut holes should be reamed smooth.

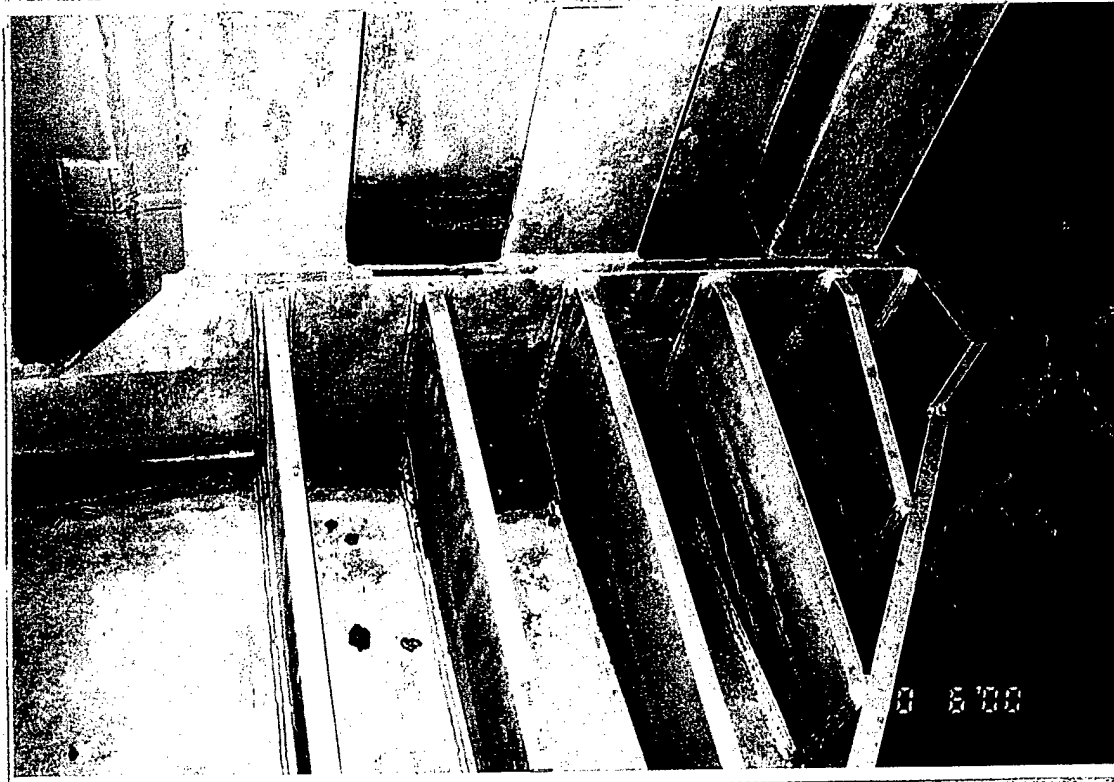
Gate 1  
Left end of bottom horizontal girder.  
Standing water, no drainage between  
multiple stiffeners. Horizontal girder  
to skin plate stiffeners, standing  
water, debris and no drainage

- Install drain hole between the multiple stiffeners at ends of the bottom horizontal girders. The recommended size for these drain holes is 1-inch in diameter.

- Install drain holes in the purlin stiffeners near the ends of the bottom horizontal girders (Plate perpendicular to skin plate, above multiple stiffeners on bottom horizontal girder). The recommended size for these drain holes is 1-inch in diameter.

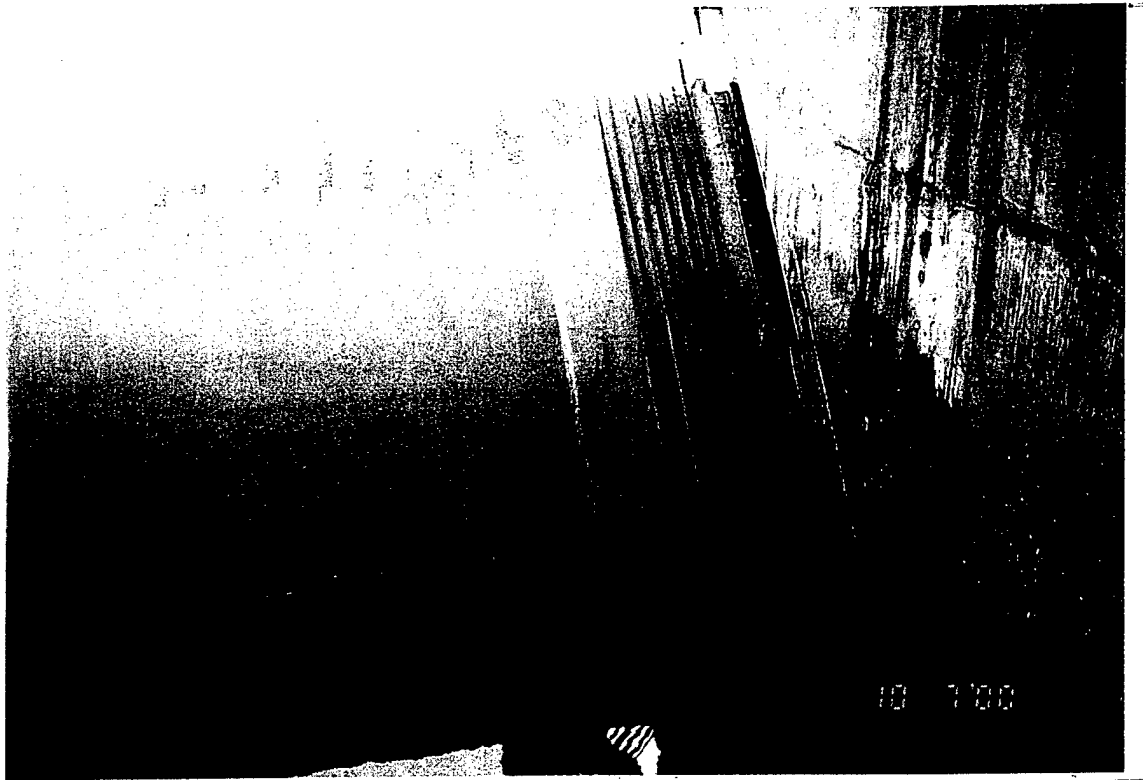
**Gate 1**  
Exposed portion of upstream gate  
face. Note: Surface collector  
installed at this time.

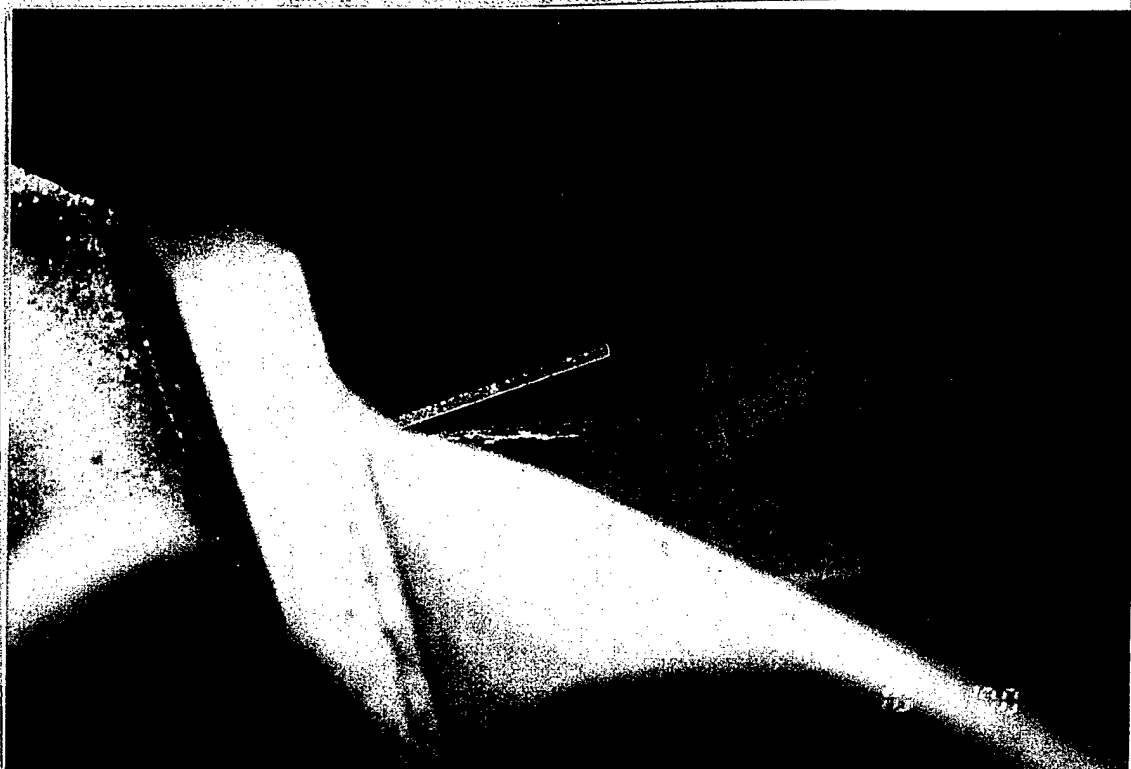
**Gate 2**  
Left frame, vertical Brace A and K at  
middle horizontal girder.  
Misalignment in vertical braces due to  
1" deformation in Brace A.

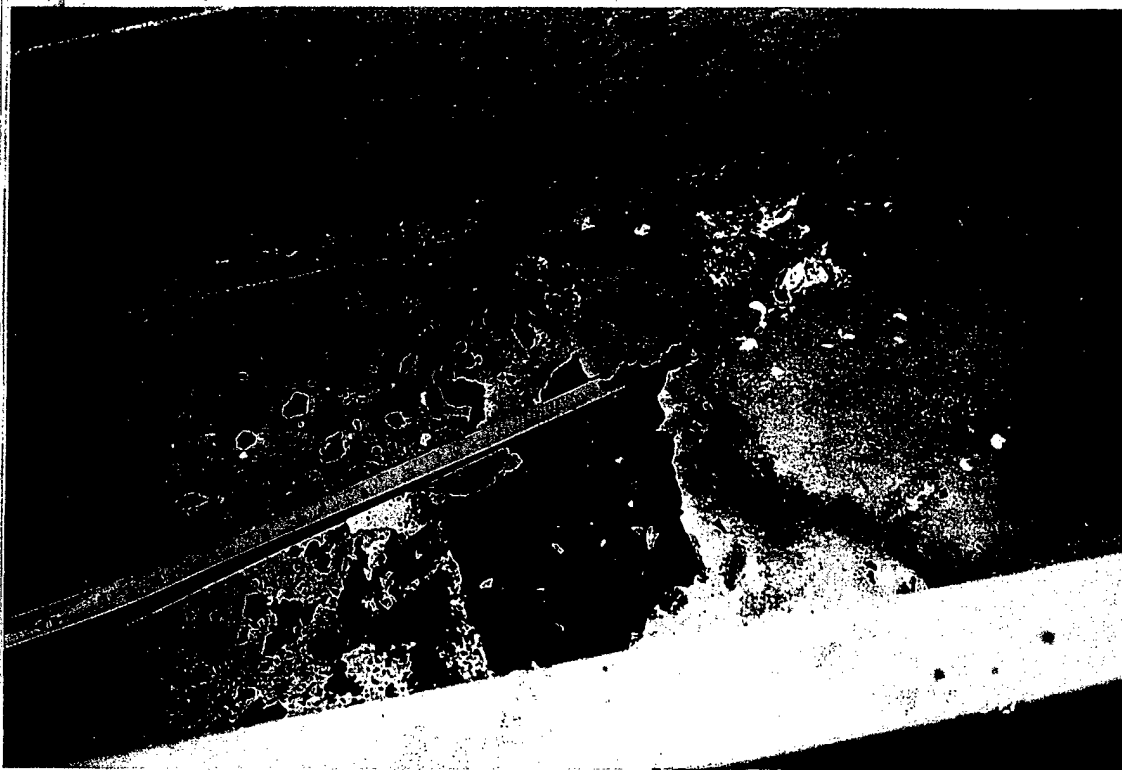
2-7

**Gate 2**  
Leak at center construction joint in  
spillway monolith.

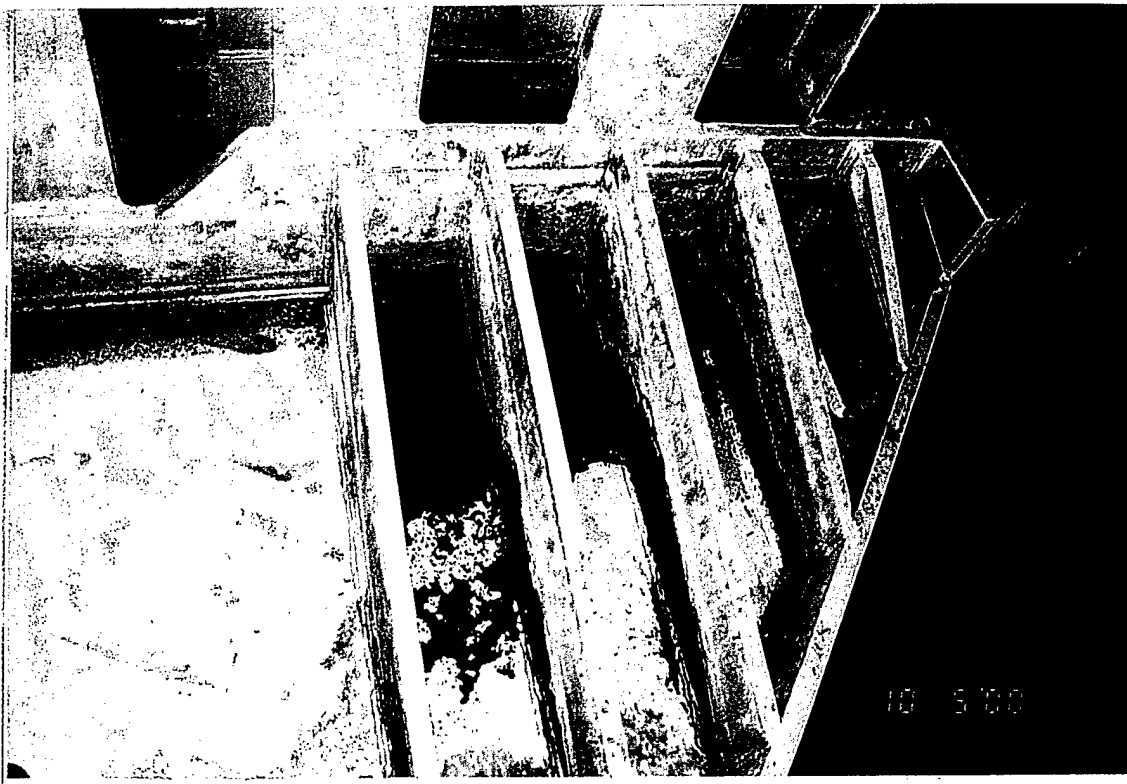
2-8

**Gate 2**  
Left end of bottom horizontal girder.  
Standing water, no drainage between  
multiple stiffeners.

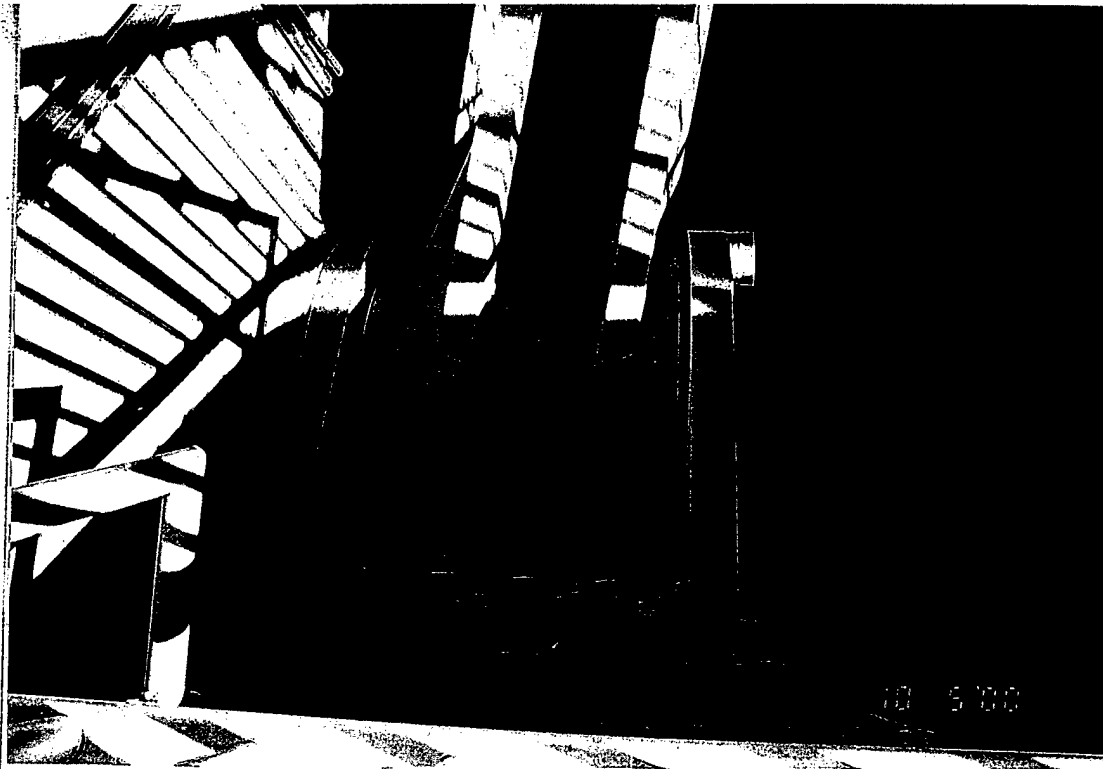
2-16

**Gate 2**  
Top of right trunnion, typical.

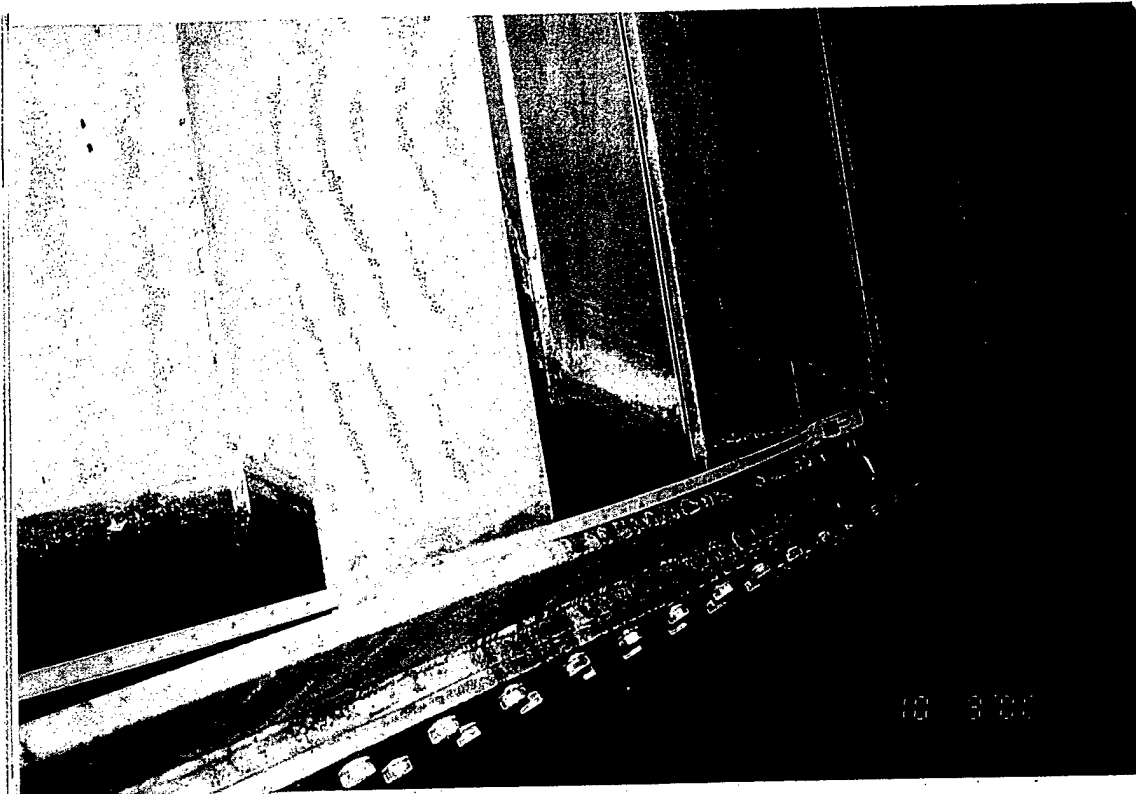
2-18

**Gate 2**

Bottom seal closure plate looking upstream. Standing water between closure plate, purlin webs and skinplate. Typical.

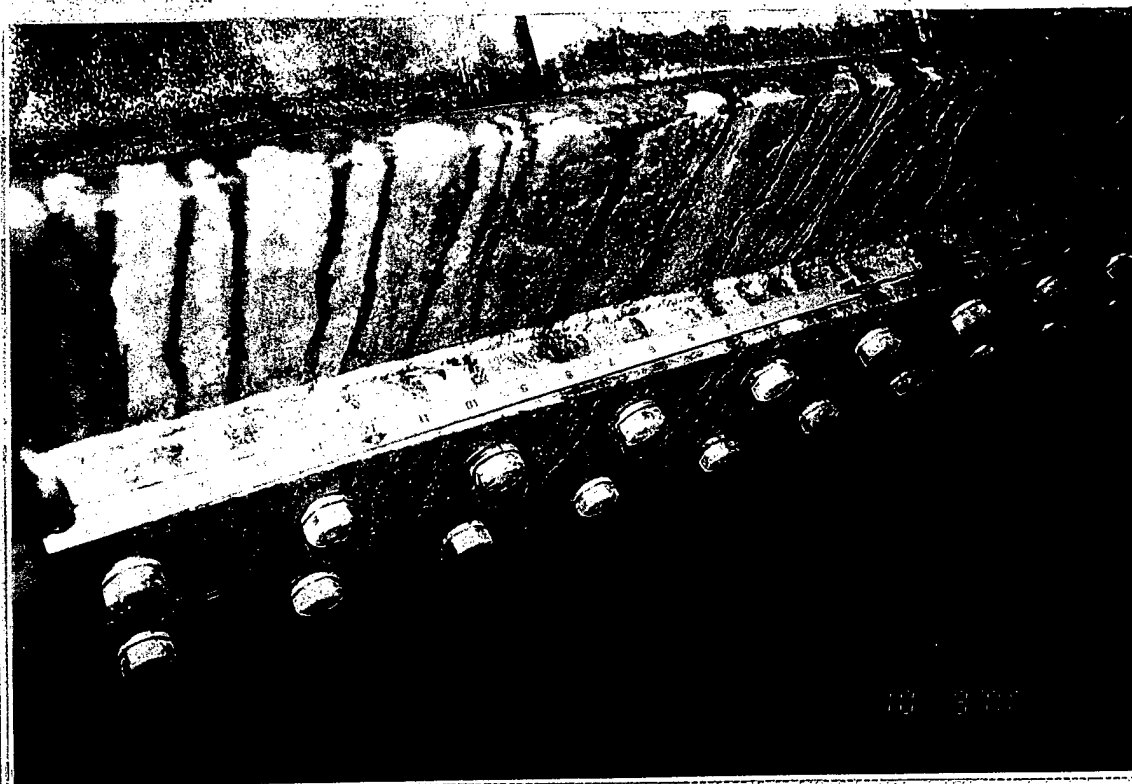
**Gate 2**

Bottom seal closure plate looking upstream. Standing water between closure plate, purlin webs and skinplate. Typical.

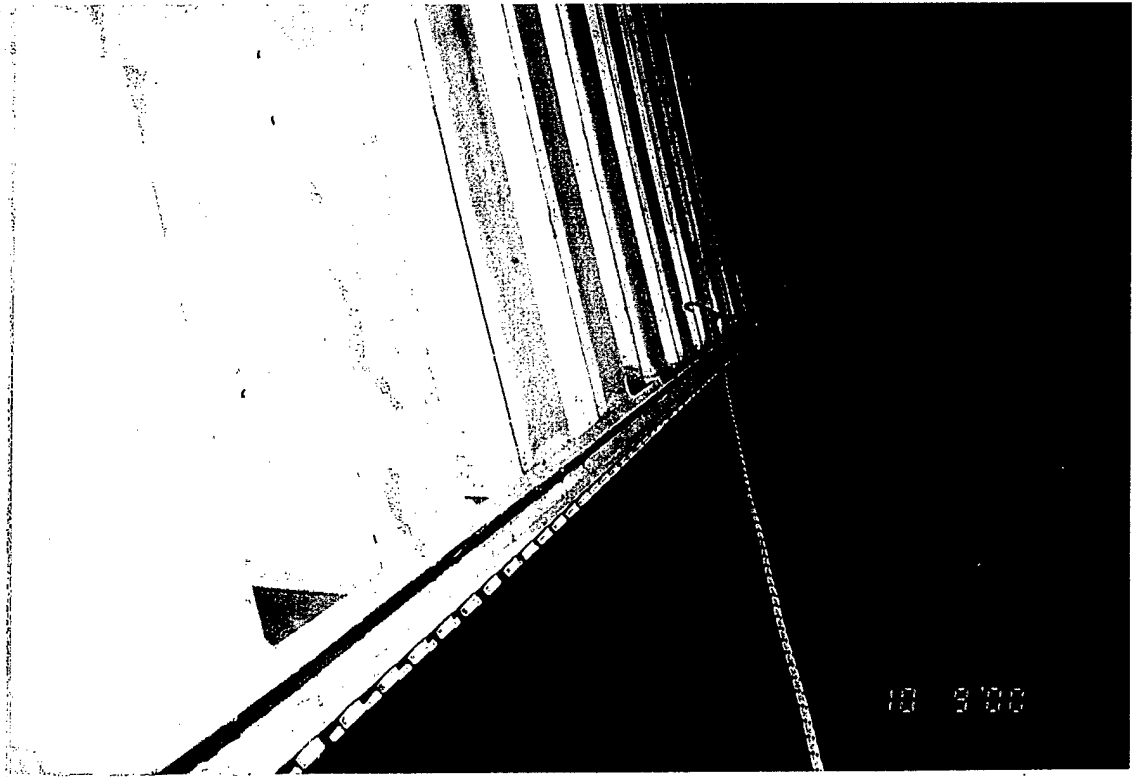
2-28

**Gate 2**  
Downstream side of bottom seal,  
typical.

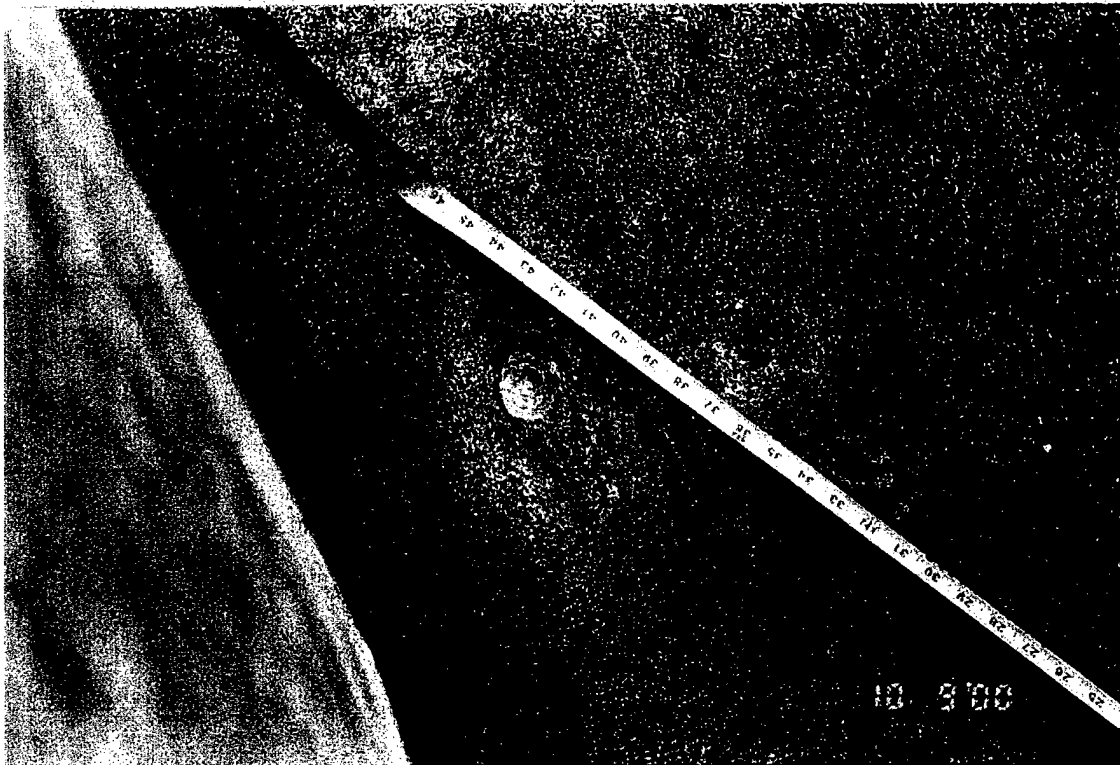
2-31

Gate 2  
Typical pitting.

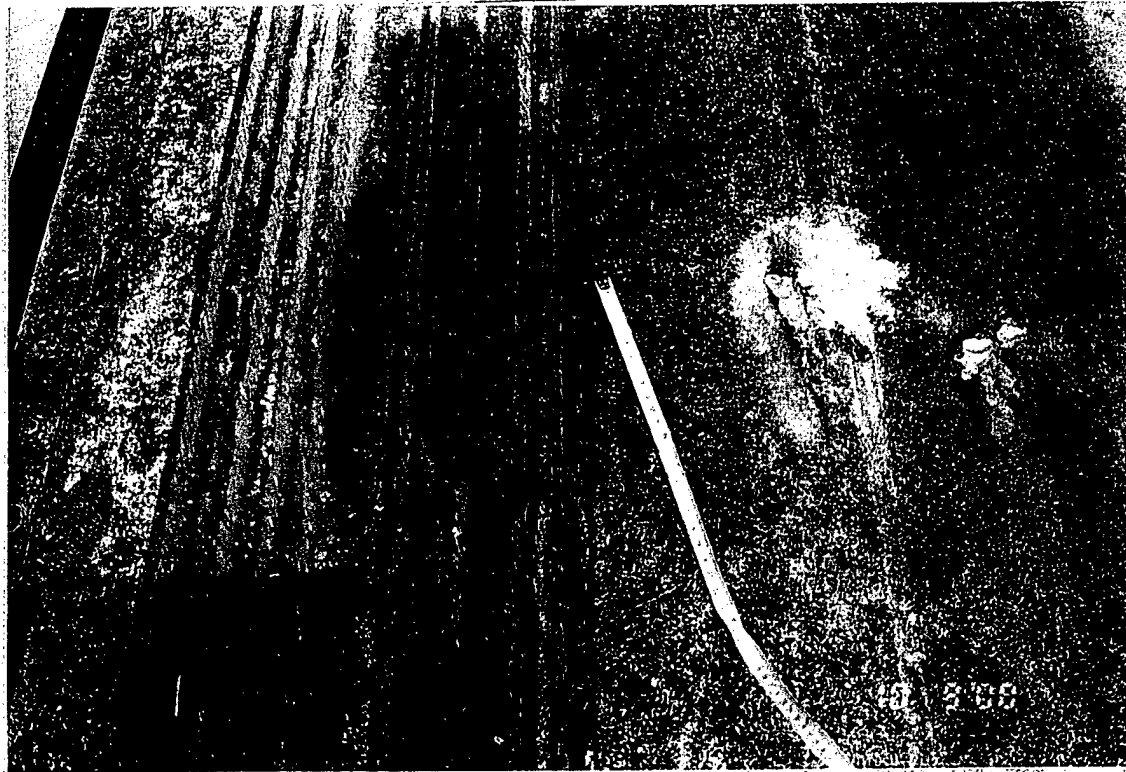
2-33

Gate 2  
Typical wear plate condition. Light  
grooves due to cable wear, light to  
moderate corrosion.

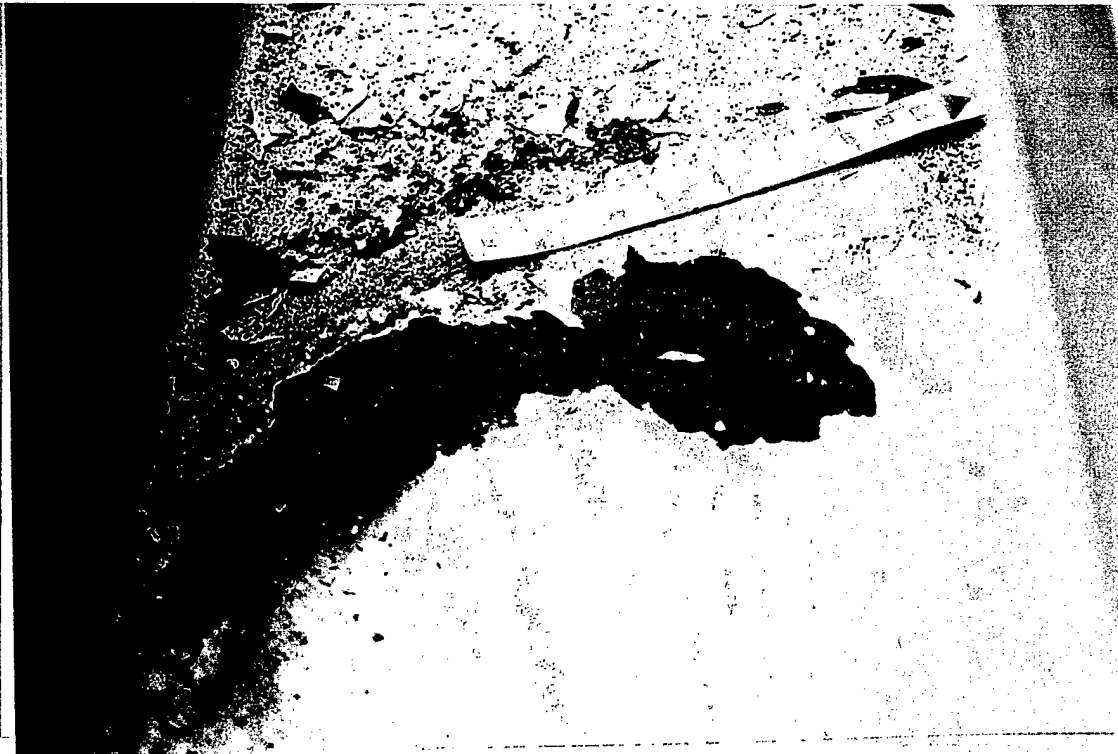
**Gate 4**

Typical wear plate condition. Light grooves due to cable wear, light to moderate corrosion.

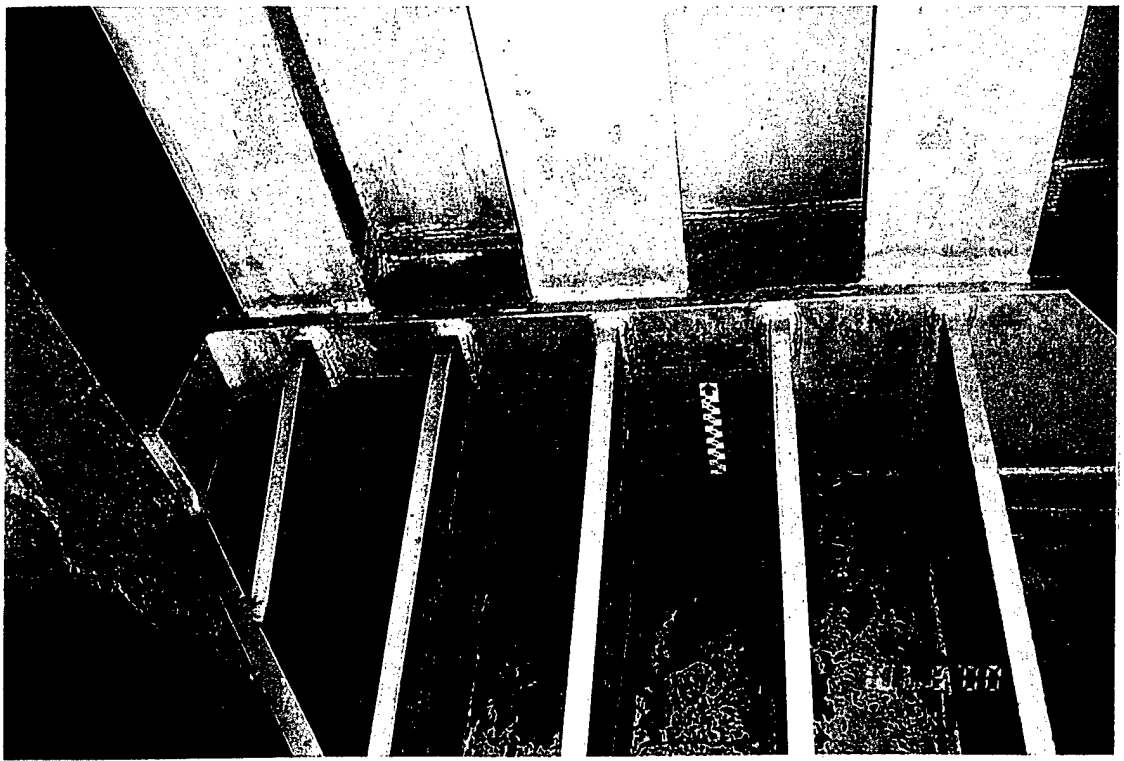
Gate 5  
Right frame, upstream end of bottom  
radial strut. Ponding due to  
inadequate drainage.

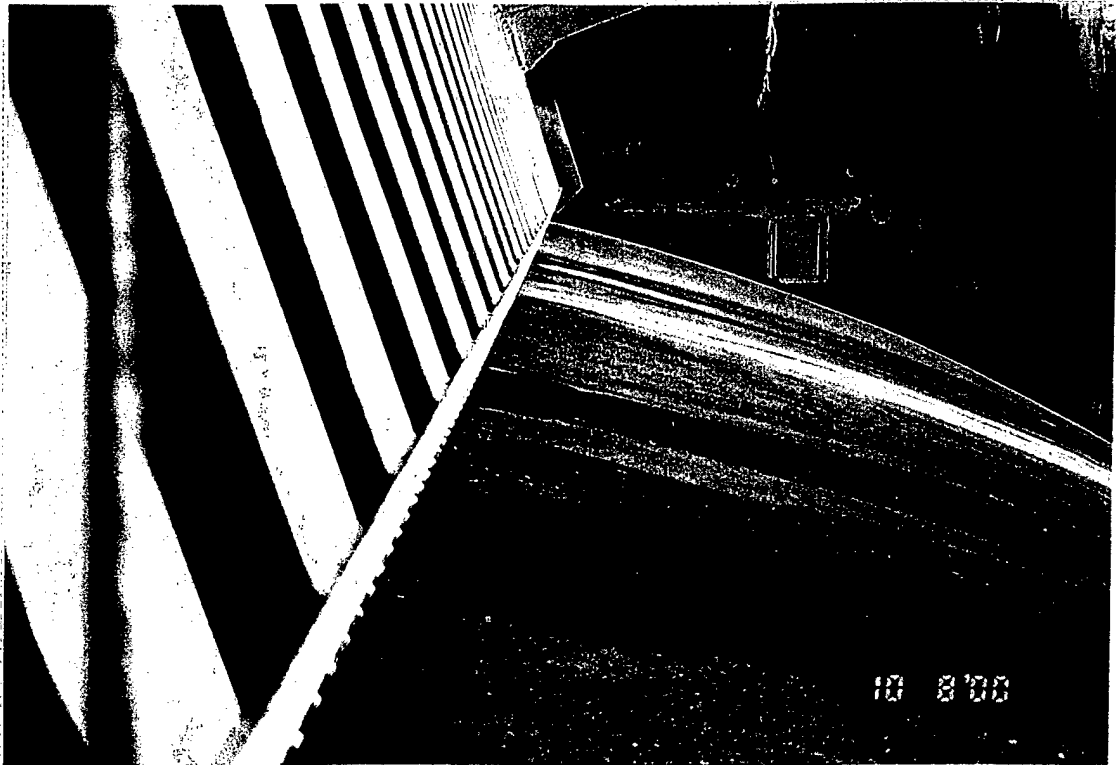
Gate 5  
Side seal, typical.

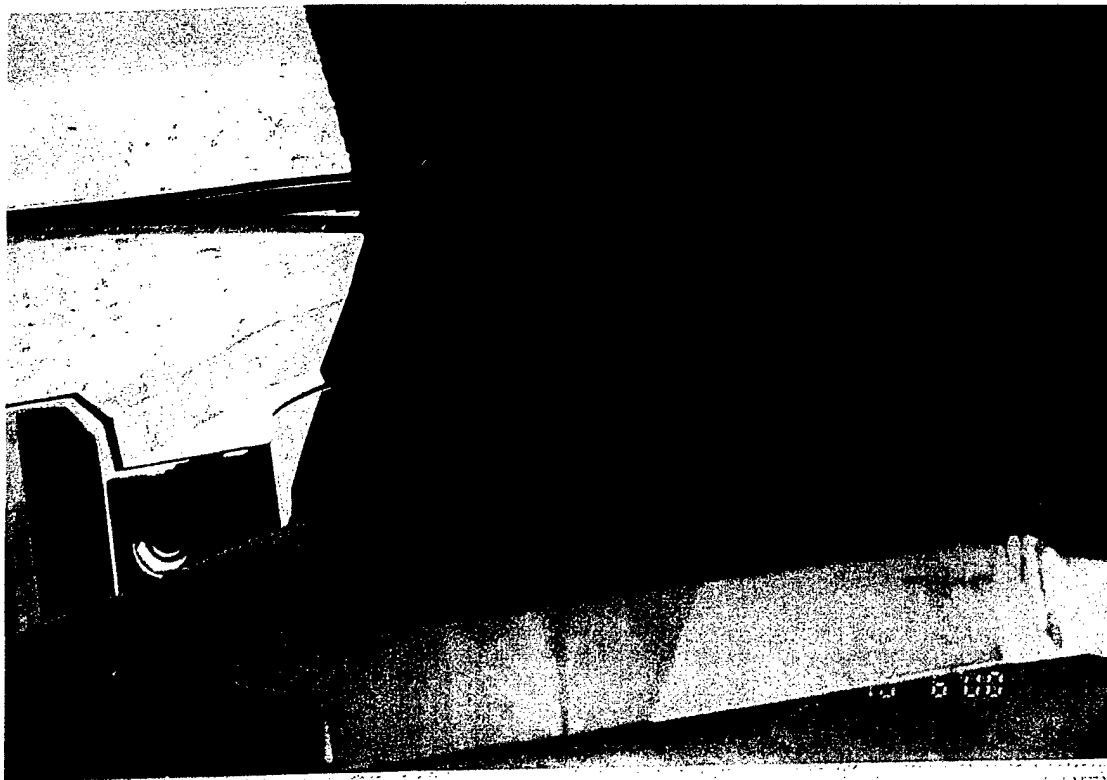
6-7

**Gate 6**  
Outside of right trunnion and yoke.  
Note: Lubrication lines.

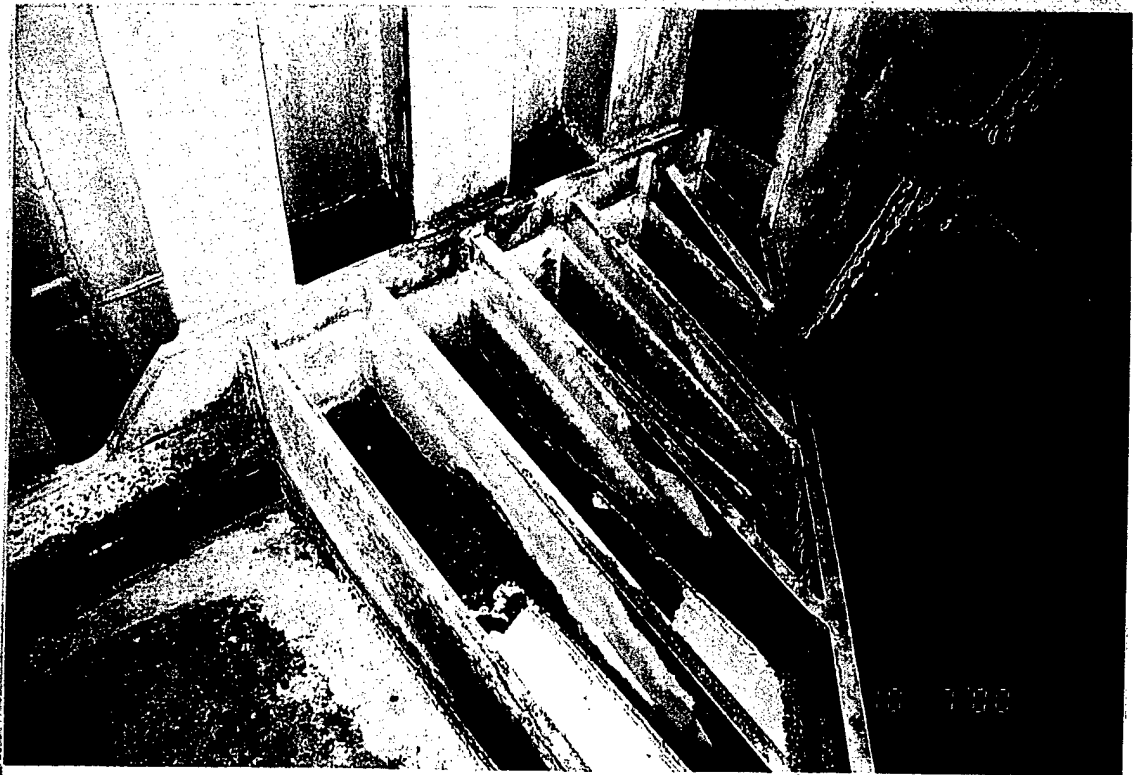
**Gate 7**

Left end of bottom horizontal girder. Standing water, no drainage between multiple stiffeners. Horizontal girder to skin plate stiffeners, standing water, debris and no drainage

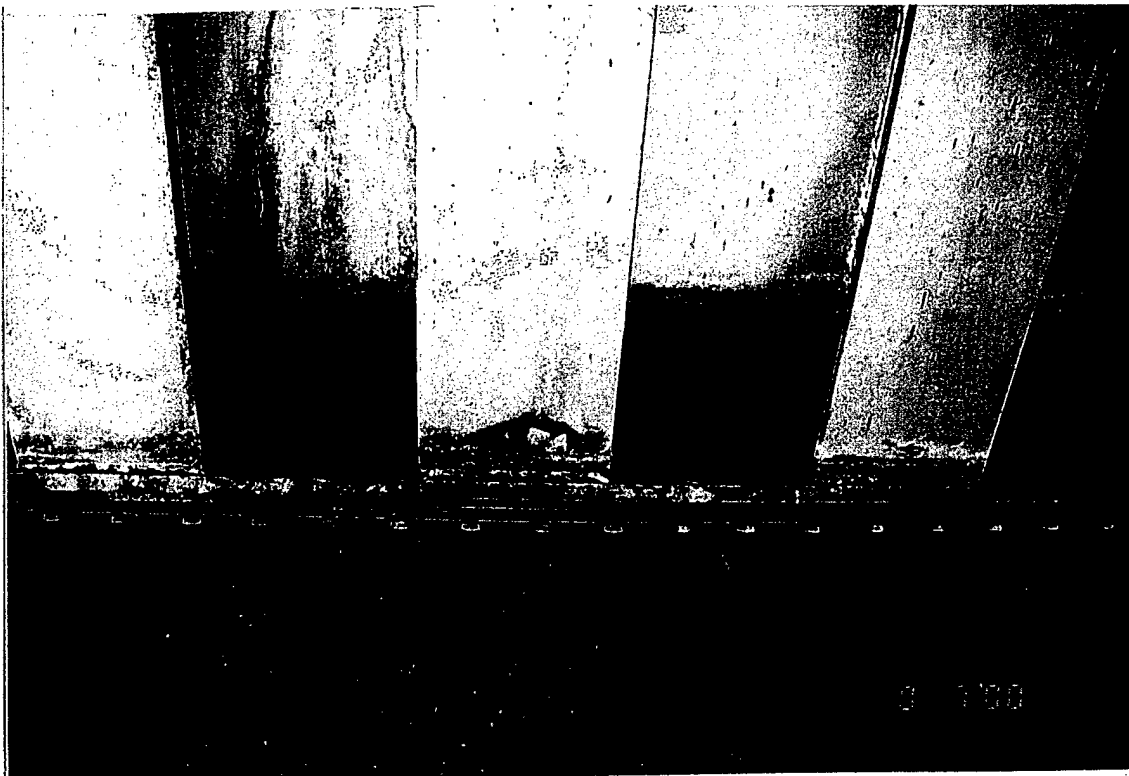
**Gate 7**  
Bottom seal closure plate looking  
upstream. Standing water between  
closure plate, purlin webs and  
skinplate. Typical.

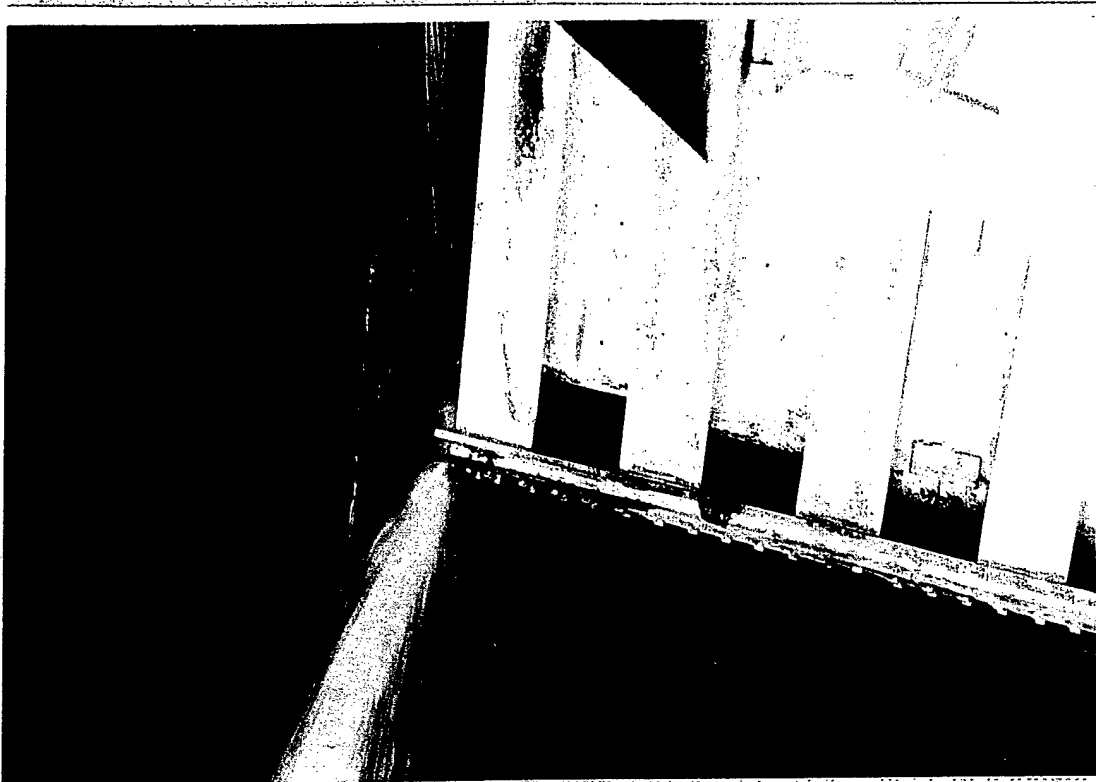
Gate 8  
Bottom right corner seal leak.

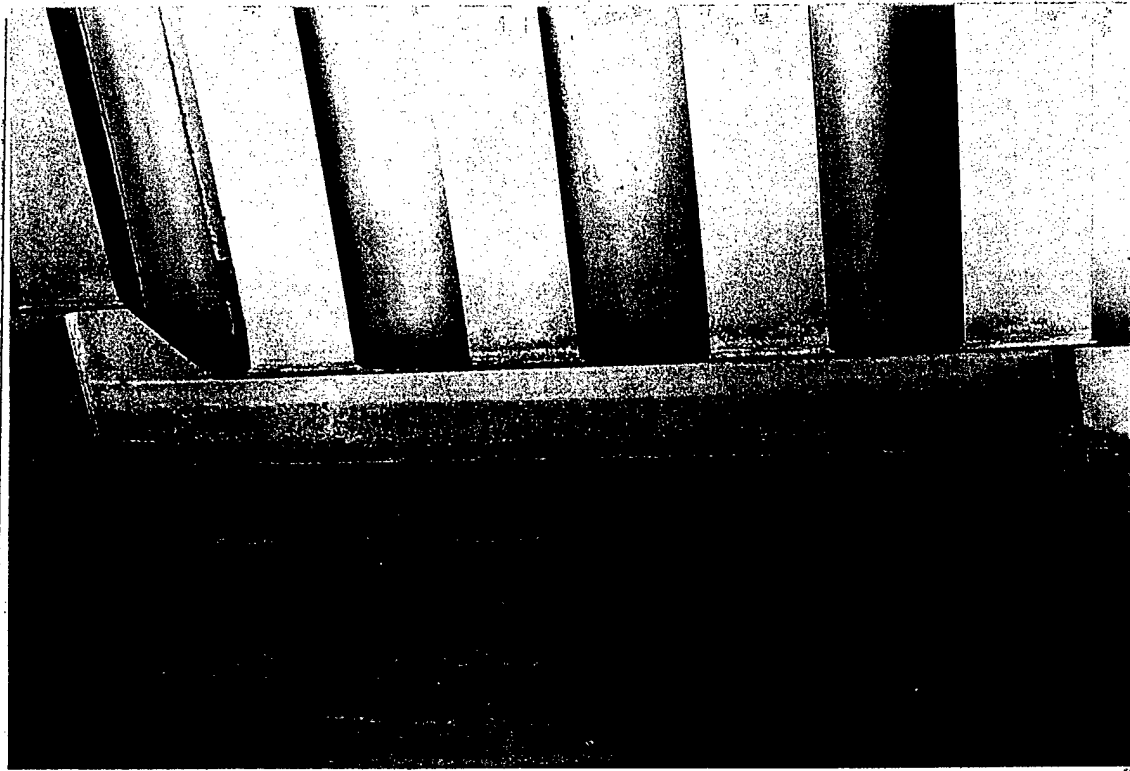
Gate 8  
Right upstream end of bottom  
horizontal girder. Standing water at  
upstream flange and web.

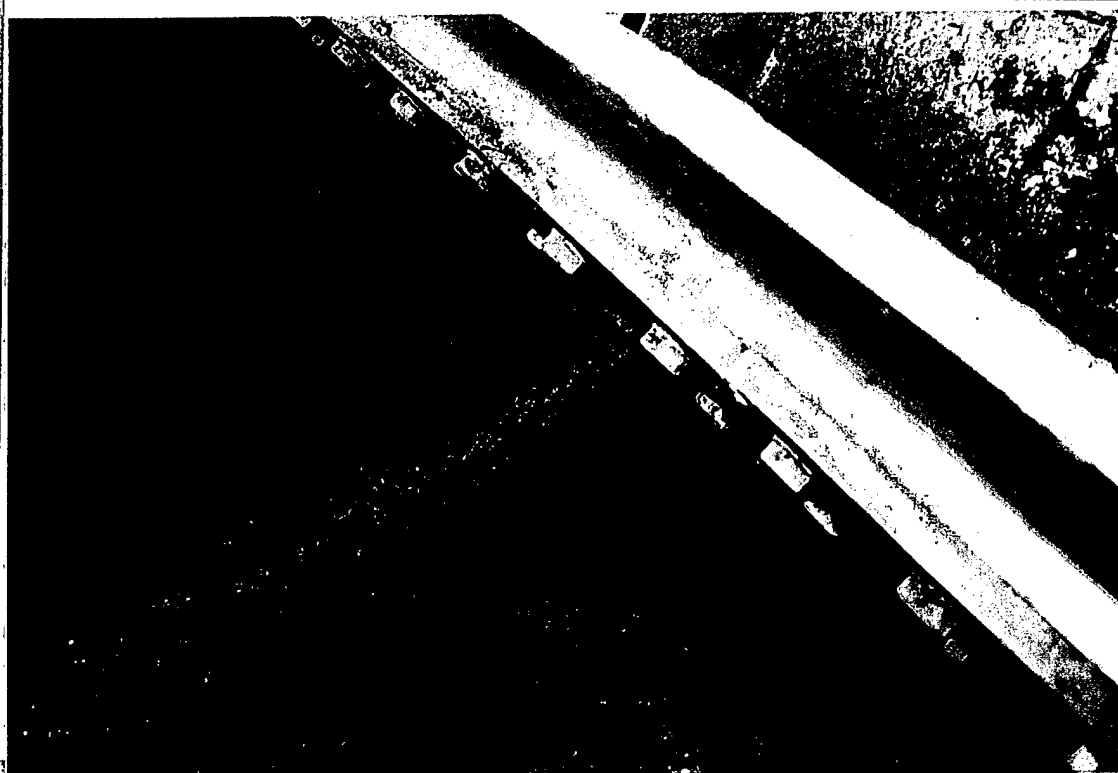
**Gate 8**  
Bottom seal keeper plate and leak at  
center construction joint in spillway  
monolith.
