<b>13. ABSTRACT (Maximum 200 words)</b> This report is an evaluation of the overall condition of the spillway tainter gates at Lower Granite Lock and Dam, Snake River Washington.				
<b>14. SUBJECT TERMS</b> Spillway tainter gates inspection testing			<b>15. NUMBER OF PAGES</b> 250	
			<b>16. PRICE CODE</b>	
<b>17. SECURITY CLASSIFICATION OF REPORT</b> Unclassified	<b>18. SECURITY CLASSIFICATION OF THIS PAGE</b> Unclassified	<b>19. SECURITY CLASSIFICATION OF ABSTRACT</b> Unclassified	<b>20. LIMITATION OF ABSTRACT</b> UL

February 2001

# Lower Granite Dam Radial Gate Inspection and Testing

US Army Corps of Engineers, Walla Walla District

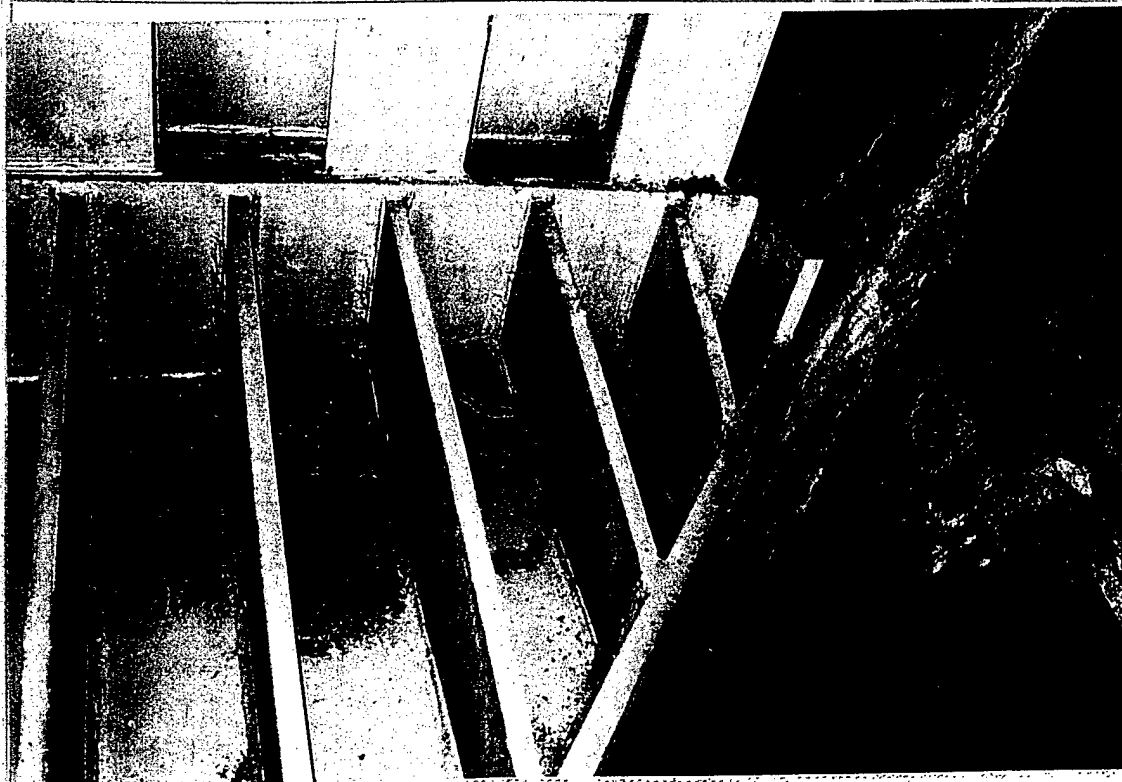
8-12

**Gate 8**  
Left end of bottom horiz. girder.  
Standing water, no drainage between  
multiple stiffeners. Horizontal girder  
to skin plate stiffeners, debris and no  
drainage.

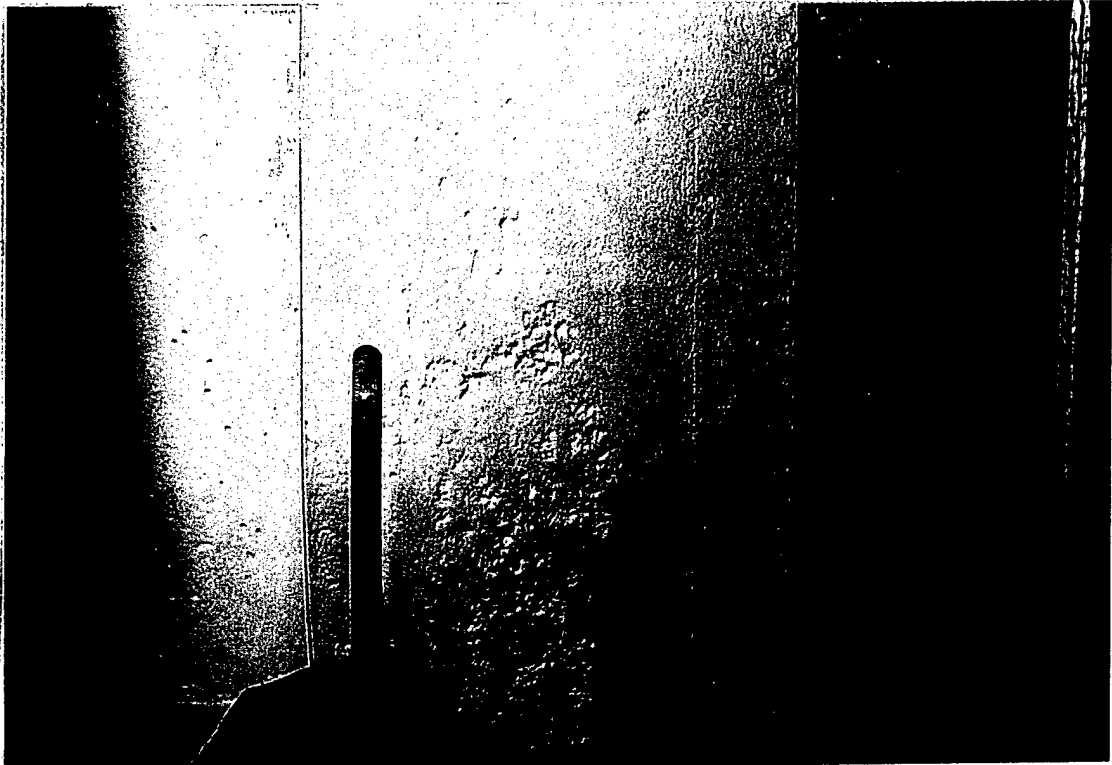
8-14

Gate 8  
Purlin flange small pitting, typical.

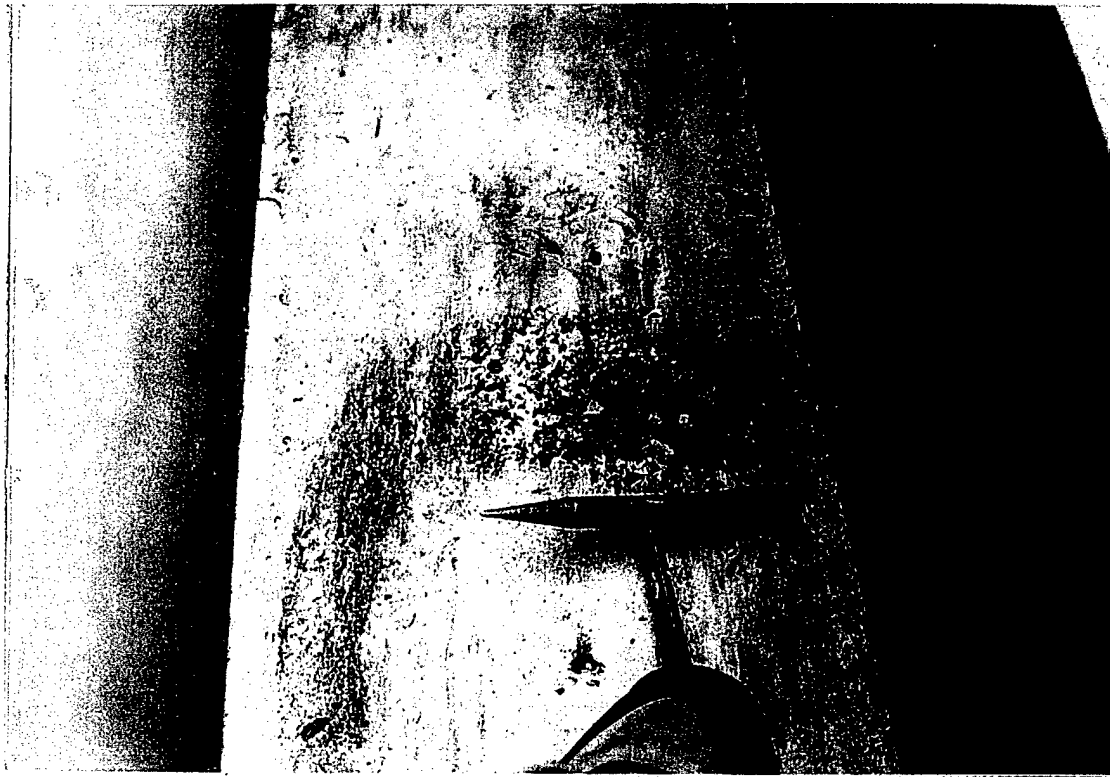
**Gate 8**  
Top left radial strut near trunnion.  
Light corrosion on top of web (after  
scraping).
