RELIEF AND RECONSTRUCTION
FUNDED WORK AT MOSUL DAM
MOSUL, IRAQ

SIGIR PA-07-105
OCTOBER 29, 2007

SUBJECT: Report on Relief and Reconstruction Funded Work at Mosul Dam, Iraq
(Report Number SIGIR PA-07-105)

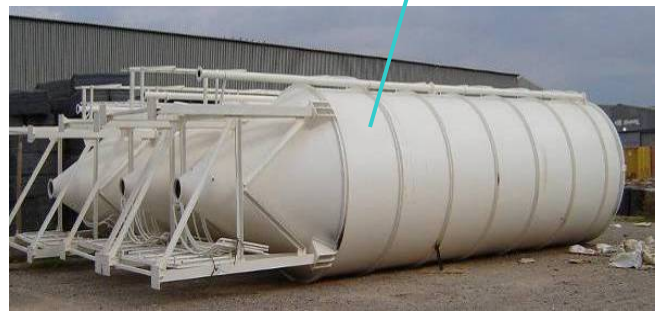
Site Photo 15. Three silos (two needed for each mixing plant)

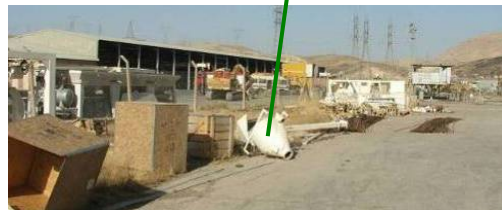
Site Photo 16. Miscellaneous 30 m³/hour concrete-mixing plant parts

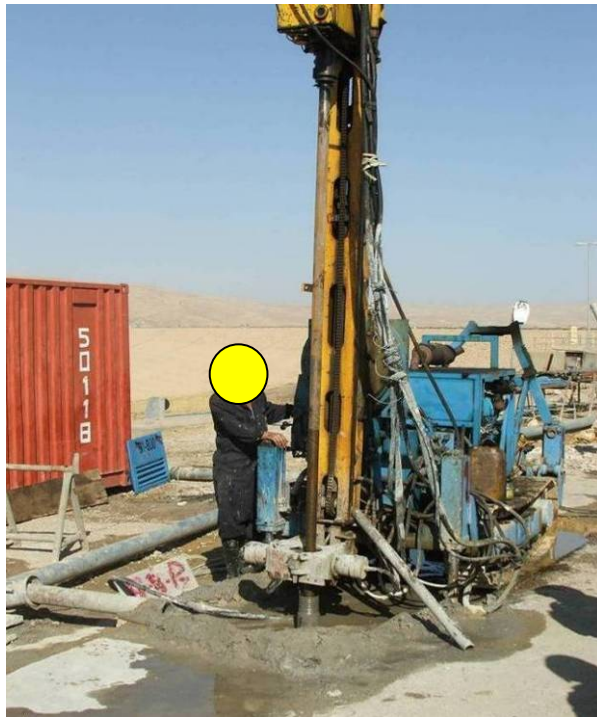
During our site visits, we observed dam personnel conducting drilling and grouting work outside and inside the gallery. We observed outdoor drilling (Site Photo 41), which must be done prior to grouting. Inside the gallery, we witnessed one hole being actively grouted. Specifically, we viewed an agitator actively mixing grout (Site Photo 42) and a grout pump actively placing the grout into a hole (Site Photos 43 and 44). In addition, ITAO representatives stated grouting activities were also ongoing during a previous site visit (Site Photo 45). Figures 8 and 9 also verify that the dam personnel are still operating a continuous grouting program.

Site Photo 41. Dam personnel conducting above ground drilling operations

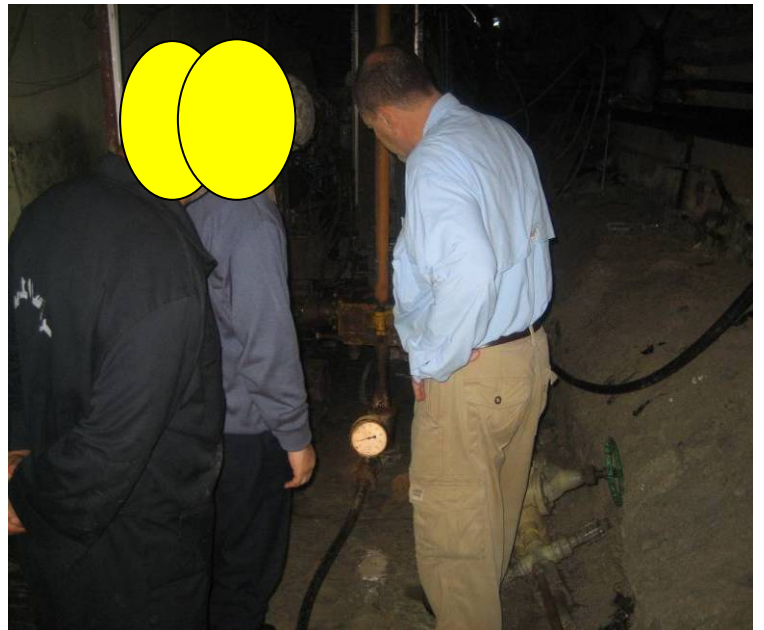
**Site Photo 45. A hole being actively grouted
(Photo courtesy of ITAO)**
