Monitoring Completed Navigation Projects Program

Periodic Inspections of Hilo, Kahului, Laupahoehoe, and Nawiliwili Breakwaters, Hawaii

Armor Unit Monitoring for Period 2001-2005

October 2011

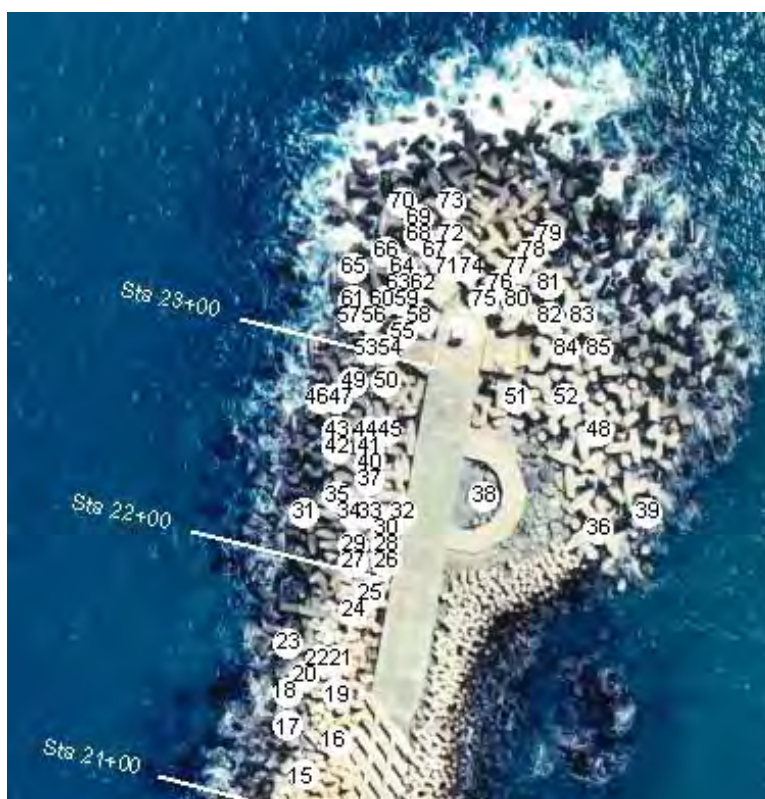
Figure 33. Approximate damage locations on Kahului West Breakwater, photograph 1.

There were 48 broken or cracked dolosse, 26 broken/cracked tribars, and six broken tetrapods on the Kahului West Breakwater. The broken units were concentrated on the ocean side of the structure between sta 21+00 and 23+00, and around the head of the structure (Figures 33 and 34).

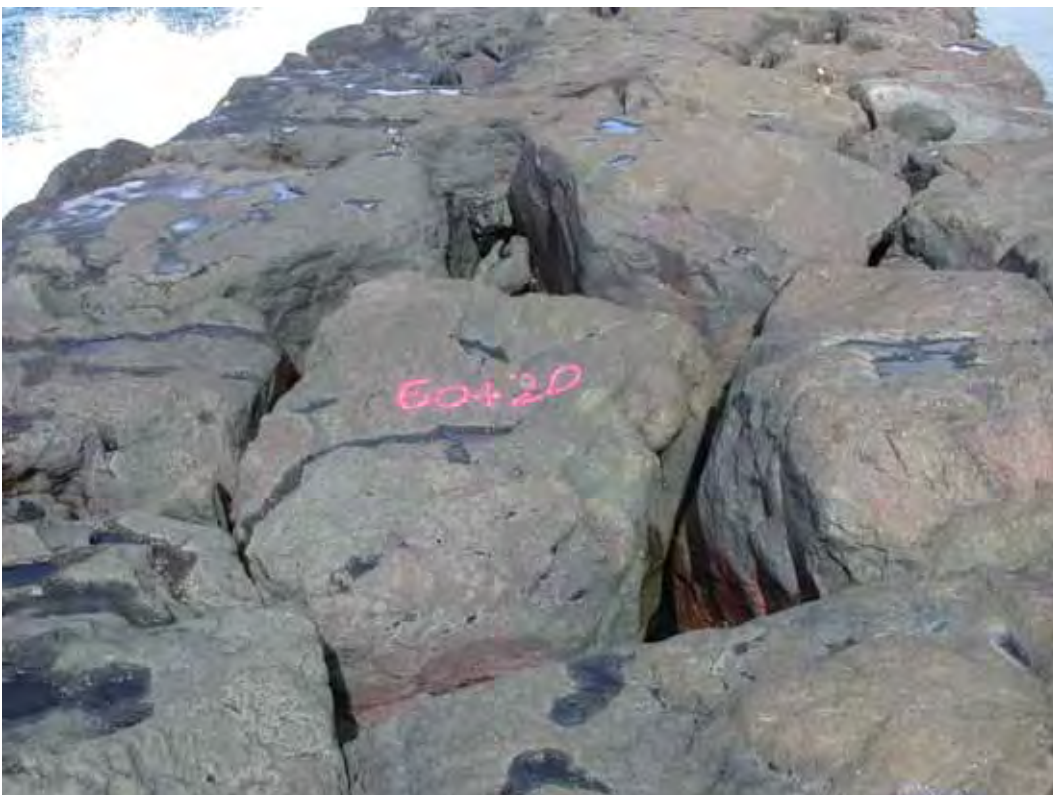
Figure A54. Sta 60+20, harbor side, unmarked copper disk.

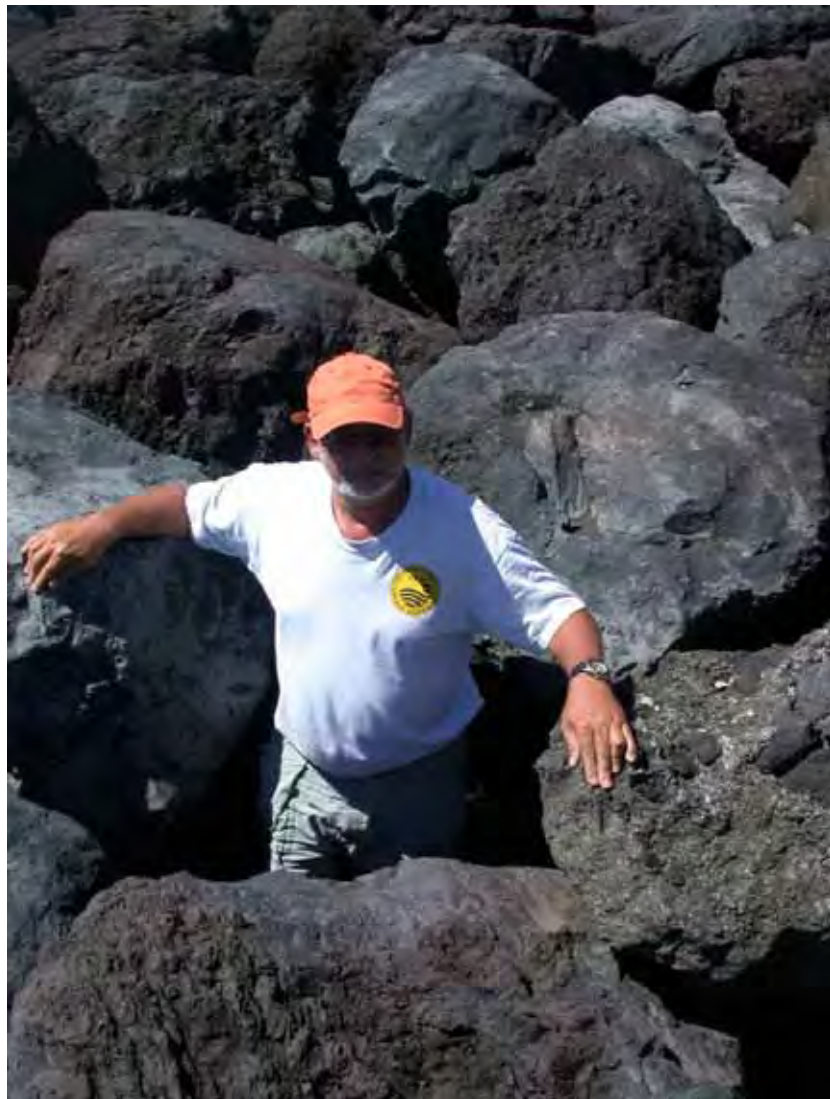
Figure C4. Void.

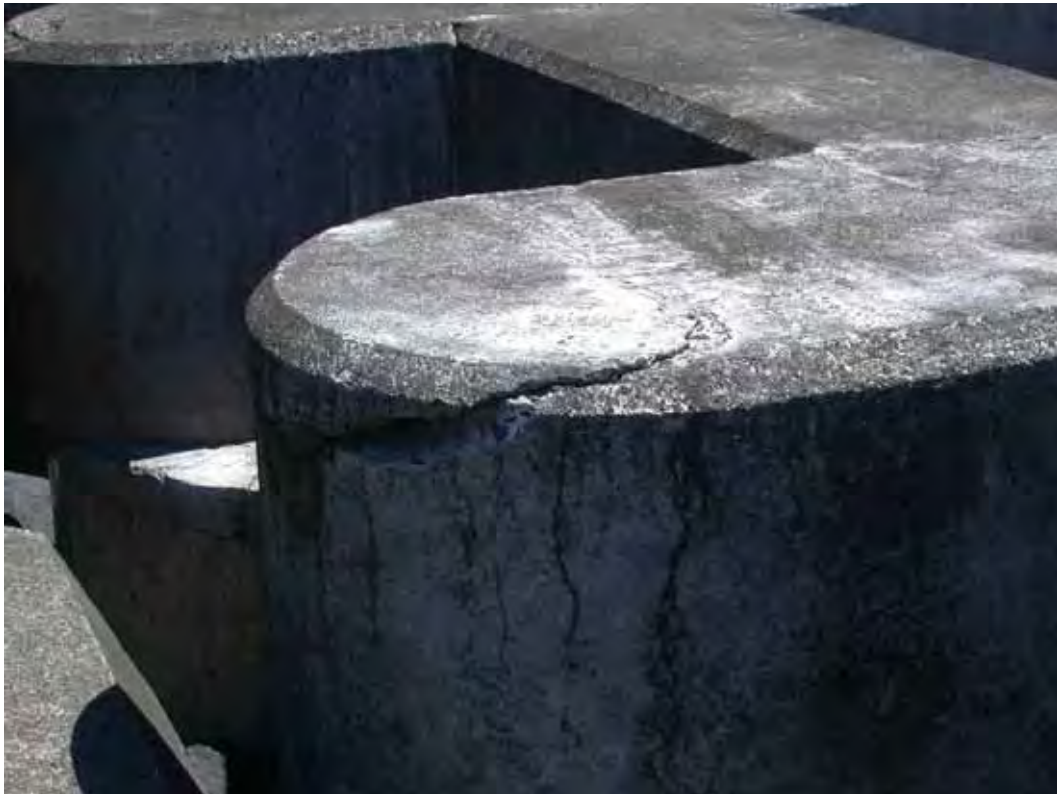
Figure C15. Rib #9, cracked.

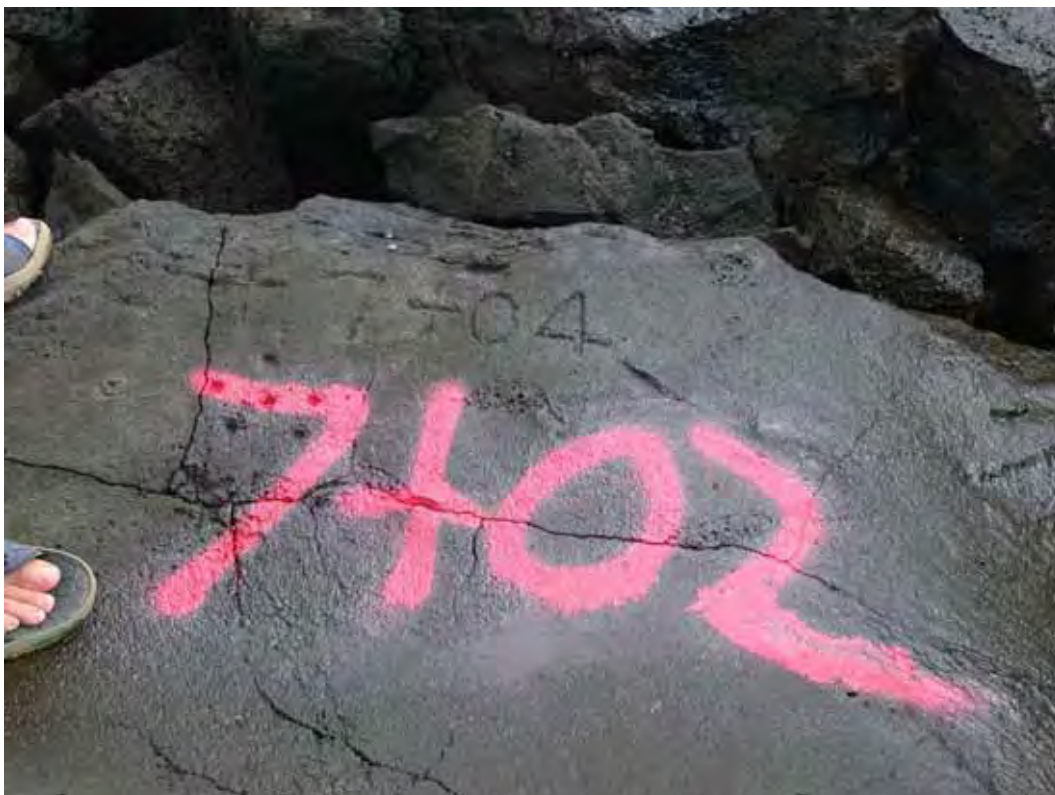
Figure D8. Sta 7+02, stone on crest with 7+04 etched in it.
