Investigation of the Corrosion Mechanism and Determination of the EMS Estimated Service Life at Site 81

February 2013

Final report

Prepared for U.S. Army Corps of Engineers
Europe District
CMR 410, Box 1, APO, AE 09049

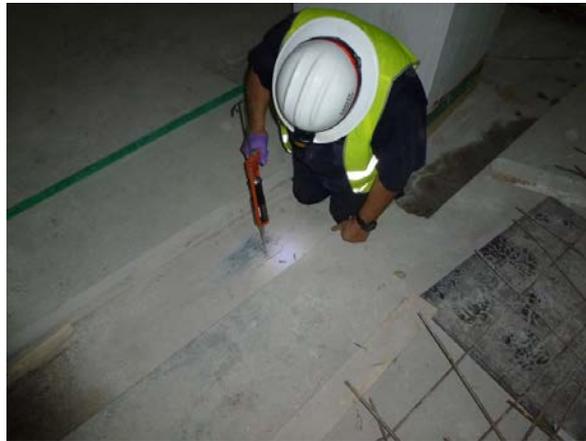
Figure 8. Existing trough in concrete liner over EMS steel plate.

The initial site inspection revealed that there were a number of approximately 16 in. (40 cm) wide troughs (Figure 8) that had been cut through the inner concrete liner to expose the EMS steel plate for inspection by others. It was decided that many of the test sites could be located within the pre-cut troughs, saving considerable work by the site contractor and allowing additional time to perform the testing.

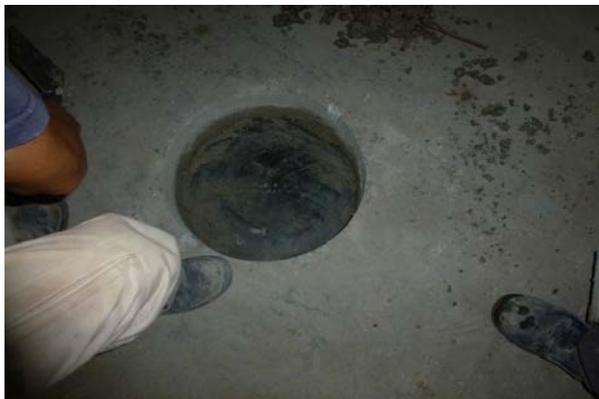
Figure 9. 16 in. diameter core hole cut to expose steel EMS for testing.

It was also determined that the site contractor had the capability of readily cutting 16 in. (40 cm) diameter core holes down to the EMS plate (Figure 9) which then could be readily removed to expose the plate. These larger access ports would also make later testing more efficient and accurate.

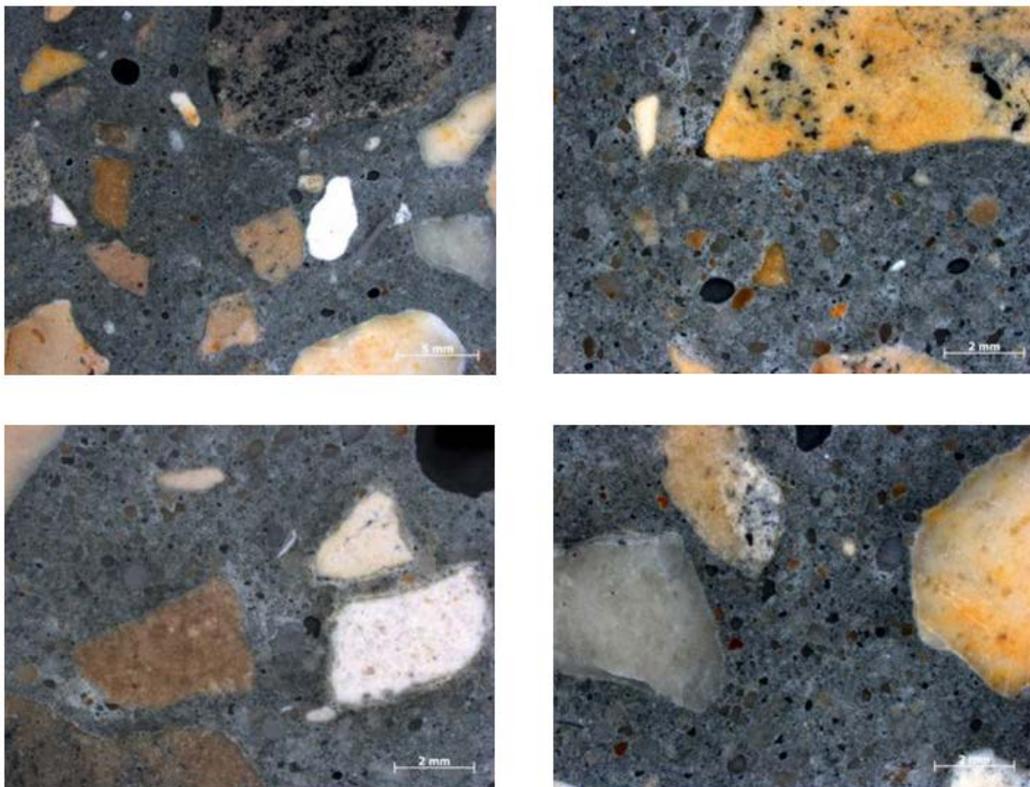
Figure D-16. Supplemental photomicrographs from core sample #17.
