DoD Corrosion Prevention and Control Program

Demonstration and Validation of Materials for Corrosion-Resistant Fencing and Guard Railings in Aggressive Climates

Final Report on Project F09-AR02

October 2015

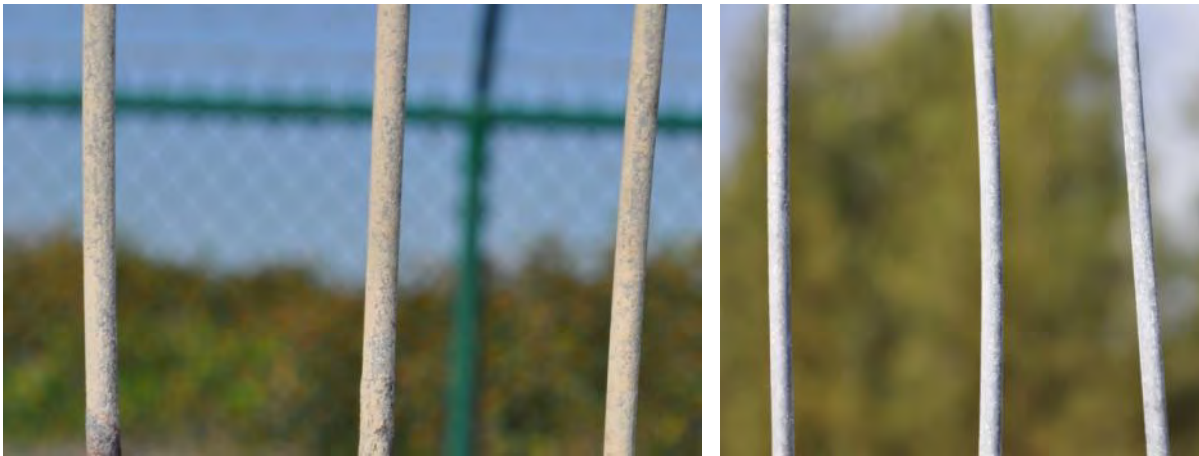
Figure 21. Galvan wire coupon at FRF (left) and KTA (right) after 6 months of exposure

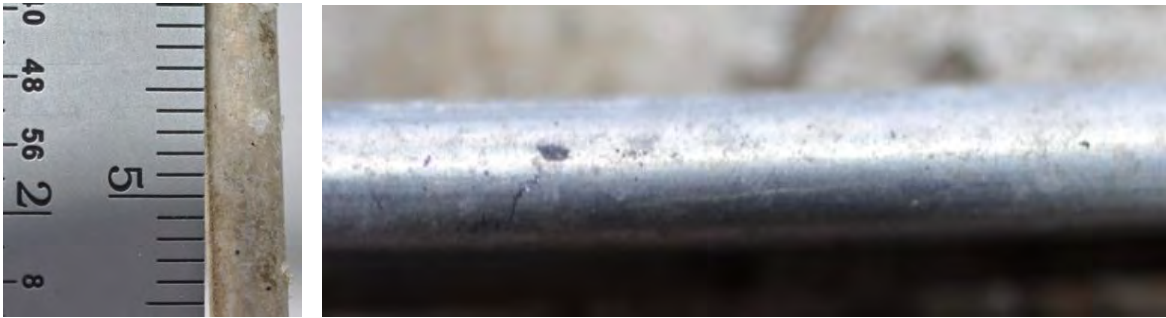
Figure 26. Aluminum wire coupon at the FRF (left) and KTA (right) after 12 months of exposure.

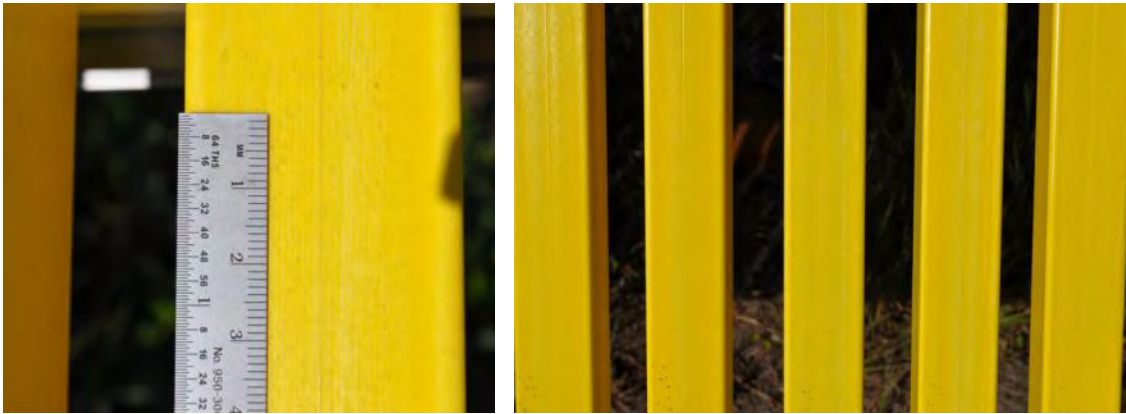
months of exposure. The FRP railings did not show signs of degradation until 6 months of exposure. The sides of railing specimens that face the sun the longest during the day were affected by color fading.

Figure 29. FRP railing coupon at FRF (left) and KTA (right) after 6 months of exposure.

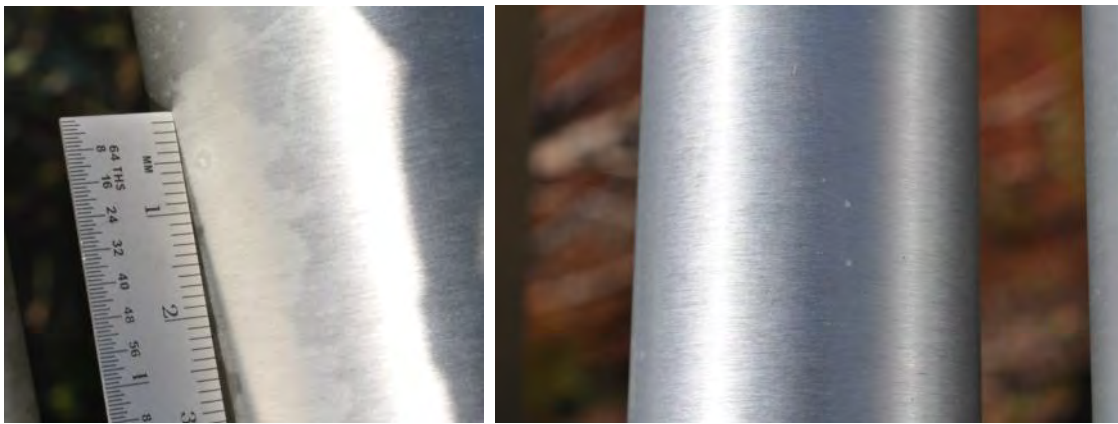
Figure 32. Aluminum railing coupon at FRF (left) and KTA (right) after 6 months of exposure.

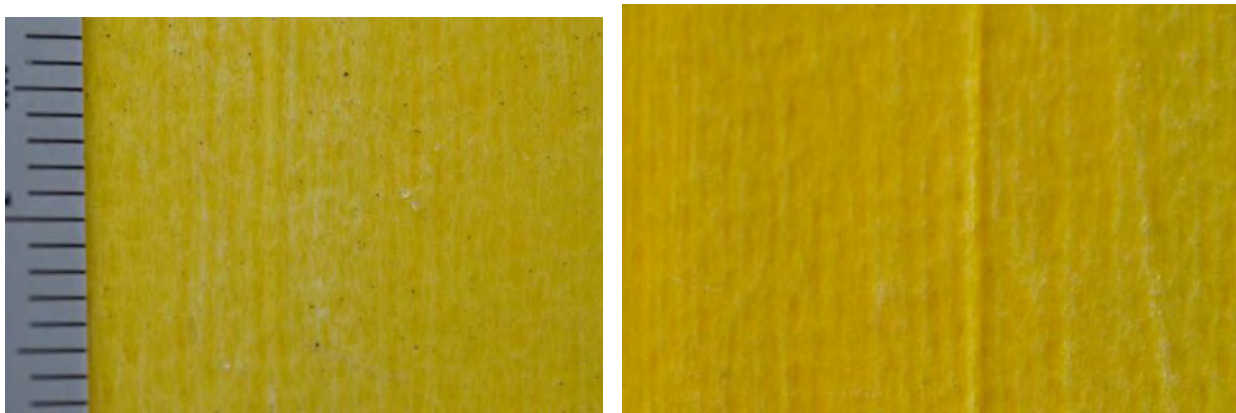
Figure 33. FRP railing coupon at FRF (left) and KTA (right) after 12 months of exposure.

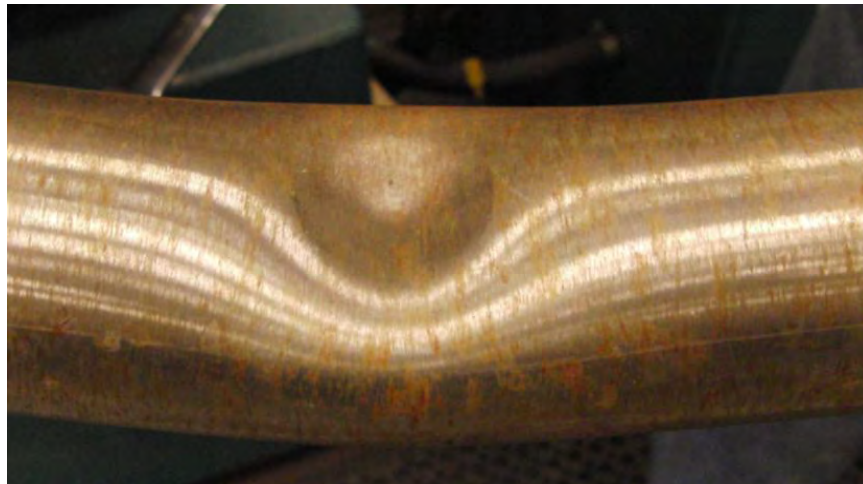
Figure 47. Cross sectional collapse of a stainless steel pipe under flexure testing.

Figure 46 shows a typical graph of steel pipe deformation as a flexure load is applied. It was found that the longitudinal shape of the pipe remained rigid and the circular cross section collapsed before the pipe began to flex, as seen in Figure 47. This same behavior was not observed in the aluminum or FRP railing specimens. The aluminum specimens were relatively ductile in comparison with steel and stainless steel, and therefore began to deform in both the cross section and longitudinally at the same time. The FRP railing had a square cross section and is not very ductile compared to either steel or aluminum, so its failure was different than the metallic specimens. Figure 48 – Figure 50 represent the change in the tangent modulus throughout the exposure period for each test site. More data can be found in Appendix E.

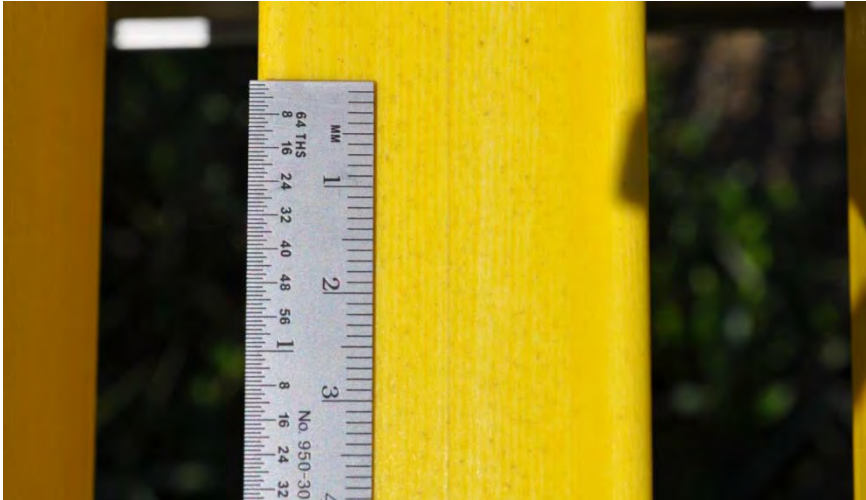
Figure B21. FRP Railing Coupon

FRP	0%	N/A	No visible corrosion

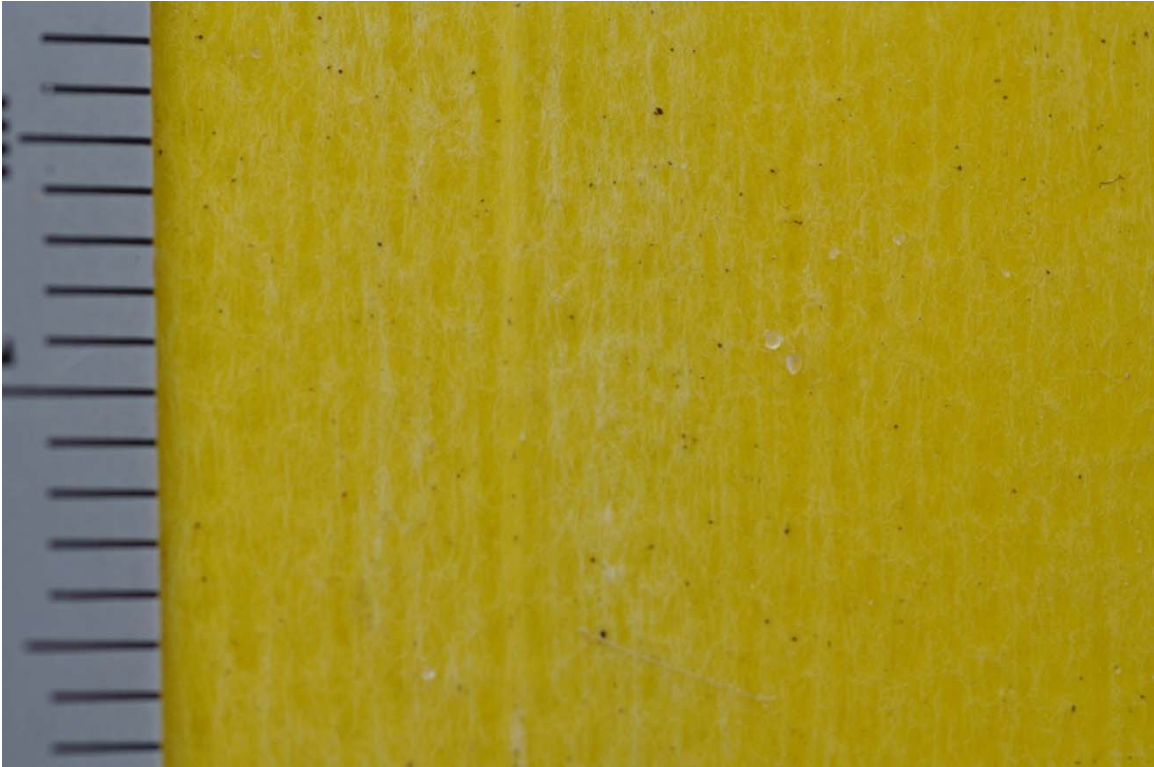
Figure B42. FRP Railing Coupon

Large deposition of salt crystal/chlorides on all materials.

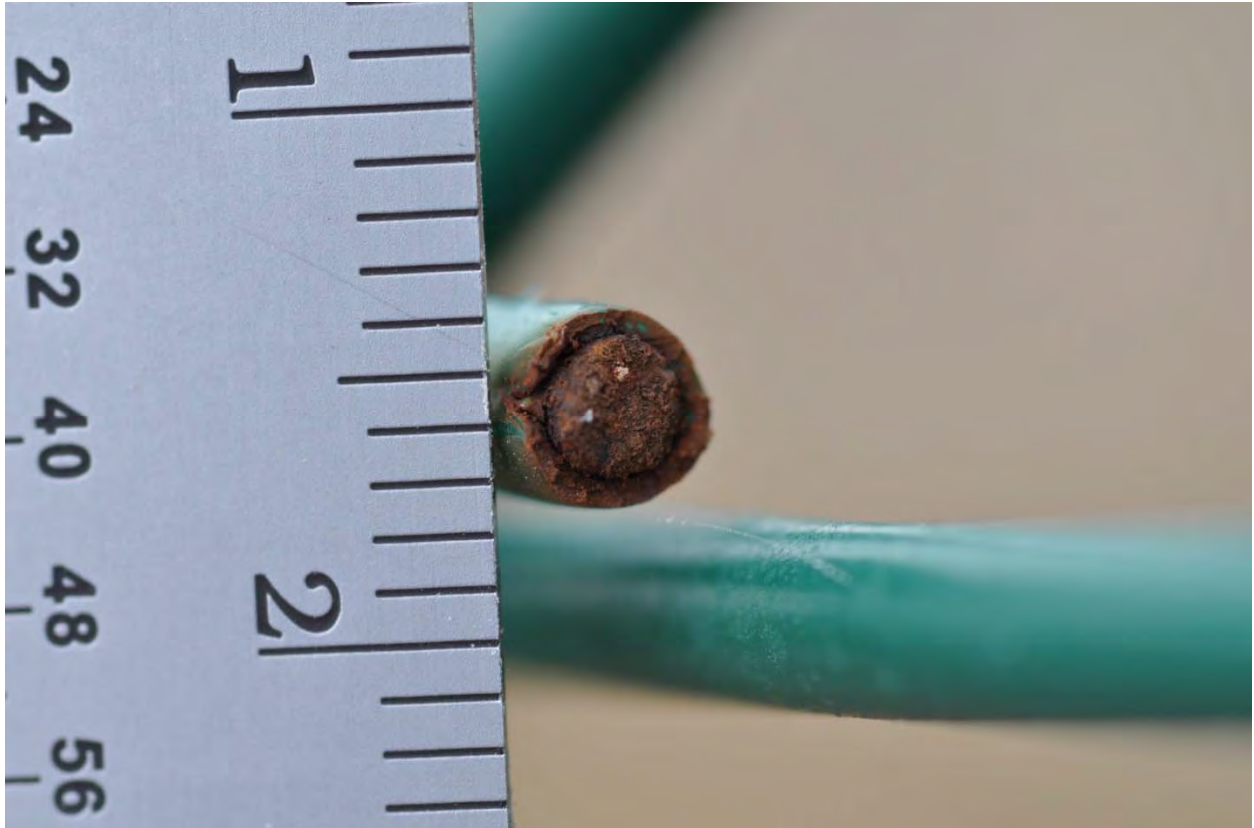
Figure B64. Fuse Bonded PVC Coated Galvanized Wire Fencing Cut Ends

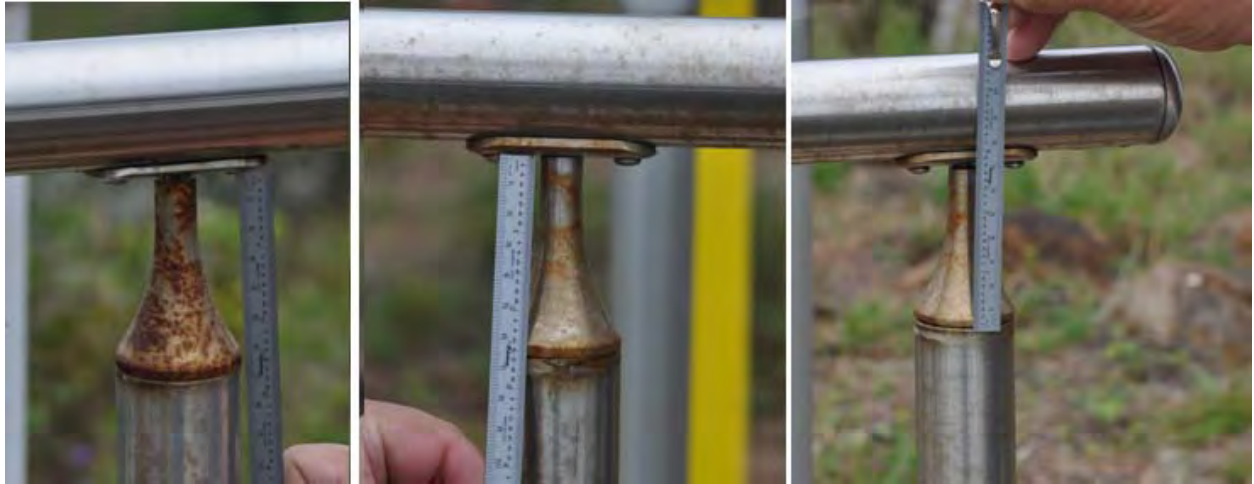
Railing Coupons				
	Stainless Steel	50%	Oxidation	Surface oxidation has discolored the material
	Aluminum	<5%	Pitting	Pitting has begun in areas where the anodize may have been damaged
	Coated Steel	10%	Rust	Rust has begun to form where the coating has failed. Discoloring of the coating due to the rust.
	FRP	0%	N/A	No visible corrosion
Fabricated Railing				
	Stainless Steel	80%	Oxidation	Surface oxidation has discolored the material. T-fittings show 90% surface corrosion likely due to lack of passivation.
	Aluminum	<5%	Pitting	Pitting has begun in areas where the anodize may have been damaged
	Coated Steel	10%	Rust	Rust has begun to form where the coating has failed. Discoloring of the coating due to the rust.
	FRP	0%	N/A	No visible corrosion

Figure B65. (Left) Southern most stainless steel T-fitting, (Center) center stainless steel T-fitting, (Right) northern most stainless steel T-fitting.

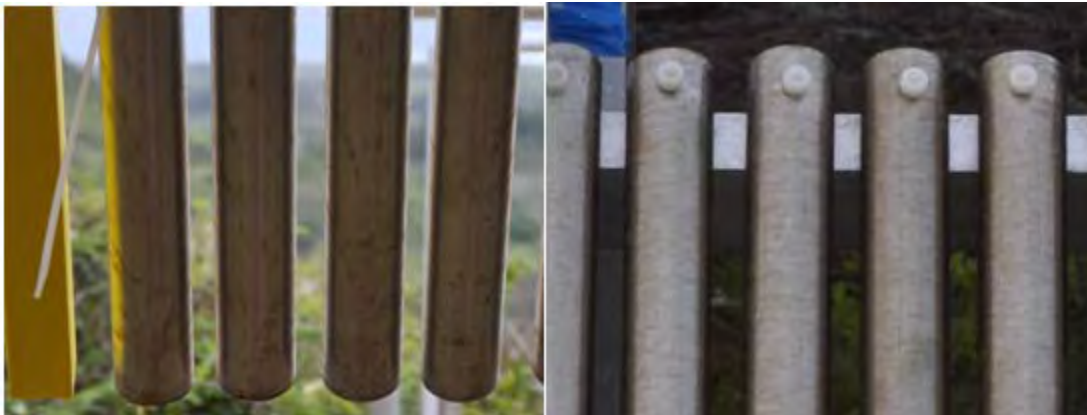
Figure B66. (Left) Stainless steel coupons facing away from the ocean; (Right) stainless steel coupons facing the Ocean.

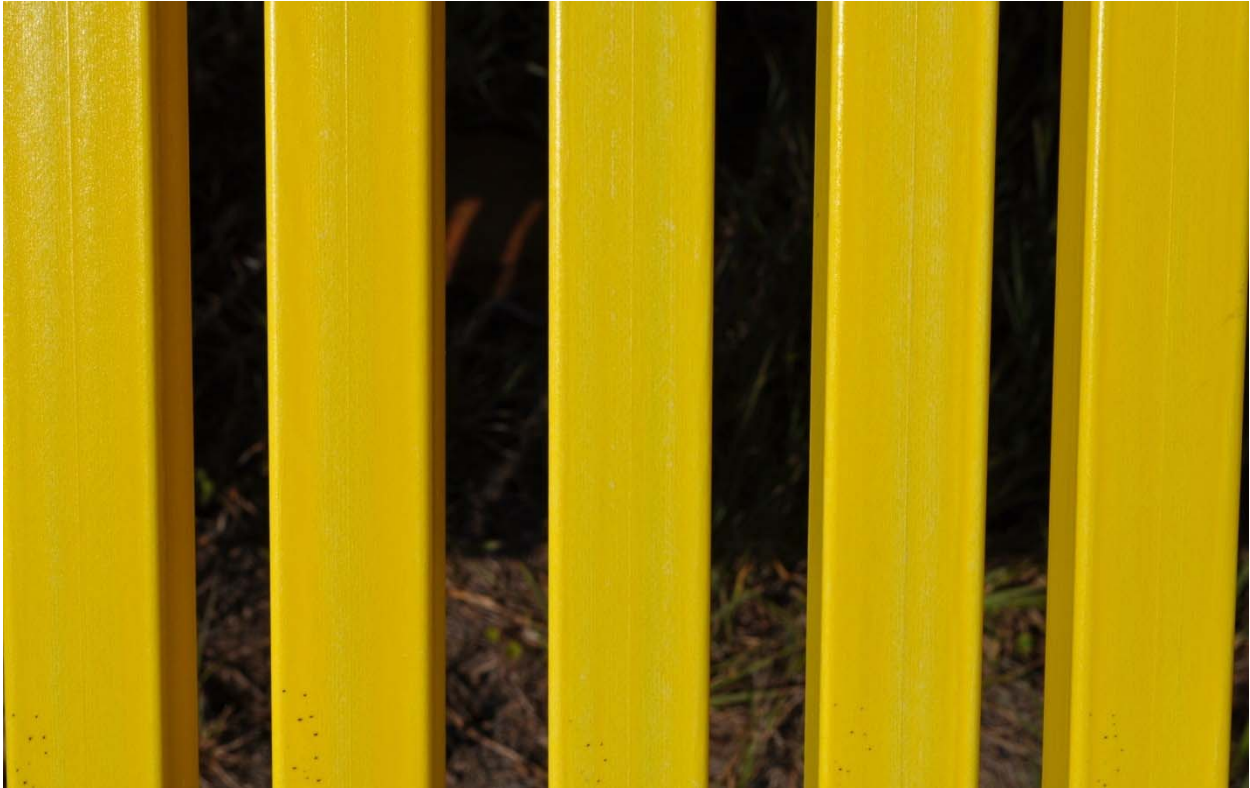
Figure B77. FRP Railing Coupon

FRP	25%	UV	Discoloring due to UV exposure on the face of the railing that faces the sun

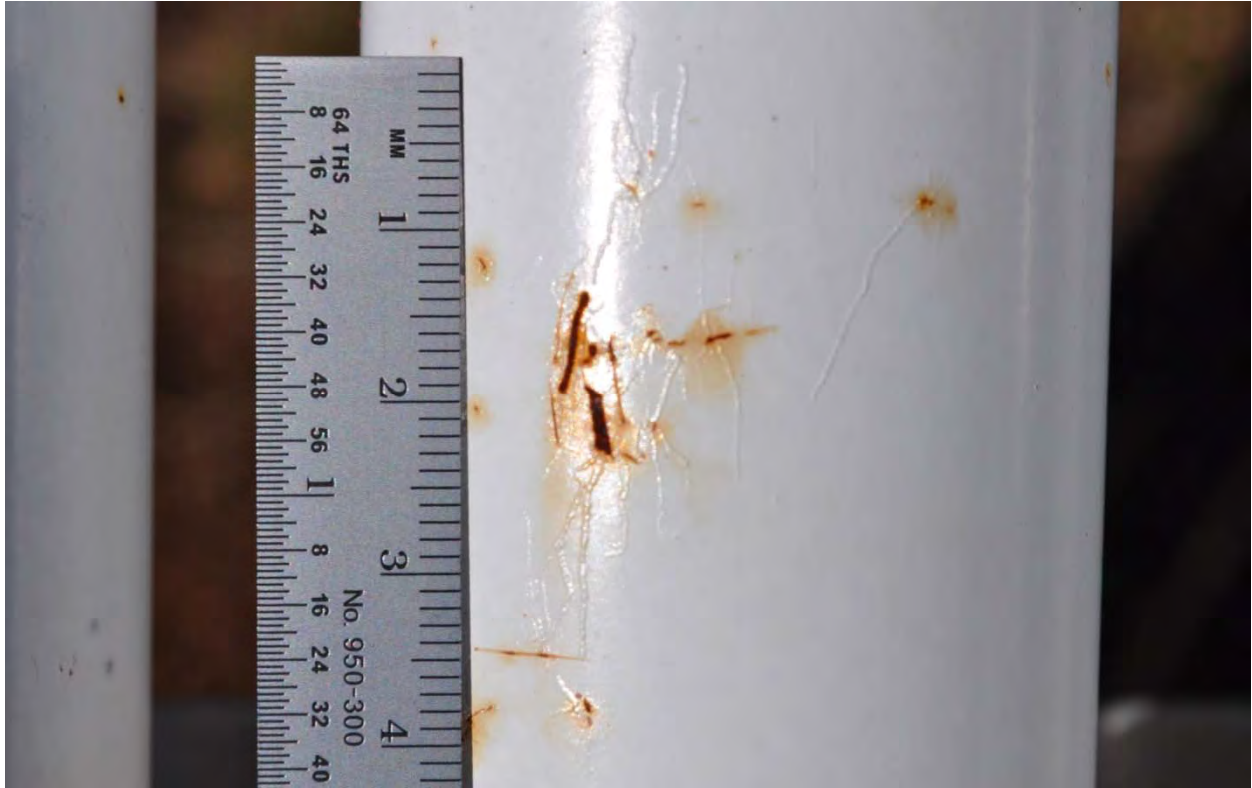
Figure B79. Coated Steel Coupon

Aluminized Steel	20%	Oxidation	White oxidation of the zinc/AL coating 95% white corrosion on Galv. Hardware
	Fuse Bonded PVC Coated Galvanized	<5%	Rust	Minor rust has begun to form around cut ends and damaged areas
Railing Coupons				
	Stainless Steel	80%	Oxidation	Surface oxidation has discolored the material.
	Aluminum	<5%	Pitting	Pitting has begun in areas where the anodize may have been damaged
	Coated Steel	10%	Rust	Rust has begun to form where the coating has failed. Discoloring of the coating due to the rust.
	FRP	25%	UV	Discoloring due to UV exposure on the face of the railing that faces the sun
Fabricated Railing				
	Stainless Steel	50%	Oxidation	Surface oxidation has discolored the material. T-fittings show 90% surface corrosion likely due to lack of passivation.
	Aluminum	<5%	Pitting	Pitting has begun in areas where the anodize may have been damaged
	Coated Steel	10%	Rust	Rusting areas have spread larger causing blistering under the coating.

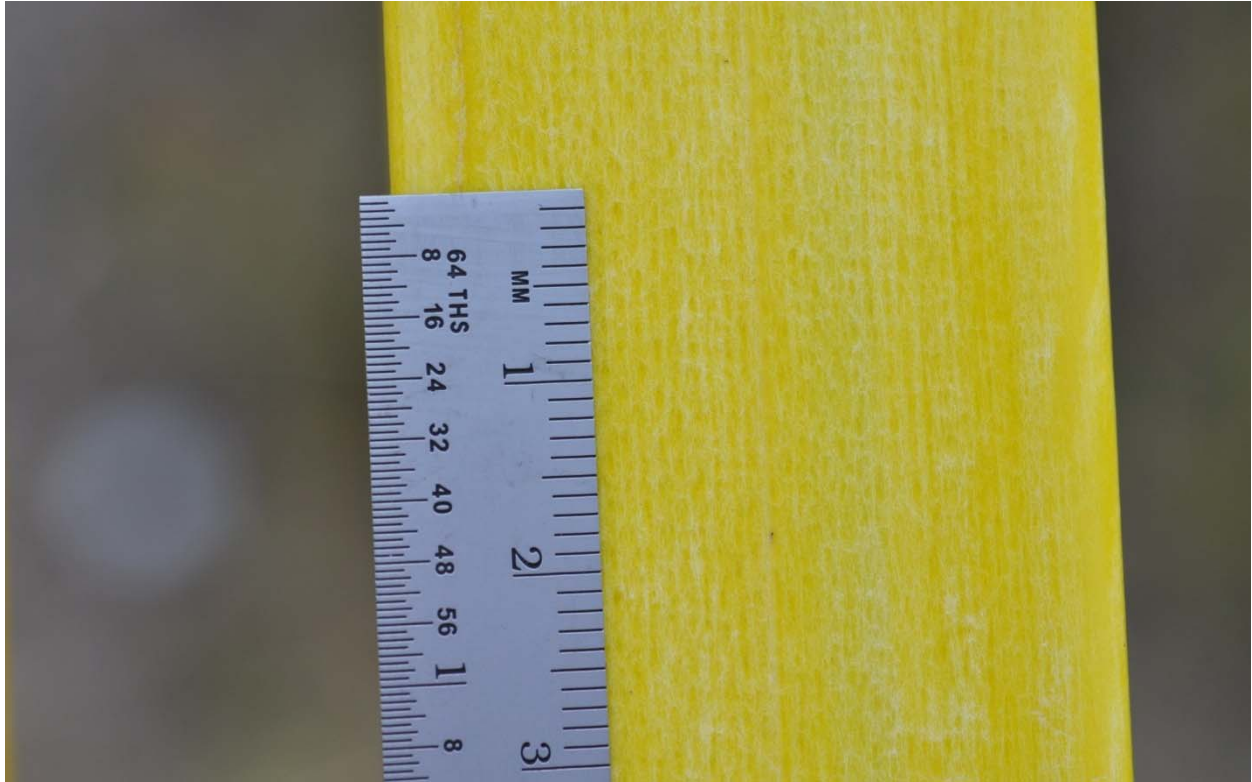
Figure B97. FRP Railing Coupon

Fuse Bonded PVC Coated Galvanized	<5%	Rust	Minor rust has begun to form around cut ends and damaged areas
Railing Coupons				
	Stainless Steel	80%	Oxidation	Surface oxidation has discolored the material.
	Aluminum	<5%	Pitting	Pitting has begun in areas where the anodize may have been damaged
	Coated Steel	10%	Rust	Rust has begun to form where the coating has failed. Discoloring of the coating due to the rust.
	FRP	25%	UV	Discoloring due to UV exposure on the face of the railing that faces the sun
Fabricated Railing				
	Stainless Steel	50%	Oxidation	Surface oxidation has discolored the material. T-fittings show 90% surface corrosion likely due to lack of passivation.
	Aluminum	<5%	Pitting	Pitting has begun in areas where the anodize may have been damaged
	Coated Steel	20%	Rust	Rusting areas have spread larger causing blistering under the coating.
	FRP	25%	UV	Discoloring due to UV exposure on the face of the railing that faces the sun

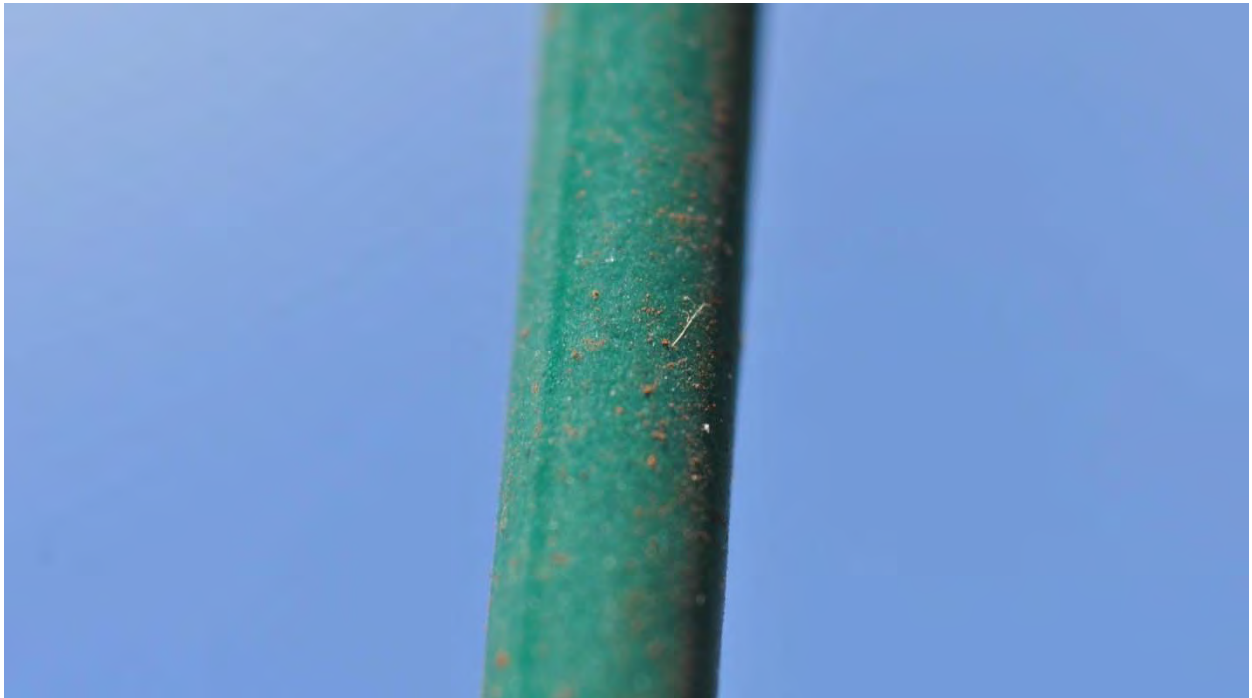
Figure B105. Standard PVC Coated Galvanized Wire Coupon

Material	% of Surface Corroded	Type of Corrosion	Notes
Fence Wire Coupons				
	Standard PVC Coated Galvanized	0%	N/A	No visible corrosion
	Fuse Bonded PVC Coated Galvanized	0%	N/A	No visible corrosion
	Standard Galvanized	50%	Oxidation/ Rust	50% of the corrosion areas have degraded past the sacrificial zinc coating and have begun to rust.
	Stainless Steel	100%	Oxidation	Surface oxidation
	Aluminum	5%	Pitting	Minor pitting
	Galfan	50%	Oxidation/ Rust	50% of the corrosion areas have degraded past the sacrificial zinc coating and have begun to rust.
	Aluminized Steel	<5%	Oxidation	White oxidation of the zinc/AL coating
Fabricated Fencing				
	Stainless Steel	75%	Oxidation	Surface oxidation has discolored the material
	Aluminum	5%	Pitting	Pitting more prevalent on the posts
	Galfan	80%	Oxidation	White oxidation of the zinc/AL coating
	Aluminized Steel	20%	Oxidation	White oxidation of the zinc/AL coating 95% white corrosion on Galv. Hardware

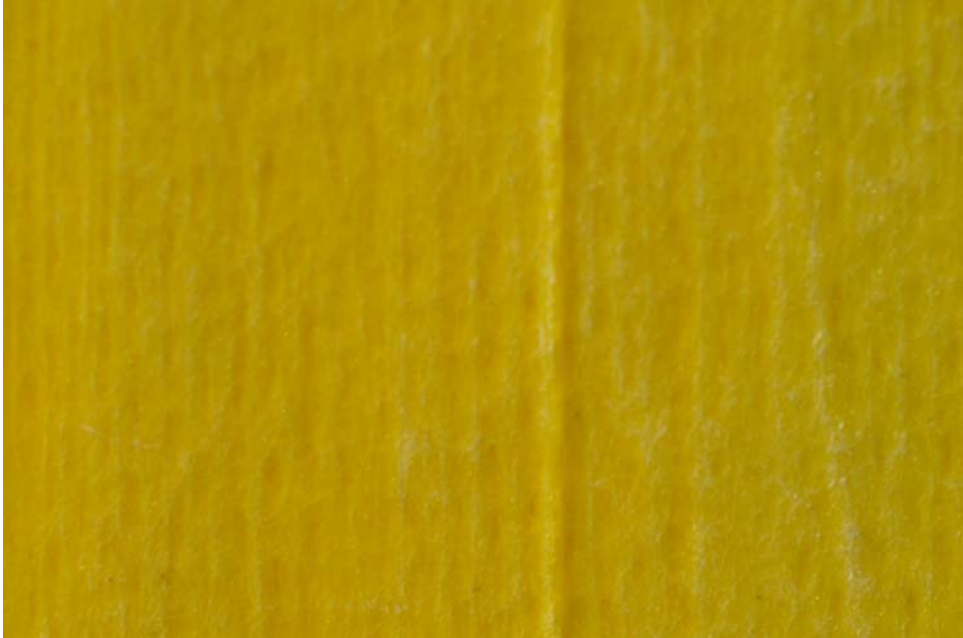
Figure B117. FRP Railing Coupon

Fuse Bonded PVC Coated Galvanized	<5%	Rust	Minor rust has begun to form around cut ends and damaged areas
Railing Coupons				
	Stainless Steel	80%	Oxidation	Surface oxidation has discolored the material.
	Aluminum	<5%	Pitting	Pitting has begun in areas where the anodize may have been damaged
	Coated Steel	20%	Rust	Rust has begun to form where the coating has failed. Discoloring of the coating due to the rust.
	FRP	25%	UV	Discoloring due to UV exposure on the face of the railing that faces the sun
Fabricated Railing				
	Stainless Steel	50%	Oxidation	Surface oxidation has discolored the material. T-fittings show 90% surface corrosion likely due to lack of passivation.
	Aluminum	<5%	Pitting	Pitting has begun in areas where the anodize may have been damaged
	Coated Steel	20%	Rust	Rusting areas have spread larger causing blistering under the coating.
	FRP	25%	UV	Discoloring due to UV exposure on the face of the railing that faces the sun

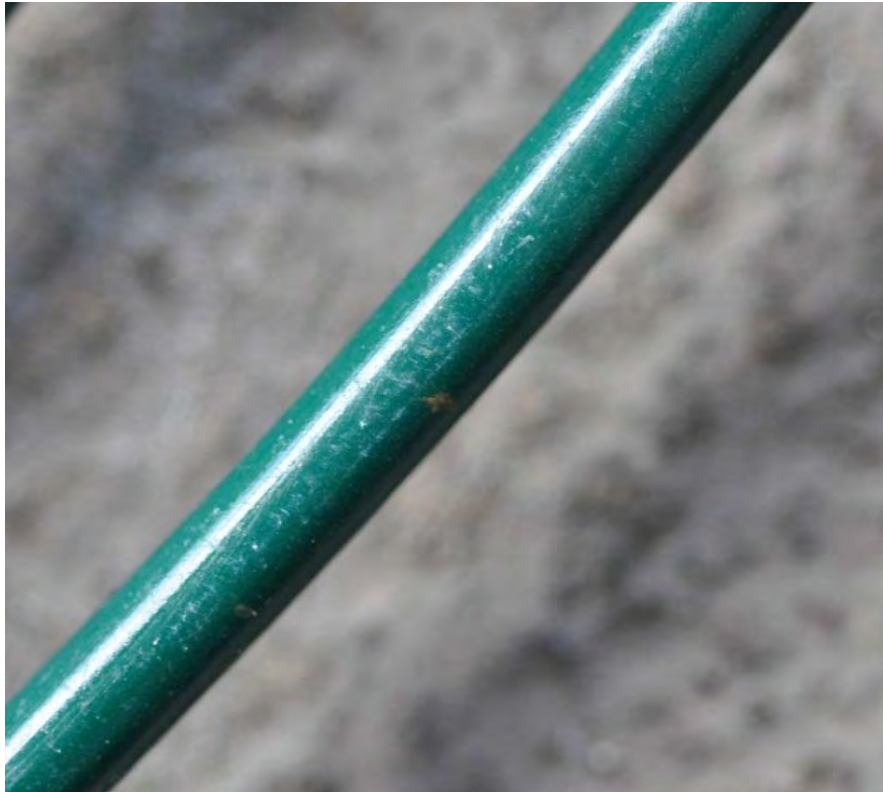
Figure B125. Standard PVC Coated Galvanized Wire Coupon

Material	% of Surface Corroded	Type of Corrosion	Notes
Fence Wire Coupons				
	Standard PVC Coated Galvanized	0%	N/A	No visible corrosion
	Fuse Bonded PVC Coated Galvanized	0%	N/A	No visible corrosion
	Standard Galvanized	50%	Oxidation/ Rust	50% of the corrosion areas have degraded past the sacrificial zinc coating and have begun to rust.
	Stainless Steel	100%	Oxidation	Surface oxidation
	Aluminum	5%	Pitting	Minor pitting
	Galfan	75%	Oxidation/ Rust	50% of the corrosion areas have degraded past the sacrificial zinc coating and have begun to rust.
	Aluminized Steel	<5%	Oxidation	White oxidation of the zinc/AL coating
Fabricated Fencing				
	Stainless Steel	100%	Oxidation	Surface oxidation has discolored the material
	Aluminum	5%	Pitting	Pitting more prevalent on the posts
	Galfan	50%	Oxidation	White oxidation of the zinc/AL coating
	Aluminized Steel	20%	Oxidation	White oxidation of the zinc/AL coating 95% white corrosion on Galv. Hardware

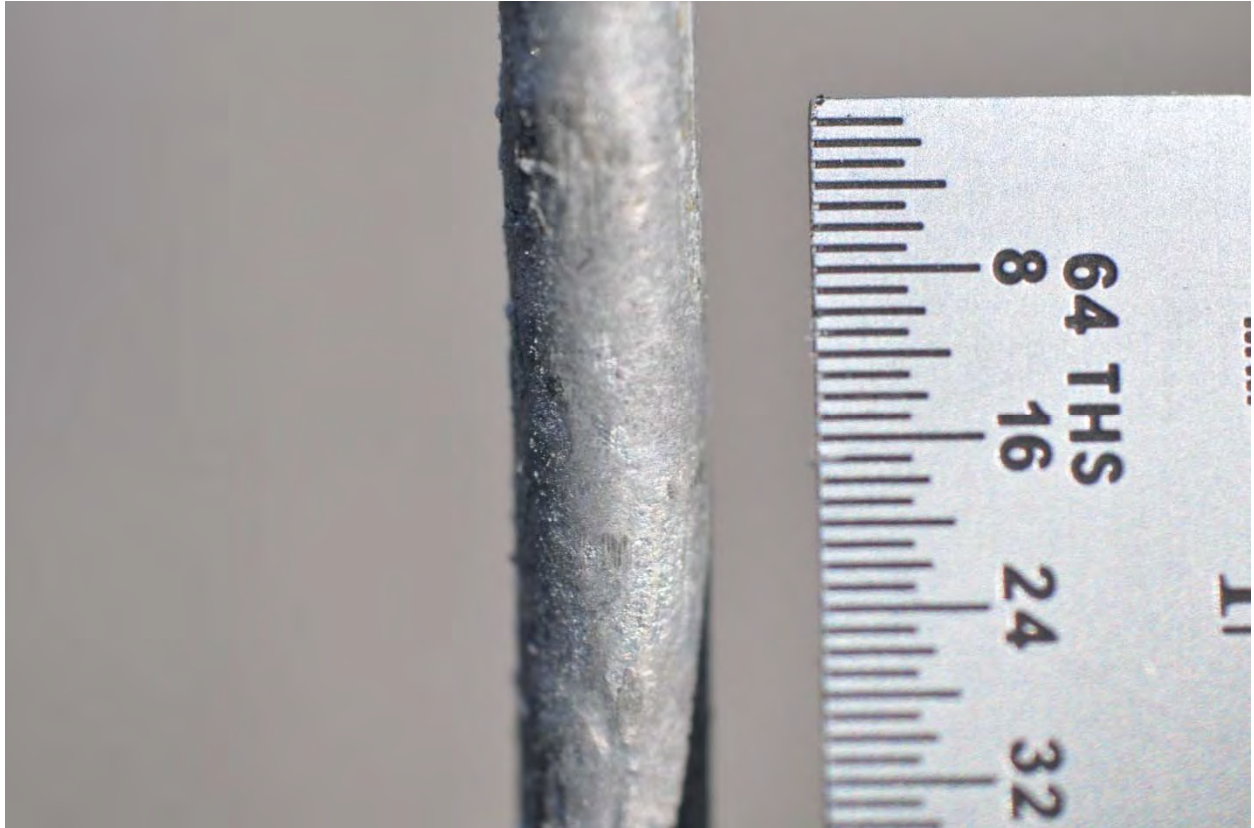
Figure B166. Aluminized Steel Wire Coupon

Each wire coupon had visible deposit of chlorides from the salt water environment.
