# FIELD FORTIFICATIONS TEST EXERCISE DESERT ROCK VI

## Project 8-12-75-001

2 November 1956

Nevada Test Site

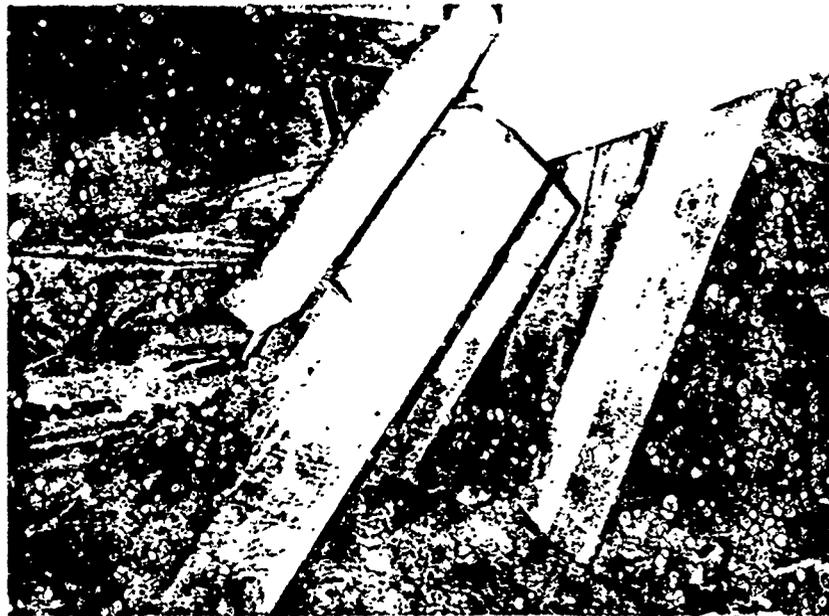
Fig. 29. A-1 structure, center span TCS (looking toward GZ).

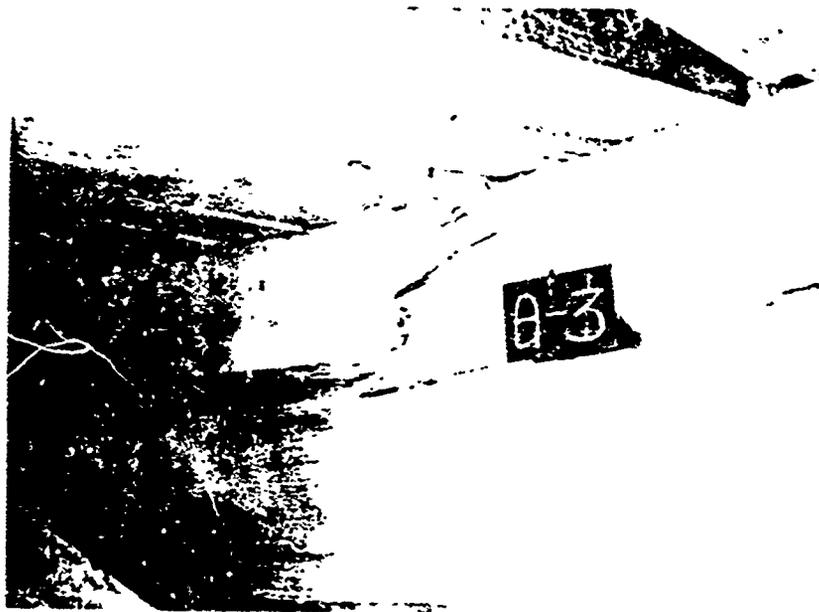
Fig. 40. A-3 structure, looking toward right entrance (GZ to left). A13239

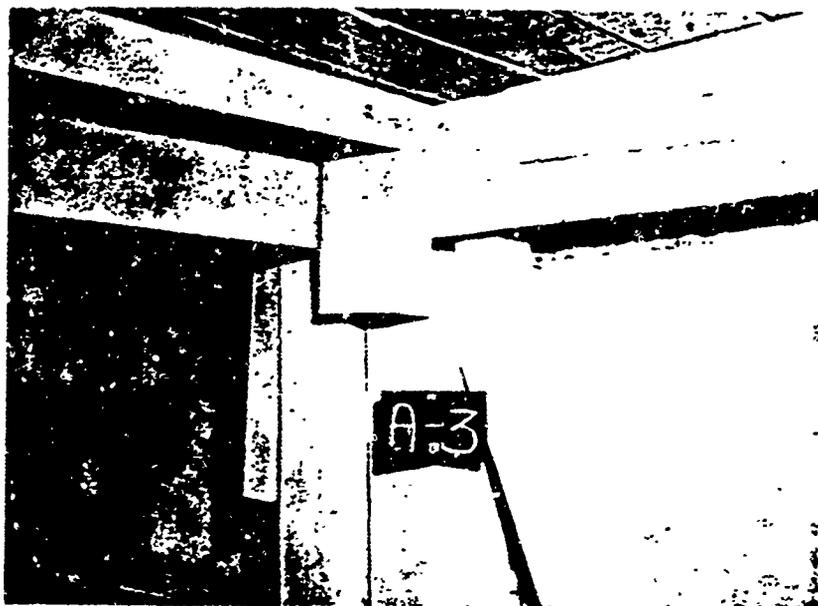
Fig. 41. A-3 structure, right front TCS cap (looking toward GZ). A13237

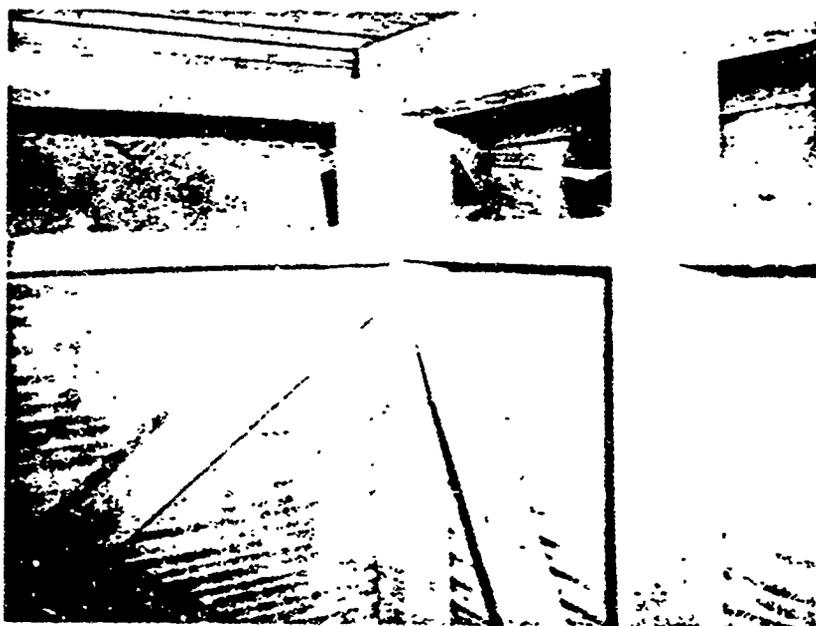
Al3238  
 Fig. 42. A-3 structure, emplacement wall right, TCS left (GZ  
 in direction of left background).

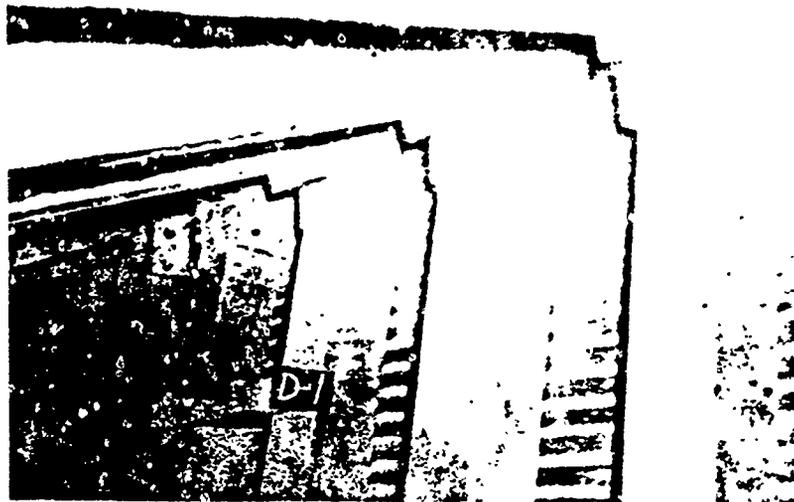
All of the 2-in. by 6-in. roofing in the entrance passages of D-1 failed (Fig. 59) except that in the outer passage at the junction of the connecting passage. At this junction, crossed, double roofing was used, and no failures occurred in either structure. The only roofing failures in D-2 were over the blast pocket at the ends of the two outer passages. Here, the roofing span was only 2 ft, 6-in. less than another span which did not fail. The 2-ft span, however, was simply supported, and the longer span was continuous through two spans of  $2\frac{1}{2}$  and 2 ft. A brief investigation of the spans revealed that the extreme fiber stress in bending, from unit loading, would be greater in the 2-ft simply supported span.

Fig. 59. Entrance passage in D-1 structure (looking toward GZ and vertical entrance shaft).

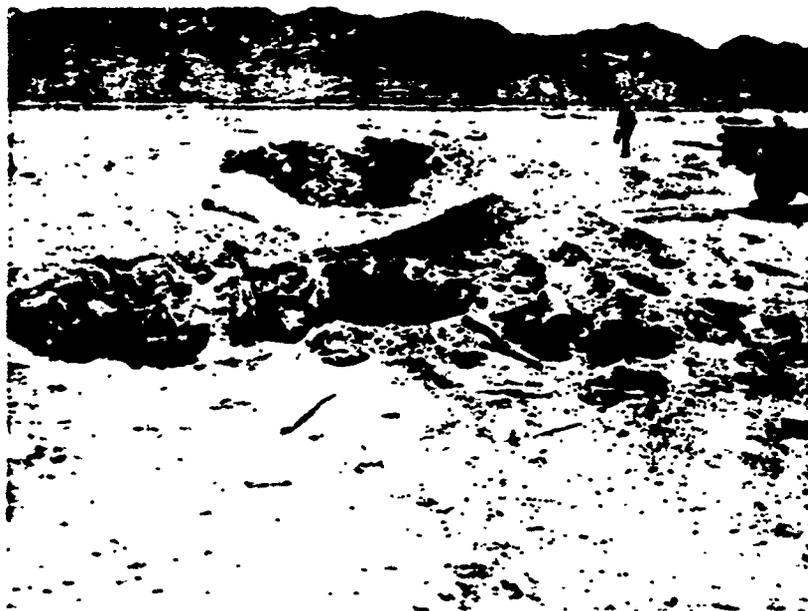
Fig. 71. F-1 structure, left entrance.

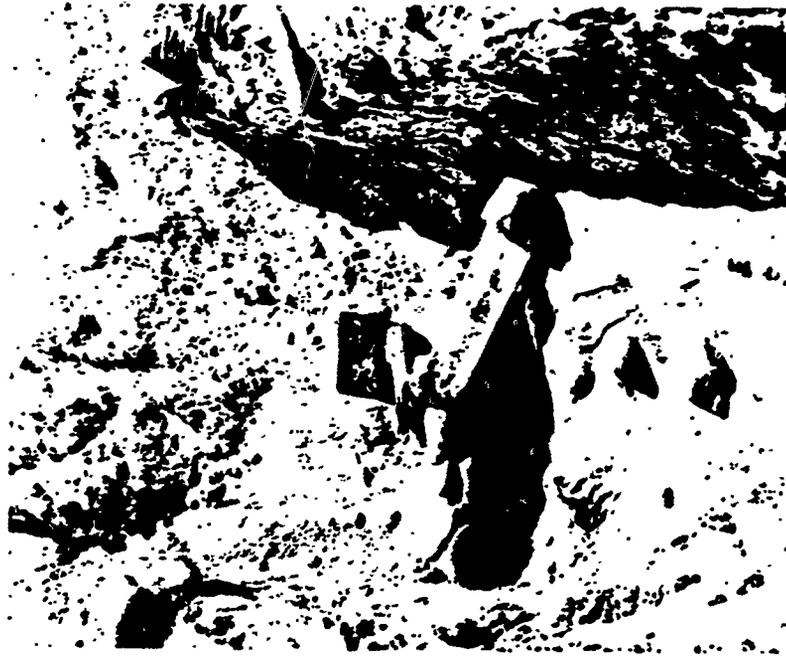
Al3339  
Fig. 74. Entrance to G-3 structure.

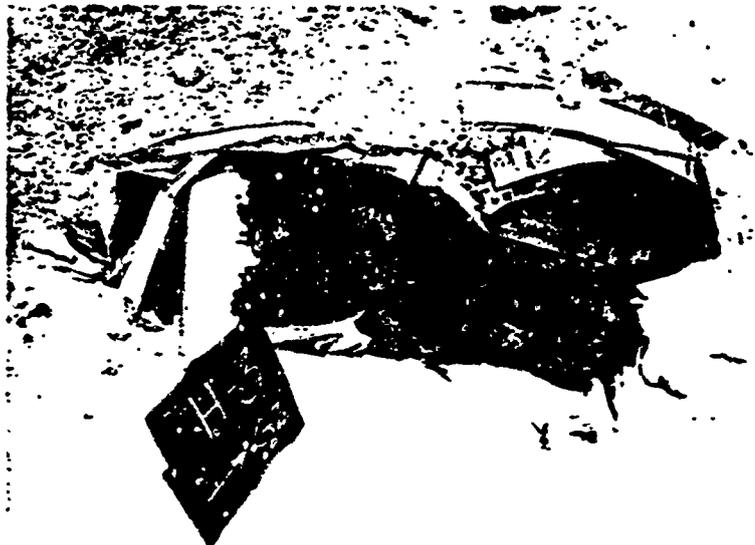
Fig. 77. H-3 structure.
